# Deck Water Spray Systems on Liquefied Gas Carriers

Sector Houston-Galveston

## Deck Water Spray Failures

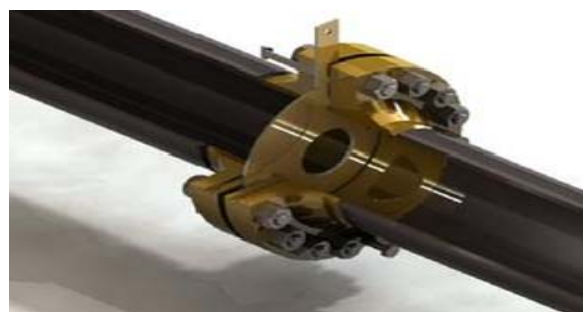
Ineffective operation of the deck water spray appears easily managed by periodic removal of the installed orifice plates & piping end caps and then flushing the debris from the system. Failure to do this allows for the rapid and substantial build up of debris behind each orifice plate. This situation, like plaque in an artery, has gone undiagnosed for decades as vessel crews endlessly poke at the clogged nozzles in futile attempts to cure a more severe and untreated issue.

Figure 4 - (above) Cutaway rendering of orifice plate installed in a pipe. Picture Credit - Omni Supply LLC.
