**TREASURY DEPARTMENT
UNITED STATES COAST GUARD**

NAVIGATION AND VESSEL INSPECTION CIRCULAR NO. 11-63

Subj: LSTs as unmanned barges; structural reinforcement and drydocking; hull inspection requirements

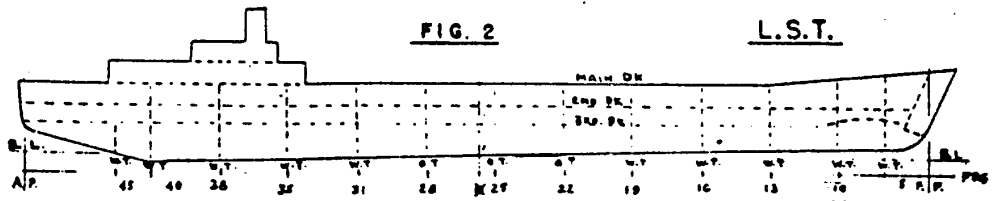
FIG. 3
ELEVATION

STRAP REINFORCEMENT OF SHELL LAPPED BUTTS, FRS. 13-35 INCL.

- (1) Existing lapped butts in shell and deck plating at Frames 13-35 inclusive shall either be reinforced by the fitting of scalloped doubler straps as shown in Fig. 3, or be modified as shown in Fig. 4. Where the reinforcement shown in Fig. 3 is used, existing welds in the lapped butts, both internal and external, must be sound with no significant localized wastage in the plating adjacent to the welds. This is especially important at the internal welds of the butts in the bottom plating (Fig. 3). Where such wastage is apparent the bottom butts shall be reworked in accordance with the method shown in Fig. 4.
