N-CFSAC

Supporting Documentation Package 1

**INVESTIGATION INTO THE CIRCUMSTANCES
SURROUNDING THE FIRE ONBOARD AND
SUBSEQUENT TOTAL CONSTRUCTIVE LOSS
OF**

**COMMERCIAL FISHING VESSEL
MISS DOLORES
(O.N. 938108)**

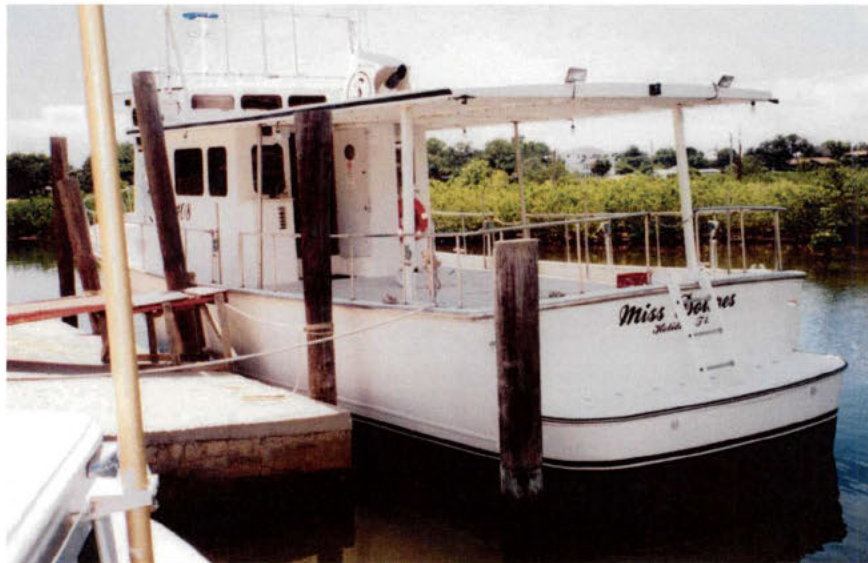
Photograph of the MISS DOLORES after construction in 1992.

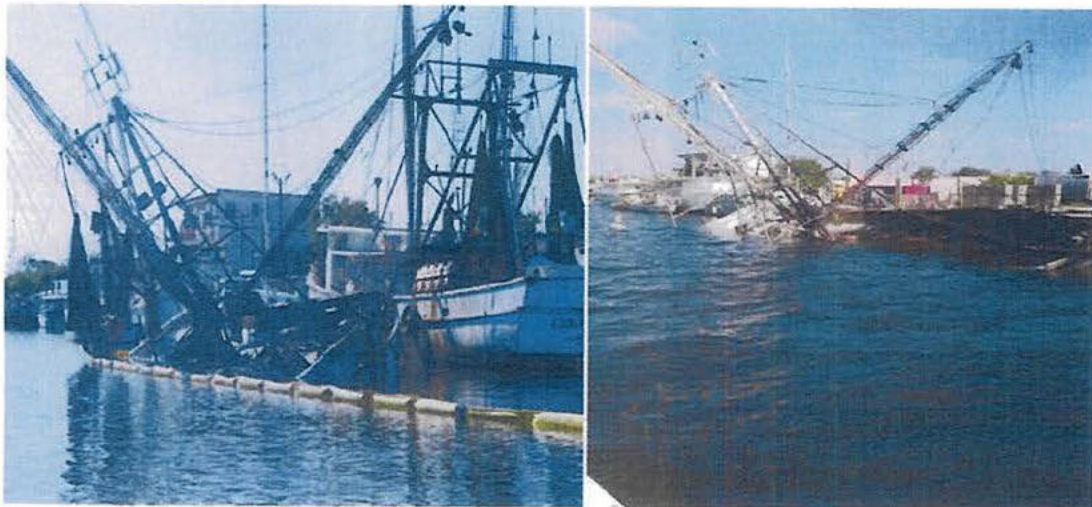
- f. Witnesses located across the river, approximately 100 feet away, reported hearing the vessel generator sounding like it was "running away" or running at high rpms. They also report seeing smoke, then later flames coming from the aft superstructure of the SKYE MARIE.
- g. The fire quickly spread from amidships into the forward cabin and eventually engulfed the entire boat except for the aft deck. The fire burned uncontrollably for approximately two and a half hours, burning the forward three quarters of the boat to the waterline.
- h. No one was on the vessel when the fire started.
- i. The vessel had no shore tie at the time of the fire.
- j. Tarpon Springs Fire/Rescue was unable to determine a source of the fire.
- k. The vessel sank in approximately 11 feet deep canal in the Anclote River near F & Y Fueling in Tarpon Springs, Florida.

- a. All electrical wiring and installations on the vessel were performed by the Mr. [REDACTED]. When completing the wiring he stated he never used any type of electrical code or manual as guidance for installing wiring or panels.
- b. Mr. [REDACTED] left the vessel with the generator running and electrical system charged. A common practice within the fishing vessel community.
