N-CFSAC

Supporting Documentation Package 3

REPORT OF INVESTIGATION
INTO THE
COMMERCIAL FISHING VESSEL (CFV)

COASTAL REIGN Capsizing & Loss of Life

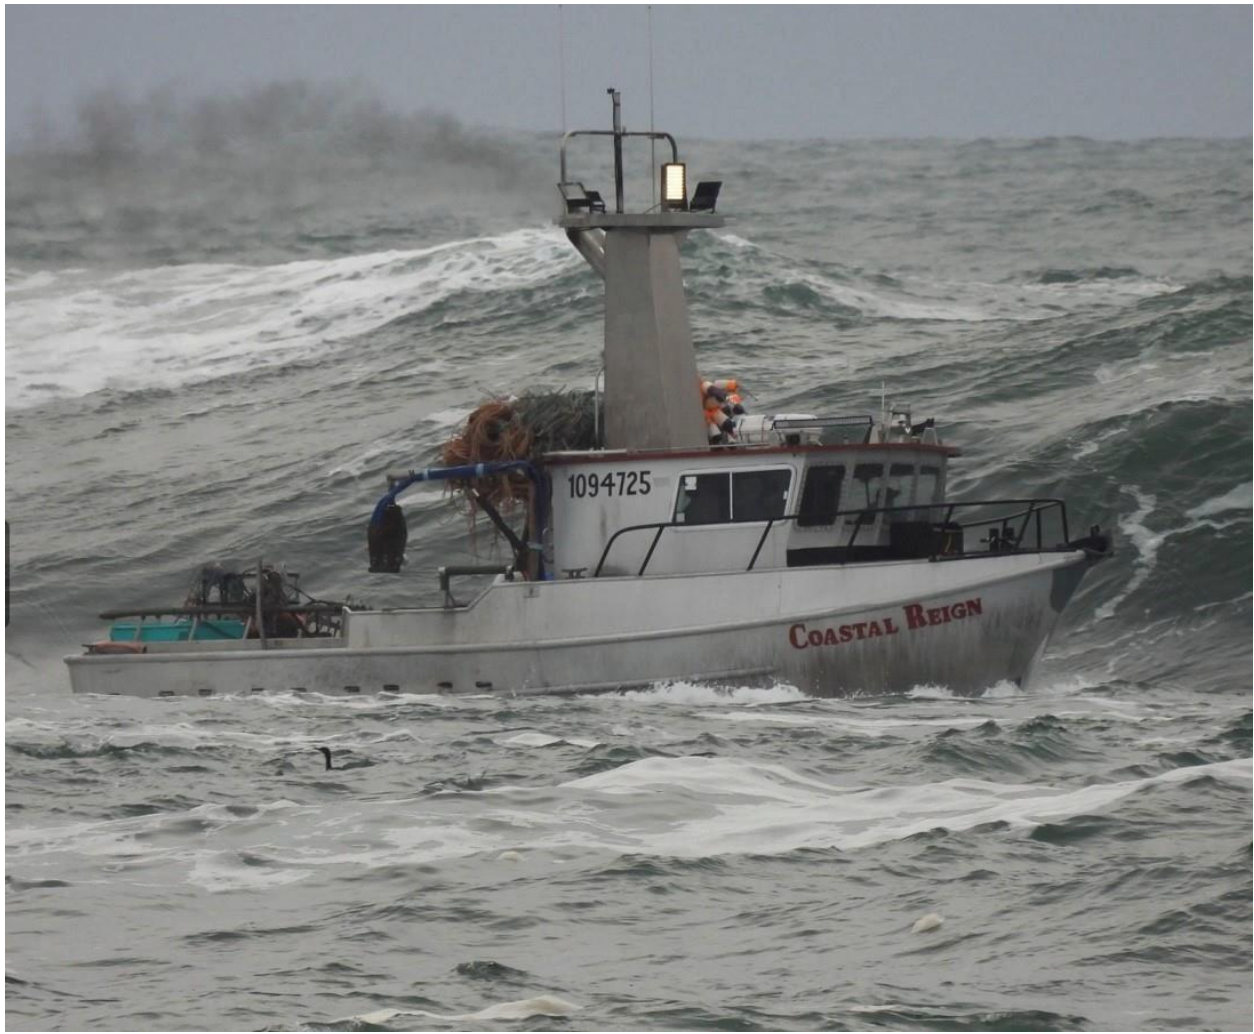
Photograph of COASTAL REIGN underway near Tillamook Bay Bar, Garibaldi, OR, February 20, 2021

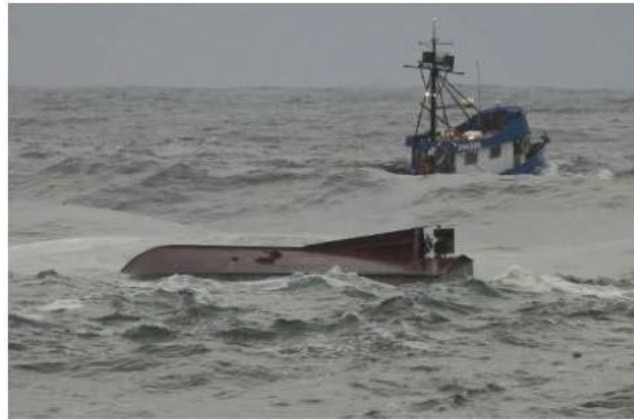
4.3.2 Post casualty photos of the hull revealed no visible defect or holes to indicate a grounding. The rudder of the vessel was standard, though small, and unable to effect quick turns in rougher water.

Photo of the COASTAL REIGN capsized at the end of the submerged South Jetty. 20 Feb 2021

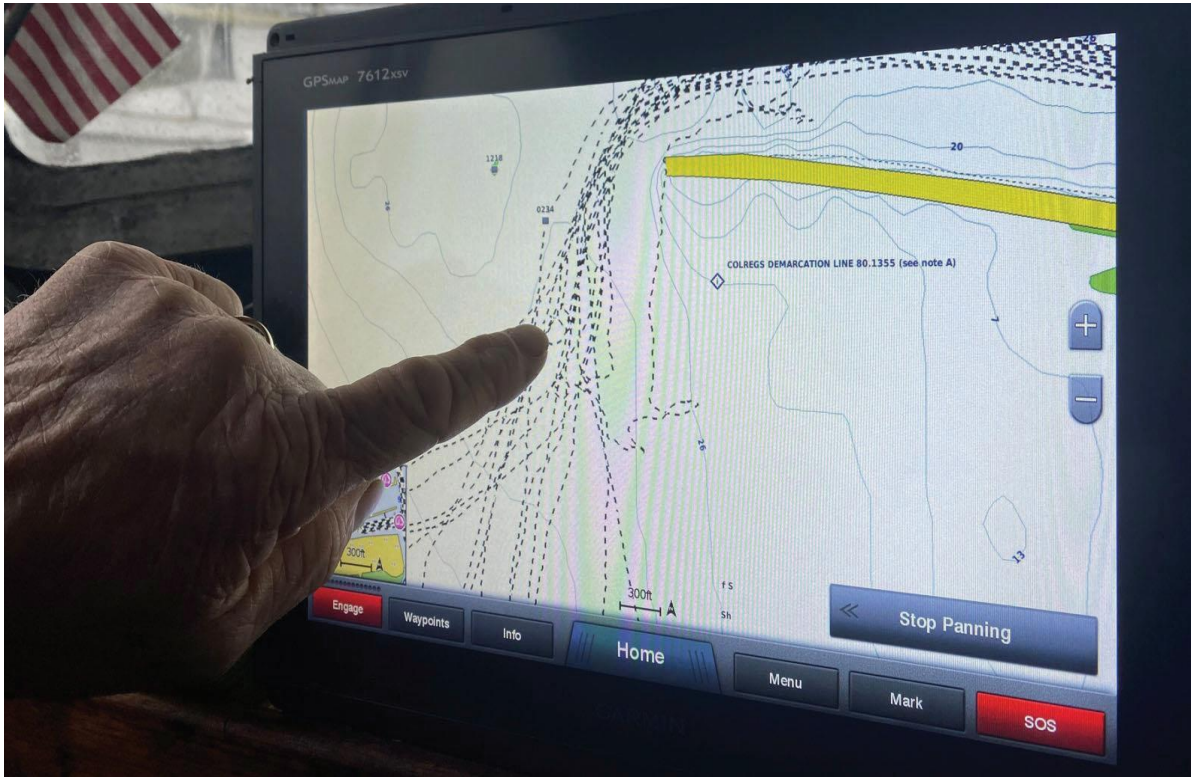
Photo of the CFV LADY LEE track lines through the South Hole. Note: chart shows full extent of the south jetty to the 'as built' length. The submerged area of the jetty colored solid as if fully configured. The electronic chart with the full length of the jetty highlighted would ensure that vessels maintain a safe distance from the submerged portion of the structure. Here, [REDACTED] is pointing to the exact location where the CFV LADY LEE set up for its approach.

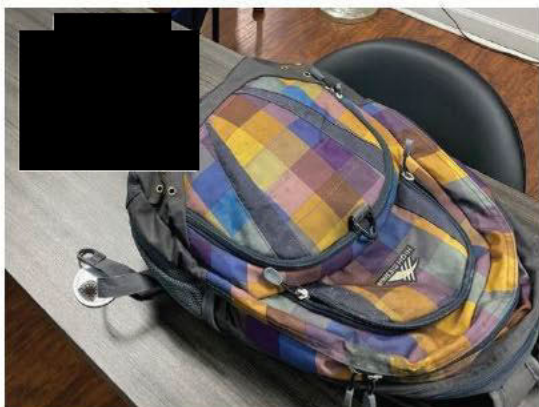
Left: Backpack found on the beach with the CFV COASTAL REIGN wreckage. Confirmed to be Mr. Zach Zappone's property. Note: plastic bag and glass jar containing green leafy organic material.

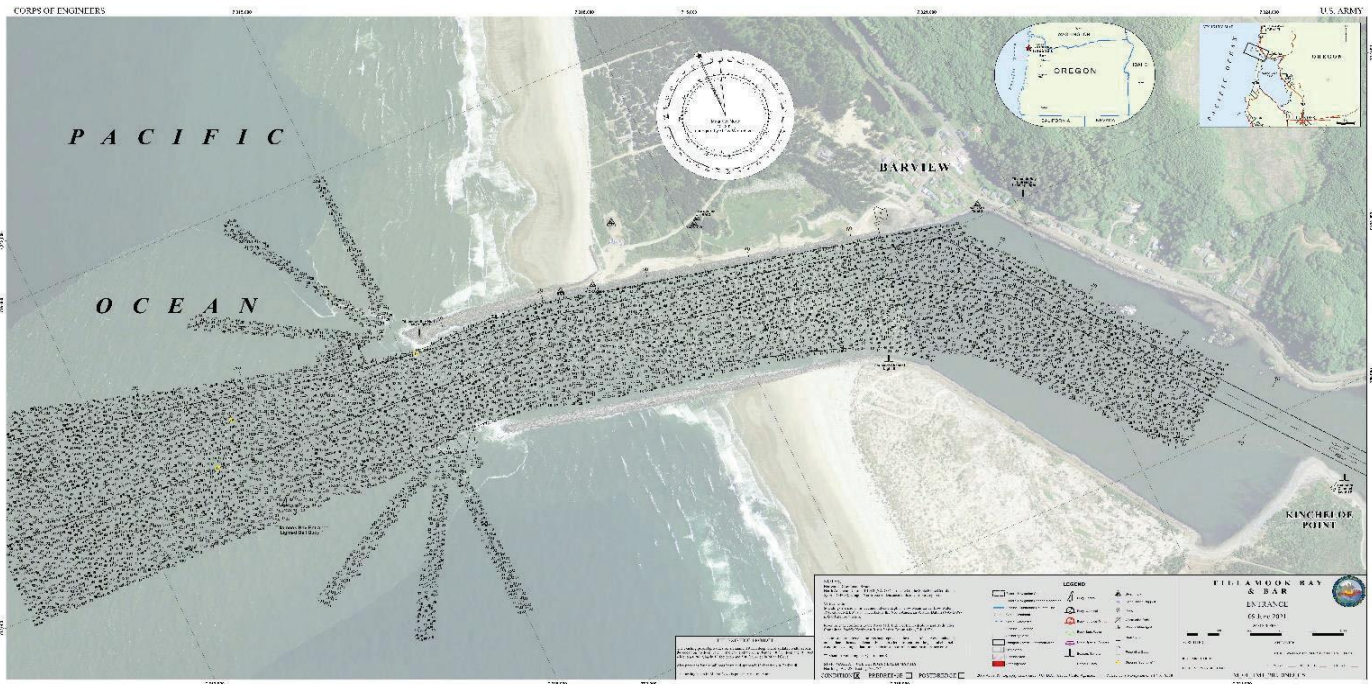
4.7.1.7 An overview photo, below, from June 2019, shows the Tillamook Channel and Bar area along with the North and South Jetties. Detailed depth data of the area shows the extent of South Jetty’s recession as no depths are identified over the submerged area of the jetty extending past the visible rocks of the structure. On this map, the area extending west of the visible portion of South Jetty measures approximately 600 feet. However, a USACE study in 2021 officially measured the submerged area as 1100 feet, a 41-foot increase since their last official study in 2014.

ACOE Aerial photo of area above, with current depth data, June 2019.

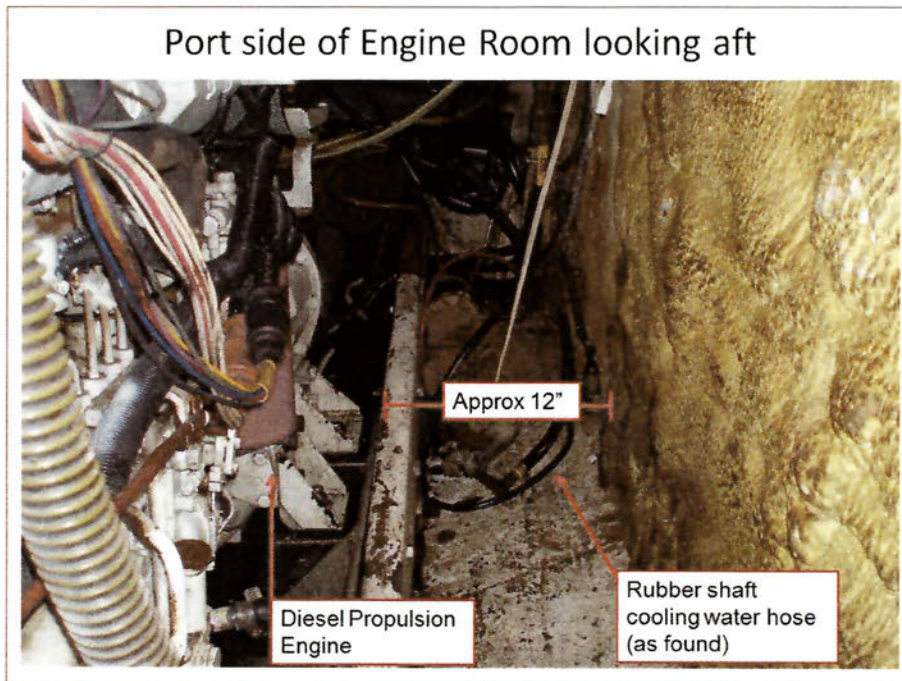
Figure 2: outboard side of main engine

a. The CFV CURRENT’s engine room consists of a single engine with a reduction gear. Attached to the reduction gear is a coupling that the propeller shaft connects to. The shaft transits the engine room aft bulkhead through a dripless shaft seal to prevent water intrusion into the engine room. The shaft seal is designed to allow water to travel through a stern tube which lubricates and cools the shaft seal. Directly above the shaft seal is the diesel generator. To access the generator or the propulsion shaft area crewmembers must walk around a narrow alleyway around the main engine, as shown in Figure 2.

b. *Environmental Conditions:* The incident occurred in a dark and cramped location in the engine room. The space was hot and noisy as well. The seas were approximately 6 to 8 feet. (See figures 2 and 3)

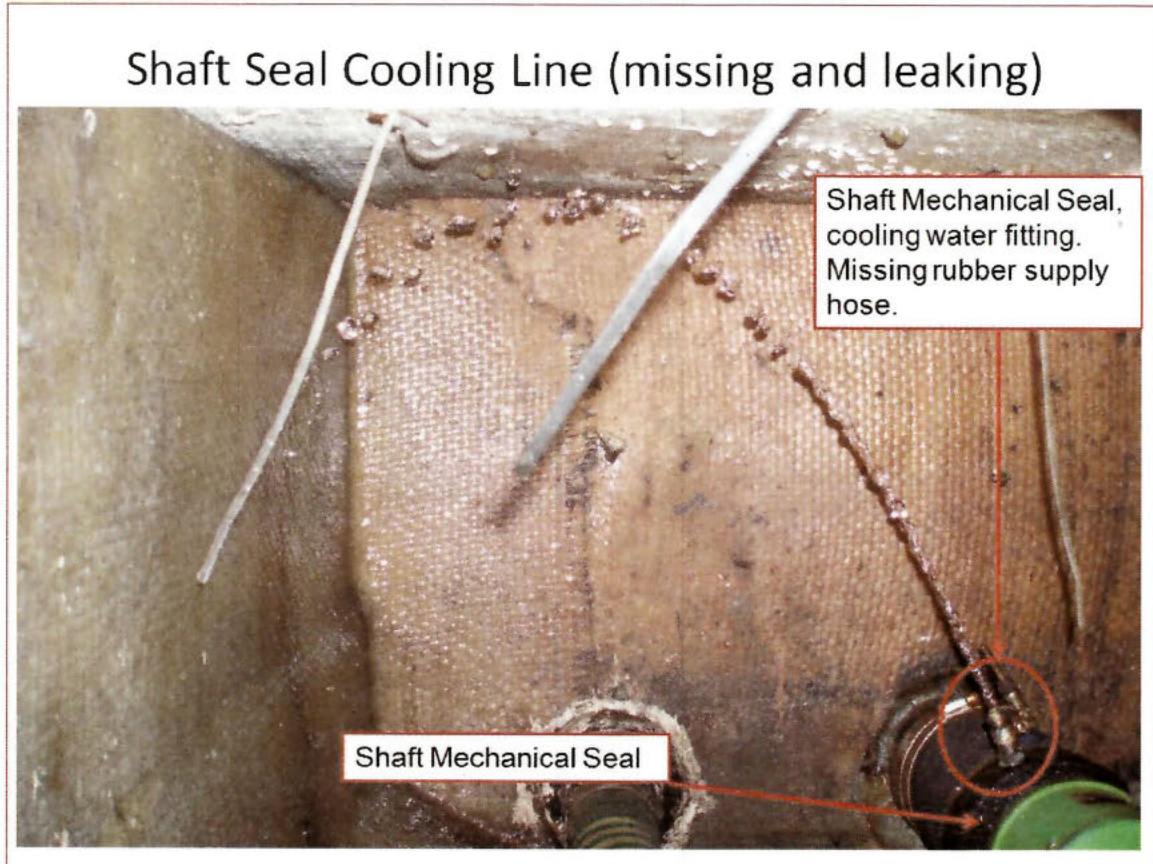
j. Approximately six or seven minutes later, Mr. [REDACTED] went to check on Mr. Rollins' progress. He found Mr. Rollins unconscious lying over the top of the propeller shaft with his sweatshirt tangled in the shaft with the shaft still turning.

k. Mr. [REDACTED] shut the engine down and yelled for help. Mr. [REDACTED] (deckhand 2) came into the engine room to assist Mr. [REDACTED] in removing Mr. Rollins from the engine room. The engine room compartment is very close quarters, dark, hot, and slippery due to residual oil on the deck.

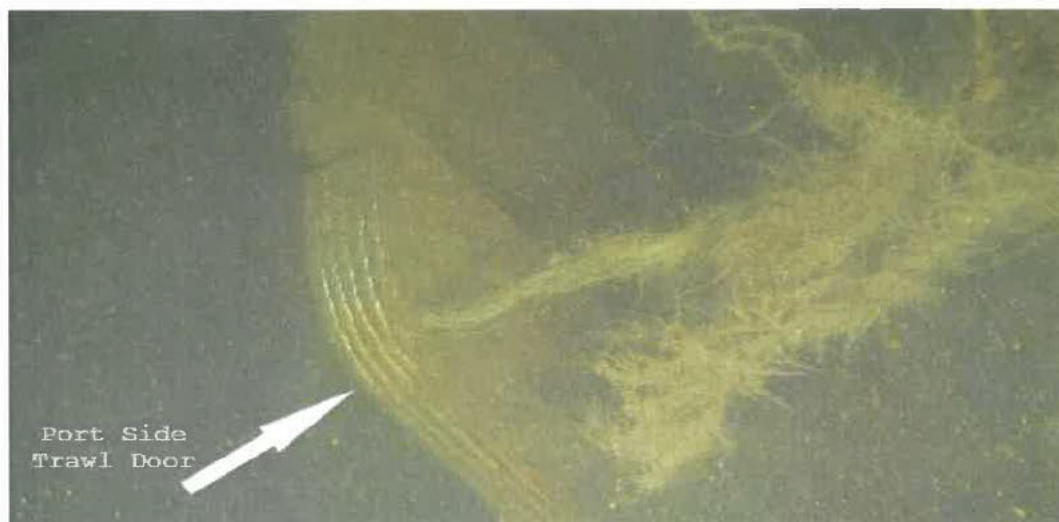
4.11.9. At 2200, the port quarter of the EMMY ROSE was visually located. As the ROV surveyed the port side of the vessel it was noted that the port side trawl door was out of place.

Figure 48: Port side trawl door of the EMMY ROSE. Image courtesy of WHOI, 2021.

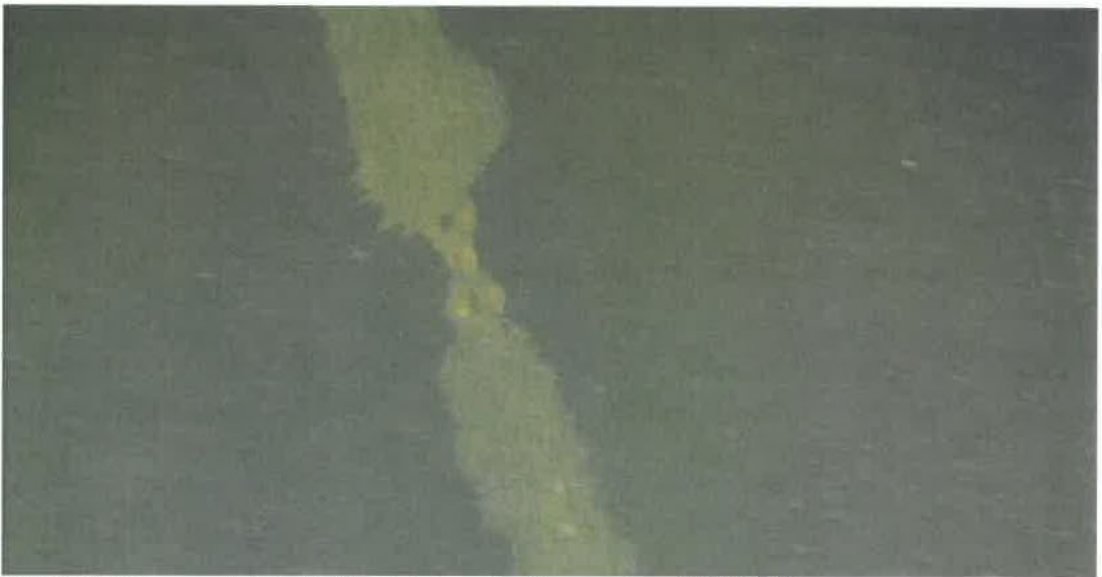
4.11.18. An inspection was completed on the port side outrigger; the port outrigger stay, turnbuckle, and paravanes chain, were all identified and appeared to be free of damage. The port paravanes chain went straight down to the sea floor. At approximately 2030, the survey was complete and dive operations were terminated.

Figure 66: Port paravanes chain leading directly to the seafloor. Image courtesy of WHOI, 2021.

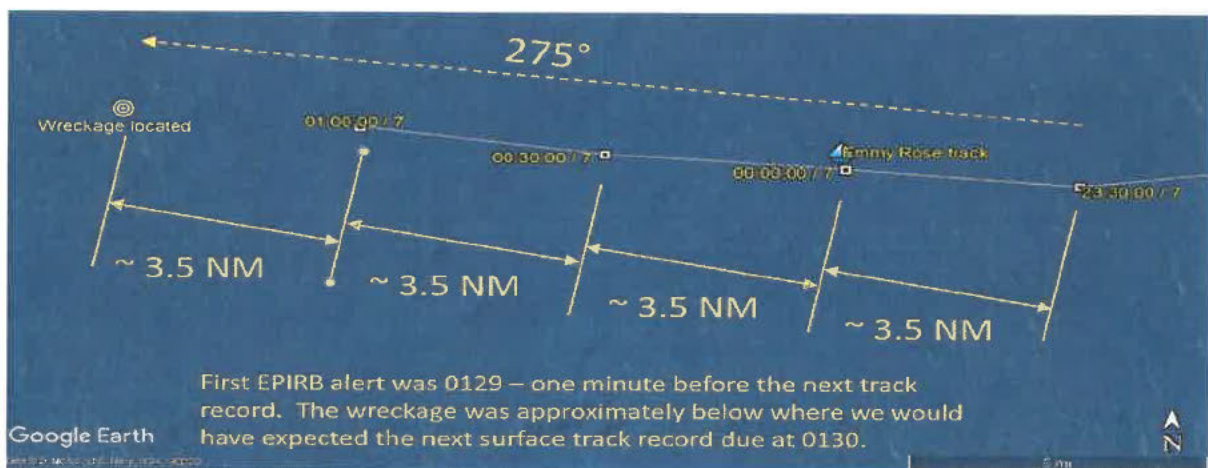
At 0100 on November 23, 2020, the EMMY ROSE was identified on VMS to be in position $42^{\circ} 18' 53.1''$ N, $069^{\circ} 33' 7.14''$ W on a course of 277° at 7 knots. The vessel was located on the seafloor in position $42^{\circ} 19' 8.106''$ N, $069^{\circ} 37' 50.766''$ W. The EMMY ROSE's resting position was approximately 3.5 NM at a 275° course from its last known position. This position indicates that the EMMY ROSE would have maintained a speed of 7 knots at a course of about 275° - 277° until approximately 0129.

Figure 70: EMMY ROSE track line relative to vessel location on seafloor. Courtesy of NTSB, 2021.

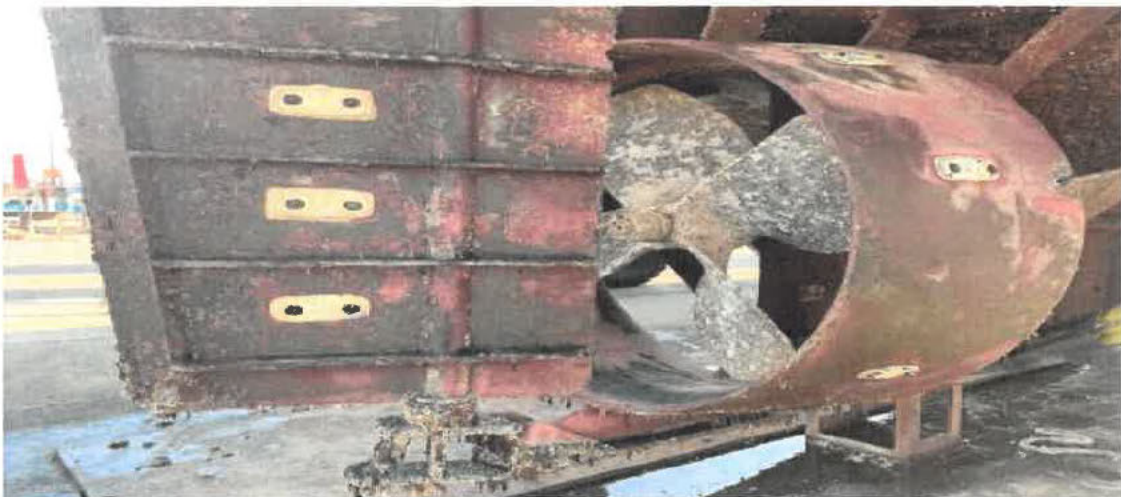
It is unlikely that water intrusion from a through hull fitting caused the vessel to sink within the known timeline of 30 minutes. To cause a rapid catastrophic flooding situation, the rudder post in the lazarette and the propeller shaft located in the fish hold would need to have fallen completely off. Given the location of the EMMY ROSE on the sea floor, it has been determined that the vessel never lost propulsion or steerage as it maintained the same course and speed for approximately 6.5 hours before sinking. Furthermore, the skeg hung design of the propulsion gear protects the rudder and propulsion shaft from inadvertently falling out of the vessel. Thus, making rapid catastrophic flooding through a hull fitting very unlikely.

Figure 71: Skeg hung steering and propulsion gear of the EMMY ROSE, Image courtesy of Marine Safety Consultants.

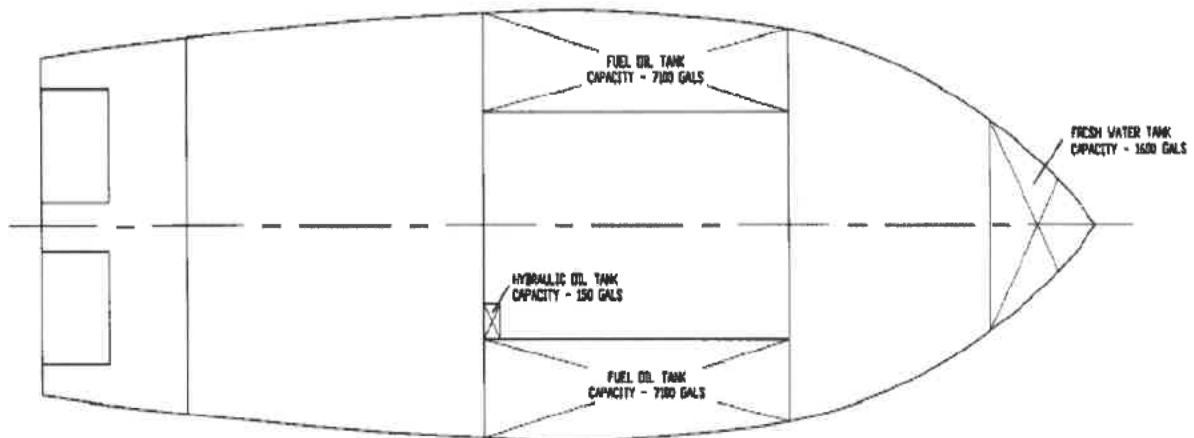
Figure 72: EMMY ROSE Fuel Tank layout. Image courtesy of Thomas M. Farrell Naval Architects, 2002.

One source of weight that had the potential to put the vessel in an unrecoverable listed condition would be an excessive internal transfer of fuel. The EMMY ROSE was equipped with two fuel tanks, which were located in the engine room and used for service to the main diesel engine and generators. Each tank was located at the outermost part of the engine room and made the port and starboard hull bulkheads. Each tank had a capacity of 7,500 gallons, were cross connected, and were both capable of providing fuel to the main engine.

Previous crewmembers stated that on two separate occasions, a transfer of fuel between the port and starboard tank caused the EMMY ROSE to list severely to starboard. These fuel transfers were unmonitored as the crewmembers who had both been asleep were awakened by a severe list in the vessels profile. Upon exiting the accommodation space to the aft deck, they witnessed the starboard side outrigger completely underwater with sea water coming over the top of the eight foot starboard bulwark rail, and the aft deck awash. On both occasions, the crewmembers went back into the accommodation space and found the Captain asleep in his bunk. Once awoken, the Captain proceeded to the engine room to transfer fuel back to the port tank, correcting the severe list.

In the two previous instances identified above, as the excessive amount of fuel was transferred transversely to the starboard tank, it negatively affected the vessels stability by shifting the vessel's center of gravity to the low (outboard) side. The EMMY ROSE laid over or "listed" about the angle of heel where the righting arm curve is zero. In this condition the vessel will not return to the upright condition due to the shift in the fuel's center of gravity, unless immediately corrected.

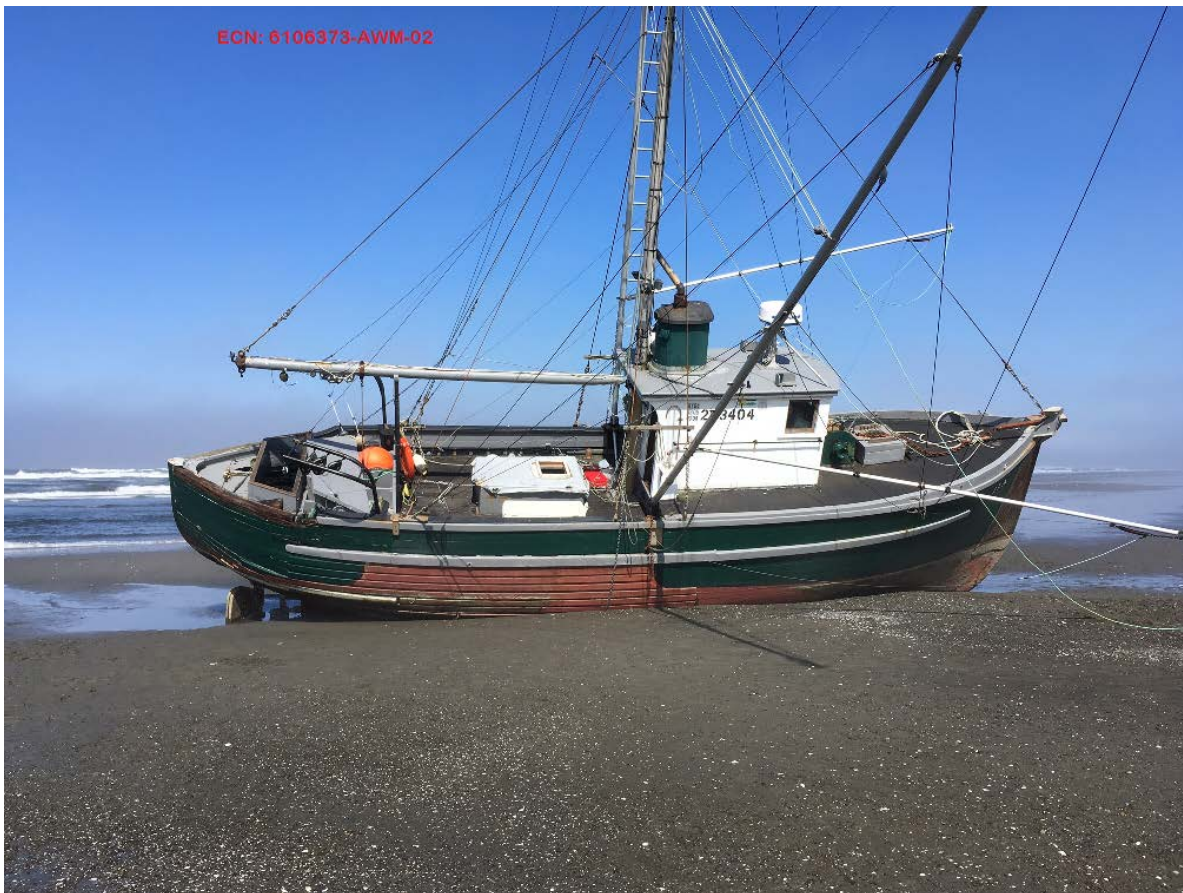
Commercial Fishing Vessel ILA Grounded on 20 August 2016

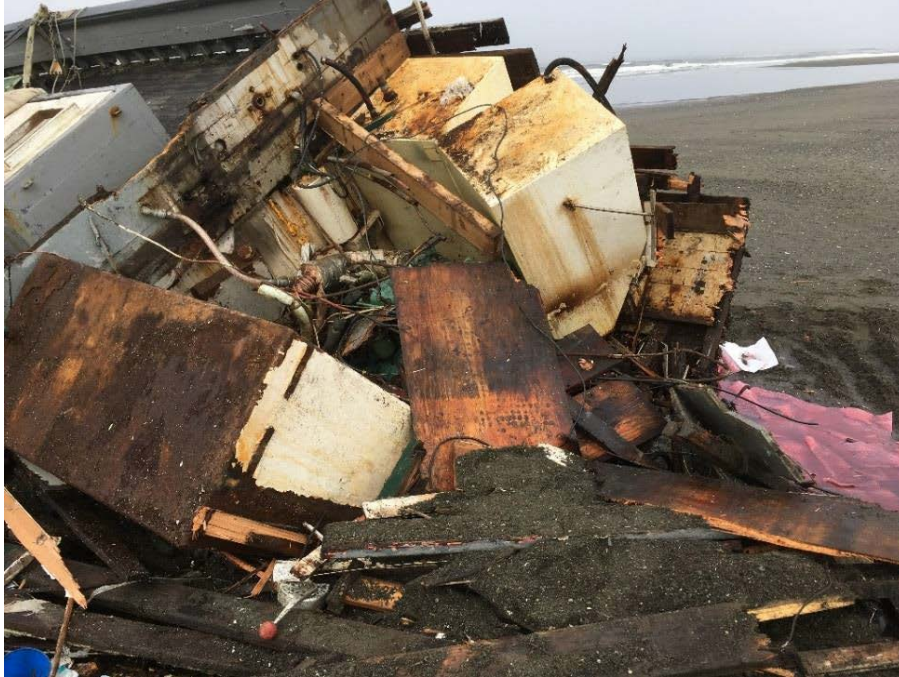
- 4.9 At approximately 1200 on 22 August 2016, Washington State Department of Natural Resources took emergency temporary custody of the vessel and hired Global Diving and Salvage to remove the wreck of the ILA from the beach. A backhoe and dump trucks were brought to the beach on August 23rd to remove the ILA which was already in pieces on the beach due to previous tidal cycles.

CFV ILA being dismantled on August 23rd.

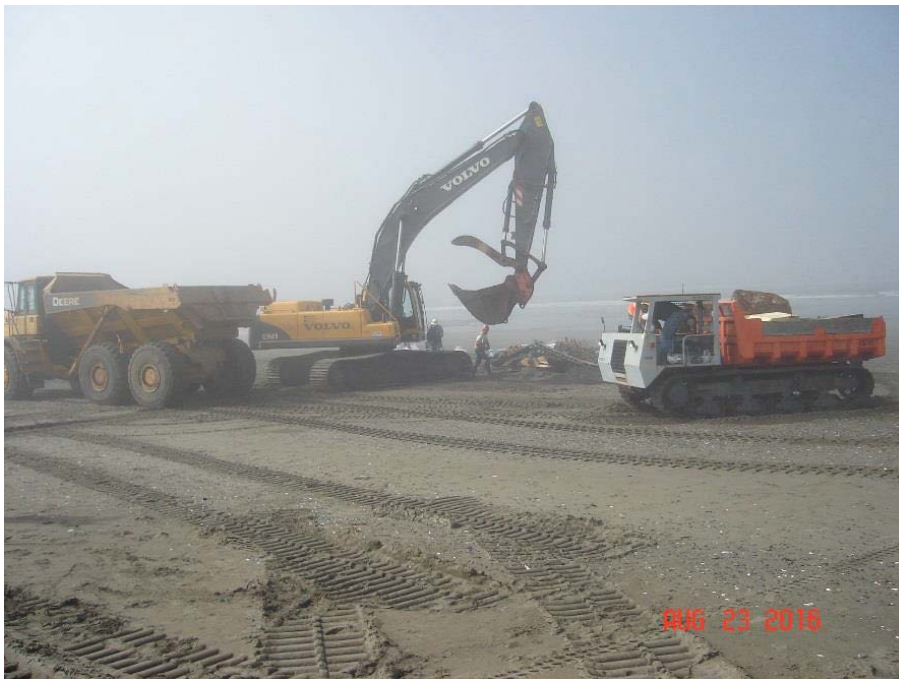
Photograph taken August 23rd, of the removal of the wrecked FV ILA.

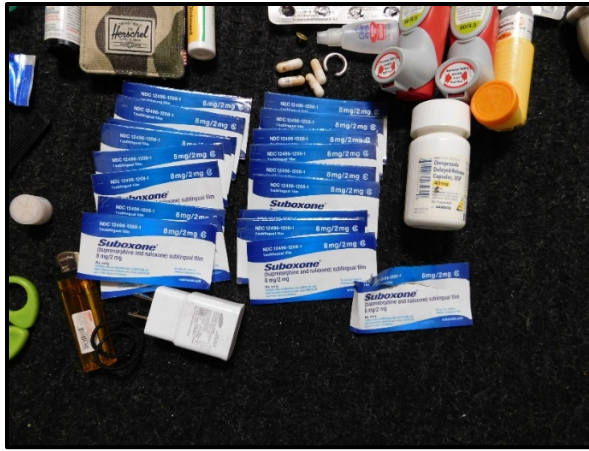
4.2.4. On April 15, 2020, the subject had 18 packets of Suboxone Film in his possession and one of them was opened.

Figure 3. Photograph provided by CG Sector Long Island Sound.

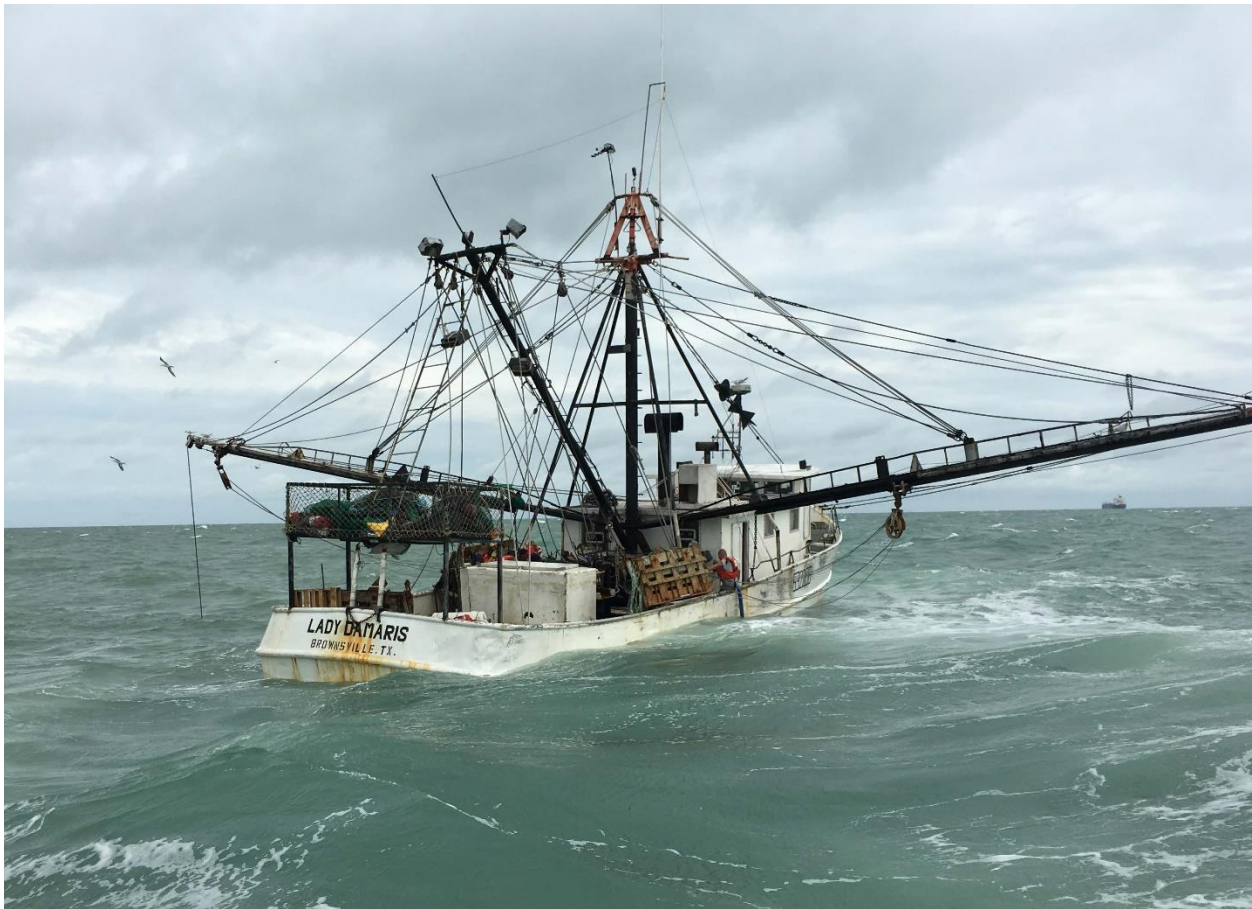
Figure 1. Photo of the LADY DAMARIS in the Gulf of Mexico on 22 June 2017

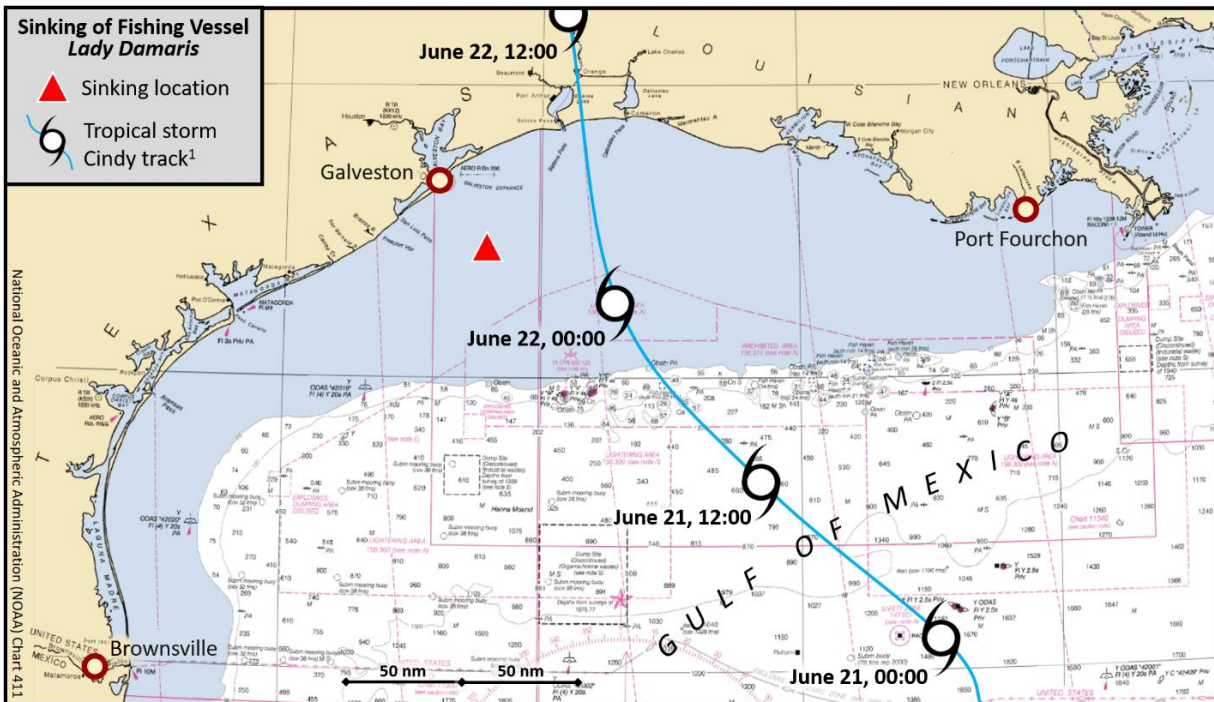
Figure 2. Depiction of Tropical Storm Cindy’s track and the sinking location of the LADY DAMARIS. NTSB graphic, used with permission.

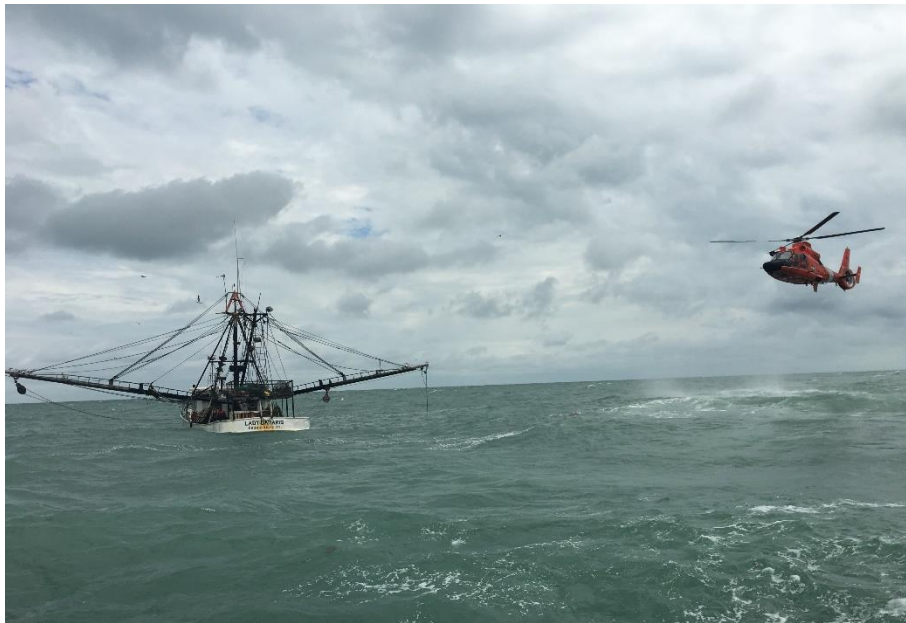
Figure 3. The LADY DAMARIS receiving assistance from CG6518 and CG45630.

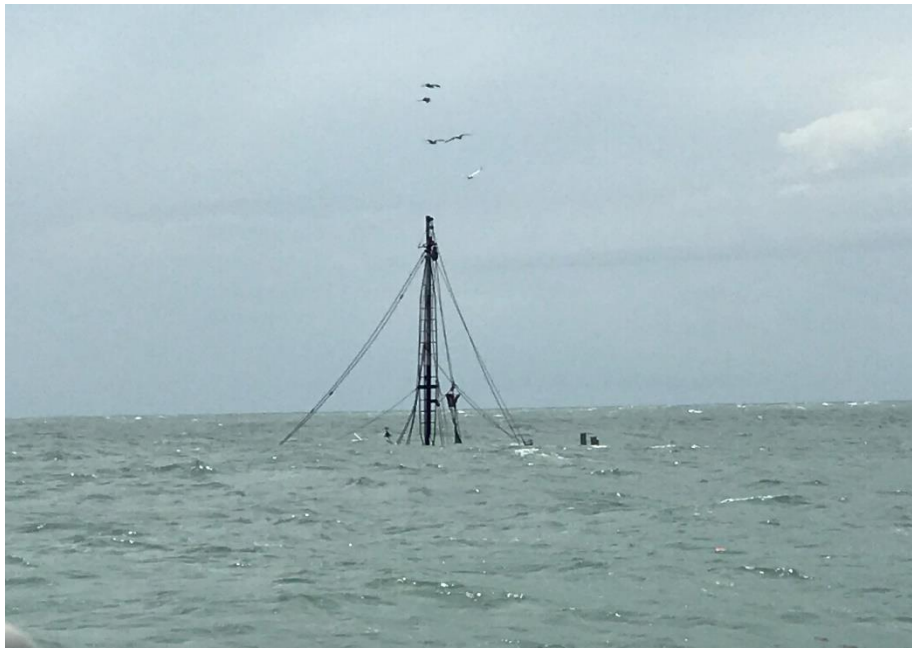
- 4.1.35 At approximately 1135, the boarding team members and the crew abandoned the LADY DAMARIS and safely embarked CG45630.
- 4.1.36 At approximately 1155, the LADY DAMARIS capsized on its starboard side.

Figure 4. The LADY DAMARIS after capsizing on the starboard side, with the port outrigger exposed above water.

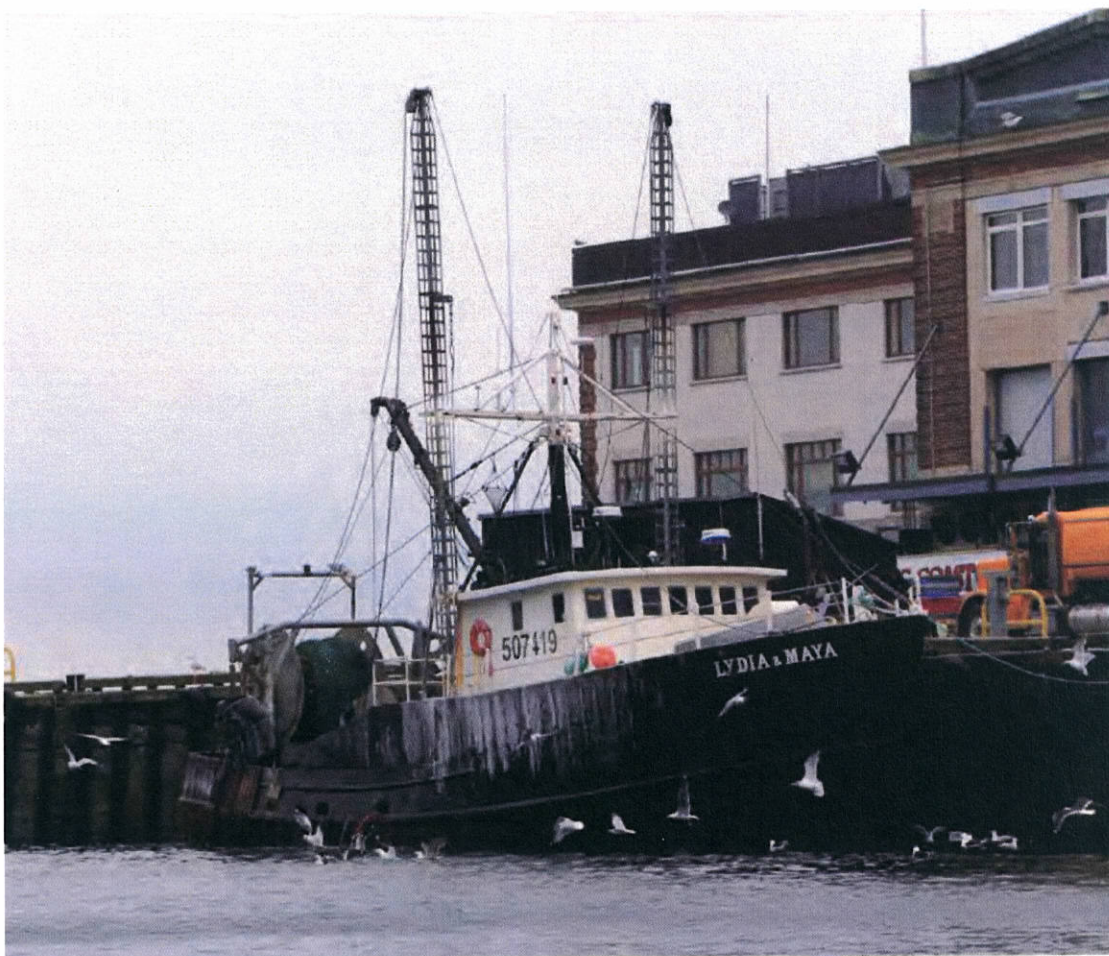
Figure 1 - F/V LYDIA & MAYA (courtesy of USCG Sector Boston)

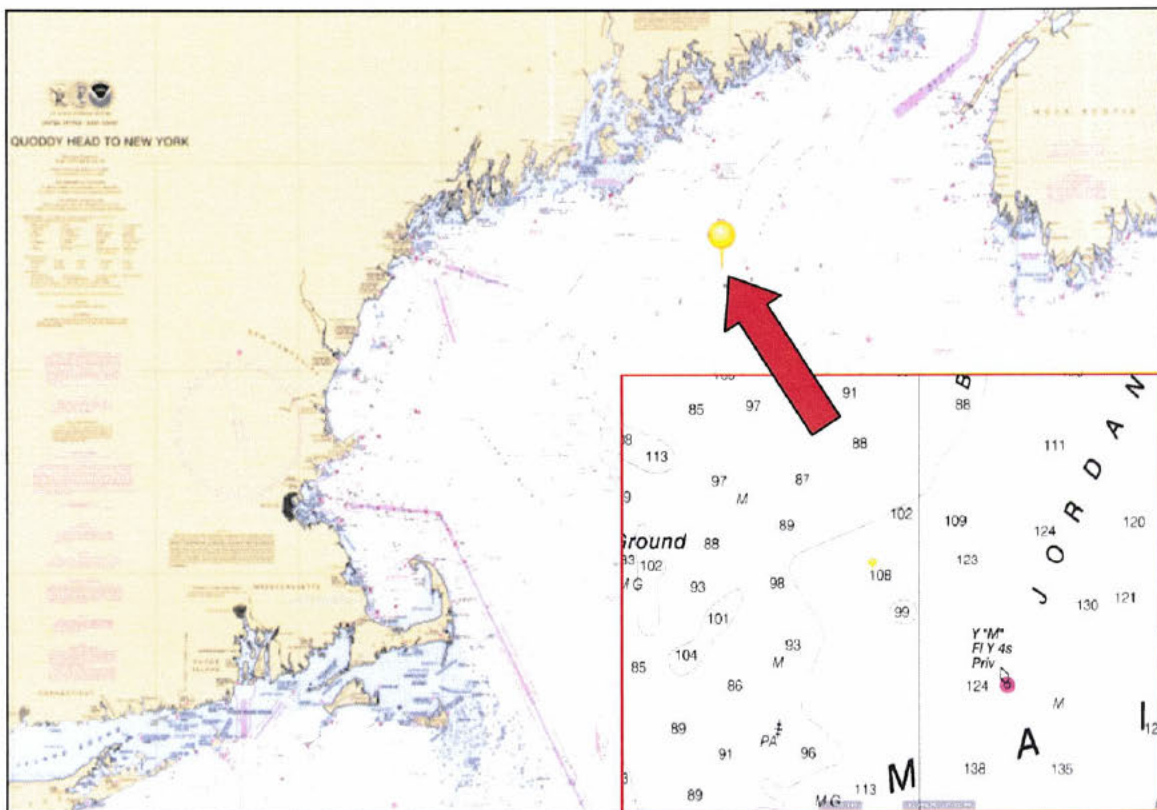
Shortly after midnight, at 12:08 a.m., Sector Northern New England watch standers reported receiving MAYDAY transmissions from the vessel LYDIA & MAYA. Upon reporting the distress signal to the Coast Guard’s Rescue Coordination Center in Boston (CGRCC), CGRCC confirmed receiving a distress alert from the Emergency Positioning Indicating Radio Beacon (EPIRB) that was registered to the vessel. Coast Guard helicopter (CGR 6026) from Air Station Cape Cod was requested and launched at 01:00 a.m. en route to the LYDIA & MAYA’s last known position, approximately forty-five nautical miles south of Southwest Harbor, Maine (*see figure 3*).

Figure 3 – Last transmitted GPS location of LYDIA & MAYA (represented by yellow pin), broadcast through the vessel’s AIS, position overlaid on NOAA Chart 13006 (West Quoddy Head to New York).

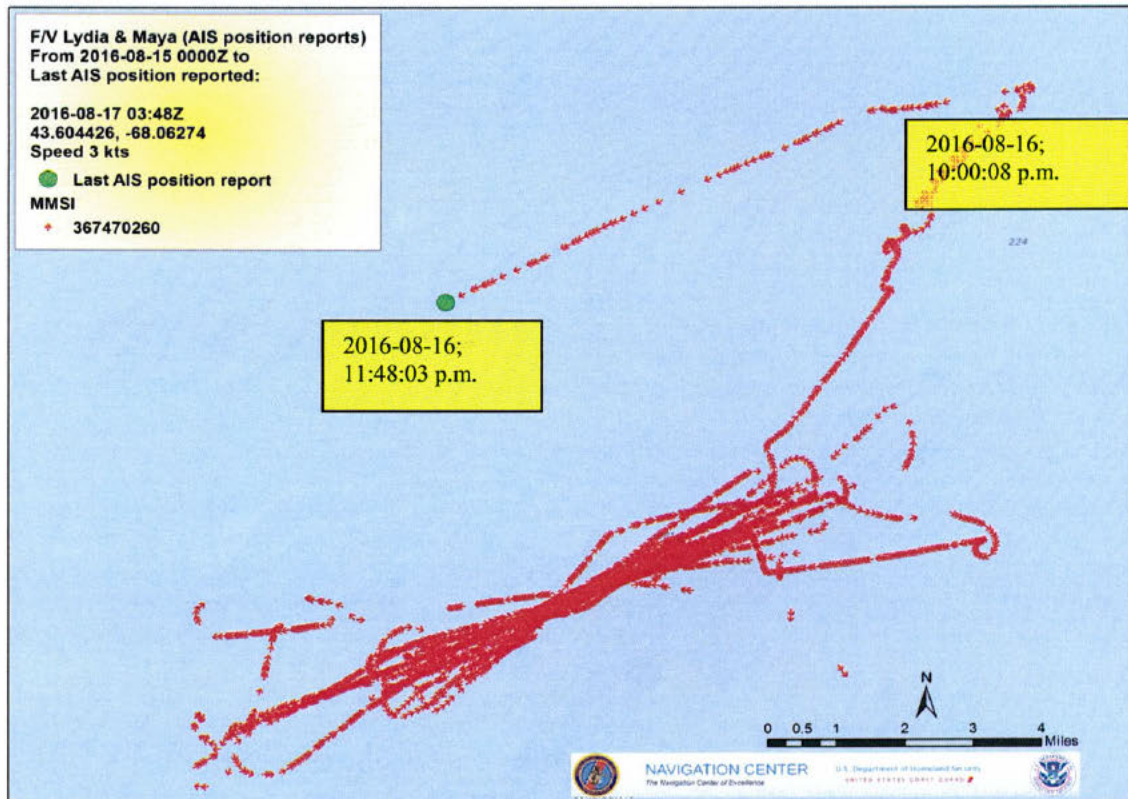
Figure 4 – Automatic Identification System (AIS) position reports of LYDIA & MAYA illustrating track lines over the last 96 hours (represented by red arrows); the LYDIA & MAYA turned back en route for Boston at 10:00 p.m. on 16 Aug 2016; the last AIS transmission received was recorded at 11:48 p.m. on 16 Aug 2016 (courtesy of USCG NAVCEN).

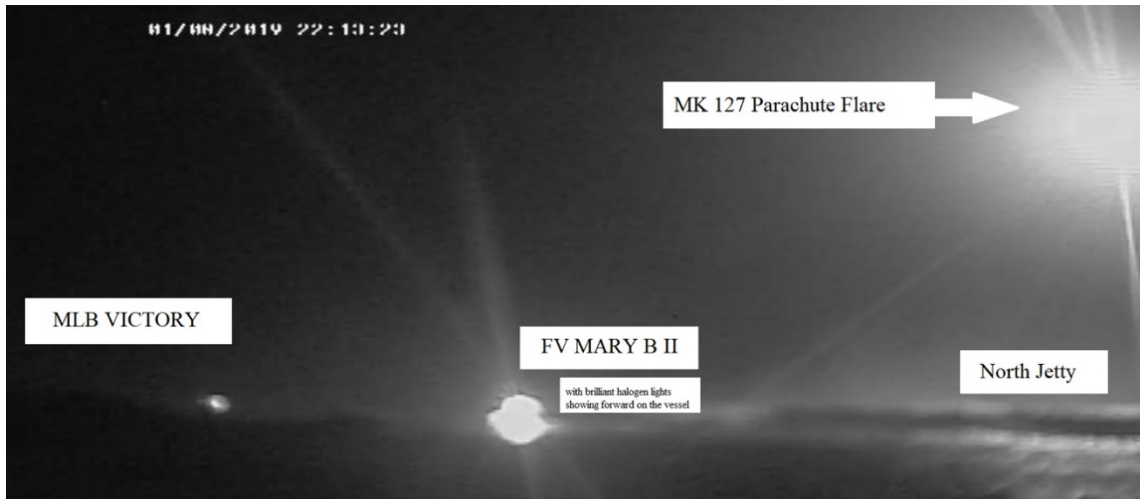
Figure 5. Screen capture from Oregon State Police closed circuit TV camera showing the illumination provided by a MK-127 parachute flare that was launched from the Coast Guard boats during the escort. (Source – Oregon State Police video, screen capture with labels from CG Exhibit 031)

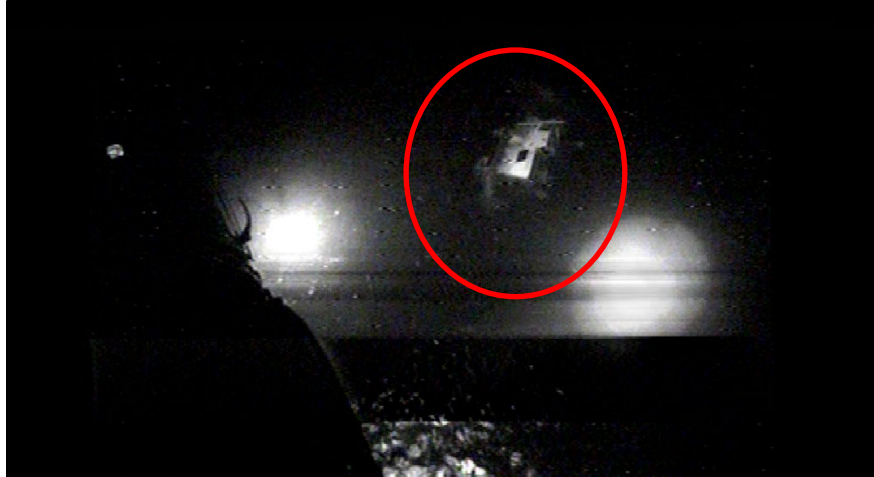
Figure 19. Screen capture from the CG Helo 6527 camera system showing the MARY B II's cabin (circled in red) partially submerged while it was floating north of the North Jetty. (Source – Coast Guard)

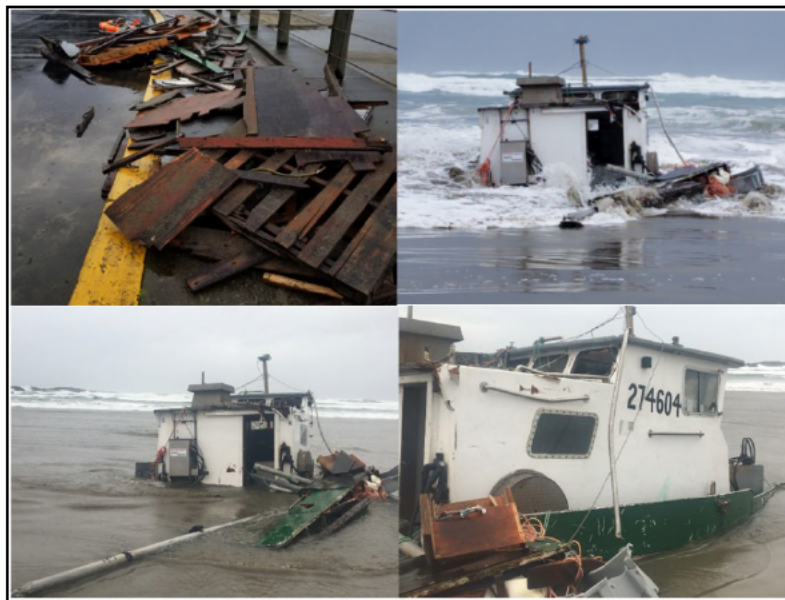
4.1.98. The wreckage of the MARY B II's wheelhouse and forward half of the main deck was set on the beach approximately 30 to 50 yards north of the North Jetty. The MARY B II's anchor had deployed which kept the remains of the vessel from drifting further onto the beach or further north. The anchoring, while unintended, helped reduce the damage from the large waves crashing on the beach.

4.1.99. The pilothouse was sunk in about 6 to 8 inches of sand. Two of the three pilothouse front windows and one of the rear windows were broken. The front port side of the pilothouse had sustained damaged which peeled off the fiberglass exposing the wood underneath. None of the side windows were broken.

Figure 21. Composite of pictures of the wreckage of the MARY B II taken January 9, 2019. Bottom left image, on the extreme left of the image, you can see the rocks of the North Jetty at Yaquina Bay Bar in the distance. (Source – Oregon State Parks, Mr. [REDACTED] CG Exhibit 007)

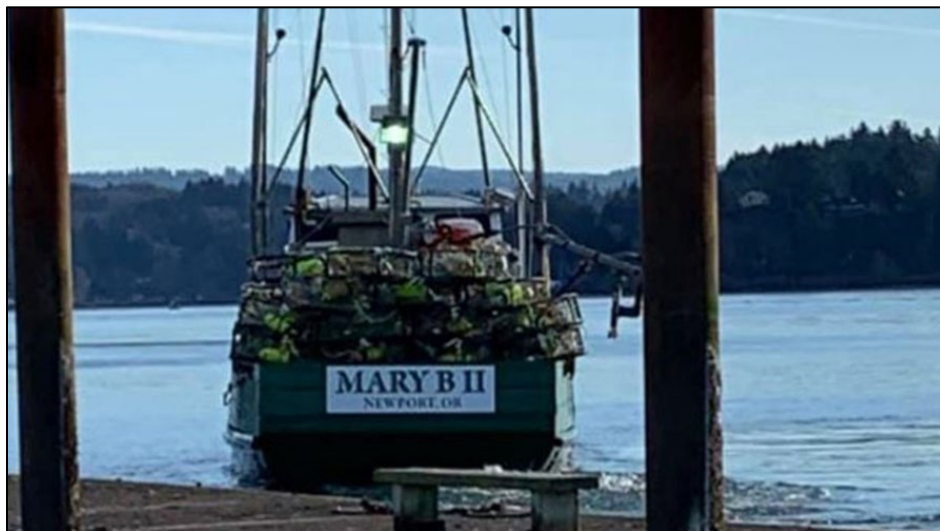
Figure 24. Image of the MARY B II leaving the dock in Newport, OR with crab pots and gear on the after deck prior to the accident voyage. Date is unknown. (Source – Lincoln City Homepage)

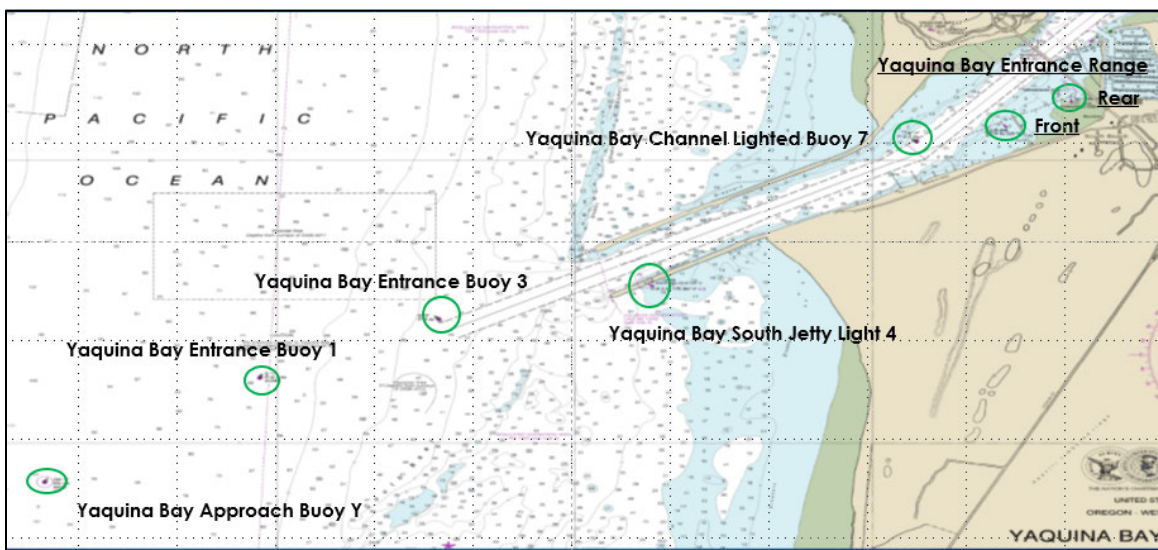
Figure 29. Image showing the location of critical aids to navigation at Yaquina Bay Bar. The USCG maintains these aids. (Source – Coast Guard, CG Exhibit 052)

4.2.42.1. Yaquina Bay Entrance Buoy 1, Yaquina Bay South Jetty Light 4, and the Yaquina Bay front and rear ranges were on station and watching properly on the night of the accident.
