N-CFSAC

Supporting Documentation Package 3

REPORT OF INVESTIGATION
INTO THE
COMMERCIAL FISHING VESSEL (CFV)

COASTAL REIGN Capsizing & Loss of Life

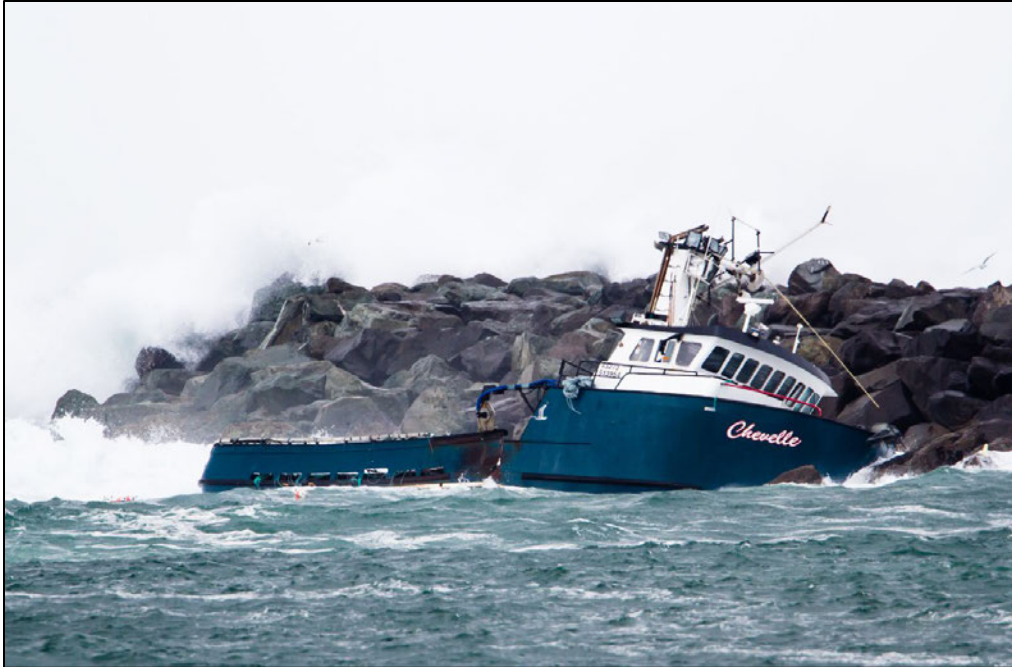
Figure 39. Image above demonstrates the danger posed by the breaking bars at the North Jetty of the Yaquina Bay Bar near the north tip. Note the large size and placement of the rocks used to form the protective jetty. The F/V CHEVELLE accident occurred in March 2012, the vessel was a total loss and all crew were recovered safely. (Photo - Mr. and Mrs. [REDACTED] ©)

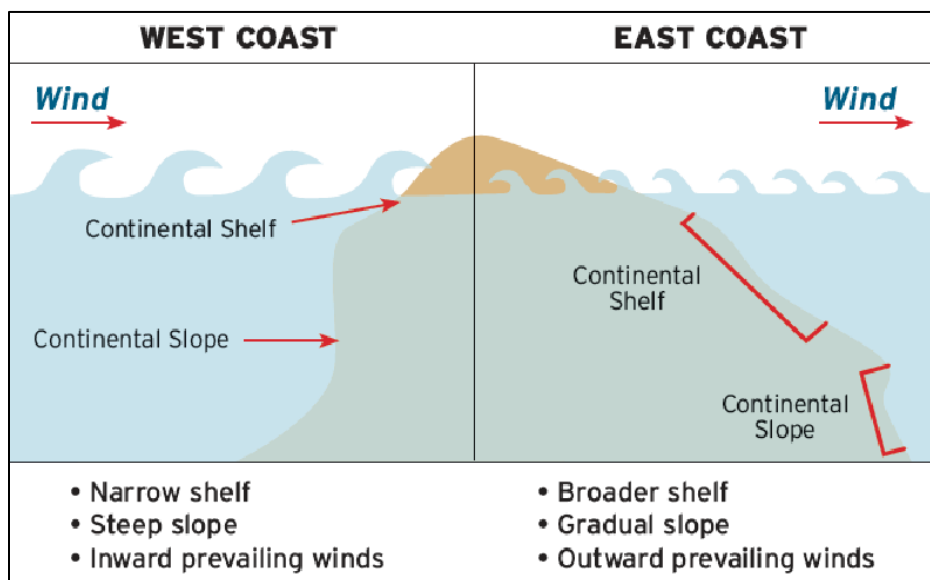
Figure 43. This figure graphically compares the interaction of the sea, wind and slope of the sea beds that make up the shoreline of the West and East Coast of the United States and how that relates to the character of the waves and swell that result. Note the larger waves caused by the prevailing winds, long ocean distance and the steep slope of the West Coast Shoreline. (Source – Used with permission, BoatU.S. Magazine)

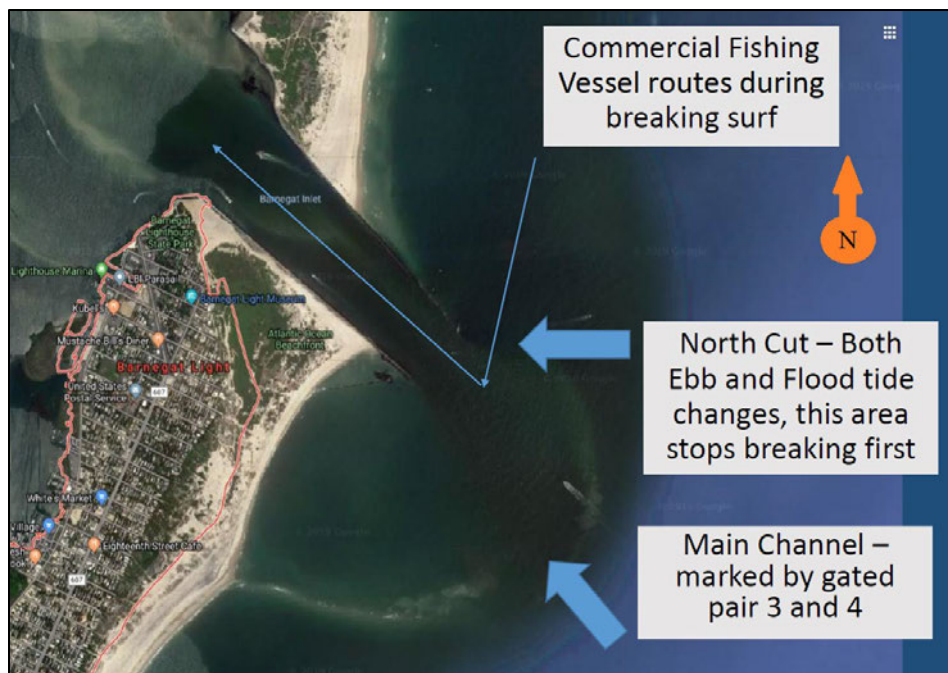
Figure 45. An aerial view of Barnegat Inlet, NJ with notes on entering the waterway and showing the route (in blue) for mariners entering the waterway where the surf is breaking. (Source – Coast Guard prepared)

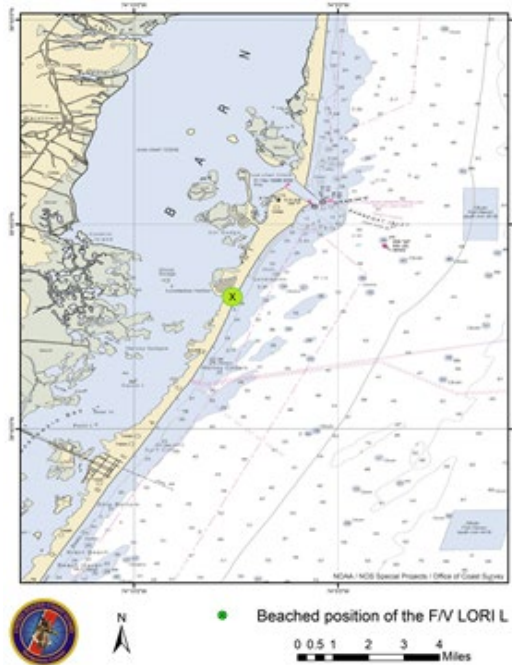
The experience and critical decision making of the operator of the MARY B II reveals a host of serious issues with his role and responsibilities as a vessel captain. In February 1997, Mr. Biernacki was employed as the captain of the LORI L. While acting as operator of the vessel, he was involved in a marine casualty where it was put on autopilot and the entire crew went to sleep. As a result of lack of lookout and vigilance, the vessel grounded on the coast of New Jersey having missed the entrance of Barnegat Inlet, NJ. The captain, Mr. Biernacki, was awakened when the vessel hit the offshore sandbar and the vessel then ended up sideways on the beach. The catch had to be unloaded and multiple vessels used to tow the vessel back into safe water.

Figure 46. Green circle with X indicates the approximate unintended beaching position of the LORI L in February 1997 several miles south of Barnegat Inlet, per Coast Guard MISLE Incident Activity number 90591 (Source - USCG Navigation Safety Center)

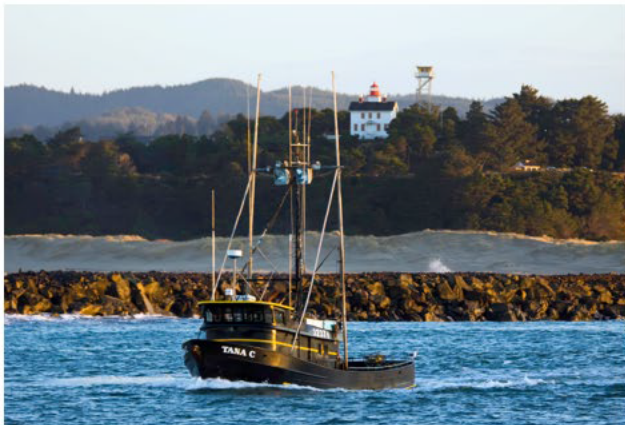
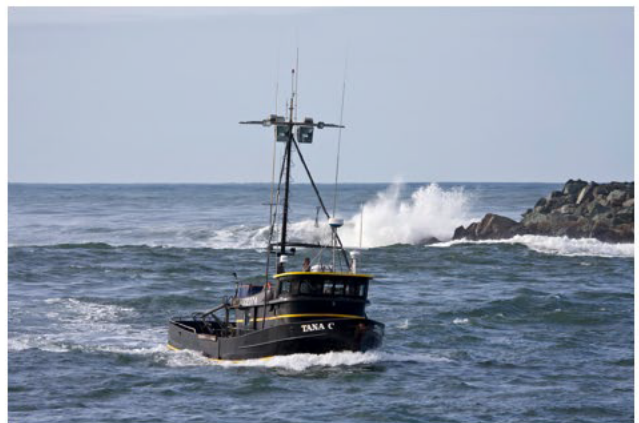
Figure 53. F/V TANA C at the Yaquina Bay Bar. Left with outriggers attached and on the right, the outriggers removed from the vessel. Dates of the photos unknown. (Source - Mr. and Mrs. [REDACTED] ©)

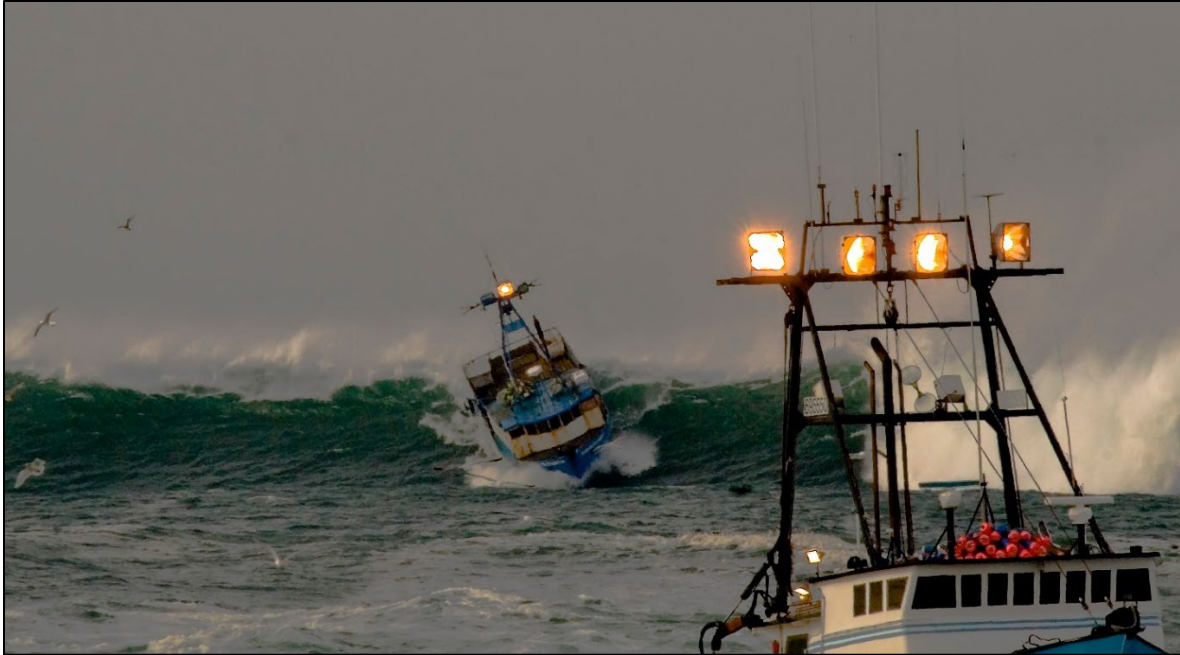
Figure 54. F/V NORSKEN FISHER and another unnamed fishing vessel in the foreground crossing the Yaquina Bay Bar on unknown date, both boats without outriggers. (Source - Mr. and Mrs. [REDACTED] ©)

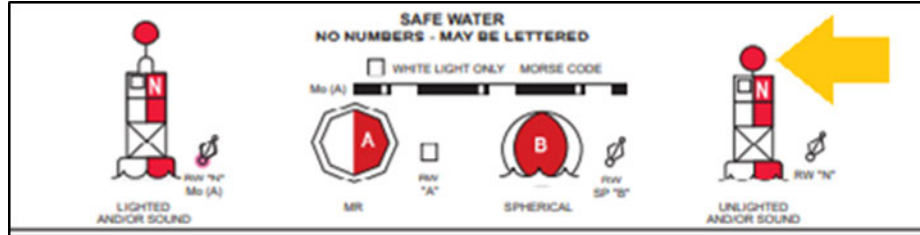
Figure 58. Image from a screen capture from the Coast Guard Light List showing a top mark (yellow arrow) which is a component of a buoy. Under normal conditions the furthest offshore buoy, “Y” buoy and others large buoys at Yaquina Bay would be equipped with a top mark. (Source – Coast Guard)

In the case of Yaquina Bay, the top marks on two of the offshore aids and the dayboards on South Jetty Light 4 were not installed and this was noted in the Coast Guard Light List, Volume VI, Pacific Coast and Pacific Islands. The Light List is updated anytime there are changes to the ATON such as discrepancies and changes to the ATON on the waterways. The image below indicates the notations about the principal ATON for Yaquina Bay Bar.

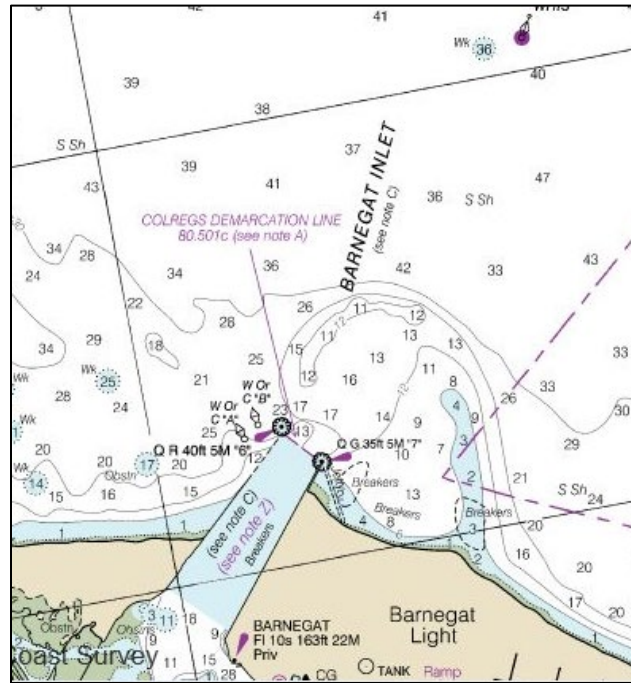
Figure 62. Screen capture of NOAA Nautical Chart 12323, Barnegat Light entrance, showing the pair of ATON lights with the magenta teardrop symbol that marks the jetties. (Source – NOAA Chart 12324)

However, the ATON structure of Barnegat Inlet differs significantly from Yaquina Bay. The extreme conditions of the Pacific Northwest, particularly the strong surf, prohibit the establishment and sustainability of ATON at the tips of the jetties. Whereas, on the East Coast, Barnegat Inlet is able to maintain lighted ATON on the jetty. In describing the lighting of the jetties in the Pacific Northwest, the Coast Guard Waterways Management witness stated:

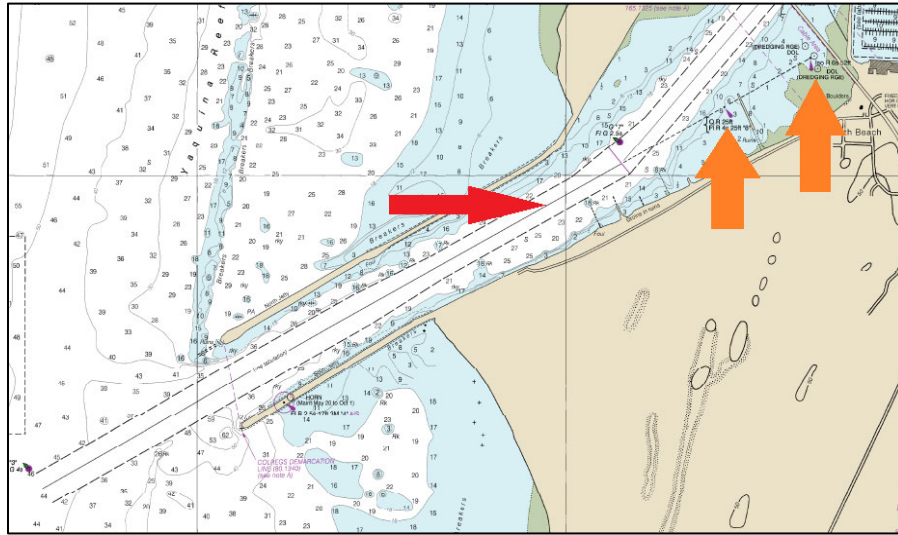
Figure 63. Screen capture of Chart 18581 showing the ranges lights (orange arrows) and the centerline of the navigation channel (red darker arrow) determined. (Source – Coast Guard, CG Exhibit 004 marked up with arrows for emphasis)

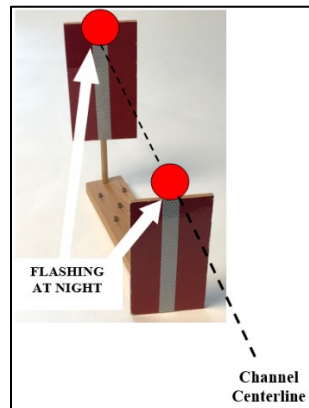
Figure 64. Coast Guard exhibit, range marker training aid. Showing the use of colored boards with vertical strips mounted on towers inside the harbor. If these two shapes were lined up as shown one on top of the other, the mariner would be on the centerline of the navigation channel. In this image if aligned with this page, the mariner would be to the left of the channel centerline and would need to steer to the right to realign the boards. (Source – Coast Guard, CG Exhibit 054, modified)

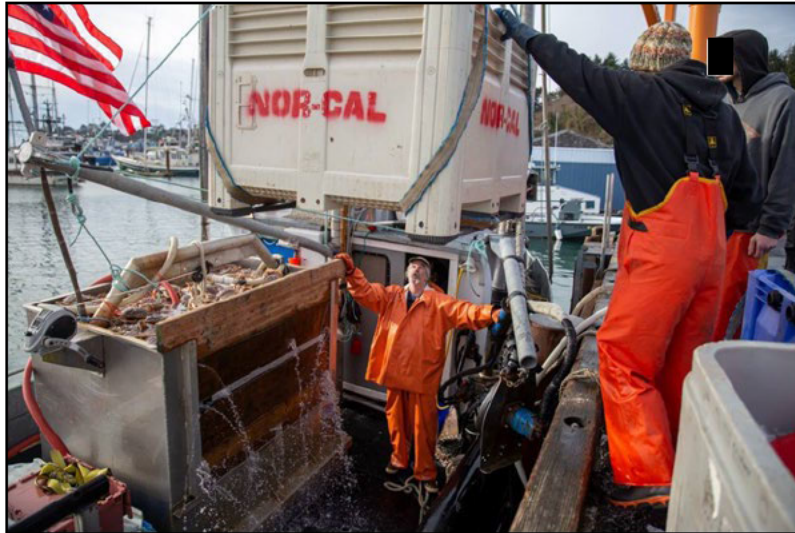
Figure 66. Crew (Mr. Porter on deck with arms extended) of the MARY B II unloading crab catch at a commercial fish processing dock. Taken January 2019. (Source – Newport News Times)

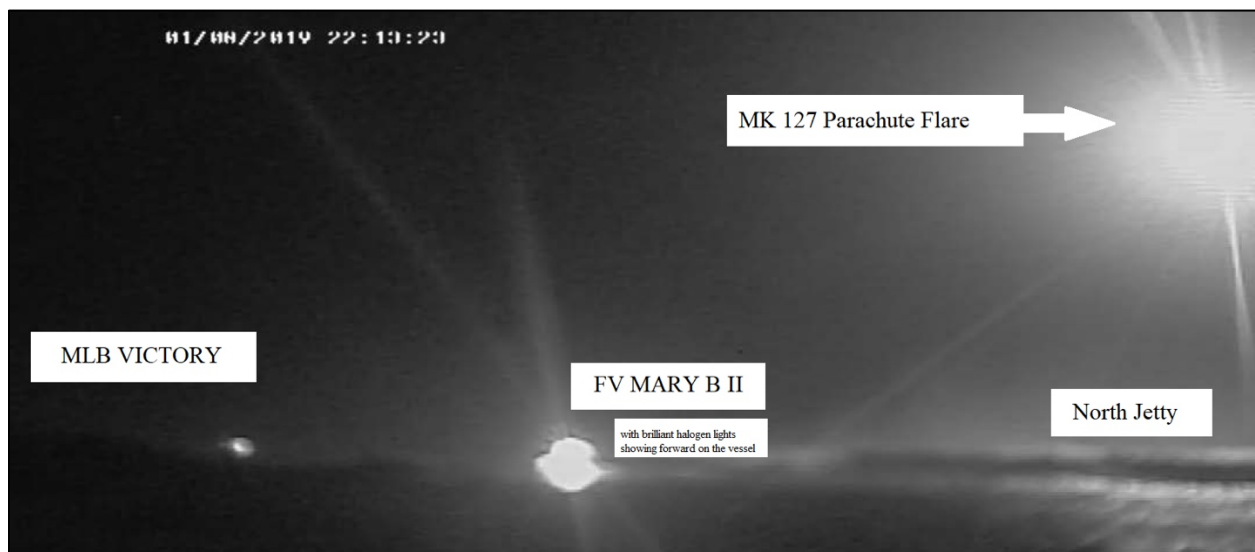
Figure 69. Screen capture from Oregon State Police closed circuit TV camera located in the vicinity of the South Jetty showing the illumination provided by the descending flares. To the right you can see the visible portion of the North Jetty (Source – Coast Guard, CG Exhibit 032 screen capture)

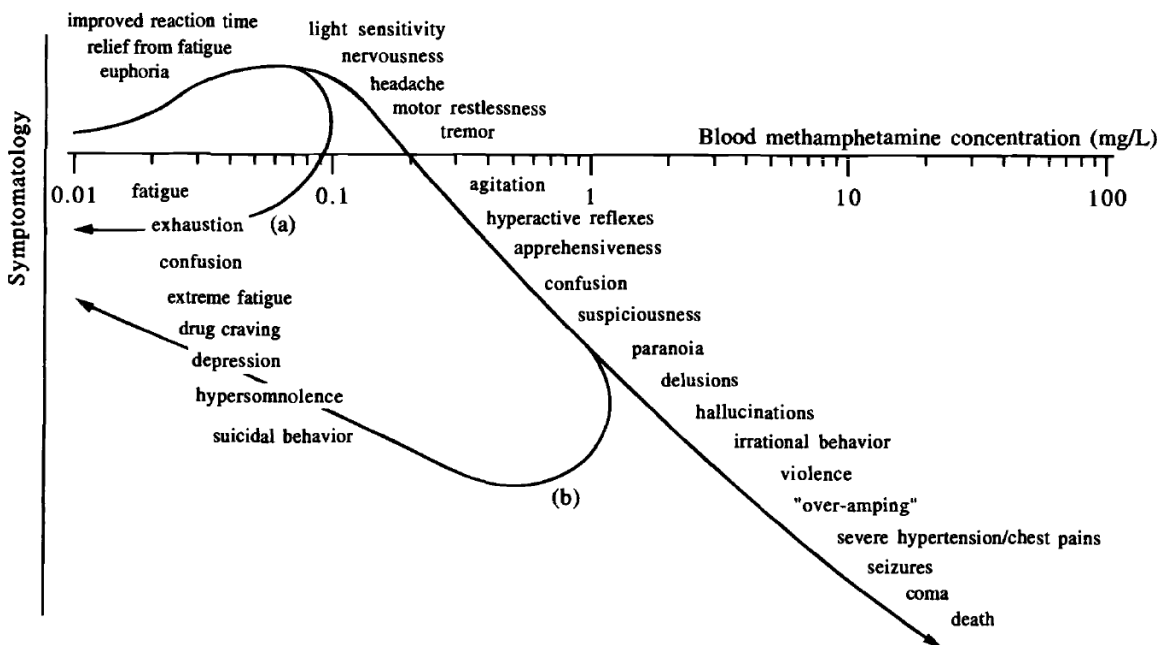
The effects of the combination of alcohol that was detected in the post mortem sampling and methamphetamine cannot be determined. The image below graphically depicts the effects of methamphetamine at low and high dose based on blood concentrations of the drug. Initially, the stimulant effect provides improved focus and reaction time.

Figure 71. Hysteresis plot showing effects of methamphetamine that impact driving performance with respect to blood methamphetamine concentration (mg/L). The figure shows examples of withdrawal effects from (a) low dose and (b) high dose drug use. (Source – [REDACTED] "Methamphetamine and Driving Impairment," Journal of Forensic Sciences, JFSCA, Vol. 41, No.3, May 1996, pp. 457-464)

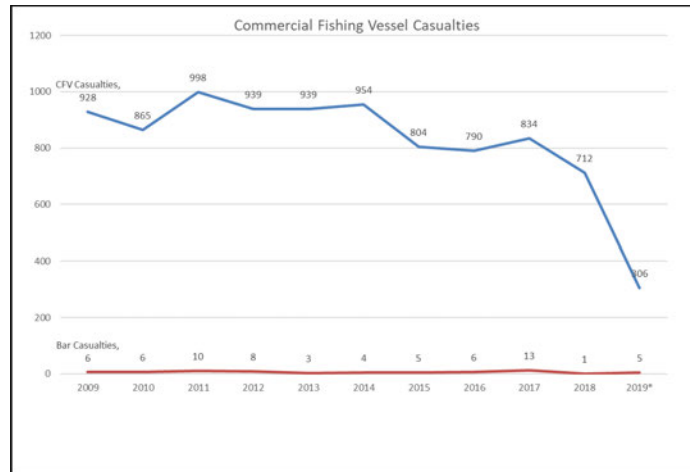
Figure 72. The statistics contained in this table are derived from the USCG MISLE database that reflects the overall operational and non-operational commercial fishing vessel accidents for the displayed period. At the bottom of the page, in red is the plot indicating the reported accidents that occur in areas described as “bars.” (Source – Coast Guard)

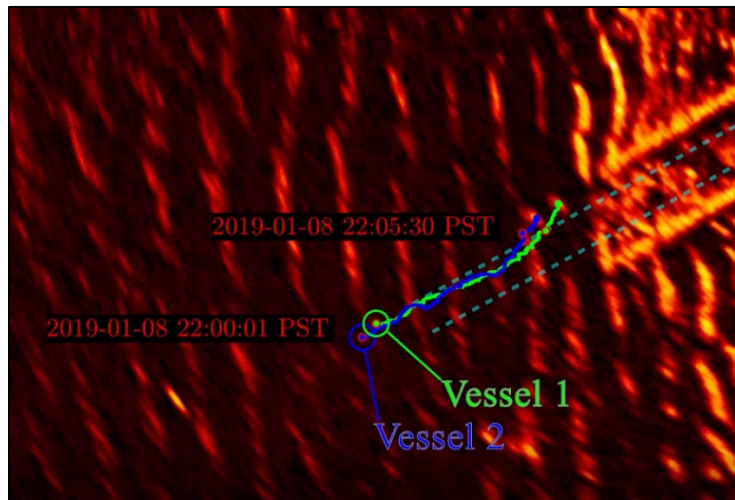
While Coast Guard crews can monitor and report on wave sets and lulls, they cannot predict the size or power of individual waves. OSU captures the reflected energy of ocean waves using marine band radar. The height and steepness of an ocean wave are characterized in colors and in the figure below you see the large ocean swells heading to the entrance of Yaquina Bay Bar. In general, you see they are red in color and move in a parallel series of waves towards the jetty ends. A bright yellow radar reflection would indicate waves that are significantly steeper and taller in height than the waves that are less bright. Near the time of the capsizing of the MARY B II, this convergence of waves began to occur and build in size.

Figure 76. Screen shot of OSU radar video showing the MARY B II (VESSEL 1) and VICTORY (VESSEL 2) nearing the North Jetty End. (Source – Oregon State University, CG Exhibit 034)

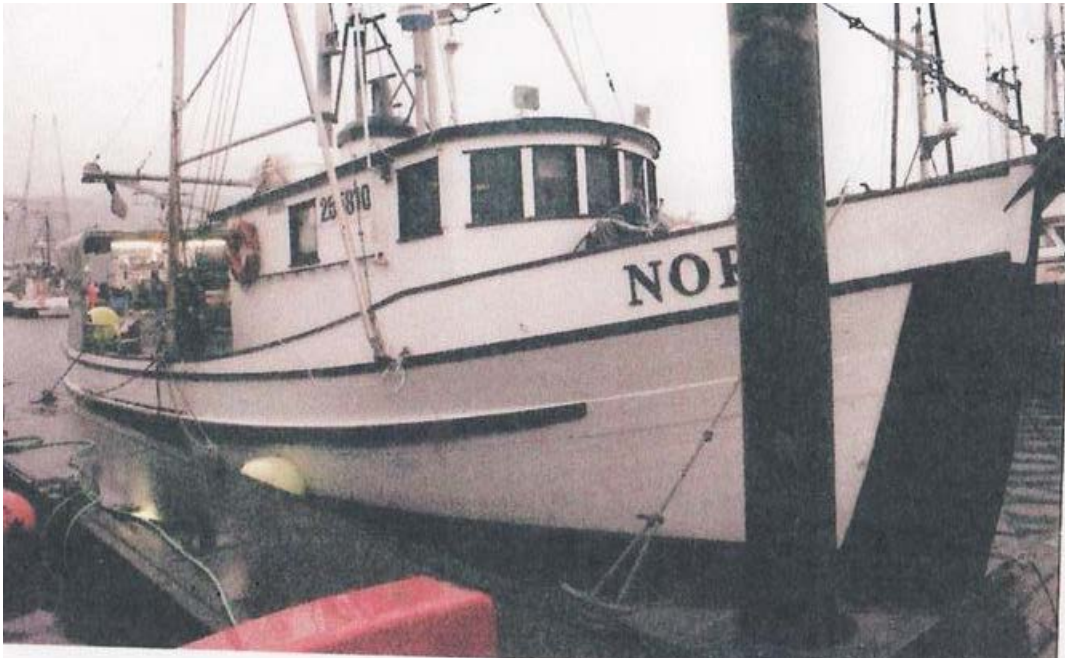
5. During a dry-dock inspection in 2012, a wooden vessel hull surveyor reported loose fasteners in the topsides and port side. The port side was re-fastened with hundreds of galvanized screws, but not the starboard. The keel fasteners were not examined. The technician recommended a complete re-fastening in the vicinity of the fish-hold area of the vessel. However, due to limited funds, no fasteners were replaced below the waterline.⁵

Figure 5: Photo of NORN at 2006 survey (Credit: All Points Nor'west Marine Surveyors)

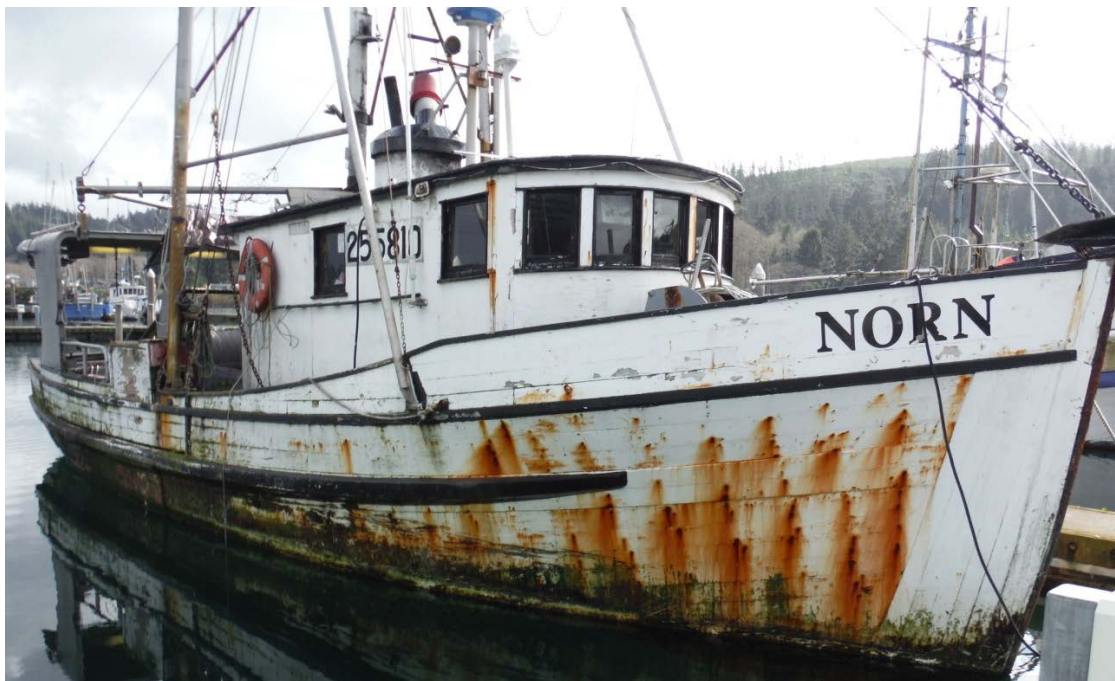
Figure 6: Photo of NORN in 2013

1. *Lack of Maintenance:* The pictures and dry-dock survey suggest maintenance was not being adequately performed. The photos also suggest that the fasteners in the NORN's hull were at some stage of decay. The dry-dock survey recommended a "complete refasten and reframe" in the vicinity of the fish-hold area. The pictures taken two years after dry-dock show rust running down from the heads of the individual fastener holes. Figure 5 depicts a photograph of NORN's starboard bow, which is also the side re-fastened in 2011. This indicates even the most recent fasteners were suffering wastage. The U.S. Coast Guard's Navigation and Vessel Inspection Circular (NVIC) 7-95 is used in the wooden vessel industry as a guide in maintaining and repairing wooden built vessels. NVIC 7-95 addresses running rust from fasteners and recommends the removal of fastenings should occur when bleeding from fastening holes are noted.

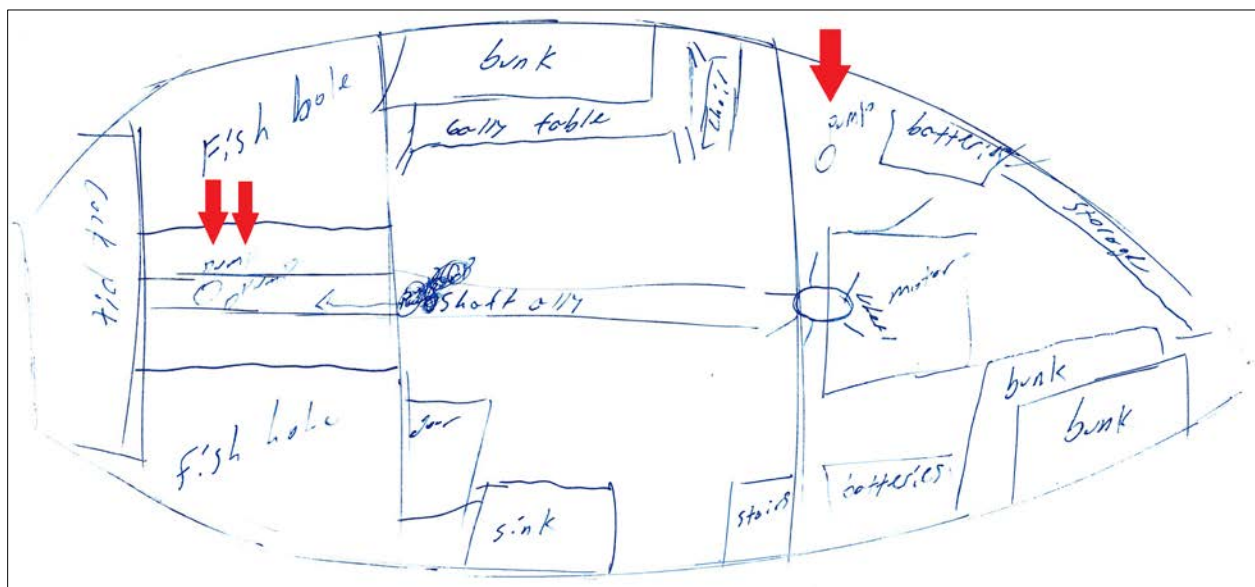
11. The NORN is outfitted with three, 2000 gallons per hour, 12-volt, bilge pumps. One bilge pump is located in the engine room, and two in the fish-hold. A float-switch automatically energizes the engine room pump and one of the pumps in the fish-hold. A toggle-switch in the wheelhouse manually operates the second pump in the fish-hold.

Figure 7: Sketch of NORN, completed by captain of vessel, noting bilge pump locations.

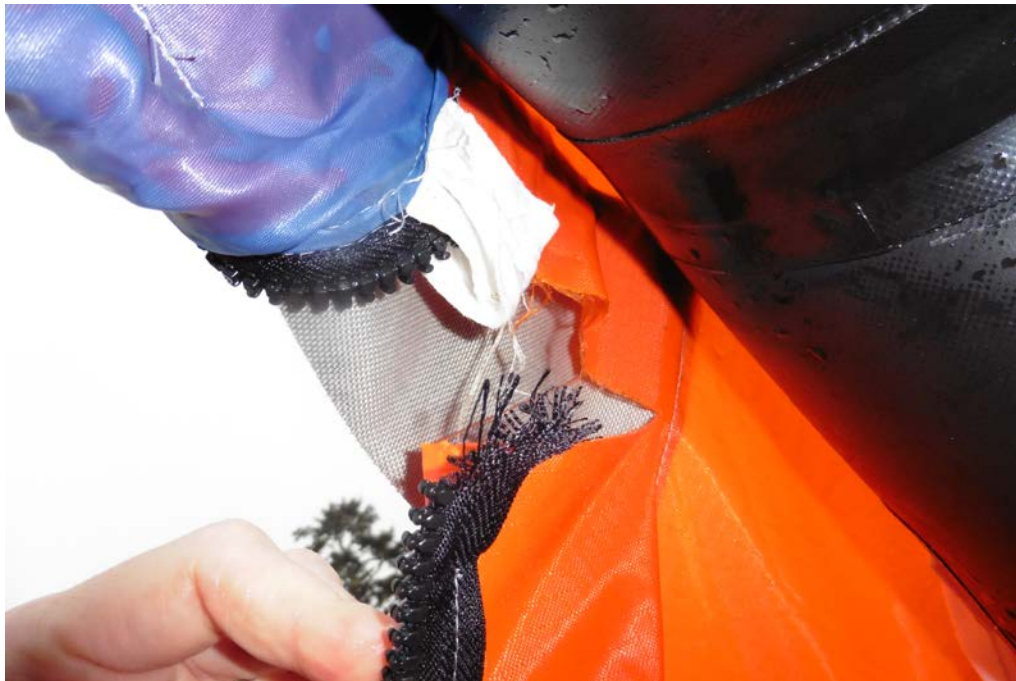
22. As the vessel sank beneath the ocean surface, the life raft painter line pulled taut and inflated the life raft. While the life raft inflated, it became tangled in the NORN's mast rigging. The captain and crew climbed aboard the life raft, but could not close the zippered flap due to a large tear in the fabric.

Figure 8: Photo of tear in life raft canopy entrance flap.

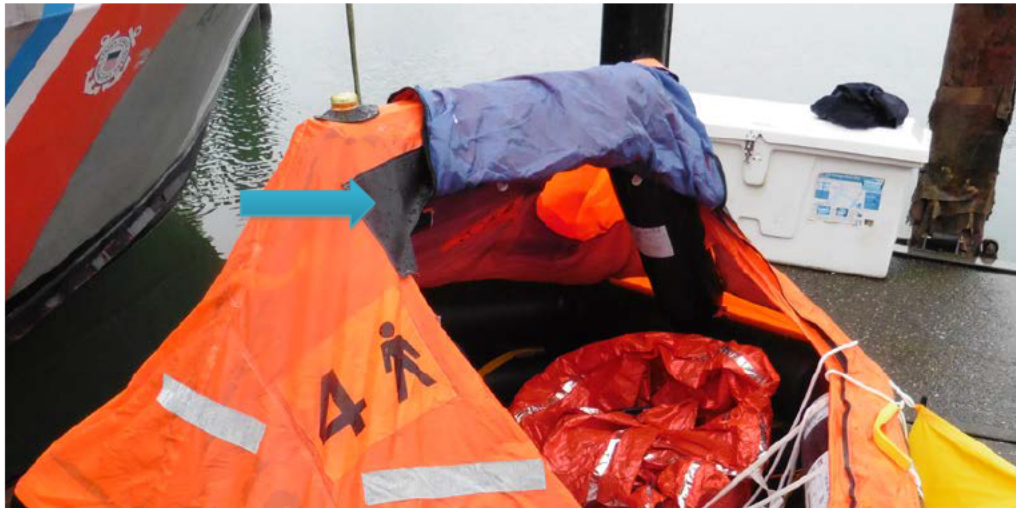
Figure 9: Photo of NORN's life raft. Arrow points to location of flap tear on opposite side.

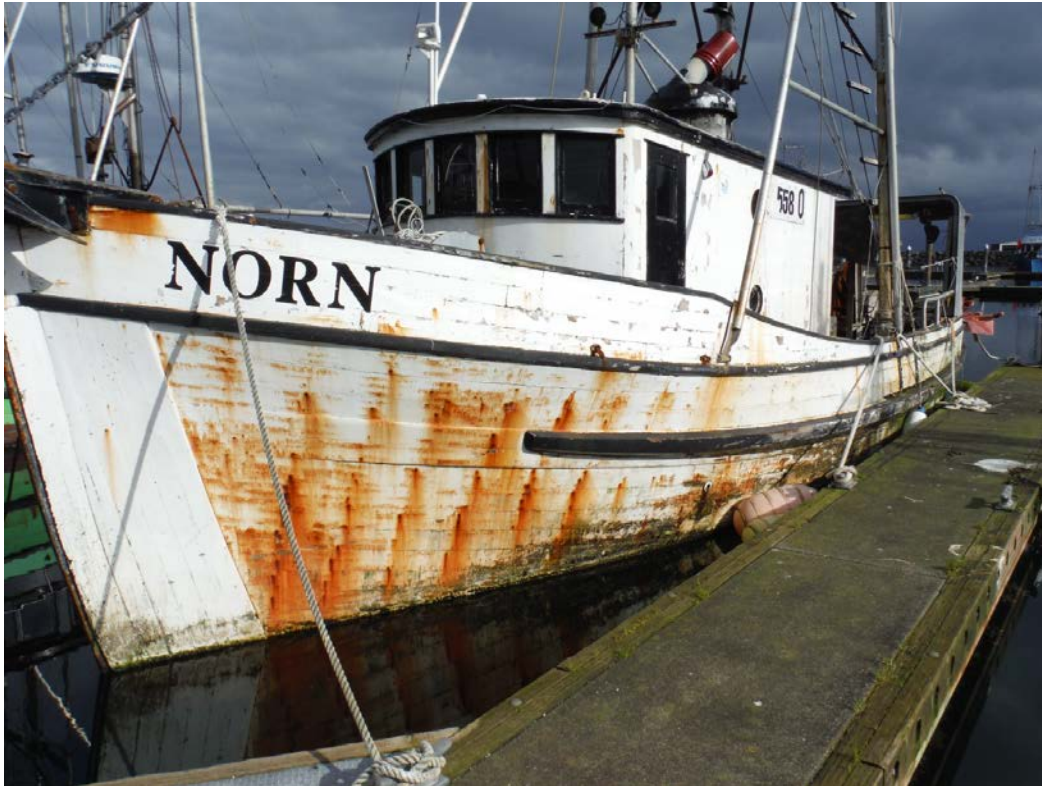
¹¹ Saturated wood acts as the electrolyte for the deeper-buried fastener. The ferrous materials located within the fishing vessel become part of a separate electro-chemical process. The fasteners become the least noble metal due to nobler piping materials within the vessel. Electrons are given up from the fastener and given to the more noble material (i.e. aluminum, brass, copper, copper-nickel, etc), while no lesser material replenishes the fasteners' lost material. The end result is wastage of the deep-buried fastener.

Figure 10: NORN's port bow. Picture taken March 2013. Bleeding fasteners are easily visible.

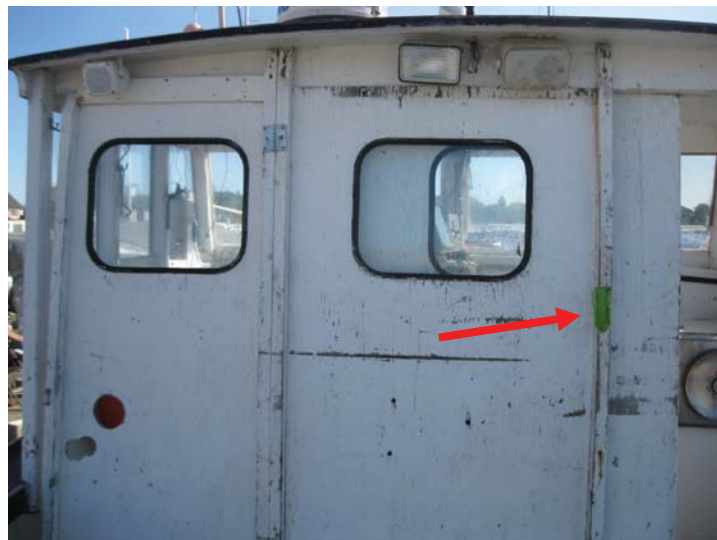
4. *Not having a knife tethered to the body:* When Mr. Philbrook was pulled from the water there was no knife found on his person. There was a sheath for a knife fastened to the outside of the pilothouse bulkhead. No knife was found in the sheath after the casualty. It is unknown whether or not Mr. Philbrook had a knife on him when he fell into the water or if he attempted to free himself from the lines caught around his leg when he was in the water. There is no state or federal regulations in place that require personnel on vessel's fishing for lobster to have a knife on their person or tethered to their body. If Mr. Philbrook had a knife tethered to his body when he fell into the water, he may have been able to use it to cut the lines wrapped around his legs and subsequently free himself.

Figure 8- Back of OUTNUMBERED's pilothouse, where Mr. Philbrook kept a knife (red arrow), picture taken by LT [REDACTED].

3. Commandant should develop a regulation that requires personnel working fishing gear on a commercial fishing vessel to have a knife capable of cutting through line tethered to their body at all times. A similar recommendation has been previously made by the National Institute for Occupational Safety and Health in 2005 for lobstermen to adapt as a safe work practice³.

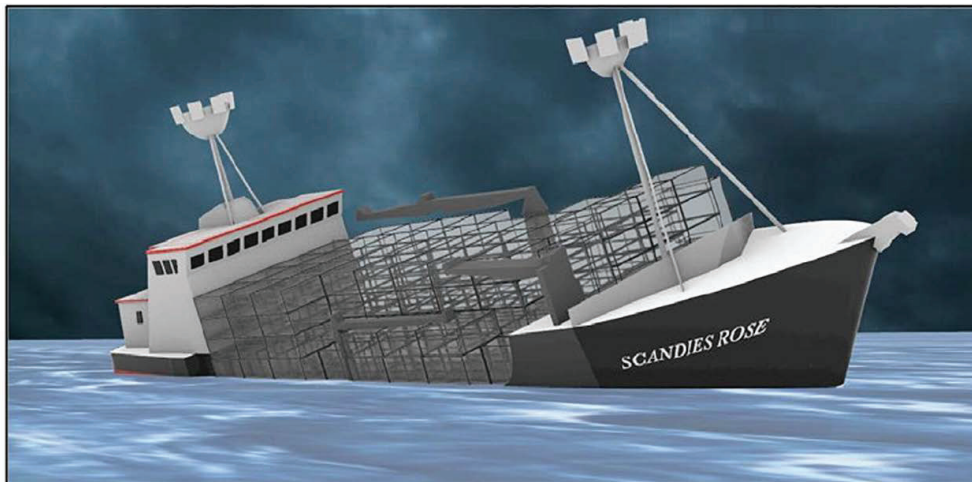
Figure 10 - SCANDIES ROSE Marine Safety Center (MSC) modeling with a 20-degree list to starboard as described in section 4.1.34.2. of the ROI. (Source Coast Guard Marine Safety Center)

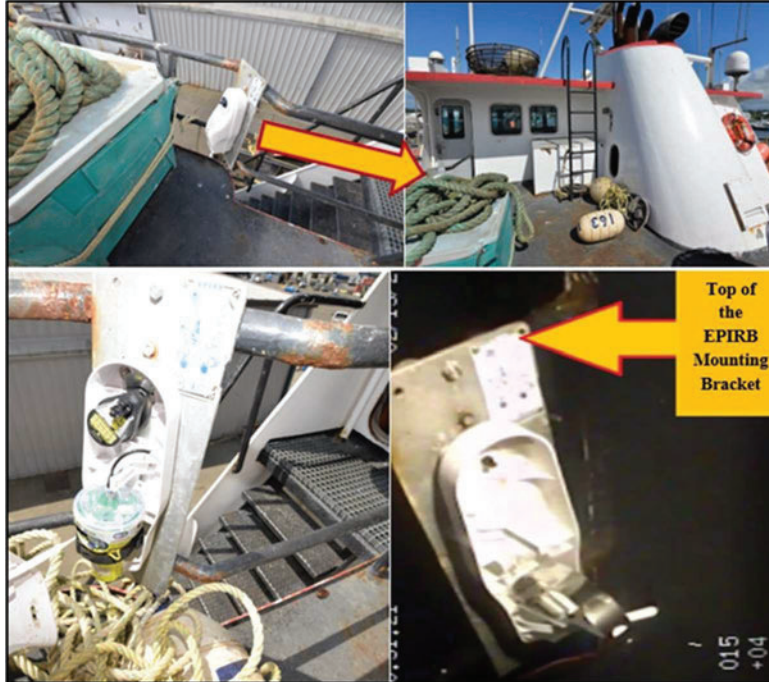
Figure 14 – Composite of photo montage of the SCANDIES ROSE EPIRB. Top left, EPIRB in housing on the inside of top rail aft of the wheelhouse. Top right is the location shown with the yellow arrow in reference to the position in relationship to the port wheelhouse door. Bottom left, the open EPIRB housing during inspection for 2019 Valuation and Condition Survey. Bottom right, the empty housing as seen during underwater site survey conducted by Remotely Operated Vehicle (ROV) in February 2020. (Source – [REDACTED] photos for 2019 Valuation Survey and bottom right, CG Exhibit 008)

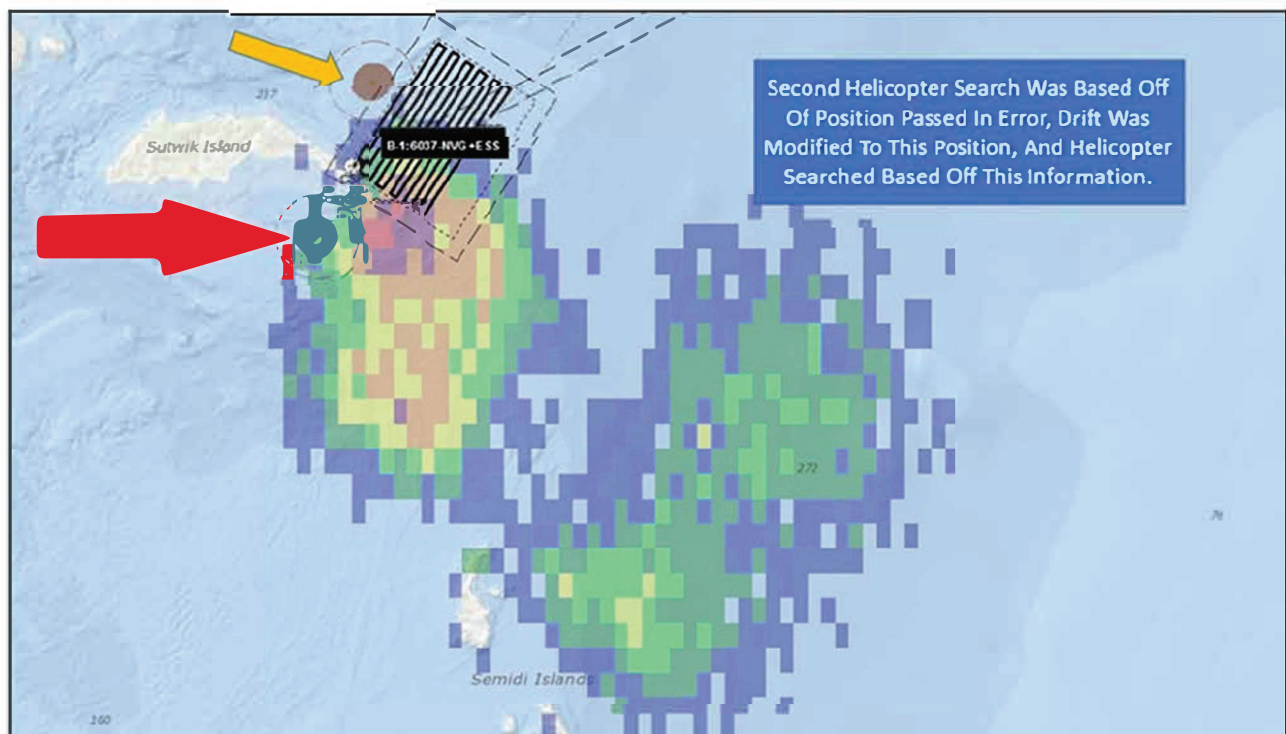
4.1.102. Due to an error in the transposition of the coordinates into the computer modeling software Search and Rescue Optimal Planning System (SAROPS), one search model was built for an area north of Sutwik Island, which was used by the second Coast Guard helicopter, the CG-6037. The SAR Program Manager talked about that error:

Figure 20 – Second search pattern with red arrow indicating the position of the SCANDIES ROSE from the distress radio message. Yellow arrow points to the incorrect position of the liferaft which was used as the center point of search #2. The small colored rectangles represent the computer modeling prediction of the best location for searching based on the computer drift modelling. Red and magenta colors indicate the greatest possible chance of search success based on the modeling of the weather conditions and the characteristics of the search object. (Source CG Exhibit 076, with markups)

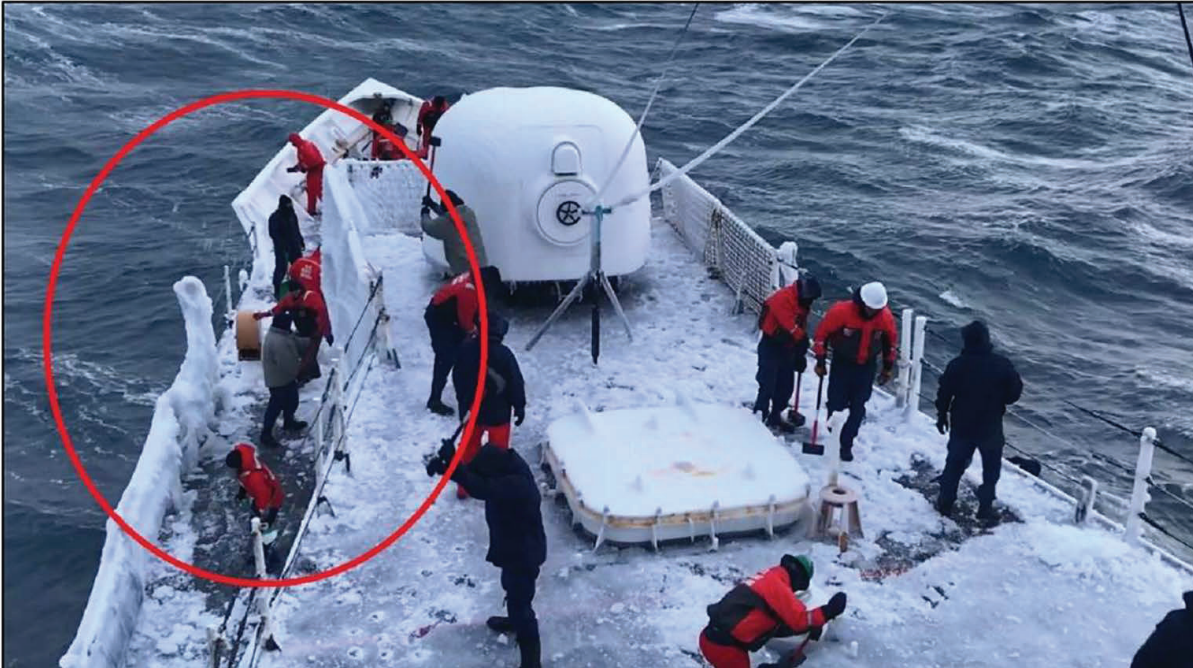
4.1.117.1. The CGC MELLON deployed crewmembers out onto the cutter's deck to conduct manual removal of the ice that had formed on the bow area and superstructure during its transit to the search area. The crew used tools to manually break the ice off rails, deck surfaces, and other fittings. This was done specifically during daylight hours to reduce the risk to the crew.

Figure 22 – Image of USCGC MELLON crewmembers on the bow of the vessel breaking ice shortly after arriving in the search area. The red circle shows the difference between a de-iced portion of the port side railing and the parts of the ship that had not yet been de-iced highlighting the level of ice accretion the CGC MELLON experienced as it steamed to the SCANDIES ROSE's last known position. (Source Coast Guard Exhibit 095 screen capture, with markups)

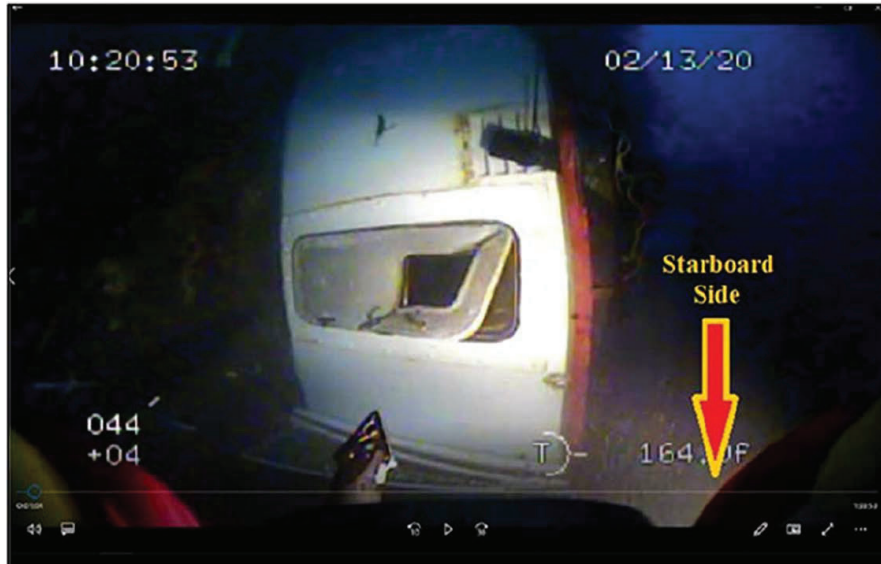
4.2.5.3. Several of the SCANDIES ROSE’s external doors were open, most notably the door leading to the accommodation spaces that was located on the after bulkhead on the starboard side and a person from the ROV team could be heard stating on the video that it appeared to have been damaged by the impact with the seafloor.

Figure 25 – After starboard side accommodation door of the SCANDIES ROSE on the after bulkhead showing damage. (CG Exhibit 008, with markup)

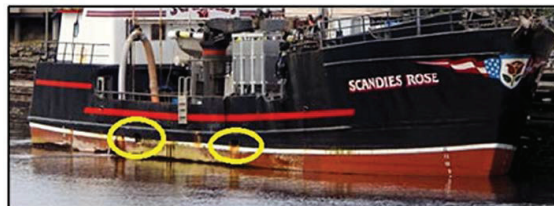
4.2.71. At the time of the sinking, the SCANDIES ROSE had two active waste chutes, one on the port side and one on the starboard side. The two steel chutes were used to discharge by-catch or other unwanted material brought onboard while fishing. The chutes ran from the main deck, down through the pipe alley voids on either side of the vessel and then passed thru the side of the hull, slightly above the waterline. When the vessel was underway or fishing, these chutes would be exposed to constant wave action and the corrosive effects of the salt water. During the period between April 15 and April 26, 2019, the starboard fore and aft chutes were attended to while the SCANDIES ROSE was at the dock while in the Seattle, WA area. The starboard side forward chute was repaired with “doublers”⁹⁹ and the aft chute was closed off. This work was performed by Aztec Marine LLC, a commercial welding contractor, who was hired to weld steel plate over sections of deteriorated steel that made up the chutes. The welders who performed the work were not certified marine welders.

Figure 33 - Starboard side of the SCANDIES ROSE prior to the repair of the overboard chutes, taken several years earlier. Yellow circles indicate two chutes, one forward and one aft through the side shell plating and into the starboard pipe alley. (Source Mr. [REDACTED] ©, with permission and with Coast Guard mark up)

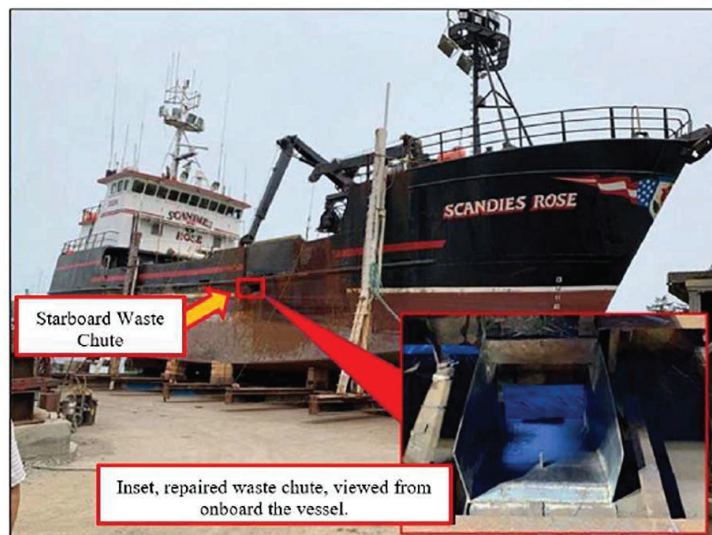
Figure 34 – SCANDIES ROSE on the blocks May 2019 at Lovric’s Shipyard, Anacortes, WA. “Starboard Waste Chute” highlighted, inset photo, lower right, displays the completely rebuilt starboard waste chute as repaired later in 2019 by High Mark Marine certified welders. (Source [REDACTED], with Coast Guard mark up)

4.2.75. The repair work was undertaken and completed in late November 2019, with an invoice date of November 22, 2019.¹⁰² The new welding contractor cut out the existing starboard waste chute and rebuilt it using 3/8" steel plate. The ABS-certified welder who conducted the welding work used a dye penetrant to inspect his welds after completion.

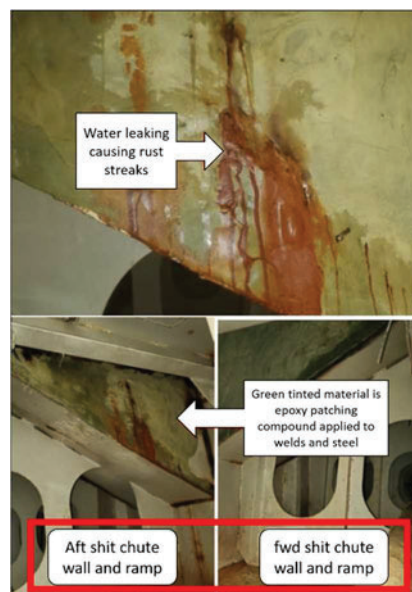
Figure 36 – Composite of the photos the SCANDIES ROSE Captain sent ashore showing the size and extent of the leakage and the areas where temporary repairs were made with a product called, “Splash Zone”®. Comments within the red box are vessel Captain’s comments, boxes with arrows are Coast Guard mark ups (Source CG Exhibit 112, with mark ups)

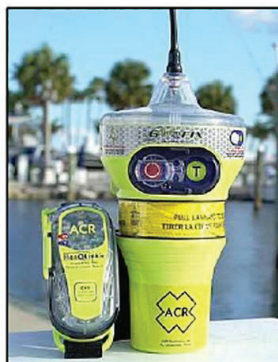
Figure 43 – To the right is an EPIRB of the type and manufacture that was carried on the SCANDIES ROSE. The EPIRB on the SCANDIES ROSE did not transmit a signal received by rescue forces and the storage bracket was empty when the ROV inspected the wreckage. On the left is one type of personal locator beacon for size comparison. (Source Coast Guard Auxiliary Photo)

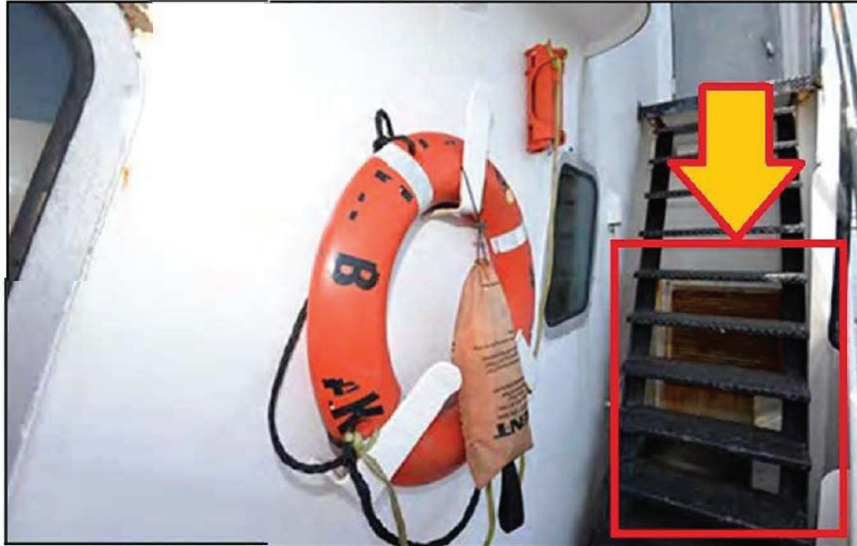
Figure 53– Engine room air intakes under and behind the stairs leading up to the SCANDIES ROSE wheelhouse highlighted by red box and yellow arrow. The air intakes are near the outboard side of the vessel and lead directly down into the vessel’s engine room. (Source CG Exhibit 004, with markup)

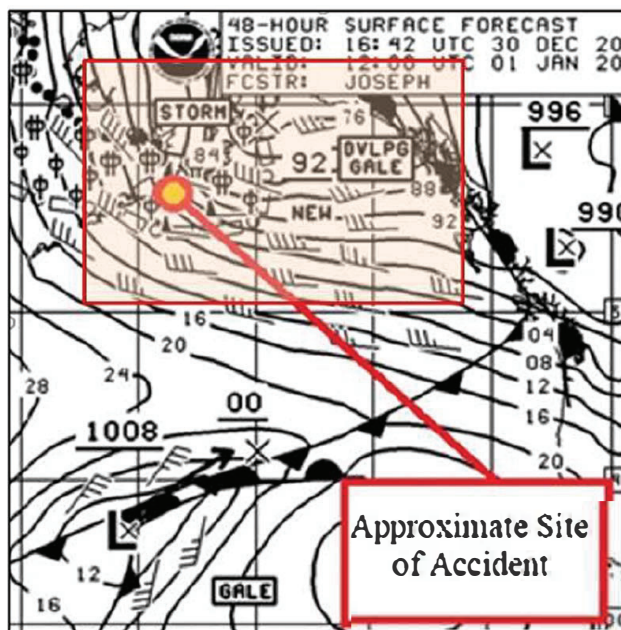
As the SCANDIES ROSE got underway from Kodiak, the forecast presented the crew with a number of hazardous conditions for their upcoming voyage. The forecast would include gale force winds and associated seas as well as freezing spray and the danger of icing of the vessel. The NWS's OPC was issuing high seas weather charts depicting winds expected to be upwards of 45 to 50 kts between False Pass and Kodiak Island, AK. This area in figure 76, below, is a very strong low pressure system, but not uncommon in Alaska. With the center of the low pressure system just to the East of the area, this would make for NW winds and heavy icing potential.

Figure 76 – Enlarged portion of the NWS OPC High Seas 48-Hour Surface Forecast issued at 7 42 a.m. AKST, December 30, 2019 thru 3 00 a.m. AKST, January 1, 2020. The approximate location of the storm is located in an area where the isobars are located close to one another and relatively close to the word “storm.” As indicated by the shaded area in the red box. (Source CG Exhibit 028)
