N-CFSAC

Supporting Documentation Package 3

REPORT OF INVESTIGATION
INTO THE
COMMERCIAL FISHING VESSEL (CFV)

COASTAL REIGN Capsizing & Loss of Life

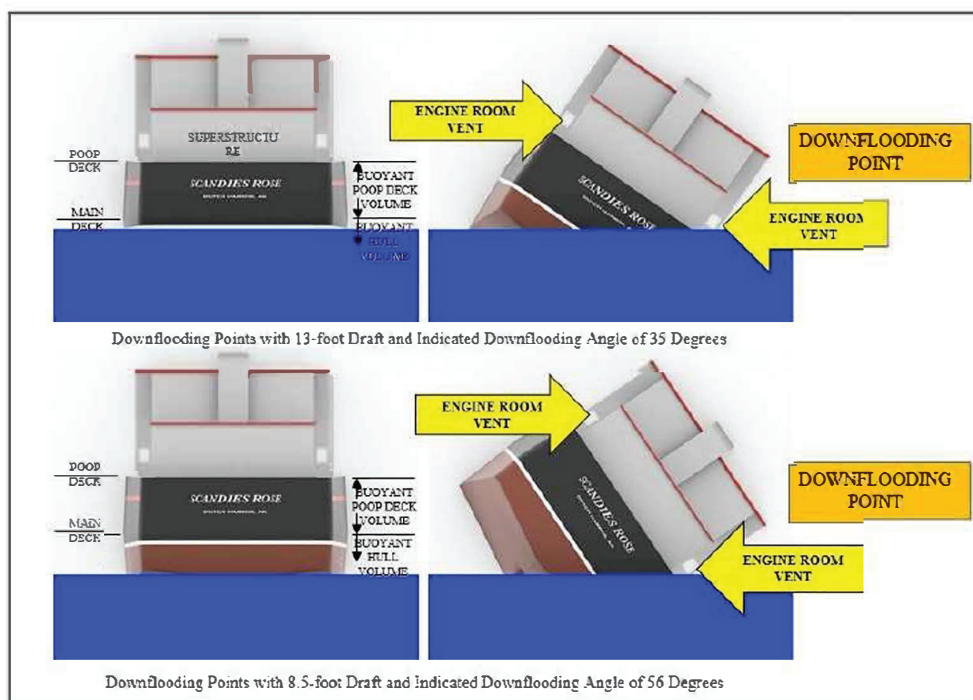
The MSC electronically modeled the downflooding point and the results of a 35-degree heel is shown in Figure 85, below:

Figure 85 – Identifications of the SCANDIES ROSE for various drafts of 13.5 ft and 8.5 ft showing the effect on where the water might enter the air intakes for the engine room which the MSC identified as the “downflooding point.” The Naval Architect that conducted the 2019 stability assessment discounted these flooding points without examining them as a potential point for flooding. He did not physically look at these intakes and assumed later when the SCANDIES ROSE sank that they led to the centerline of the vessel and would have negligible effect on potential downflooding. (Source Coast Guard)

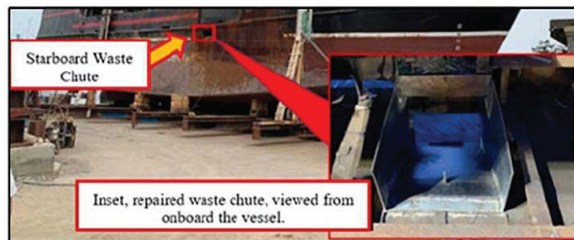
An example of this was the repairs to the overboard waste chutes on the starboard side of the hull conducted by a welding company in early 2019. Later after heading to sea, the Captain notified the shore side managers that the repairs leaked, specifically near the forward starboard chute welds. The Captain texted the manager and majority owner photos with descriptive labels on the image while the vessel was at sea and in one of the text messages he mentions "thru the splash zone that we applied to keep from sinking last winter" and "I thought this had been repaired in the shipyard."²²⁸ It is the Marine Board's opinion based on available evidence that the Captain was referring to the April 2019 repair work performed at dockside by Aztec Welding in Seattle. The owner then arranged for a Kodiak based welder to board the vessel at the dock and repair the leaks identified in the photos of the forward overboard waste chute on the starboard side.

There is no evidence or testimony that, upon notification of weld failures near the forward chute, anyone examined the early 2019 repair where the aft waste chute was closed off to the deck and the side of the hull with the use of welded doubler plates. This closure of the aft overboard chute was carried out by the same welder who did the welding work on the forward chute which would later have to be repaired in Kodiak by a certified welder and subjected to non-destructive testing. Captain [REDACTED] text messages sent ashore in November 2019 focused on the leaks coming from the forward starboard chute. The Kodiak welder cropped out the wasted metal along with the suspect porous welds and fabricated a new overboard chute, fitted it in place, welded it up and then conducted a non-destructive

The work and subsequent NDT testing attested to the quality of the welding work replacing the starboard forward overboard chute.²⁴²

Figure 94 – SCANDIES ROSE on the blocks May 2019 at Lovric's Shipyard, Anacortes, WA. "Starboard waste chute" highlighted, with inset photo showing repaired waste chute as viewed from onboard the vessel, looking outboard. Inset photo, lower right, displays the completely rebuilt starboard waste chute as repaired later in 2019 by High Mark Marine certified welders in Kodiak, AK. (Source [REDACTED])

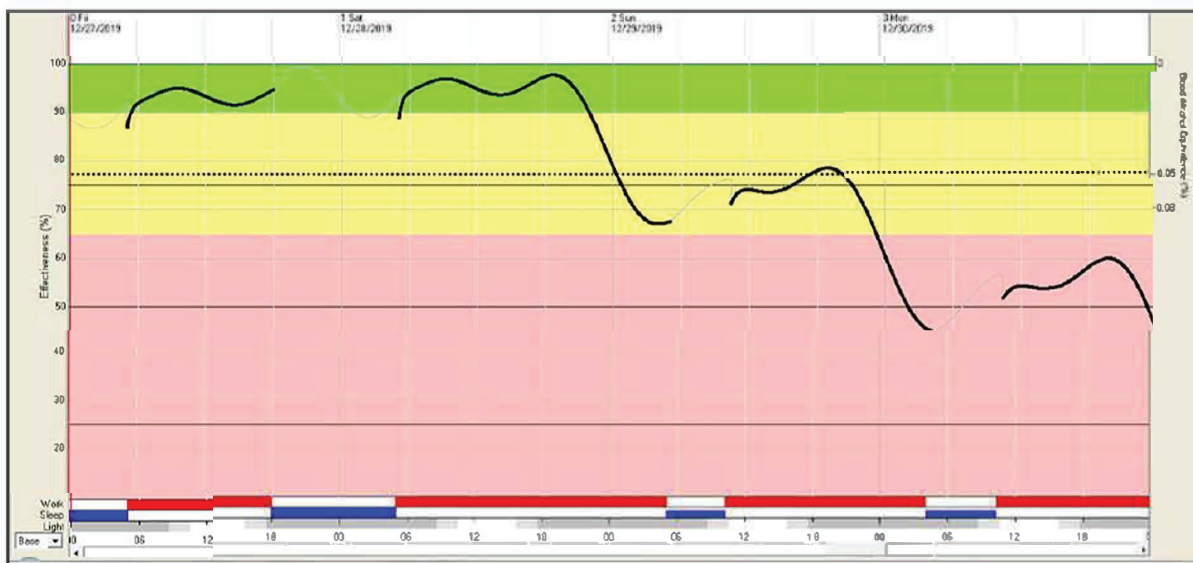
Figure 95 – FAST Analysis documenting the level of fatigue for Mr. [REDACTED] based on his work/rest history examined in this investigation. (Source Coast Guard)

The analysis, conducted by the Coast Guard’s Office of Safety and Environmental Health, assumed good “effectiveness” level on day 1 as there was no previous data to consider. Even in the best case scenario, by the end of day 2, the member’s effectiveness decreased as the sleep period was short and taken in periods of the day when the biological clock was not prepared for sleep. The analysis indicated that, at this point, an expected consequence on alertness and performance is comparable to someone under the influence of alcohol—at this level of ‘effectiveness’ this crewmember “would be expected to perform as well as someone with a blood alcohol equivalence of .05” as noted in figure 95, above.²⁴⁸ Once the vessel got underway and was in transit to the fishing grounds, the analysis recognized that the member had more of an opportunity to get more rest, but some of those hours were not during hours when the body is used to sleeping so the sleep was not considered restorative. The analysis concluded that “any member who experienced a work schedule similar to Mr. [REDACTED] probably all the crew who participated in the preparation of the boat, would have experienced similar alertness and performance consequences.”²⁴⁹

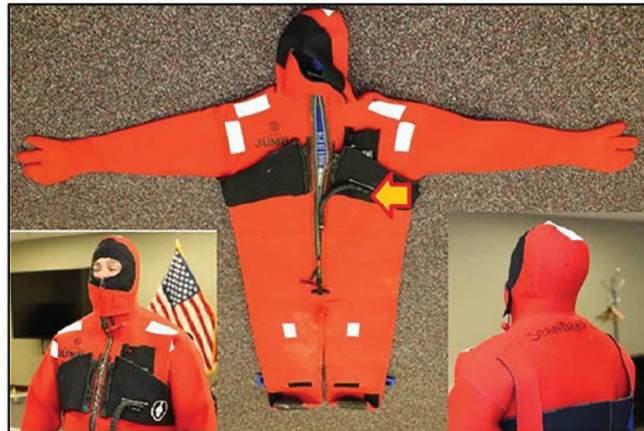
Prior to leaving Kodiak, the crew had participated in the required drills and one person was instructed to put on an immersion suit. As the new crewmember onboard, Mr. [REDACTED] was directed to demonstrate the proper donning of a survival suit while the rest of the crew observed. There is ambiguity in the guidance and regulations when discussing pre-departure drills revolving around the “donning” of immersion suits. In the case of the SCANDIES ROSE, only one crewmember practiced donning the immersion suit and it is not known when the last time other crewmembers actually donned an immersion suit.

Figure 101 - Composite of photos of one of the survivor's actual survival or immersion suit. The yellow arrow indicates the manual inflation tube for inflating the bladder to assist upright floatation. Mr. [REDACTED] is wearing the suit in this demonstration. (Source CG Exhibit 103 composite with mark ups)

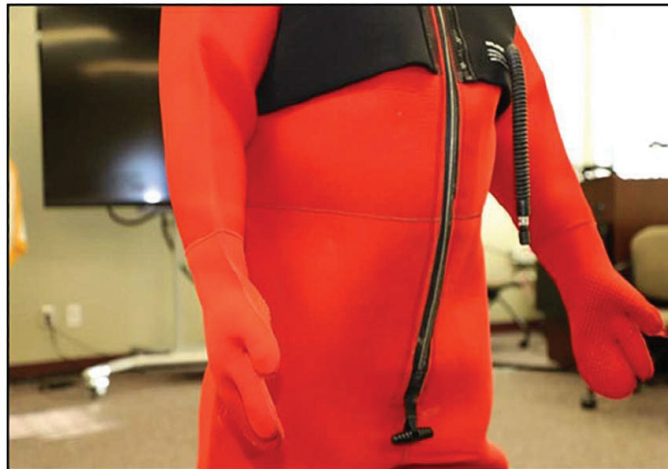
The survivors noted that manual dexterity was limited while wearing the suit. The ability to use a person's hand to open items in the equipment bag and grasp objects is severely

compromised, as the suits have a three-finger mitten style hand covering which is permanently connected to the arm structure of the suit. The tradeoff between dexterity and hypothermia protection is a design challenge and these suits conform to existing regulations in terms of design and construction. However, the survivors were able to get to the inventory of the equipment pack, launch flares, and signal the rescue helicopter with a flashlight. It appears they successfully completed these tasks despite the difficulty with manual dexterity and the immersion suits functioned as intended protecting them from moderate to severe hypothermia.

Figure 102 – SCANDIES ROSE survival or immersion suit showing the three-finger glove which is attached to the neoprene arm of the suit. The three-finger glove protects the hand from hypothermia but compromises manual dexterity for tasks like opening buckles or activating flares. (Source CG Exhibit 103)

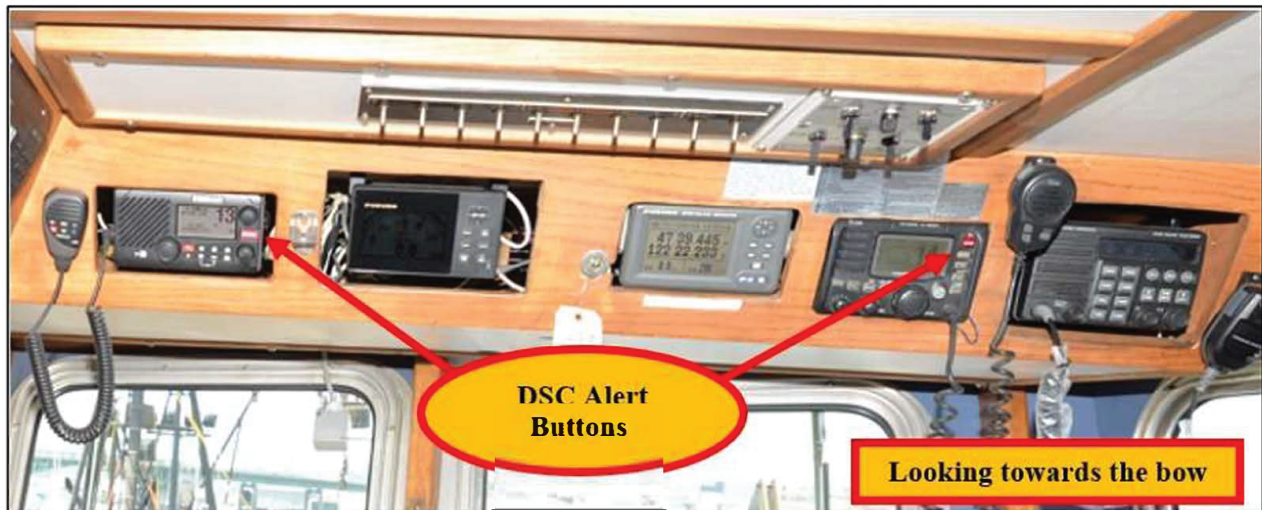
Condition and Valuation Reports for the SCANDIES ROSE included photographs of the vessel's communications equipment. Figure 105, below, shows two VHF radios mounted on the overhead console of the wheelhouse starboard operating station. Both of these radios are models equipped with the DSC feature as indicated by the red "distress" plastic cover on the push button that would then activate the DSC alert. The Marine Board found no evidence that these radios noted figure 105, below, were set up and properly configured with the SCANDIES ROSE's Maritime Mobile Service Identity (MMSI) number²⁶³ and with a GPS input to provide positional information if the feature was used in a distress situation.

Figure 105 – Marine VHF radios above the starboard control station on the SCANDIES ROSE. The red arrows indicate the location of the DSC buttons on each radio. Each radio was manufactured with the DSC feature built in, but there is no evidence that this feature was properly configured with MMSI number and GPS input for use in an emergency. (Source CG Exhibit 004, with mark ups)

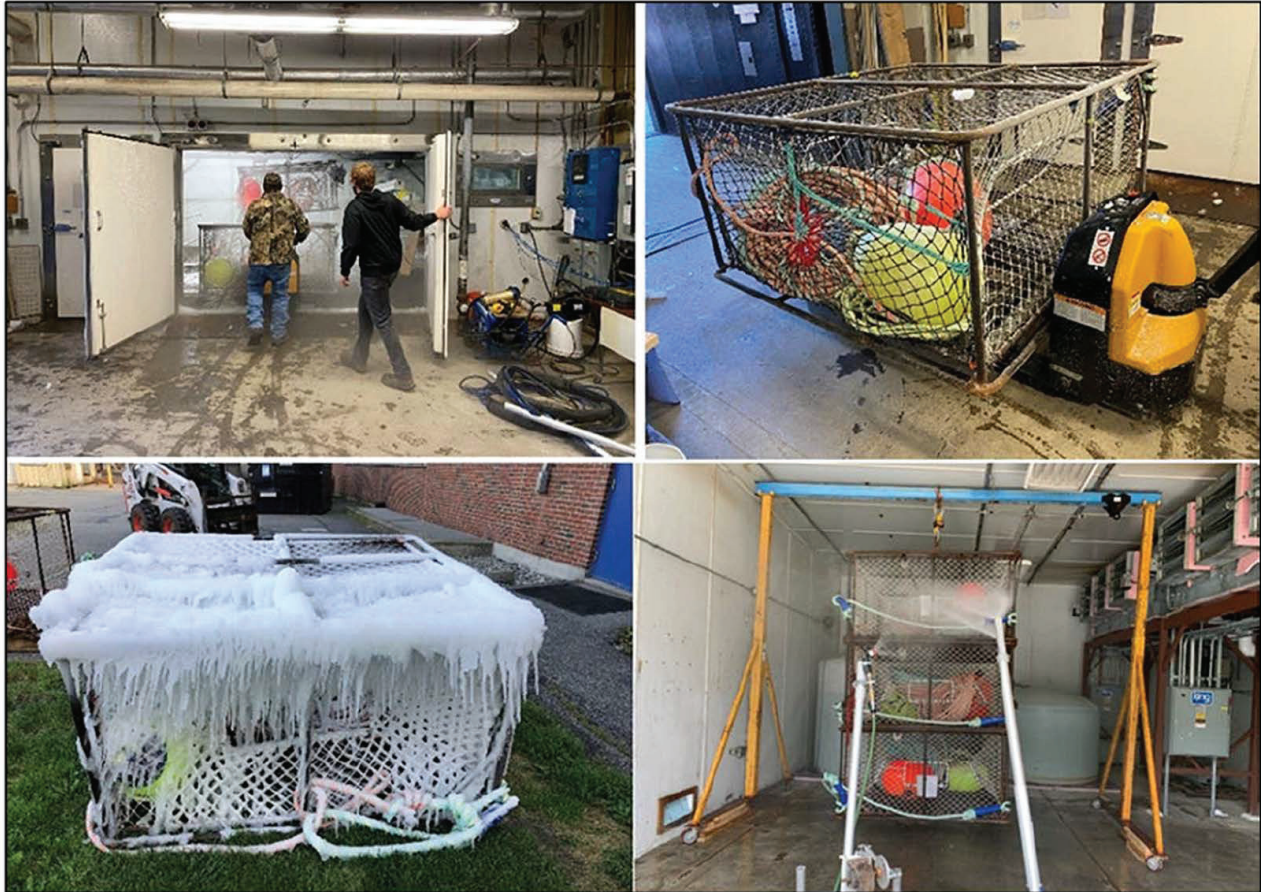
Figure 109 – Testing at the CRREL facility in Hanover, NH in September 2021. In this composite of testing photos, top left two technicians enter the smaller of the two test chambers to set up for two vertical pot stack testing. Top right one of the pots with the associated gear being maneuvered into the test chamber. Lower, left a single pot after removal from the chamber showing the formation of ice on the single pot. Lower right inside the larger chamber with a triple pot stack hanging from the load cell. In the foreground are the two oscillating sprayers directing saltwater spray onto the triple pot stack based on the configuration requirements in the test plan matrix of tests. (Source Coast Guard)

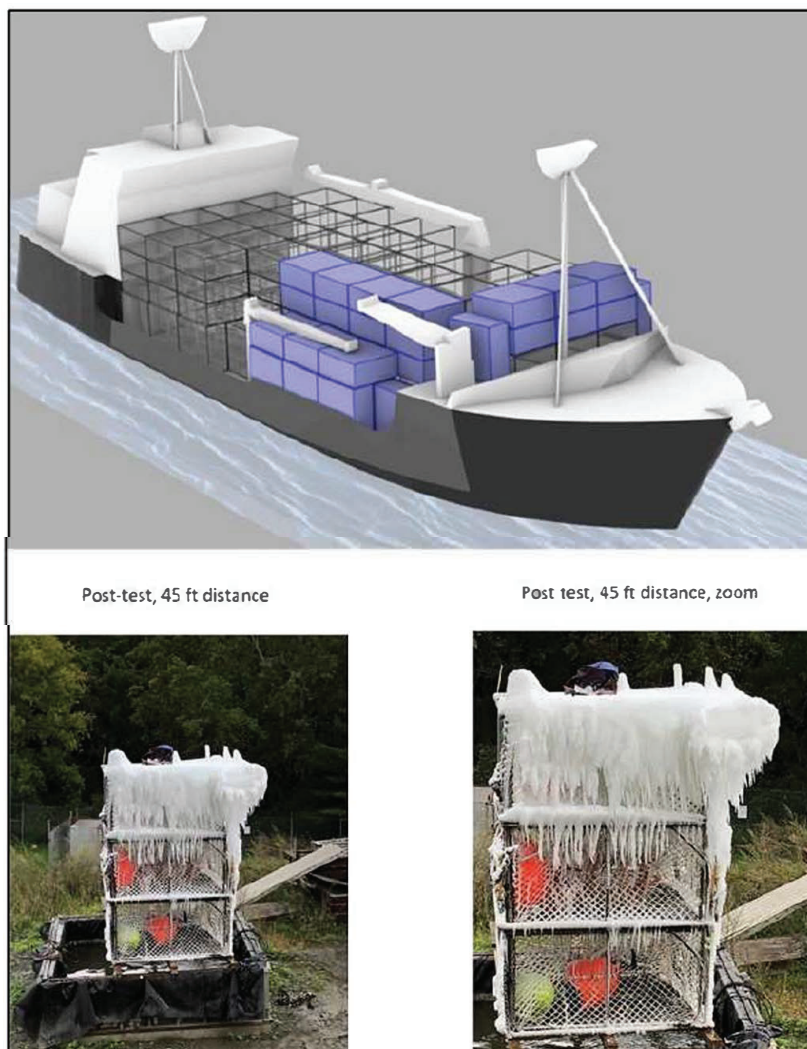
¹⁷³ The MSC provided a comprehensive model of the SCANDIES ROSE potential for asymmetrical ice accretion which can be viewed in the upper image of figure 110. Complete details can be found in CG Exhibit 138.

One of the aspects of this series of experiments was to determine the thickness of ice created by a saltwater spray on crab pots on a vessel. The two survivors testified about ice they saw form on the vessel and the crab pot stacks from their vantage point in the wheelhouse of the SCANDIES ROSE. Onboard the vessel, the distance from the wheelhouse to the forward pot stack would have been approximately 65 ft. At the conclusion of one of the tests on the triple pot stack, the stack was moved outside the chamber and placed approximately 45 feet from the camera and the camera would look at the top of the stack from an angle roughly simulating the viewing angle from the SCANDIES ROSE wheelhouse. In figure 110, below you can see the difficulty of accurately determining the thickness of ice when there is no reference point for the frame of the pots. One can also see an example of how the ice formed vertically in a stack of pots in the test chamber, and, in addition to the accretion on the frame, developed overhanging icicles of three-foot length.

Figure 110 – Top, MSC Model²⁷² of the SCANDIES ROSE which shows distance from the wheelhouse to the forward parts of the vessel and the potential ice load for 24 of the crab pots onboard which would have had the highest exposure to heavy freezing spray, indicated by the purple color. Below left, a triple pot stack when viewed at a distance of 45 feet showing the thickness of ice. Below right, a close up at the same distance showing the type of ice that formed vertically on the mesh and inside the pots. (Source Coast Guard)

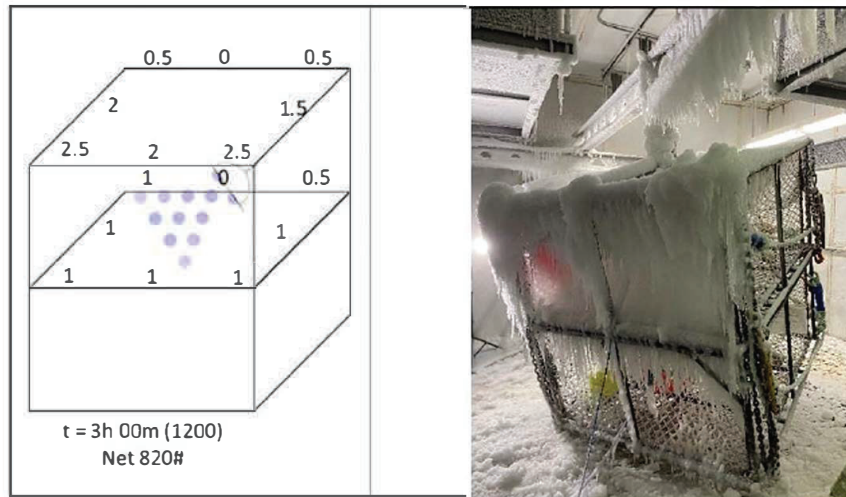
Figure 111 – A double pot stack which was subjected to a side spray of saltwater for a period of three hours, showing a net weight gain of 820 pounds and extensive amount of external ice which included ice on the suspending chains attached to the overhead load cell. In the diagram at the left top, one can see the thickness of ice on top of the pot frame and along the bottom frame as indicated by the associated measurements in inches. (Source Coast Guard)

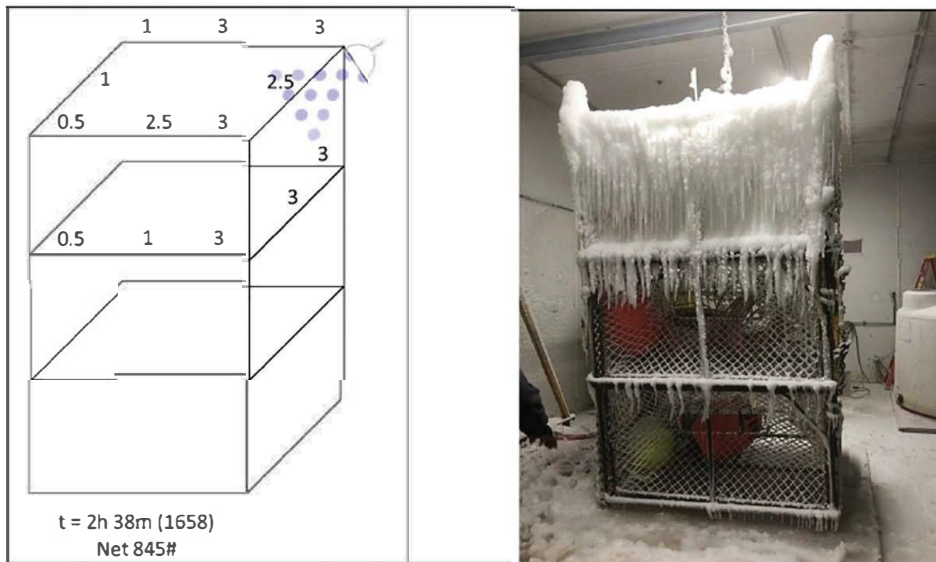
Figure 112 – A triple pot stack which was subjected to a corner spray of saltwater for a period of 2 hours and 38 minutes, showing a net weight gain of 845 pounds and the suspending chains attached to the overhead load cell. In the diagram at the left top, one can see the thickness of ice on top of the pot frame and along the bottom frame as indicated by the associated measurements in inches. (Source Coast Guard)

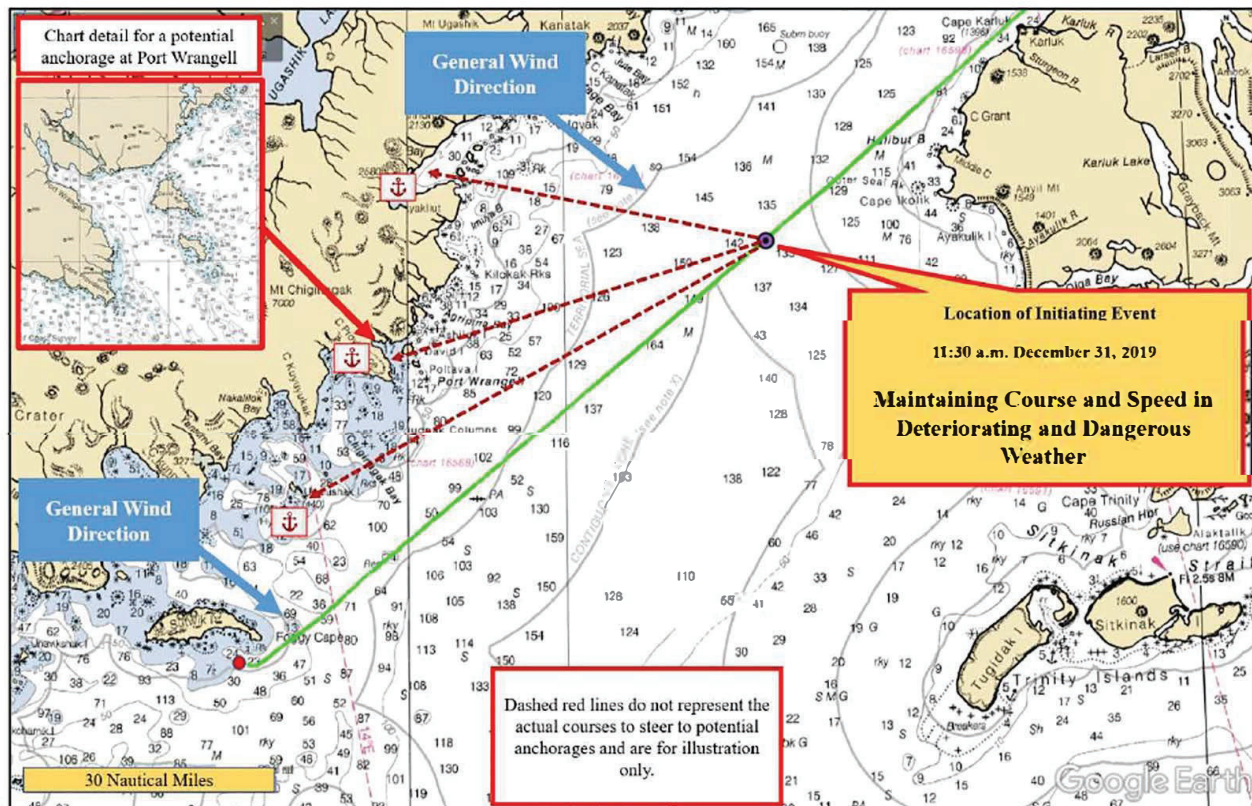
6.1.1. The initiating event for this casualty occurred when the SCANDIES ROSE maintained course and speed in deteriorating and dangerous weather. The Captain of the

SCANDIES ROSE failed to seek refuge as the freezing spray, which was forecasted, and ice continued to form on the vessel during the morning of December 31, 2019. At approximately 11:30 a.m. the vessel continued on its course and speed to the fishing grounds. All of the actions and decisions made by Captain [REDACTED] that caused the SCANDIES ROSE to continue on the intended voyage as opposed to seeking a safe harbor along the route travelled cannot be precisely determined, as the Captain perished in the accident and he did not communicate his reasoning to the surviving crew. Based on the available evidence and analysis, the causal factors were:

Figure 113 – Location of the “Initiating Event” for the accident, the decision point where the Captain of the SCANDIES ROSE maintained course and speed towards False Pass, despite the dangerous anticipated weather, phone call to the AMATULLI, ice having formed on the vessel and pots and daylight to observe his vessel. The red dashed lines indicate potential points where the SCANDIES ROSE might have anchored due to the weather and ice formation which would have afforded the vessel protection from the ice formation. (Source Coast Guard)

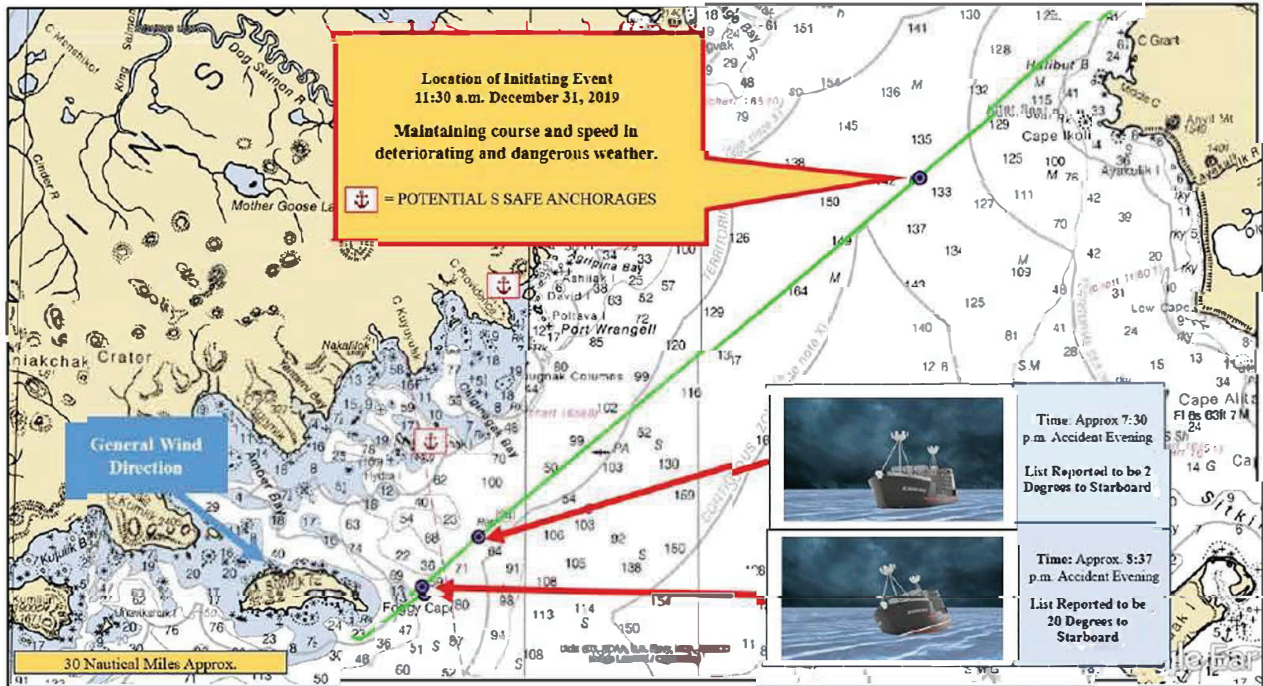
6.1.4. The stability of the vessel continued to degrade and the starboard list increased to 20 degrees. Causal factors associated with the loss of stability were:

Figure 114 – Track of the SCANDIES ROSE on the accident evening with positions for reported two-degree list reported at approximately 7 00 p.m. and then the list of approximately 20 degrees reported at approximately 8 37 p.m. on the accident evening. Insets show the RHINO computer model visualization of the listing vessel superimposed for illustration purposes. (Source Coast Guard)

6.1.4.1. The Captain and crew failed to acknowledge and address that the change in list which went from “a couple of degrees” to the next reported measurement of list of 20 degrees to starboard was an emergency situation.

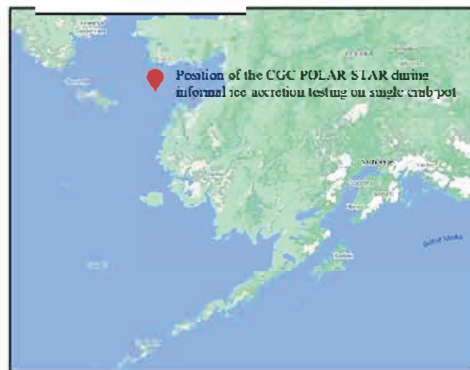
Figure 117 – The symbol on the map indicates the position of the Coast Guard's POLAR STAR when they were conducting the onboard single crab trap icing informal test. The test used freshwater over a 72-hour period with ambient air temperature at approximately 15° Fahrenheit. (Source Coast Guard)

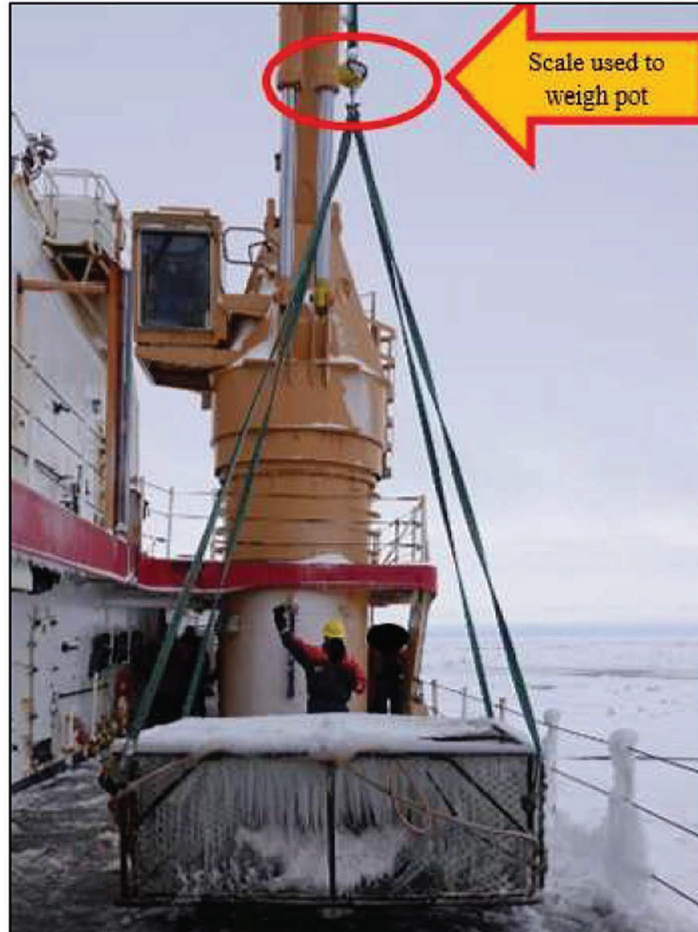
ship's crane with a load cell in the lifting rig capable of weighing an object up to 3,000 pounds. The dry weight of the crab pot and gear at the start of the experiment was just under 1,000 pounds. At the conclusion of the 72-hour period, the pot encrusted with ice exceeded the capacity of the 3,000 pound scale. This non-scientific study was discussed in the MBI Hearing and would lead to a formal scientific study conducted by the RDC.

Figure 118 – The crab pot that was subjected to the freezing freshwater spray is weighed onboard the POLAR STAR at the conclusion of a 72-hour period. The yellow arrow points to the scale mounted in the lifting apparatus. (Source Coast Guard)
