**United States Coast Guard**  
**Office of Investigations and Casualty Analysis**  
**Safety Alerts, Safety Advisories, Lessons Learned**  
**2008-2012**

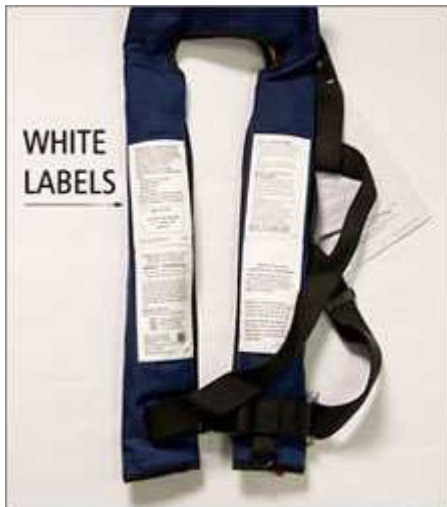
#### **Image 1**

Product with white labels are **not** part of this recall.

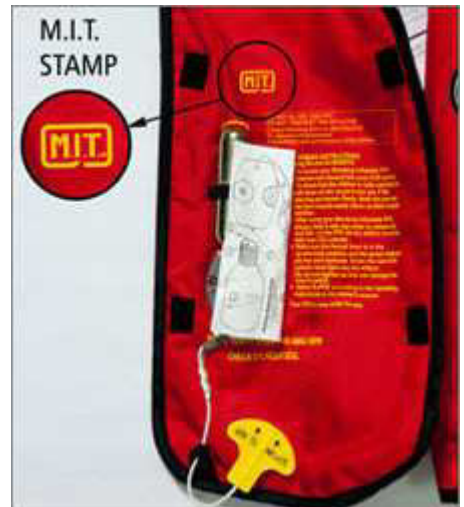
#### **Image 3**

Any MD2010 or MD2012 with an "MIT" stamp is OK to use and does not need to be returned.

**All MD2010 and MD2012 PFD's without the stamped MIT logo as shown in Image 3 (above) should be returned to Mustang Survival for inspection.**

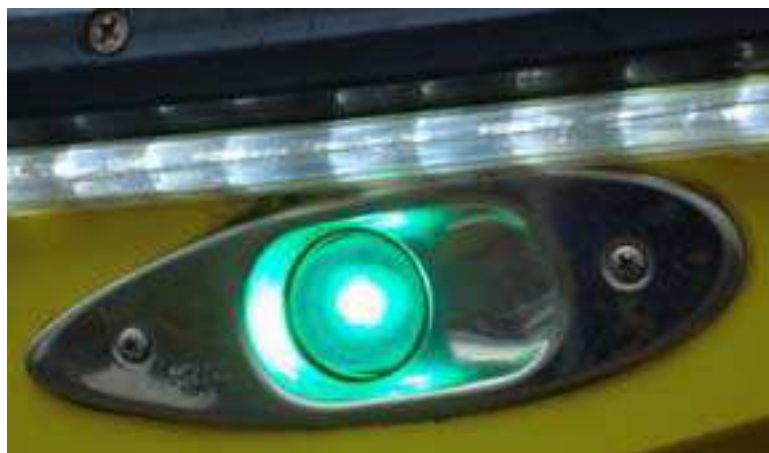
The Coast Guard recognizes that many vessel owners choose to place decorative lights onboard their vessels during the Holiday season. The Coast Guard **strongly reminds** vessel owners not to illuminate such lights during routine navigation unless operating in a Holiday boat parade or when the vessel is secured dockside. This issue was highlighted during a recent casualty whereby the owner of a passenger vessel had installed decorative Holiday type LED (Light Emitting Diode) lighting around the periphery of the vessel. The LEDs were contained in a clear flexible hose and securely attached. Near the bow of the vessel the lighting was adjacent and slightly above the port and starboard navigation lights. At night this installation, can impair the “distinctive character” of the navigation lights as set out in Rule 20 of the Navigation Rules. (Photograph below shows daytime view.)

Additionally, Rule 22 of Navigation Rules states that vessel sidelights have a two mile range for vessels 12 meters or more in length but less than 50 meters in length. In this particular casualty a side light navigation fixture was found installed on the passenger vessel that was stamped 1 nautical mile vice two miles. Vessel owners and operators and marine inspection personnel should ensure that the proper navigation lighting fixtures are installed, that all components operate correctly and that regulatory requirements with respect to Navigation Lighting are met.

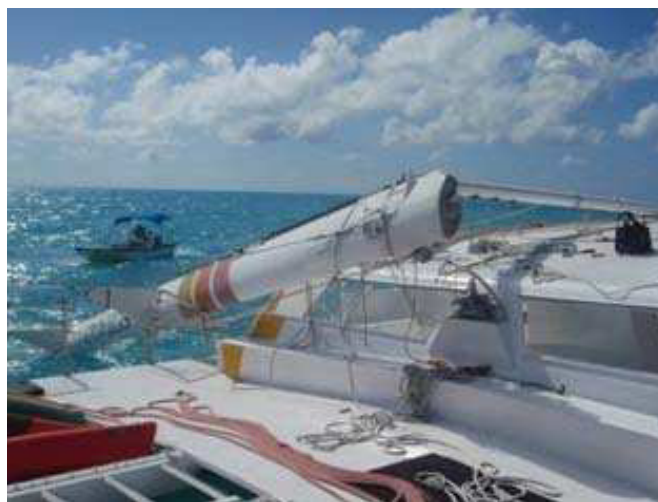
Common among the dismasting casualties was the failure of the mast's standing rigging. While this investigation is ongoing, initial forensic metallurgical analysis of the failed cable strands showed visual corrosion and evidence of fatigue failure. The shroud cable and swageless end fitting had been installed seven years prior.

The Coast Guard **strongly reminds** all commercial vessel owners/operators, especially those of passenger carrying sailing catamaran's of similar build, of their responsibility to maintain their vessels, associated equipment, systems and components in a satisfactory condition suitable for their employed service at all times. Owner and operators should not wait until regularly scheduled Coast Guard inspections to identify problems but should be ever vigilant and implement routine inspection, maintenance, and repair procedures in accordance with good marine practice and in alignment with applicable requirements. Owners and operators should consult the vessel manufacturer or other naval architecture, marine engineering services or qualified rigger regarding any concerns they might have regarding the regular flexing and working of their vessel's standing rigging

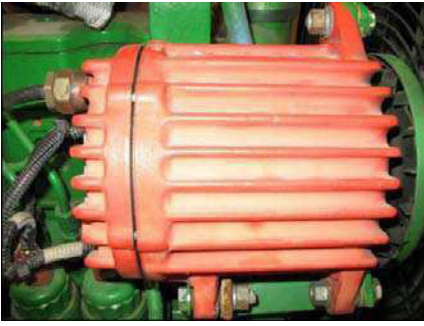
See the photographs below for examples of electrical components on electronically-controlled pump engines that should be examined, repaired or replaced. All electric starters should be removed and replaced with a hydraulic starter with a manual hand pump, or a pneumatic starter with the air compressor located in a non-hazardous location.

**Alternators:** If an alternator is used, it should be an approved flameproof or explosion proof alternator.

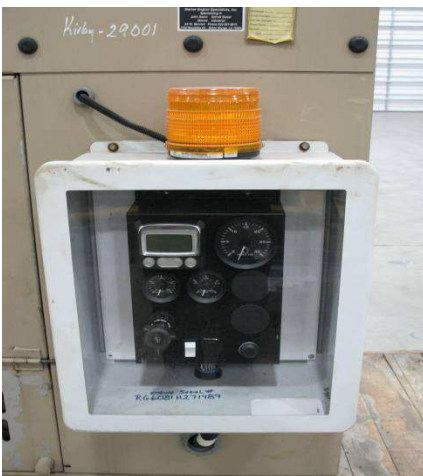
Cable entries on flameproof or explosion proof enclosures require sealing fittings that are suitable for the enclosure.

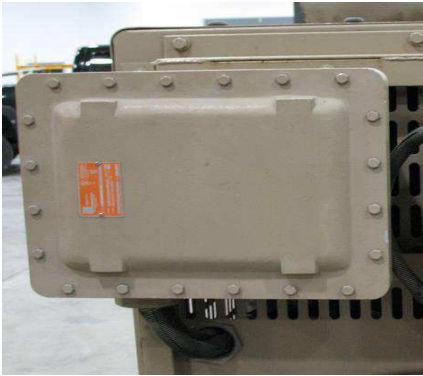
Typical acceptable electronic display – This particular one was approved by the Marine Safety Center (John Deere Part No. RE531478)

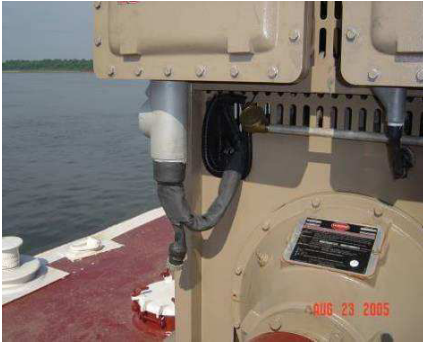
On this particular ECU, a large hole was drilled in the bottom of the enclosure with multiple wiring harnesses coming into it and installed without any sealing compound installed in the cable gland. This is not acceptable in hazardous locations.

**Engine control units (ECU) should be installed in an explosion-proof enclosure or outside the hazardous zone.**

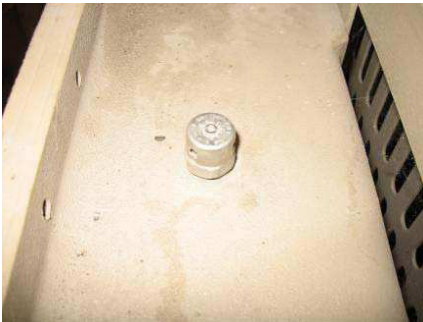
An acceptable engine control unit (ECU) enclosure is shown here with a sealing compound installed in a proper cable gland. Sealing compound poured in the conduit or cable seal fitting should surround each individual insulated conductor and the outer jacket of the cable, unless the cable is gas tight. Cables should be prevented from being pulled out of the conduit or cable seal fitting.

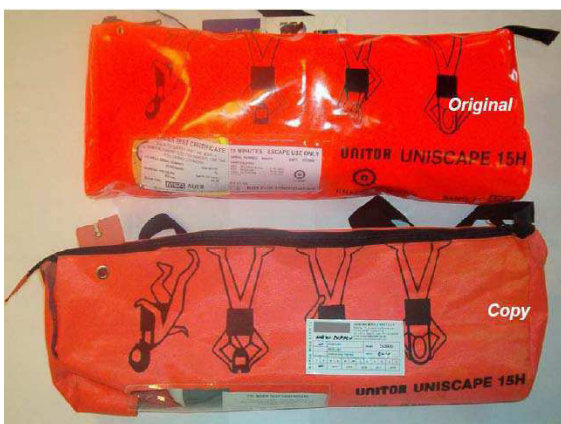
An authentic Unitor UNISCAPE 15H is contained in a shiny PVC bag. When viewed from the front with the instruction icons upside down, the zipper opens from left to right, and at the most left section of the zipper is a two centimeter gap covered by a clear tab that has a button closure.

The **fake reproduction** is contained within a **dull canvas-like** material bag. When viewed from the front with the instruction icons upside down, the **zipper opens from right to left**, and at the most left section of the zipper there is no opening, although a tab made of what appears to be the same material of the bag is present with a button closure. This unit will not automatically activate.
