UNITED STATES COAST GUARD

REPORT OF THE INVESTIGATION INTO THE

COMMERCIAL FISHING VESSEL CAROL ANN (O.N. 906483), PRESUMED LOSS OF
LIFE AND TOTAL LOSS OF VESSEL NEAR BRUNSWICK, GA, ON
OCTOBER 14, 2023.

SINKING OF THE COMMERCIAL FISHING VESSEL CAROL ANN (O.N. 906483) AND PRESUMED LOSS OF THREE LIVES NEAR BRUNSWICK, GEORGIA ON OCTOBER 14, 2023

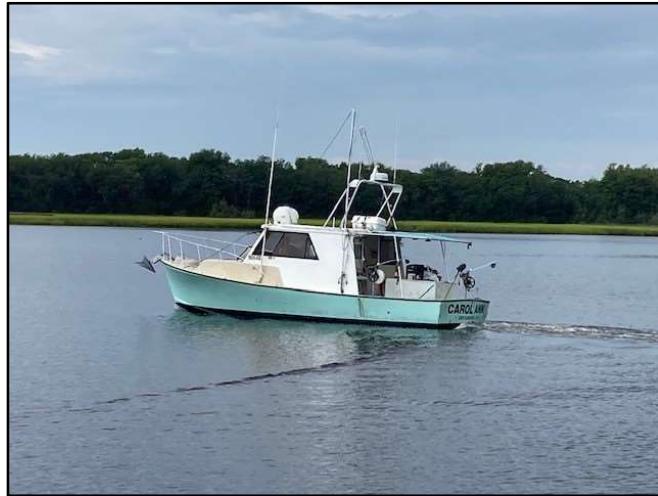
Figure 1: Photograph of F/V CAROL ANN taken August 16, 2023. Source: USCG

5.15.1 Fire: The engine of the F/V CAROL ANN caught fire offshore resulting in the sinking of the vessel and subsequent disappearance of the crew members. The recovered fish box was part of the F/V CAROL ANN and showed no signs of fire and/or smoke damage. Pictures of the vessel and the description from the owner place the fish box on the stern of the vessel aft of the engine compartment. See Figures 1, 3, 5, and 13.

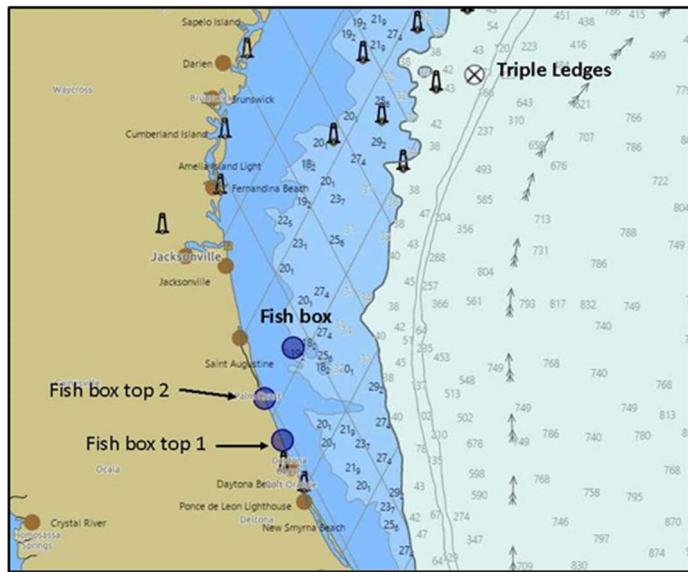
Figure 12: Location of fish box, lids, and likely fishing grounds. Source: USCG.

4.2.9.2 No other debris collected could be positively identified as belonging to the F/V CAROL ANN.
