**UNITED STATES COAST GUARD**

**REPORT OF THE INVESTIGATION  
INTO THE  
FIRE AND SUBSEQUENT LAND-BASED FIREFIGHTER  
FATALITIES ONBOARD GRANDE COSTA  
D'AVORIO (9465382) WHILE CONDUCTING CARGO  
OPERATIONS AT BERTH 18, PORT NEWARK, NEW  
JERSEY ON JULY 5, 2023**

16732/IIA #7735267  
03 Dec 2025

**FIRE AND SUBSEQUENT LOSS OF TWO LAND-BASED FIREFIGHTER LIVES  
ABOARD THE ITALIAN FLAGGED ROLL-ON ROLL-OFF/CONTAINER VESSEL  
GRANDE COSTA D'AVORIO (IMO# 9465382) WHILE CONDUCTING CARGO  
OPERATIONS AT BERTH 18, PORT NEWARK, NEW JERSEY ON JULY 5, 2023**

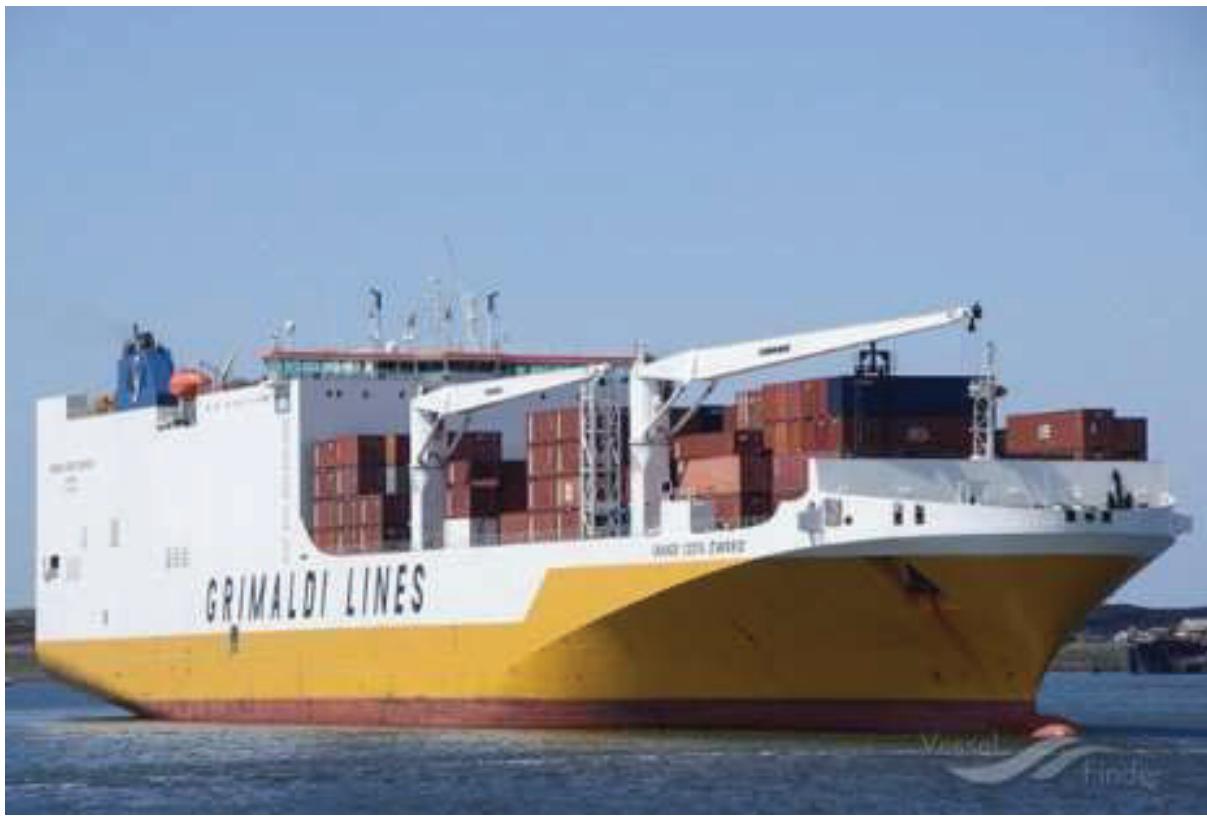
Figure 1. Photograph of GRANDE COSTA D'AVORIO pre-incident from [www.VesselFinder.com](http://www.VesselFinder.com).

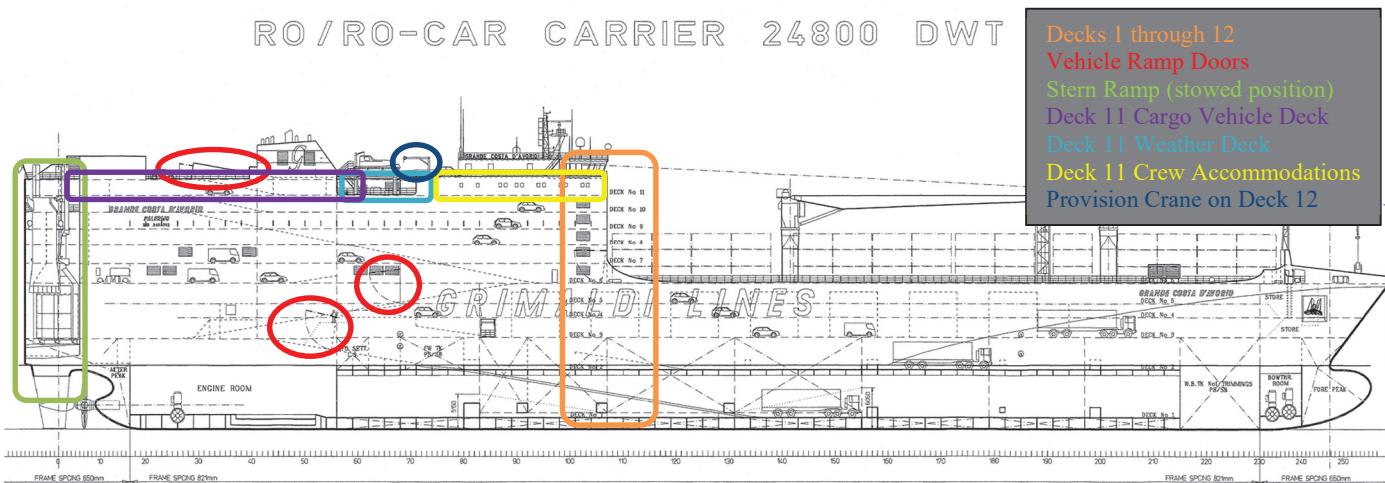
Figure 7. General arrangement of GRANDE COSTA D'AVORIO. Developed by Coast Guard Investigators.

4.2.1.3.5. *WTD-12*. The vessel had a hydraulically actuated WTD at the top of the vehicle ramp from deck 11 to deck 12 as indicated by the red circle on deck 12 in Figures 7 and 8 and pictured in the following Figure 10. This door was opened at 0554 after the vessel arrived in port and remained open throughout the loading of the vessel and the incident. No policy or regulation existed to prohibit this door from remaining open while not in use in port and this was common practice throughout the Ro-Ro industry. IMO regulation only required this door to be closed before proceeding to sea and at all times while underway. The door functioned to close-off and protect the vehicle ramp and cargo vehicle garage spaces from weather while at sea. It was considered a watertight door by the vessel's Damage Control Plan<sup>37</sup> and served as part of the boundary for sealing Fire Protection Zone C.

*5.8. Lack of Duplicate WTD-12 Controls.* WTD-12 was located on the top weather deck of the vessel along the port side at the top of the ramp that provided vehicle access from deck 11 to deck 12 (see Figures 7 and 8). It served to close-off the vehicle ramp and cargo vehicle garage spaces from weather while at sea. It further served as the top-most exterior boundary to the low-pressure CO<sub>2</sub> fire suppression system’s Fire Protection Zone C. The door was designed and constructed to have a single set of operating controls located just inside the door slightly down the ramp. To open or close the door, the operator had to insert a key and keep the corresponding button on the control panel depressed until the door reached the desired position. As a result, operation could only occur from within Fire Protection Zone C. The ICLL in effect at the time of the vessel’s construction required doors located on the ends of superstructures to be weathertight and have operating controls located on both sides of the door. Further, SOLAS Chapter II-2 in effect at the time of the vessel’s construction required that doors creating boundaries for CO<sub>2</sub> protected spaces have the capability of being closed from outside the space. When queried as part of this investigation, the classification society,

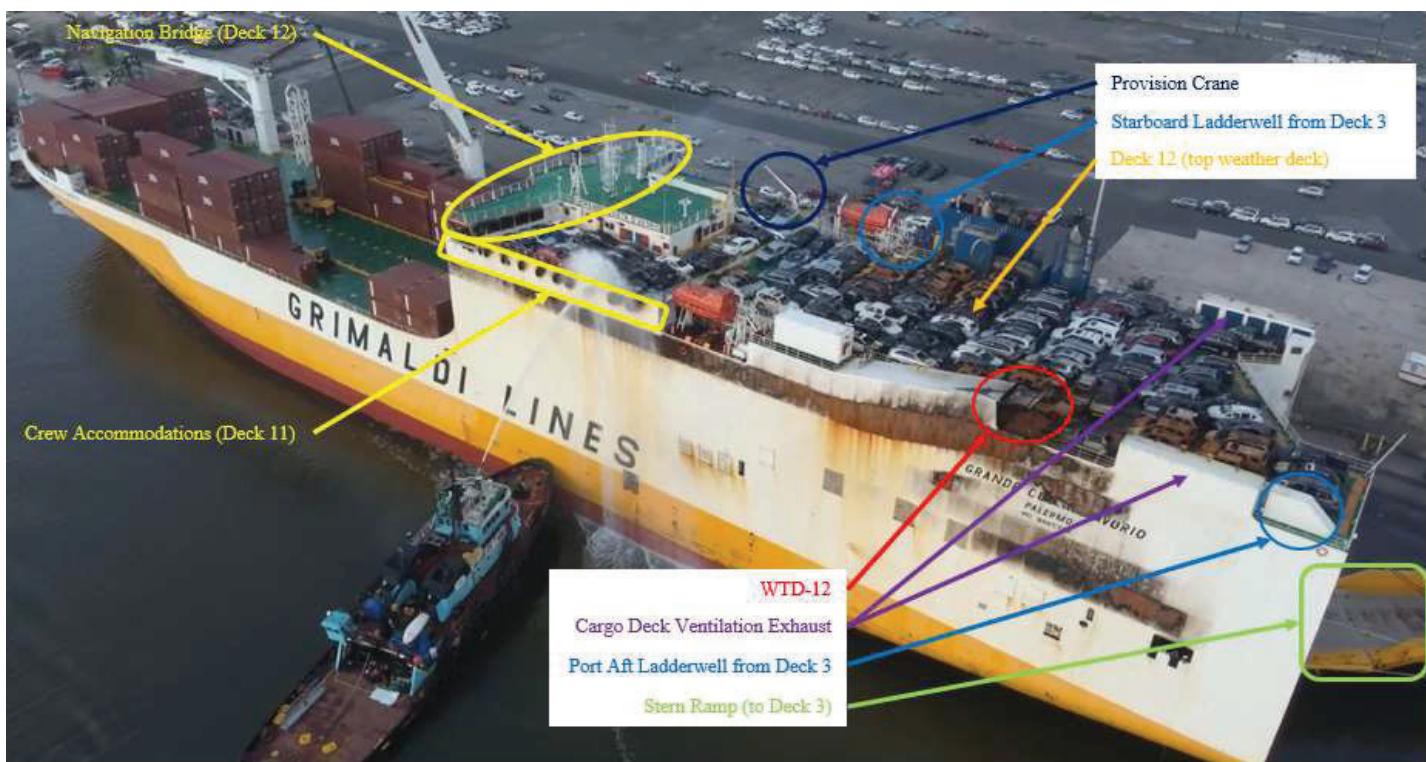
Figure 8. Port aspect of GRANDE COSTA D'AVORIO post-fire indicating significant areas of the vessel. Developed by Coast Guard Investigators.

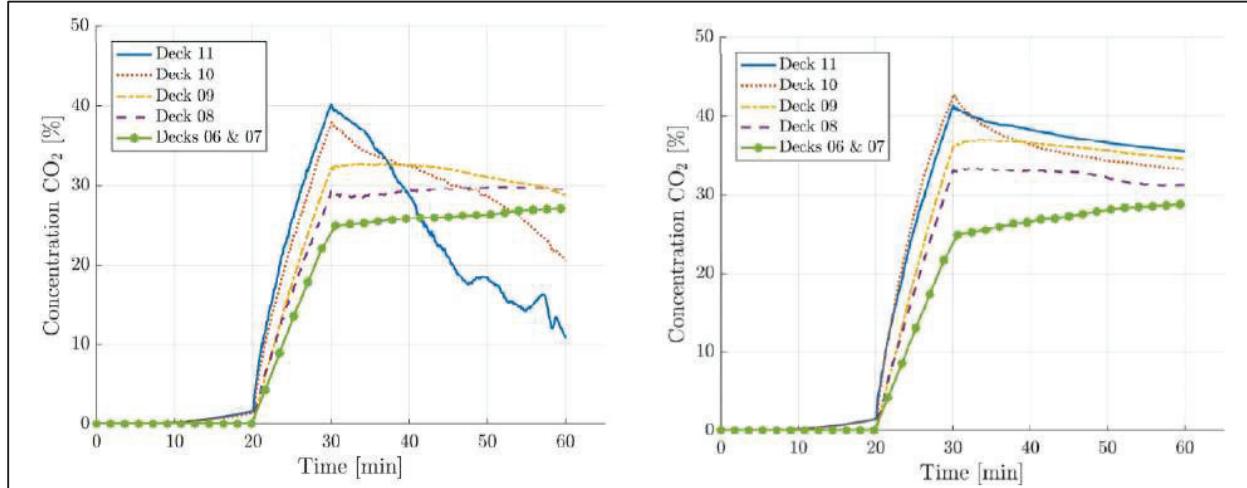
Figure A3. Scenario 1 model - Average CO<sub>2</sub> gas concentrations on each deck.

Figure A5. Scenario 2 model - Average CO<sub>2</sub> gas concentrations on each deck.
