**REPORT OF THE INVESTIGATION
INTO THE
COLLISION BETWEEN CGC WINSLOW GRIESSER
(WPC-1116) AND COMMERCIAL FISHING VESSEL
DESAKATA WITH LOSS OF LIFE OFF THE COAST OF
DORADO, PR AUGUST 8TH, 2022**

**THE COLLISION BETWEEN U.S. COAST GUARD CUTTER WINSLOW GRIESSER
(WPC-1116) AND COMMERCIAL FISHING VESSEL DESAKATA WITH THE LOSS
OF ONE LIFE OFF THE COAST OF DORADO, PUERTO RICO ON AUGUST 8, 2022**

INVESTIGATING OFFICER'S REPORT

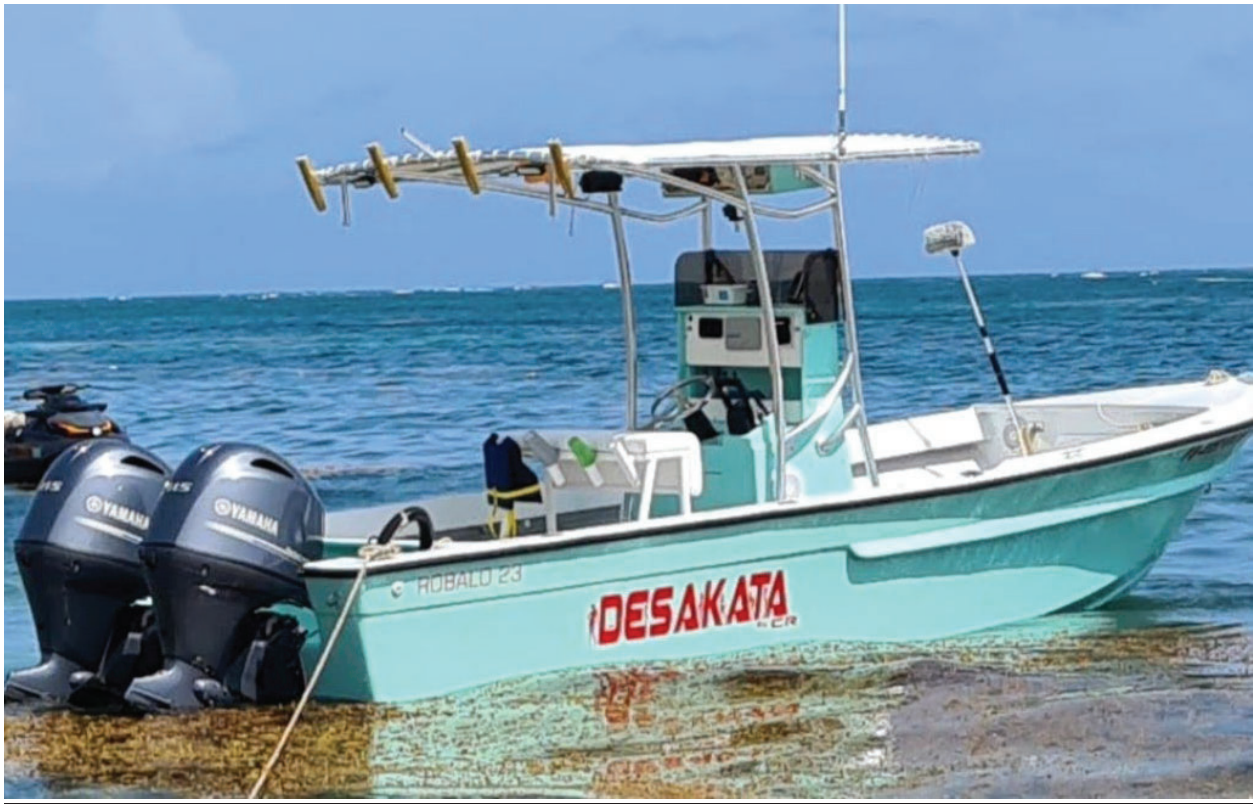
Figure 2. Center – Console boat DESAKATA before collision. (Source: Samuel Rosario)

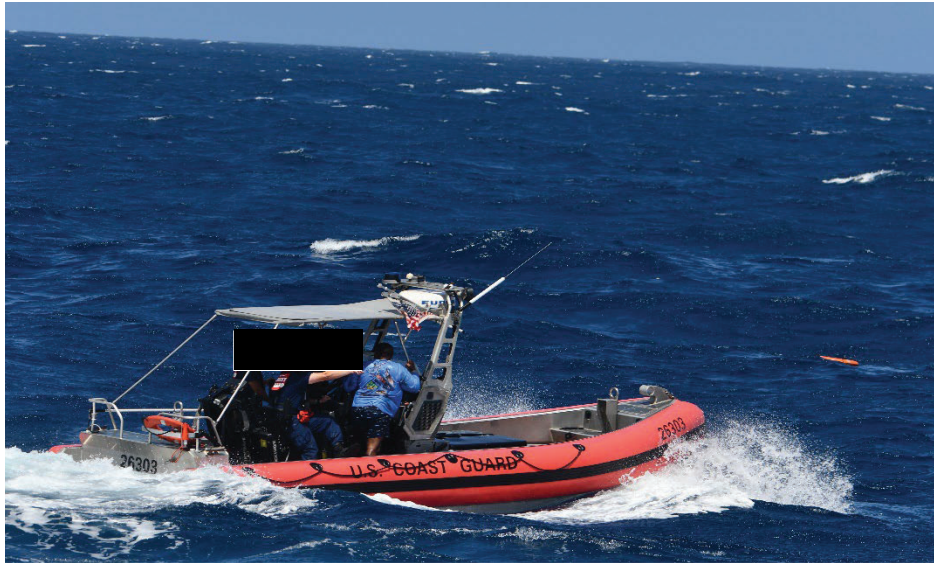
3.1.26. At approximately 1426, WINSLOW GRIESSER launched the Over the Horizon (OTH) cutter boat and recovered both of DESAKATA's injured personnel from the water.

Figure 9. The OTH heading back to WINSLOW GRIESSER after recovering the two persons in the water.

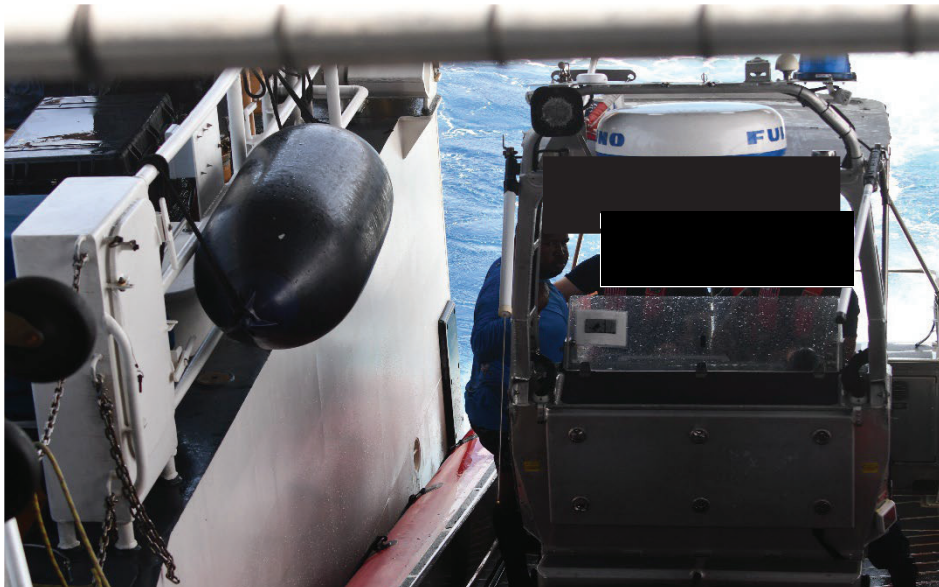
3.1.27. At approximately 1435, the OTH was recovered by the cutter after several failed attempts due to the sea stake.

Figure 10. OTH was recover by WINSLOW GRIESSER after recovering the two persons from the water.

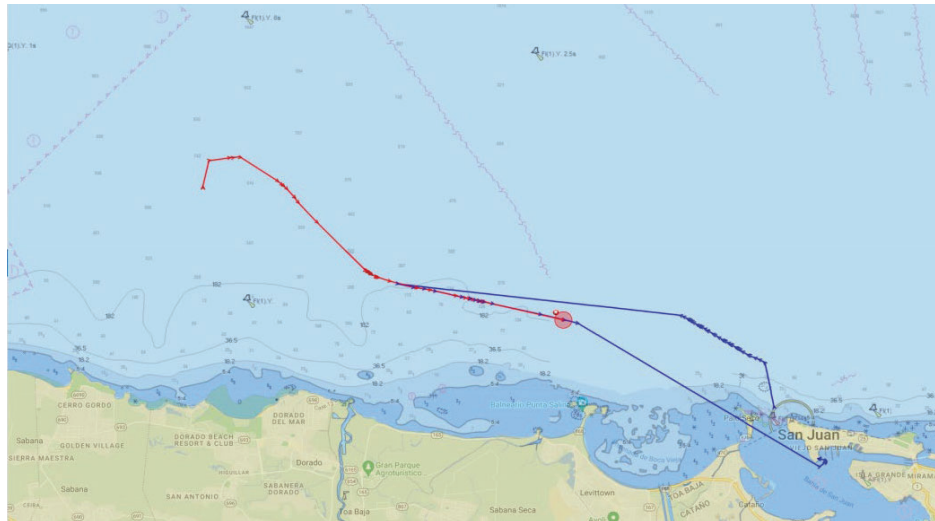
3.1.29. At approximately 1440, WINSLOW GRIESSER departed the scene to begin an emergency transit to San Juan Harbor.

Figure 11. Complete trackline of WISLOW GRIESSER on the day of the collision. (Source: Coast Guard)
