**UNITED STATES COAST GUARD**

**INVESTIGATION INTO THE CIRCUMSTANCES  
SURROUNDING THE SINKING OF THE**

# **F/V LADY MARY**

**65 NM SOUTHEAST OF CAPE MAY, NEW JERSEY ON  
MARCH 24, 2009, WITH MULTIPLE LOSS OF LIFE**

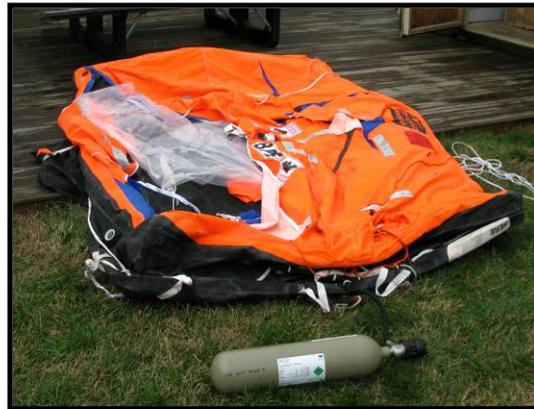
**Figure 7: Recovered LADY MARY life raft**

(3) The Rescue Swimmer was lowered to the water by a harness. Once in the water, he disconnected from the hoist cable and swam to the life raft, but did not find anyone inside. The Rescue Swimmer did see two paddles, a big survival kit, and a blue case, but he could not say for certain whether or not the EPIRB was in the life raft. The Rescue Swimmer recorded the life raft’s make, model and serial number to help identify the owner, since there were no obvious markings that would have linked it to the

LADY MARY. In accordance with standard procedures, the Rescue Swimmer punctured the life raft with his knife in an attempt to scuttle it and prevent it from becoming the source of another report. The life raft deflated but did not sink. Seeing that the life raft was still afloat, the Pilot flew the helicopter directly over the top and attempted to

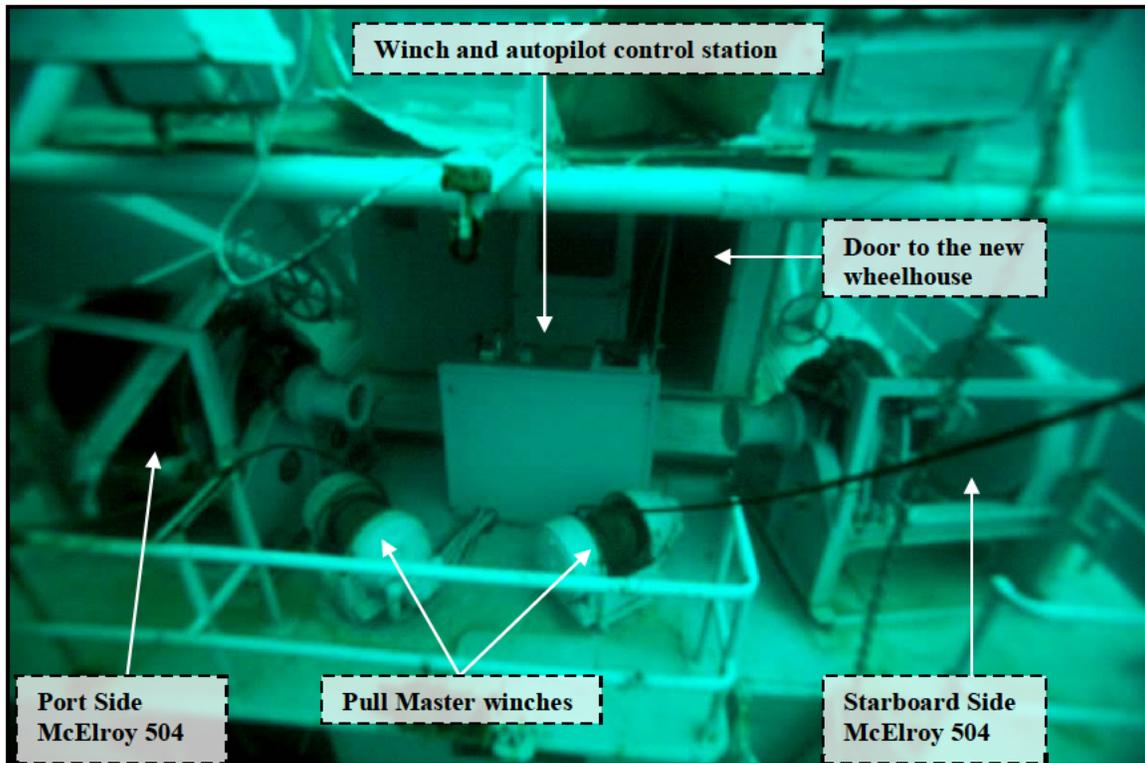
Figure 3: Winch deck of the sunken LADY MARY

(5) Before the vessel was purchased by Smith & Smith Inc., the main haul back winch was located on the main deck, on centerline, and aft of the existing deckhouse. The winch was a 504 double drum McElroy. This winch was not onboard when the vessel was purchased by Smith & Smith Inc. in 2001. After the shucking house was added to the LADY MARY, two 504 McElroy single drum winches were placed on the top of the shucking house, just aft of the new wheelhouse, and canted outboard to line up with the blocks hanging from the gallows as shown in Figure 3. The winches were placed on top of the shucking house, purportedly to improve safety, by ensuring that the crew would not come in contact with the scallop dredge cable during operations.<sup>150</sup> An aft facing console was installed between the two winches, with controls for the winches and engines.<sup>151</sup>

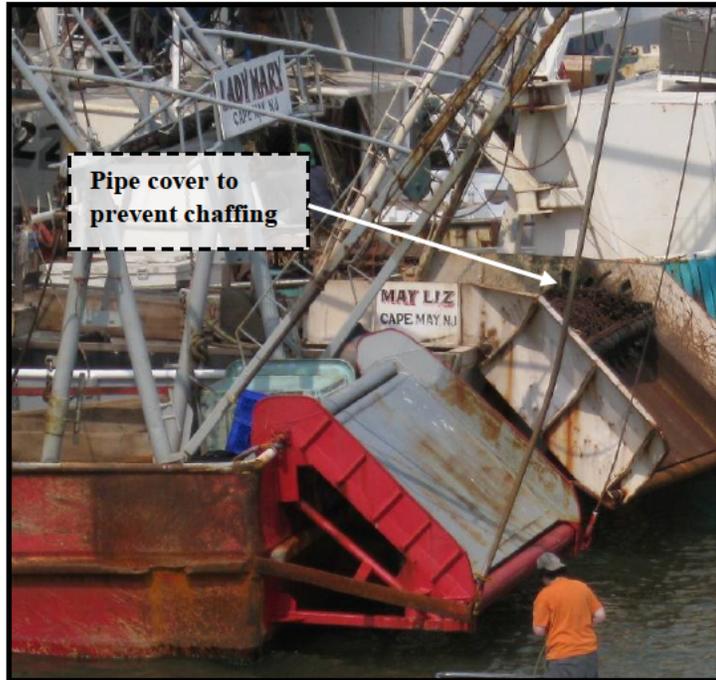
Figure 4: LADY MARY stern ramp, August 25, 2008

(12) The Shore Manager testified that in late summer 2006, a ramp was added on to the stern of the LADY MARY while she was moored in Cape May, NJ. See the adjacent Figure. The stern ramp was constructed of 5/16" steel plate, and was 16' wide by 6' tall. The bottom of the stern ramp was supported by 4" X 4" schedule 80 steel supports. These supports were welded directly to the transom, without doublers, and braced with gussets. An additional 1" X 6" flat bar was added on each side of the vessel from the rub rail on the aft corner to the bottom corner of the stern ramp. The purpose of these flat bars was to

keep the dredge from catching on the roller pins at the bottom corners of the stern ramp. The Shore Manager stated that the purpose of the ramp was to guide the scallop dredge over the transom and onto the main deck during the haul-back. The Shore Manager reported that the LADY MARY's draft increased about 1" due to the addition of the ramp. He felt this was a safer alternative to lifting the dredge and chain bag over the port side bulwarks because the stern ramp haul-back operation did not involve lifting the dredge into the air and prevented the dredge from swinging and spinning.<sup>160</sup>

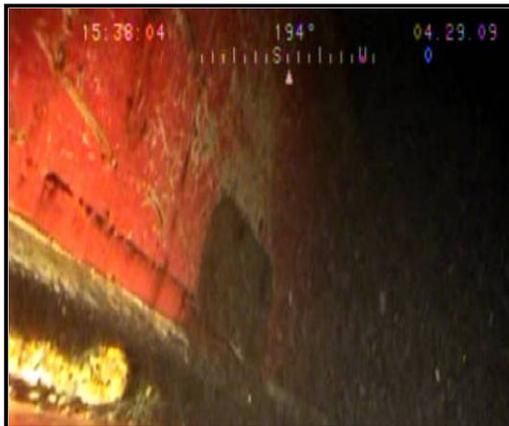
**Figure 10: Port forward freeing port**

(8) The LADY MARY’s main deck bulwarks were approximately 3.5’ high and contained four freeing ports for the aft section of the main deck, two on each side. The freeing ports were 21” long and there was a metal plate chained near each freeing port. When the crew brought up a load of scallops, they slid these metal plates into guide rails which held the plates over the freeing port openings. This prevented scallops from being washed overboard.<sup>186</sup>

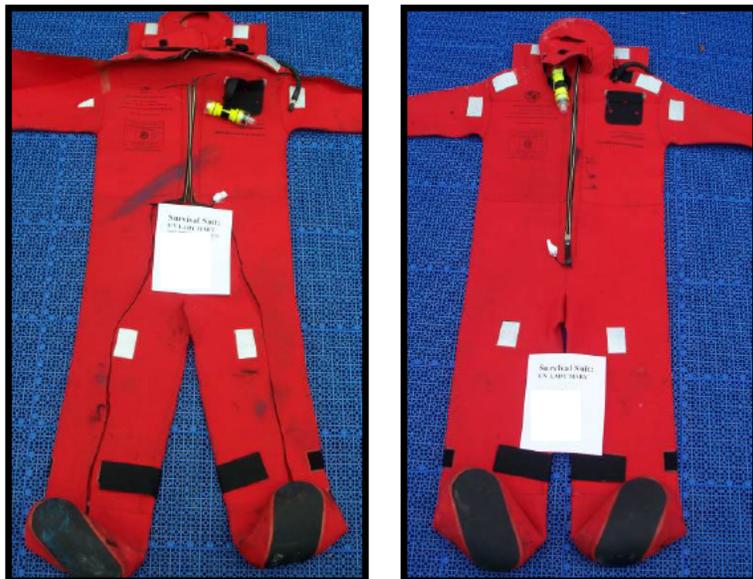
**Figure 20: The Captain's and Survivor's survival suits**

“one very small leak in the seam of the zipper.” The Captain's survival suit was cut when it was removed for the Medical Examination and could not be tested, but appeared to be in good condition. The Survivor's suit and the Captain's suit were Sterns Cold Water Immersion Suits, labeled as Adult Universal size. Deckhand 1's survival suit was disposed of in a biohazard bin at the Medical Examiner's office, and

could not be recovered for examination.<sup>218</sup>

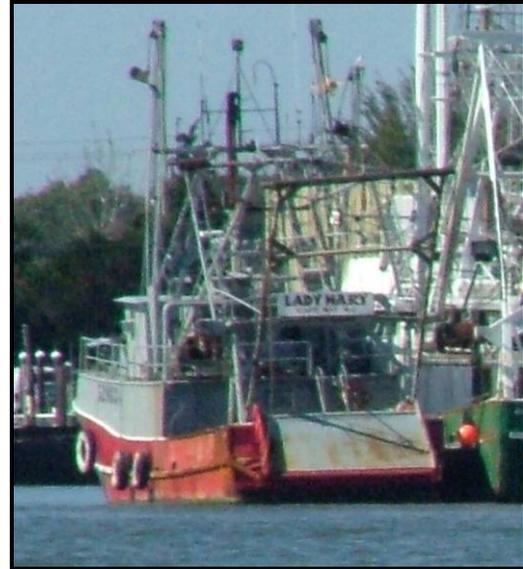
Figure 23: Stern view from October 2008

(2) The Previous Captain only used the stern ramp twice. The first day that he used it, the vessel caught just as many scallops as normal. On the second day, the scallop dredge flipped over a few times during the haul-back, and the Previous Captain felt that the stern ramp recovery was taking too long and losing him money. The Previous Captain decided not to use the stern ramp any more.<sup>281</sup>

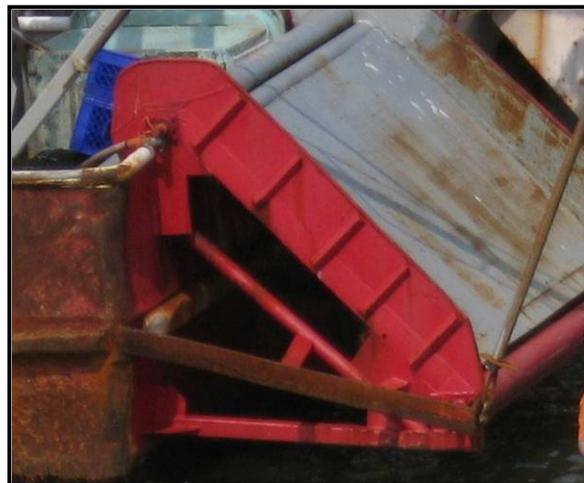
Figure 24: Stern ramp showing flat bar

(4) There was a 1" X 6" flat bar on each side of the vessel, from the rub rail on the aft corner to the bottom corner of the stern ramp. The purpose of these flat bars was to keep the dredge from catching on the roller pins at the bottom corners of the stern ramp when the dredge was being deployed over the side bulwarks. If the dredge caught on the roller pins, it would flip over.<sup>283</sup>

(5) In an interview, the Survivor stated that it was not uncommon for the scallop dredge and the dredge towing wire to come in contact with the stern ramp or get caught under the stern ramp during recovery. Sometimes the scallop dredge was even brought on deck while the dredge towing wire remained stuck on the stern ramp.<sup>284</sup>

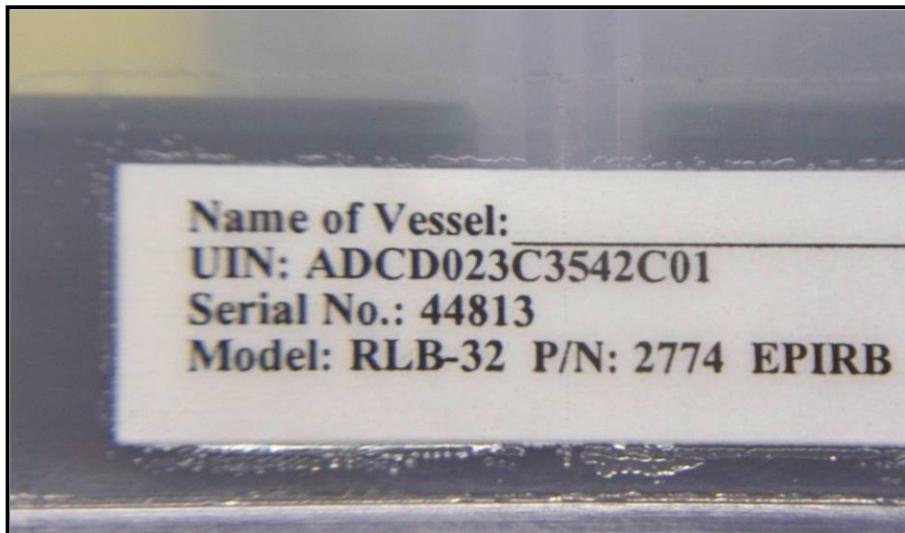
Figure 25: Specifications affixed directly on the EPIRB by the manufacturer

(2) During the LADY MARY's final voyage, the requirements described above were met with an ACR Electronics EPIRB, mounted in a hydrostatic release bracket located just forward of the new wheelhouse. Some of the EPIRB specifications were affixed directly to the beacon by the manufacturer. The full details of the EPIRB specifications are listed in the Table at the bottom of the page.<sup>294</sup>

Brand name	ACR Electronics
Model	RLB-32
Unique Identification Number	ADCD023C3542C01
Serial Number	44813
FCC ID Type Approval Number	B668L2ACR-RLB-32
Battery Expiration Date	9/2011

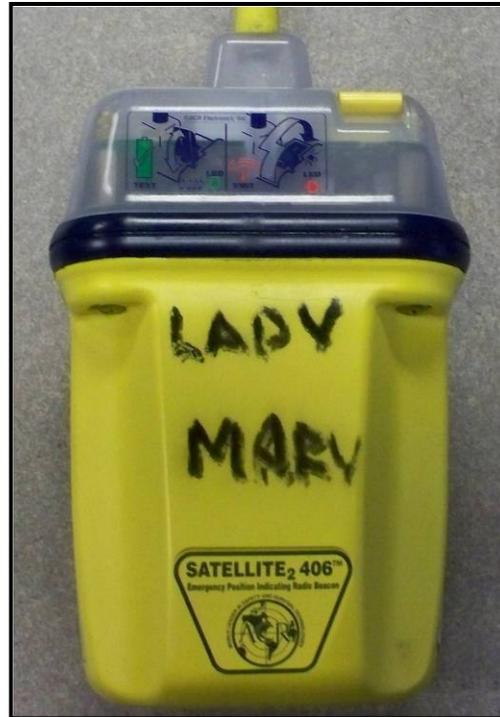
Figure 26: LADY MARY EPIRB

(5) The EPIRB on the LADY MARY did not have an internal GPS transponder or an external GPS interface. This was an optional feature offered at the time of purchase. When an EPIRB is equipped with a GPS, the distress alert sent by the unit will include a self identified position, along with the unique identification number of the unit. If a 406MHz EPIRB is not equipped with a GPS, the location of the unit is identified by the satellite system which detects the signal. The CFR does not require a Category 1 406MHz EPIRB to be equipped with a GPS.<sup>297</sup>

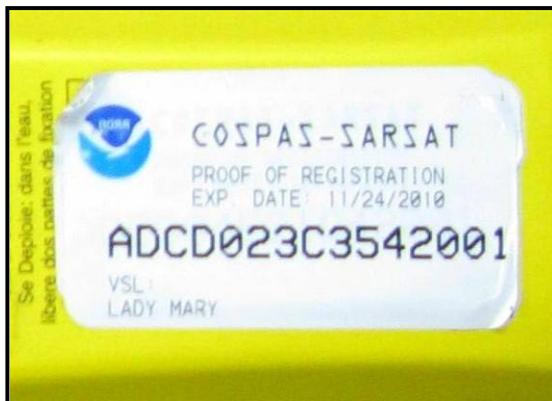
**Figure 28: EPIRB Proof of Registration Decal**

(8) On November 25, 2008, NOAA SARSAT mailed another letter to Smith & Smith Inc. This letter thanked them for renewing the EPIRB's registration and indicated that the information was entered into the NBR database. The letter included a new printout of the recorded information and a new decal. The decal mailed with this letter was affixed to the LADY MARY's EPIRB, on top of the other two decals, and had an expiration date of 11/24/2010. This decal lists the UIN of ADCD023C3542001, which is the same incorrect UIN that was originally entered into the NBR database in January 2008.<sup>307</sup>

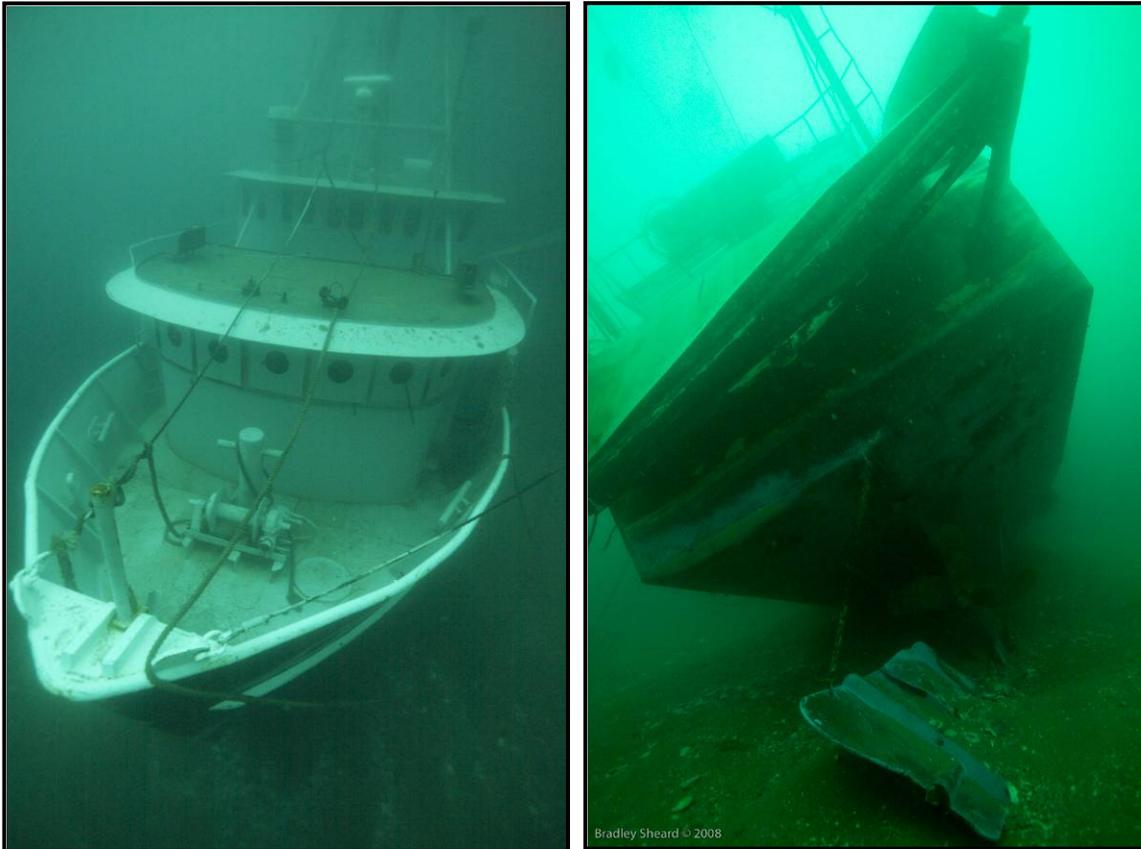
**Figure 31: Bow and stern views of the sunken LADY MARY**

(1) The sunken LADY MARY was located in position 38° 35.713'N, 073° 41.463'W. The heading of the vessel was approximately 350 degrees true, and the depth of water was 210'. The vessel was resting on her keel, and listed to port with the chine resting on the ocean floor. The angle of the main deck, as the vessel rested on the bottom, was 50° from the horizontal.<sup>326</sup>

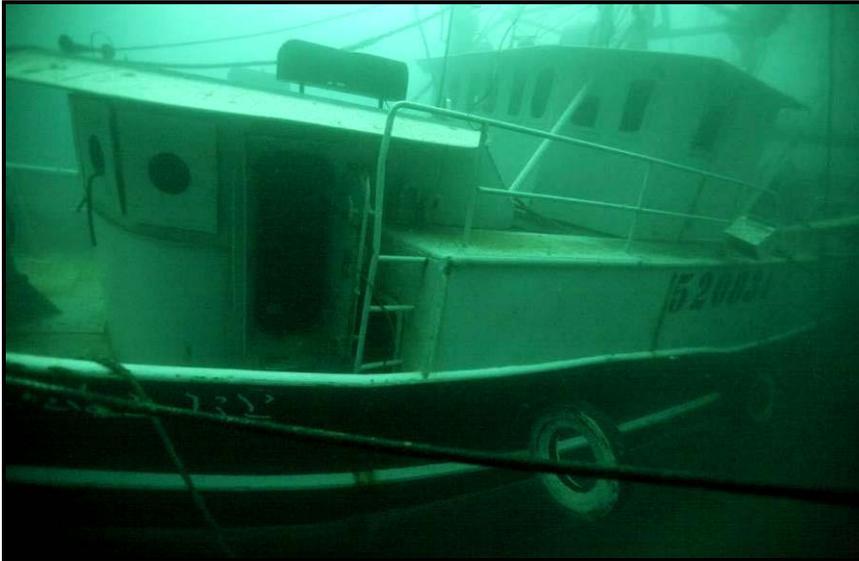
**Figure 32: Port bow of the sunken LADY MARY**

(2) Beginning at the bow of the LADY MARY, there was no anchor visible anywhere on the foc'sle of the vessel. The Shore Manager testified that there was an anchor onboard when the vessel departed Cape May on March 18, 2009.<sup>327</sup> When the LADY MARY sank, both of the watertight doors to the old wheelhouse were dogged shut. The lead commercial diver testified that his team could not open the starboard door and that the port door was only held closed by one dog (out of four total dogs). The commercial diver testified that one of his team members opened the port door and entered the old wheelhouse. From inside the old wheelhouse, the diver swam aft into the galley and then checked the forward portion of the port passageway. The aft portion of the port passage

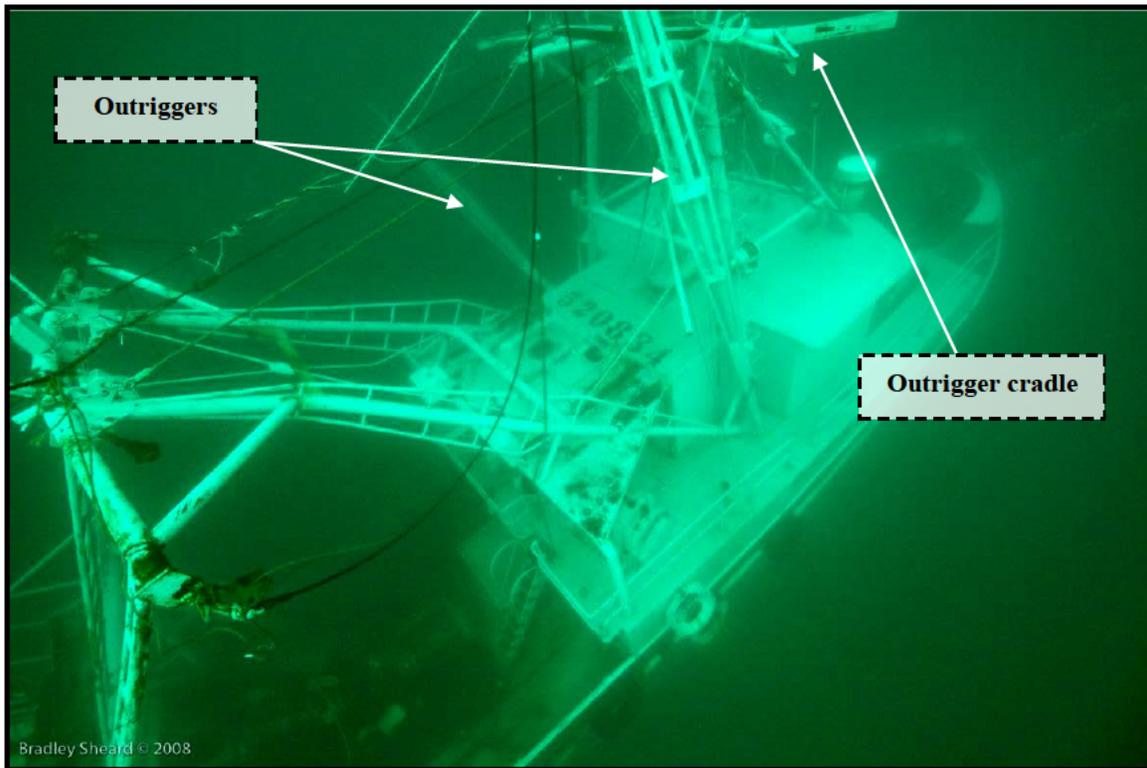
**Figure 34: View of the sunken LADY MARY from above**

(3) The commercial diver testified that the LADY MARY's outriggers were in good condition. The port outrigger was down, with the port stabilizer (bird) hanging only a couple of feet below the end of the outrigger. The starboard outrigger was up, but it was not resting in the cradle attached to the mast – it was aft of the cradle. The starboard bird

was found resting on the main deck of the vessel, attached to the end of the outrigger with a long length of chain and wire.<sup>329</sup>

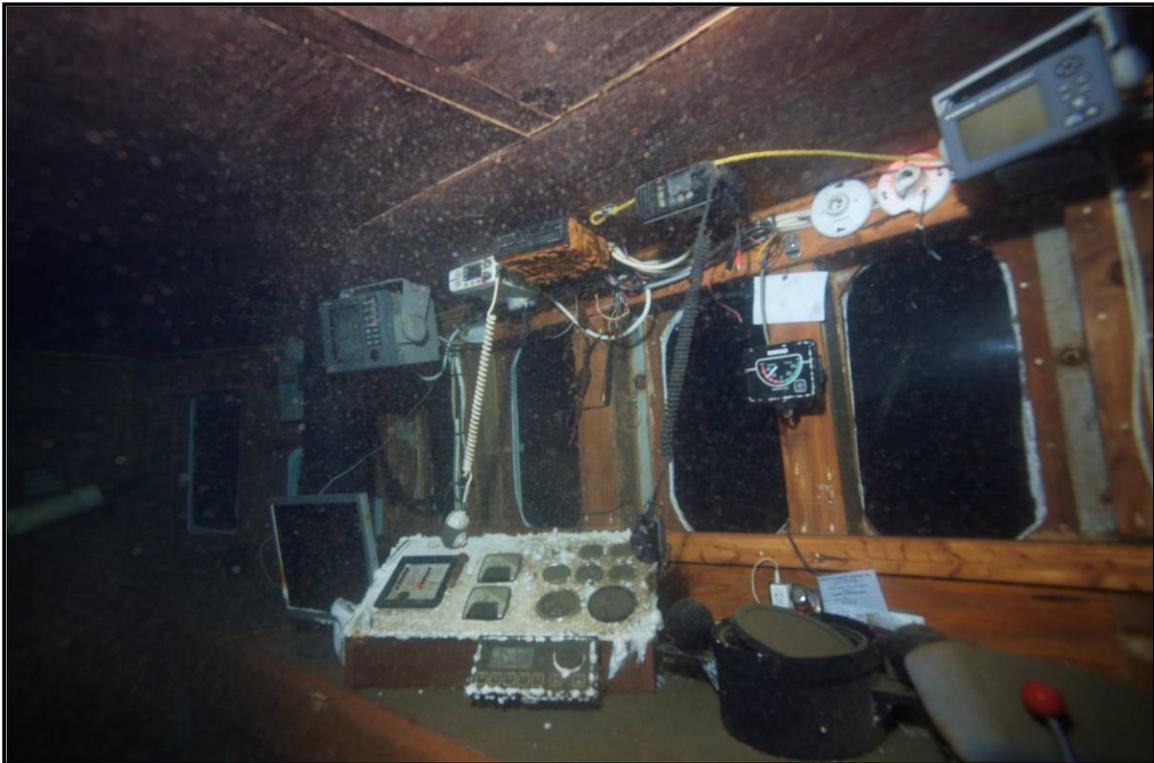
**Figure 36: New wheelhouse**

(5) The commercial diver testified that the door to the new wheelhouse was open and that one of his divers saw a survival suit inside this space, still in the bag. The rudder angle indicator in the new wheelhouse was pointing to port. The Shore Manager testified that the increments labeled on the rudder angle indicator were 20 and 40 degrees.<sup>331</sup>

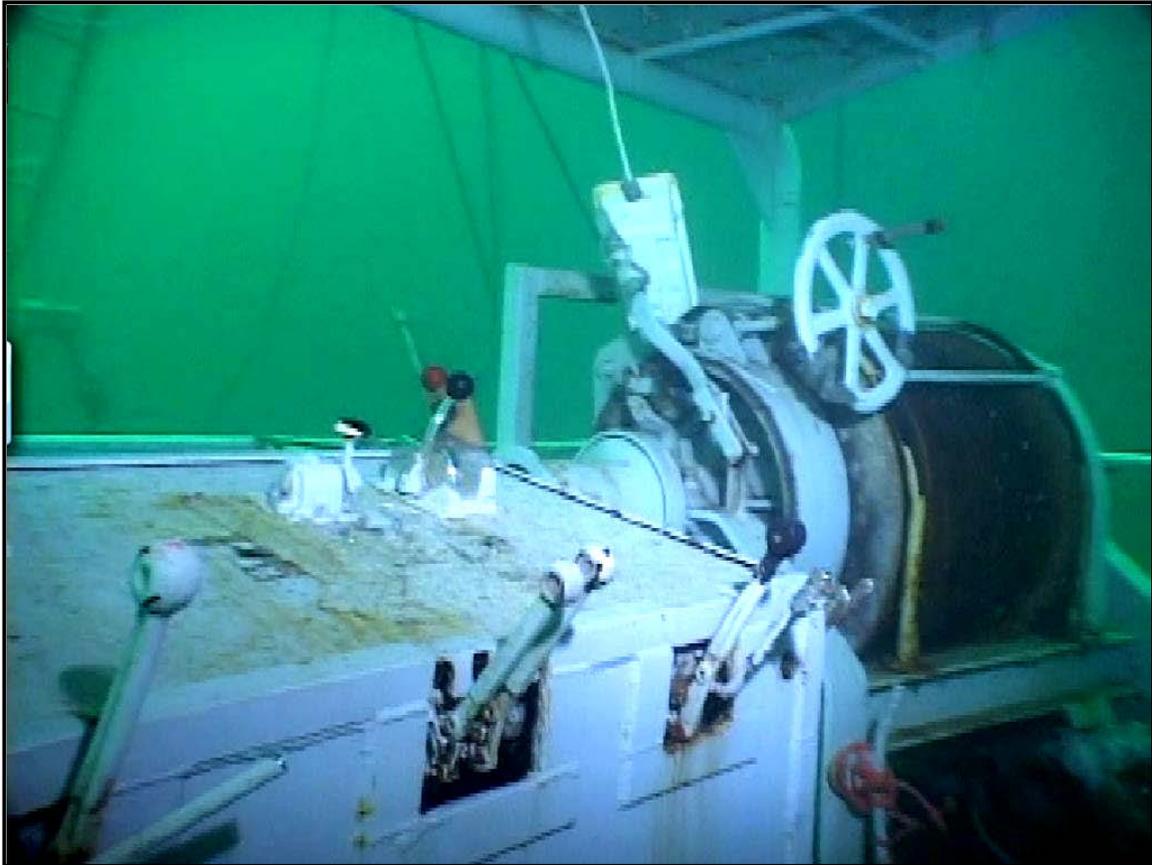
**Figure 37: View from winch deck, looking aft at console and port side McElroy winch**

(6) On the winch deck, just aft of the control console, were the two Pullmaster winches. The wire on the port winch drum was neatly wound, but the wire on the starboard winch

drum was loose, disorganized, and crossed over itself a number of times. Outboard of the Pullmaster winches were the two McElroy 504 main winches. The port main winch drum was full and the starboard was empty.<sup>332</sup>

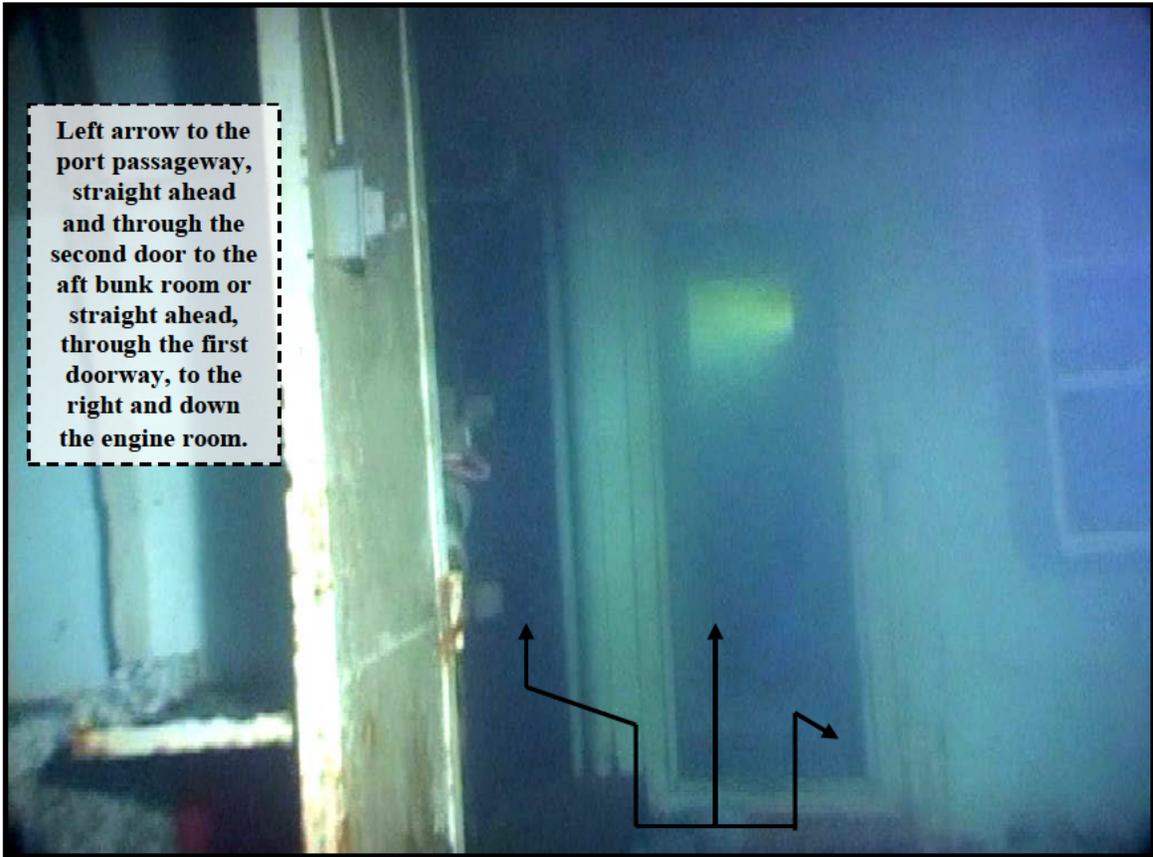
Figure 38: View looking into the superstructure from the aft shucking house door

(7) The lead commercial diver testified that one of his team members attempted to look into the forward bunkroom of the *LADY MARY*, and got a partial view of the space but could not go inside this space because of obstructions. His team members also checked the bunkroom located in the upper wheelhouse and the bunkroom on the main deck, just aft of the galley. The divers did not see crewmembers in any of the bunkrooms. The divers were not able to check the engine room.<sup>333</sup>

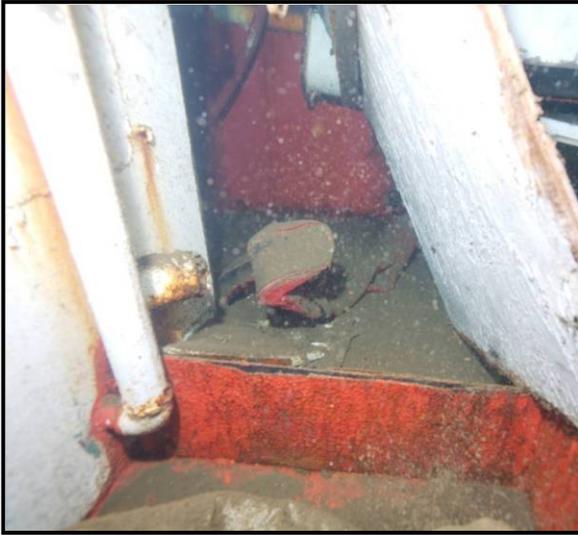
**Figure 41: Survival suit in shucking house**

(8) The aft door to the shucking house was missing. The lead commercial diver testified that one of his divers found a survival suit in the shucking house. The survival suit was out of the bag and was located forward of the fish hold hatch near the starboard passageway.<sup>334</sup>

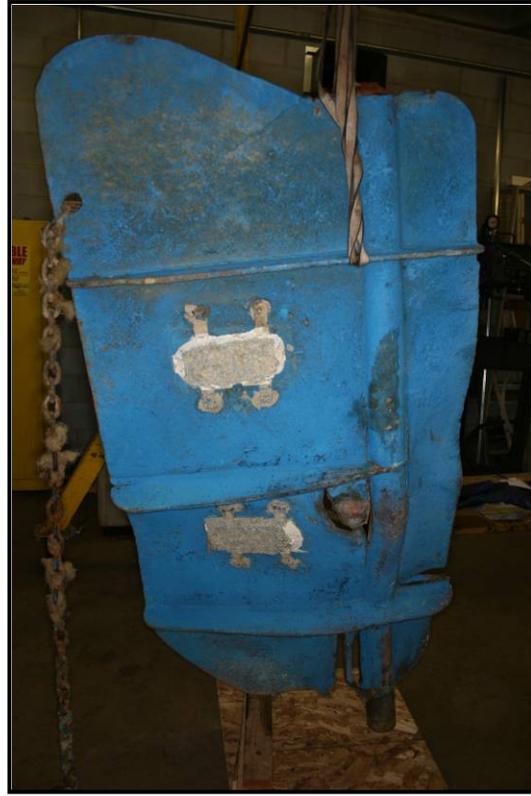
**Figure 26: Starboard side view of the rudder**

(18) The LADY MARY's rudder shoe was missing. The lead commercial diver testified that one of his team members blew out the sand around the bottom of the keel, and found there was no rudder shoe attached to the aft end of the keel. In addition, the aftermost starboard strut, between the skeg and the hull, had a large chunk missing just above where it attached to the keel.<sup>345</sup>

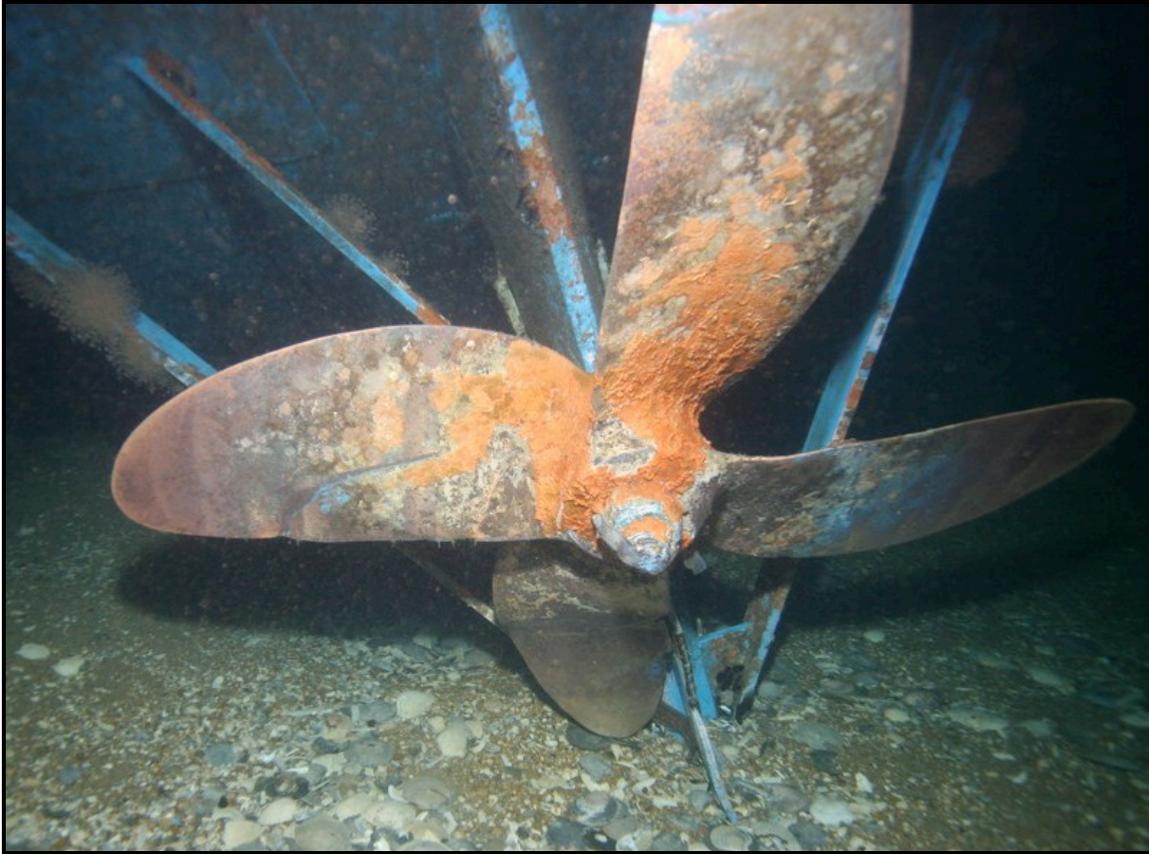
**Figure 27: Propeller and rudder stock**

(20) The lead commercial diver testified that he and his team did not see any damage to the LADY MARY's hull forward of the transom (see paragraph 16 above). There was a small dent in the hull on the starboard bow, but the lead diver felt that this was a preexisting dent. The lead diver also testified that he and his team did not observe any paint transfers on the LADY MARY, with the exception of the coloring that he observed on one edge of the rudder, as described in paragraph 17 above.<sup>347</sup>

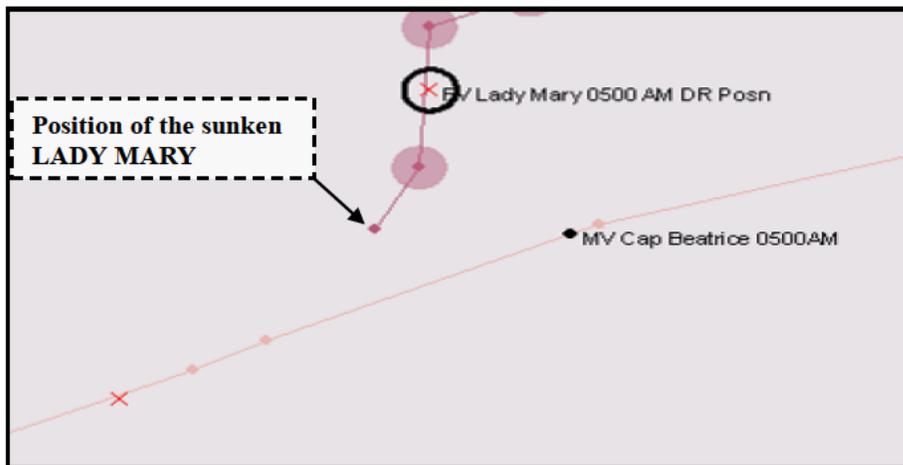
Figure 49: LADY MARY and CAP BEATRICE 0500 positions, 1.28 NM apart

(10) A combined plot of the LADY MARY VMS track lines and the CAP BEATRICE AIS track lines was made, including circles around each position to represent the navigational error of those reports as shown in the Figure below. As mentioned in section B.12.a above, the LADY MARY was equipped with a non-GPS VMS unit, so its navigational error was 300 meters (0.16 NM). As mentioned in the paragraph above, the navigational error of the CAP BEATRICE was 10 meters (0.005 NM). The combined plot shows that the track lines of the two vessels did not intersect. The distance between the 0500 CAP BEATRICE position, and a 0500 dead reckoned position of the LADY MARY was 1.28 NM, or 1.11 NM after subtracting the navigational errors. The distance between the 0506 CAP BEATRICE position, and a 0506 dead reckoned position of the LADY MARY was 2 NM.<sup>375</sup>

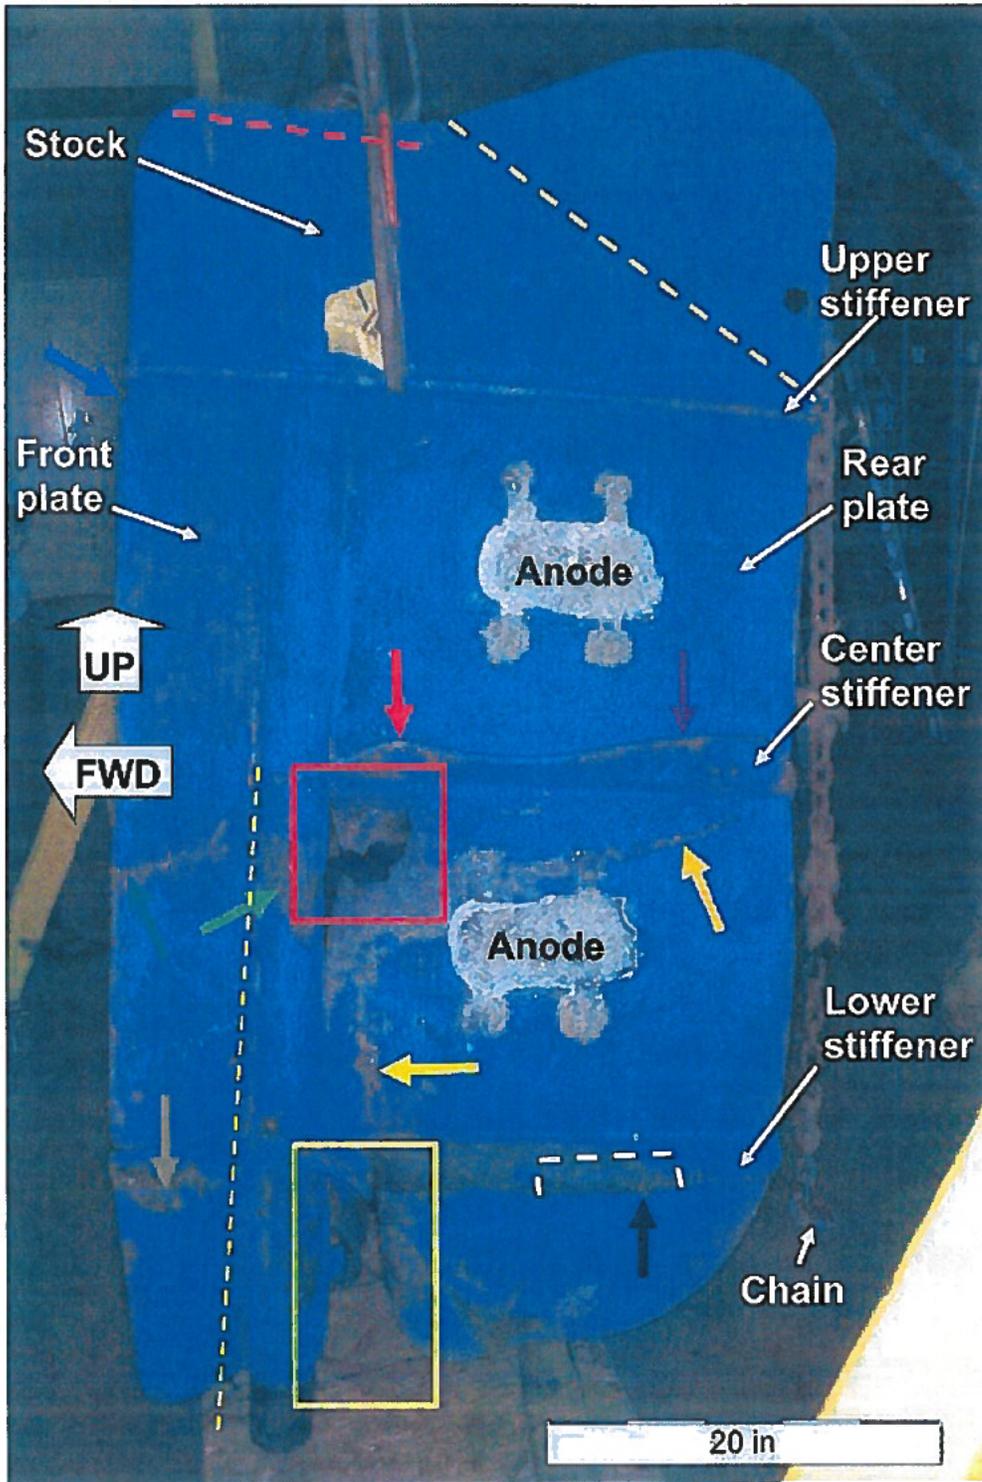
The indentation on the rear plate is contained within the red box in Figure 1. The indentation was located between the center stiffener and the lower stiffener, and offset to the rear of the centerline of the stock. A closer view of the indentation is illustrated in Figure 4 with the forward and up directions indicated. The plate, stock, and center stiffener are identified. The examination revealed that the upper quadrant of the indentation described the arc indicated by the yellow dashed line. Above the arc was an indentation that displayed the straight edge indicated by the white arrow with the curved end indicated by the black arrow. The indentation was at its deepest on the straight line and tapered to nothing as it approached the arced indentation. On the torn edge at the lower portion of the indentation, within the red box, the examination revealed a flat surface area with the straight rear edge

Directly below the lower stiffener fracture the rear plate had been fractured and further forward it had been separated from the stock. The fracture and the separation are contained within the yellow box in Figure 1 and are illustrated in Figure 6 with the plate, the stock and the lower stiffener identified. Examination of the fracture revealed that the rear edge, indicated by the red arrow in Figure 6, was well defined, straight and extended from slightly below the stiffener almost to the bottom edge of the plate, where it was curved to starboard. The port side edge of

Figure 1. The port side of the rudder as received for examination.

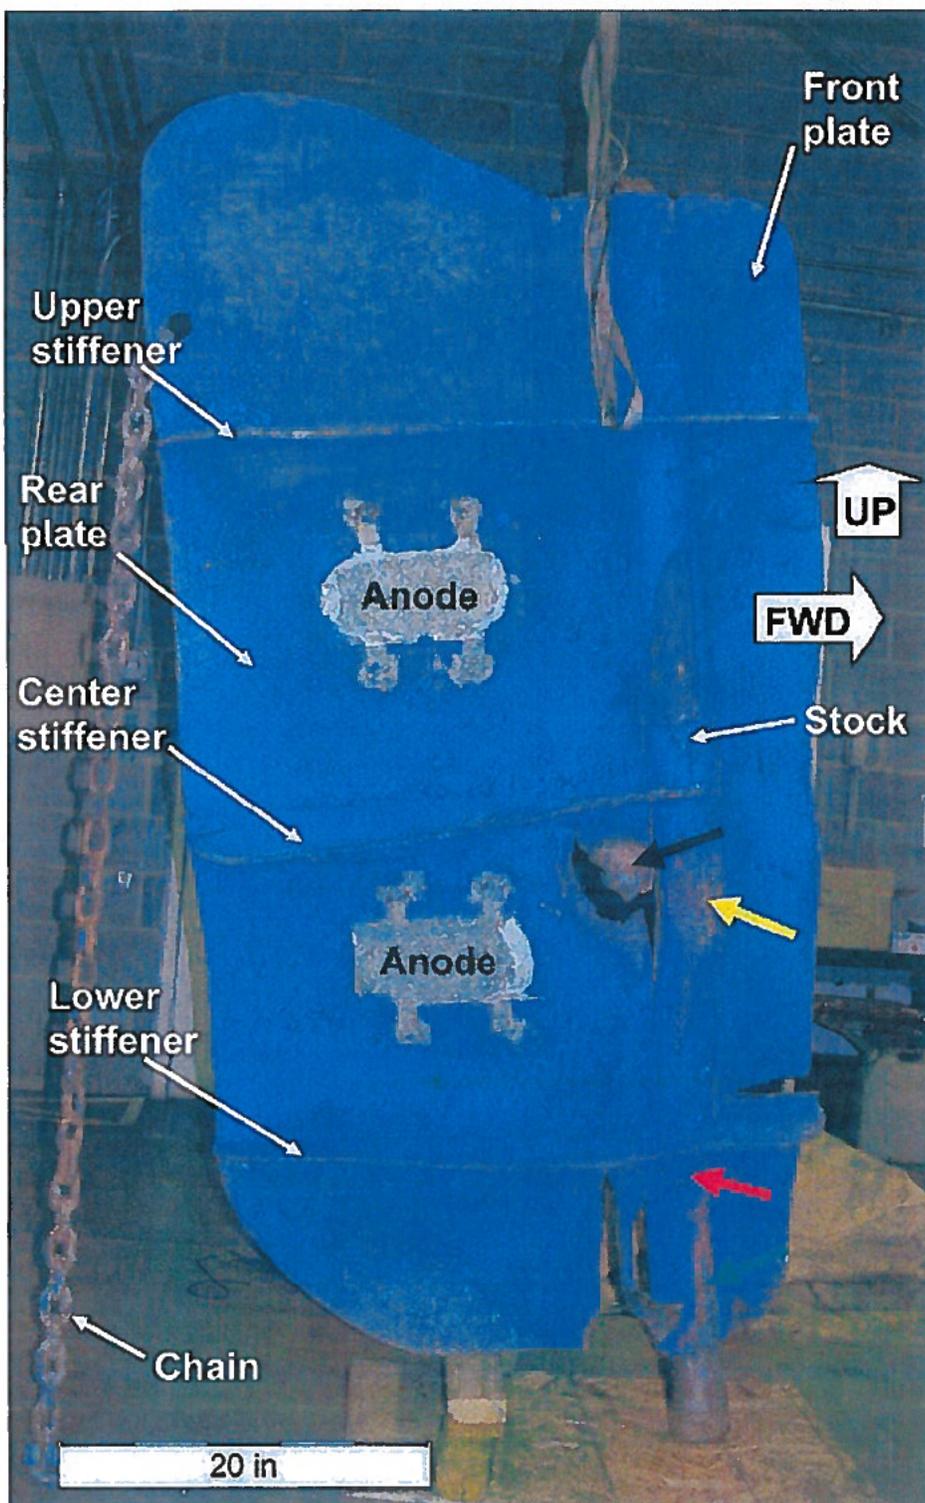
Figure 2. The starboard side of the rudder as received for examination.

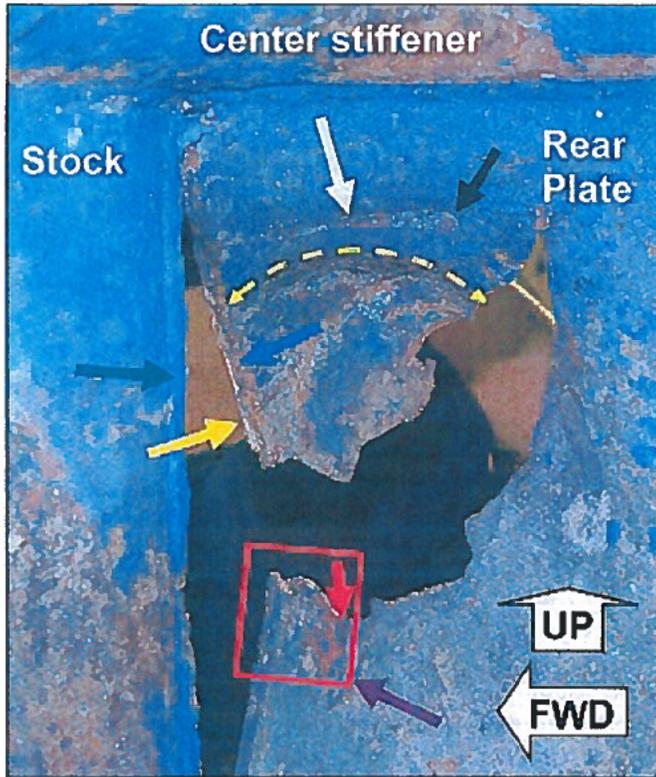
Figure 4. A port side view of the rudder indentation located within the red box in Figure 1.

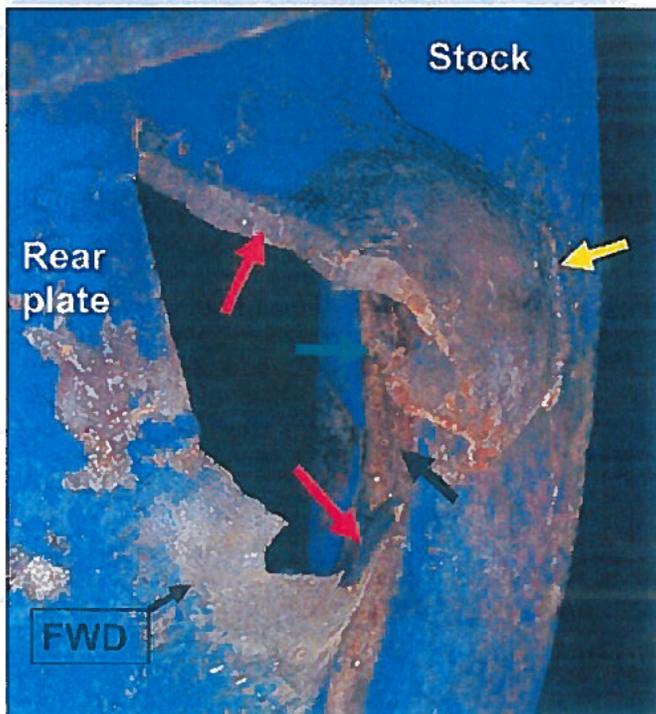
A view of the indentation on the starboard side looking forward is illustrated in Figure 5 with the stock and rear plate identified. The displaced material displayed a bulbous appearance with fractures to the rear and below being consistent with a relative upward motion of the indenter into the rudder, or a relative downward motion of the rudder onto the indenter. The fracture faces in the plate, indicated by the red arrows, were inclined at approximately 45-degrees, and displayed surface lines oriented along the thickness, consistent with an overload event. The green arrow and the yellow arrow indicate the weld bead similarly indicated in Figure 4. The black arrow indicates the original surface of the stock located between the weld beads, consistent with little to no penetration of the welds on both sides.

Figure 5. A starboard side view of the rudder indentation, also indicated by the yellow arrow in Figure 2.

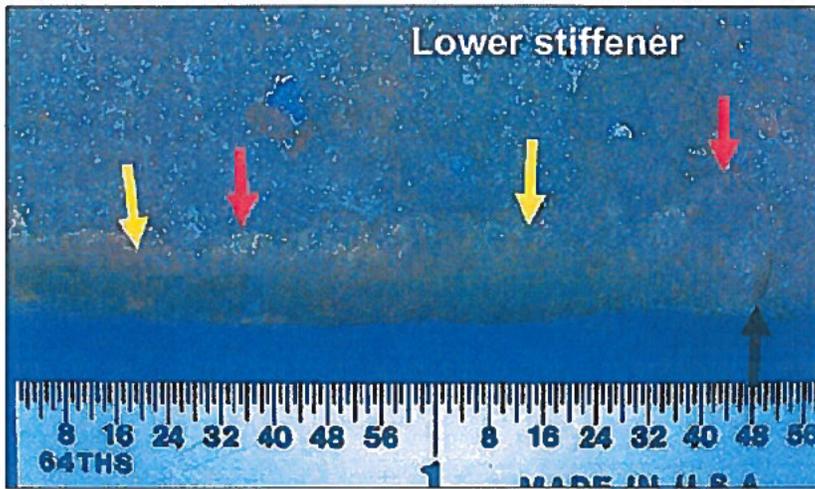
Figure 13. A portion of the sample removed from the port lower stiffener, indicated by the white dashed box in Figure 1.

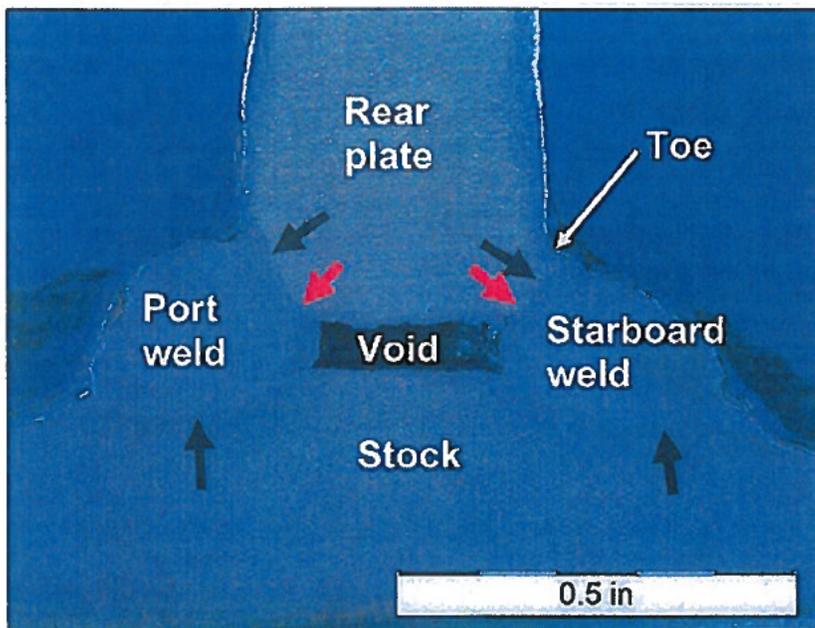
Figure 14. A sectional view of the weld at the stock to rear plate interface indicated by the black arrow in Figure 11.

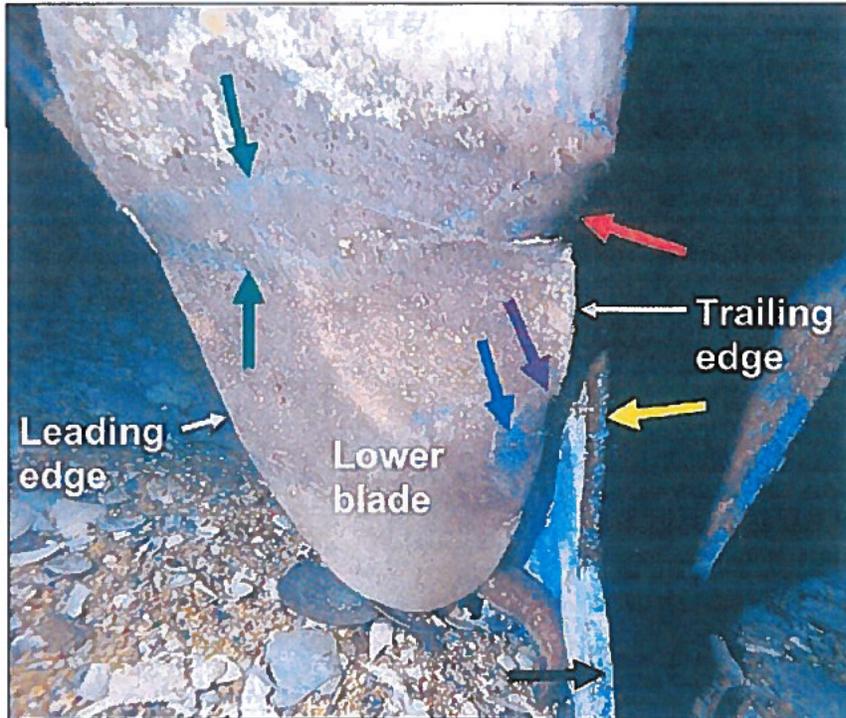
Figure 18. The outer portion of the lower propeller blade.

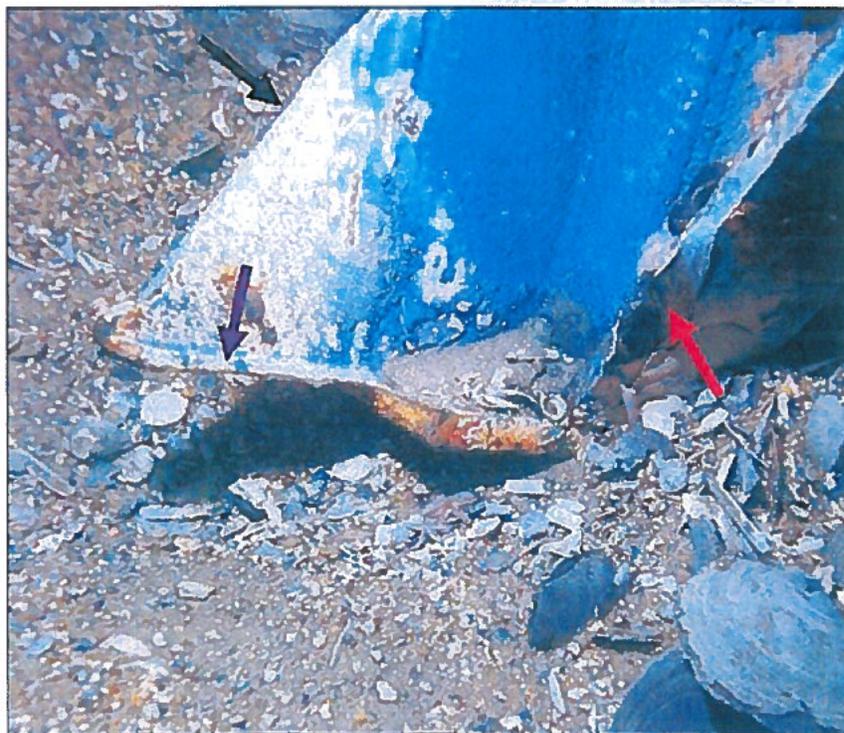
Figure 19. The structure at the rear of the vessel where the skeg is normally attached.

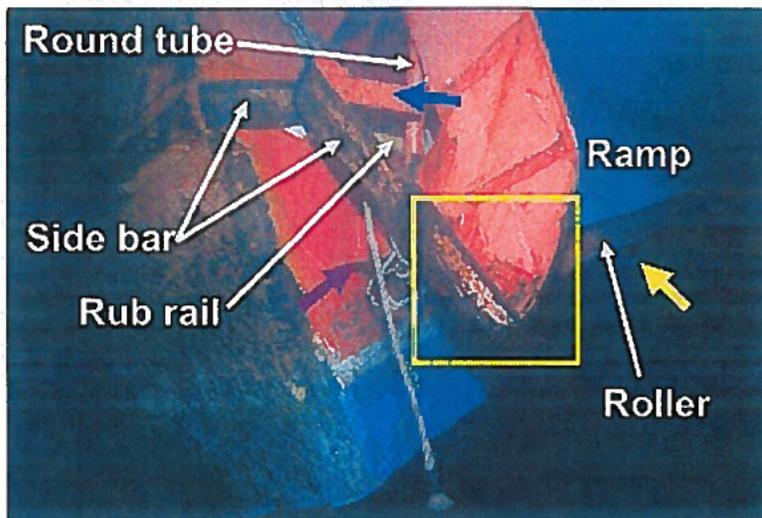
Figure 21. The lower port side of the ramp.

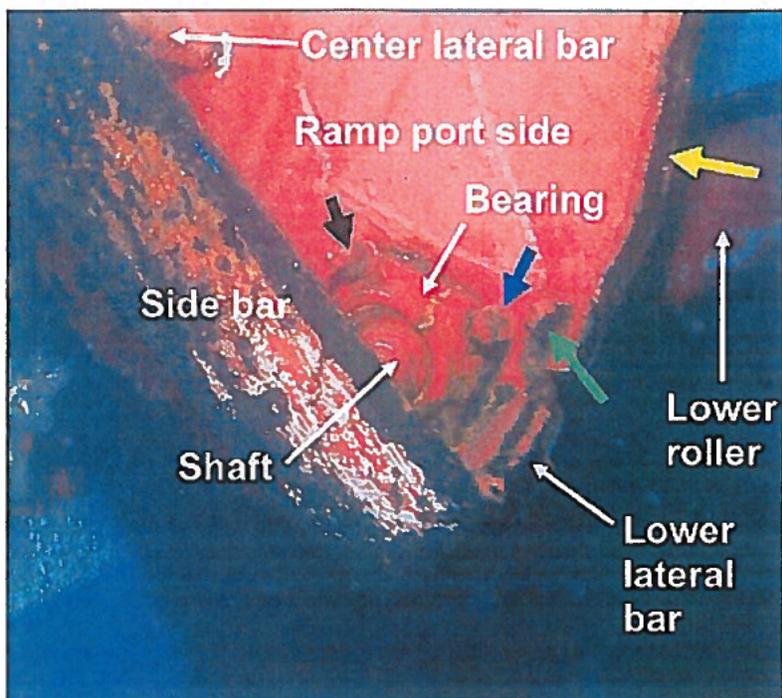
Figure 23. A closer view of the lower port side of the ramp contained within the yellow box in Figure 22.
