**UNITED STATES COAST GUARD**

**INVESTIGATION INTO THE CIRCUMSTANCES  
SURROUNDING THE SINKING OF THE**

# **F/V LADY MARY**

**65 NM SOUTHEAST OF CAPE MAY, NEW JERSEY ON  
MARCH 24, 2009, WITH MULTIPLE LOSS OF LIFE**

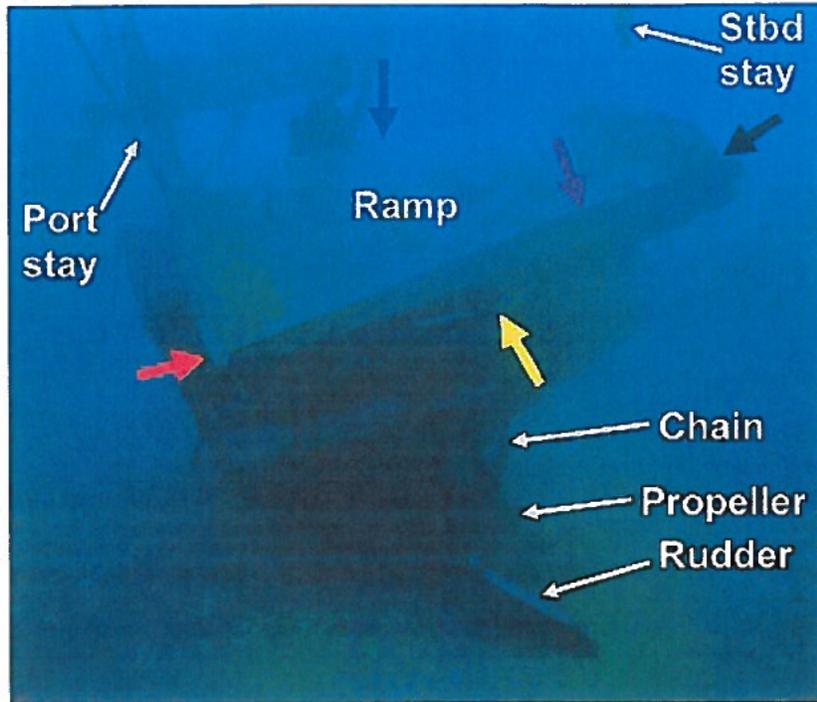
Figure 25. Recovering and tying back the port stay would take time and be inconsistent with a task to be performed during the reportedly rapid sinking event.

Figure 25. The rear of the submerged vessel.

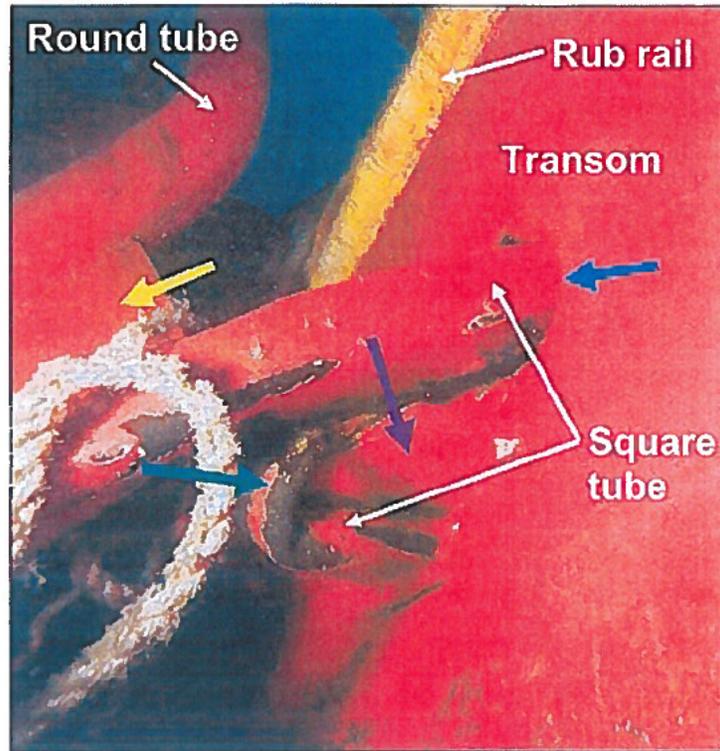
Figure 27. The penetration into the lazarette by the port side square tube.

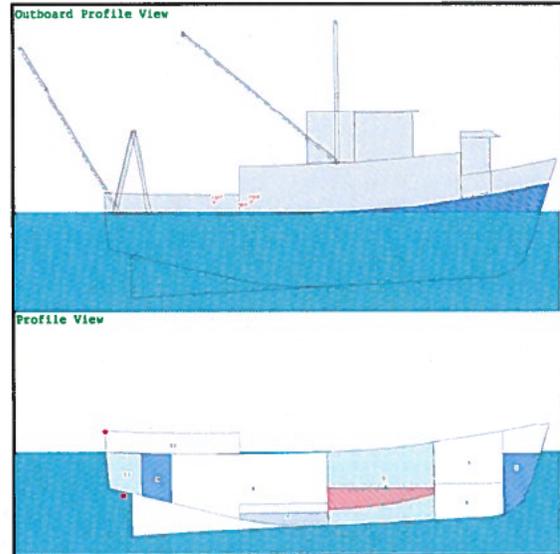
#	Condition	Minimum Freeboard (ft)	Door Sill Height (ft)	Fish Hold Hatch Height (ft)
1-1	Pre-Casualty	1.3	2.5	3.6
1-2	Lazarette Flooded to the Waterline	-0.4	1.6	2.5
1-3	1-2 + 6000 Gallons in the Engine Room	-0.2	1.2	2.3
1-4	1-2 + Engine Room Flooded 100%	-0.4	0.5	1.7

**Figure 10: Lazarette and Engine Room Flooded 100% (1-4)**

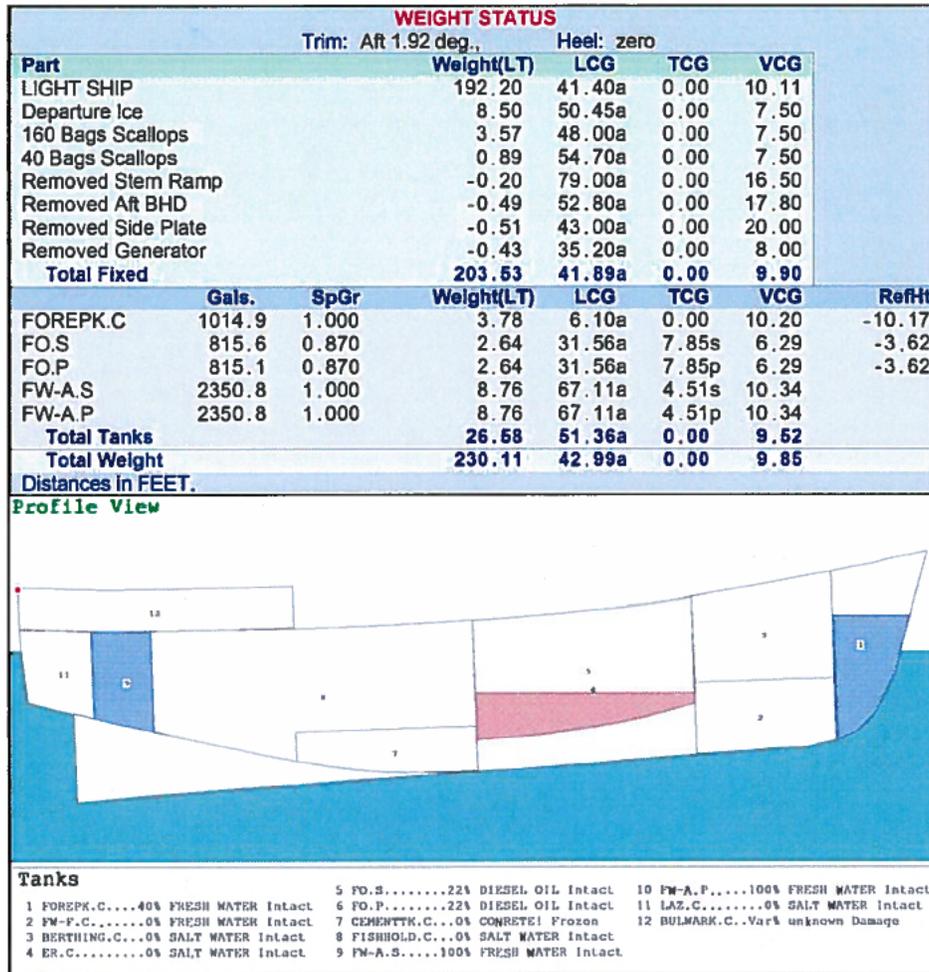
To estimate the impact of recent modifications to the vessel, the Marine Board requested that the previous three scenarios be run with weights removed to simulate the reversal of the modifications. Figure 16 details the pre-casualty condition with the modifications removed. Of note, but not readily apparent from the figure, is that the cement ballast and the scallops on deck

Figure 16: Estimated Pre-Casualty Condition with Modifications Reversed

In the pre-casualty condition, the 5 percent reduction in weight from removing the modifications increases the model's freeboard by approximately 4 inches. When scenarios 1 through 3 are repeated, the 4 inch rise is consistent through all the results. Although 4 additional inches of freeboard would have reduced the probability of catastrophic downflooding, it is important to note that in condition 2-4 the downflooding points are still below the water line, and the model sinks.
