# UNITED STATES COAST GUARD

## ARCTIC ROSE

OFFICIAL NUMBER 931446, IN THE BERING SEA ON  
APRIL 2, 2001, WITH ONE PERSON DECEASED AND  
FOURTEEN PERSONS MISSING AND PRESUMED DEAD

**SINKING OF THE UNINSPECTED FISHING VESSEL ARCTIC ROSE, OFFICIAL  
NUMBER 931446, IN THE BERING SEA ON APRIL 2, 2001, WITH ONE PERSON  
DECEASED AND FOURTEEN PERSONS MISSING AND PRESUMED DEAD**

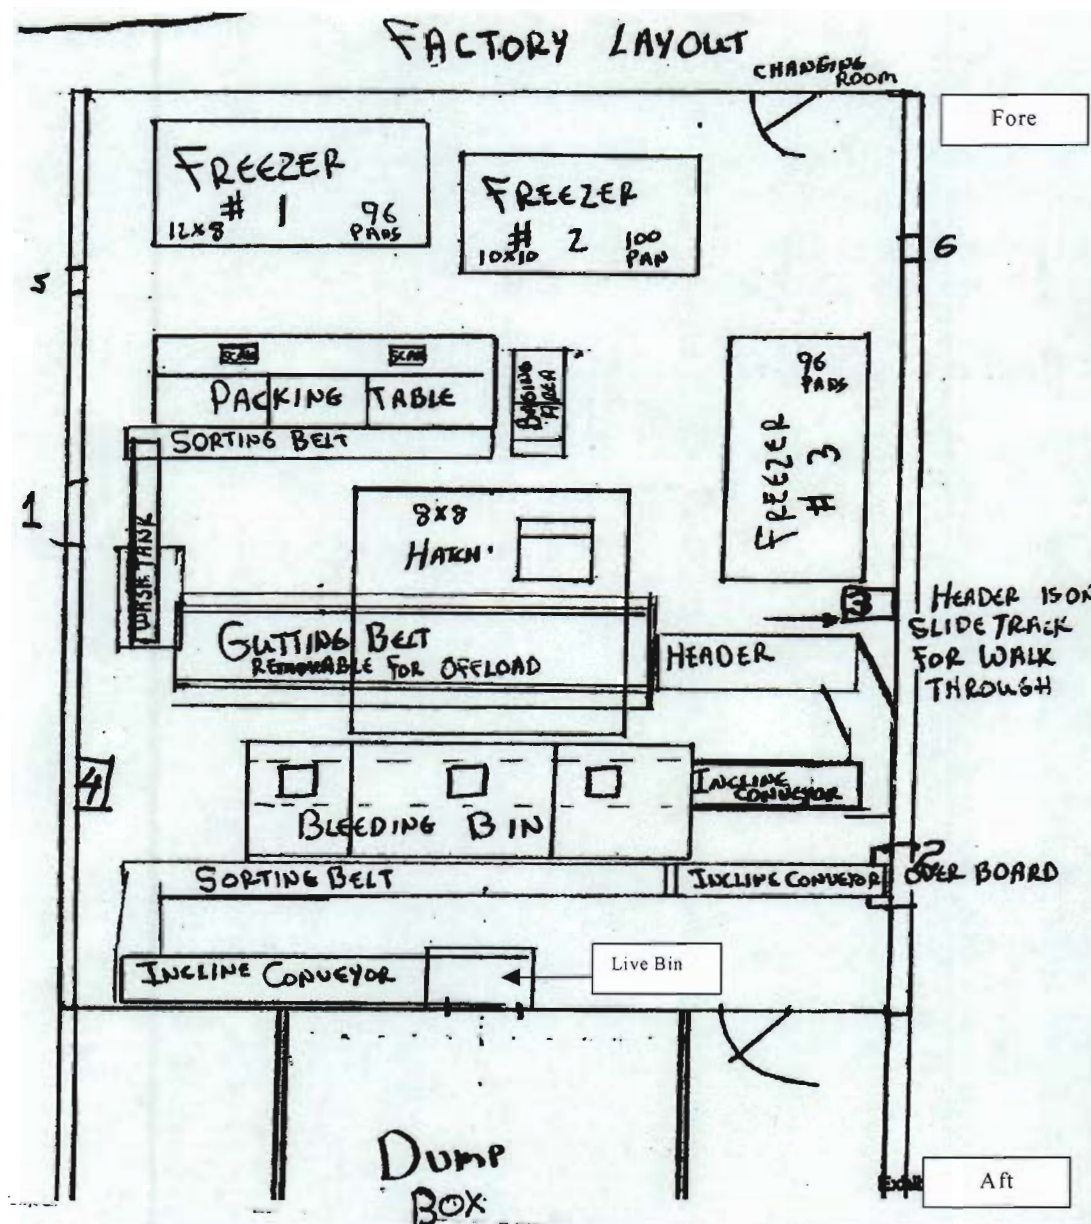
Figure 4  
Drawing of Processing Space

The processing space (See Figure 4) received a complete overhaul with all old equipment removed except for 2 plate freezers. The following new stainless steel equipment was installed: packing table with 2 Marel scales, wash tanks with incline conveyor, break tank gutting belt heading machine, bleeding bins, bleeding bin conveyor with incline conveyor, sorting belt with incline conveyors, dump box with incline conveyor and hydraulic sliding hatch, bleeding bins with three hydraulic doors. Tsurimi and Vaughn sump pumps were installed respectively on the port and starboard sides of the processing space. The deck of the processing space had steel framing and new fiberglass grating installed throughout. This grating was at a minimum of five inches off the floor. The by-catch and waste overboard discharge chutes were raised to four feet and five feet above the deck respectively. Both overboard chutes were fitted with closures. The by-catch chute was fitted with a manual guillotine type closure and the waste discharge chute was fitted with a flopper door. During the fall of 2000, the Cummins MDE was replaced with a Luger 6170. A Maxim model J10 water maker and Mitshubishi centrifuge diesel purifying system were installed in the auxiliary machinery space. The refrigeration system was completely overhauled. The

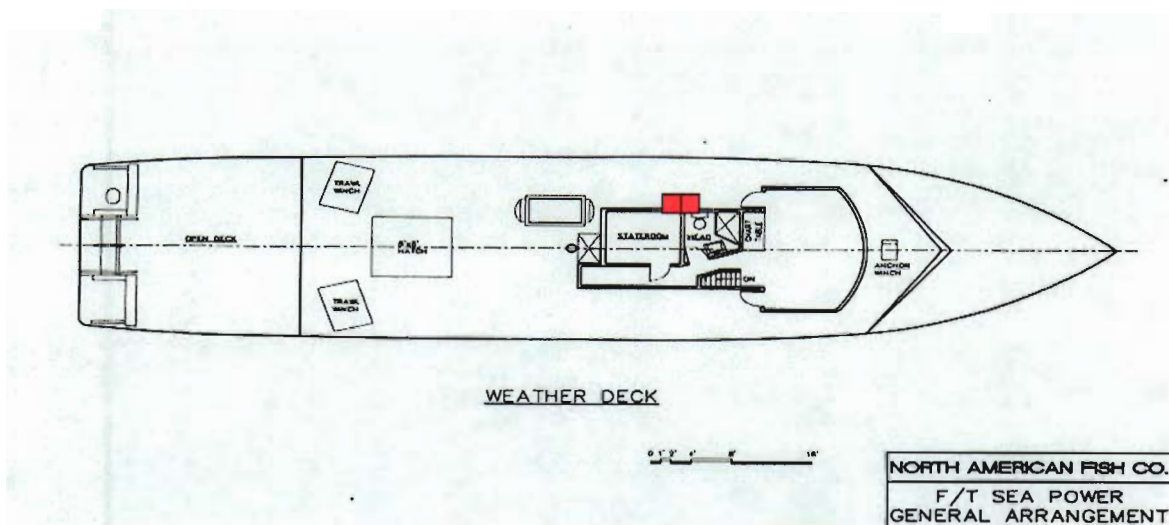
Figure 6  
Drawing of weather deck  
The red boxes are the proximate location of the wooden boxes

Captain Rundall's body was located within the debris field in a properly donned immersion suit. The immersion suit was full of water. The immersion suits were stowed in a wooden box at the port side of the pilothouse level on the weather deck (see Figure 6). Seven empty immersion suits were recovered by the vessels on scene, all of which were found out of their storage bags.

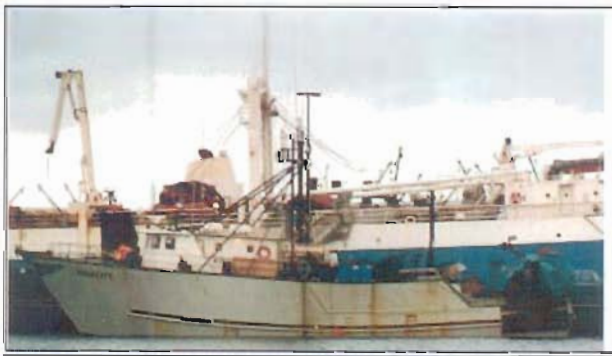
Figure 13  
Port view of TENACITY (1996)  
Note addition of processing space  
on main deck.

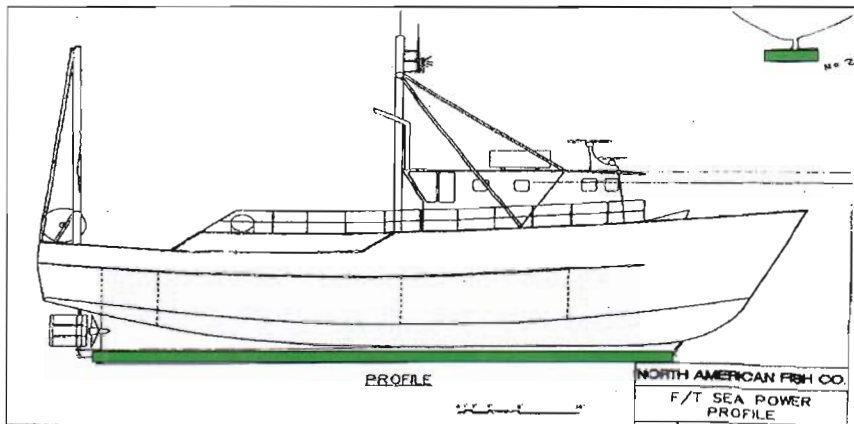
Figure 14  
Profile drawing  
showing location of  
keel shoe (shaded  
green) on ARCTIC  
ROSE

Green shaded area  
represents the keel  
shoe and is not to  
scale.

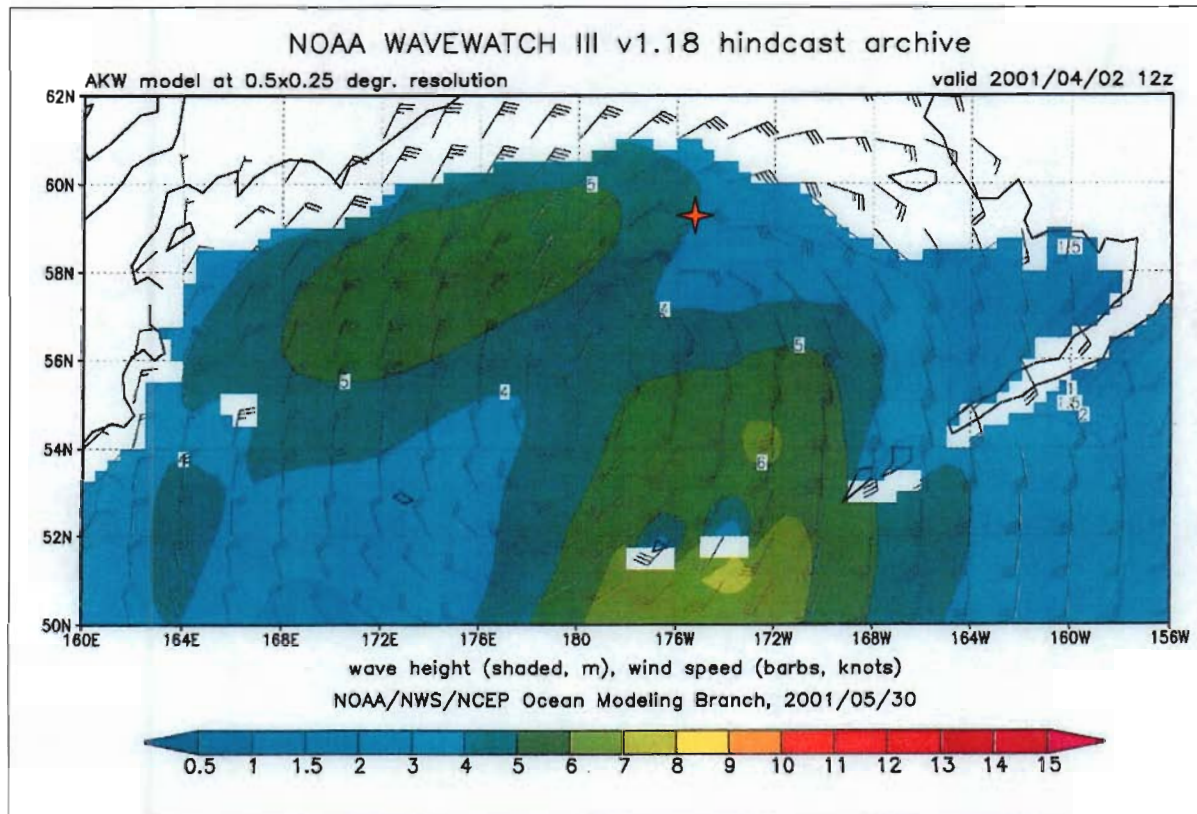
The NWS generated a hindcast (Figure 20) of the weather in the vicinity of the sinking based on weather reports from Coast Guard and other commercial sources operating in the vicinity of the sinking. Their analysis indicates a significant weather event occurred at the ARCTIC ROSE's last known position. A weather phenomenon known as a Triple Point, which is an area of a frontal system where a cold, warm and occluded front join together and is usually associated with severe weather, passed over the ARCTIC ROSE's position. It is highly probable, based on the Triple Point, the vessel experienced three distinct weather patterns within a brief period of

Figure 20  
National Weather Service Hindcast for 4am April 2, 2001.  
The orange star is the approximate position of the ARCTIC

The NWS hindcast shows the weather was worse than forecasted. In testimony provided to the Marine Board, Dr. [REDACTED] of the NWS indicated that waves could reach significant heights of 24 feet and could be accompanied by sustained winds of up to 45 knots.

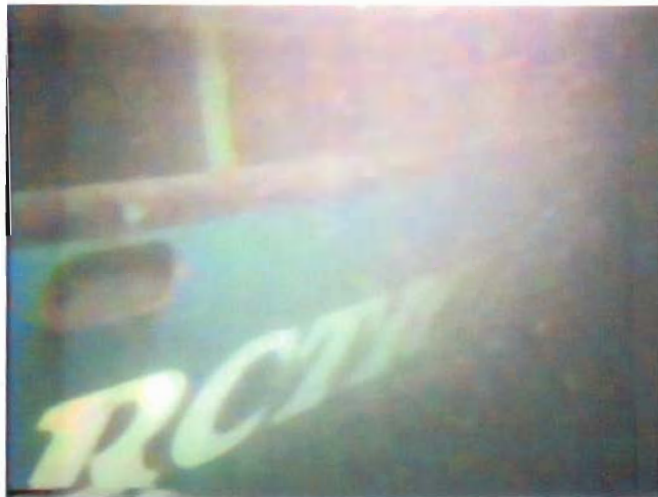
Figure 28  
Photo of  
Arctic Rose  
(2001)

water. Shortly thereafter, the Board received its first look at the vessel, which was sitting upright on the sea floor in 73 1/3 fathoms, or 428 feet, of water in the location 58° 56.22 minutes North latitude and 175° 53.10 minutes West longitude. The location is approximately 200 miles northwest of St. Paul Island, Alaska. The ROV was maneuvered slowly up the port side of the hull and revealed the name – ARCTIC ROSE. The ROV

made several passes along the port bow and port side of the pilothouse. Multicolored polypropylene lines used to mend the trawl net had unraveled from their cardboard spools and were floating above the wreck. As the ROV maneuvered around the wreck, several lines were sucked into the ROV's impellers and entangled it. Efforts to free the ROV resulted in the ROV's umbilical cord parting and the loss of the ROV.

- The vessel's hull was intact.
- The vessel's pilothouse was undamaged with all windows visibly examined found intact.
- The aft weathertight door to the processing space from the trawl deck was open.
- The vessel's rudder was over to port.
- The trawl net was on the reel and the cod end was in the dump box.
- The trawl doors were missing.
- There was no evidence of fire or explosion to the vessel.
- The starboard overboard discharge chute was partially open.
- The wires were spooled on the trawl winches as indicated by the tattle tale marks.
- Trawl gear, mud lines and wires had shifted to the starboard side of the vessel.
- The vessel landed on the sea floor stern first as shown by the plow marks aft where the vessel's kort nozzle made its initial impact.

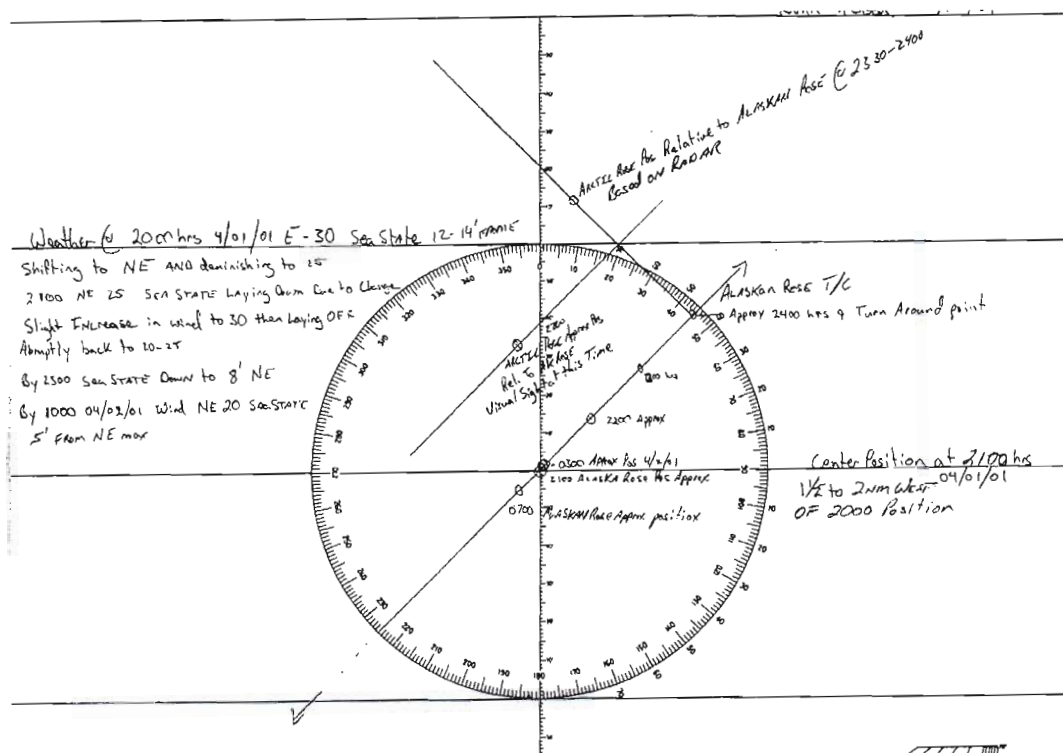
Figure 31  
 Universal plotting sheet depicting relative  
 position and heading of ARCTIC ROSE on  
 April 1 and 2

The Marine Board conducted an analysis of the ARCTIC ROSE's position based on testimony provided by Mr. [REDACTED] the EPIRB position and Captain Rundall's stated intent to remain in the area to begin fishing on the morning of April 2<sup>nd</sup>. Trawling vessels will give each other a wide berth to prevent their tow wires or nets from becoming entangled. The ARCTIC ROSE was maintaining a position to the northwest of the ALASKAN ROSE. At the time of the last sighting, the ARCTIC ROSE was moving away from the ALASKAN ROSE. The ALASKAN ROSE was running on a track line from Northeast to Southwest to maintain their position to fish at first light.

The Marine Board established a vessel heading of 315° T with a relative position of twelve miles northwest of the ALASKAN ROSE and making a turn to port at the approximate time of the casualty.

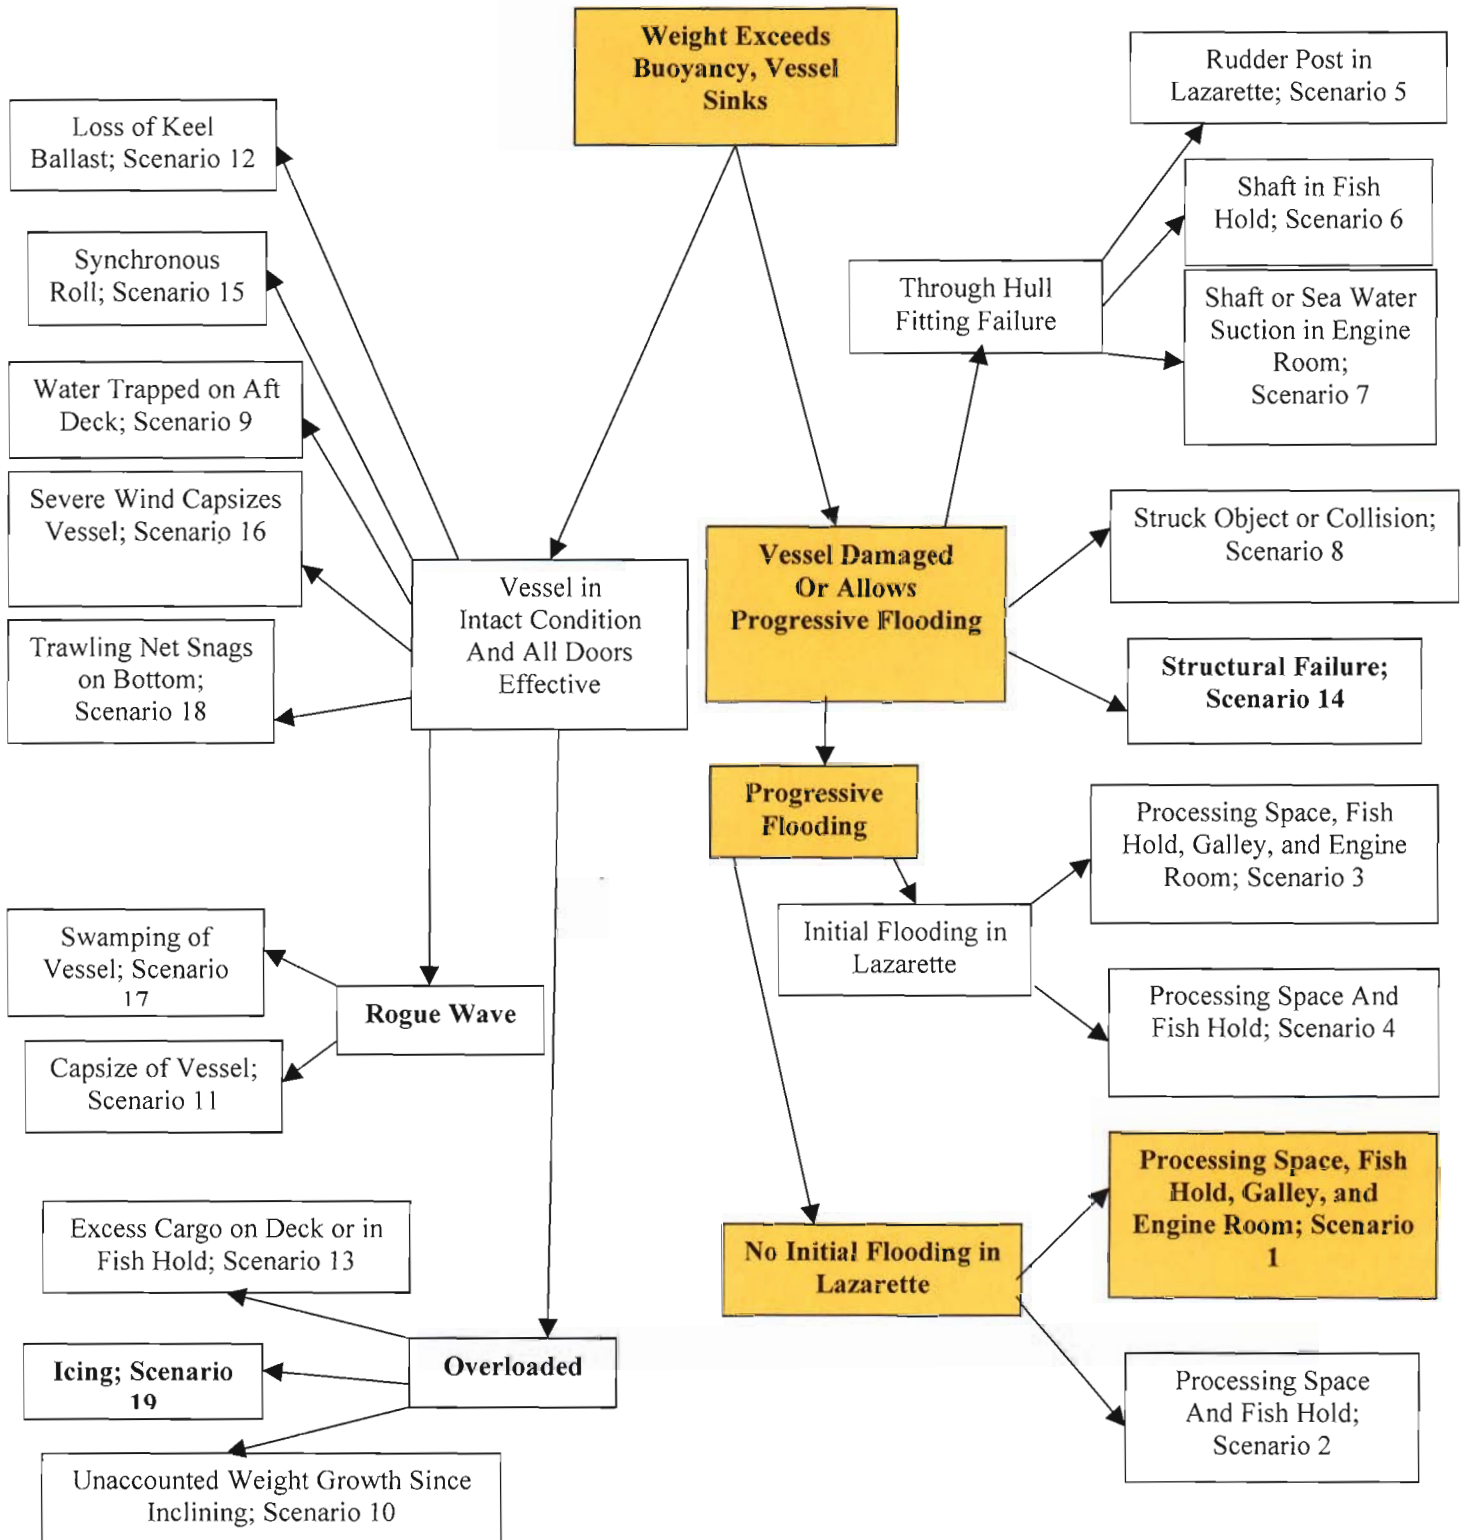
## **SCENARIO 1**

### **PROGRESSIVE FLOODING INTO PROCESSING SPACE, FISH HOLD, GALLEY, AND ENGINE ROOM**

7. Based on the ARCTIC ROSE's rapid loss of positive stability and reserve buoyancy, the ROV video showing the aft door to the processing space open, testimony on the lack of watertight integrity above the main deck, and the arrangement of the vessel, it is most likely that progressive flooding of the processing space, fish hold, engine room, and galley was the cause of the loss of the ARCTIC ROSE.

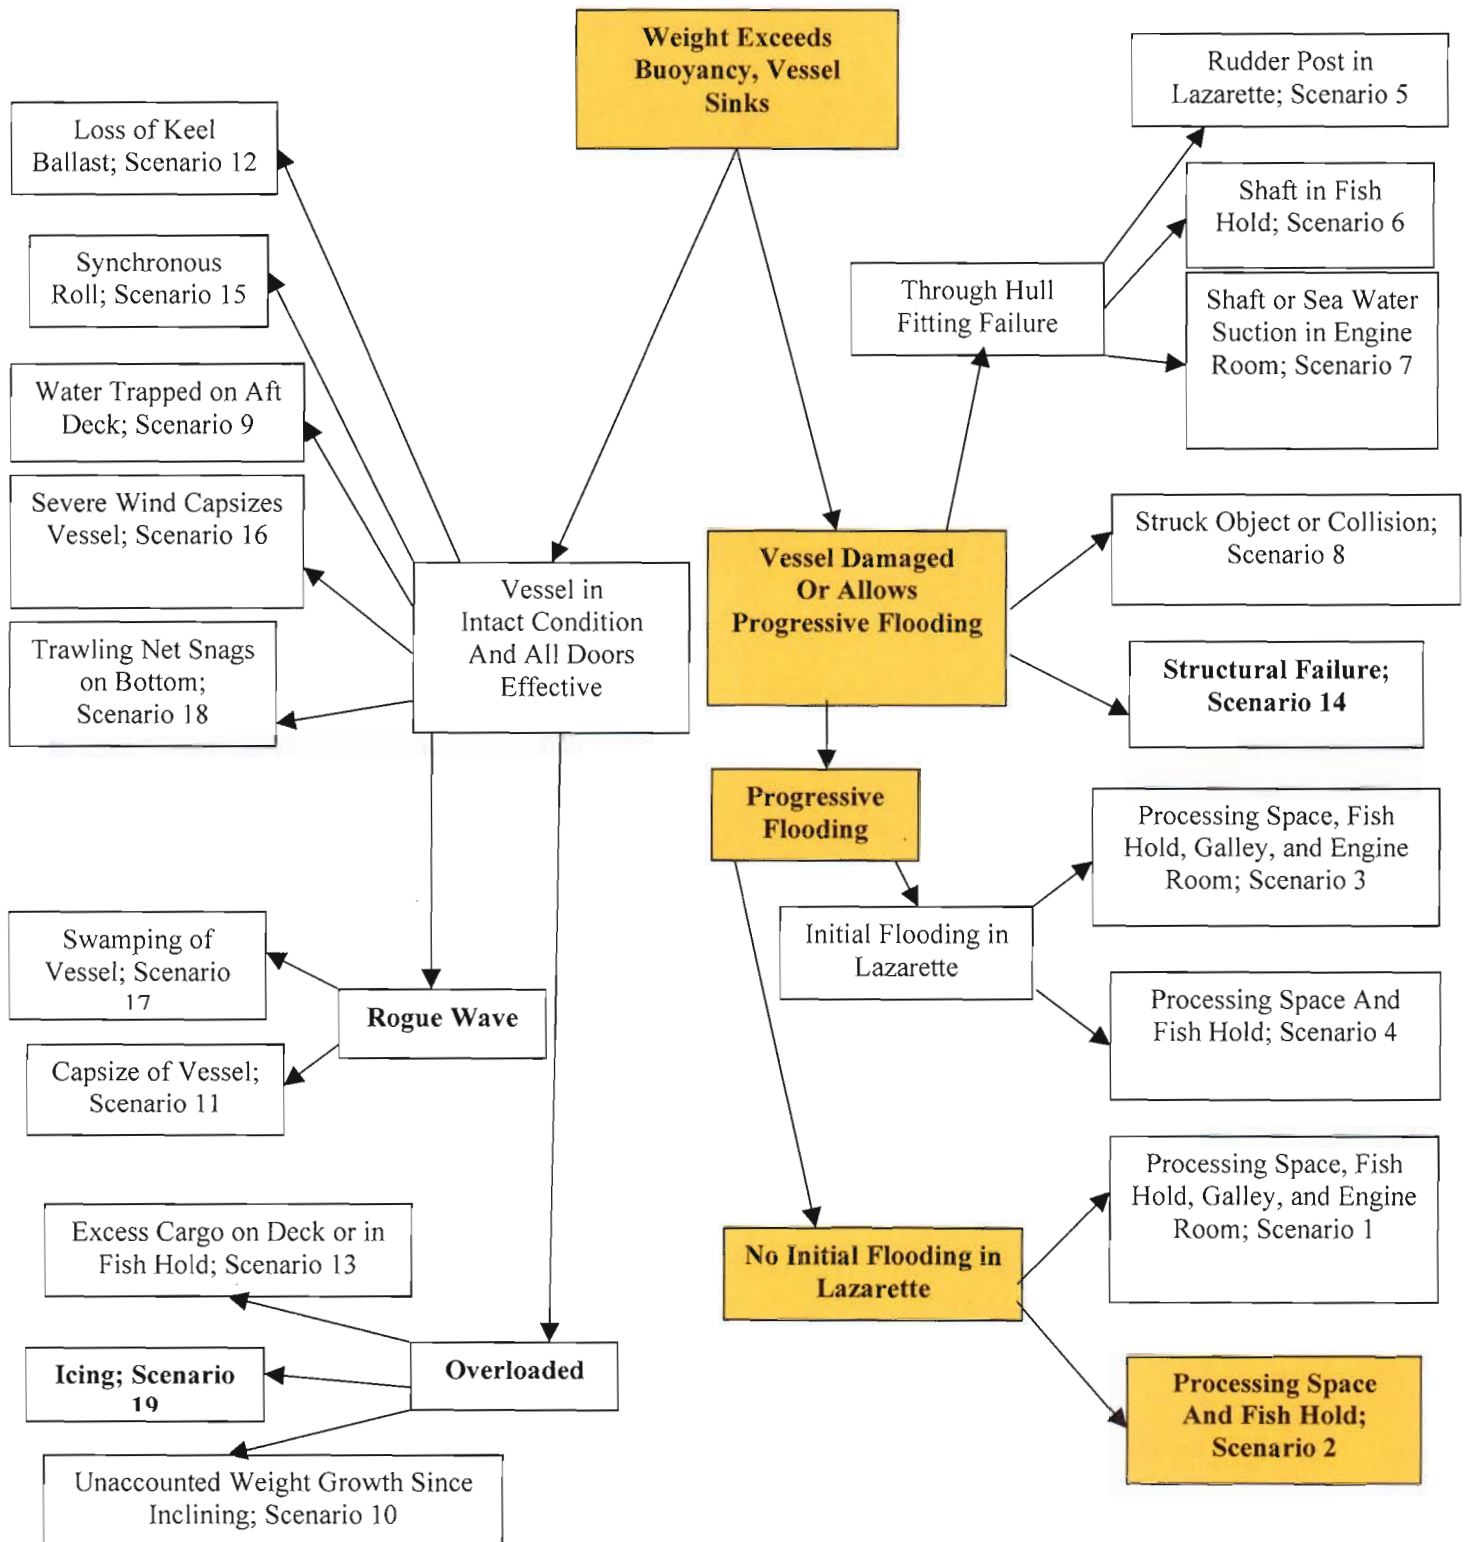
## **SCENARIO 2**

### **PROGRESSIVE FLOODING INTO PROCESSING SPACE AND FISH HOLD**

7. Based on the ARCTIC ROSE's rapid loss of positive stability and reserve buoyancy, the ROV video showing the aft door to the processing space open, testimony on the lack of watertight integrity above the main deck, and the arrangement of the vessel, it is likely that progressive flooding of the processing space and fish hold could have caused the loss of the ARCTIC ROSE. However, progressive flooding of the processing space and fish hold only is not the most likely scenario, because the non-weathertight doors leading into the changing room, engine room, and galley would have had to prevent any water entry. Testimony provided to the Marine Board indicated this weathertight door from the processing space to the mudroom was always open. The loss of reserve buoyancy of the processing space and fish hold alone would probably not be enough to sink the vessel.

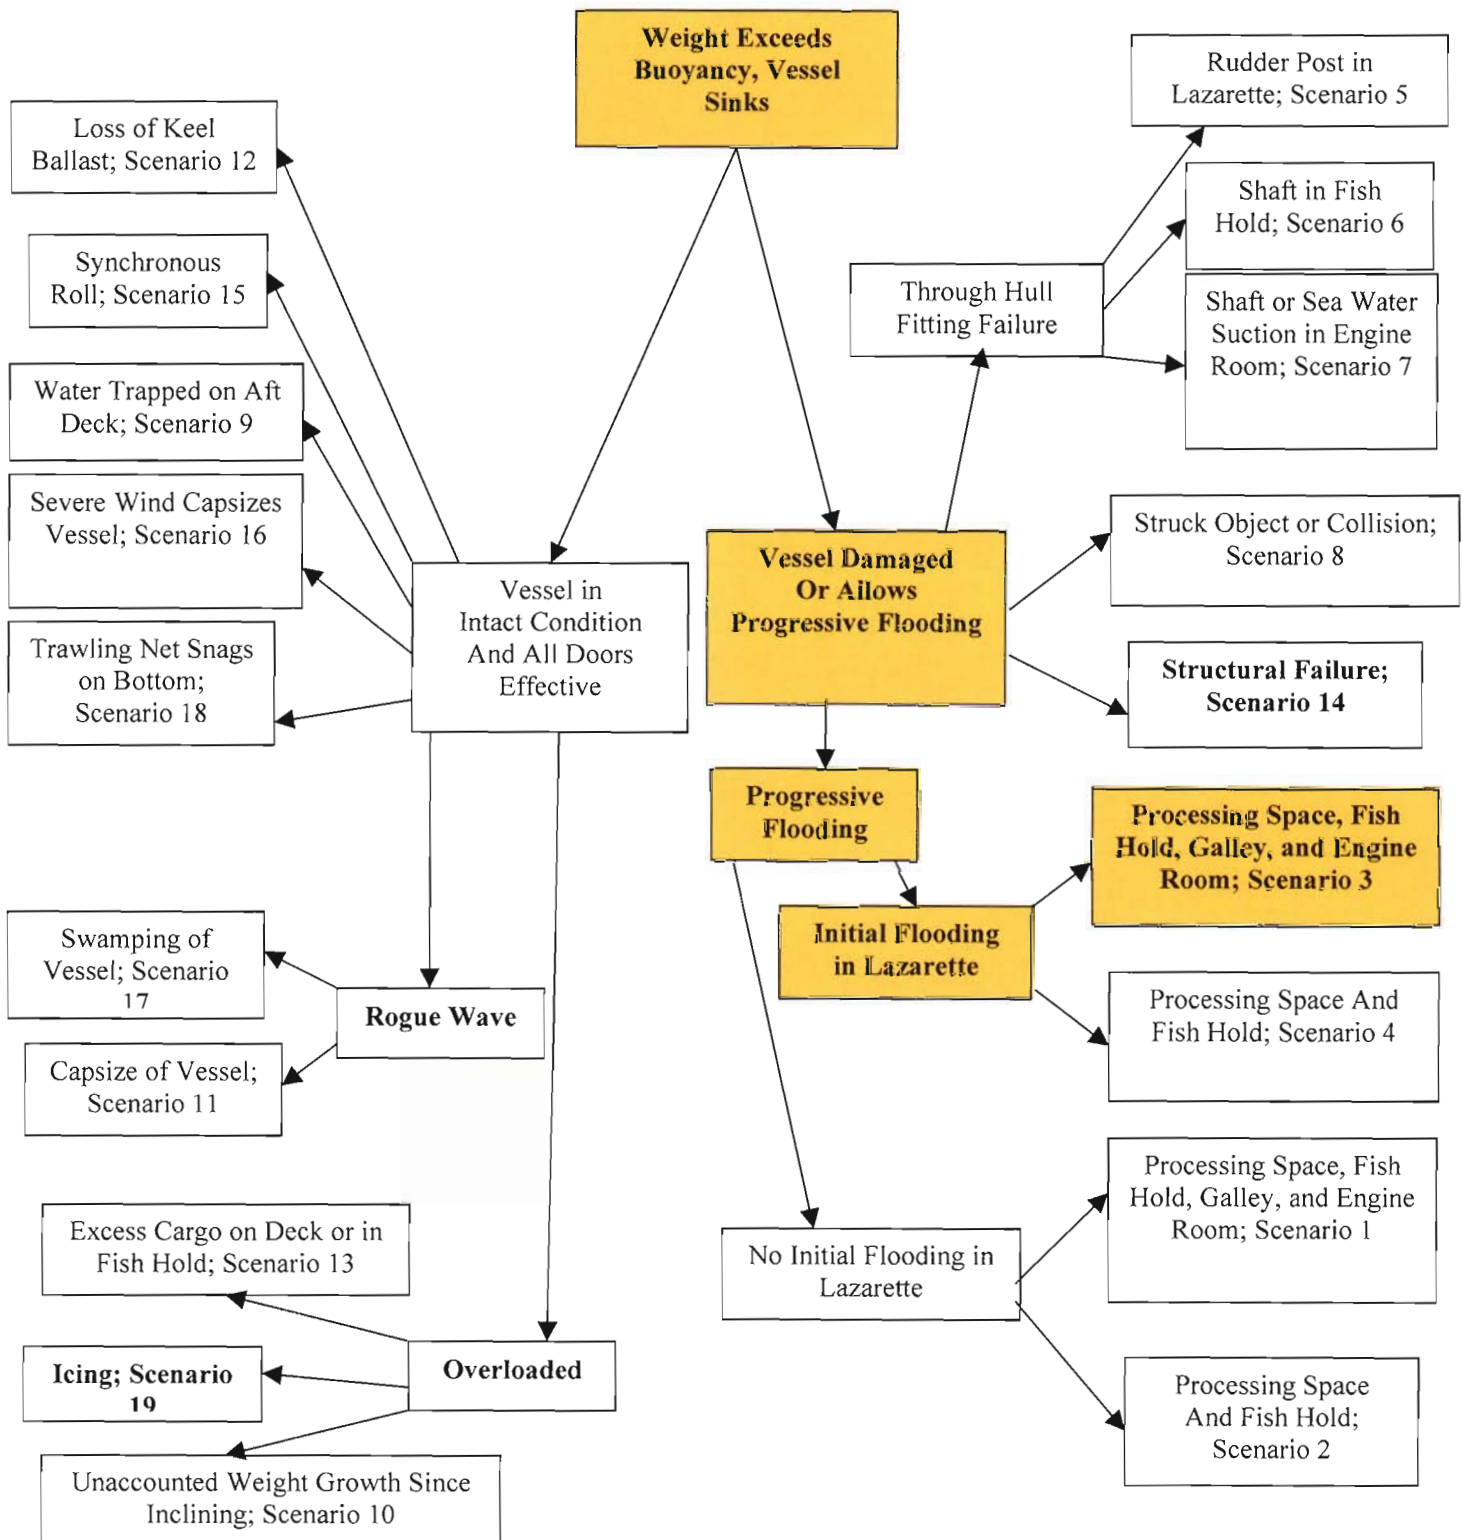
### **SCENARIO 3**

#### **PROGRESSIVE FLOODING INTO PROCESSING SPACE, FISH HOLD, GALLEY, AND ENGINE ROOM WITH LAZARETTE FLOODED TO EQUILIBRIUM**

8. Based on the ARCTIC ROSE's rapid loss of positive stability and reserve buoyancy, the ROV video showing the aft door to the processing space open, testimony on the lack of watertight integrity above the main deck, and the arrangement of the vessel, it is possible that progressive flooding of the processing space, fish hold, engine room, and galley after the lazarette flooded to equilibrium was the cause of the loss of the ARCTIC ROSE. However, based on the lack of evidence the lazarette was flooded at the time of the casualty, it is not the most likely scenario analyzed.

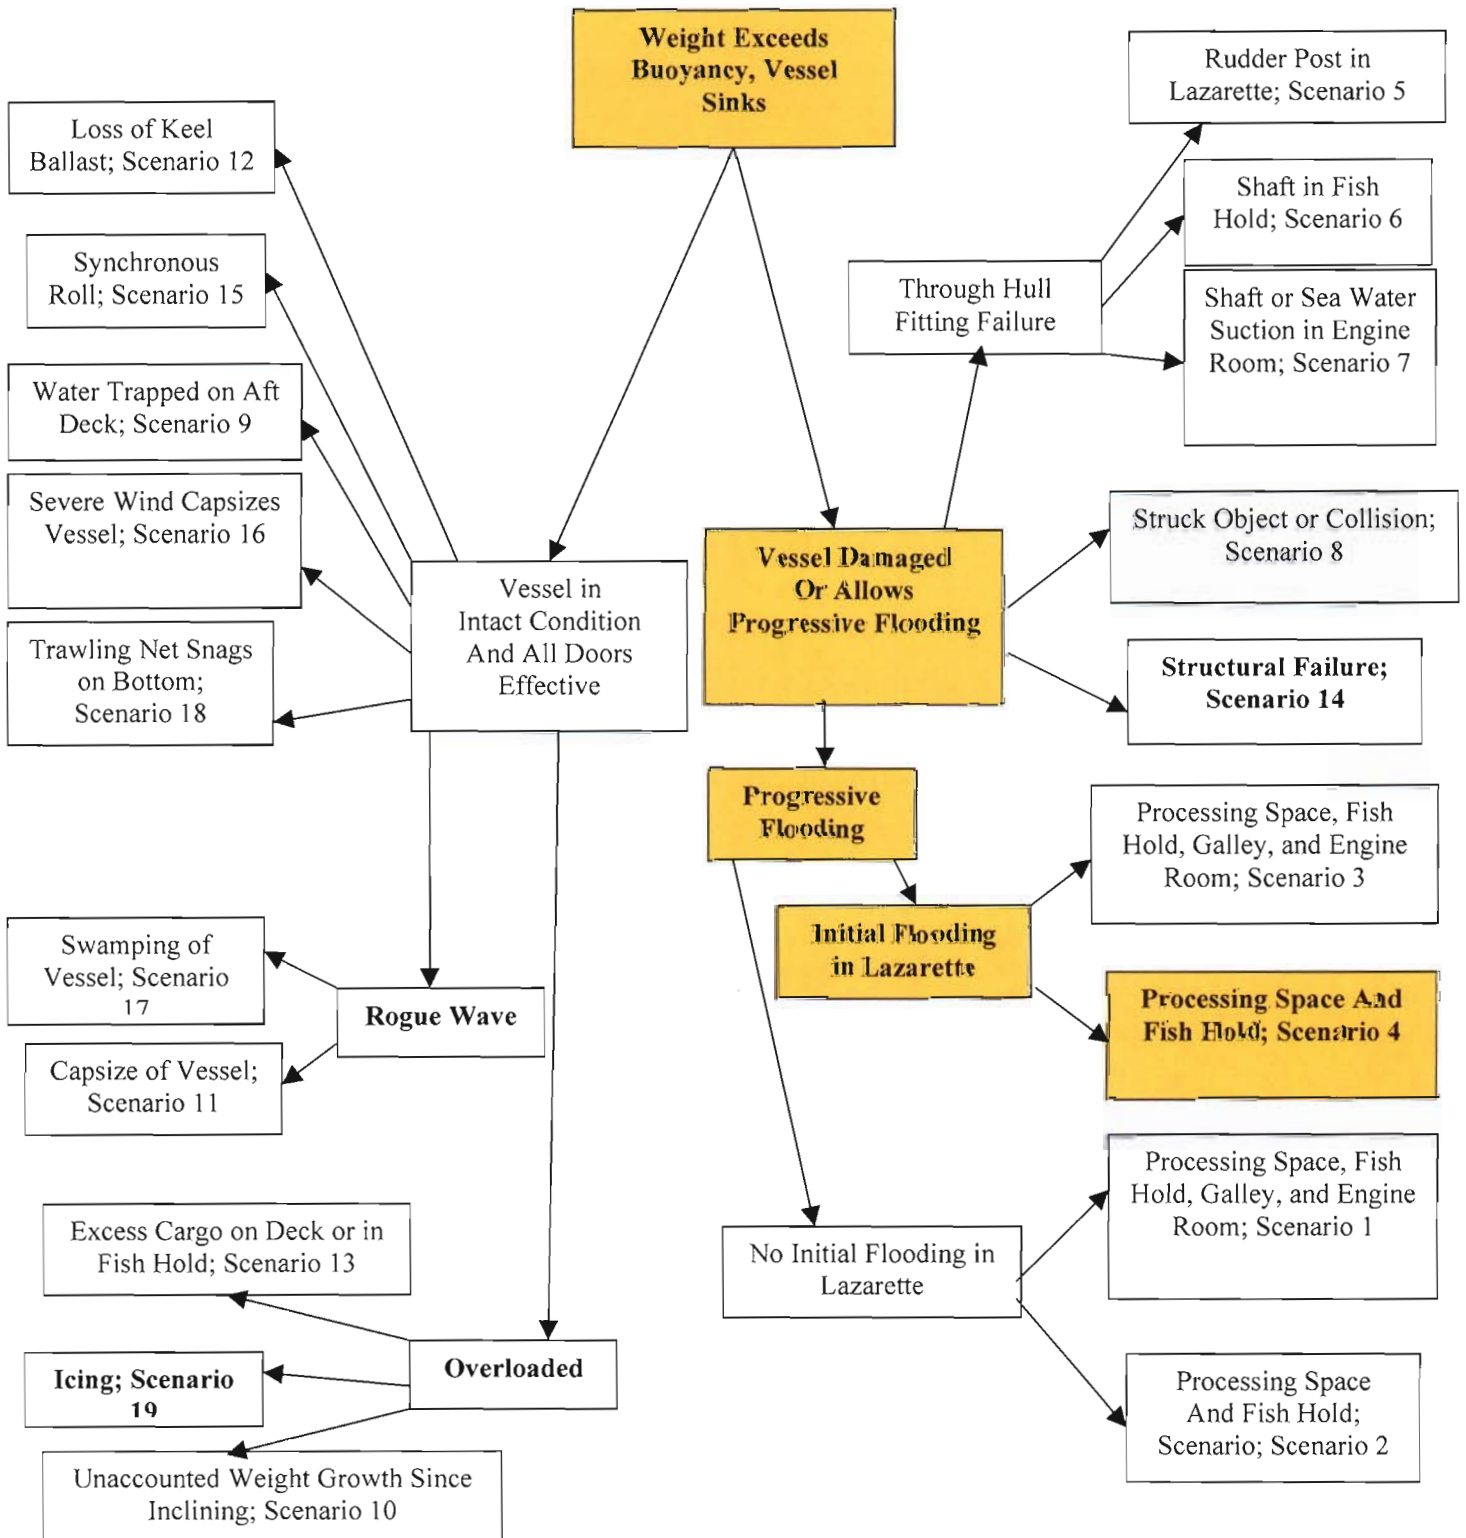
## **SCENARIO 4**

### **PROGRESSIVE FLOODING INTO PROCESSING SPACE AND FISH HOLD WITH LAZARETTE FLOODED TO EQUILIBRIUM**

8. Based on the ARCTIC ROSE's rapid loss of positive stability and reserve buoyancy, the ROV video showing the aft door to the processing space open, testimony on the lack of watertight integrity above the main deck, and the arrangement of the vessel, it is possible that progressive flooding of the processing space and fish hold after the lazarette flooded to equilibrium was the cause of the loss of the ARCTIC ROSE. However, based on the lack of evidence the lazarette was flooded at the time of the casualty, and the necessity for other spaces to eventually flood, it is not the most likely scenario analyzed.

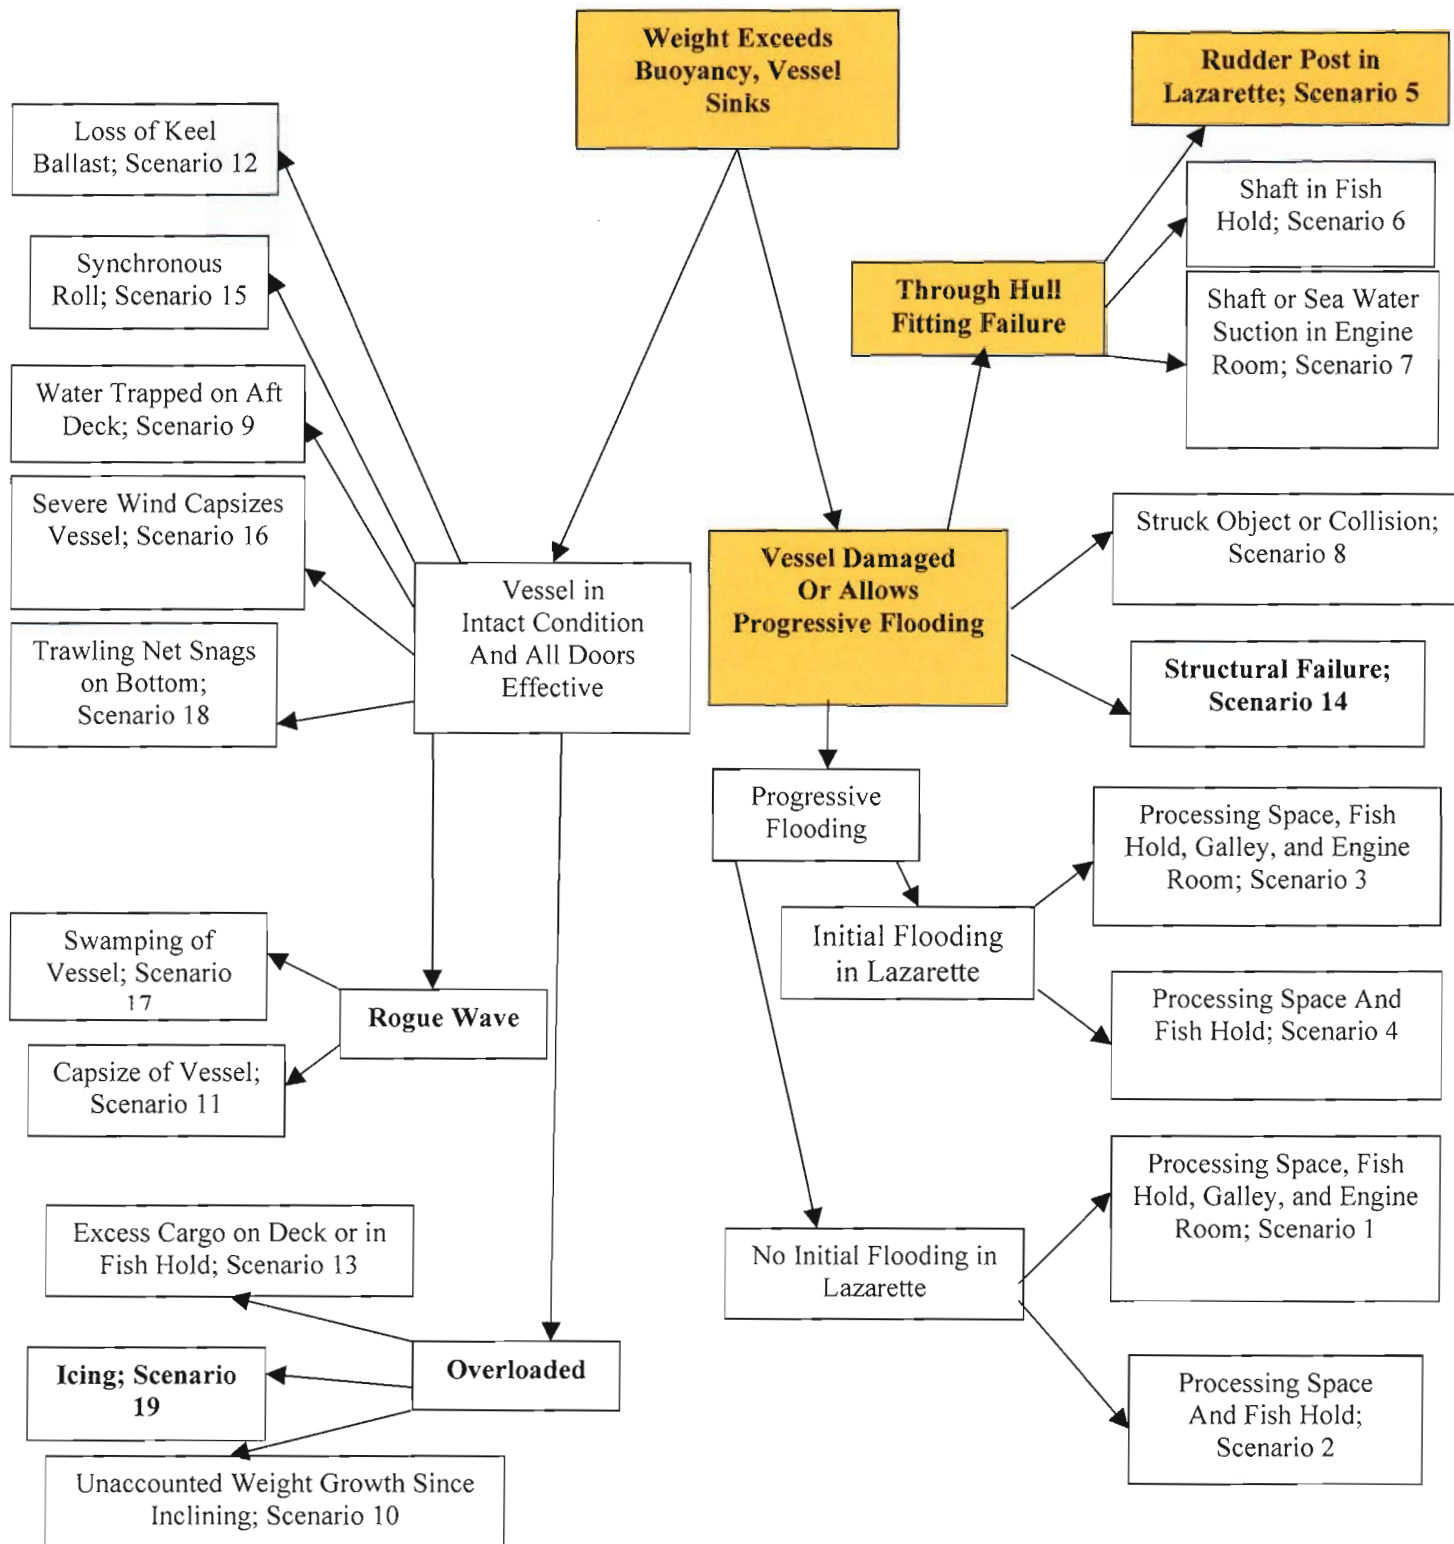
## **SCENARIO 5**

### **THROUGH HULL FITTING FAILURE: RUDDER POST IN LAZARETTE AND DRY HOLD**

5. Based on the ARCTIC ROSE's stability characteristics with the lazarette and dry stores spaces flooded and the lack of evidence of structural damage around the rudder post, it is unlikely that the loss of the ARCTIC ROSE was due to failure of a through hull fitting in the lazarette and dry store spaces.

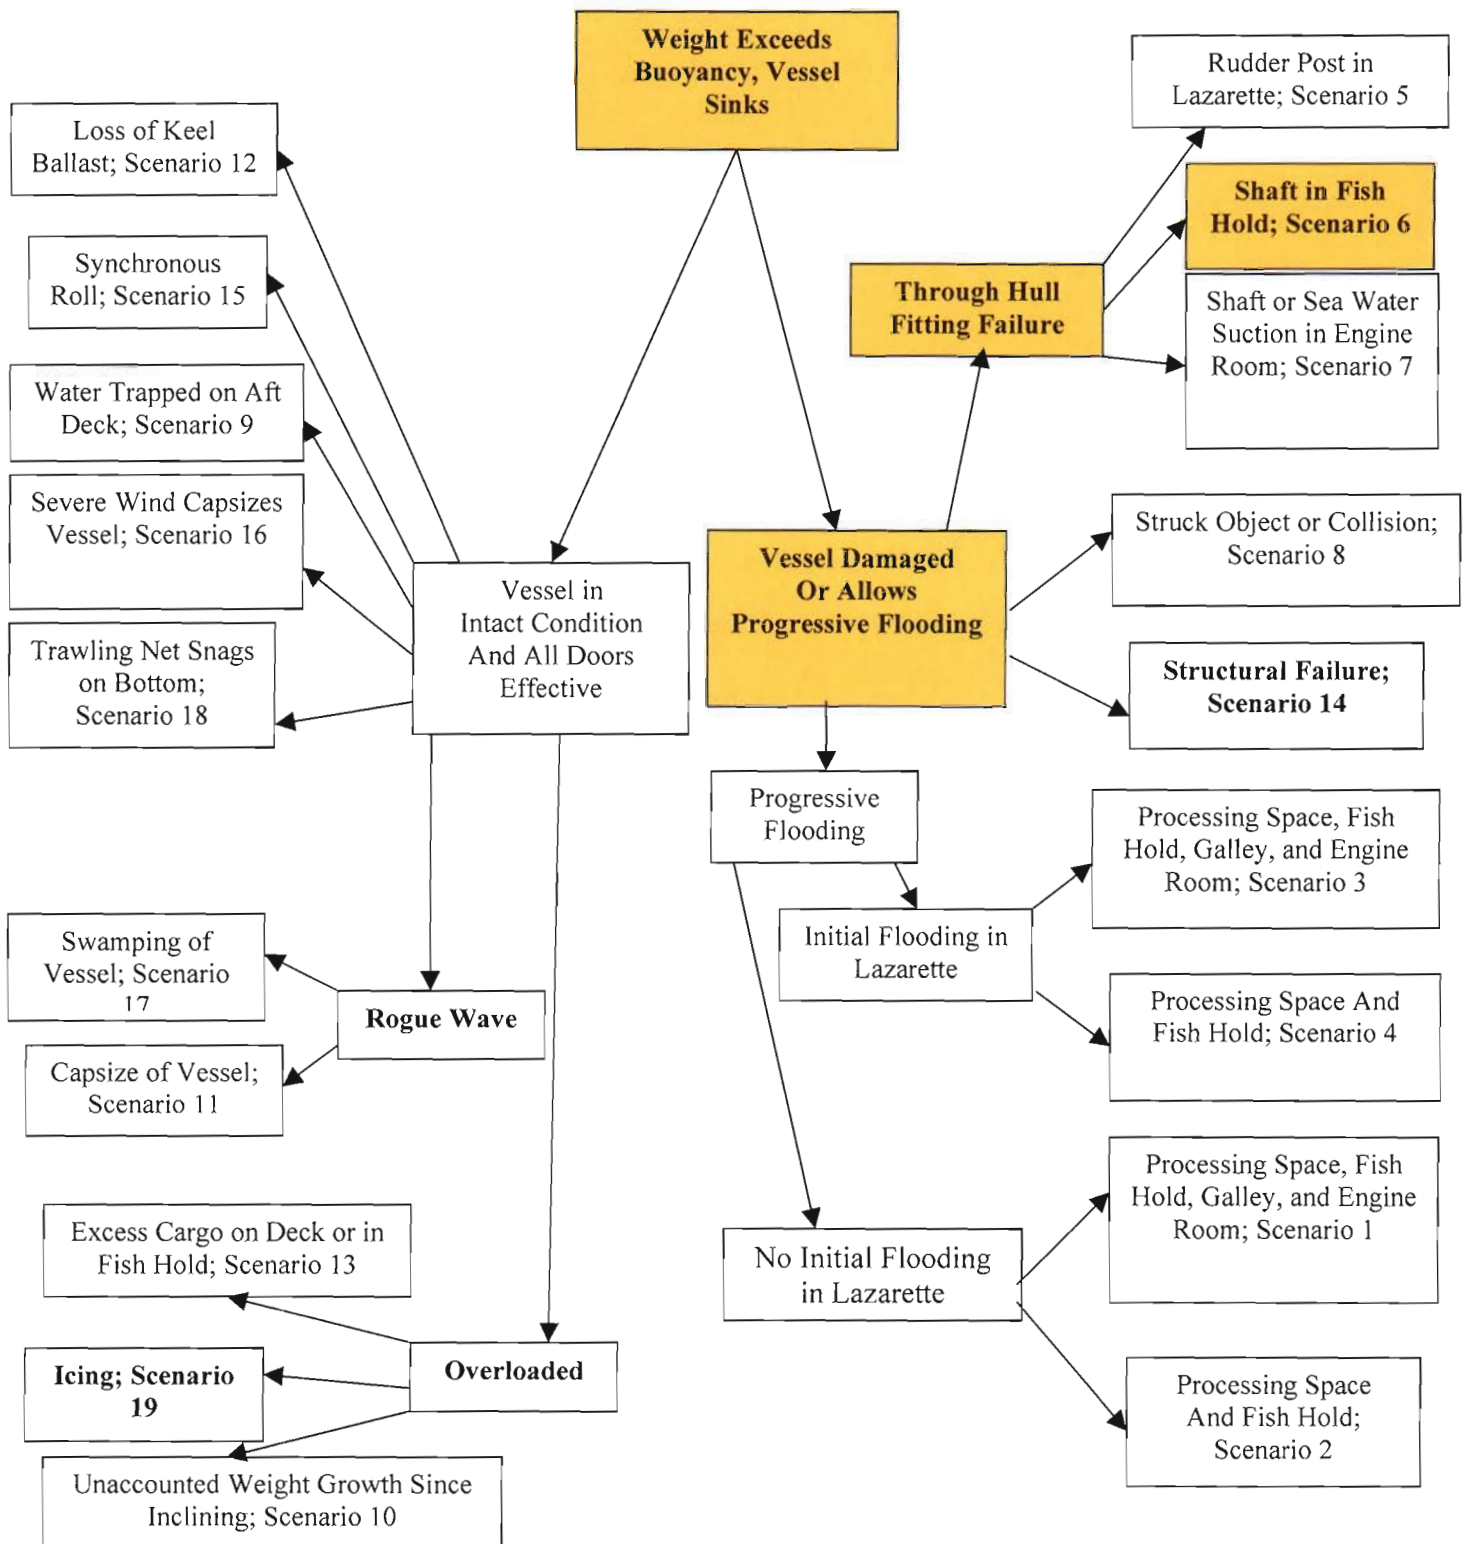
## SCENARIO 6

### THROUGH HULL FITTING FAILURE: SHAFT IN FISH HOLD

4. Based on the ARCTIC ROSE's stability characteristics with the fish hold space flooded and the lack of evidence of structural damage at a through hull fitting, it is unlikely that the loss of the ARCTIC ROSE was due to failure of a through hull fitting in the fish hold.
