# UNITED STATES COAST GUARD

## ARCTIC ROSE

OFFICIAL NUMBER 931446, IN THE BERING SEA ON  
APRIL 2, 2001, WITH ONE PERSON DECEASED AND  
FOURTEEN PERSONS MISSING AND PRESUMED DEAD

**SINKING OF THE UNINSPECTED FISHING VESSEL ARCTIC ROSE, OFFICIAL  
NUMBER 931446, IN THE BERING SEA ON APRIL 2, 2001, WITH ONE PERSON  
DECEASED AND FOURTEEN PERSONS MISSING AND PRESUMED DEAD**

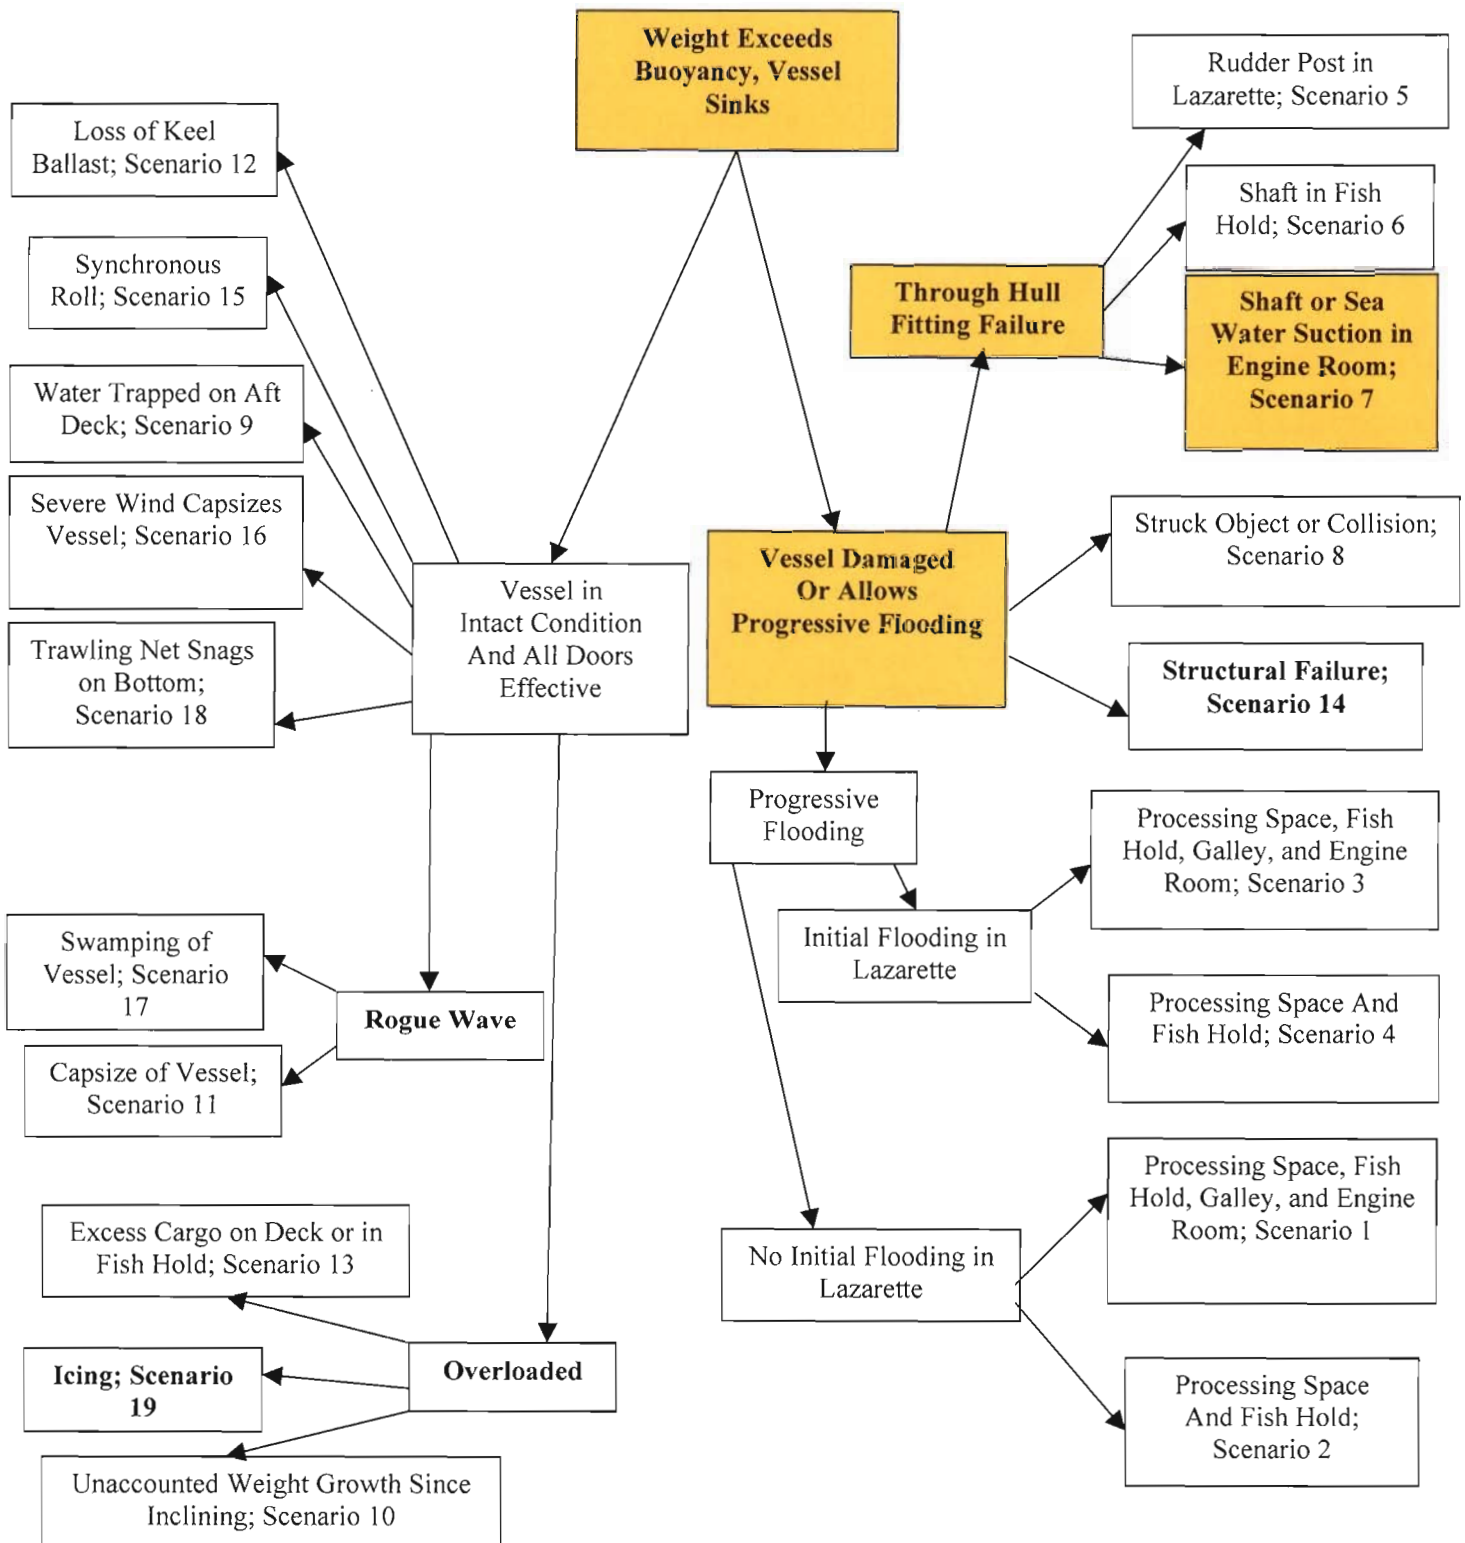
## **SCENARIO 7**

### **THROUGH HULL FITTING FAILURE: SHAFT OR SEA SUCTION IN ENGINE ROOM AND MACHINERY SPACE**

5. Based on the ARCTIC ROSE's stability characteristics with the engine room and machinery space flooded and the lack of evidence of structural damage around the engine room, it is unlikely that the loss of the ARCTIC ROSE was due to failure of a through hull fitting in the engine room or machinery space.

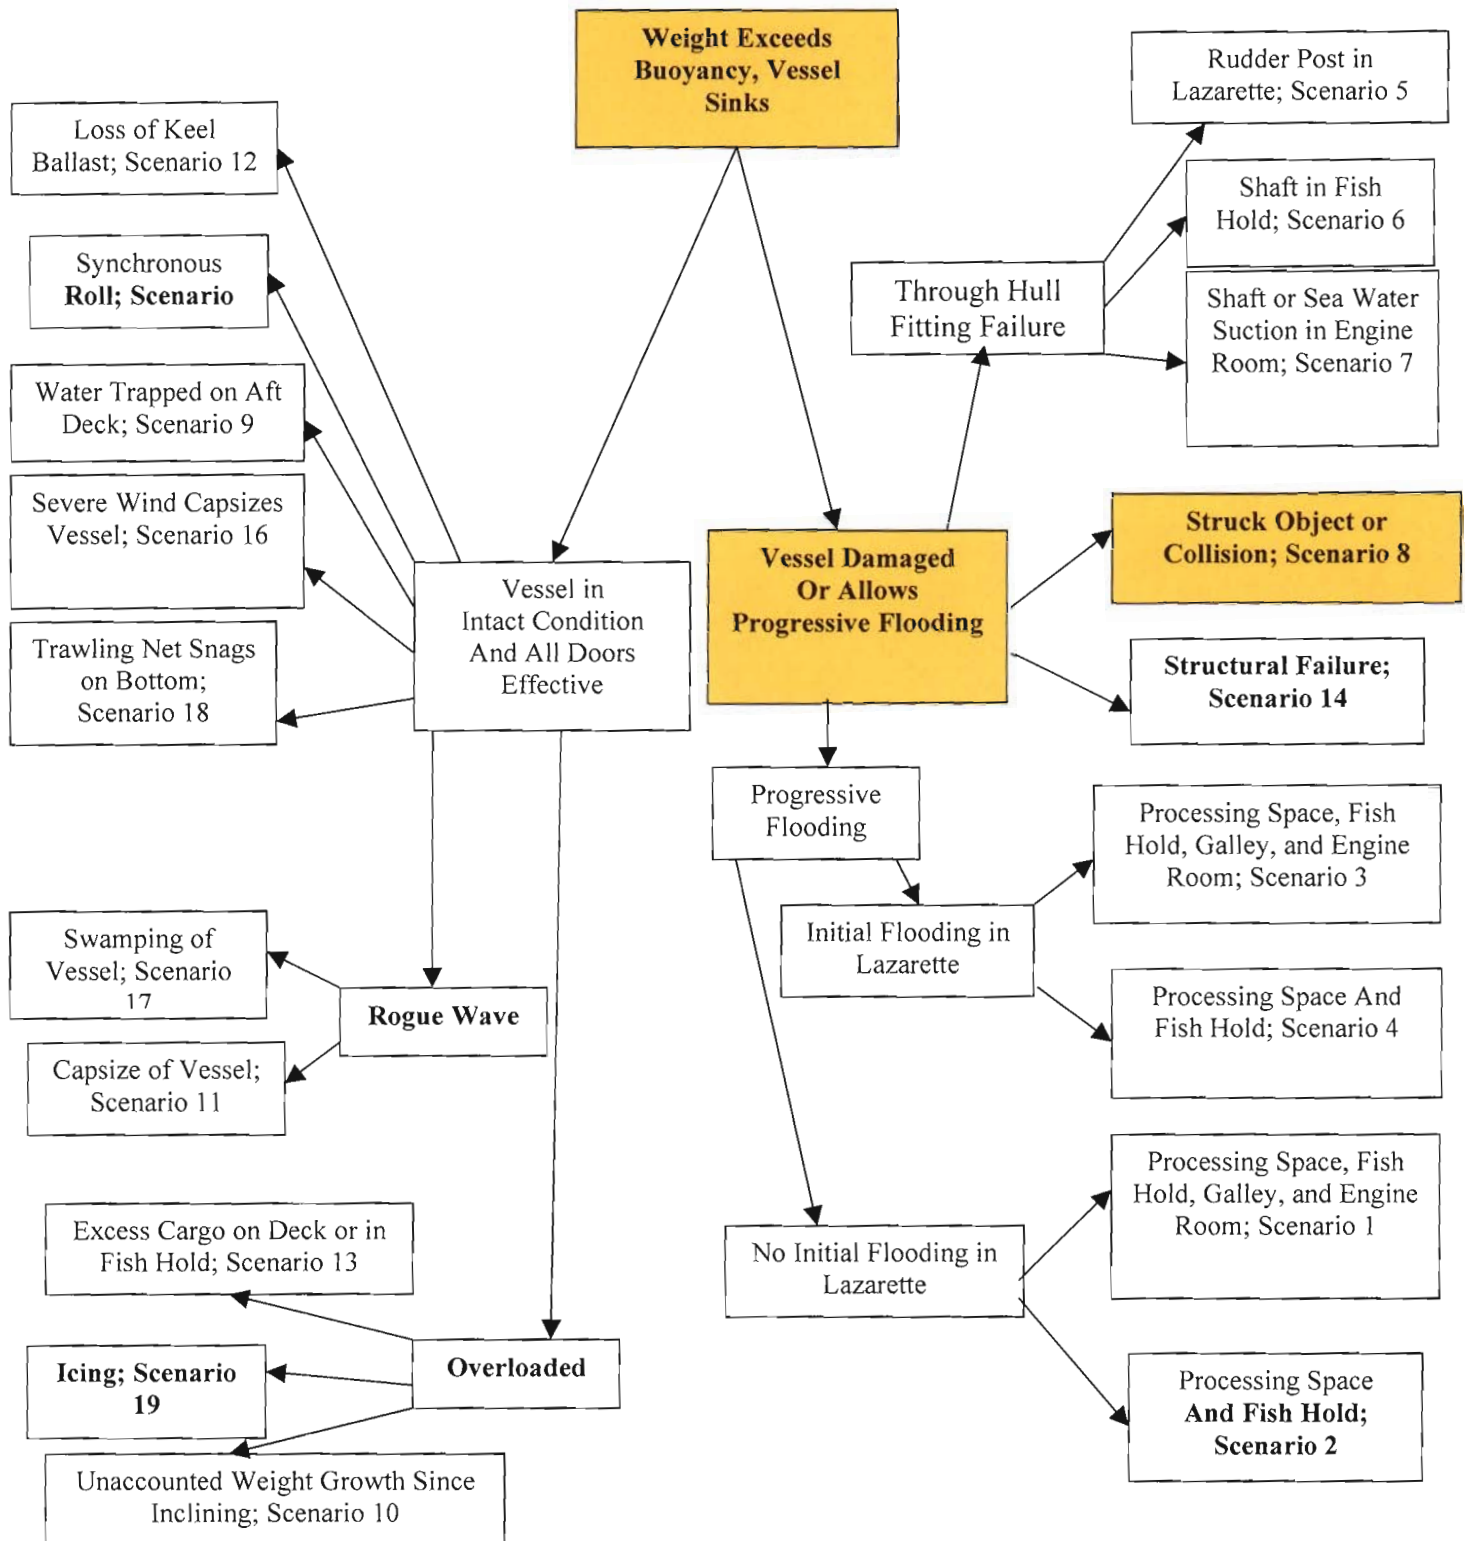
## SCENARIO 8

### STRUCK OBJECT OR COLLISION

6. Based on the ARCTIC ROSE's stability characteristics with either the fuel oil wing tanks or the forepeak compartment flooded, and the lack of evidence of structural damage on the outside of the vessel, it is unlikely that the loss of the ARCTIC ROSE was due to striking a submerged object or colliding with an object.

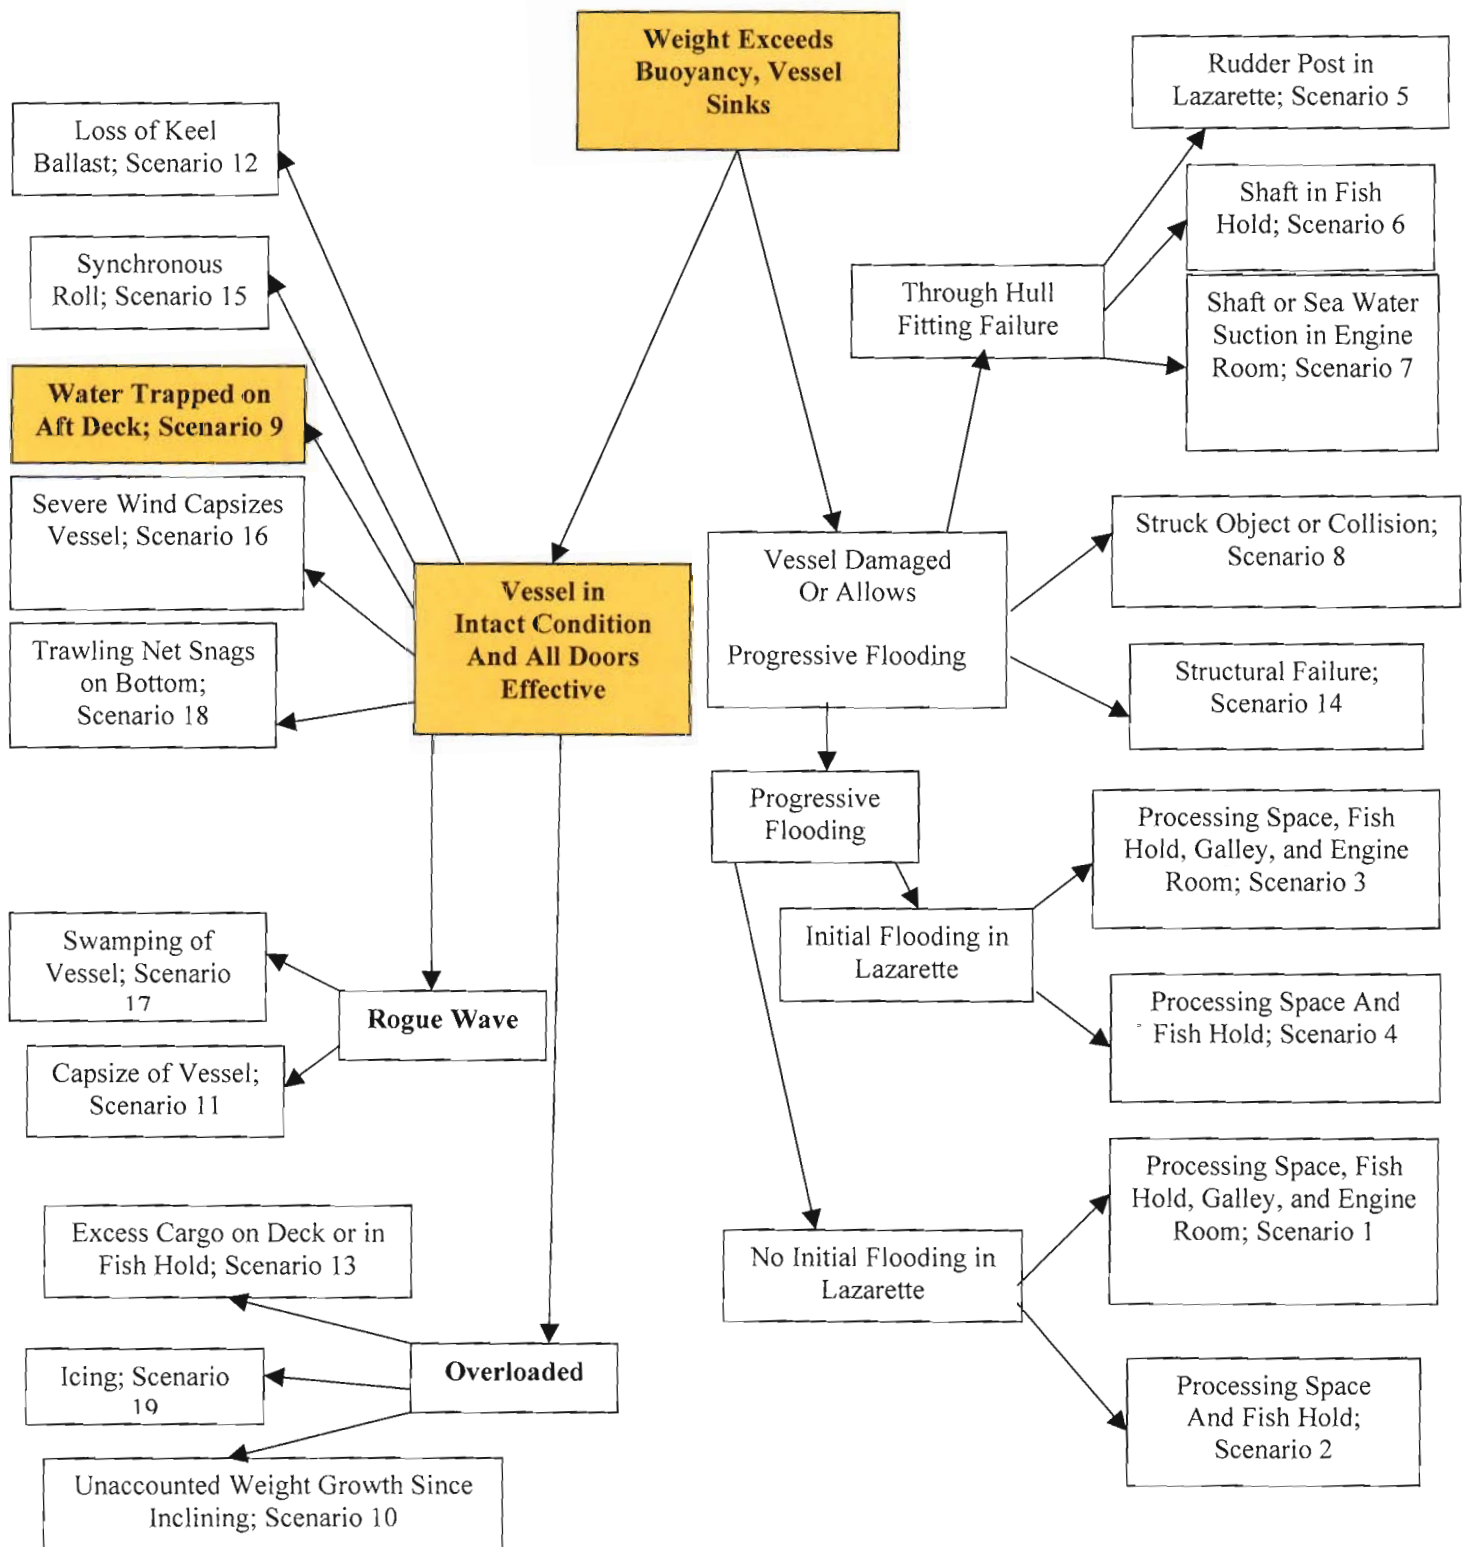
## SCENARIO 9

### WATER TRAPPED ON AFT DECK

4. Although the ARCTIC ROSE's stability would be reduced by water trapped on the after deck, the large range of stability, large reserve buoyancy of the vessel, and lack of evidence that water could gather and remain trapped on deck make it unlikely that the loss of the ARCTIC ROSE was due solely to water trapped on the after deck.

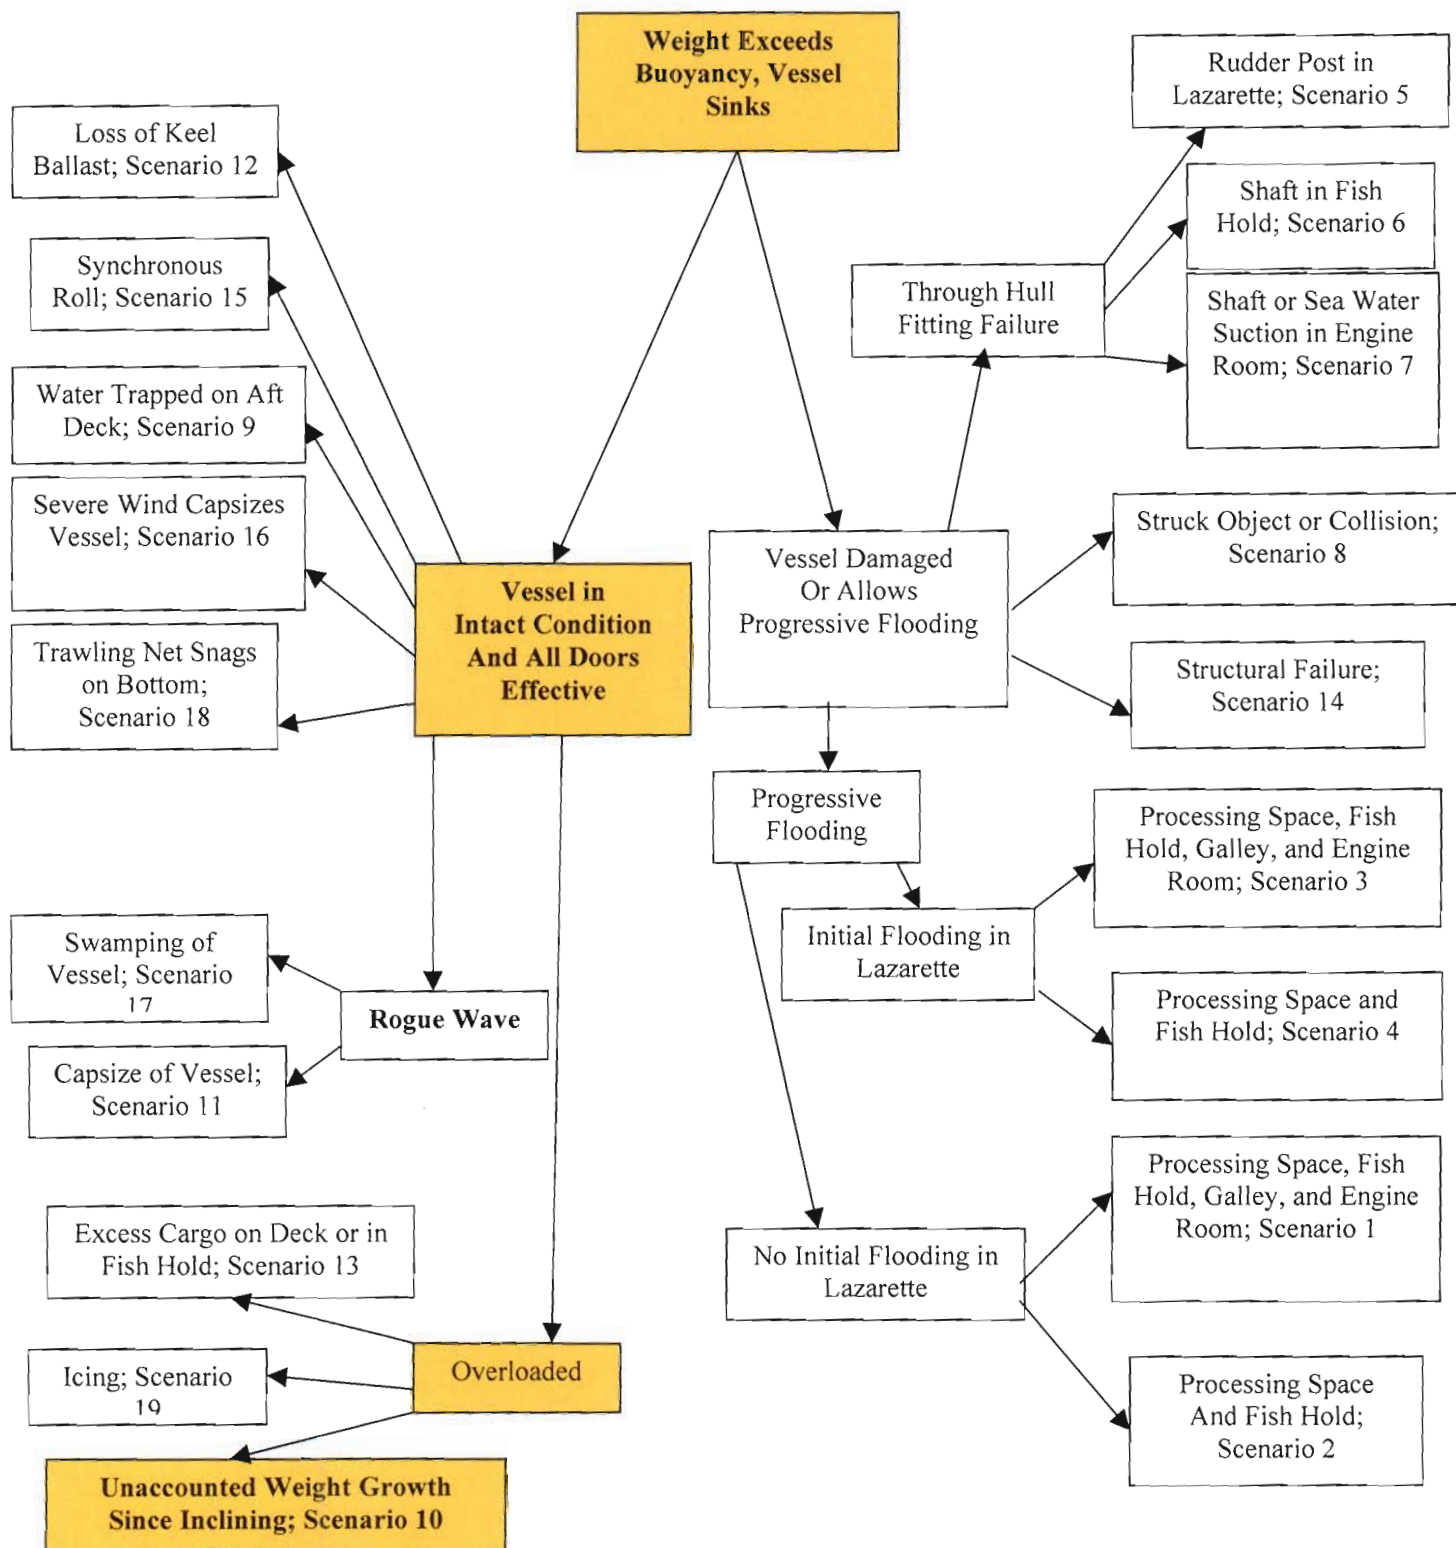
## SCENARIO 10

### UNACCOUNTED FOR WEIGHT GROWTH SINCE INCLINING

3. Based on the accurate correlation between the list of weights added, removed, or moved provided by Jensen Maritime Consultants and the testimony collected by the Marine Board, the ARCTIC ROSE' stability was very likely not severely affected by unaccounted for weight growth.

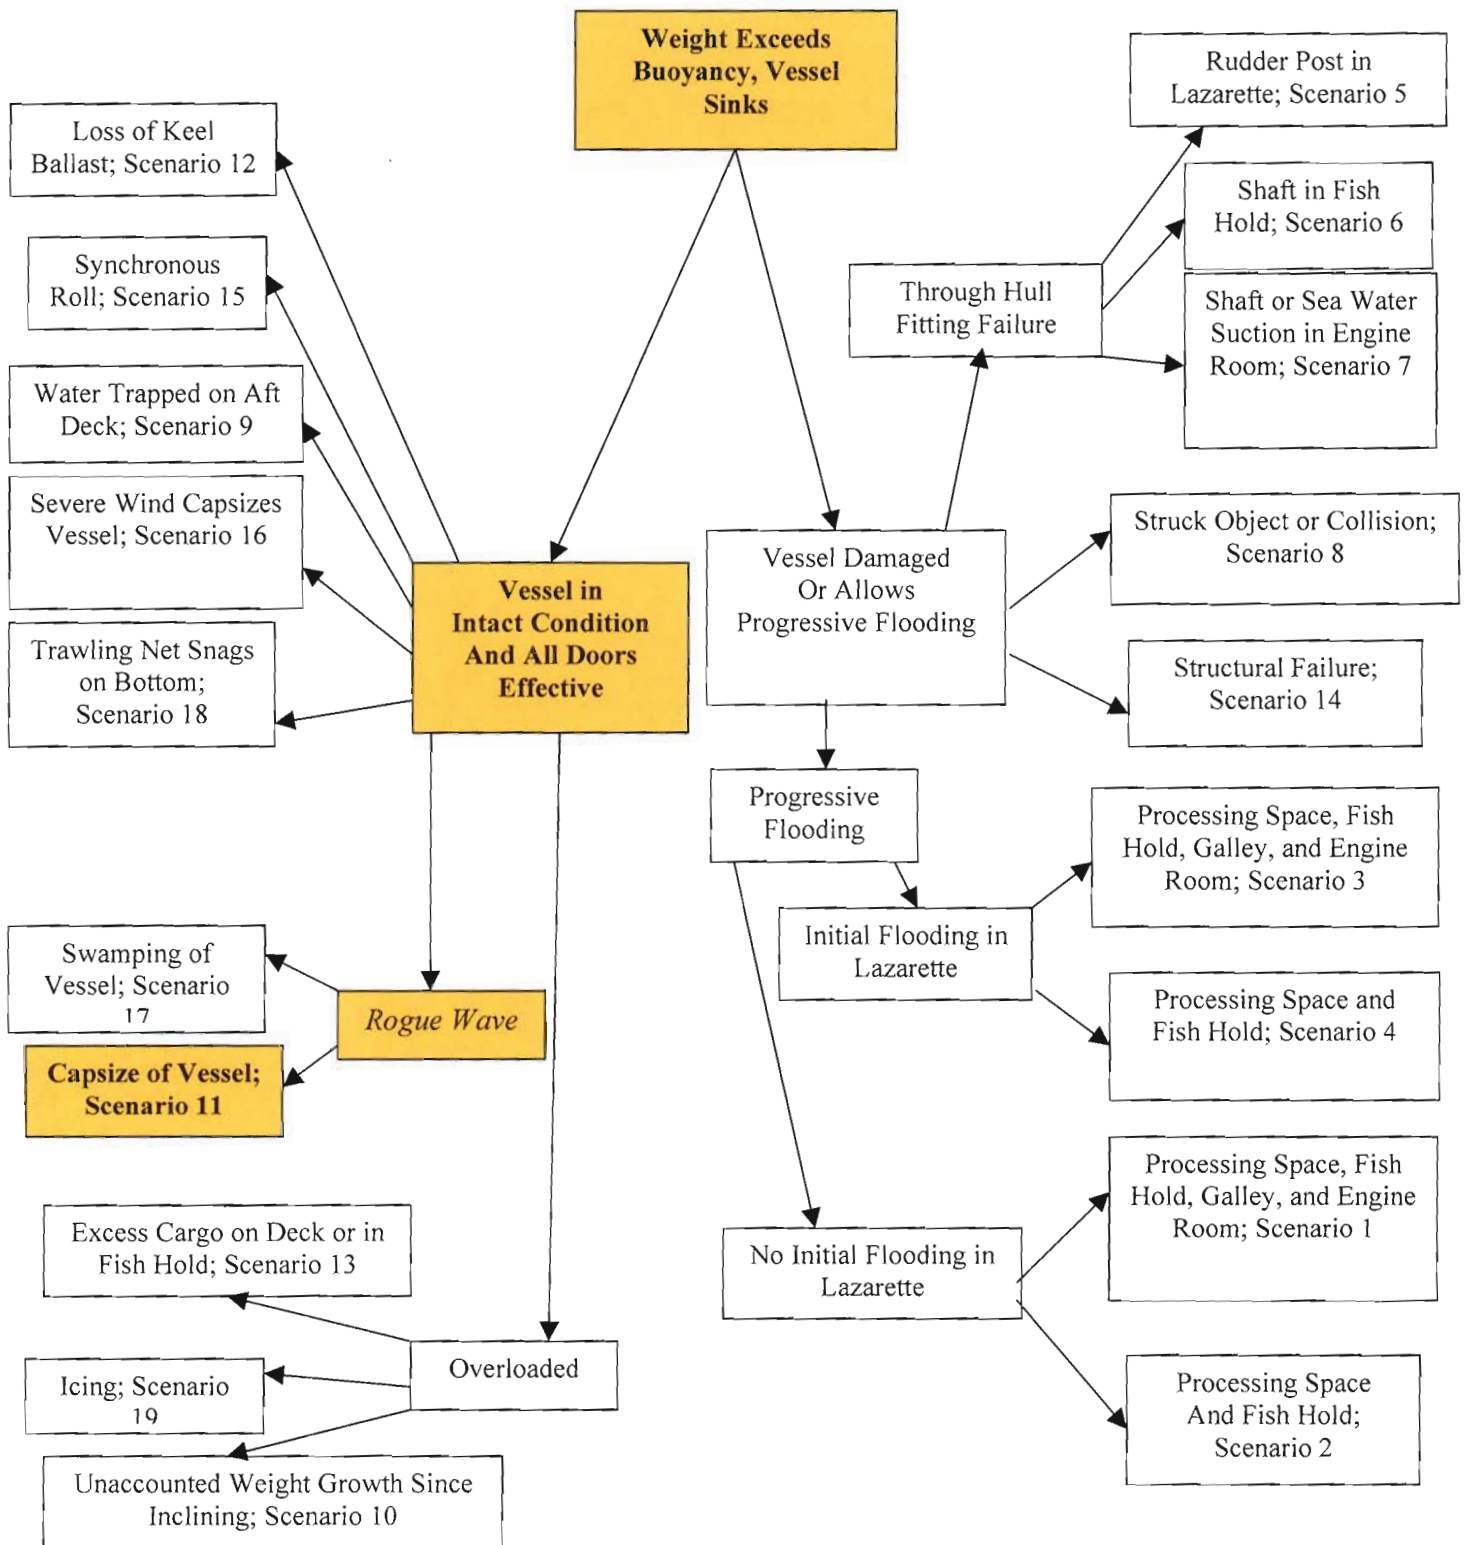
## SCENARIO 11

### CAPSIZING OF VESSEL DUE TO ROGUE WAVE

5. Based on the extremely large wave height calculated as necessary to cause the capsize of the ARCTIC ROSE, and the size of the seas on the night of the casualty, it is very unlikely that the loss of the vessel was due to a rogue wave.

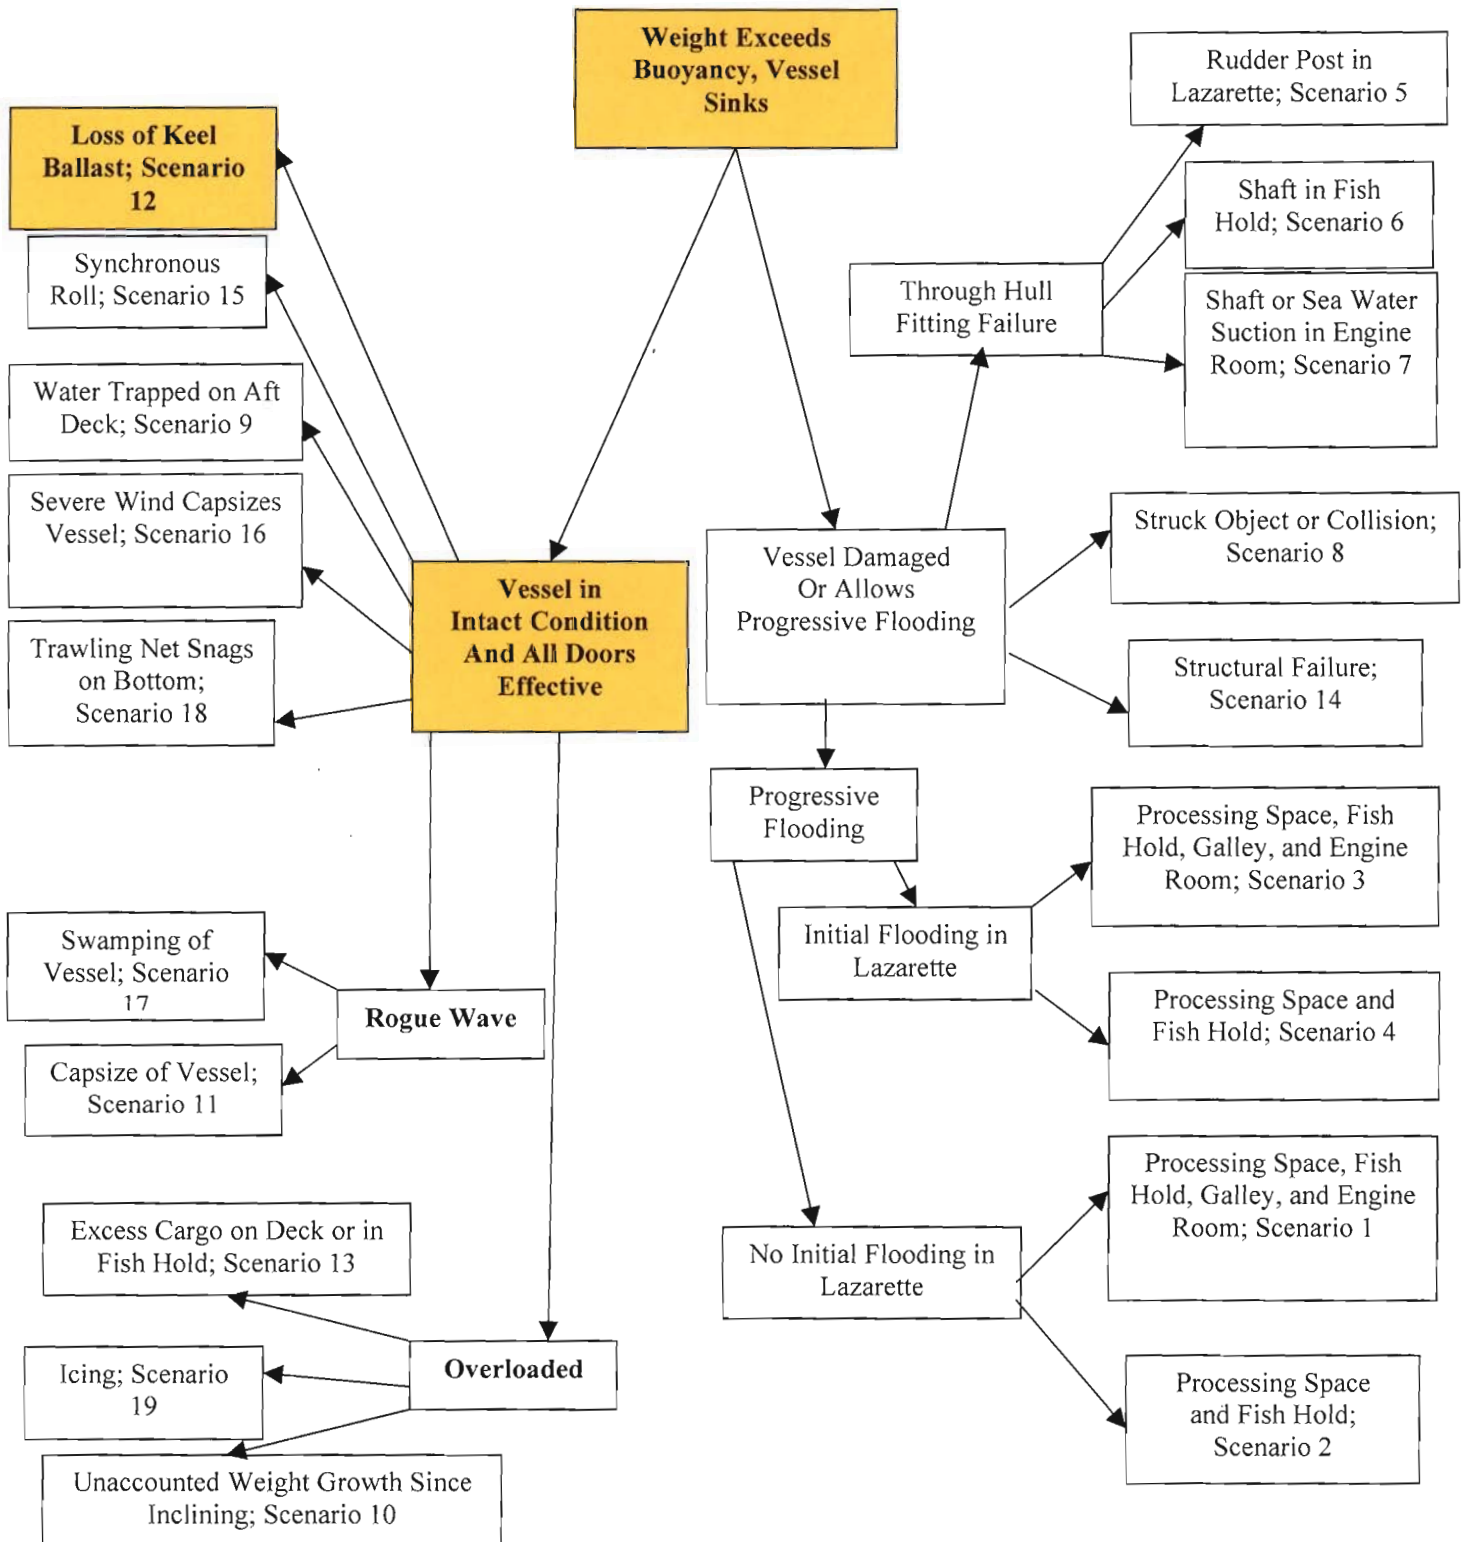
## SCENARIO 12

### LOSS OF KEEL BALLAST

4. Based on the ARCTIC ROSE's stability characteristics without the keel ballast and the fact there was no evidence of structural damage around the keel area, it is unlikely that the loss of the ARCTIC ROSE was due to the loss of the keel ballast.

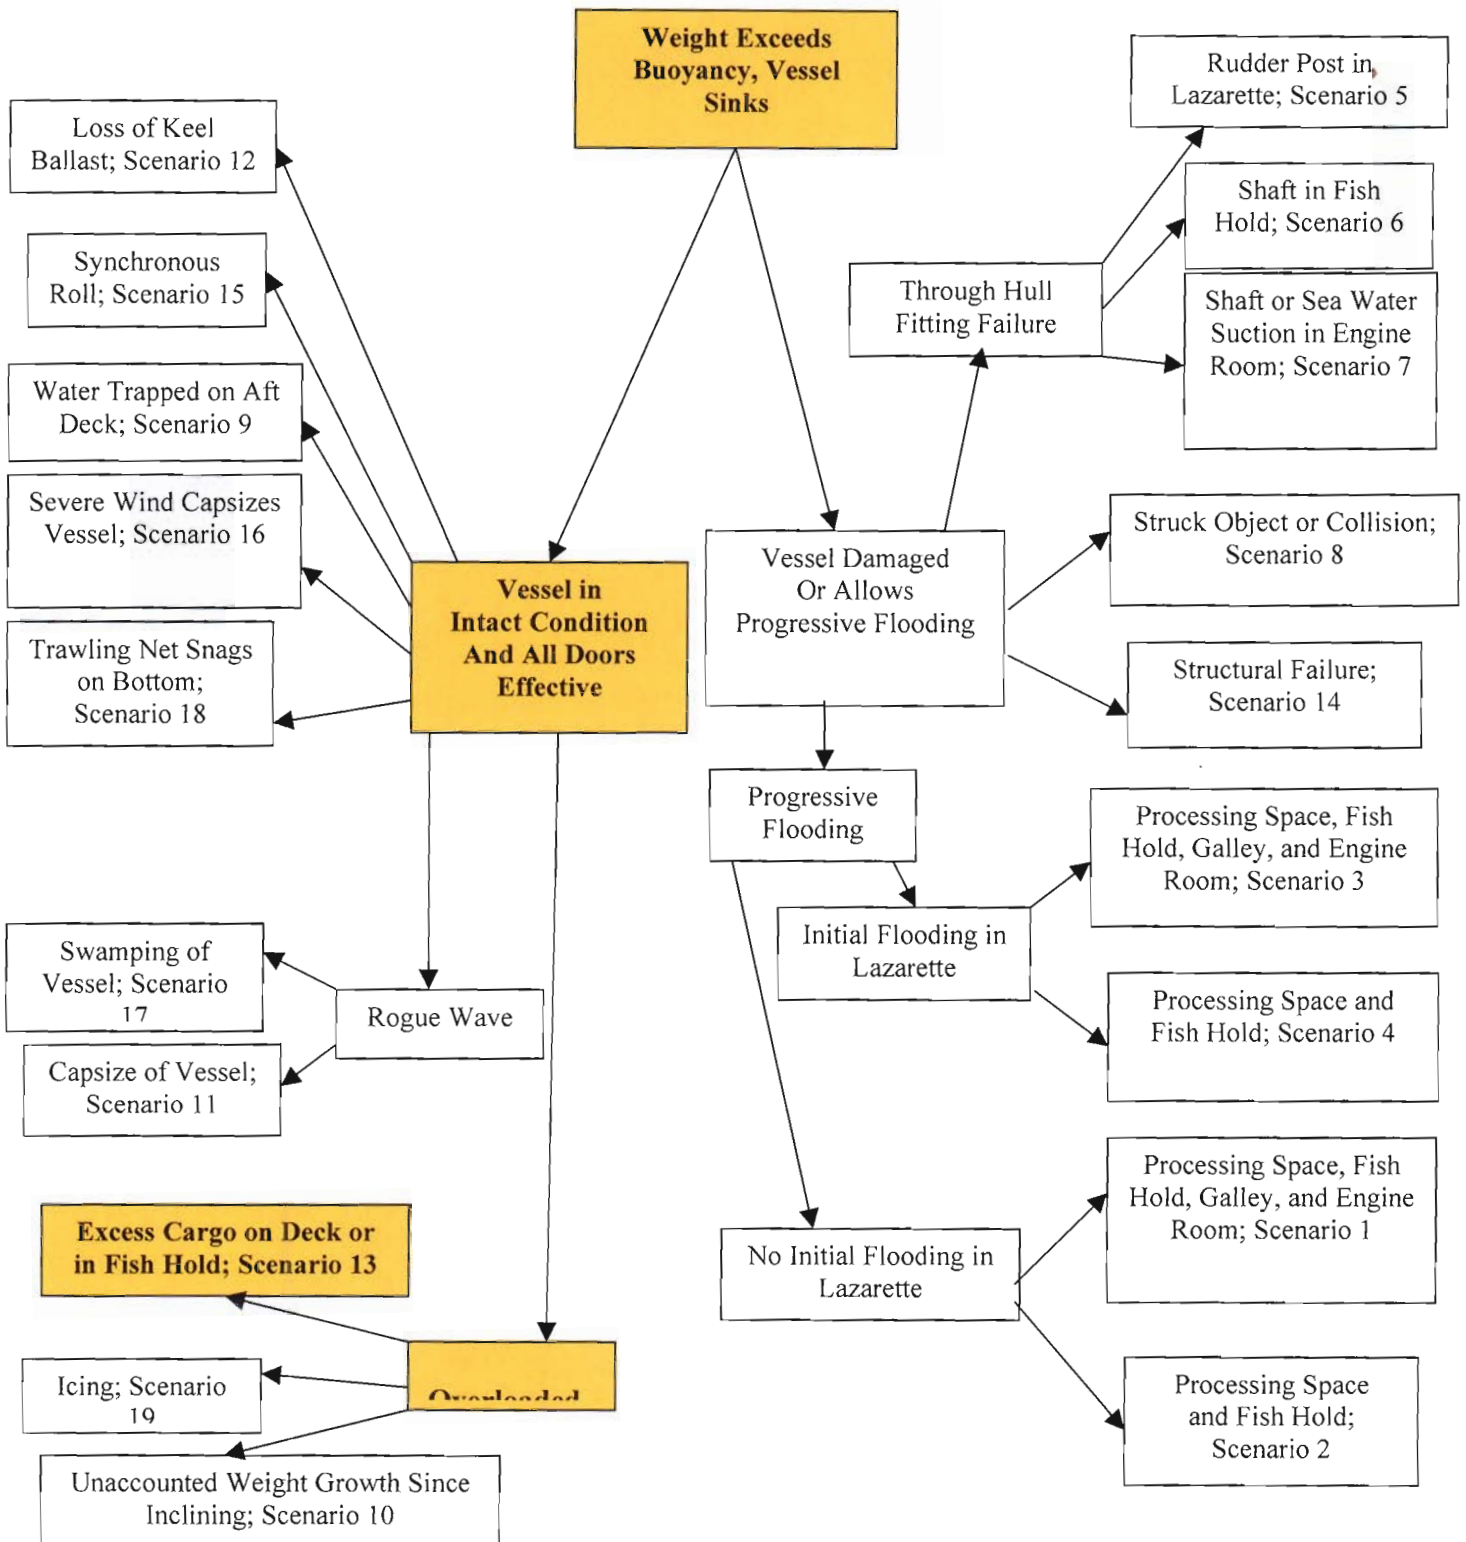
## **SCENARIO 13**

### **OVERLOADED WITH EXCESS CARGO ON DECK OR IN FISH HOLD**

3. Based on the cargo loads provided to the Coast Guard by the Marine Board of Investigation and the ROV video, it is very unlikely the loss of the ARCTIC ROSE was due to the vessel being overloaded with excess cargo on deck or in the fish hold.

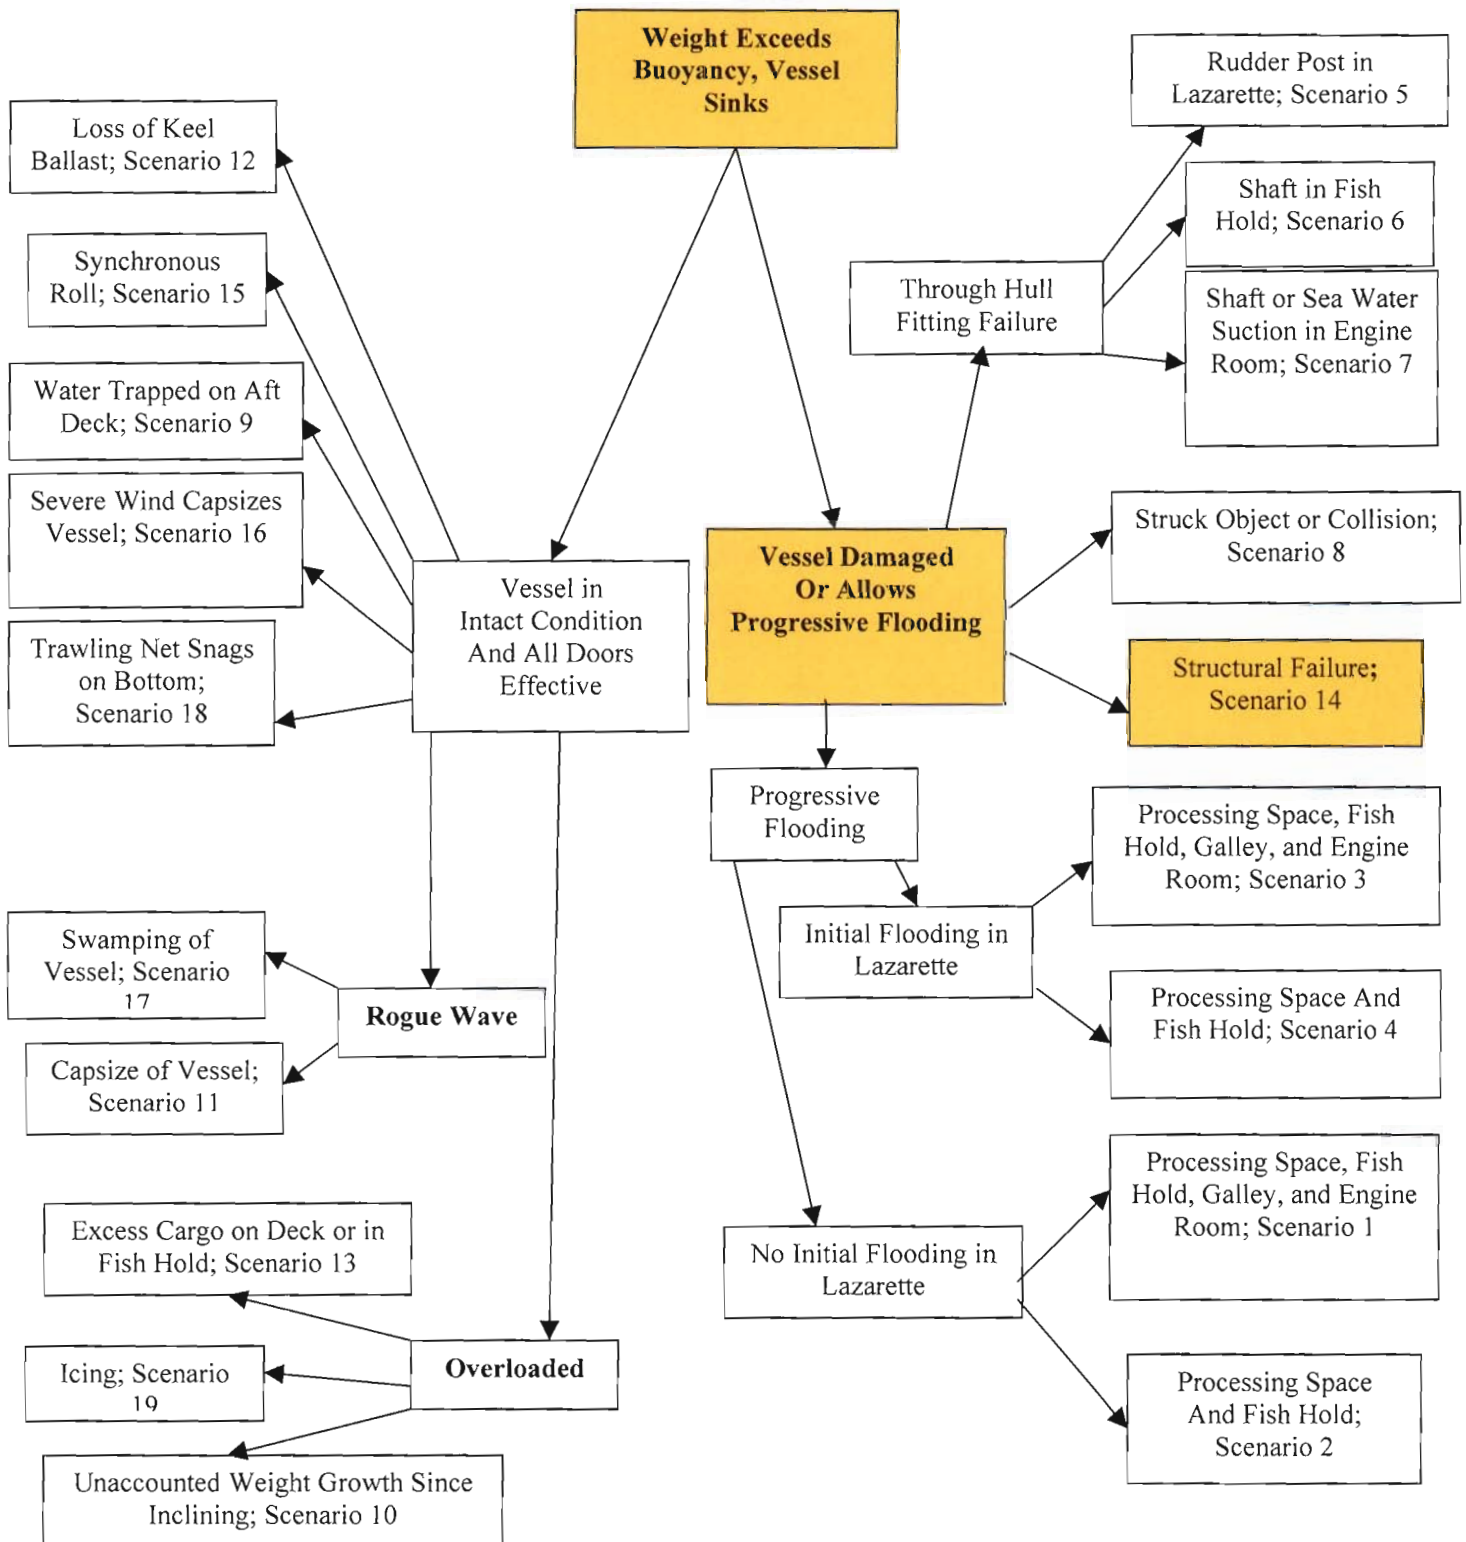
## **SCENARIO 14**

### **STRUCTURAL FAILURE**

4. Based on the ROV video of the ARCTIC ROSE side shell, deck plating, and bottom plating, it is very unlikely that the vessel sank due to a global structural failure.

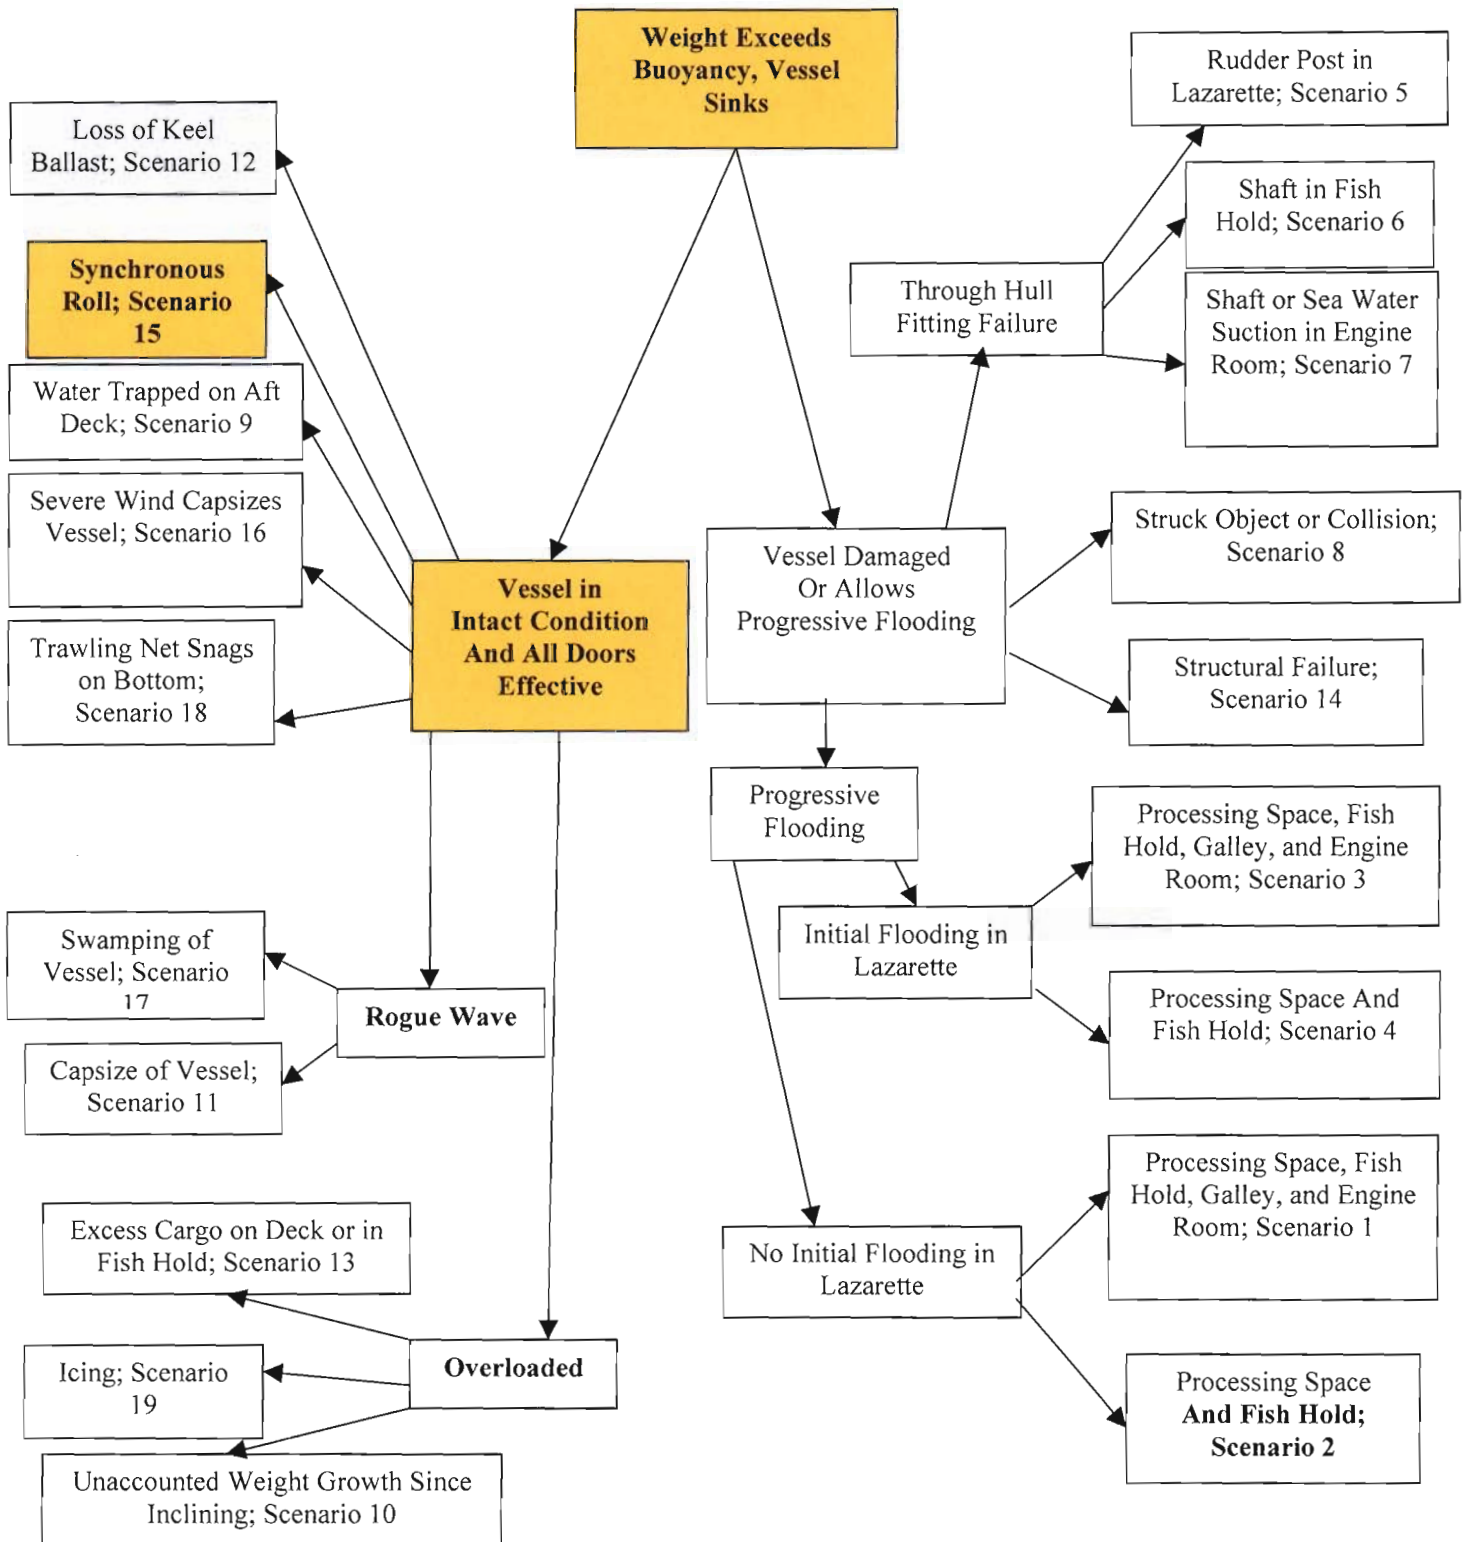
## SCENARIO 15

### SYNCHRONOUS ROLL

4. Based on the roll characteristics of the ARCTIC ROSE, the weather conditions the night of the vessel's loss, and the probable speed of the vessel, it is very unlikely that the loss of the ARCTIC ROSE was due to synchronous roll.
