# UNITED STATES COAST GUARD

## ARCTIC ROSE

OFFICIAL NUMBER 931446, IN THE BERING SEA ON  
APRIL 2, 2001, WITH ONE PERSON DECEASED AND  
FOURTEEN PERSONS MISSING AND PRESUMED DEAD

**SINKING OF THE UNINSPECTED FISHING VESSEL ARCTIC ROSE, OFFICIAL  
NUMBER 931446, IN THE BERING SEA ON APRIL 2, 2001, WITH ONE PERSON  
DECEASED AND FOURTEEN PERSONS MISSING AND PRESUMED DEAD**

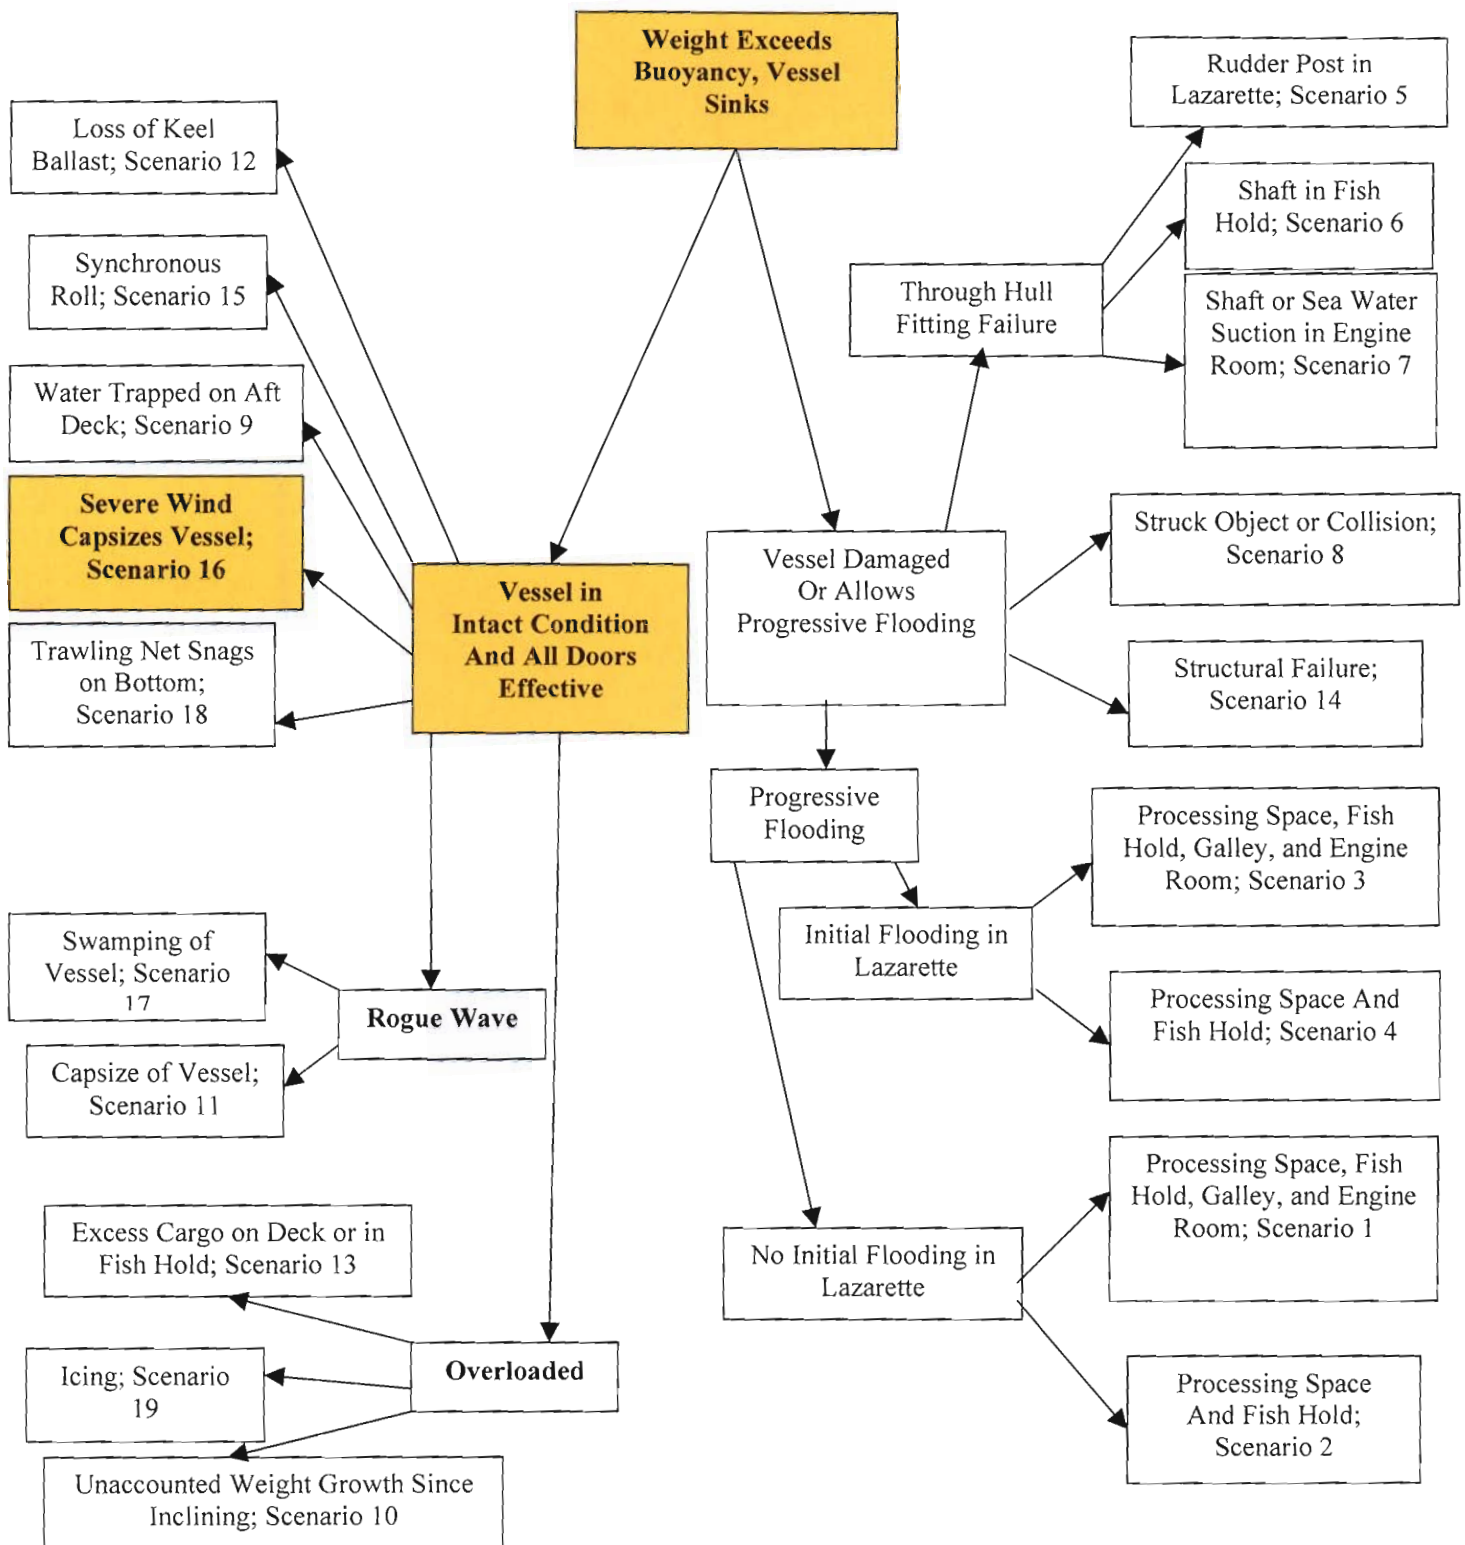
## SCENARIO 16

### SEVERE WIND CAPSIZES VESSEL

4. Based on the ARCTIC ROSE's stability characteristics when a 100 knot wind was applied, it is very unlikely that a severe wind would heel the vessel past its angle of vanishing stability and capsize the vessel.

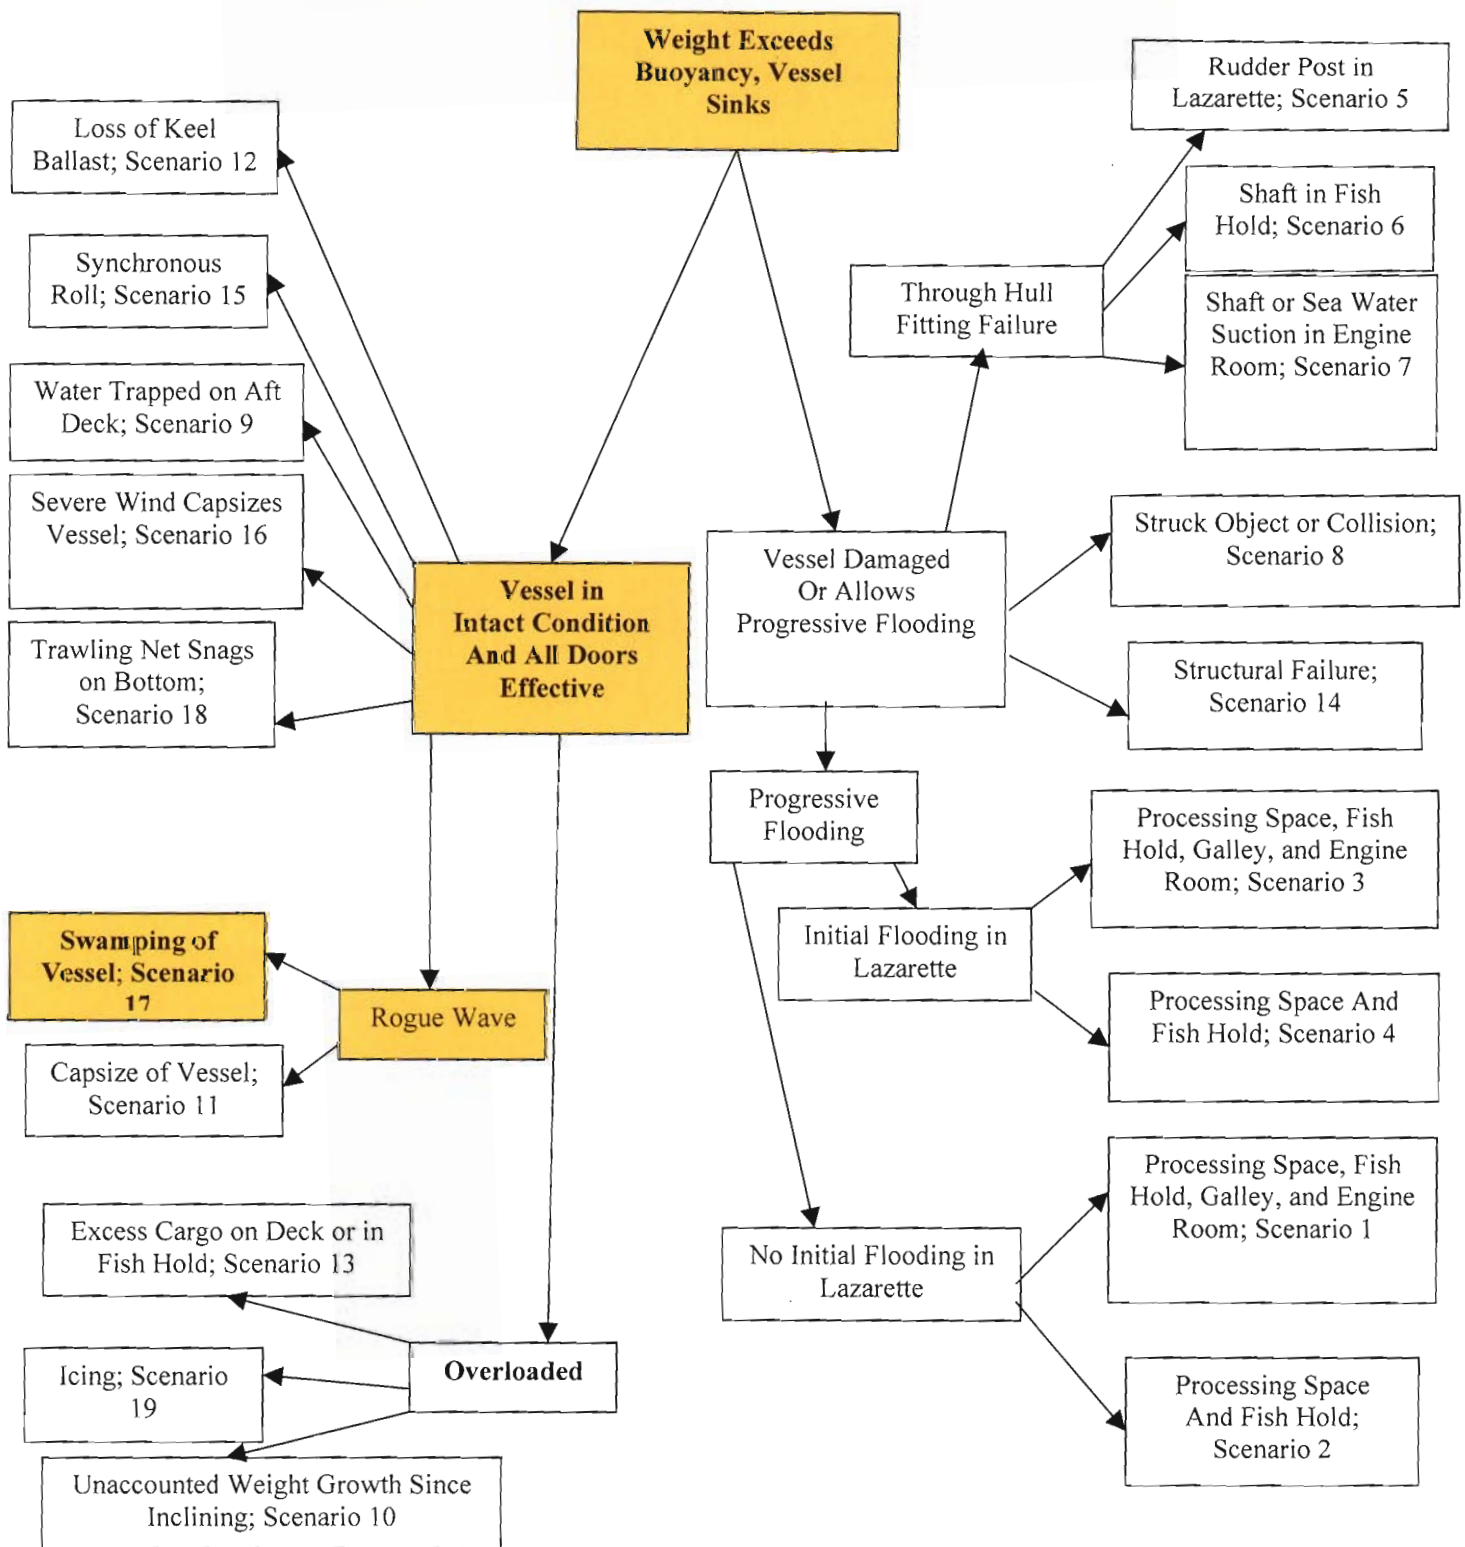
## SCENARIO 17

### SWAMPING OF VESSEL DUE TO ROGUE WAVE

3. Based on the extremely large volume of water that would be needed to swamp the ARCTIC ROSE, the small aft deck area, and the relatively small door opening through which water could enter the processing space, it is very unlikely that a rogue wave swamped the vessel and caused it to sink.

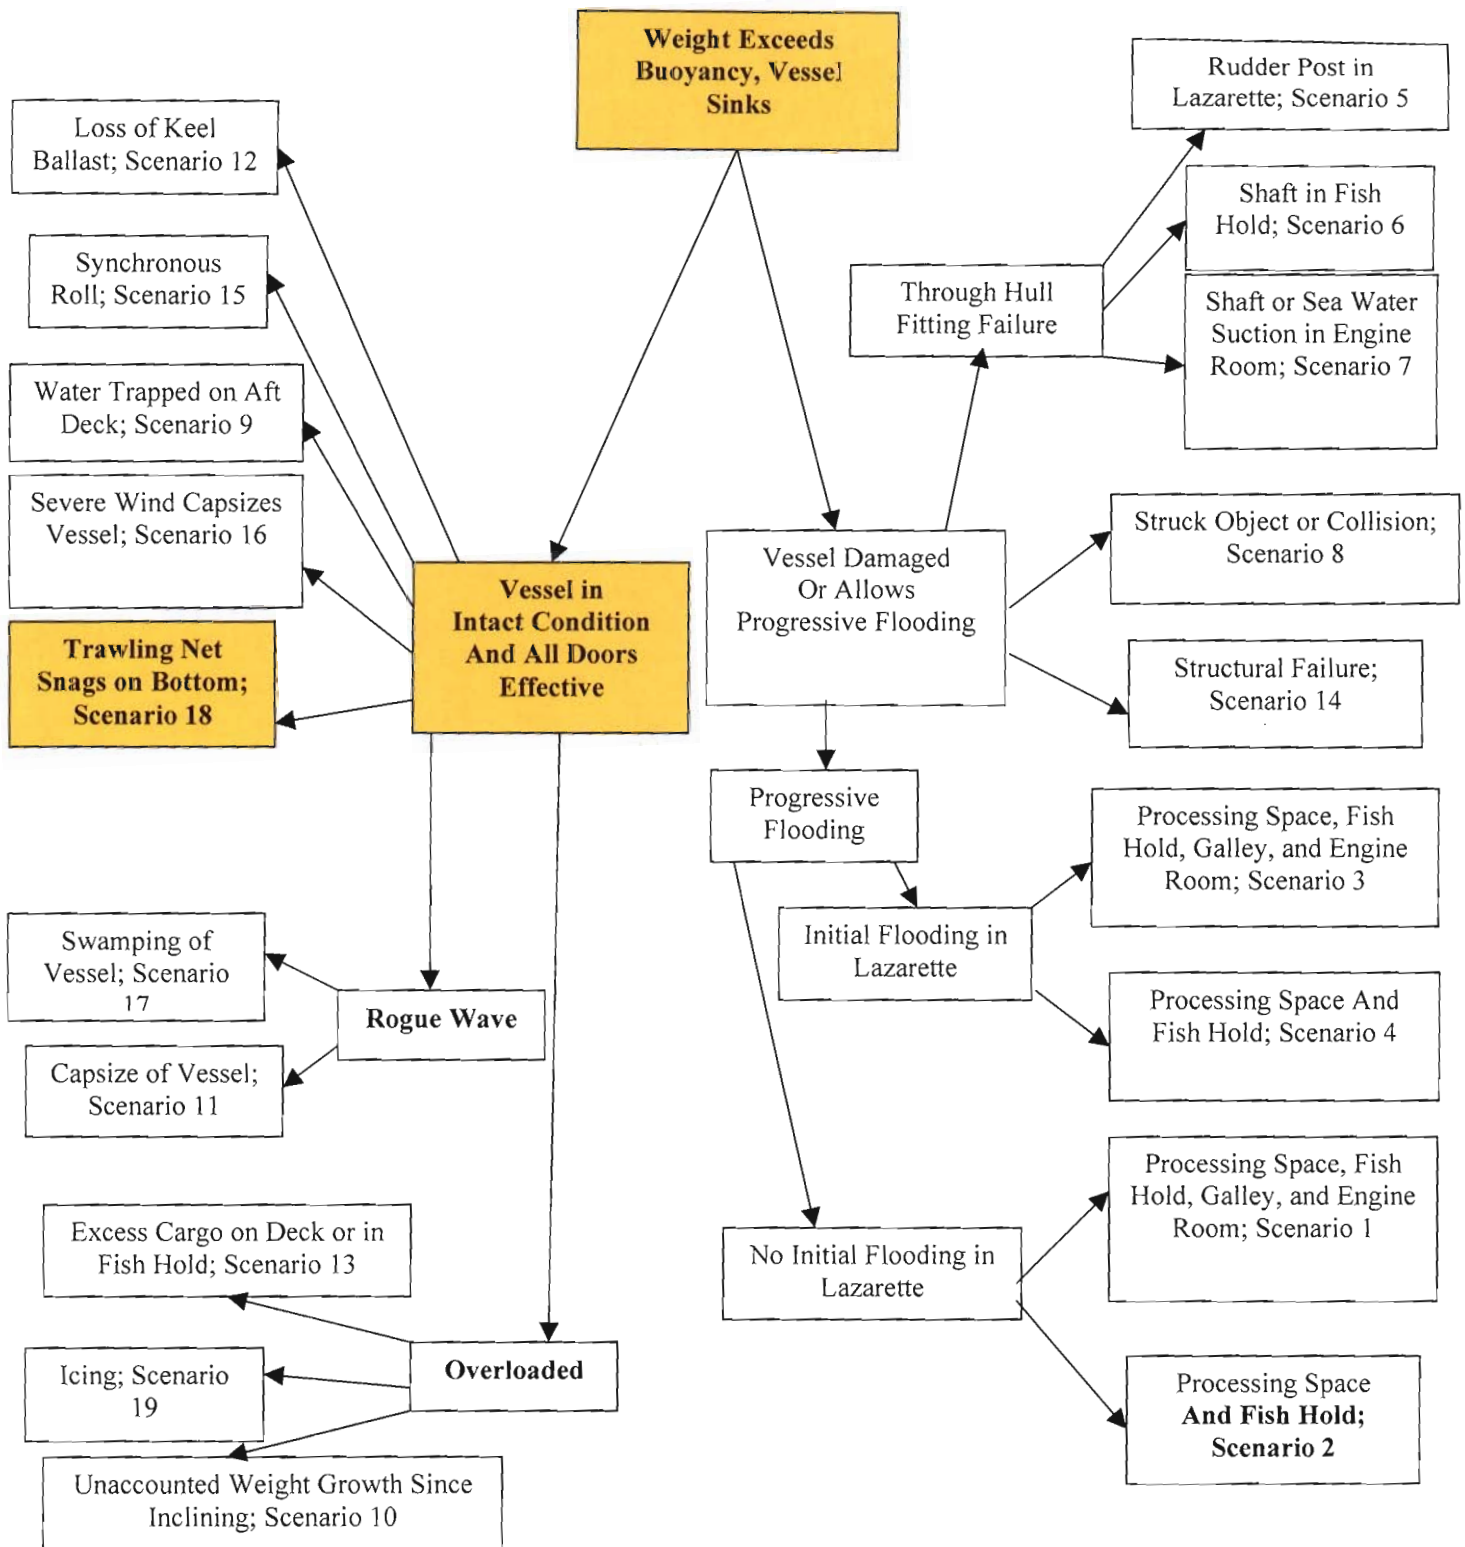
## SCENARIO 18

### TRAWLING NET SNAGS ON BOTTOM

3. Based on the ROV video which shows the trawling net stowed on the aft reel, it is very unlikely that the ARCTIC ROSE sank due to the trawling net snagging the bottom and dragging the aft end of the vessel down.

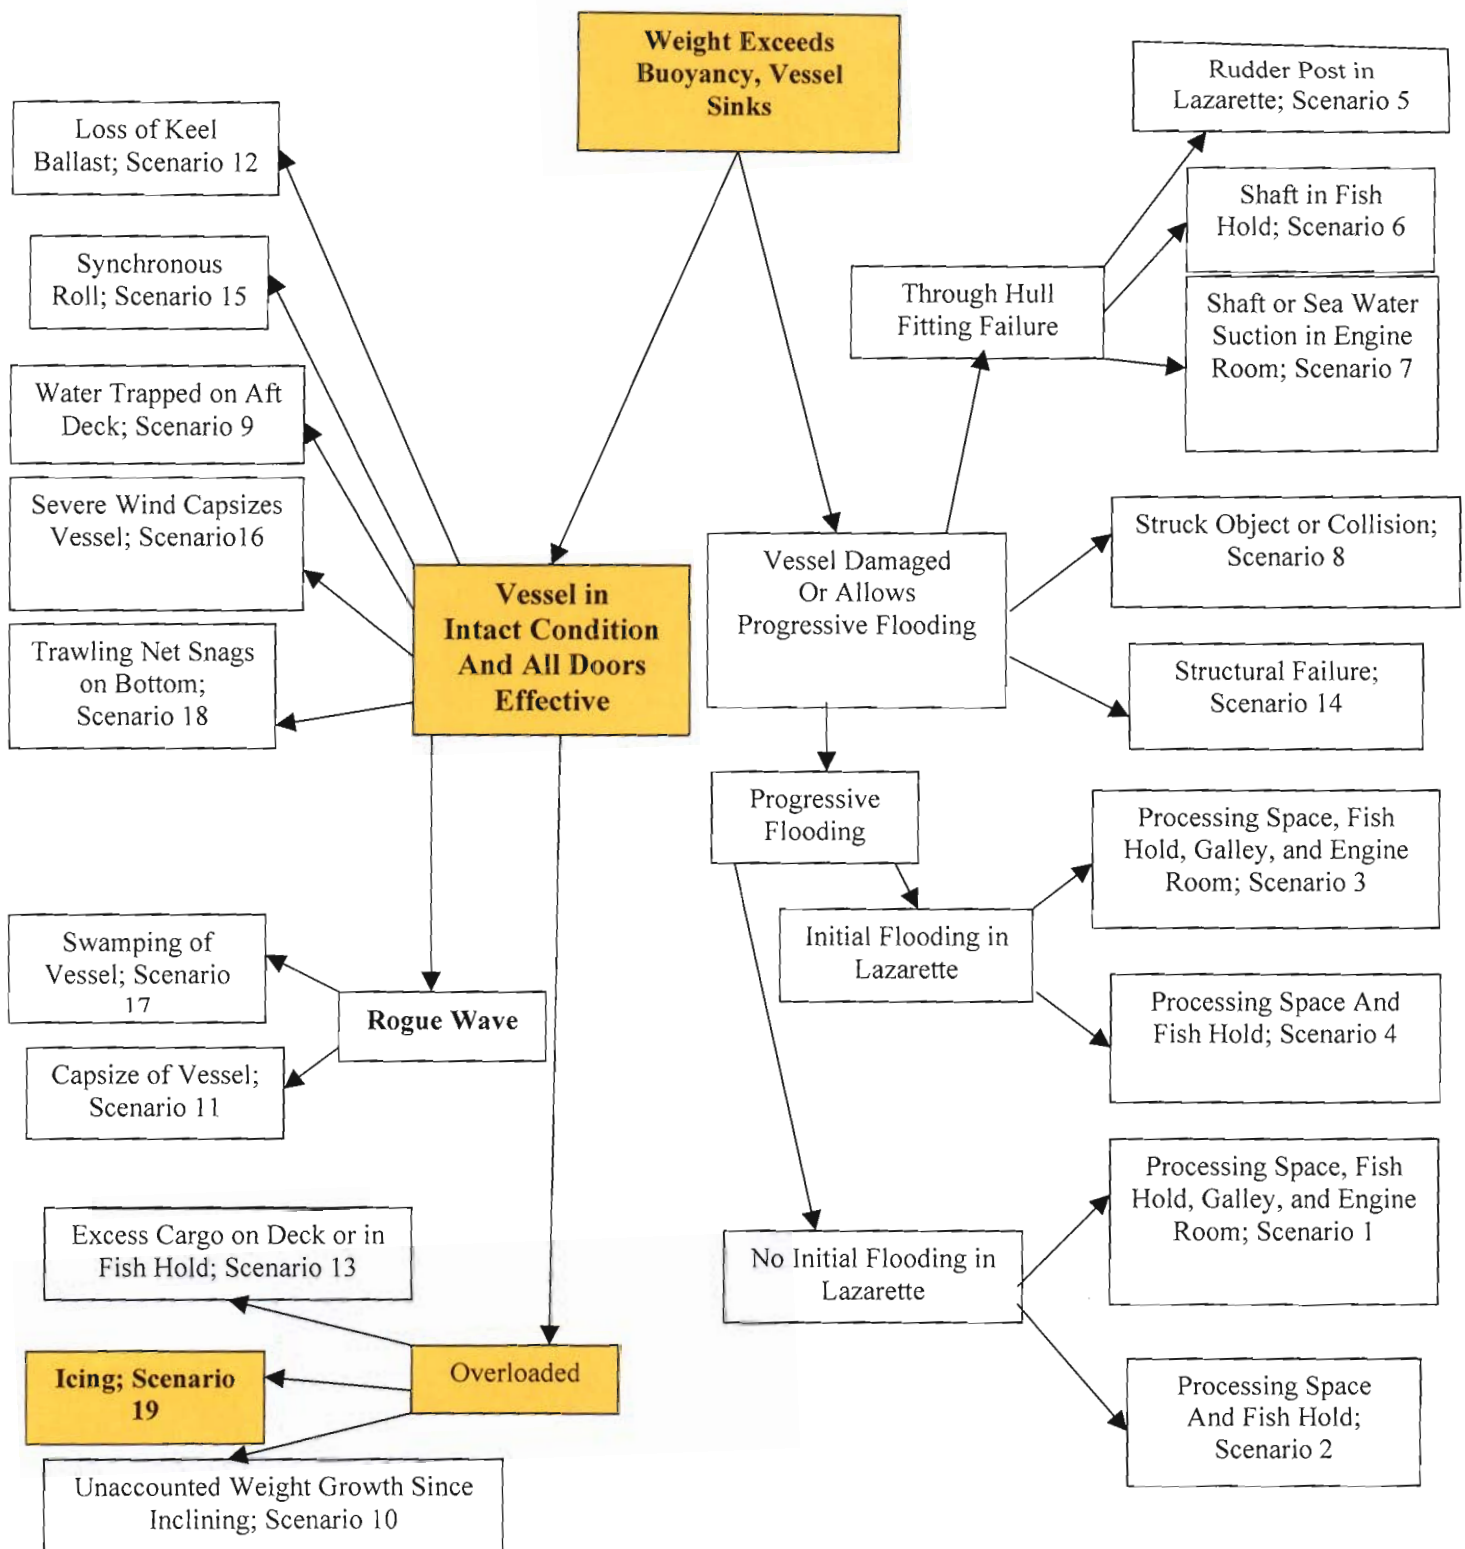
## **SCENARIO 19**

### **OVERLOADED DUE TO ICING**

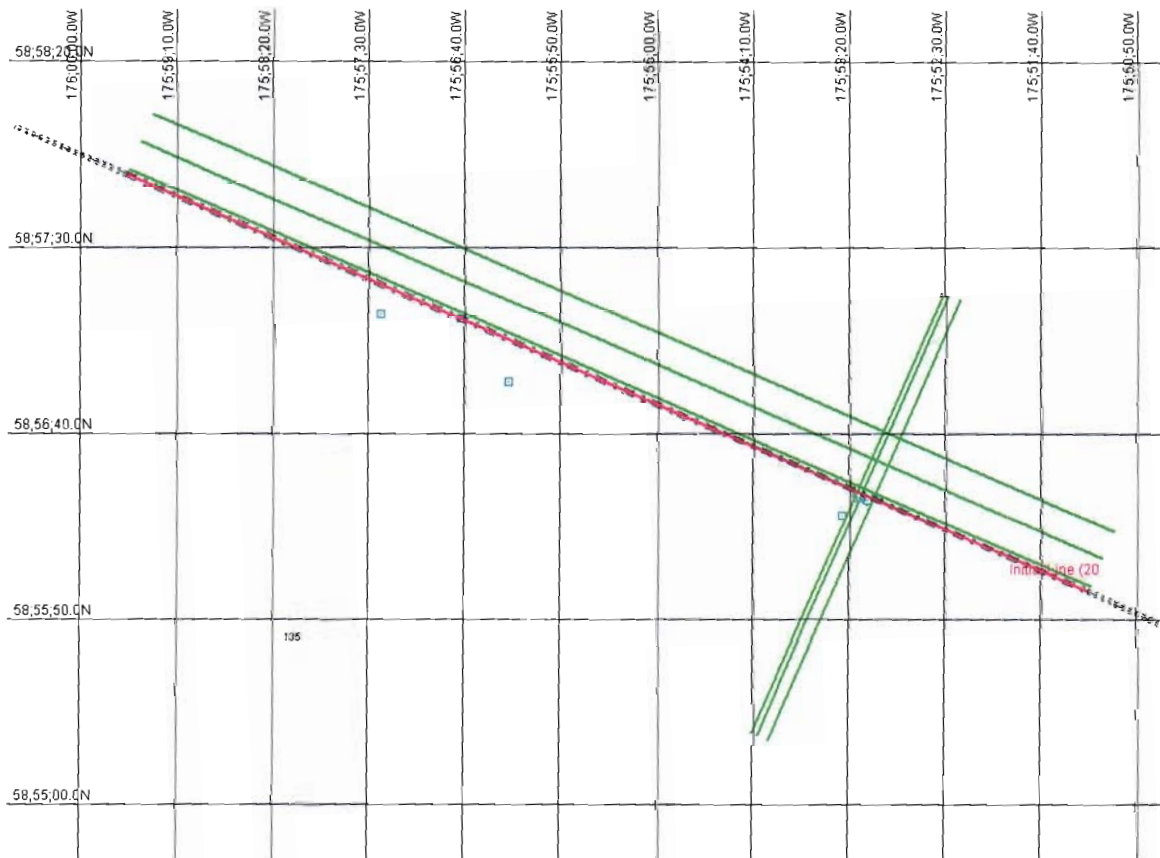
Once on-scene the M/V OCEAN EXPLORER conducted a pass on the initial trackline using its bottom scanning sonar to check for any possible snags so as not to entangle or damage the Klein 5000. At 0330, during the third sonar pass, a large target was found. Subsequent passes revealed a silhouette that matched the profile of the ARCTIC ROSE.

Using these techniques, the team located the wreckage and identified the ARCTIC ROSE soon after the start of the search. The ARCTIC ROSE lies at a 428 feet depth, 200 miles northwest of St. Paul Island in the Bearing Sea. It took the team only two hours from putting the towfish in the water to locate the vessel. The team made several passes to resolve the image at the bottom and look for any debris that may entrap the ROV.

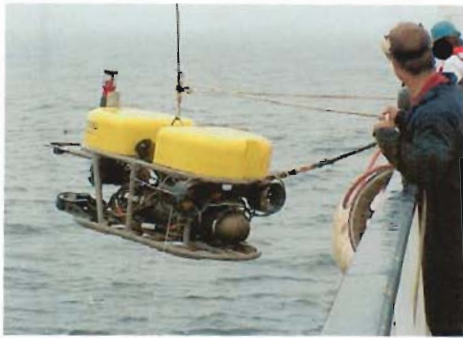
The team arrived on-scene on August, 22, 2001, but rough sea conditions forced the team to wait for better operating conditions. After loitering for several days, the weather calmed falling within the minimum weather window for safe ROV operations. The ROV was lowered over the side and operationally tested. The MAXRover descended to the wreck. The video camera was activated and filmed the wreckage for clues. The MAXRover completed five dives and surveys of the wreckage. The Marine Board was able to examine the entire stbd hull, stern/transom area, the trawl deck along with all associated equipment, and the exterior of the processing space. The Marine Board was also able to view the aft port section of the hull, keel cooler, shaft, kort nozzle and rudder. The Marine Board was able to learn a great deal about the vessel and its condition.

The Marine Board discovered the following details concerning the vessel:

1. No hull failure or excessive corrosion,
2. No damage or indication that the vessel was rammed or struck an object prior to the sinking,
3. No buckled decking or side shell insets,
4. The vessel's rudder was hard over to port,
5. The vessel appeared to strike the bottom stern first,
6. The aft weathertight door to the processing space was open,
7. A starboard guillotine closure for the by-catch overboard discharge chute was open,
8. Heavy gear was strewn across the deck and resting over the starboard bulwarks of the vessel,
9. The vessel's trawl doors are missing,
10. The vessel's trawl net was on the net reels, and;
11. The vessel's propeller and shaft were in place.
