UNITED STATES COAST GUARD

**REPORT OF THE INVESTIGATION
INTO THE
B. No. 255 (O.N. 603622) EXPLOSION, FIRE, AND
DISCHARGE OF OIL APPROX. 3 MILES FROM PORT
ARANSAS, TX WITH TWO CREWMEMBERS
DECEASED OR PRESUMED DECEASED ON
20 OCTOBER 2017**

MISLE ACTIVITY NUMBER: 6291947

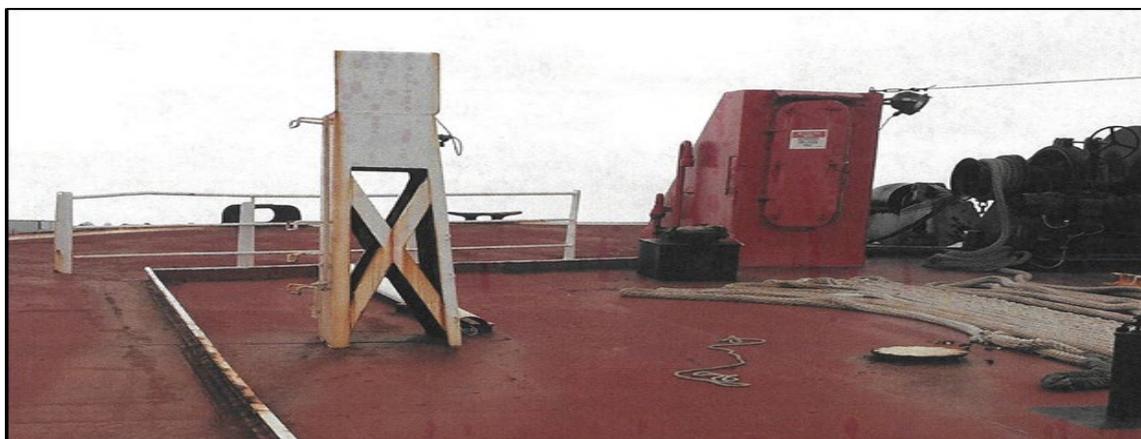
2.1.5.2. An electric motor controller for the windlass is located just inside the dog house. The electric motor control box is connected to the electrical outlet inside the forepeak by a 25-foot umbilical cord. When in use, the umbilical cord prevents the dog house door from closing as it lays across the door's coaming. The umbilical cord allows the windlass operator to move about the bow area during anchoring operations in order to observe the position of the anchor chain while raising (weighing) or lowering anchor.

Figure 3: Picture of the “doghouse”, which provides access to compartment 2 of the forepeak, located on the bow of B. NO. 255. The anchor windlass is located on the right side of the doghouse in the picture. Picture provided by ABS.

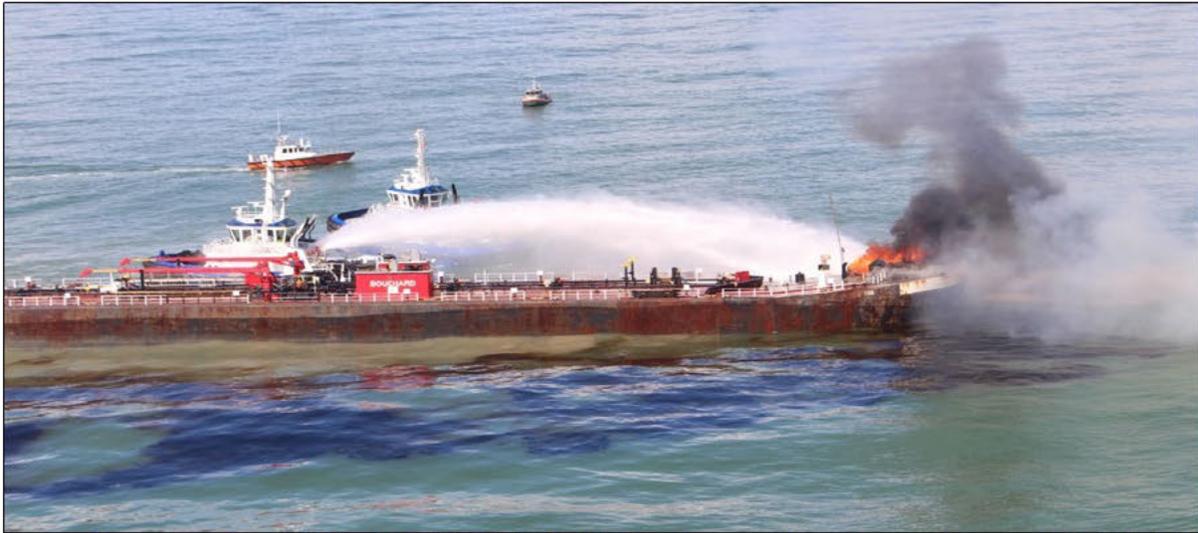
4.1.21.1. Both Signet vessels returned to port where the Refinery Terminal Fire Company provided the vessel with fire-fighting foam. Upon return to the burning B. NO. 255, each Signet vessel applied a blanket of fire-fighting foam onto the barge and ultimately extinguished the fire at approximately 1100.

Figure 6: Picture of SIGNET POLARIS and SIGNET CONSTELLATION conducting firefighting efforts on the burning B. NO. 255. A U. S. Coast Guard and pilot small boat are in the background. Picture taken by the U.S. Coast Guard on October 20, 2017.

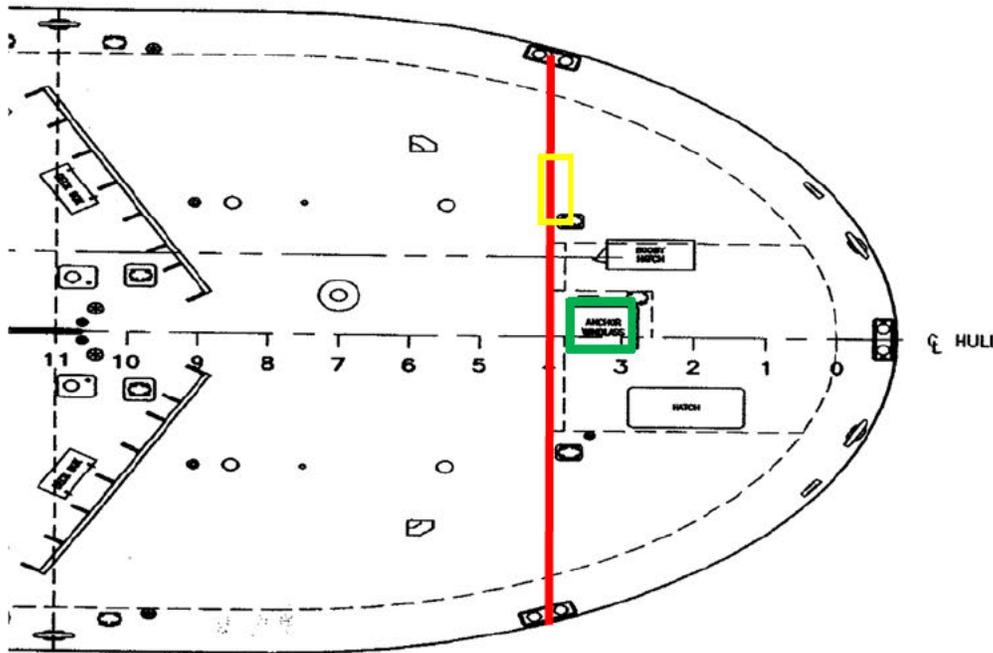
Figure 20: General Arrangement Diagram provided by ABS. Closer view of B. NO. 255's bow below deck. The number 1 port/starboard cargo tanks are located aft of the transverse bulkhead (left of vertical red line indicating transverse bulkhead). The chain locker, located beneath the anchor windlass, is identified by the green box. The location of steel analyzed as part of the damage survey is identified by a yellow box. Colored lines added. Diagram provided by ABS.

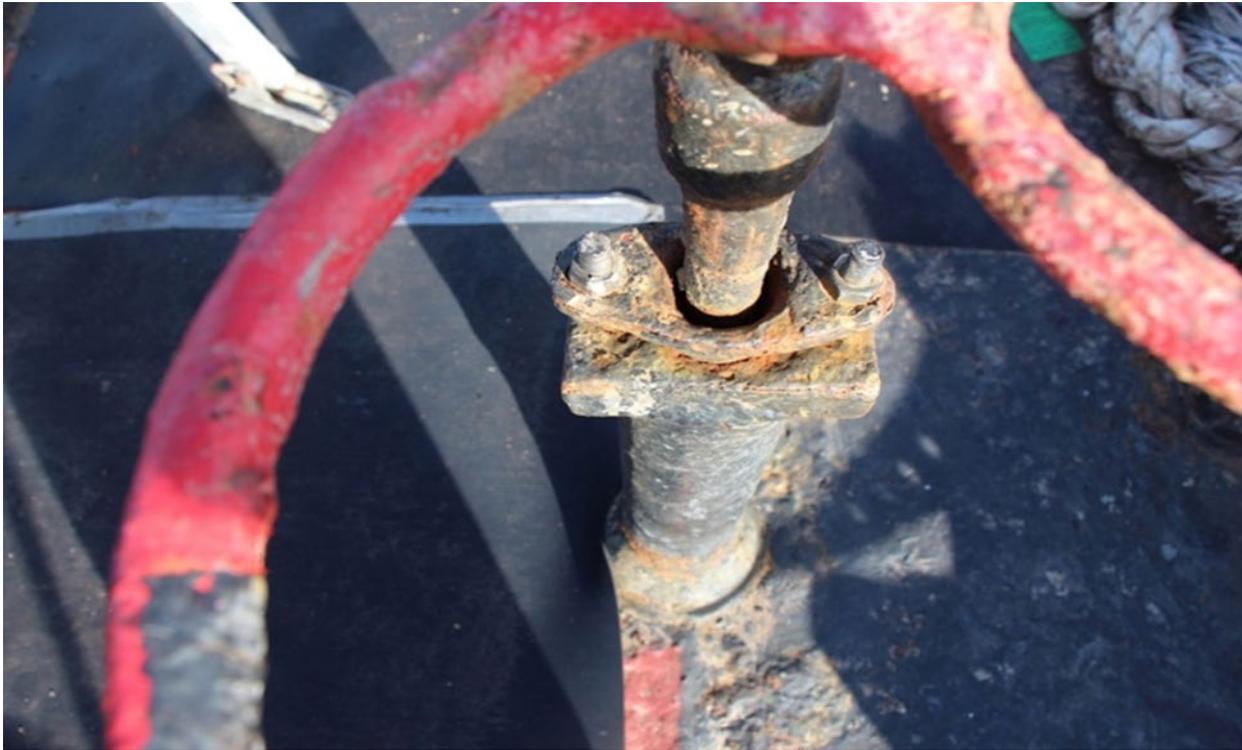
Figure 21: Picture of the number one starboard cargo tank main valve stem on the B. NO. 255. Picture taken by the U.S. Coast Guard on December 12, 2017
