UNITED STATES COAST GUARD

**REPORT OF THE MARINE BOARD OF INVESTIGATION
INTO THE
STEAM SHIP EL FARO (O.N. 561732)
SINKING AND LOSS OF THE VESSEL
WITH 33 PERSONS MISSING AND PRESUMED DECEASED
NORTHEAST OF ACKLINS AND CROOKED ISLAND,
BAHAMAS
ON OCTOBER 1, 2015**

MISLE ACTIVITY NUMBER: 5735749

September 24, 2017

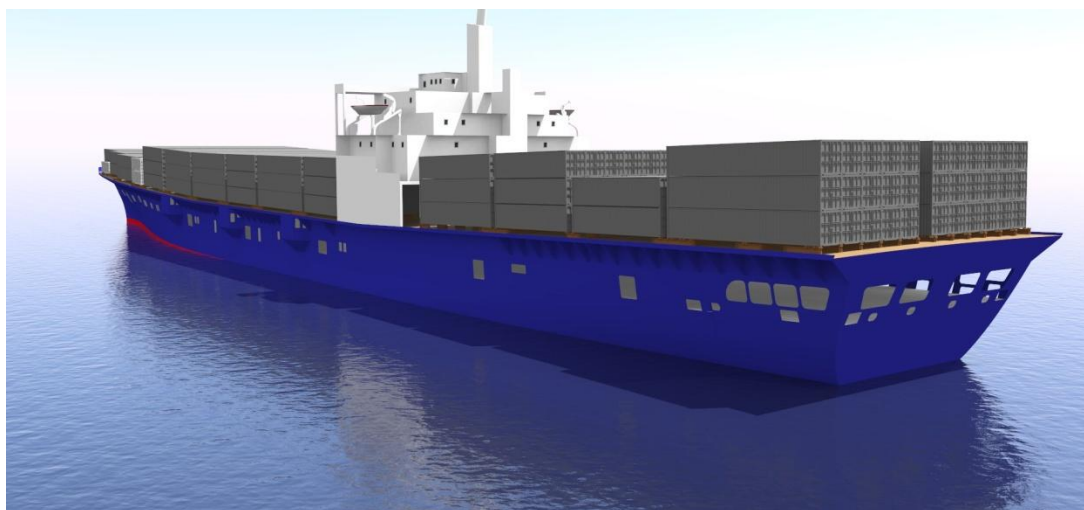
Figure 4. EL FARO computer rendering showing the vessel in the departure condition, with mean draft 30.1 feet, 0 degree list, and the stern trimmed down 5.0 feet. Illustration produced by the USCG Marine Safety Center.

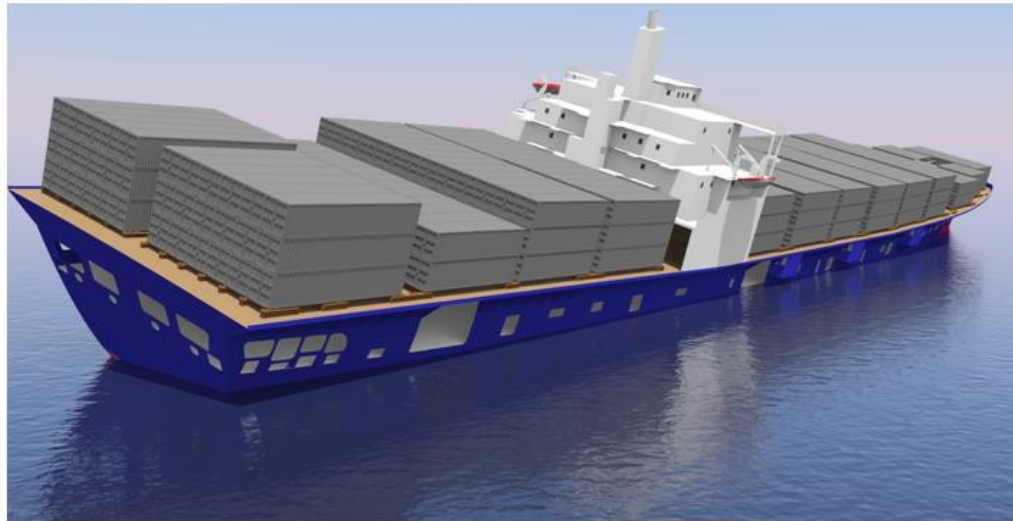
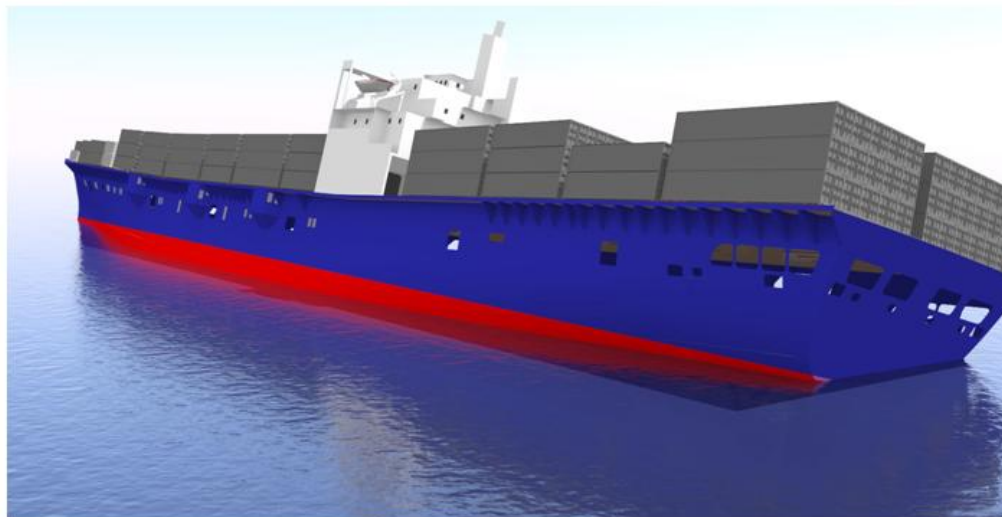
Figure 9. EL FARO computer rendering with 15 degree starboard list and trimmed down by the stern 5.8 feet, due to flooding of Hold 3 estimated at 20% and wind heel. Illustration produced by the USCG Marine Safety Center.

The Coast Guard MSC Lube Oil Modeling and Analyses of EL FARO¹⁴⁴ demonstrated that the lube oil system suction pipe bell mouth opening in the lube oil sump tank, using the 24.6” departure sounding obtained from the CargoMax entry, would have broken above the lube oil surface, resulting in a potential loss of suction at an 18° static list to port (see figures 9 and 10 below).

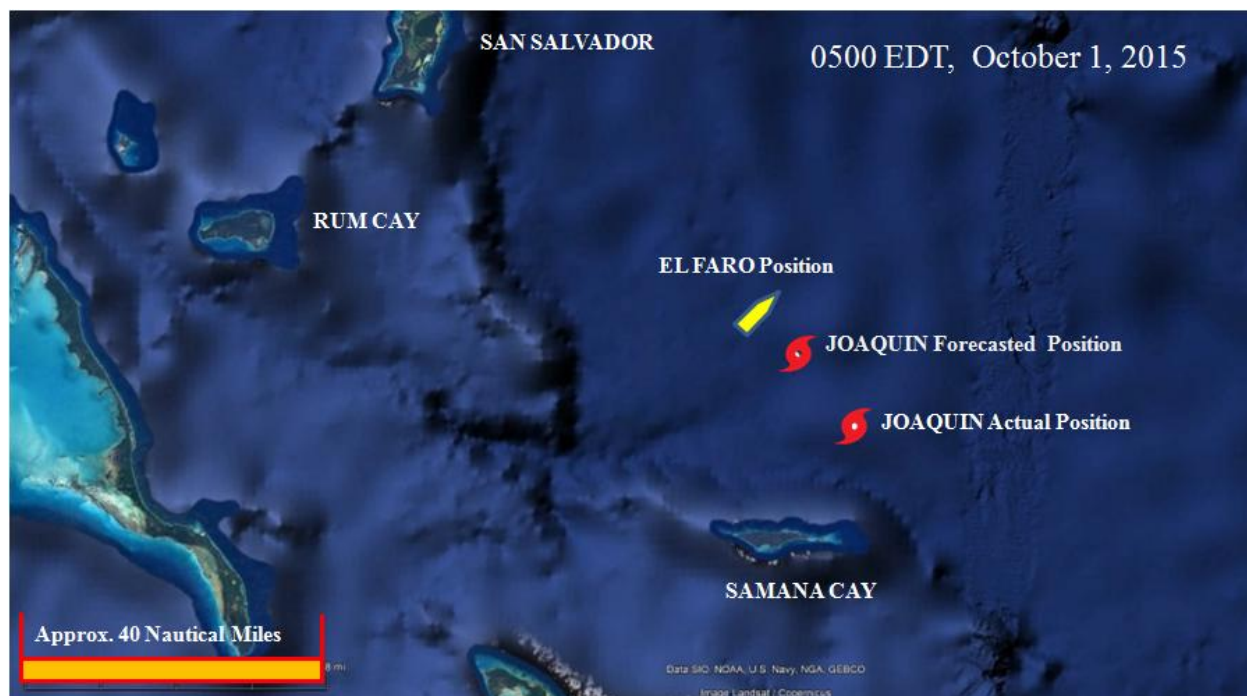
Figure 10. Google Earth image showing the 5:00 AM positions of EL FARO, the center of Hurricane Joaquin as detailed in NHC Advisory 14, and the center of Hurricane Joaquin determined during a NHC post-storm ‘best track’ analysis.

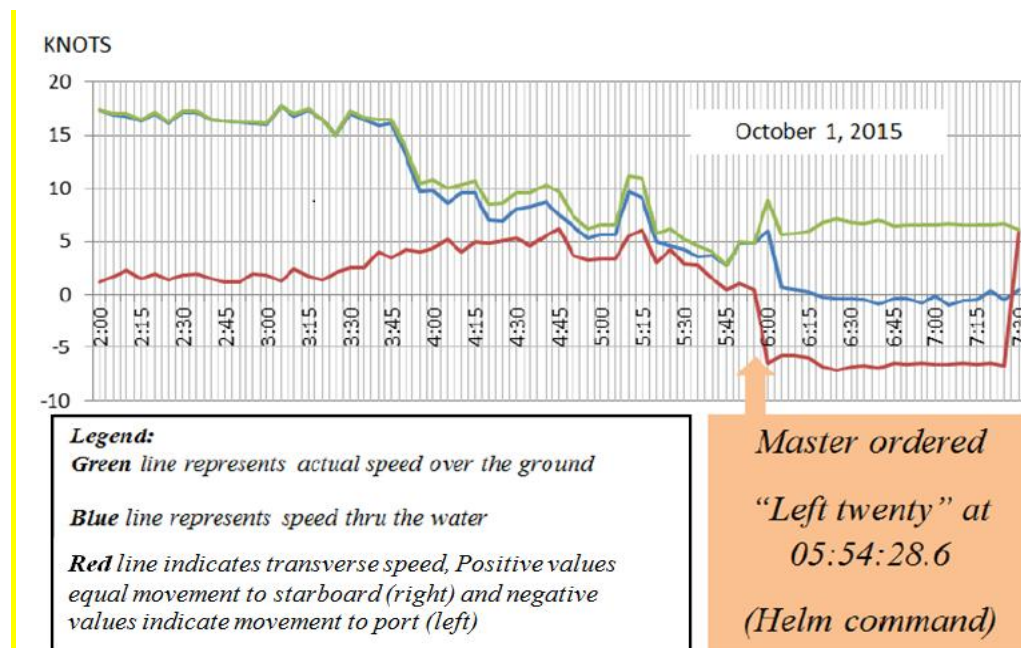
Based on radar and VDR parametric data, EL FARO’s propulsion was reduced just prior to 6:00 AM. Around this time, EL FARO’s heading was approximately due north, but the vessel started to be set in a westerly direction.

Figure 12. Graph of EL FARO's speed over ground and speed through the water on October 1, 2015.

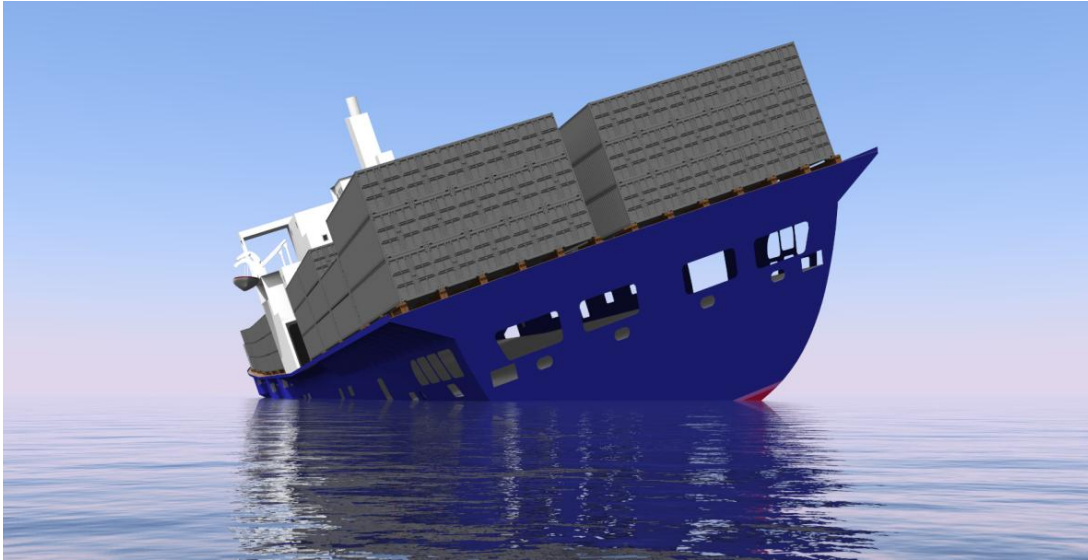
Figure 14. EL FARO modeling with 20 degree port list and departure trim down by the stern at 5.8 feet due to flooding of Hold 3 estimated at 20% and wind heel. Illustration produced by the USCG Marine Safety Center.

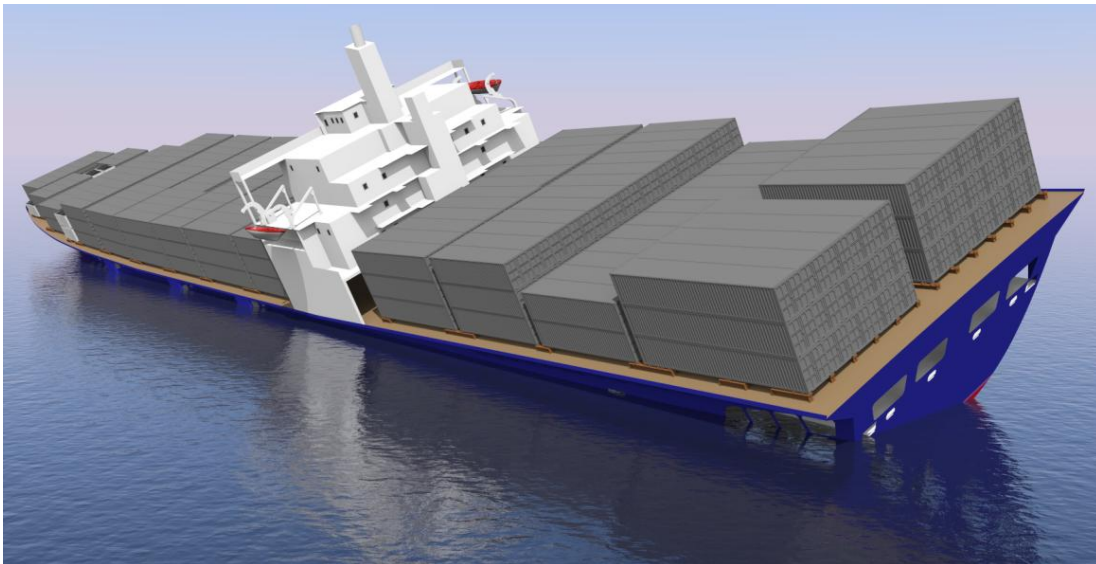
Figure 15. EL FARO computer rendering with 25 degrees port list and departure trim of down by the stern at 5.8 feet due to flooding of Hold 3 estimated at 20% and wind heel. Illustration produced by the USCG Marine Safety Center.

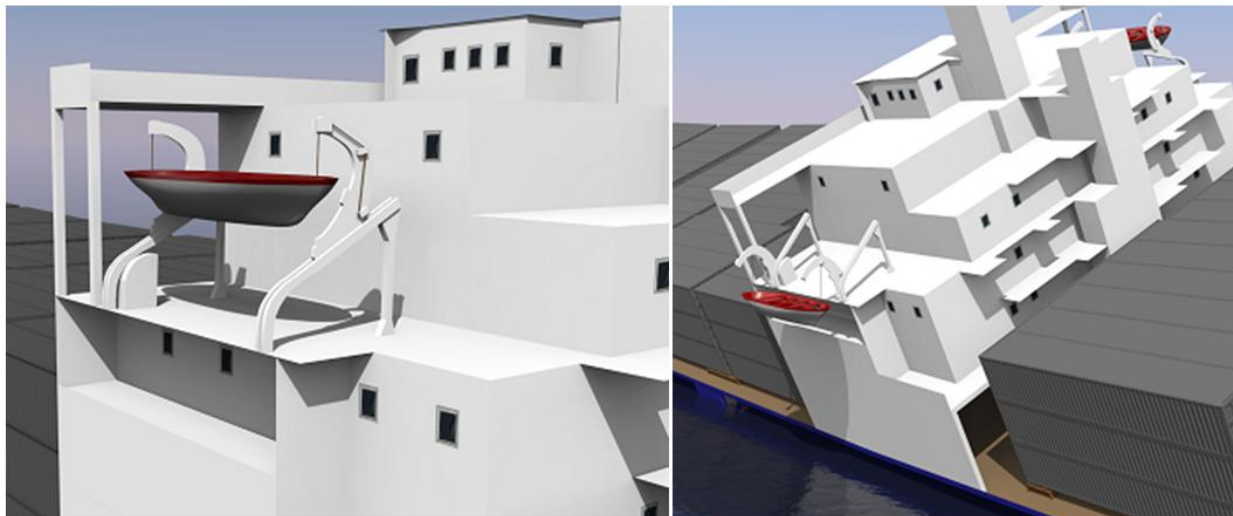
Figure 16. EL FARO computer rendering. On the left, the port lifeboat is shown in the davit in its normally stowed position with EL FARO on an even keel. On the right, the lifeboat is shown lowered to the embarkation deck with EL FARO listing 25 degrees to port. There is no evidence that the use of the lifeboats was discussed by the crew. Large life rafts were stored in close proximity to the lifeboats. Illustration produced by the USCG Marine Safety Center.

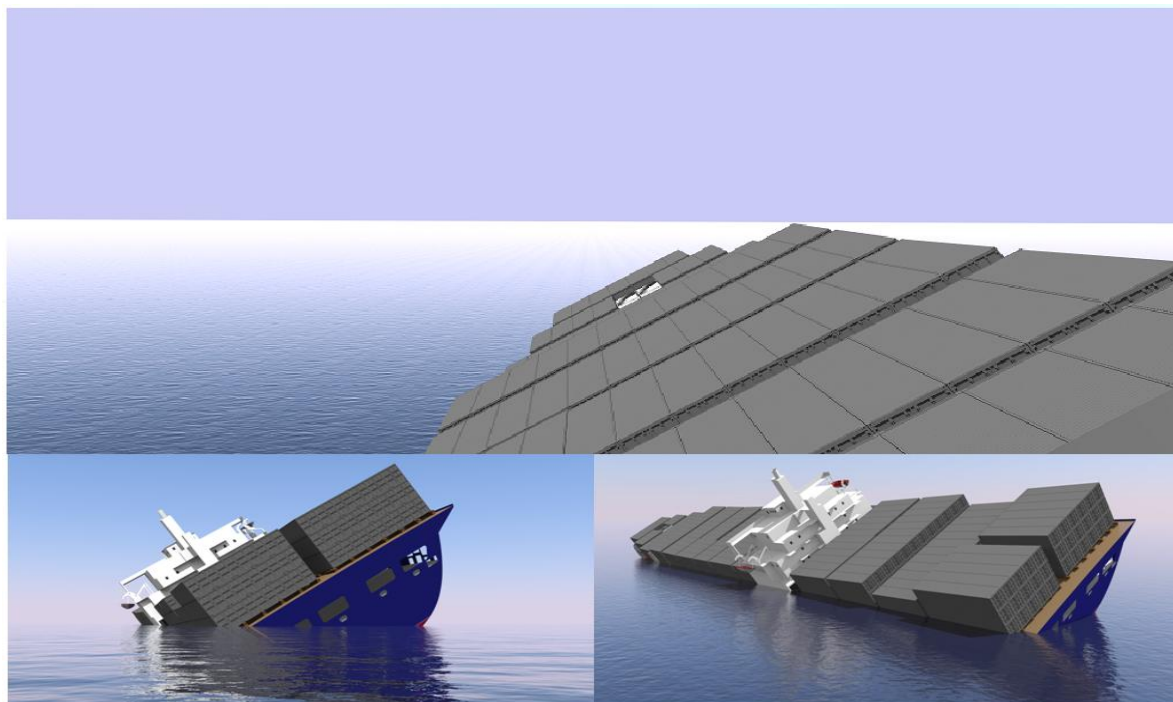
At 7:30 AM, the Master twice stated, “Bow is down.”

Figure 17. EL FARO computer renderings showing the vessel with progressive flooding and wind heel, listing to port at 35 degrees with 5.0 feet aft trim and 37.0 foot draft amidships. The upper illustration simulates a view forward from the starboard side of the navigation bridge which was the assumed location of the vessel Master when the Master makes the “bow is down” statement at 7:30 AM on the VDR audio transcript. Illustration produced by the USCG Marine Safety Center.

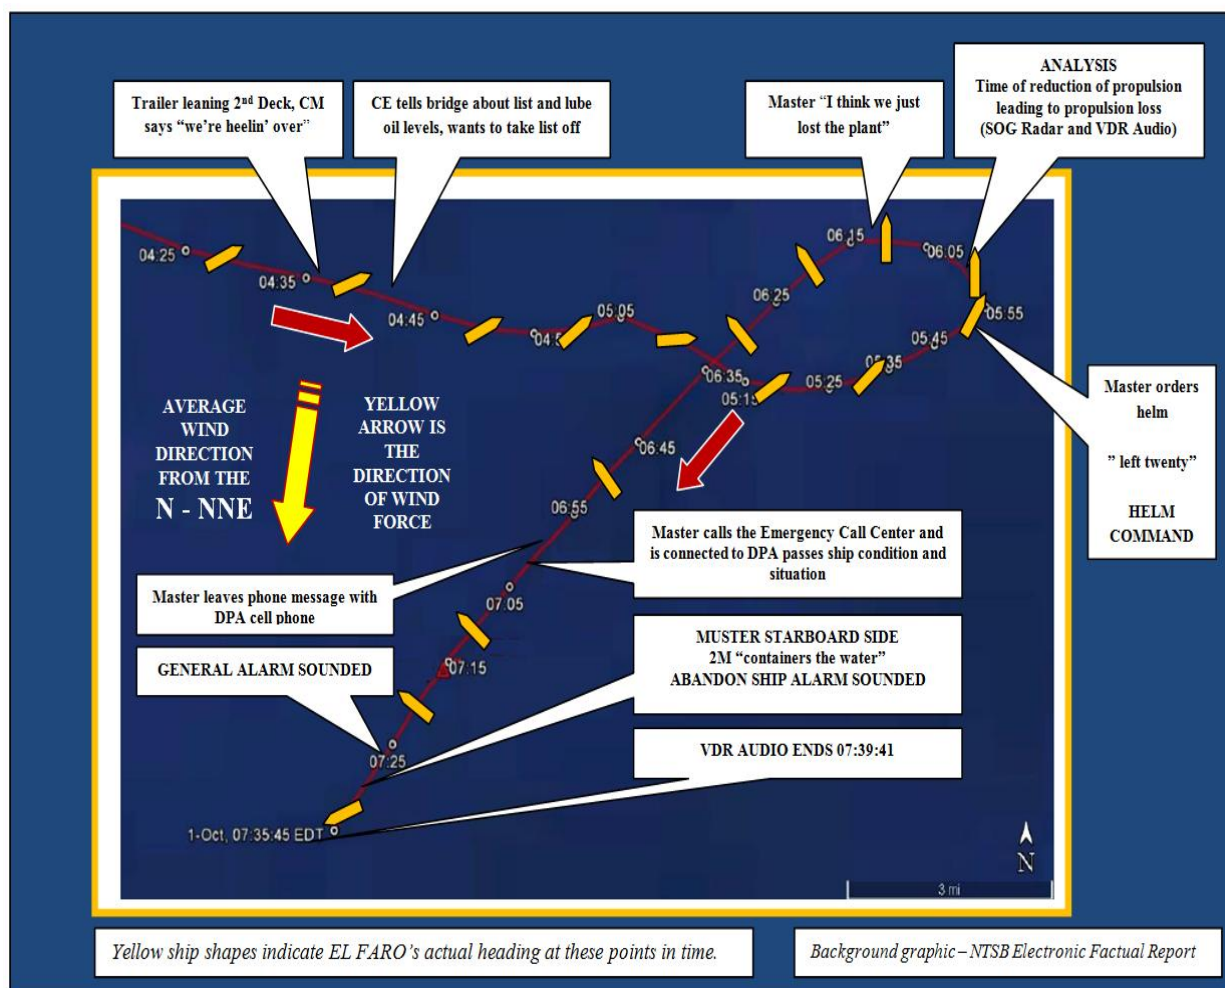
Figure 18. Illustration of significant events between 4:20 AM on October 1 and the sinking, showing ship heading and course over ground.

EL FARO’s last recorded position on the VDR parametric data, at 7:35 AM, was 23-23.4N, 073-54.0W. The main wreckage of EL FARO was located on October 31, 2015, approximately one nautical mile away, in position 23-22.9N, 073-54.9W, and at a depth of approximately 15,400 feet.

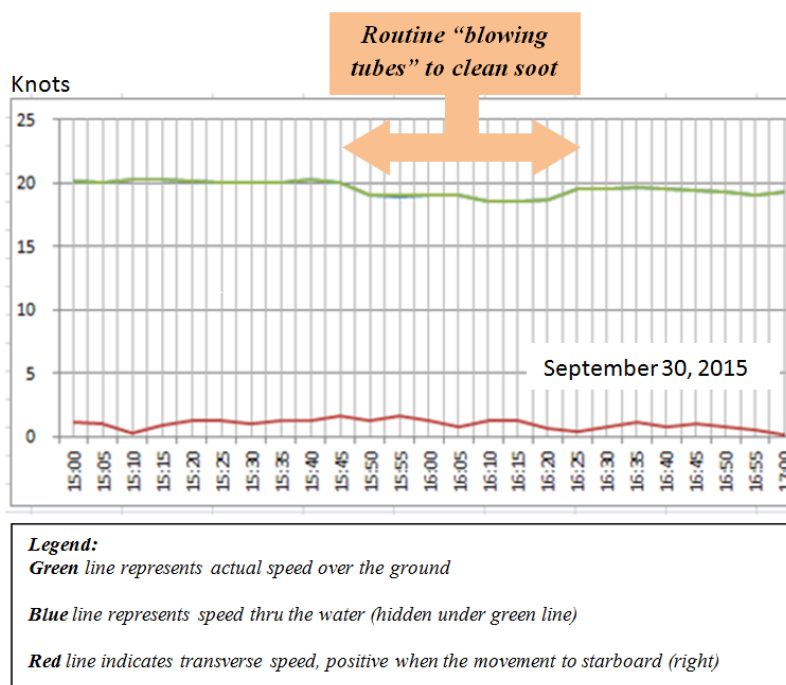
Figure 23. Speed graph from EL FARO showing the typical reduction in speed that resulted from "blowing tubes."

On the morning of the accident at 3:46 AM, the 2/M made the following remark to the C/M while discussing shaft speed reductions:

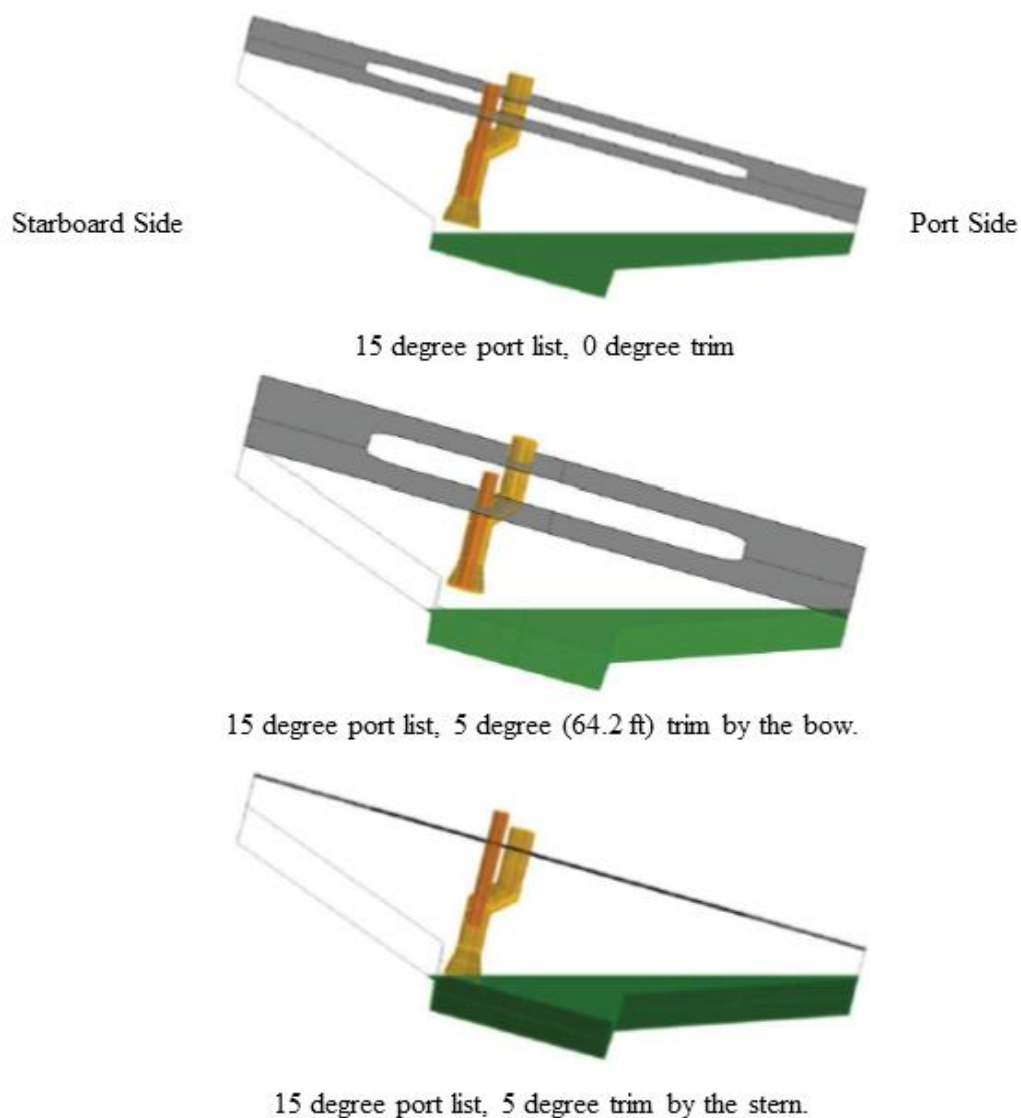
Figure 25. End views of the lube oil sump for the design low level capacity at 15 degree port list and differing trims.

The Coast Guard MSC Lube Oil Modeling and Analysis¹³⁰ demonstrated that the 18” Low Level Capacity shown on the drawing, when combined with a 15 degree port list, would result in the main lube oil sump suction bellmouth coming out of the oil. It also demonstrated that lube oil pocketing would occur in the lube oil gravity tank based on a port list condition, due to a 33” offset of the supply and overflow piping to starboard inside the lube oil gravity tank.

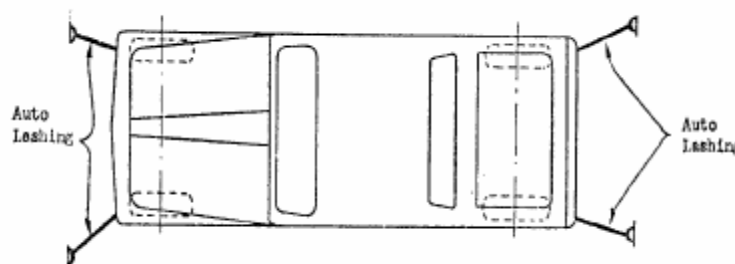
Figure 32. Image from Cargo Securing Manual for vehicles stored below the main deck. (MBI Exhibit 040)

The above image from the CSM shows auto lashings attached directly to D-rings secured to the deck. On EL FARO, a long chain running athwartships was secured to D-rings at each side. Auto lashings were secured to these chains instead of to individual D-rings.

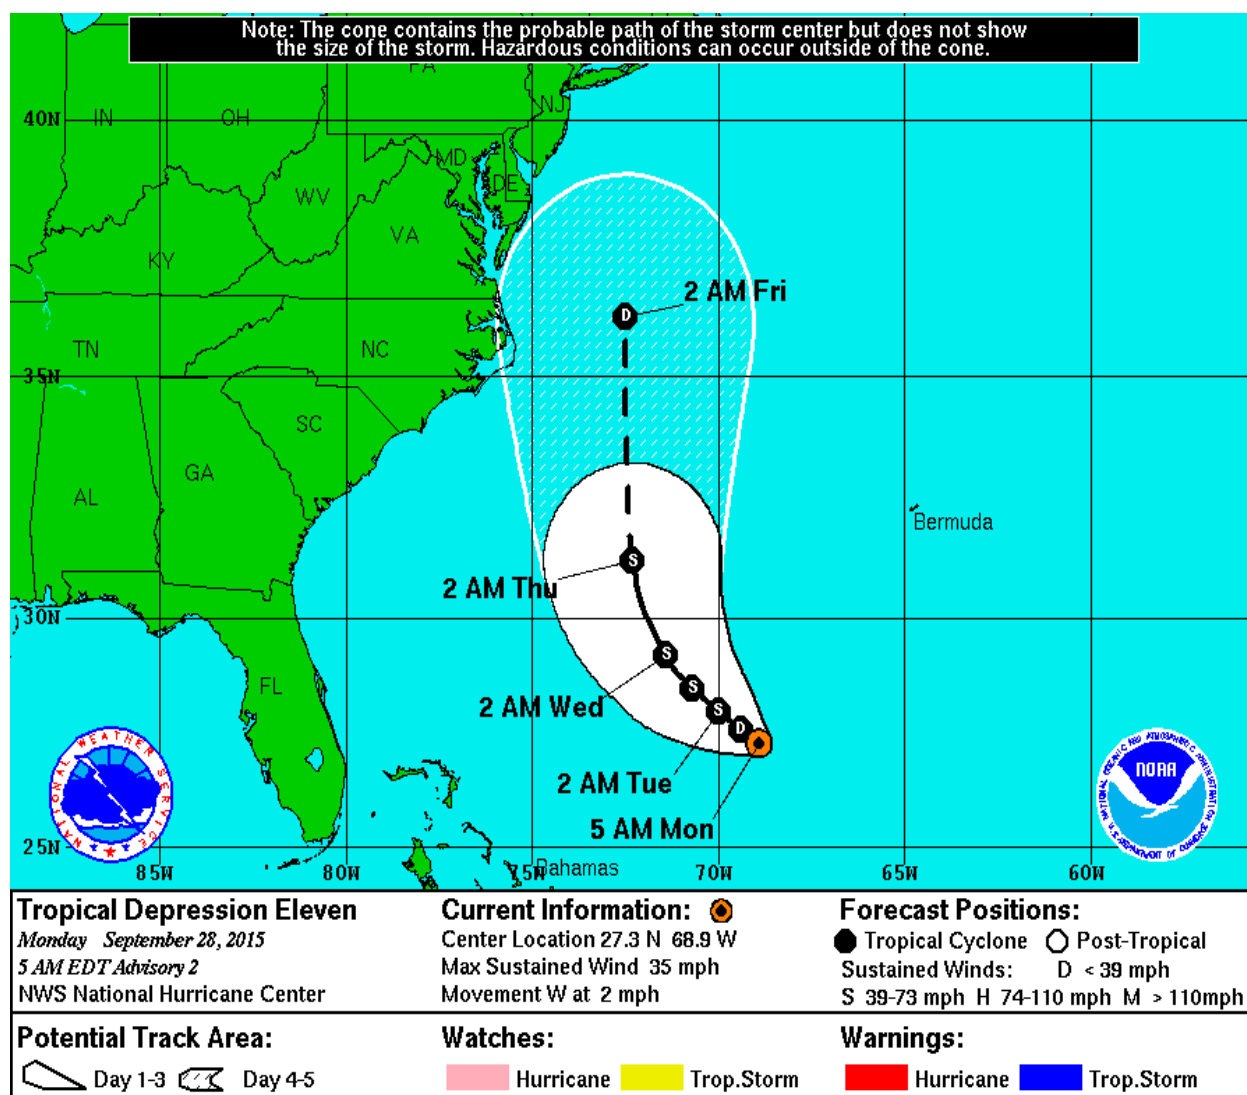
The initial forecast for Joaquin had errors that were much larger than normal. So for example the 3 day forecast that would have verified the morning of October 1st had a track error...it was 536 miles. So the 3 day forecast verifying it at 8:00 AM October 1st. That's an extraordinarily large area. That's really about 1 in 100 type of track error. The 48-hour track forecast that verified at the same time had an error of 180 miles and that's something like a 90 or 95th percentile of error. So it's certainly a very large error. By the time one day it was a 62 mile error, the 1 day forecast was verified at 8:00 AM and that's more in line, at least close to what the average was. So the earlier forecast, track forecast had errors that were much larger than normal for us. The same was true with the intensity errors. The 3 day intensity error that verified at that time was 80 knots too low. The 2 day forecast that verified at that time was 60 knots too low. And the 1 day was 30 knots too low. So the forecast called for a relatively weak system, the initial forecast called for a relatively weak system to head off to the west and northwest and this instead it moved west southward and southward and strengthened.

Figure 39. NHC Tropical Depression Eleven 5 AM EDT Advisory 2 with 5-day Cone and Warnings dated September 28, 2015. Early forecasts for the storm that would become Hurricane Joaquin indicated the system would head in a Northwesterly direction. The 2 AM Thu projection of a Tropical Storm off the coast of South Carolina correlates to the morning of the accident voyage (October 1, 2015).

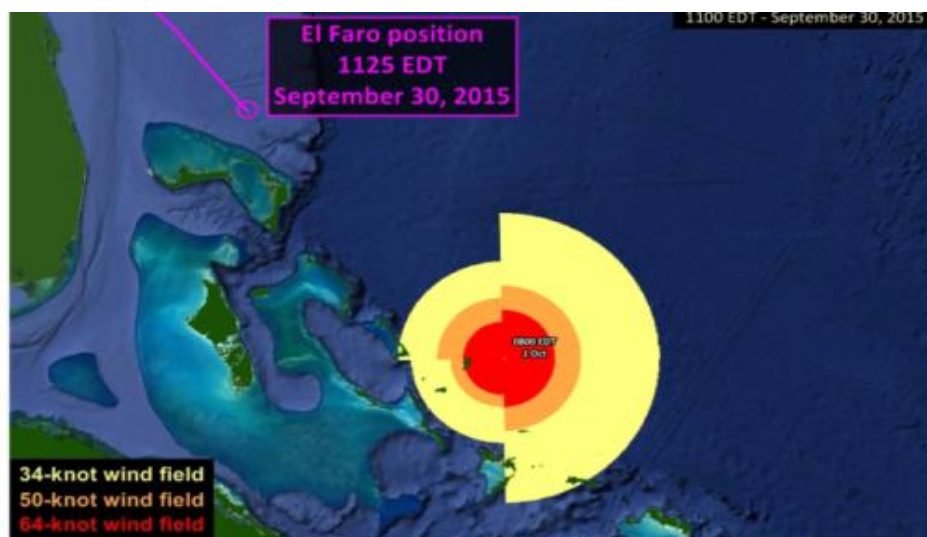
Figure 40. EL FARO position at 1125 EDT September 30, 2015 showing relationship with Hurricane Joaquin wind fields. (Source: NTSB Weather Factual Report)

Specialist Unit was asked about this in a follow up interview and they stated that Hurricane Joaquin had an unusual asymmetry that resulted in displacement of the wind fields from the southwest. As a result, as the storm progressed on its southwesterly course, the wind fields were forced tighter to the storm on the leading edge, and expanded further out on the trailing edge. Examples of the resulting quadrants are shown below in the graphical overlay of the 11:00 EDT September 30, 2015, forecast and advisory.

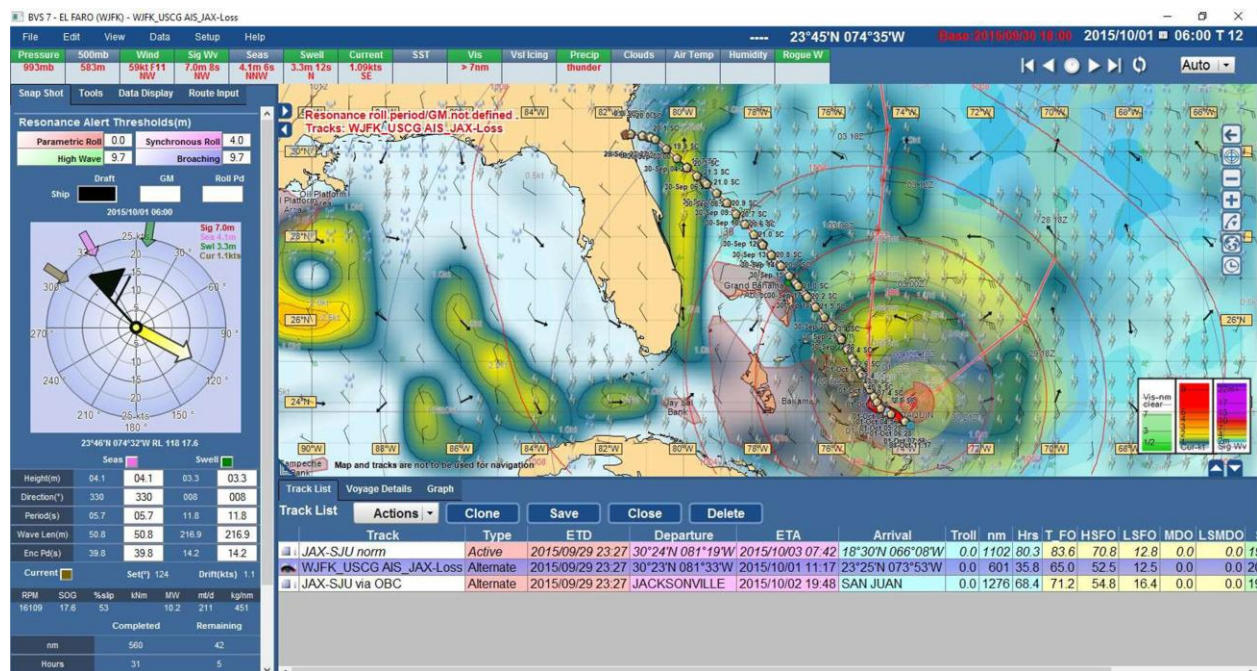
Figure 45. BVS weather package transmitted to EL FARO at 11:04 PM on September 30, 2015, and downloaded at 4:45 AM on October 1, 2015.

During the testimony from AWT, it was discovered that there was an error in one weather package sent on September 30, 2015. The message sent at about 0900Z (5:00 AM EDT) contained the same NHC forecast and advisory overlaid from the previous weather package sent at 0300Z (11:00 PM EDT) on September 29, 2015. The 0300Z weather package contained the

NHC forecast and advisory information published at the nominal time of 2100Z on September 29, 2015. This error meant that the 0900Z BVS weather package that was sent to EL FARO on September 30, 2015, still contained the NHC forecast and advisory from 12 hours prior. However, the 0900Z weather forecast with the duplicate NHC forecast did include properly updated oceanographic and atmospheric model data generated by AWT.²³³ The repeated hurricane forecast that was replicated in the error can be seen in the graphics above.

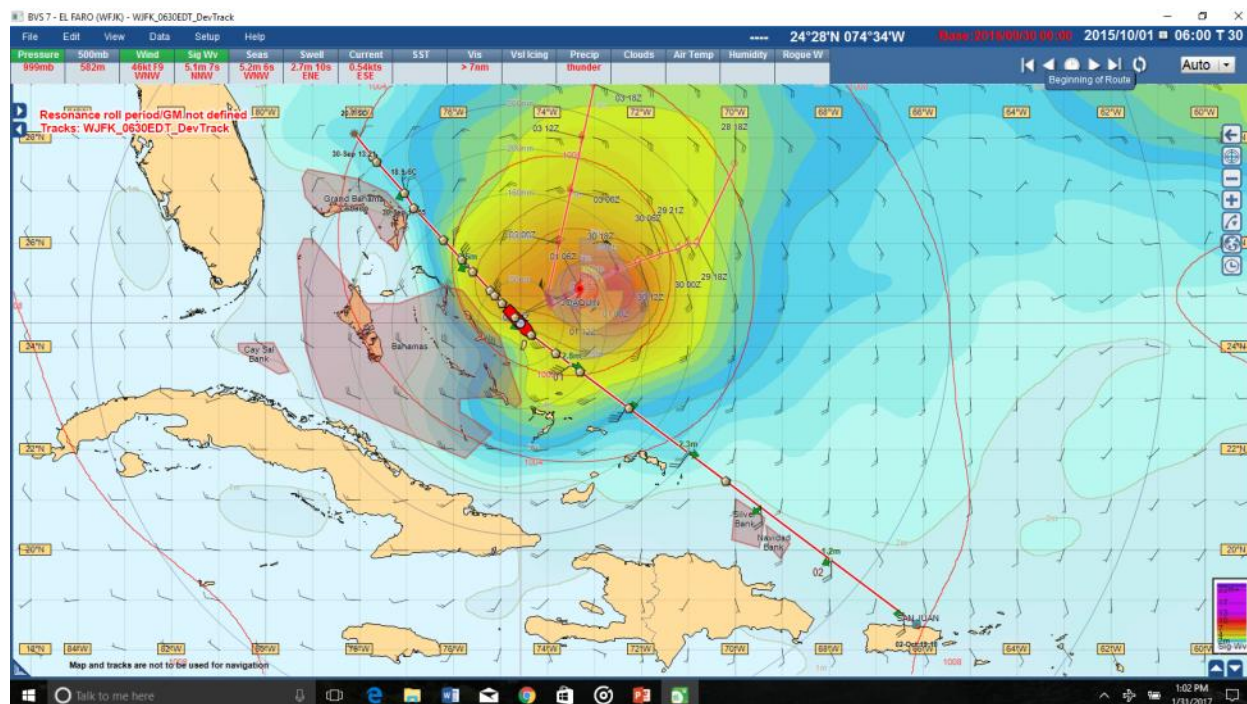
Beginning at about 6:14 AM on September 30, 2015, the C/M and Master discussed the weather and potentially altering EL FARO’s trackline.²³⁴ The route chosen provided two waypoints, waypoints “Alpha” and “Bravo.” The resulting trackline was then entered into BVS. The BVS screenshot below shows the new route with the weather forecast that was downloaded at 6:08 AM on September 30, 2015. This was the BVS forecast data package that was available to the Master and C/M at the time they were choosing waypoints “Alpha” and “Bravo.” The Tropical Cyclone forecasted track depicted in this package delivered to EL FARO is the duplicate report showing the NHC’s forecast from 5:00 PM on September 29, 2015.

Figure 46. BVS screenshot of EL FARO's adjusted route along with the weather forecast downloaded at 6:08 AM on September 30, 2015.

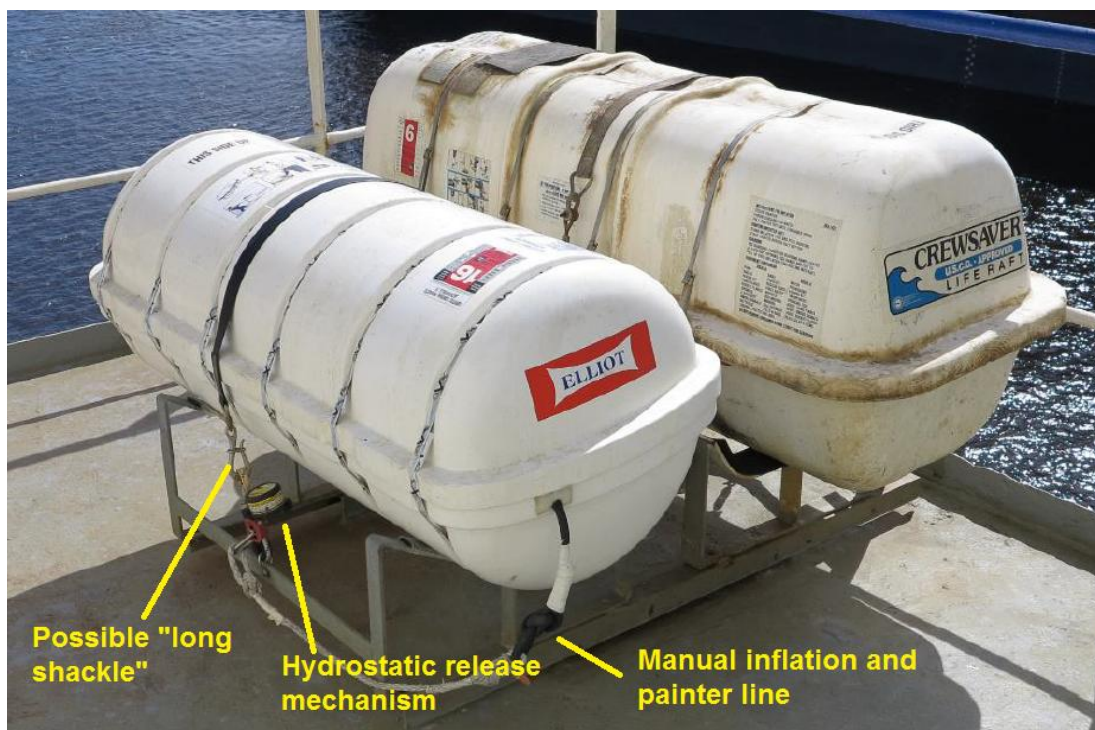
In addition to the required rafts, EL FARO had two additional 25-person rafts in cradles or lashed to the railings near the boat deck.³⁴⁸ The additional rafts were placed on EL FARO after issues with the davit deck foundations were discovered on EL YUNQUE in mid-summer 2015. These extra rafts were still onboard EL FARO when the ship departed Jacksonville on September 29.

Figure 50. Required 25 person life raft with extra raft on the port side of EL YUNQUE showing the stowage of the rafts and the hydrostatic release mechanism.

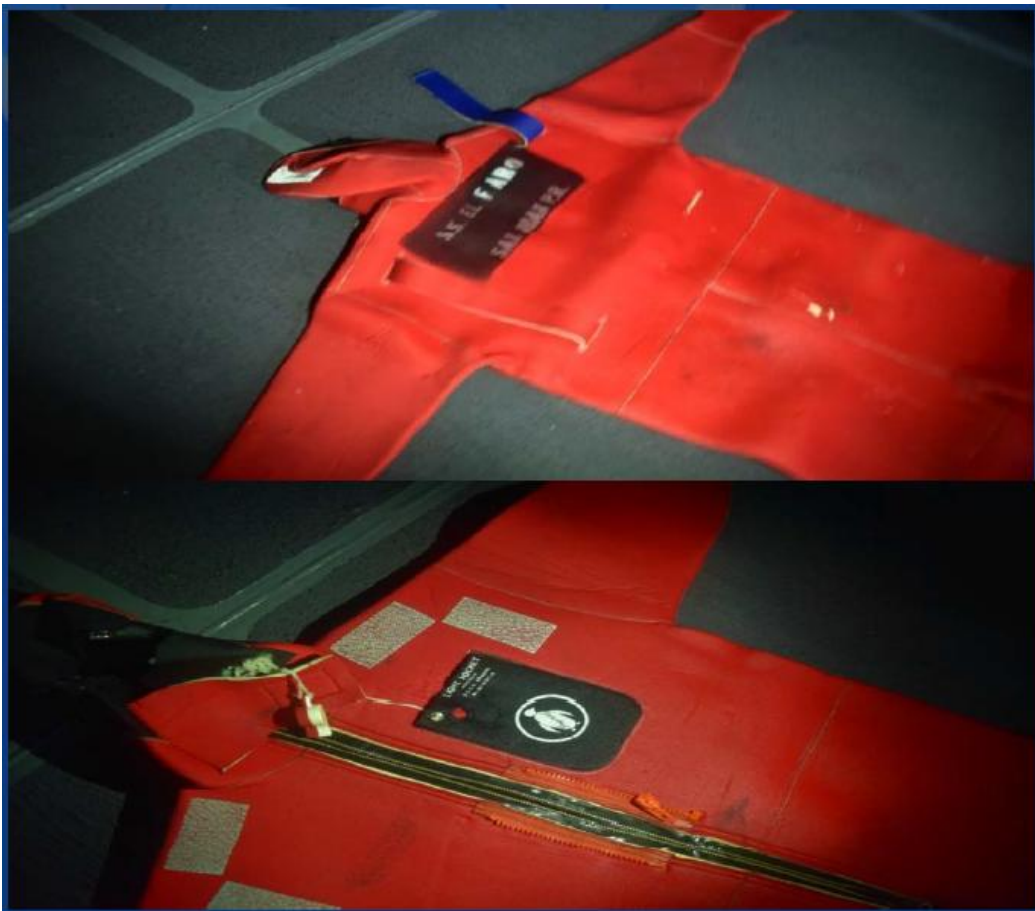
Three EL FARO immersion suits were located during search and rescue activities. One of the suits found floating at sea contained a deceased crew member’s remains, which were not able to be identified or recovered. Further details regarding that suit are discussed in the Search and Rescue section of this report. Two other empty immersion suits, found floating on the surface, were recovered and brought ashore. One of the recovered suits was undamaged. The other recovered suit had a large tear at the waist on the front right side extending from the zipper to the side of the suit. The two recovered immersion suits were manufactured in June of 1985.

Figure 51. One of the two immersion suits that were recovered during the EL FARO search.

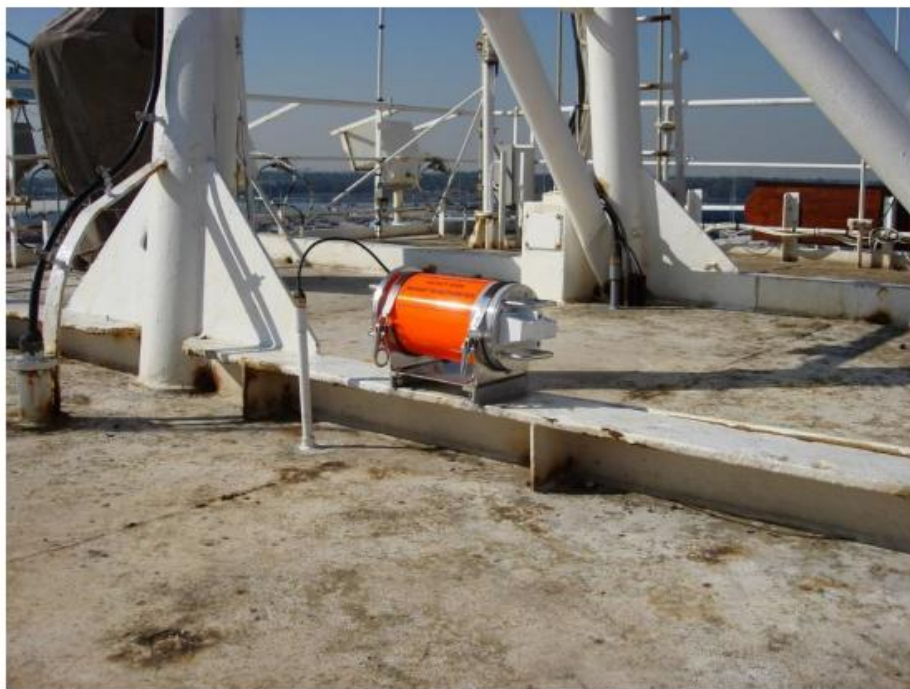
Figure 62. Archive photo of the EL FARO S-VDR capsule mounted on a beam on the flying bridge, port side. (Source: Radio Holland)

pinger battery expiration date must be after the expiration of the APT certificate. The IMO,³⁹¹ on the other hand, only required that the battery not be expired at the time of the APT. The acoustic beacon itself was set to expire in May 2015 and the typical service protocol³⁹² was to change out the beacon itself to ensure reliability. The checklist that the APT technician used to verify proper operation included the notation that the battery should have been replaced as part of the inspection and issuance of the Compliance Certificate.³⁹³

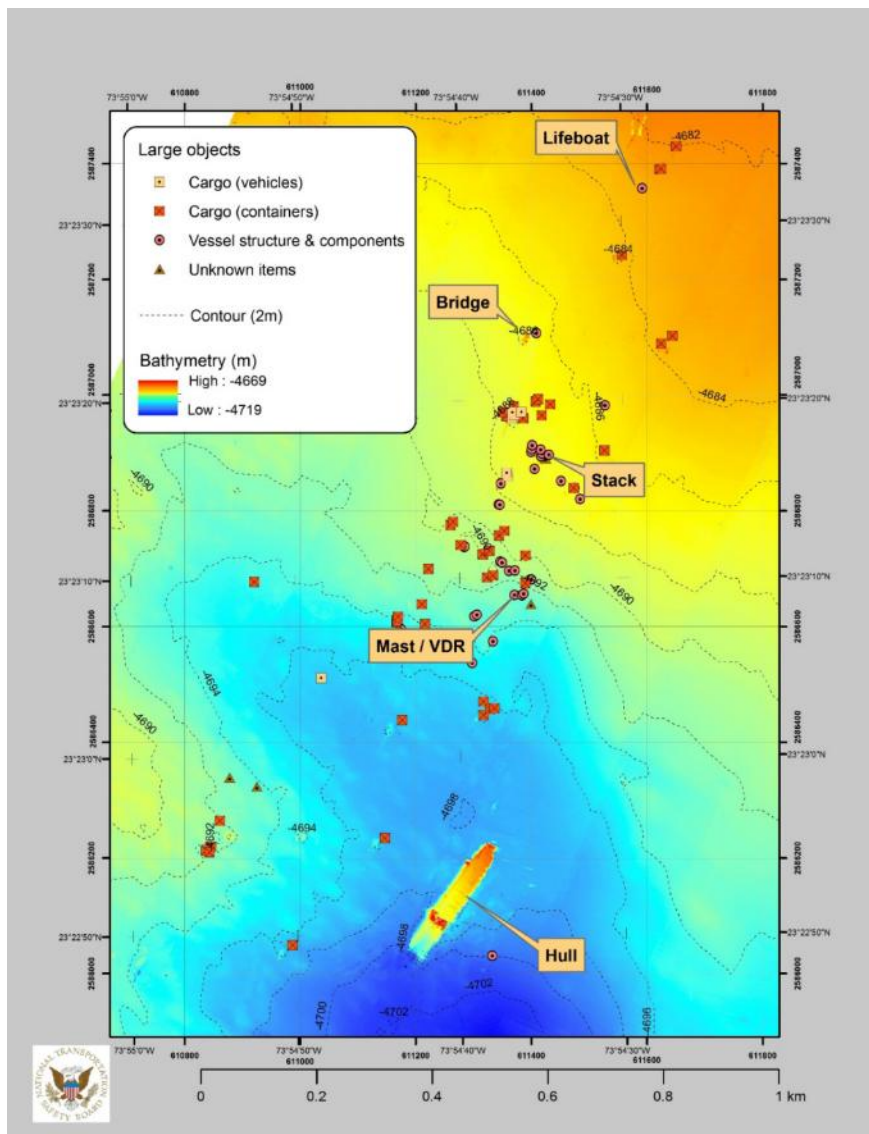
Figure 64. Composite EL FARO debris field chart (reproduced from NSTB Naval Architecture Group factual report).

The ship’s accommodations space, called the “house,” is partially intact, and the majority of that structure remains affixed to the hull. The navigation bridge was separated from the rest of the vessel and was located north of the vessel, as indicated in figure #64. The navigation bridge structure was damaged, but landed upright and structurally intact on the sea floor, about half a mile from the hull. The deck that housed the staterooms and offices for senior officers immediately below the bridge is missing, and the bulkheads for that portion of the superstructure are scattered around the wreck. The rest of the superstructure decks were still affixed to the hull along with ship fixtures, including the lifeboat davits, ladders, and lockers. There were large, arch-shaped scratches noticeable on the vertical surface of the exterior accommodation space on the port side of the vessel, in the vicinity of where the port lifeboat was cradled. The exterior starboard side vertical surface of the accommodation area does not have this same damage, and the starboard lifeboat davits were not as severely damaged as the portside davits.

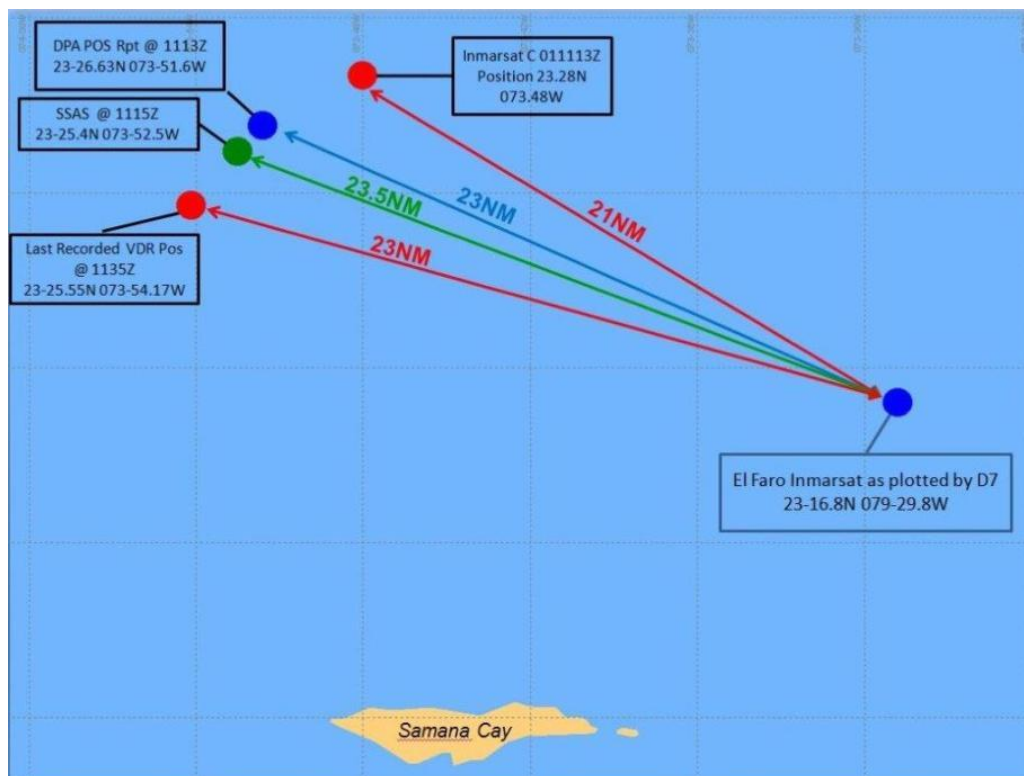
DD.dd. SAROPS did not distinguish the difference between tenths of degrees or minutes in this format.⁴¹⁹ The United States recognizes the format as degrees, decimal degrees⁴²⁰ and it is the watchstanders responsibility to convert coordinates into that format before entering them into SAROPS.

Figure 67. D7CC electronic alert plot SAROPS. The position entered into SAROPS (displayed on the right) was more than 20 nautical miles away from the actual last known position of EL FARO.

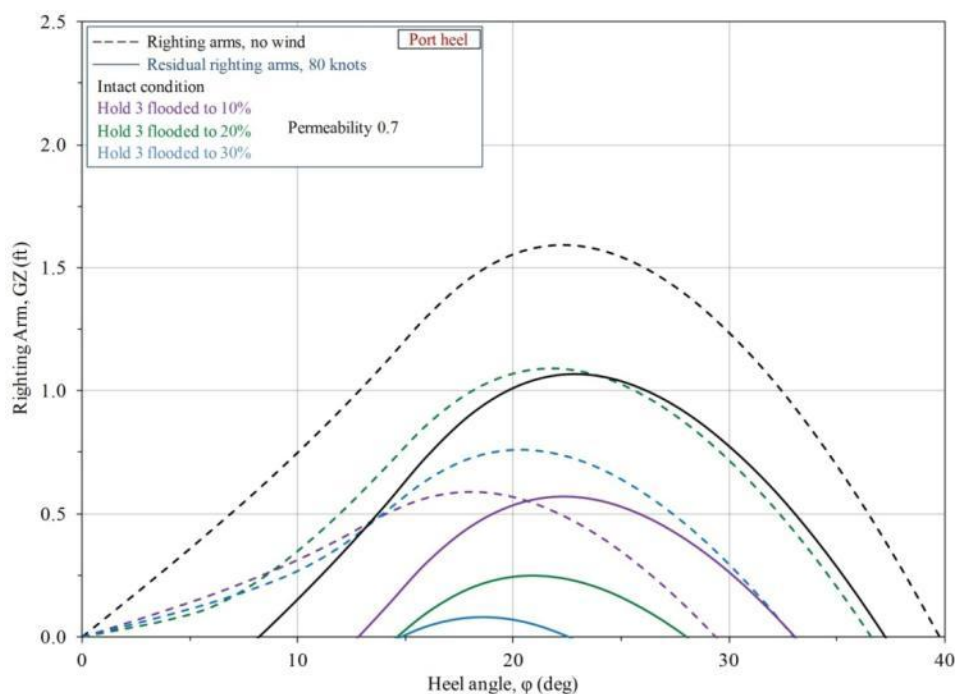
Regardless of the initial source or sources of flooding on EL FARO during the accident voyage, the free surface associated with the floodwater in the cargo holds combined with hurricane force winds and seas would have inevitably resulted in the capsizing of the vessel. The capsizing may have been slowed or temporarily arrested as containers on deck began to wash overboard, but as the vessel slowly rolled onto its port side, a large volume of floodwater would have been entering through the ventilation openings into all of the cargo holds and the engine room, resulting in the sinking.

Figure 71. Righting arms (dashed curves) and residual righting arms (solid curves) with 80 knot beam winds with Hold 3 flooded to 10%, 20%, and 30%. Permeability is 0.7 (Figure 6-24 of the MSC report).

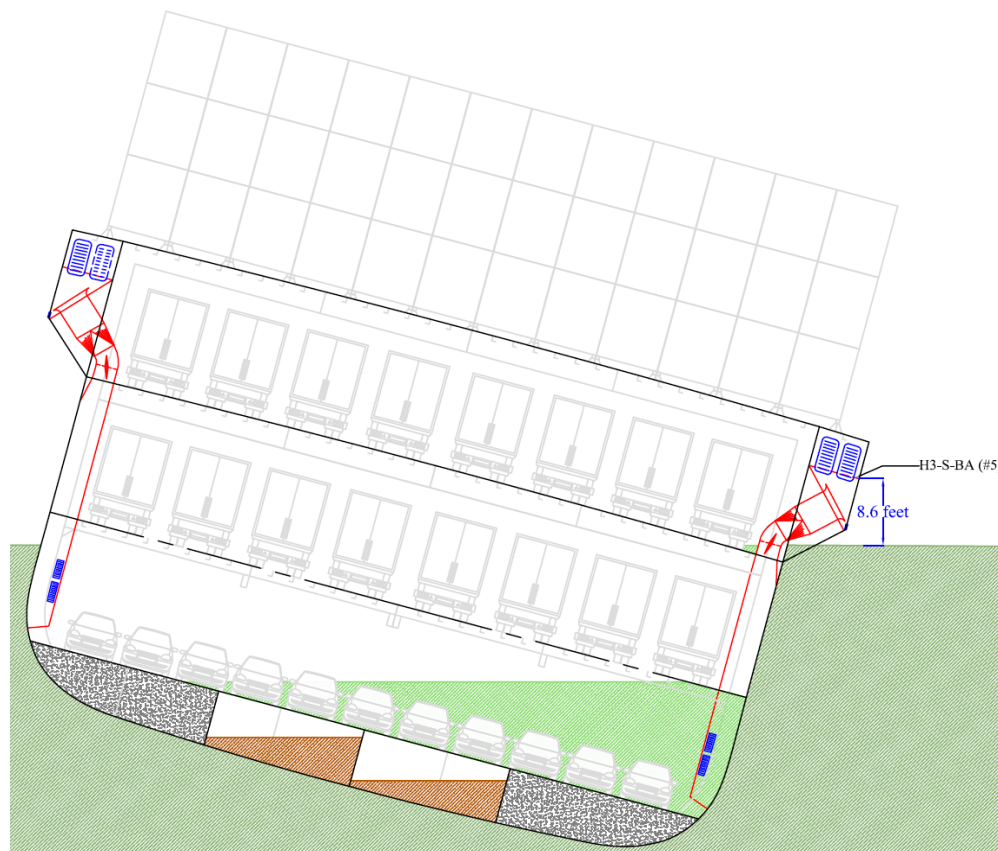
Figure 72. Section at frame 143 (Hold 3 ventilation supply trunk) with flooding of Hold 3 to 20% with heel angle 15 degrees. Downflooding point at the top of the vertical baffle plate is shown (Figure 6-18 of the MSC report).

EL FARO’s side shell openings for the ventilation trunks posed a risk to the vessel when the ship was listing. This risk existed despite the internal baffles and other protective design features within the ventilation trunks. The ventilation trunks were especially vulnerable to a sustained heel because flood water would not drain out of the trunks as effectively and the height of the internal baffle plates would be partially degraded due to the heel. Seawater would enter the openings at greater volumes as the ship was settling into the water due to the weight of the flood water and green water on deck. After losing main propulsion around 6:00 AM on October 1, 2015, the available VDR data indicated that EL FARO was lying in the trough of the seas aligned with the trough, which is an extremely vulnerable position for a ship in high seas. As EL FARO’s crew attempted to combat the flooding and discussed the survivability of the ship, the Master and C/M appeared to be uncertain about the ship’s downflooding points, bilge system, reserve buoyancy, and stability. At 7:22 AM the Master made the following statements while talking to the engine room on the house phone:
