UNITED STATES COAST GUARD

**REPORT OF THE MARINE BOARD OF INVESTIGATION
INTO THE
STEAM SHIP EL FARO (O.N. 561732)
SINKING AND LOSS OF THE VESSEL
WITH 33 PERSONS MISSING AND PRESUMED DECEASED
NORTHEAST OF ACKLINS AND CROOKED ISLAND,
BAHAMAS
ON OCTOBER 1, 2015**

MISLE ACTIVITY NUMBER: 5735749

September 24, 2017

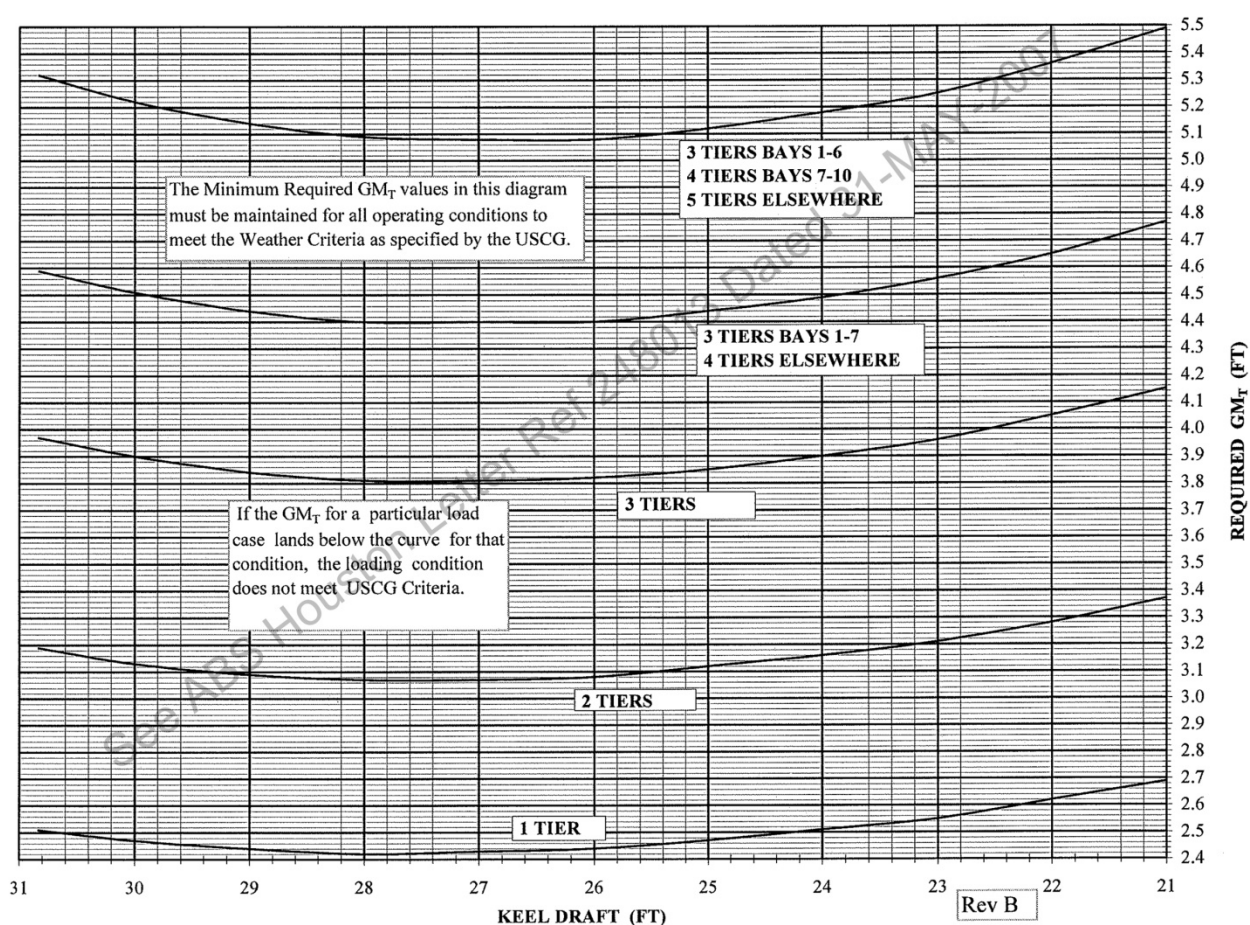
- (2) The minimum required GM curves provided on page 16 of the T&S Booklet produced by Herbert Engineering Corporation (see Figure 4-1) were generated based upon the minimum GM required to meet the intact stability criteria of 46 CFR 170.170 (see Section 5 of this report for additional information about intact stability criteria). However, in MBI hearing testimony [38, 39, 40] it was noted that Herbert Engineering did not complete a damage stability analysis to confirm that, after the 2005-2006 conversion, the limiting criteria would remain the intact stability criteria for all loading conditions, and ABS had no records of a damage stability analysis being completed. This is important because the 2005-2006 conversion resulted in a 2-foot increase in the load line draft (28'-1-1/16" to 30'-2-3/8"), and therefore the previous damage stability analysis completed in 1993 no longer applied. In his MBI hearing testimony [38, 39], Mr. Thomas Gruber of ABS submitted results of his independent SOLAS probabilistic damage stability analysis performed in May 2016 [41], where he applied the damage stability standards which would have been applicable in 2005-2006. Mr. Gruber's analysis determined that for GM values of approximately 2.9 feet at both the load line

Figure 4-1: Minimum required GM curves from the 2007 T&S Booklet [12].

intact stability criteria as reflected in the T&S Booklet. However, for load conditions with 2 or fewer tiers of containers loaded, the limiting stability criteria could be the damage stability criteria, and this was not reflected on the minimum required GM curves of the T&S Booklet (see Figure 4-1). However, as pointed out in Section 4.2, for the full load departure condition of the accident voyage, the limiting stability criteria would have been the intact stability criteria, which was properly reflected in the T&S Booklet and incorporated in the CargoMax stability software, since the majority of the container stacks were 3 tiers.

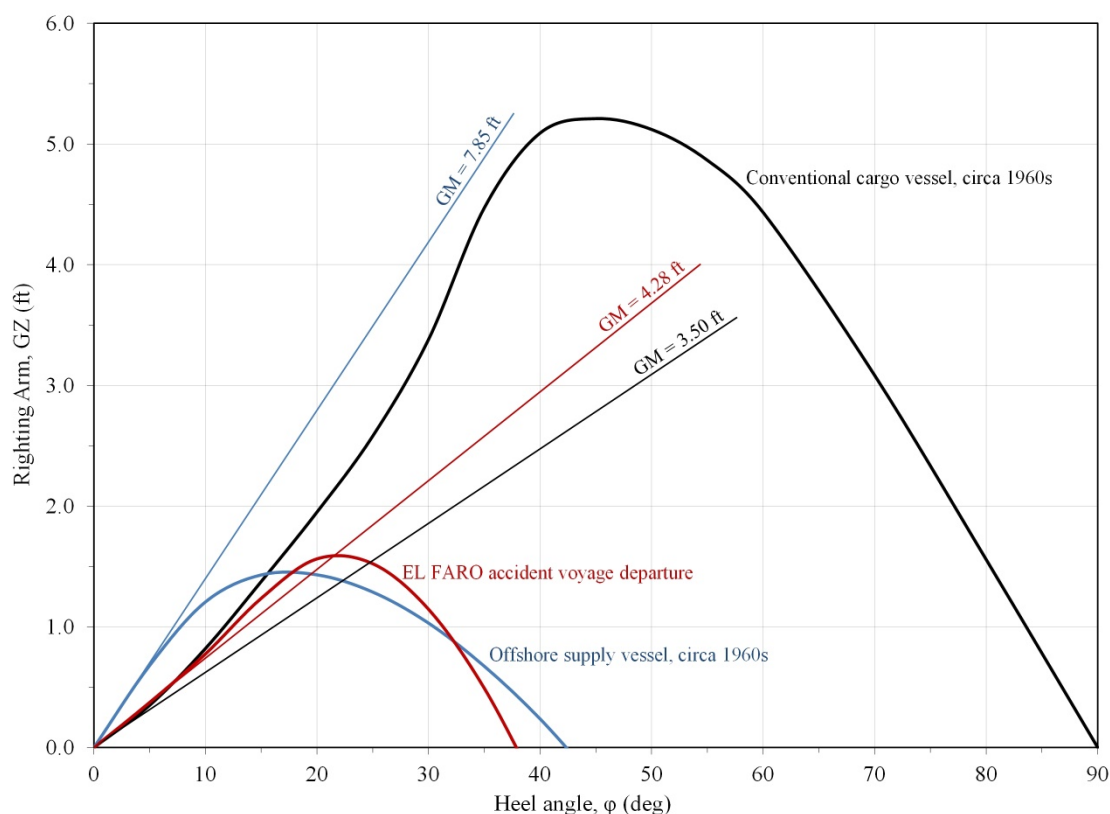
As discussed previously, GM is a good indicator of the initial stability for small angles of heel in response to small heeling forces and moments; however it is in general a poor indicator of overall stability, especially in response to large heeling forces and moments as might be experienced by a vessel in heavy weather where high winds and seas can be expected. The range of stability, maximum righting arm and angle, and area under the righting arm curve are the more important stability characteristics for heavy seas, and GM provides little or no insight into these characteristics. It is instructive to consider the general characteristics of the stability curve of the EL FARO prior to completing numerical assessment in comparison to the righting arm and energy criteria specified by the 2008 IS Code. Noting the previously discussed comparison of righting arm curves for a conventional cargo vessel and offshore supply vessel circa 1960s (Figure 5-3) provided by Mok and Hill [51], it is instructive to plot the righting arm curve for the EL FARO accident voyage departure condition along with these vessels, as shown in Figure 5-6. It is apparent that although the EL FARO had a GM larger than the conventional cargo vessel, the total righting energy available to resist capsizing (represented by the total area under the righting arm curve) is only a fraction of the conventional cargo vessel (16% in this illustration), and is even less than the offshore supply vessel. This is due to lower freeboards causing deck edge immersion at lower angles of heel compared to the conventional hull, resulting in lower range of stability and lower overall righting energy.

Figure 5-6: Comparison of righting arm curves for the EL FARO accident voyage departure condition with the conventional cargo vessel and offshore supply vessel from Figure 5-3.

The righting arm curves for the EL FARO are generally characterized by relatively small area (righting energy) and range of stability compared to conventional cargo vessels (see Figure 5-6). These characteristics are especially significant in consideration of limited residual righting arms and righting energy with the vessel subjected to heeling forces and moments as might be experienced in heavy weather where high winds and seas can be expected. These characteristics are significant in consideration of limited residual righting arms and righting energy when subjected to flooding.

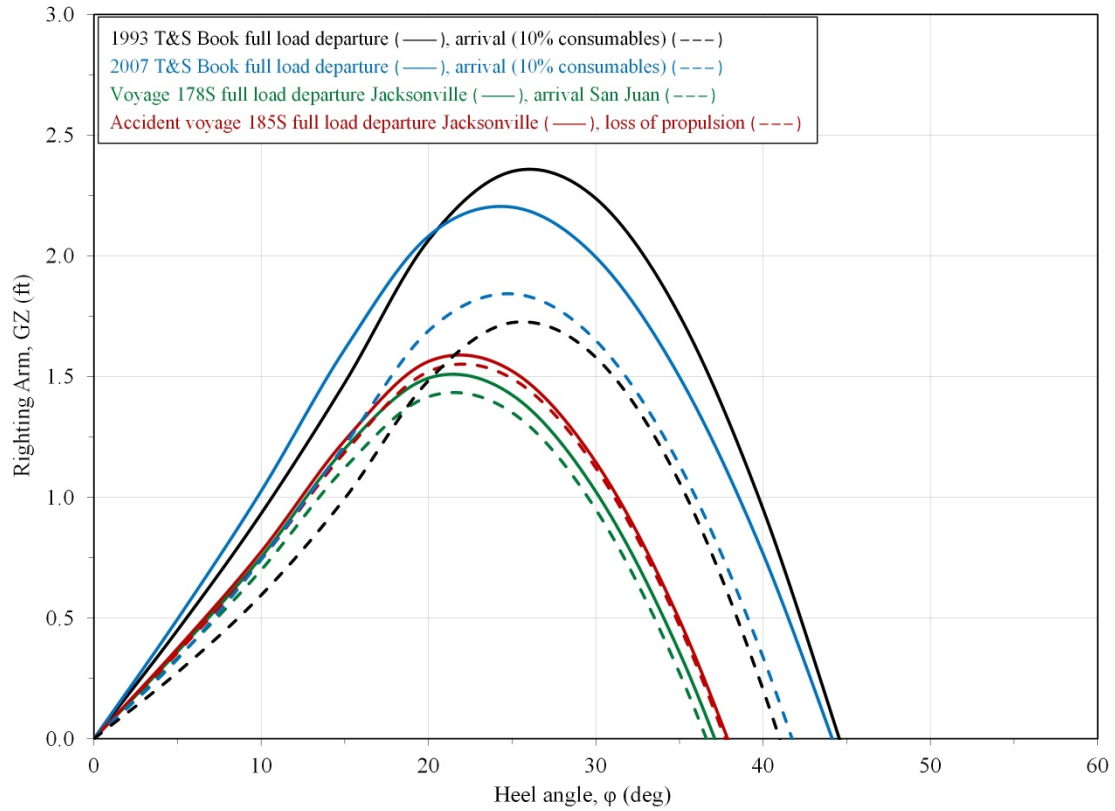
For the righting arm curves shown in Figure 5-7, the 2008 IS Code righting arm criteria were applied, with results summarized in Table 5-2. Red (*italics*) indicates that the attained value does not meet the specific criteria and green indicates that the attained value meets the specific criteria. For the general righting arm criteria (Part A, Section 2.2), due to the relatively low range of stability, the actual operating conditions of voyage 178S and the accident voyage 185S do not meet criteria for minimum area between 30 and 40 degrees and minimum angle of maximum righting arm. All of the eight conditions meet the severe wind and rolling righting arm criteria (Part A, Section 2.3). This can be seen in greater detail in Figure 5-8, which illustrates the application of the criteria for the accident voyage (185S). In order for the EL FARO to have fully met the criteria of Part A of the 2008 IS Code at the full load draft, the minimum required GM would have been approximately 6.8 feet, which is 2.5 feet greater than the GM of the actual departure loading condition of the accident voyage.

Figure 5-7: Righting arm curves for the eight benchmark full load conditions.

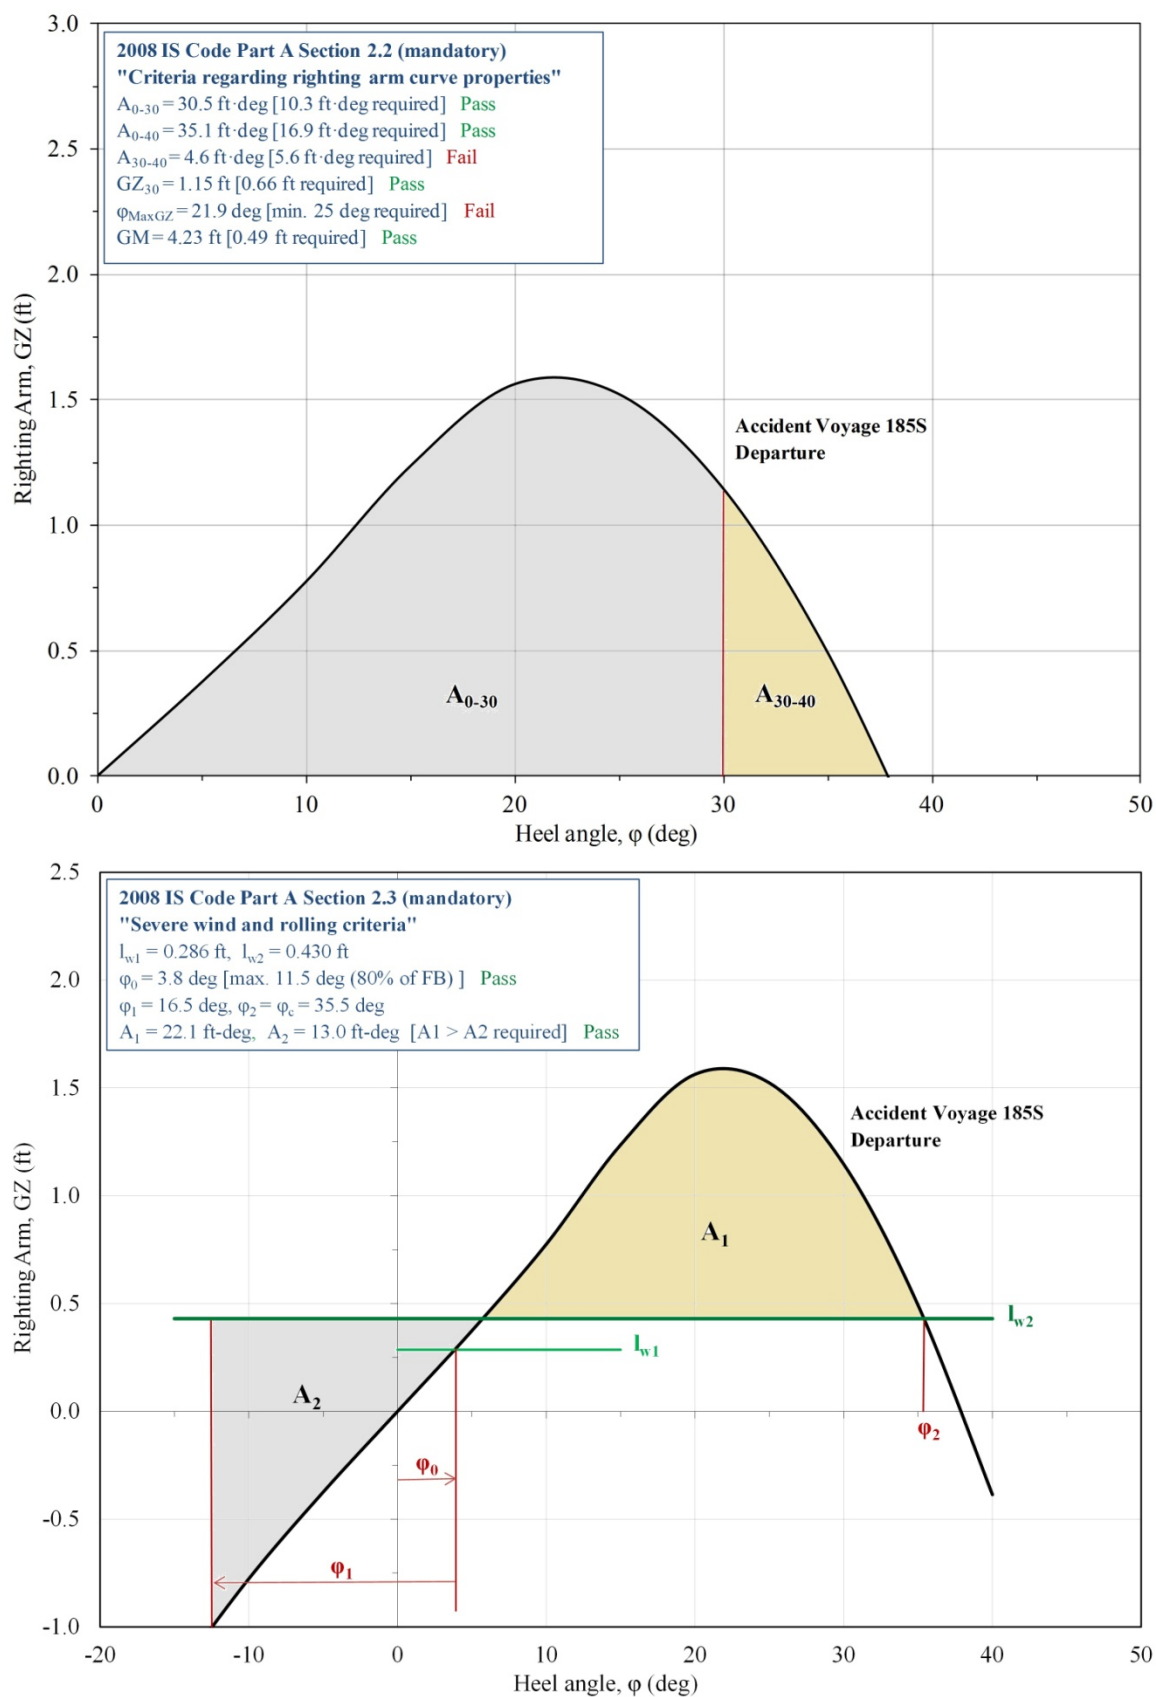
Figure 5-8: Application of 2008 IS Code righting arm criteria to the accident voyage (185S).

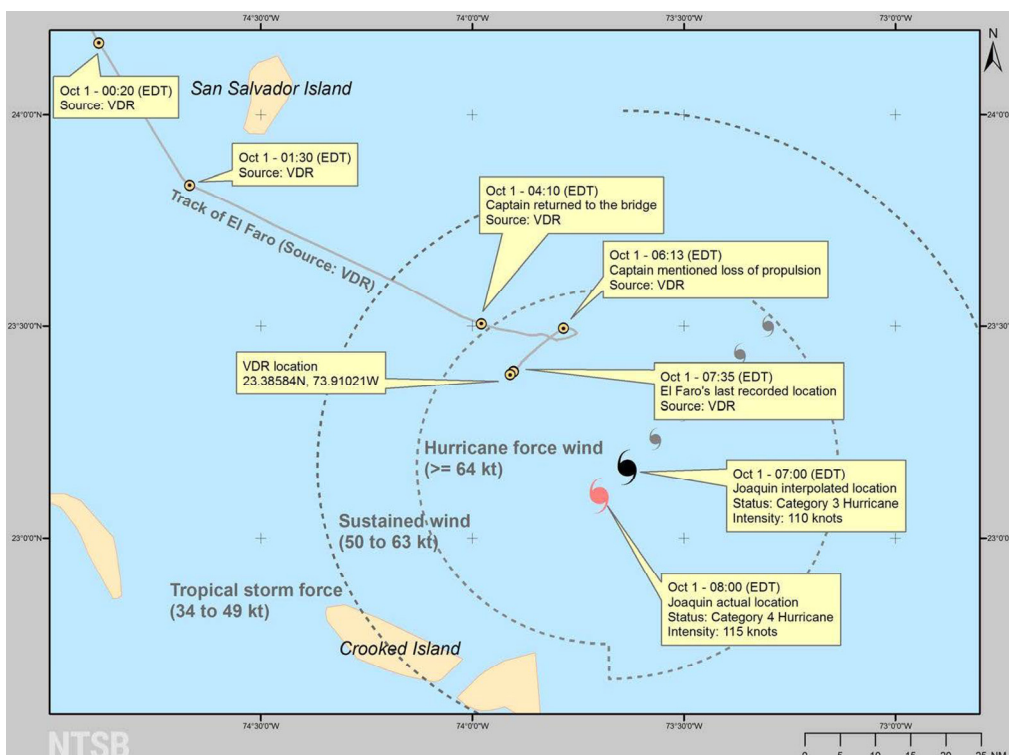
Wind and wave directions from the simulations are slightly different than those based on actual ship and storm track data provided in the NTSB Weather Group Factual Report [66], which suggests wind and waves were from the east or northeast during the final hours prior to sinking. This is illustrated in Figure 6-1 which shows the actual EL FARO track and Joaquin storm track over the morning hours on October 1, 2015 (as annotated). As can be seen on the graphic, prior to the loss of propulsion, the vessel was heading east-southeast, with winds generally off the port bow. Following the turn to port and loss of propulsion around 0600, until the sinking around 0740, the ship was drifting in a southwesterly direction. Based on hydrodynamic considerations, the ship would likely have been drifting during this time with beam to the wind and waves. Based on normal counter-clockwise storm rotation, it can be estimated that the winds were out of the northeast at 70-90 knots (sustained) between 0600 and 0740. This is consistent with the statement made by the Captain at 0710 on the VDR transcript [64 (pg. 477)].

Figure 6-1: EL FARO track and Hurricane Joaquin storm track around the time of loss of propulsion and sinking. NTSB graphic.

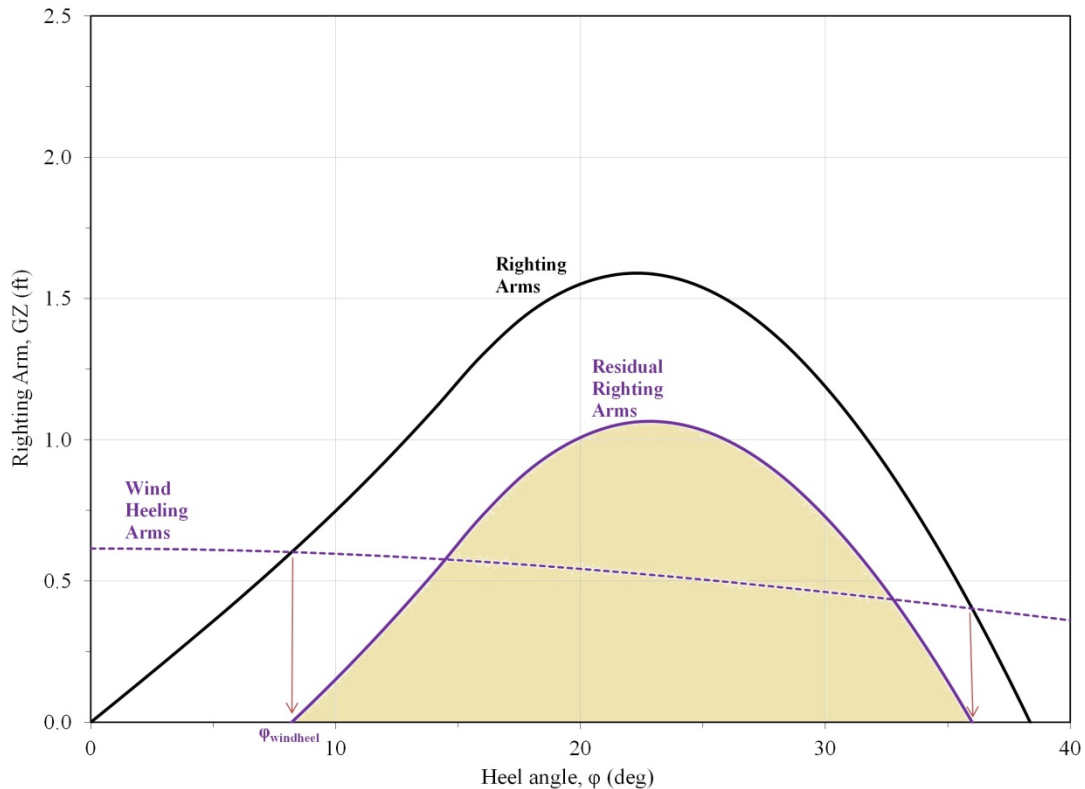
For a steady wind (or prolonged gust) in calm water the ship would reach an equilibrium angle where the wind heeling moment (heeling arm) is balanced by the righting moment (righting arm). The residual righting arms are then calculated by simple subtraction of the heeling arms from the righting arms at each angle φ . The residual righting energy as the vessel is heeled by the wind (i.e. the reduced energy available to resist capsizing) is the area under the residual righting arm curve. This is shown graphically in Figure 6-2, which uses the EL FARO accident voyage condition at loss of propulsion, with 80 knot beam wind. Note that this condition does not consider the effects of flooding or cargo shifting, which will be addressed subsequently.

Figure 6-2: Effect of wind heeling arms on the righting arms, shown for the accident voyage condition at the time of loss of propulsion, with 80 knot beam wind (not including effects of flooding or cargo shifting). Starboard heel is shown.

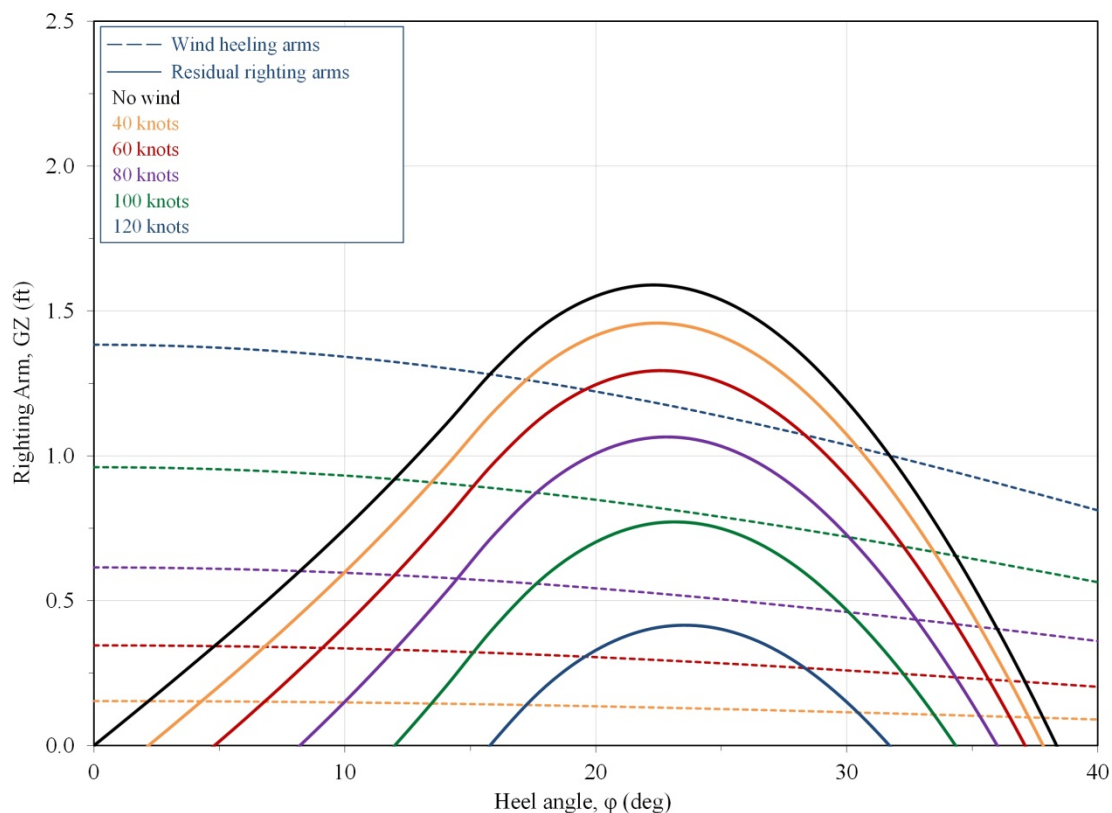
Figure 6-3 provides a graphical illustration of the effects of various beam wind velocities (from 40 to 120 knots) on the righting arm curve for the accident voyage condition at the time of loss of propulsion (not including effects of flooding or cargo shifting). From the plots and based on the estimated wind conditions at the time of the loss of propulsion from 70-90 knots, it can be estimated that a wind heel angle of 7-11 degrees could be attributable to the steady beam wind alone. This does not include dynamic roll effects, as the ship would roll about the wind heel angle due to wave-driven roll motions. This also does not include the effects of flooding including the important free surface effects, as will be addressed subsequently.

Figure 6-3: Heeling arms for beam winds from 40 to 120 knots (dashed curves) and residual righting arms (solid curves) for the accident voyage condition at the time of loss of propulsion (not including the effects of flooding or cargo shifting). Starboard heel is shown.

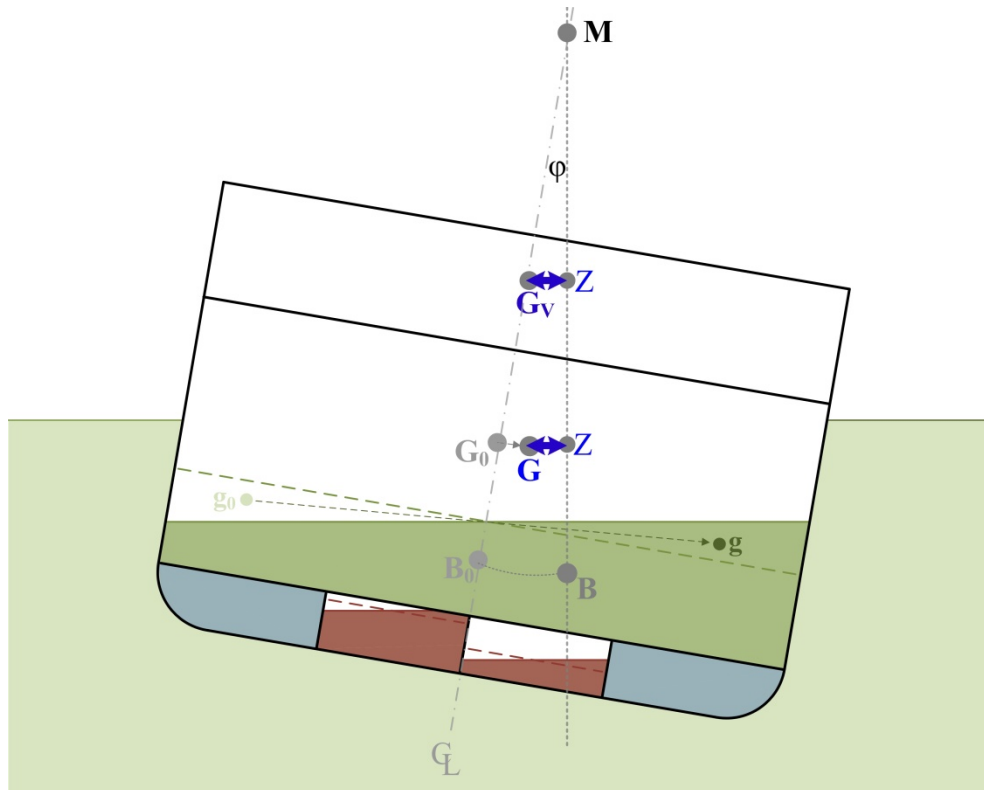
Second, as floodwater in compartments usually involves free surface, which is free to move as the vessel rolls and pitches (heels and trims) unless water completely floods a compartment to the overhead, there is an additional horizontal and vertical shift in the ship's center of gravity, and this is detrimental to the stability of the vessel. Specifically, the effect of the free surface is a resulting horizontal and vertical shift of the center of gravity due to the shifting of the weight of the "wedge" of liquid on the free surface, as illustrated in Figure 6-4. This resulting shifting of the ship's center of gravity (G_0G) reduces the righting arms and has the equivalent effect on the righting arms (GZ) as a virtual rise in the center of gravity (G_0G_v). This virtual rise in the ship's center of gravity is the same as the "free surface correction" (FSC) applied to GM for intact stability analysis. Free surface is always detrimental to the stability of the vessel. The horizontal component of the weight shift also results in an increase in angle of heel or trim. For flooded compartments with large free surface areas, especially those with full-beam widths such as cargo holds, the free surface effect can be significant. The free surface effect is also important for tanks carrying liquids which are neither empty nor full, and is included in the "free surface correction" discussed in previous sections of this report. A more thorough discussion of free surface effects is provided by Moore [47]. Note that as the liquid level in a compartment or tank is raised toward the overhead, the free surface effect is significantly reduced (and eventually eliminated as the compartment or tank is completely filled). This reduction in the free surface effect as the liquid level approaches the compartment or tank overhead is known as "pocketing," and is important for many conditions of flooding.

Figure 6-4: Flooding and free surface effect. Shifting of the ship's center of gravity (G_0G) has the equivalent effect on the righting arms (GZ) as a virtual rise in the center of gravity (G_0G_v).

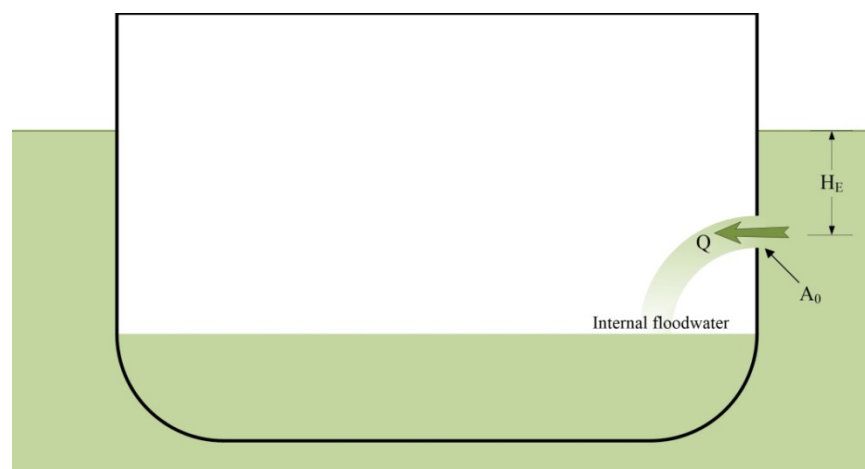
where A_0 is the area of the opening (ft^2), C_D is a dimensionless coefficient of discharge which depends primarily on the geometry of the opening (approximately 0.6 for flow through a sharp-edged opening), g is the acceleration due to gravity (32.2 ft/s^2), and H_E is the external hydrostatic water head (height) above the opening (ft). Figure 6-5 illustrates the geometry of the flow.

As a simple example, for a small opening of area 1 ft^2 located 1 ft below the external waterline, the calculated flow rate (Q) is approximately $4.8 \text{ ft}^3/\text{s}$, which is equivalent to 36 gal/s or $2,160 \text{ gal/min}$. Noting that the bilge pumping system on EL FARO had a capacity less than $1,000 \text{ gal/min}$, the bilge pumping system would be ineffective at keeping up with flooding through even a small opening just below the waterline.

Figure 6-5: Geometry and nomenclature for the Bernoulli's equation for orifice fluid flow for calculation of flooding rate.

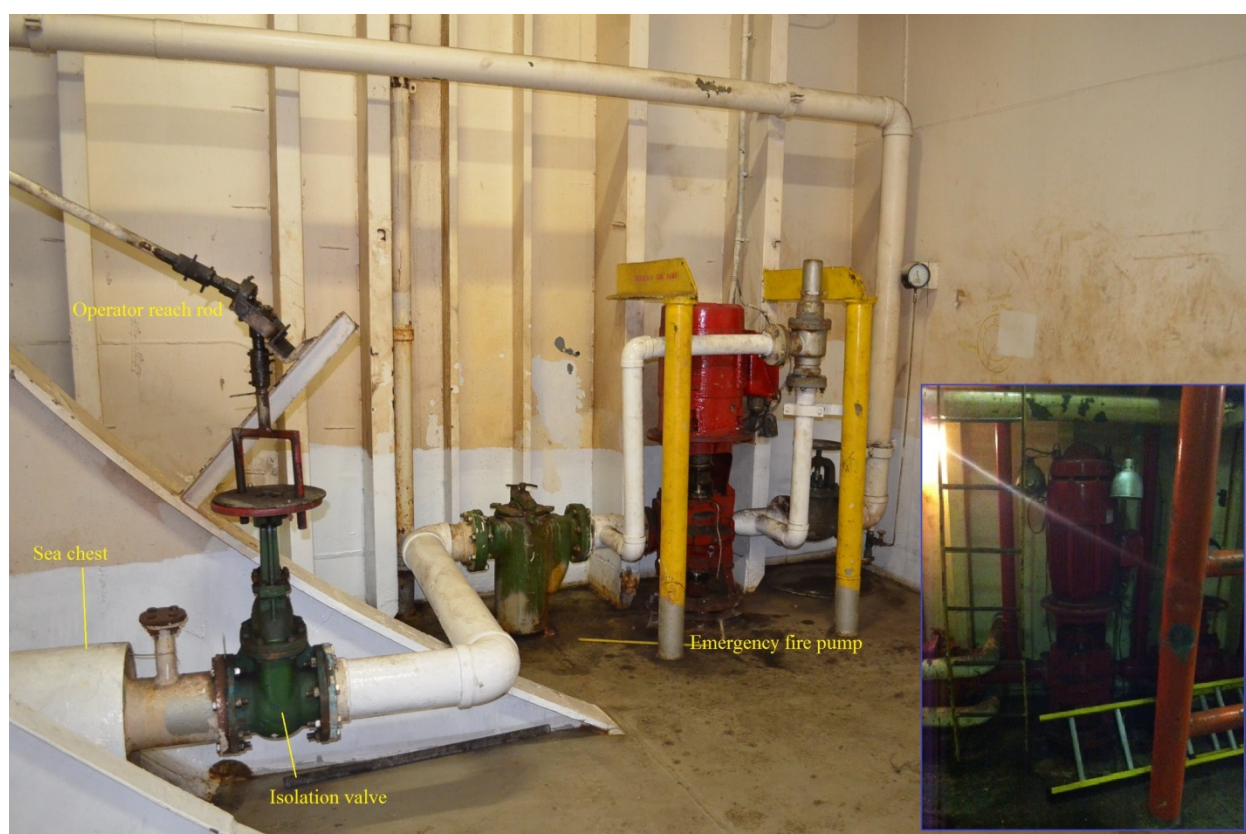
During the final hour the crew attempted to identify potential sources of additional water ingress into cargo Hold 3. Based on a statement by the Chief Mate [64 (pg. 482)], the Chief Engineer identified the potential for flooding from the emergency fire pump piping, which was located on the 4th deck (tanktop, innerbottom) in the aft starboard corner of Hold 3 (see Figure 6-7). It was speculated that it may have been damaged by floating automobiles which had broken free in the lower hold. Although no visual identification of this potential source of flooding was made, the crew discussed potential methods of isolating the emergency fire pump piping from the engine room. There was no discussion on the audio transcript of closing the sea chest isolation valve with the hand-wheel remote operator from the 2nd deck starboard side (see Figure 6-6 and Figure 6-7).

Figure 6-7: Emergency fire pump station in Hold 3, aft starboard 4th deck (tanktop, innerbottom), showing the sea chest, isolation valve, and manual remote operator on sister vessel EL YUNQUE (EL FARO similar but not identical). Inset photo shows part of the arrangement onboard EL FARO. USCG photo with Tote, Inc. photo inset.

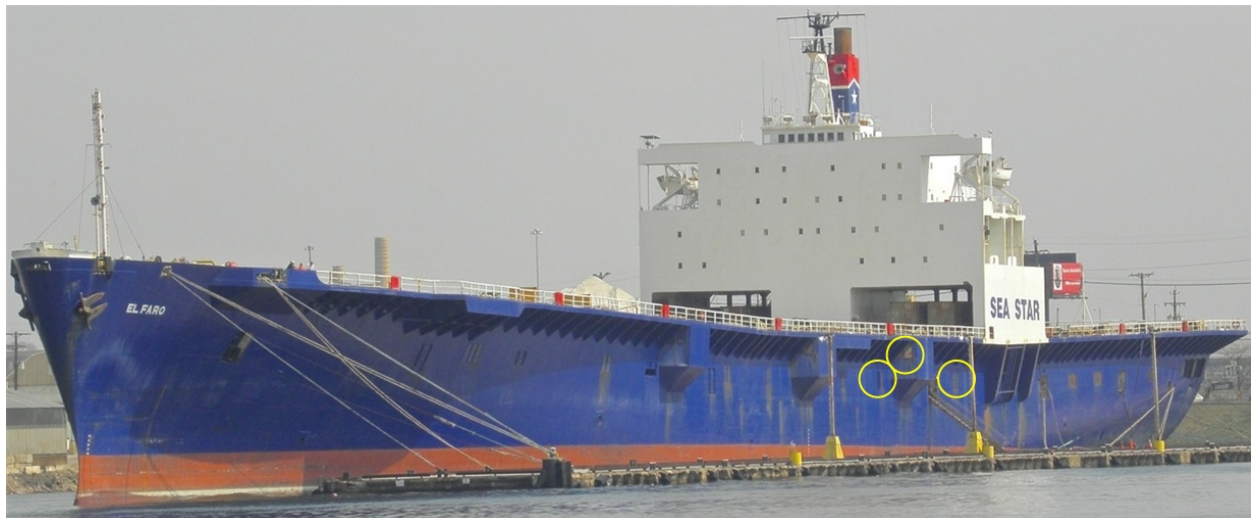
The cargo hold ventilation system consists of ventilation supply trunks with integrated supply fans and fire dampers and ducting, and ventilation exhaust trunks with integrated fire dampers and ducting. The supply and exhaust trunks for Holds 2, 2A and 3 were all similar in configuration and differed primarily in internal details and height due to the sheer of the 2nd deck, with the Hold 3 openings being the lowest and closest to the waterline due to deck sheer and vessel trim aft. Figure 6-8 shows a photograph of the EL FARO port side, highlighting the ventilation supply and exhaust hull openings for Hold 3.

Figure 6-8: EL FARO port side showing ventilation supply and exhaust louvered hull openings. The openings for Hold 3 are highlighted. Photo copyright Will Van Dorp, used with permission.

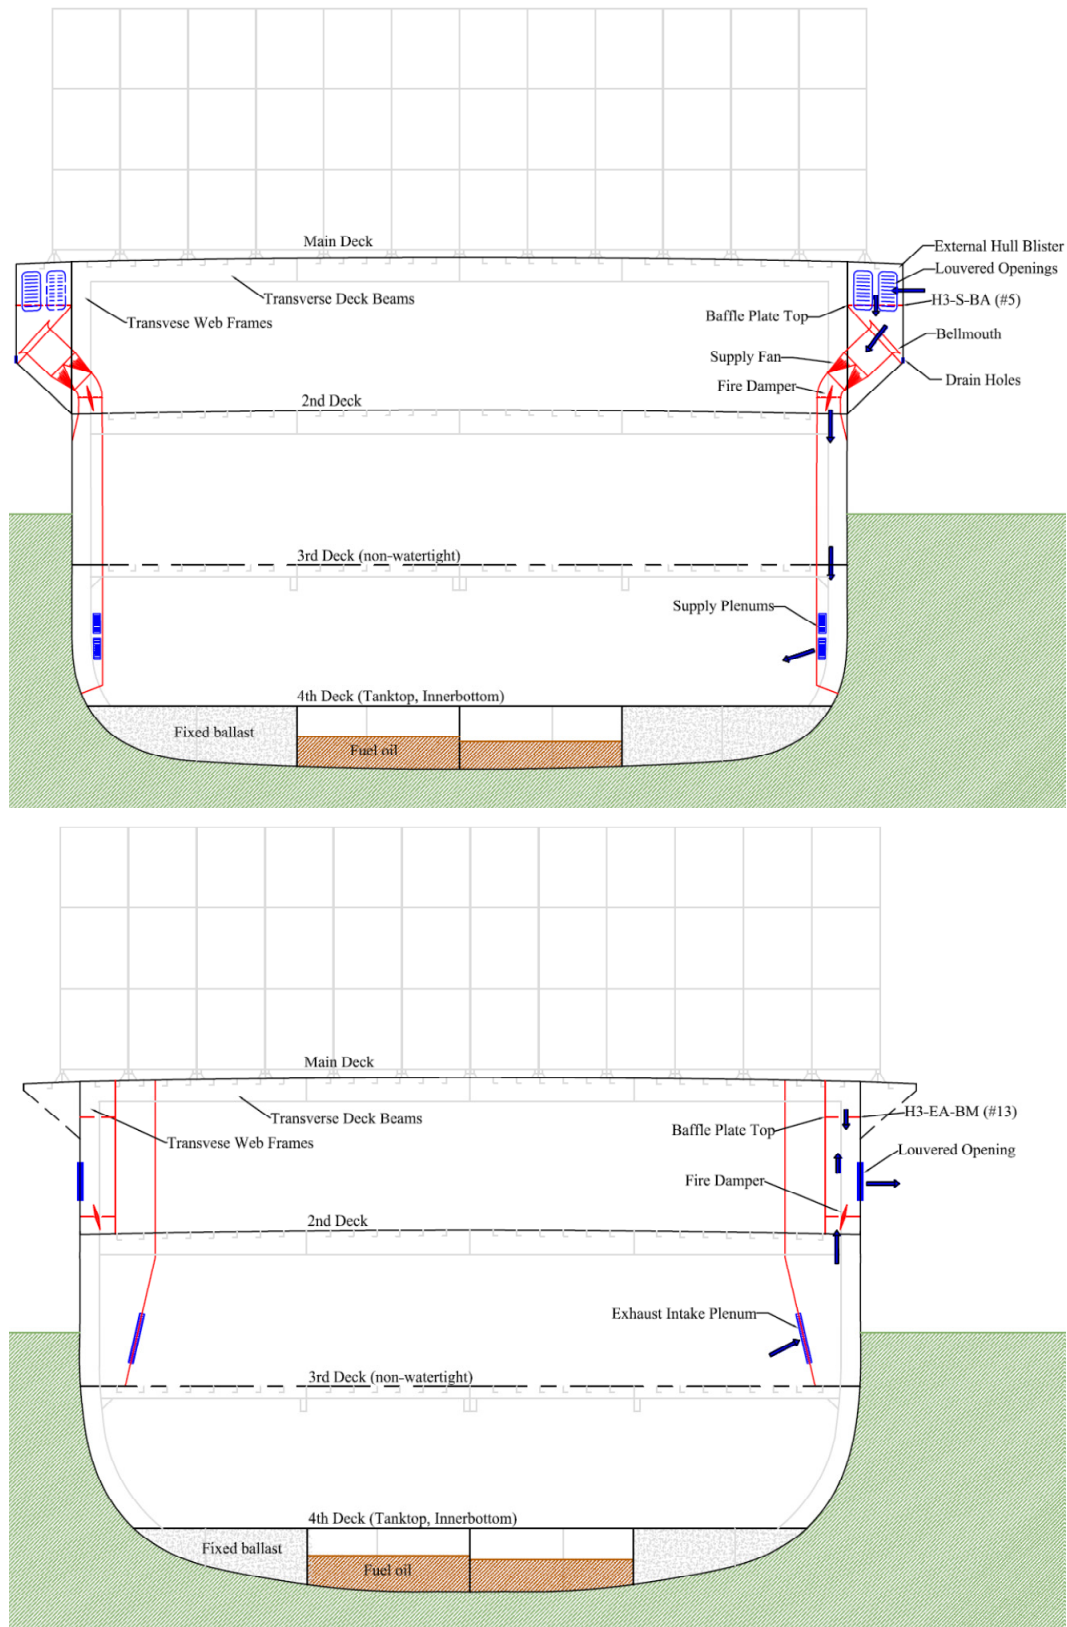
Scaled drawings of sections at frames 143 and 159 showing the supply and aft exhaust arrangements are provided in Figure 6-9. The section at frame 143 shows the Hold 3 ventilation supply arrangement. The supply arrangement includes an external hull blister with side shell louvered openings, baffle plates, bellmouth, supply fan, fire damper and supply plenum. The louvered openings are forward and aft of the bellmouth, separated by the vertical baffle plates. The section at frame 159 shows the Hold 3 aft exhaust arrangement. The exhaust arrangement includes an intake plenum, a fire damper, and an exhaust trunk with a 12-ft high baffle plate and side shell louvered opening. The louvered opening is forward of the fire damper trunk, separated by the vertical baffle plate. Based on the system design, the baffle plates were intended to provide a vertical boundary to limit water from entering the cargo hold through the fire dampers. For the accident voyage, the tops of the baffle plates were approximately 25 feet above the still waterline, and they would submerge at an angle of heel of approximately 27-29 degrees.

Figure 6-9: Sections at frames 143 (top) and 159 (bottom) showing Hold 3 ventilation supply and exhaust arrangements, respectively. Normal air supply and exhaust paths are shown.

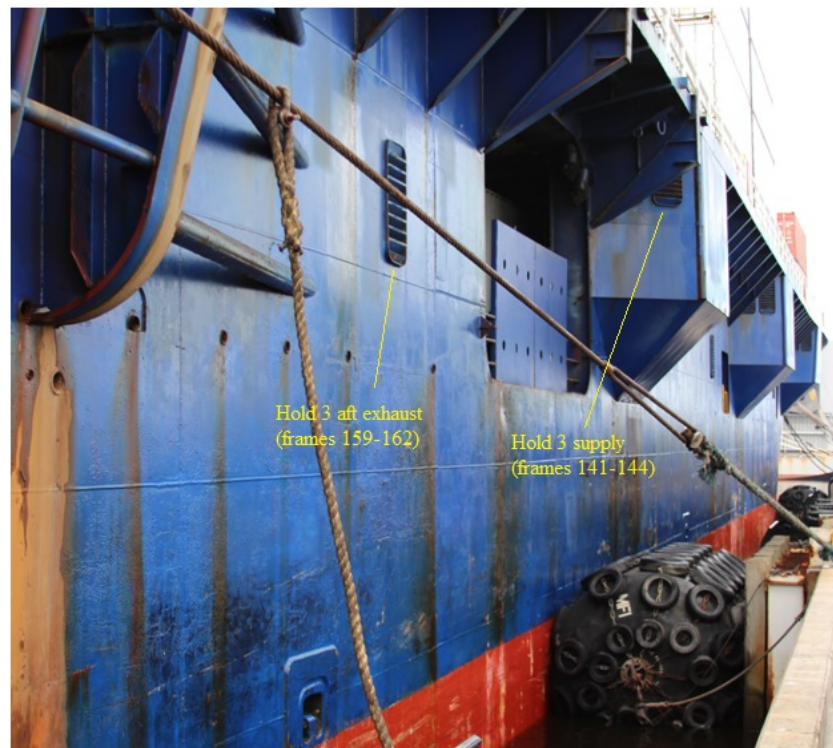
Figure 6-10 through Figure 6-14 provide a series of photographs showing important components of the cargo hold ventilation system which illustrate the vulnerability of flooding through the ventilation supply and exhaust openings on the EL FARO. The ventilation system could be secured in the case of fire by manually closing the fire dampers. Otherwise the fire dampers were required to remain open at all times in port and at sea to provide positive ventilation of the vehicles holds, as required in 46 CFR 92.15-10. Based on MBI hearing testimony [19, 20, 32], crews did not close the fire dampers at sea for heavy weather. There was also no shipboard documentation in the form of a damage control plan or emergency plan which might recommend securing of the fire dampers in the case of extremely high seas to prevent flooding of the cargo holds.

Figure 6-10: Starboard ventilation louvered hull openings for Hold 3 ventilation supply and aft exhaust. Note that red paint delineates the load line (approximate full load waterline). Photo of sister vessel EL YUNQUE. USCG photo.

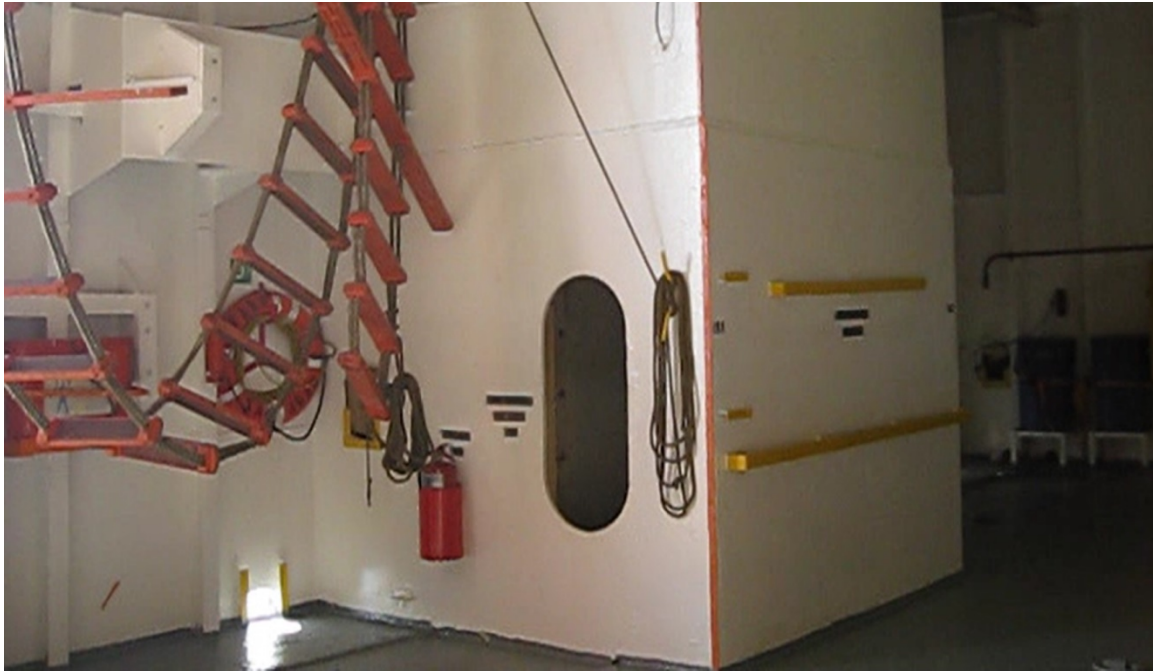
Figure 6-11: Hold 3 aft ventilation exhaust trunk with racking bulkhead, frames 159-162 starboard, 2nd deck. Screen capture from video taken September 2008 provided by Tote, Inc.

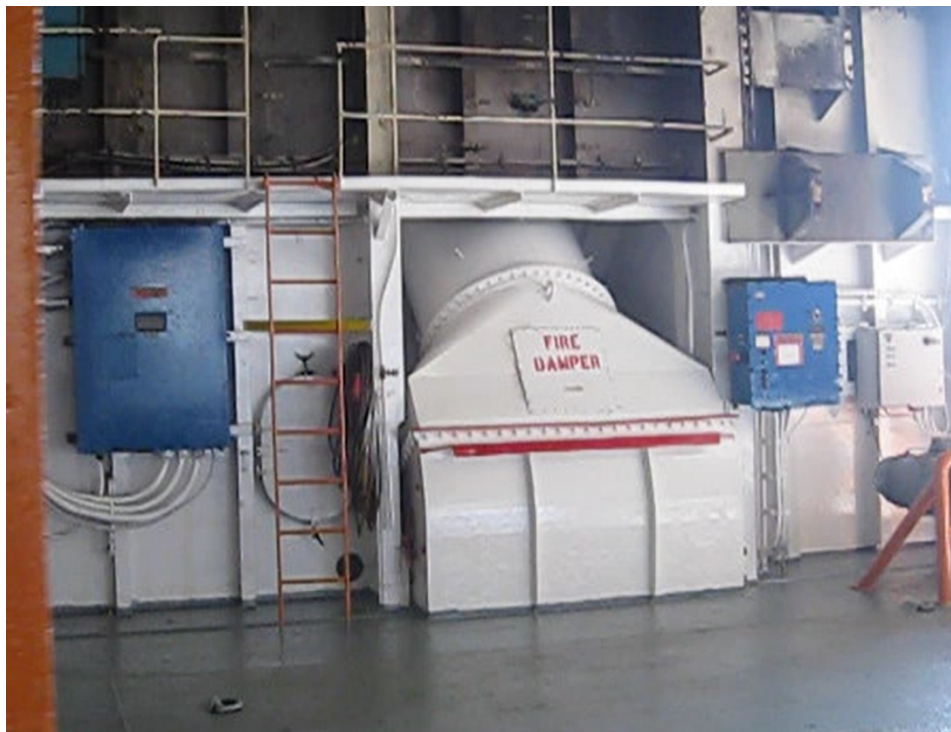
Figure 6-12: Hold 3 ventilation supply fan and fire damper enclosure, frames 141-144 starboard, 2nd deck. Screen capture from video taken September 2008 provided by Tote, Inc.

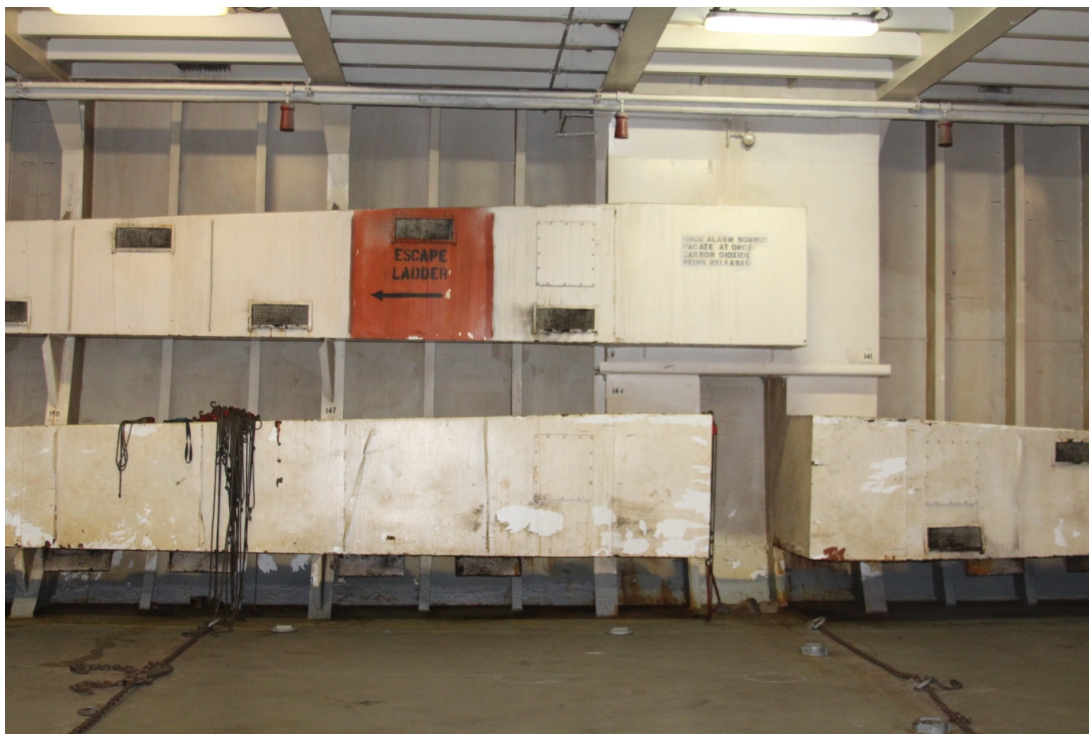
Figure 6-13: Ventilation supply plenums inside Hold 3, frames 141-144 port, 4th deck (tanktop, innerbottom). Photo of sister vessel EL YUNQUE. USCG photo.

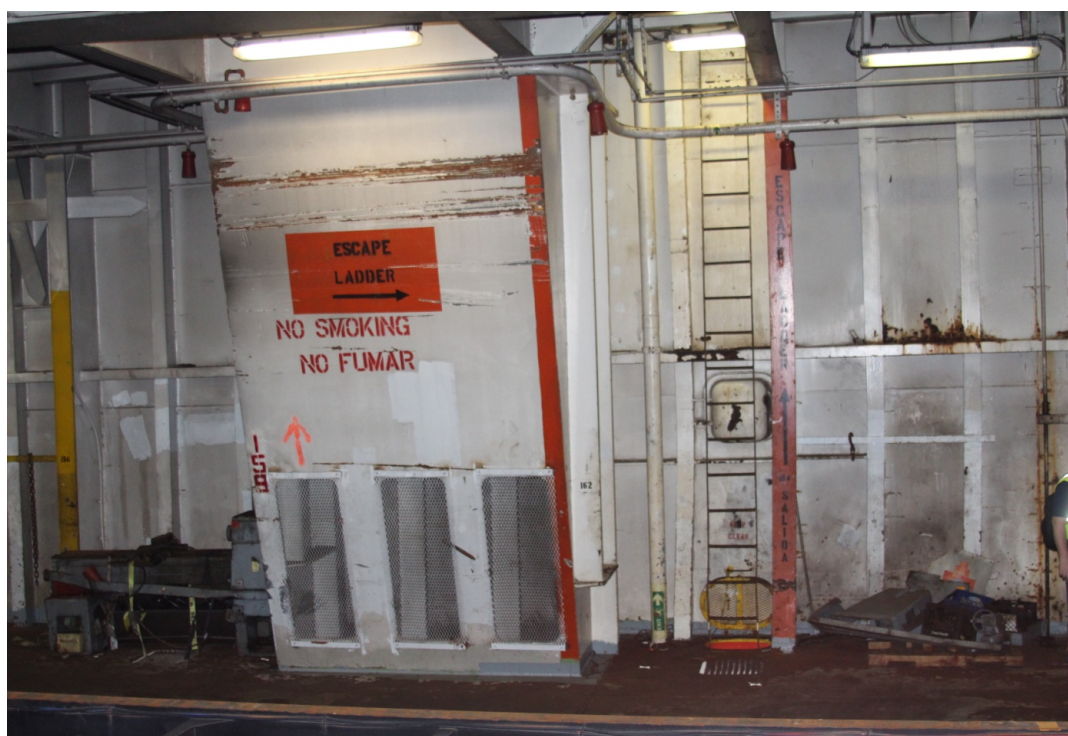
Figure 6-14: Ventilation exhaust intake plenum inside Hold 3, frames 159-162 starboard, 3rd deck. Hold 3 starboard scuttle personnel access ladder and remote operator rod for the emergency fire pump suction valve (sea-chest isolation) are shown on the right. Photo of sister vessel EL YUNQUE. USCG photo.

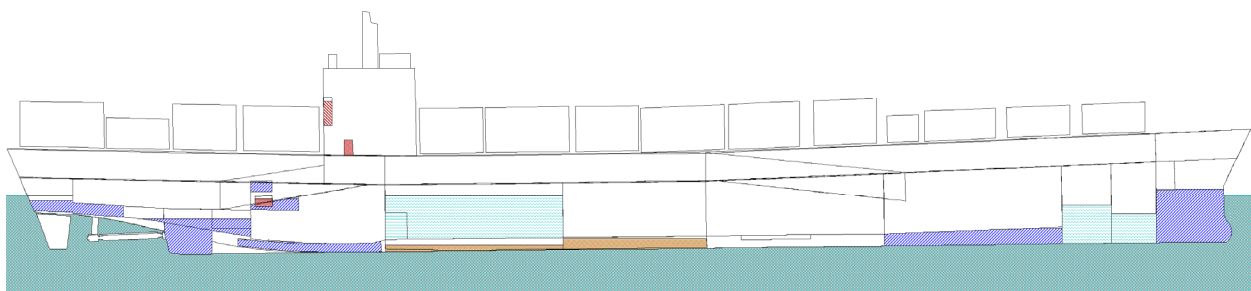
Figure 6-16: Centerline inboard profile from the GHS software showing the condition with Hold 3 flooded to equalization (i.e. flooded to the external waterline). Permeability is 0.8.

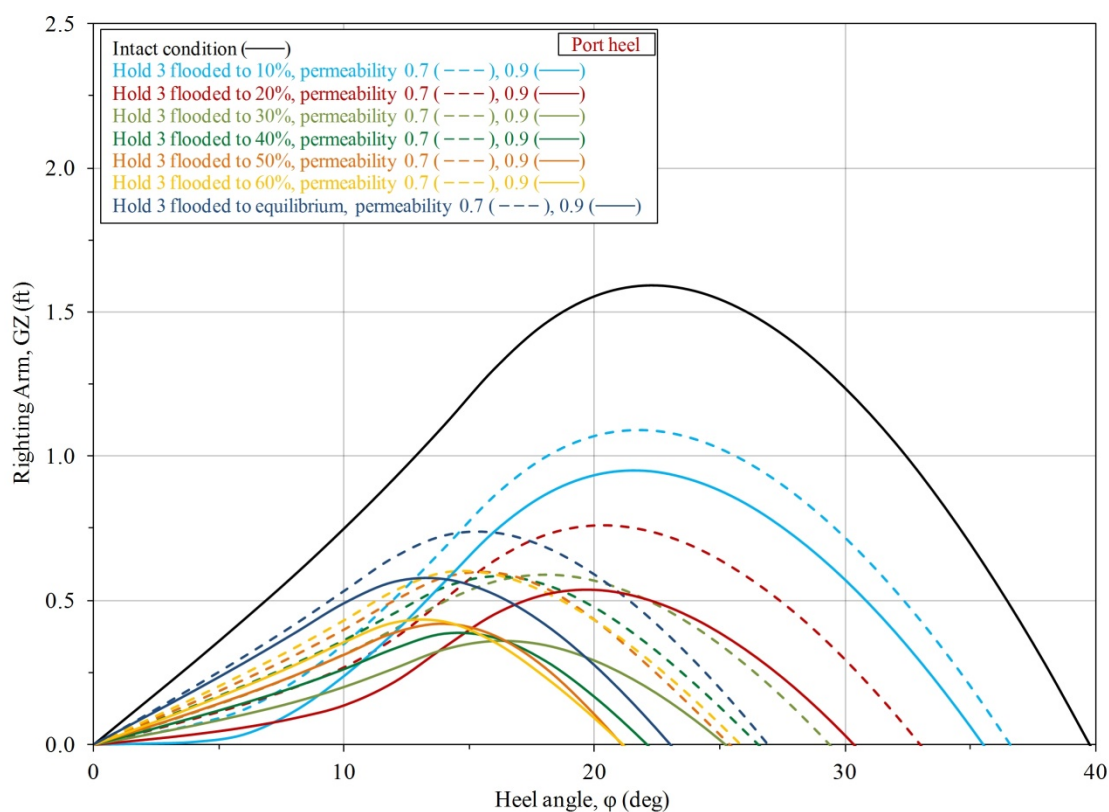
One of the important conclusions that can be drawn from Table 6-3 and Figure 6-17 is the reduced righting arms and GM (slope of the righting arm curve) at the lower percentages (10% and 20%) for the higher permeability value (0.9) due to the initial free surface effect. However, as discussed previously, it is likely that due to the existence of the tightly packed automobiles in the lower holds, the effective initial permeability value would be closer to 0.6-0.7 and would only increase to an average value of approximately 0.8 as the floodwater levels increased toward the overhead of the lower hold. This is illustrated in Figure 6-18 which shows scaled drawings of the sections at frame 143 (location of the Hold 3 supply trunk) and frame 159 (location of the Hold 3 aft exhaust trunk). The loading of containers, trailers and automobiles are shown to scale and approximate position based on the Final Stow Plan [70]. The figure shows Hold 3 flooded to the 20% level, showing the effective reduction in permeability due to the automobiles, and also the impact of pocketing as the loose water hits the overhead (3rd Deck). In the figure, the flooding level at 20% and heel angle of 15 degrees are shown for example, as this was a condition which might have existed at early stages of flooding in Hold 3, based on the VDR audio transcript as previously discussed, and based on combined wind heel considerations as will be discussed. The scaled drawings in the figure also show how close the Hold 3 ventilation openings (tops of the baffle plates) would be to a still waterline with a 15 degree wind heel angle. The relative rise in water height due to waves and vessel roll motion would bring these ventilation openings to submergence, at least intermittently. This will be discussed in more detail subsequently.

Figure 6-17: Comparison of righting arm curves for flooding of Hold 3 in 10% increments. Dashed curves are for permeability 0.7, solid curves are for permeability 0.9. Port heel is shown.
