UNITED STATES COAST GUARD

**REPORT OF THE MARINE BOARD OF INVESTIGATION
INTO THE
STEAM SHIP EL FARO (O.N. 561732)
SINKING AND LOSS OF THE VESSEL
WITH 33 PERSONS MISSING AND PRESUMED DECEASED
NORTHEAST OF ACKLINS AND CROOKED ISLAND,
BAHAMAS
ON OCTOBER 1, 2015**

MISLE ACTIVITY NUMBER: 5735749

September 24, 2017

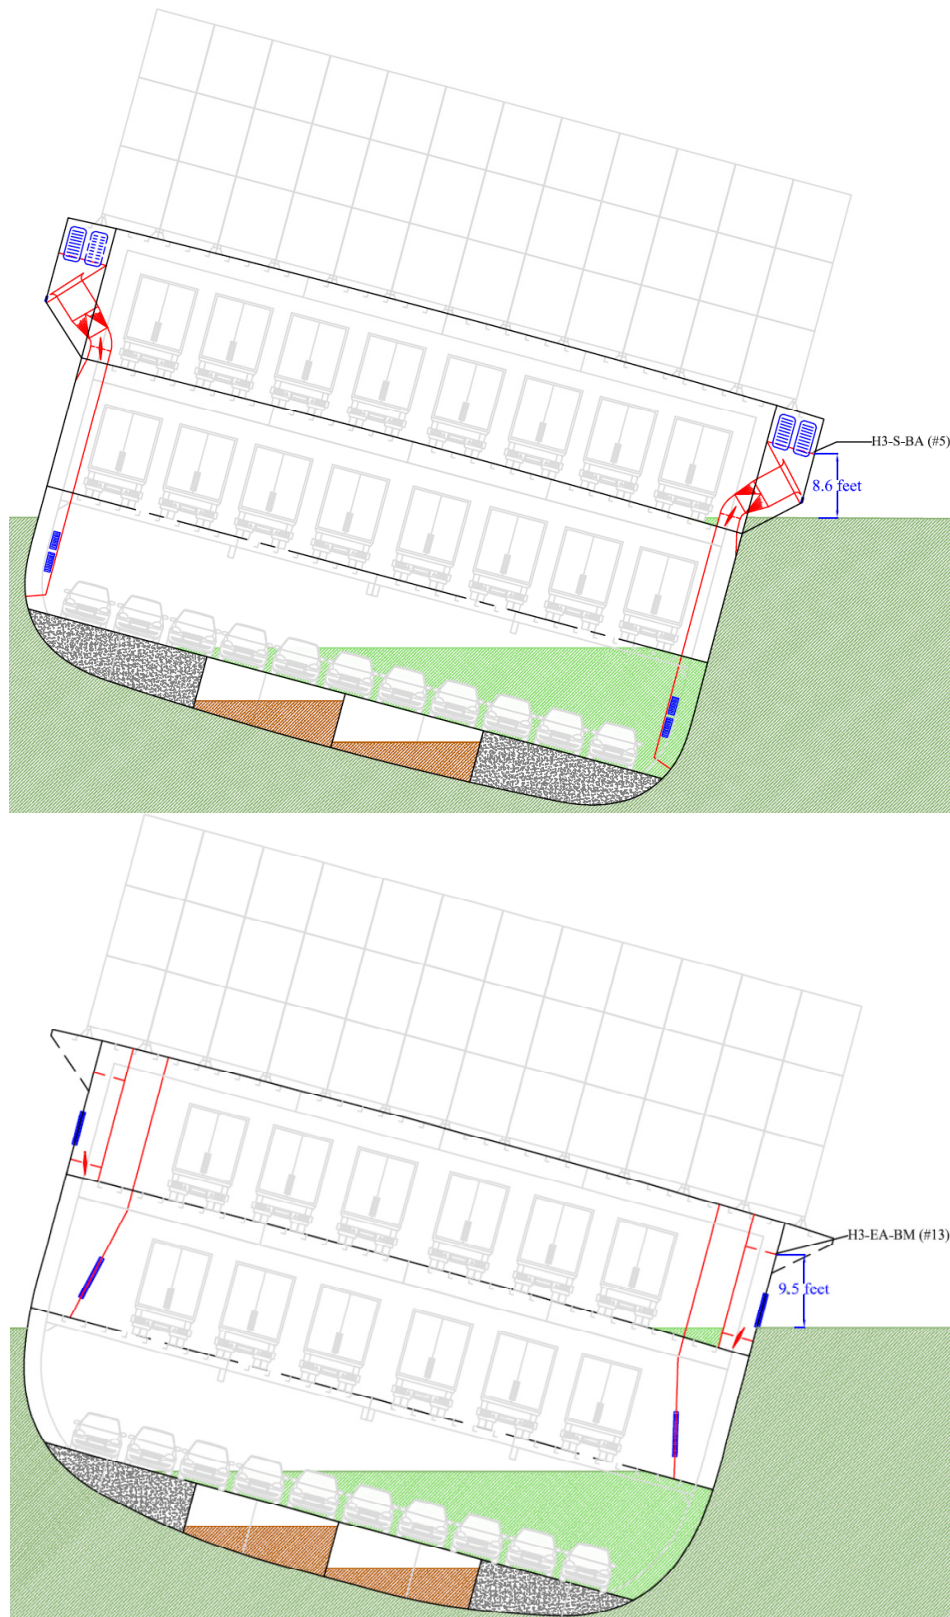
interaction of the free surface with the overhead of the compartment or tank. This is important for the lower cargo holds because the 3rd deck, while essentially non-watertight (see Figure 6-9 and Figure 6-15 below), contains relatively small deck plate openings which would limit the rate of flow of water through the deck as the vessel rolls in the seaway. From a pure hydrostatics perspective the deck is considered non-watertight and the internal floodwater level would eventually equalize and rise above the deck for a given angle of heel, but due to the dynamic nature of the ship's roll motion, water would experience a partial dynamic "pocketing" effect, and therefore free surface effect would be significantly reduced in the lower cargo holds. This is illustrated in Figure 6-18 below.

Figure 6-18: Scaled drawing of sections at frame 143 (Hold 3 ventilation supply trunk) and frame 159 (Hold 3 aft ventilation exhaust trunk), with flooding of Hold 3 to 20% with permeability 0.7 and heel angle of 15 degrees shown for example.

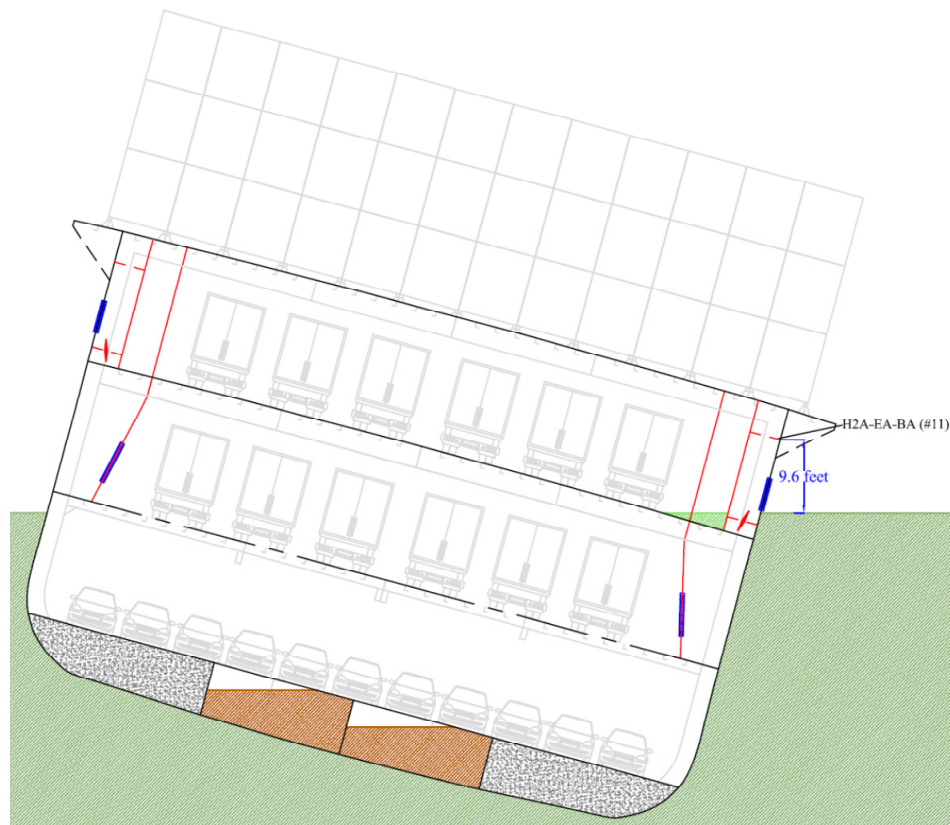
As discussed previously, it is not clear from the VDR audio transcript when and where progressive flooding was occurring prior to the eventual capsizing of the vessel at approximately 0739 on October 1st [64 (pp. 507-508)]. However, as Hold 3 continued to flood, eventually the ventilation openings for Hold 2A would have been brought to intermittent submergence as their freeboards were reduced due to the flooding of Hold 3, in combination with the wind heel, waves and roll motion. This is illustrated in Figure 6-19, which shows a scaled drawing of the section at frame 134/22, the location of the aft ventilation exhaust trunk for Hold 2A. For a wind heel angle of 15 degrees, the waterline is shown incorporating the effect of flooding of Hold 3 to 20%. It should be noted that it is likely that Hold 2A (and perhaps also Hold 2) may have been taking on some water, at least intermittently, as the vessel rolled about a wind heel angle of 15 degrees and while Hold 3 was flooding.

Figure 6-19: Scaled drawing of section at frame 134/22 (Hold 2A aft ventilation exhaust trunk) with still waterline resulting from flooding of Hold 3 to 20% with permeability 0.7 and heel angle of 15 degrees shown for example.

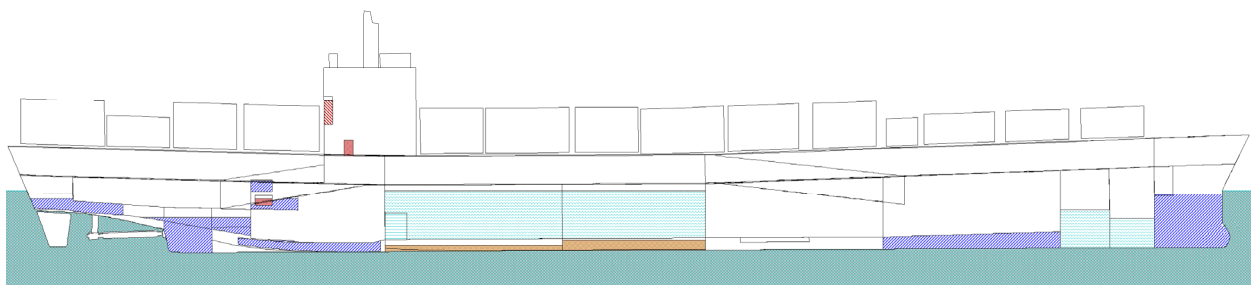
To demonstrate the hydrostatic effects of flooding Hold 2A after the flooding of Hold 3, flooding of Hold 2A is calculated in 10% increments for an average permeability value of 0.8. Figure 6-20 shows a centerline inboard profile graphic from the GHS software with Holds 3 and 2A flooded and equalized. Table 6-4 provides calculated values of displacement, floodwater weight, GM, drafts and trim, for each of the 10% flooding increments. Figure 6-21 shows righting arm curves for each of the 10% flooding increments.

Figure 6-20: Centerline inboard profile from the GHS software showing the condition with Holds 3 and 2A flooded to equalization. Permeability is 0.8.

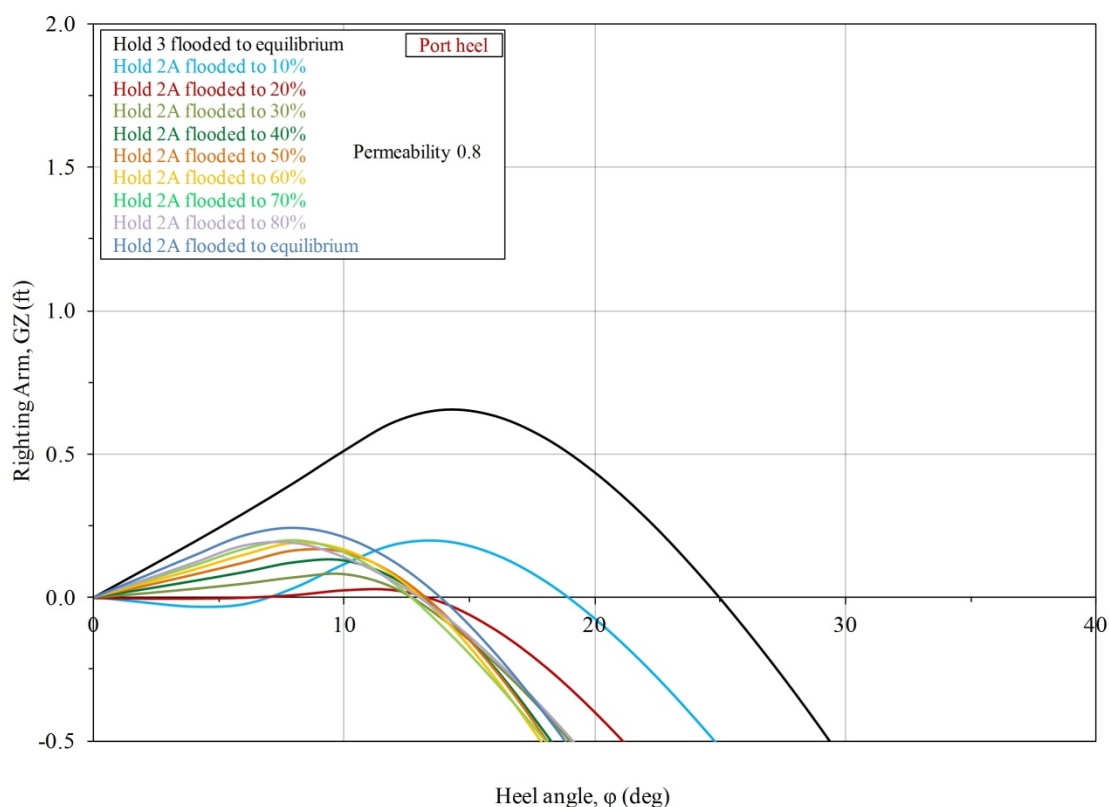
As was the case with flooding of Hold 3 by itself, there is a significant reduction in GM and righting arms at lower levels of flooding (most notably 10% and 20%) due to the initial free surface effect. In fact, for the 10% level, GM and the initial righting arms are actually negative (see Figure 6-21), indicating a condition referred to as “lolling.” In this lolling condition, even without the contribution of wind heel, the vessel would not be able to remain upright but would flop to either side to a “lolling angle” (approximately 7 degrees as shown in Figure 6-21 for the 10% level). With wind heel this type of condition may only be noticeable as an apparent increase in the wind heel angle. However, as was the case for flooding of Hold 3 by itself, in reality due to the existence of the tightly packed automobiles in the lower holds, the effective permeability value would be closer to 0.6-0.7 and would only increase to an average value of 0.8 as the floodwater levels increased toward the overhead of the lower hold, so this lolling effect would also be reduced.

Comparison of Figure 6-17 and Figure 6-21 indicates a significant reduction in righting arms with flooding of Hold 3 and additional flooding of Hold 2A. While theoretically there could be sufficient residual righting energy (area under the righting arm curve) to survive flooding of these 2 compartments in calm water, with almost any significant wind heel and additional wave effects including dynamic rolling, the vessel would likely have capsized. To confirm this limitation, MSC ran a number of additional analyses with different combinations of compartment flooding. It is evident that any additional free surface effect due to the flooding of a third cargo hold would be sufficient to capsize the vessel, even in calm water.

Figure 6-21: Righting arm curves for progressive flooding of Hold 2A in 10% increments with Hold 3 flooded to equilibrium. Permeability is 0.8. Port heel is shown.

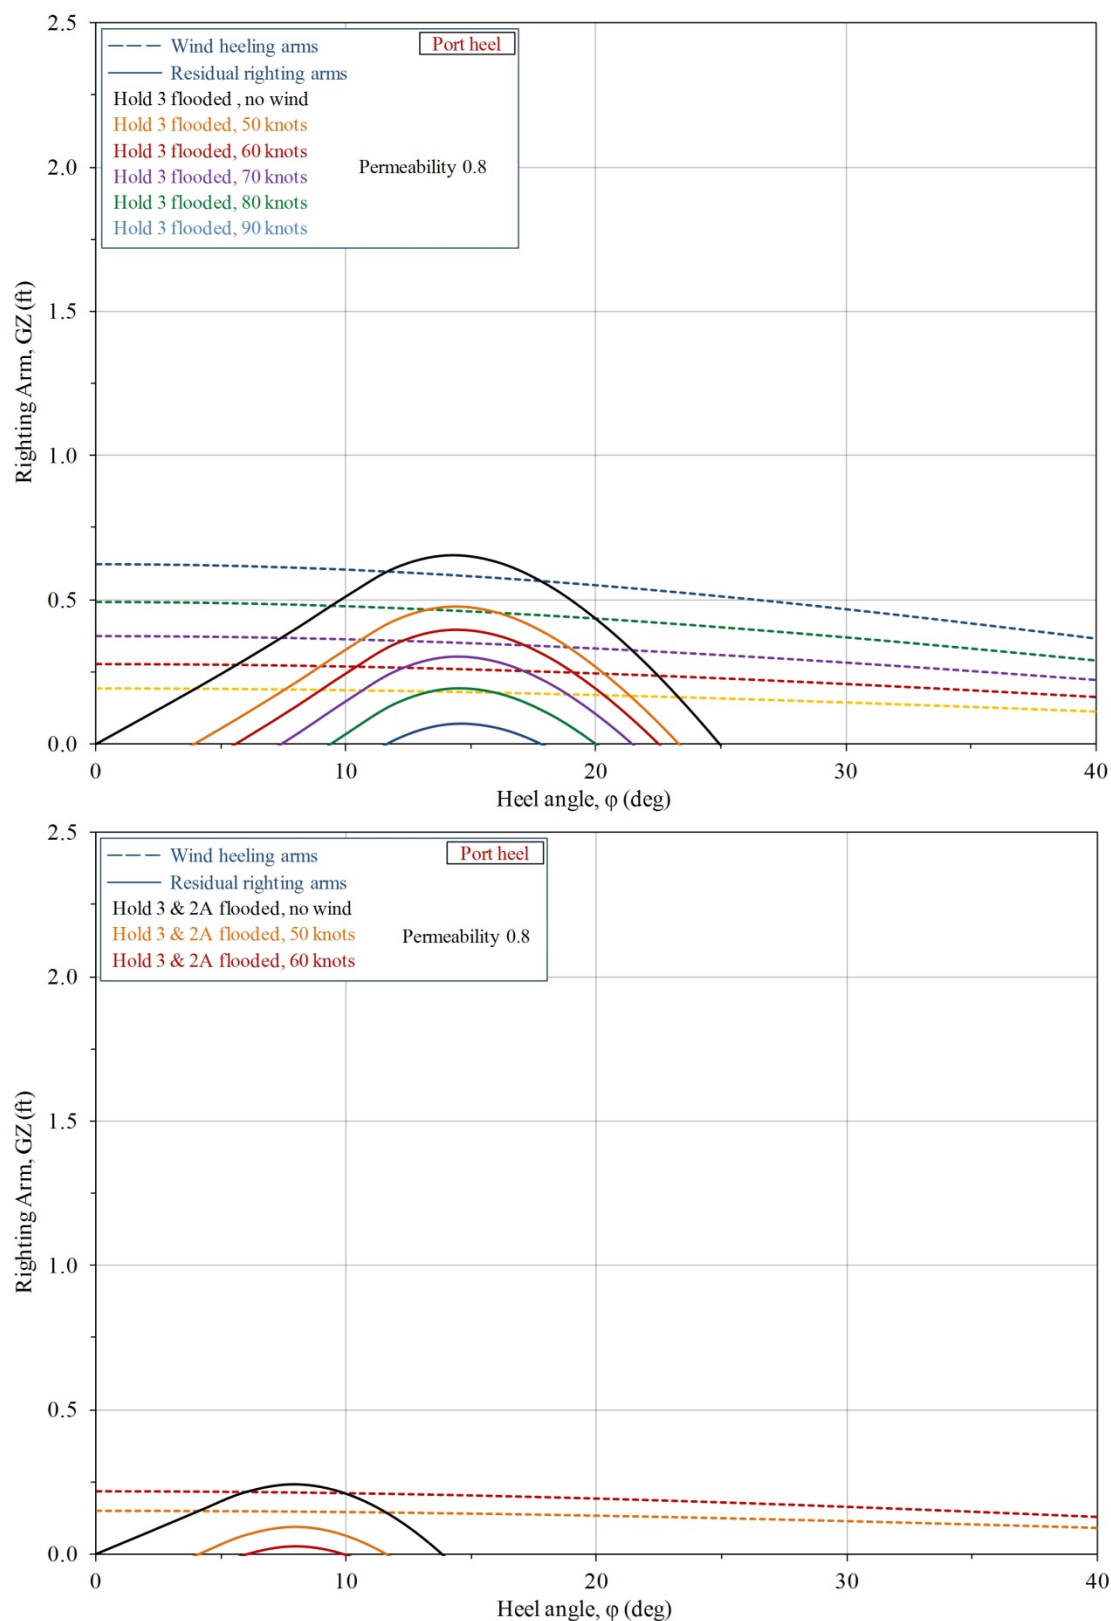
As illustrated in Figure 6-17 and Figure 6-21, flooding of Hold 3 and progressive flooding of Hold 2A would have left the ship with limited righting energy (area under the righting arm curve). The general effects of wind heel on the righting arm curve, including the calculation of residual righting arms and residual righting energy were discussed in Section 6.3. The combination of flooding and wind heel would have left the ship with little or no residual righting energy. Figure 6-22 shows the effects of wind heel on the righting arms with complete flooding of Hold 3 (top) and with complete flooding of Hold 3 and Hold 2A (bottom), both with average permeability of 0.8. Note that intermediate levels of flooding in either case would have reduced righting arms as shown in Figure 6-17 and Figure 6-21. One of the important conclusions that can be drawn from Figure 6-22 is that it is unlikely that the ship could survive uncontrolled flooding into even a single cargo hold with winds in excess of 70 or 80 knots, and it is unlikely that it could survive flooding of more than one cargo hold except in benign conditions with little wind and waves.

As discussed previously, for initial flooding of the lower cargo hold of Hold 3, the effective permeability factor would be closer to 0.7 up to the 20-30% flooding level. Combining these levels of flooding with permeability factor of 0.7 and wind heel in the range 70-90 knots, it can be demonstrated that a wind heel with initial flooding of Hold 3 could lead to a combined wind heel angle of approximately 15 degrees. This is illustrated in Figure 6-23, which shows wind heeling arms for 70, 80 and 90 knot winds and calculated residual righting arms, for flooding levels 10%, 20% and 30% in Hold 3, with permeability 0.7. It is clear that achieving a 15 degree heel angle as stated in the VDR transcript is possible with combined wind heel and initial flooding of Hold 3. Figure 6-24 shows the same calculation information, but shows righting arms with and without 80 knot wind for Hold 3 flooding levels 10%, 20% and 30%. It is important to recognize from these plots that the residual righting energy (area under the righting arm curves) is reduced significantly even for lower levels of flooding up to 30% when considered in combination with 80 knot beam wind. Thus, it is apparent that the vessel would have been in a vulnerable state and susceptible to capsizing even with flooding only of Hold 3, when considering the combined effects of partial flooding, wind heel and roll motion.

Figure 6-22: Wind heeling arms (dashed curves) and residual righting arms (solid curves) with Hold 3 flooded to equilibrium (top) and Hold 3 and Hold 2A flooded to equilibrium (bottom). Permeability is 0.8.

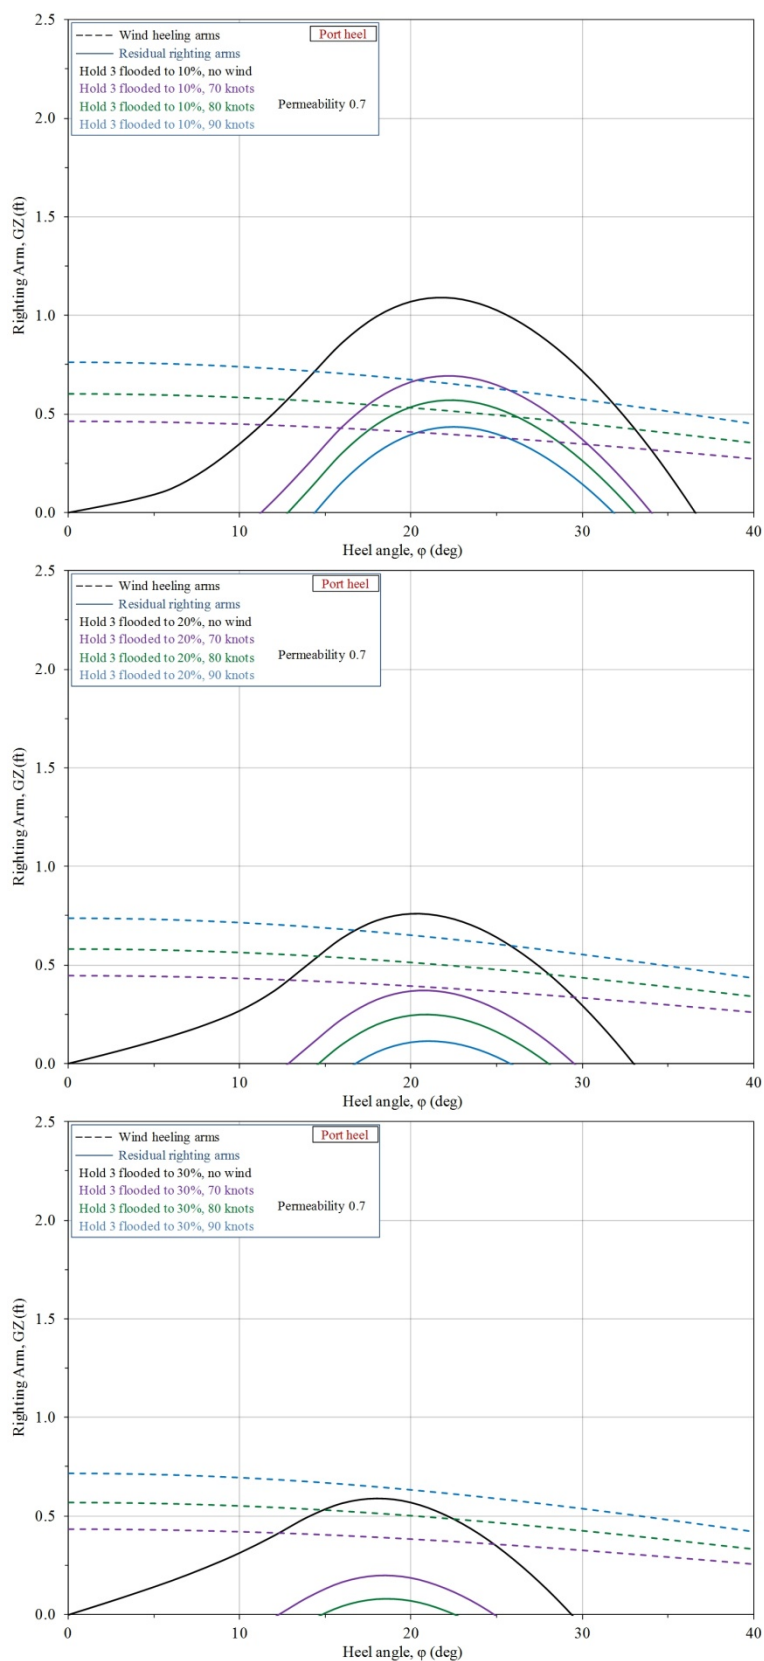
Figure 6-23: Beam wind heeling arms (dashed curves) and residual righting arms (solid curves) with Hold 3 flooded to 10% (top), 20% (middle) and 30% (bottom). Permeability is 0.7.

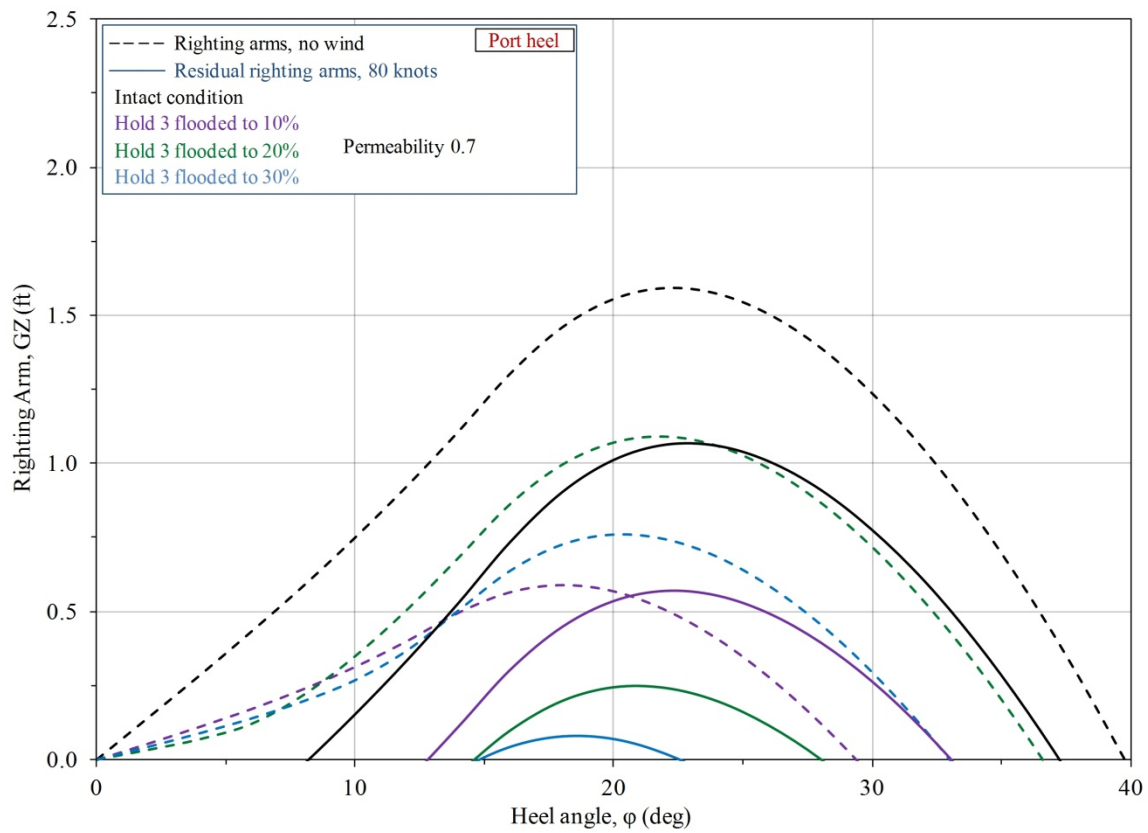
Figure 6-24: Righting arms (dashed curves) and residual righting arms (solid curves) for 80 knot beam winds with Hold 3 flooded to 10%, 20%, and 30%. Permeability is 0.7.

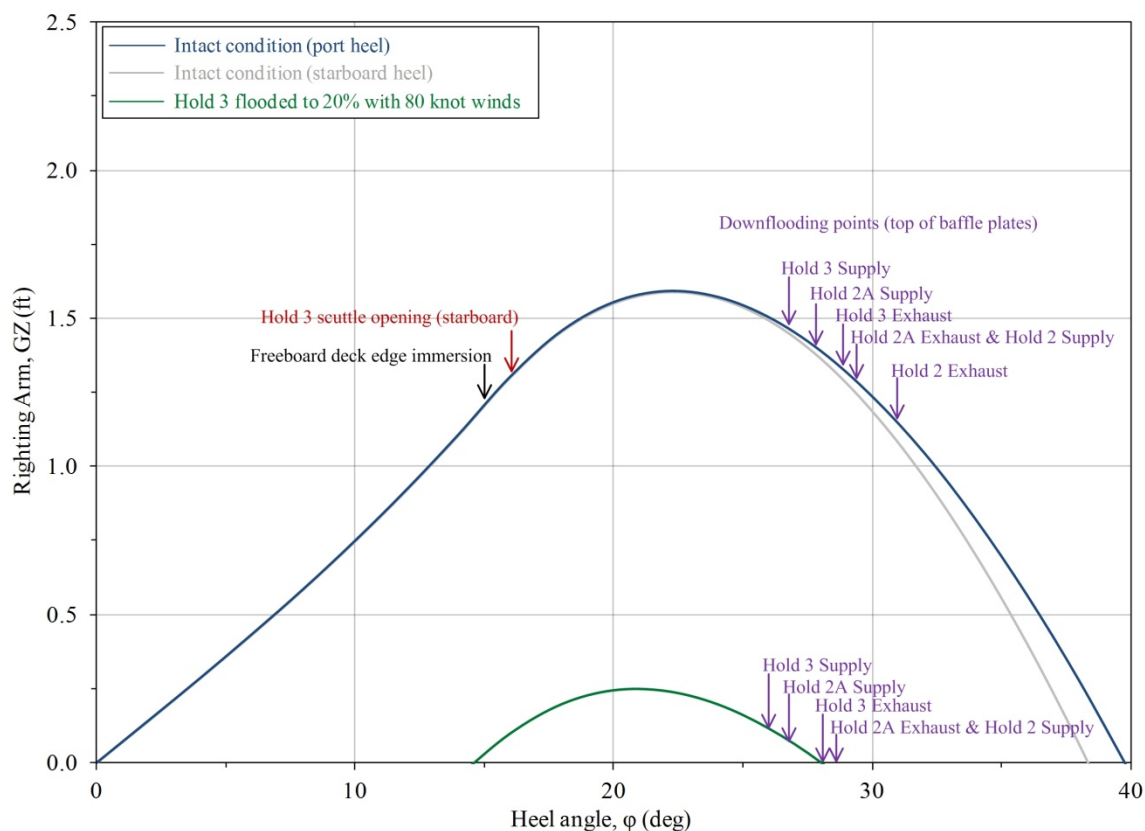
The flooding vulnerability presented by the cargo hold ventilation system was discussed in Section 6.4 and downflooding points were listed in Table 6-2. Downflooding angles for these points are tabulated and plotted on the righting arm curves for the intact condition at loss of propulsion (without flooding) and for the condition with Hold 3 flooded to 20%. Table 6-5 provides the downflooding angles for the listed points and Figure 6-25 plots downflooding points for each hold on the righting arm curves.

Figure 6-25: Righting arm curves with annotated downflooding angles from Table 6-5: intact condition (at loss of propulsion, without flooding) and Hold 3 flooded to 20% with 0.7 permeability and 80 knot winds.

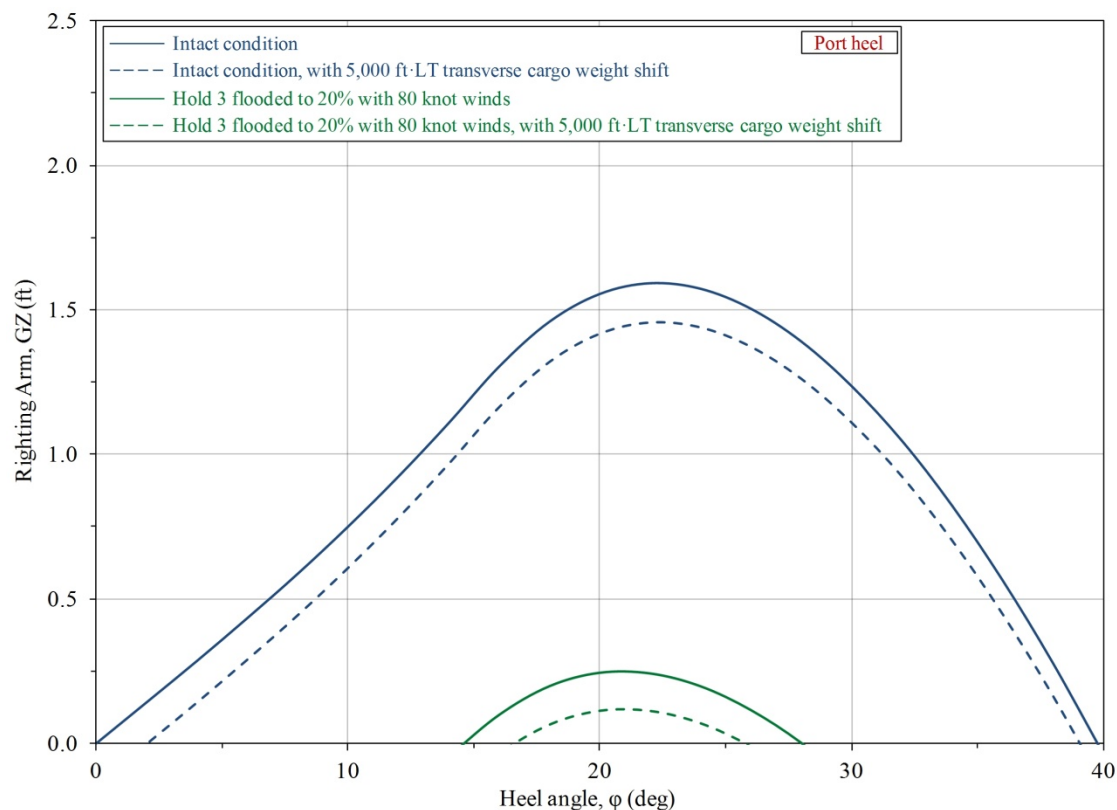
In the foregoing analyses, no consideration was given to the impact of cargo shifting, or cargo loss. Although there was no mention specifically of large-scale cargo shift or loss until the very end of the VDR audio as the vessel slowly capsized, there was one mention of a single trailer cargo shift which was witnessed by the Chief Mate at 0436 [64 (pg. 380)] and there was some discussion of automobiles breaking free and floating in Hold 3 [64 (pg. 486)]. Cargo shifting can best be considered in this analysis as a transverse weight shift; specifically a given transverse moment which might be calculated based on shifting of a given number of trailers or containers by a given transverse distance. This is illustrated in Figure 6-26 below, which shows the effects of a transverse moment applied to the intact condition (at the loss of propulsion, not including floodwater and beam wind) and the condition with Hold 3 flooded to 20% with 80 knot beam winds. The 5,000 ft·LT transverse moment (weight multiplied by distance shifted) is shown as an example and is based on a notional shift of 20 containers of weight 25 LT each, shifting an average 10 feet. The net effect of any transverse weight shift is equivalent to a transverse shift in the ship's center of gravity, which results in a reduction in the righting arms and a list as shown. Note that in this case, even a 5,000 ft·LT transverse weight shift produces small reductions in righting arms and small induced heel angles, when compared to large reductions in righting arms and induced heel angles due to floodwater and hurricane force beam winds as discussed

previously. However, it should be noted that even small transverse shifts in containers would exacerbate effects of floodwater and beam winds.

Figure 6-26: Comparison of righting arm curves with effects of transverse cargo weight shifts: intact condition (at loss of propulsion, without flooding) and Hold 3 flooded to 20% with 0.7 permeability and 80 knot winds.

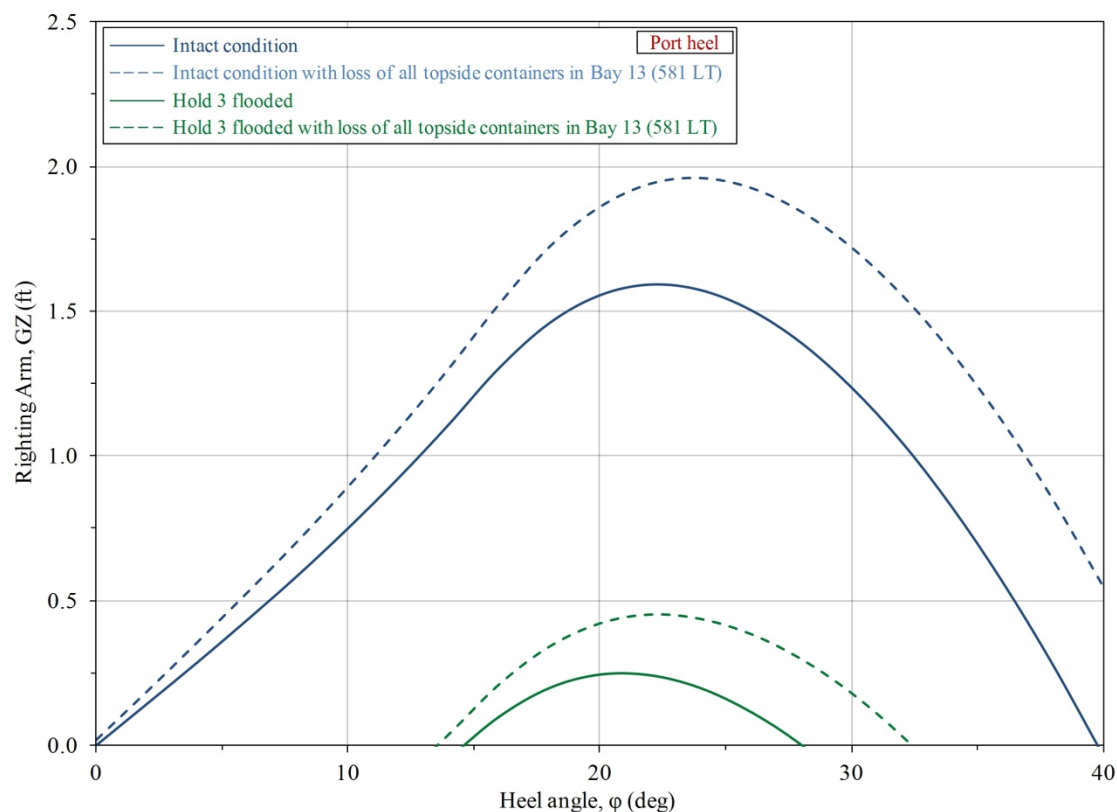
The complete loss of topside containers as the vessel took heavy rolls in the seaway or while capsizing would actually lead to a temporary improvement in the stability condition of the vessel. This is the case because complete loss of topside containers would necessarily lower the ship's center of gravity and increase righting arms, providing temporary additional righting energy and stability margin. This is illustrated in Figure 6-27, which shows for an example the potential effects of a complete loss of all containers in Bay 13 (581 LT) applied to the intact condition (at the loss of propulsion, not including floodwater and beam wind) and the condition with Hold 3 flooded to 20% with 80 knot beam winds. However, it is also feasible that entire bays of containers or sections of bays could lose structural integrity and experience partial failure or deformation and lean to one side without actually washing overboard. This has occurred on container vessels in heavy seas in recent years, including as a consequence of so-called “parametric” roll motions. In this case, the results would be similar to those of container shifting shown in Figure 6-26 for example. There was, however, no statement made by the EL FARO crew on the VDR audio transcript regarding the loss or shifting of topside containers, until just prior to vessel capsizing at 0729 when it was noted that containers were in the water [64 (pg. 498)].

Figure 6-27: Comparison of righting arm curves with complete loss of all containers in Bay 13 for example: intact condition (at loss of propulsion, without flooding) and Hold 3 flooded to 20% with 0.7 permeability and 80 knot winds.

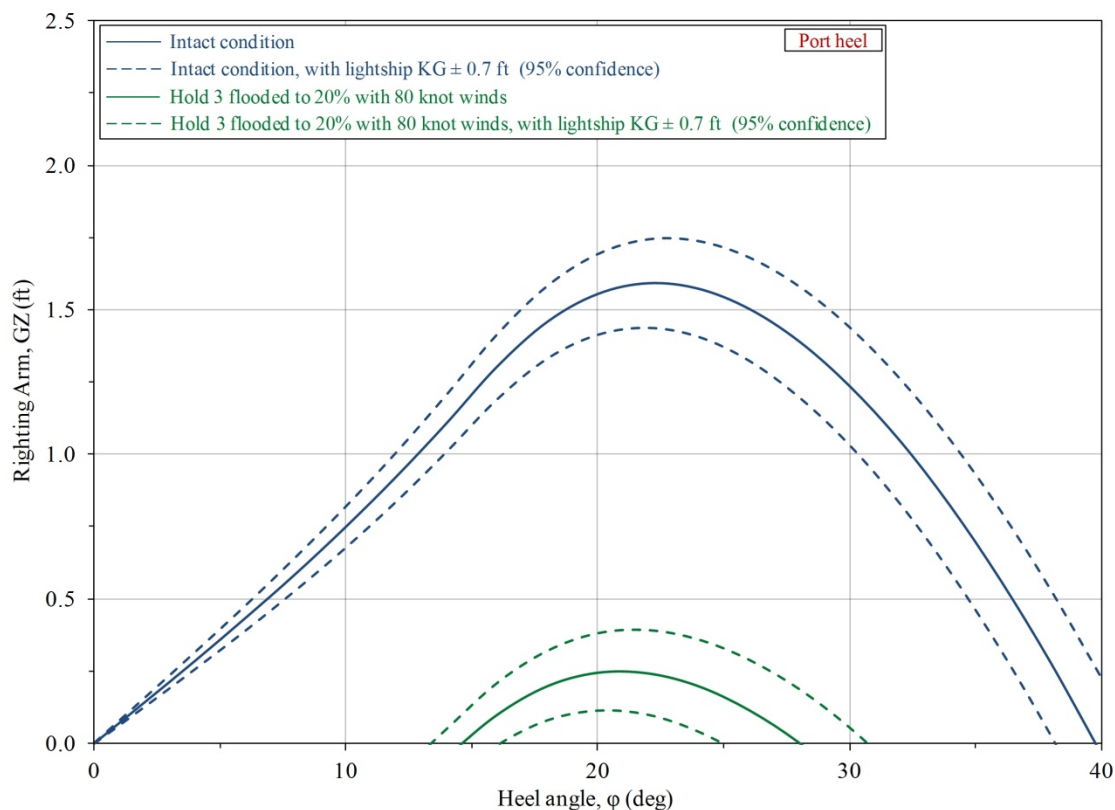
report), there exists a 95% confidence that uncertainty in the height of the center of gravity (KG) is on the order of 0.7 ft for the departure condition and for the lightship condition (see Table 3-2). These uncertainties could be considered in assessing the previous analyses, or should at least be used as a reminder of the uncertainty in any calculated results. To illustrate, Figure 6-28 provides a comparison of the righting arms for the accident voyage loading condition prior to the loss of propulsion (intact condition) and with Hold 3 flooded to 20% with 80 knot beam winds, with uncertainty in calculated lightship KG included. It should be noted that these righting arm curves include the uncertainty in the lightship KG, but do not include the additional uncertainty in the cargo and tank loading and weight and free surface associated with the floodwater. The primary point in illustrating this is to highlight the significant impact that uncertainty in the assumed lightship KG has on the righting arms. Note that for all of the previous righting arm plots, significant differences would exist in the calculated angle of wind heel and residual righting energy, depending on the desired level of confidence in the results.

Figure 6-28: Comparison of righting arm curves with effects of uncertainty in lightship KG considered: intact condition (at loss of propulsion, without flooding) and Hold 3 flooded to 20% with 0.7 permeability and 80 knot winds.

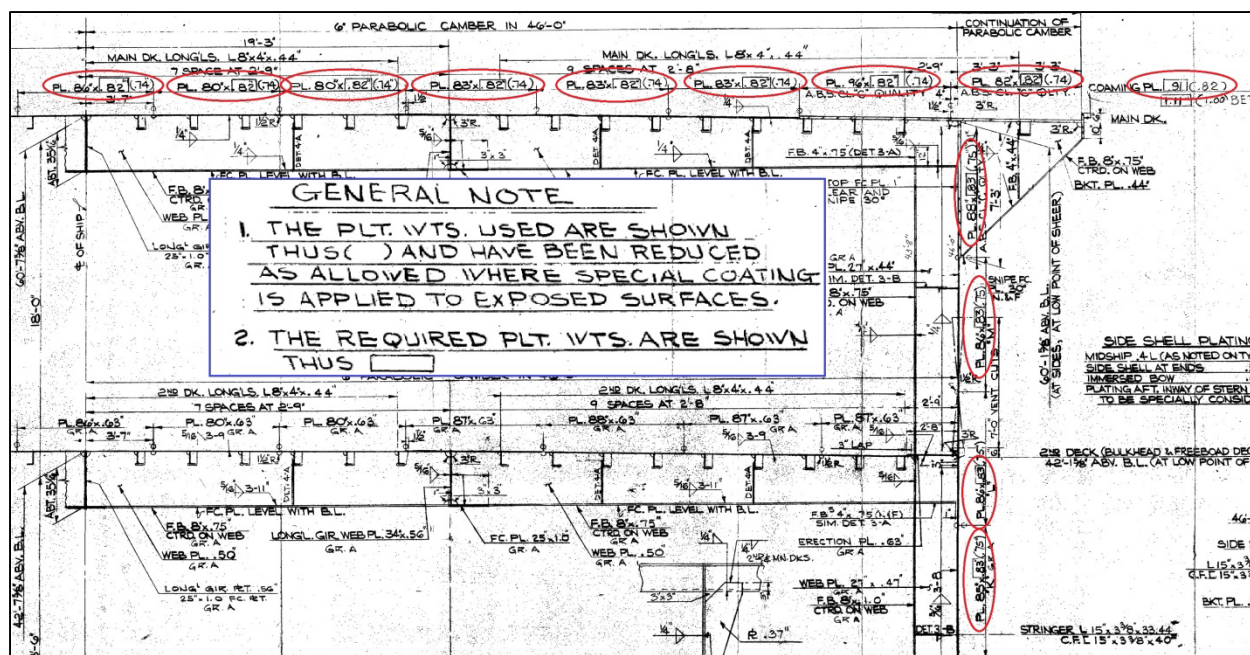
It should be noted that this class of vessels was originally designed to a maximum still water bending moment (SWBM) of 415,000 ft·LT and was constructed in accordance with the reduced plate scantling provisions of SVR 1974/15.7 and 174/16.5.10. These provisions permitted the shell plating above the deepest service draft, and exposed deck plating, to be reduced up to 10% from minimum required thickness, if they were provided with special protective coatings for corrosion control. In accordance with this allowance, and as indicated in Figure 7-2, side shell plating strakes K, L, M and N (extending from roughly 31.3 ft-BL (above baseline) up to the Main Deck), the coaming plate, and all of the vessel's Main Deck plating strakes, were all specified at 90% of the calculated scantling requirements of ABS SVR 1974/15.3 and 16.5.

Figure 7-2: Reduced scantlings as permitted for strake plating with corrosion control coating (highlighted Midship Section Drawing [5]).

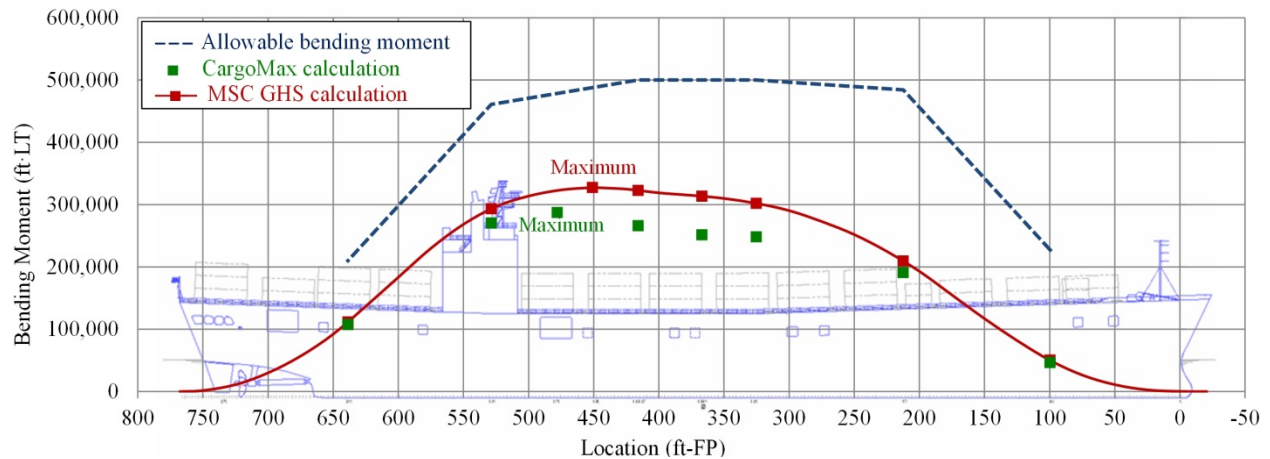
As discussed in Section 2 of this report, a lightship weight distribution was created for the MSC GHS computer model, and bending moment calculations were included in assessment of the accident voyage 185S departure condition. Figure 7-3 provides a plot of the calculated still water bending moments. For comparison, bending moments calculated by CargoMax are included, along with the allowable still water bending moment.

The bending moments calculated using the MSC GHS computer model are approximately 13% higher amidships compared to the CargoMax values, but are still within the ABS allowable bending moment limits. The differences in calculated bending moments can be attributed to differences in the estimated lightship weight distribution.

Figure 7-3: Calculated and allowable still water bending moments for the accident voyage 185S departure condition.

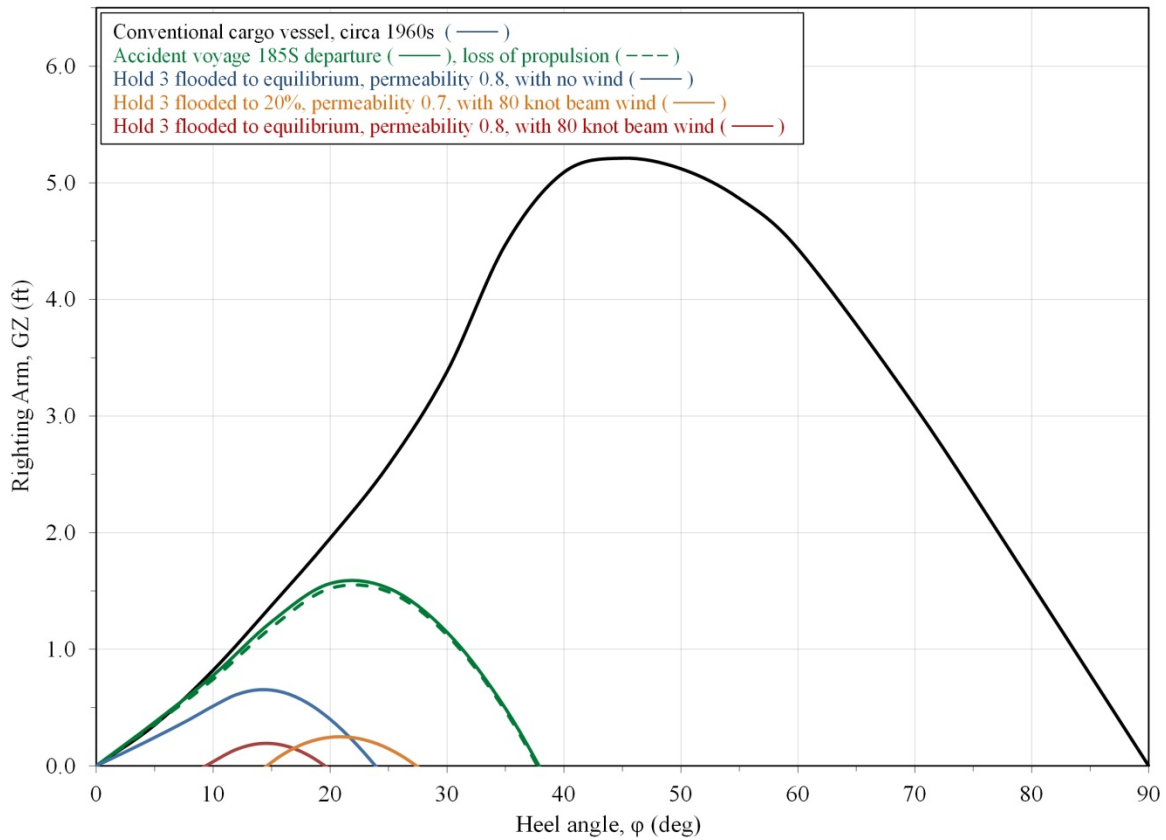
Figure 8-1: Righting arm curves for the accident voyage, with comparison to a conventional cargo vessel (conventional vessel curve reproduced from [51] with permission).

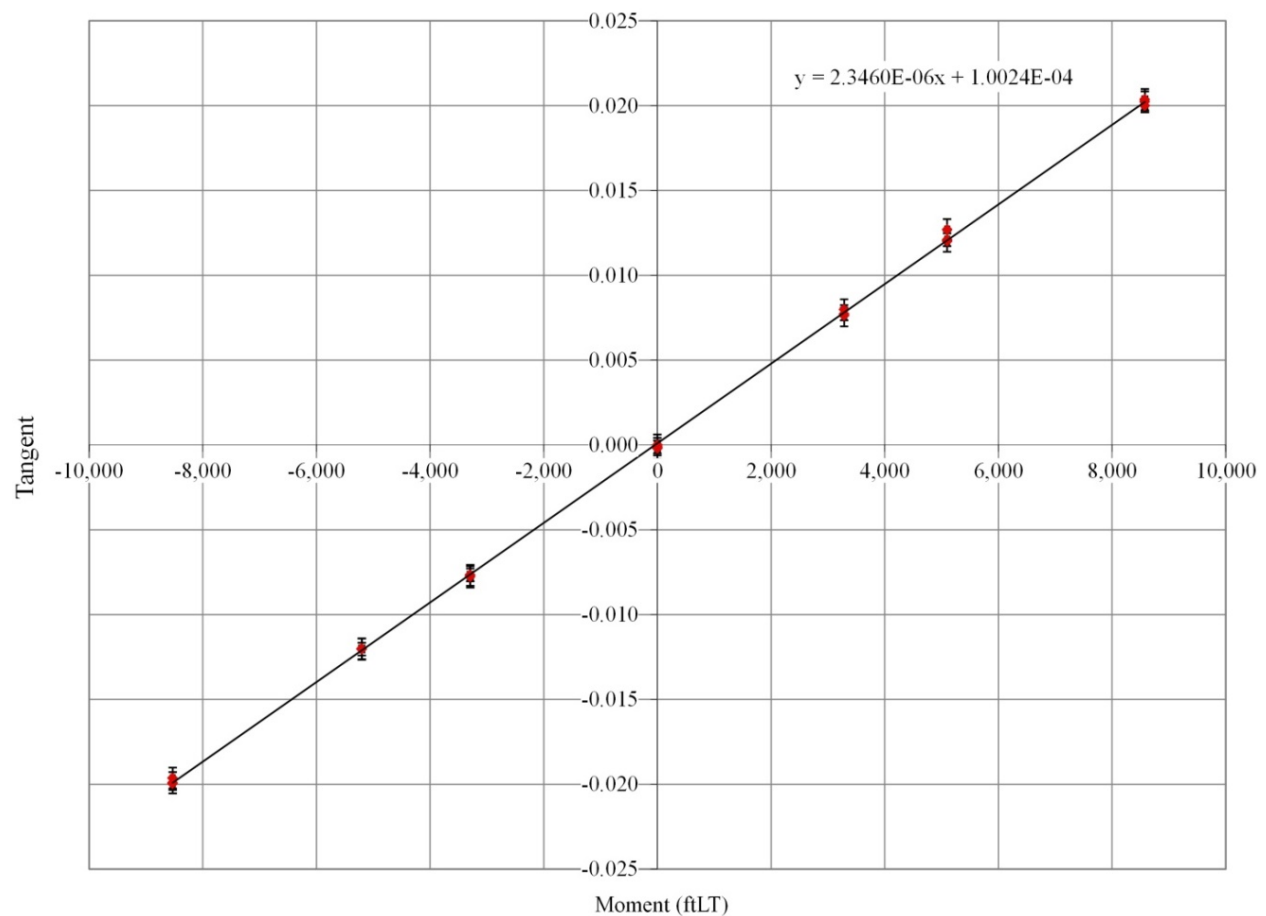
The uncertainties in moment and tangent for each of the 21 measurements are plotted as error bars in Figure A-1. Note that the relative uncertainties of the moment values at only 1.5% are much smaller compared to the relative uncertainties of the tangent values, so the error bars for the moment values are difficult to see in the figure.

Figure A-1: Plot of moment vs. tangent data from the inclining with standard least-squares linear fit. Error bars show estimated 95% confidence level uncertainties for each data point based on separate error assessment.

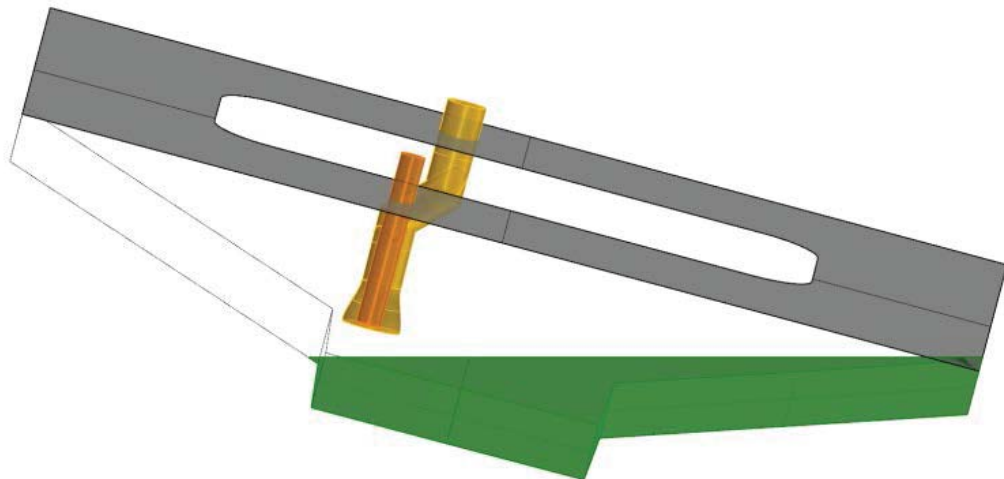
**Figure 8. End View of Sump for the Design Low Level Capacity
15° Port List; 5° (64.2 ft) Trim by the Bow**

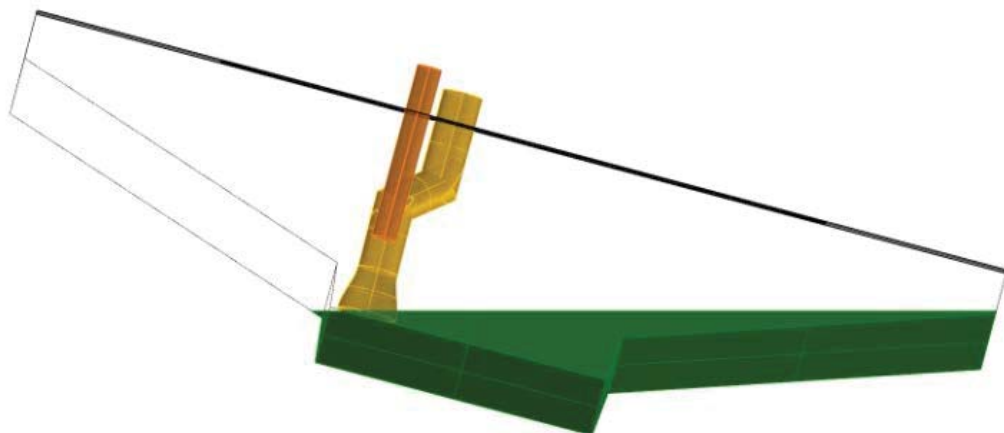
**Figure 9. End View of Sump for the Design Low Level Capacity
15° Port List; 5° (64.2 ft) Trim by the Stern**

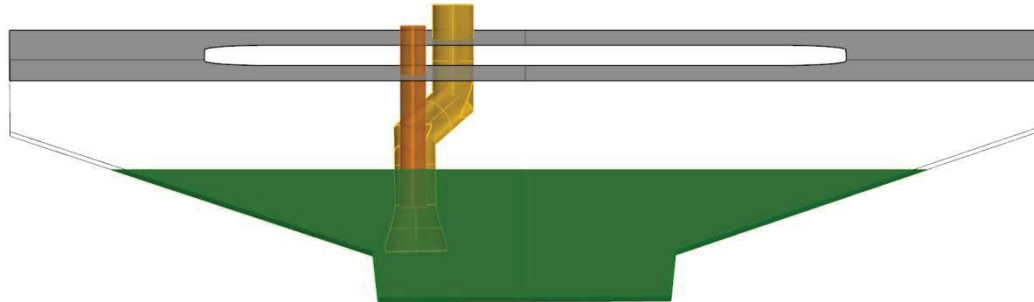
- (2) Accident Voyage Departure Loading The following two figures are for the sump at the accident voyage departure loading volume of 163.8 ft^3 , as taken from the EL FARO CargoMax printout for the accident voyage (MBI Exhibit 059). These visualizations have been corrected from those used in the animation presented at the MBI public hearing. Both depict a trim of 5 ft by the stern, which corresponds to an angle of 0.4° . Figure 11 shows the suction pipe opening breaking the lube oil surface, indicating a potential loss of suction at an 18° static list (as opposed to 19° shown in the animation). Per the CG-INV memorandum request, starboard list conditions were not examined for this trim.

**Figure 10. End View of Sump for the Accident Voyage Departure Loading
 0° List; 5 ft (0.4°) Trim by the Stern**

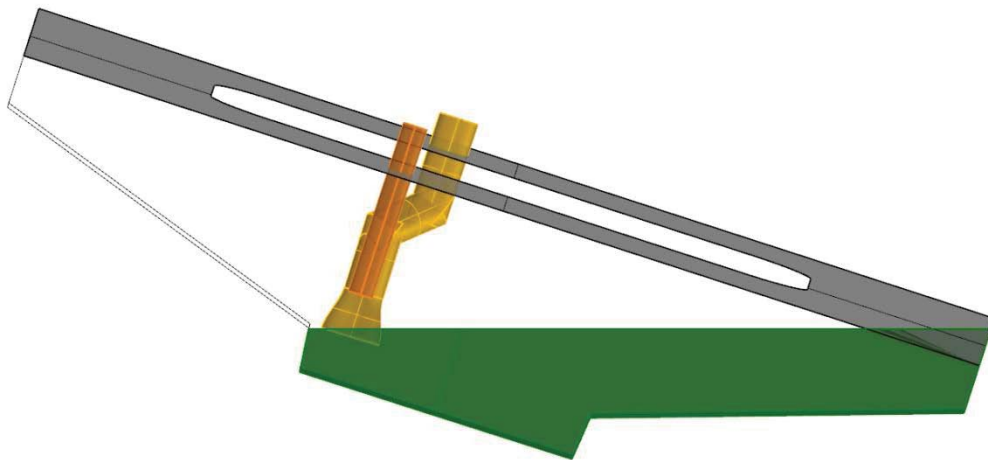
The Coast Guard MSC Lube Oil Modeling and Analyses of EL FARO¹⁴⁴ demonstrated that the lube oil system suction pipe bell mouth opening in the lube oil sump tank, using the 24.6” departure sounding obtained from the CargoMax entry, would have broken above the lube oil surface, resulting in a potential loss of suction at an 18° static list to port (see figures 9 and 10 below).

**Figure 11. End View of Sump for the Accident Voyage Departure Loading
 18° Port List; 5 ft (0.4°) Trim by the Stern**
