UNITED STATES COAST GUARD

**REPORT OF THE MARINE BOARD OF INVESTIGATION
INTO THE
STEAM SHIP EL FARO (O.N. 561732)
SINKING AND LOSS OF THE VESSEL
WITH 33 PERSONS MISSING AND PRESUMED DECEASED
NORTHEAST OF ACKLINS AND CROOKED ISLAND,
BAHAMAS
ON OCTOBER 1, 2015**

**STEAM SHIP EL FARO (O.N. 561732) SINKING AND LOSS OF THE VESSEL WITH
33 PERSONS MISSING AND PRESUMED DECEASED NORTHEAST OF ACKLINS
AND CROOKED ISLAND, BAHAMAS ON OCTOBER 1, 2015**

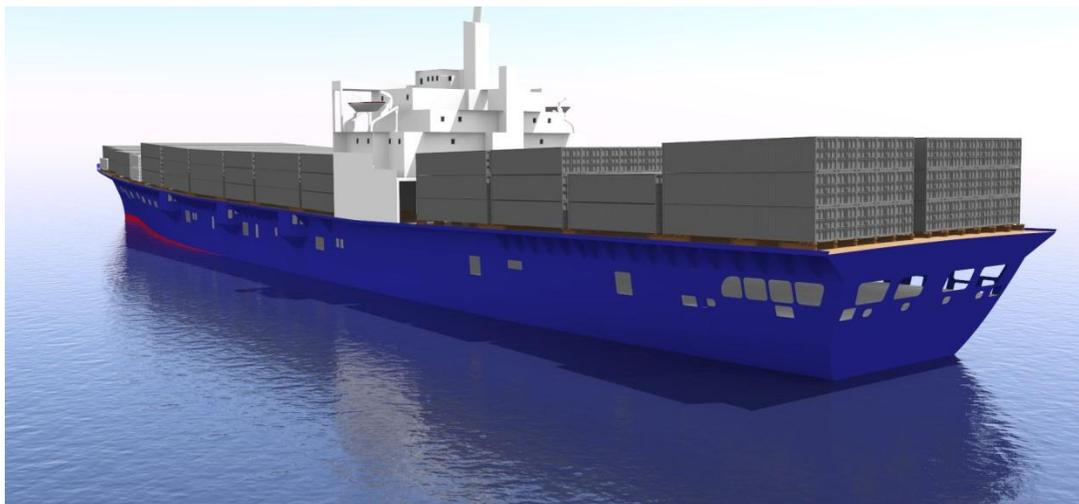
Figure 4. EL FARO computer rendering showing the vessel in the departure condition, with mean draft 30.1 feet, 0 degree list, and the stern trimmed down 5.0 feet. Illustration produced by the USCG Marine Safety Center.

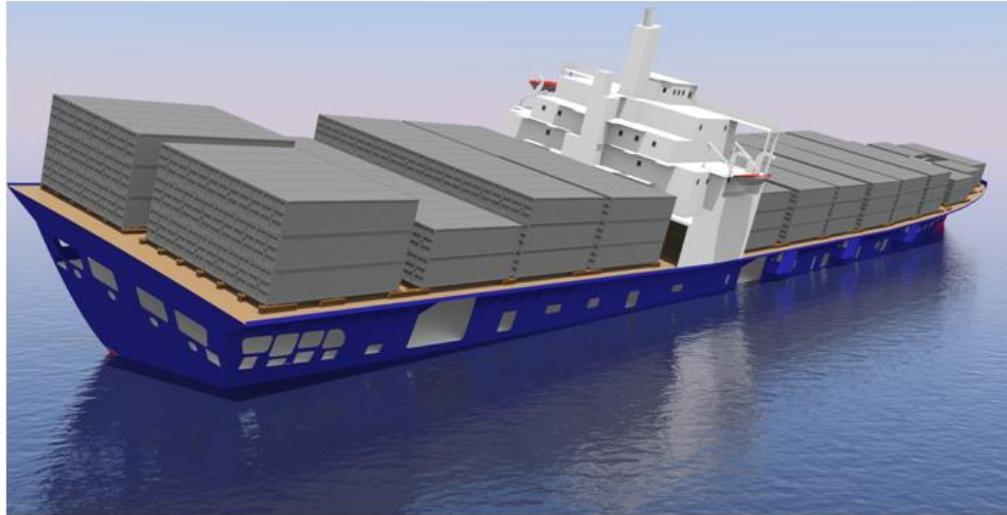
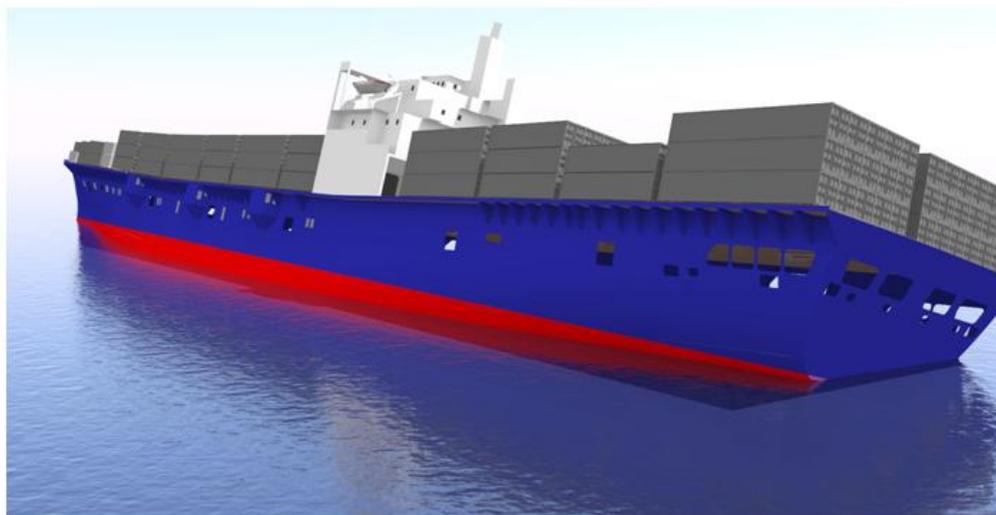
Figure 9. EL FARO computer rendering with 15 degree starboard list and trimmed down by the stern 5.8 feet, due to flooding of Hold 3 estimated at 20% and wind heel. Illustration produced by the USCG Marine Safety Center.

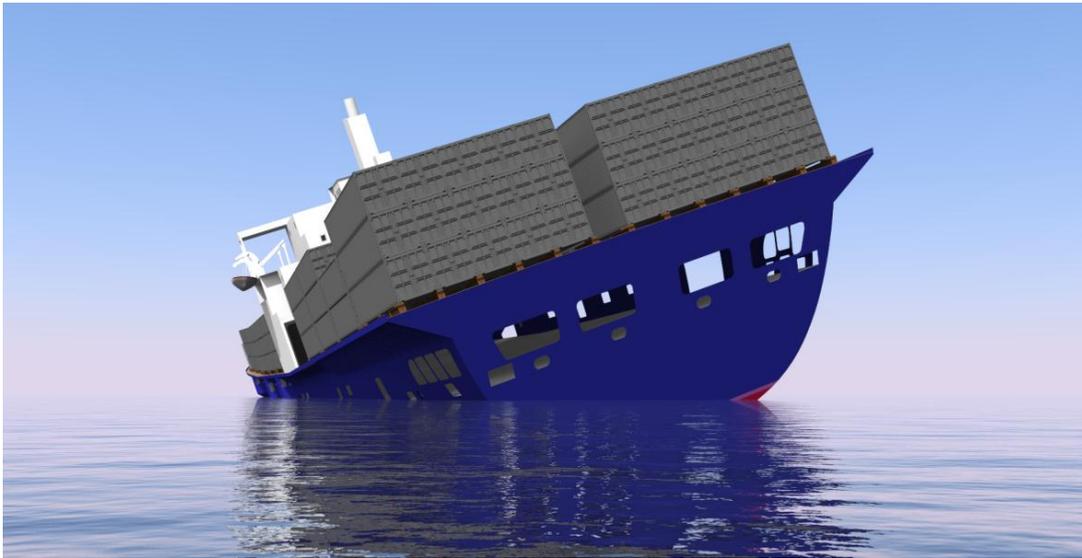
Figure 14. EL FARO modeling with 20 degree port list and departure trim down by the stern at 5.8 feet due to flooding of Hold 3 estimated at 20% and wind heel. Illustration produced by the USCG Marine Safety Center.

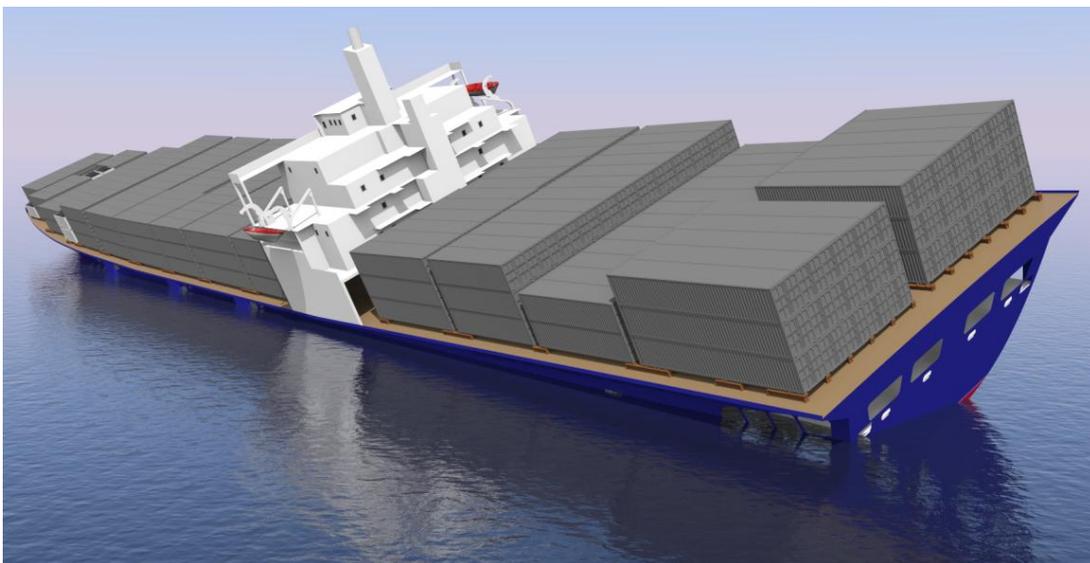
Figure 15. EL FARO computer rendering with 25 degrees port list and departure trim of down by the stern at 5.8 feet due to flooding of Hold 3 estimated at 20% and wind heel. Illustration produced by the USCG Marine Safety Center.

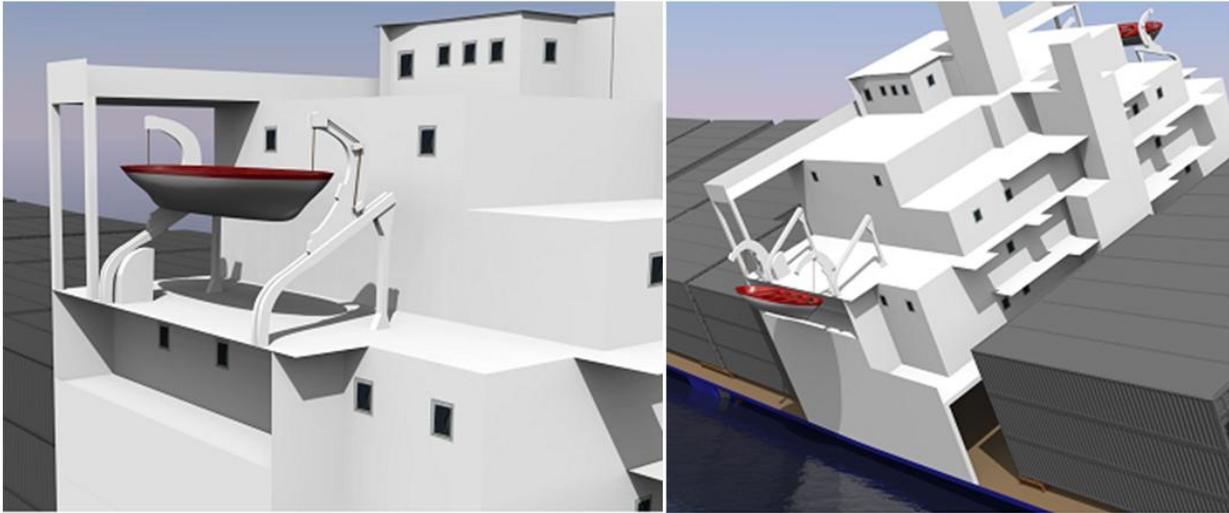
Figure 16. EL FARO computer rendering. On the left, the port lifeboat is shown in the davit in its normally stowed position with EL FARO on an even keel. On the right, the lifeboat is shown lowered to the embarkation deck with EL FARO listing 25 degrees to port. There is no evidence that the use of the lifeboats was discussed by the crew. Large life rafts were stored in close proximity to the lifeboats. Illustration produced by the USCG Marine Safety Center.

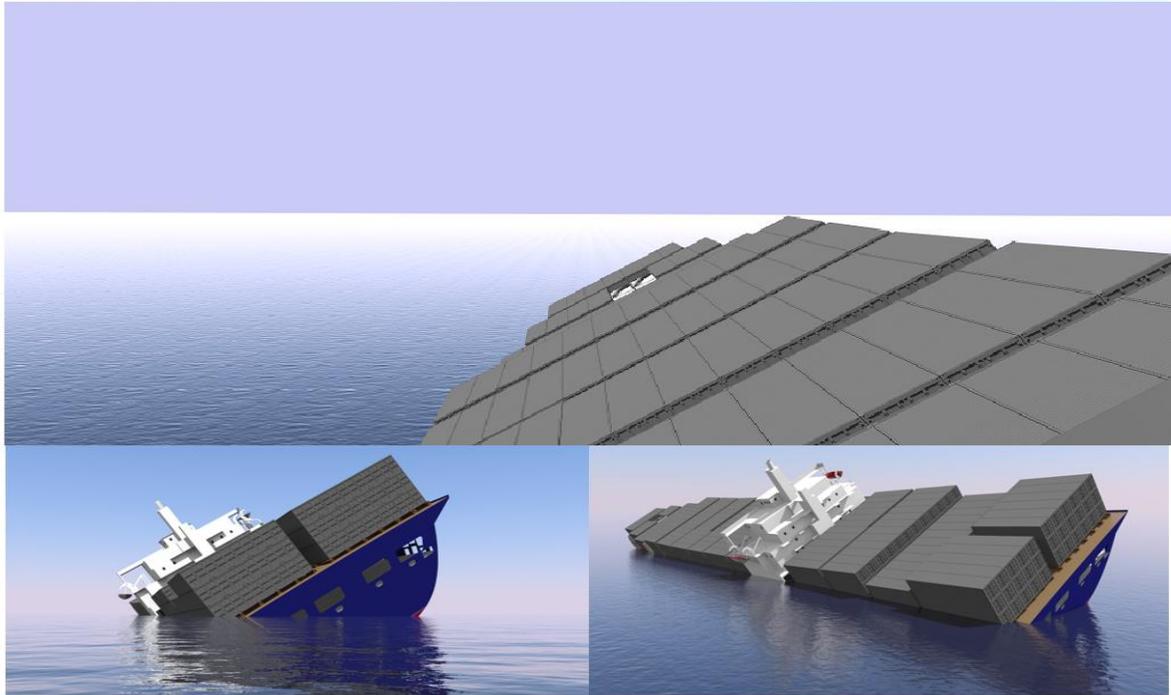
Figure 17. EL FARO computer renderings showing the vessel with progressive flooding and wind heel, listing to port at 35 degrees with 5.0 feet aft trim and 37.0 foot draft amidships. The upper illustration simulates a view forward from the starboard side of the navigation bridge which was the assumed location of the vessel Master when the Master makes the “bow is down” statement at 7:30 AM on the VDR audio transcript. Illustration produced by the USCG Marine Safety Center.

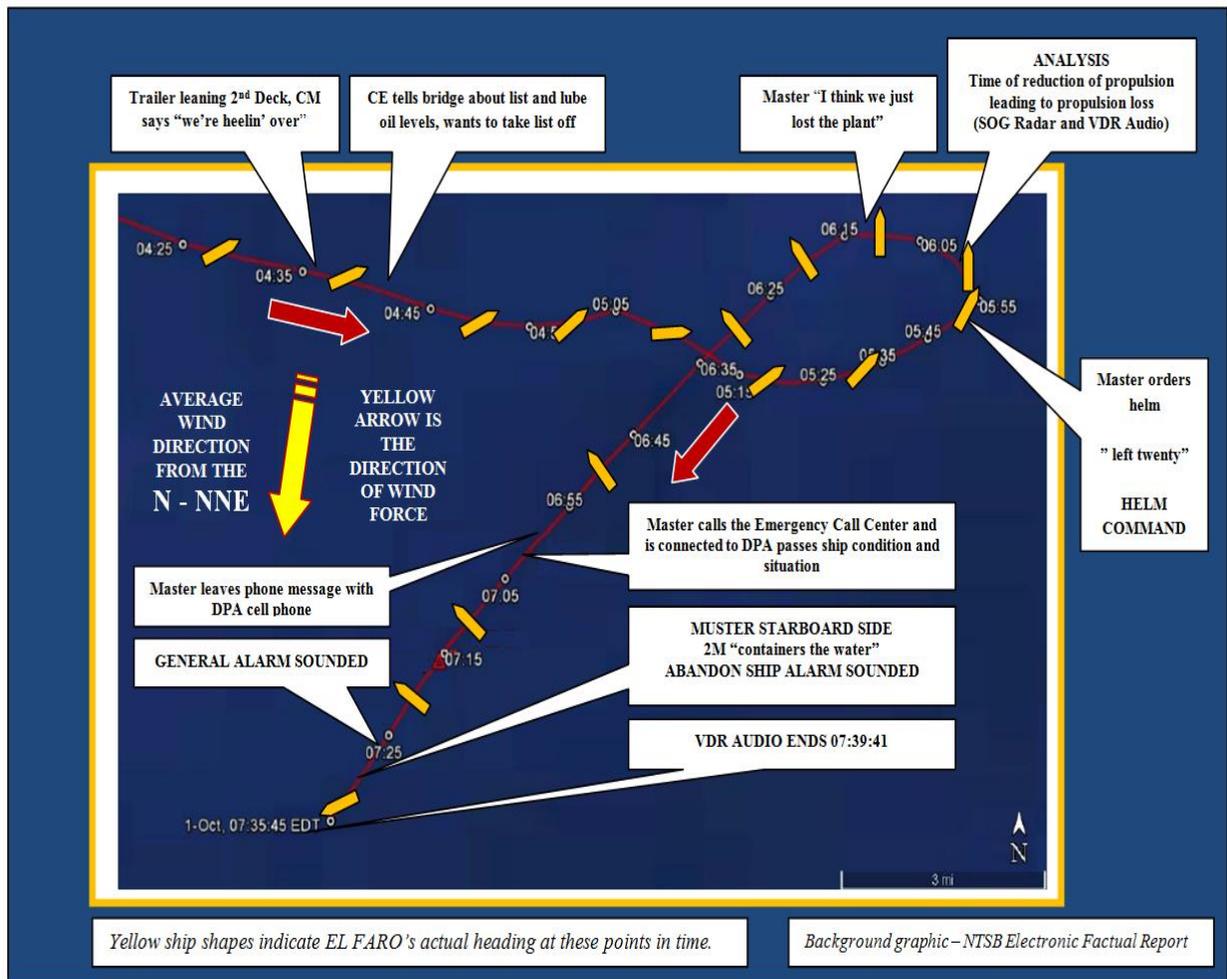
Figure 18. Illustration of significant events between 4:20 AM on October 1 and the sinking, showing ship heading and course over ground.

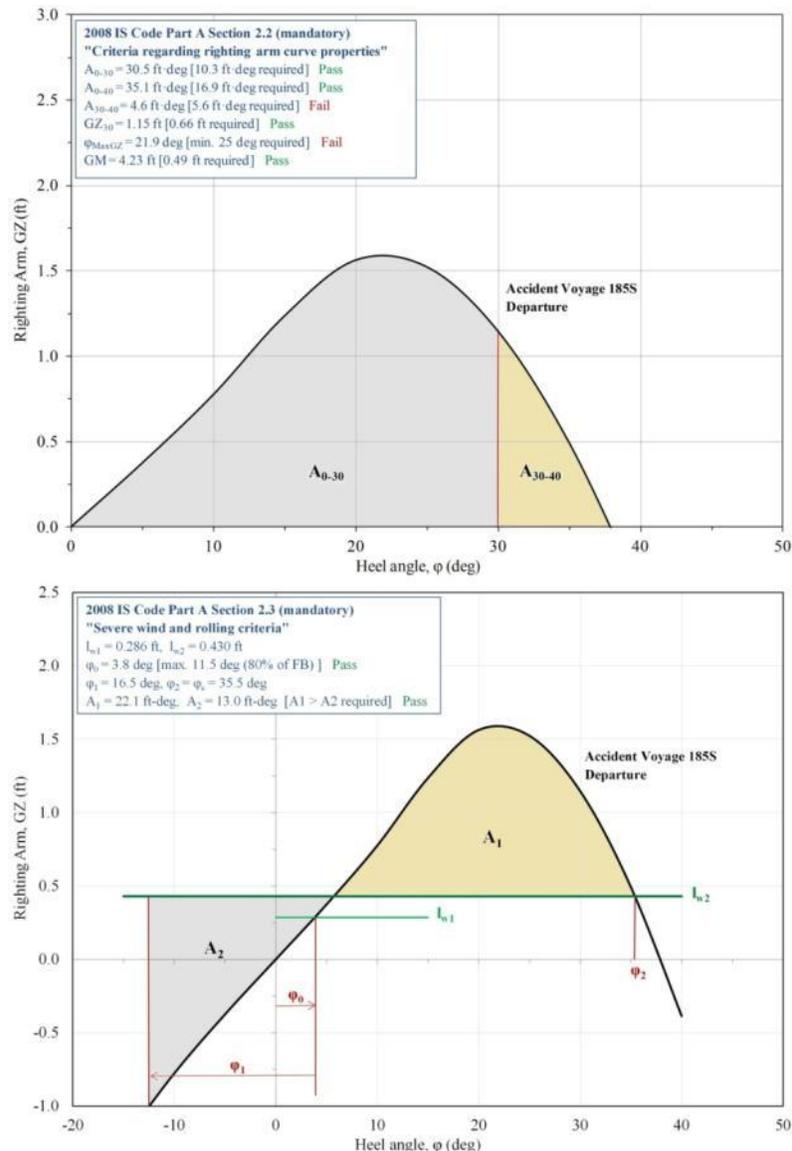
higher minimum GM value of 3.3 feet.⁸⁶ This suggests that for most EL FARO load conditions with two or more tiers of containers loaded, the limiting stability criteria would be the intact stability criteria (46 CFR § 170.170), but for some load conditions with less than two tiers of containers loaded, the limiting stability criteria could be the damage stability criteria. The potential for damage stability to be the limiting criteria was not reflected on the minimum required GM curves in EL FARO’s T&S Booklet.⁸⁷ However, for the full load departure condition of the accident voyage, since the majority of container stacks were three tiers high, the limiting stability criteria was the intact stability criteria (46 CFR § 170.170), which was properly reflected in EL FARO’s T&S Booklet and incorporated in its CargoMax stability software.

Figure 22. Application of 2008 IS Code righting arm criteria to the accident voyage departure loading condition. (Source: Figure 5-8 of the MSC report)

For the righting arm curves shown in Figure 5-7, the 2008 IS Code righting arm criteria were applied, with results summarized in Table 5-2. Red (*italics*) indicates that the attained value does not meet the specific criteria and green indicates that the attained value meets the specific criteria. For the general righting arm criteria (Part A, Section 2.2), due to the relatively low range of stability, the actual operating conditions of voyage 178S and the accident voyage 185S do not meet criteria for minimum area between 30 and 40 degrees and minimum angle of maximum righting arm. All of the eight conditions meet the severe wind and rolling righting arm criteria (Part A, Section 2.3). This can be seen in greater detail in Figure 5-8, which illustrates the application of the criteria for the accident voyage (185S). In order for the EL FARO to have fully met the criteria of Part A of the 2008 IS Code at the full load draft, the minimum required GM would have been approximately 6.8 feet, which is 2.5 feet greater than the GM of the actual departure loading condition of the accident voyage.

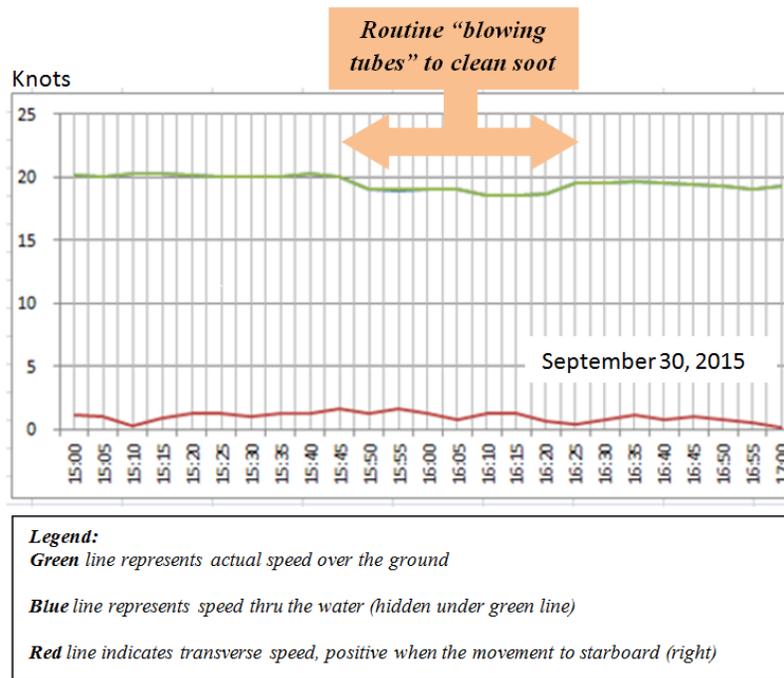
Figure 23. Speed graph from EL FARO showing the typical reduction in speed that resulted from "blowing tubes."

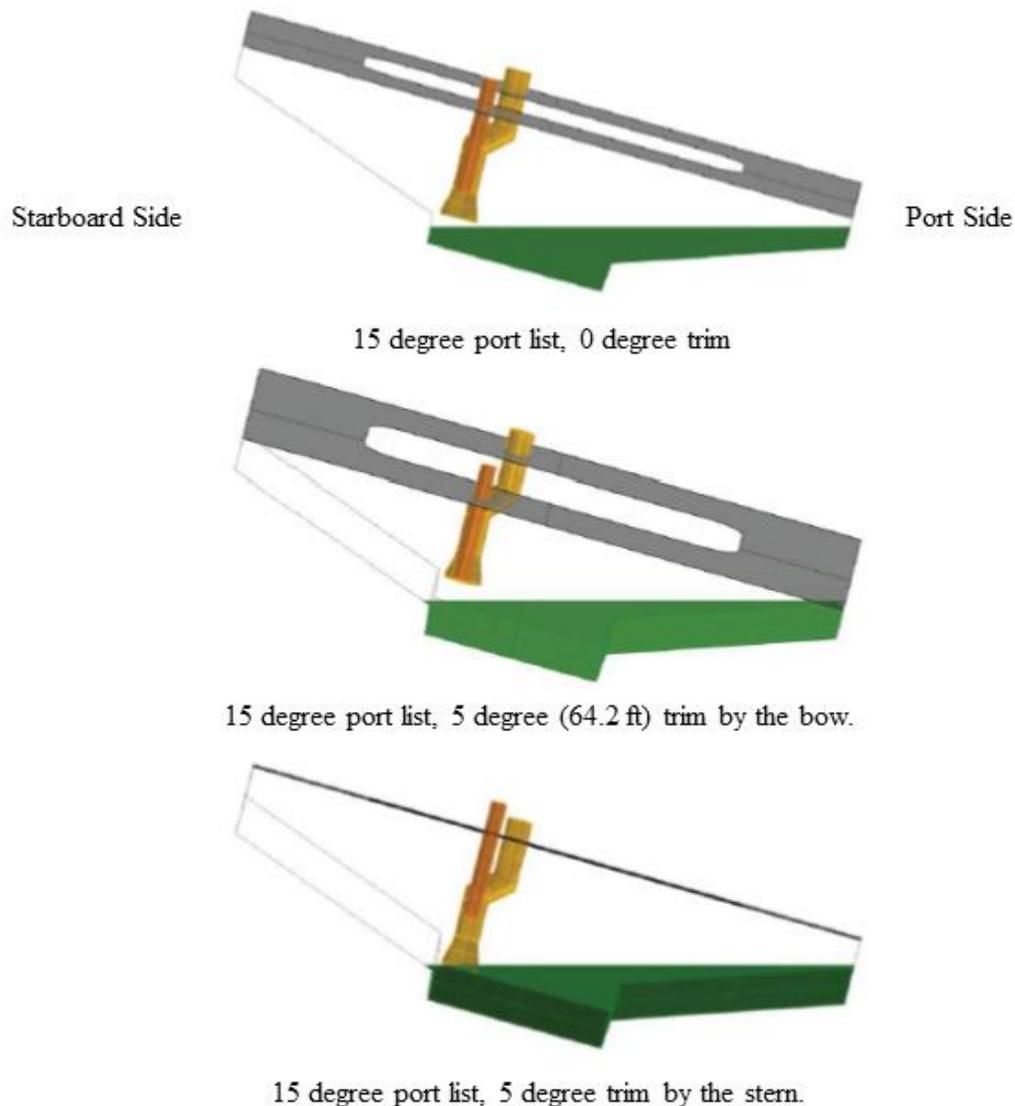
The Coast Guard MSC Lube Oil Modeling and Analysis¹³⁰ demonstrated that the 18” Low Level Capacity shown on the drawing, when combined with a 15 degree port list, would result in the main lube oil sump suction bellmouth coming out of the oil. It also demonstrated that lube oil pocketing would occur in the lube oil gravity tank based on a port list condition, due to a 33” offset of the supply and overflow piping to starboard inside the lube oil gravity tank.

Figure 25. End views of the lube oil sump for the design low level capacity at 15 degree port list and differing trims.

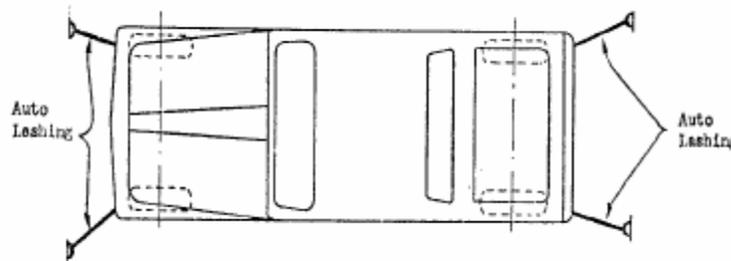
Figure 32. Image from Cargo Securing Manual for vehicles stored below the main deck. (MBI Exhibit 040)

The above image from the CSM shows auto lashings attached directly to D-rings secured to the deck. On EL FARO, a long chain running athwartships was secured to D-rings at each side. Auto lashings were secured to these chains instead of to individual D-rings.

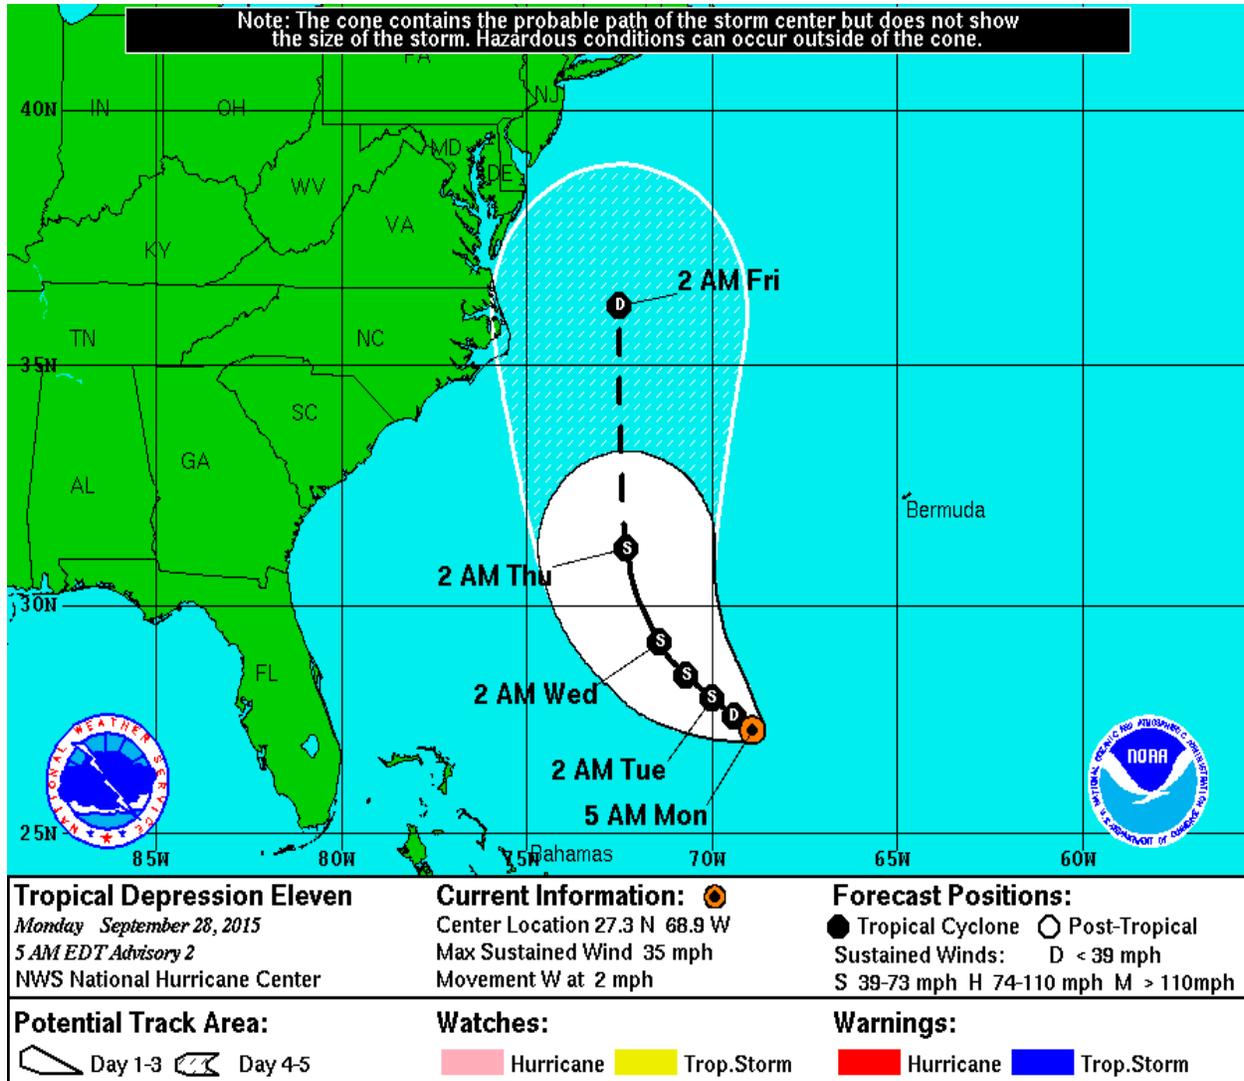
The initial forecast for Joaquin had errors that were much larger than normal. So for example the 3 day forecast that would have verified the morning of October 1st had a track error...it was 536 miles. So the 3 day forecast verifying it at 8:00 AM October 1st. That's an extraordinarily large area. That's really about 1 in 100 type of track error. The 48-hour track forecast that verified at the same time had an error of 180 miles and that's something like a 90 or 95th percentile of error. So it's certainly a very large error. By the time one day it was a 62 mile error, the 1 day forecast was verified at 8:00 AM and that's more in line, at least close to what the average was. So the earlier forecast, track forecast had errors that were much larger than normal for us. The same was true with the intensity errors. The 3 day intensity error that verified at that time was 80 knots too low. The 2 day forecast that verified at that time was 60 knots too low. And the 1 day was 30 knots too low. So the forecast called for a relatively weak system, the initial forecast called for a relatively weak system to head off to the west and northwest and this instead it moved west southward and southward and strengthened.

Figure 39. NHC Tropical Depression Eleven 5 AM EDT Advisory 2 with 5-day Cone and Warnings dated September 28, 2015. Early forecasts for the storm that would become Hurricane Joaquin indicated the system would head in a Northwesterly direction. The 2 AM Thu projection of a Tropical Storm off the coast of South Carolina correlates to the morning of the accident voyage (October 1, 2015).

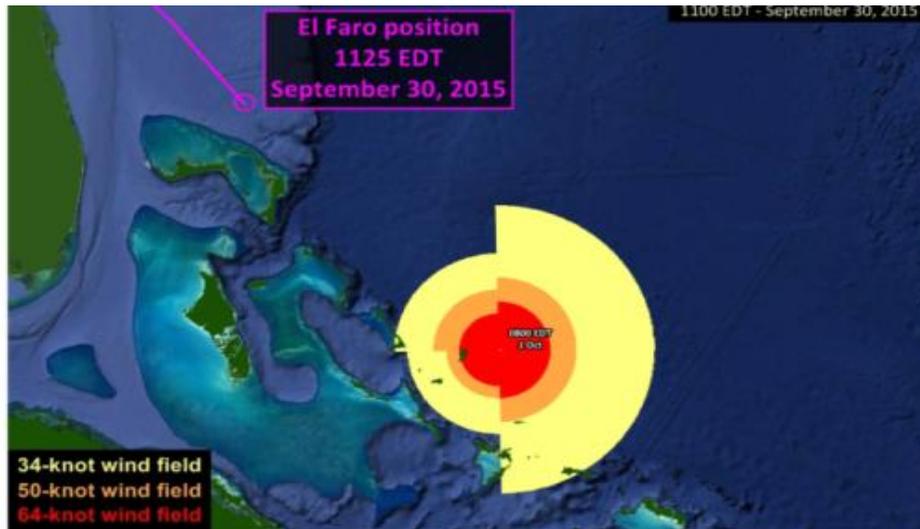
Specialist Unit was asked about this in a follow up interview and they stated that Hurricane Joaquin had an unusual asymmetry that resulted in displacement of the wind fields from the southwest. As a result, as the storm progressed on its southwesterly course, the wind fields were forced tighter to the storm on the leading edge, and expanded further out on the trailing edge. Examples of the resulting quadrants are shown below in the graphical overlay of the 11:00 EDT September 30, 2015, forecast and advisory.

Figure 40. EL FARO position at 1125 EDT September 30, 2015 showing relationship with Hurricane Joaquin wind fields. (Source: NTSB Weather Factual Report)

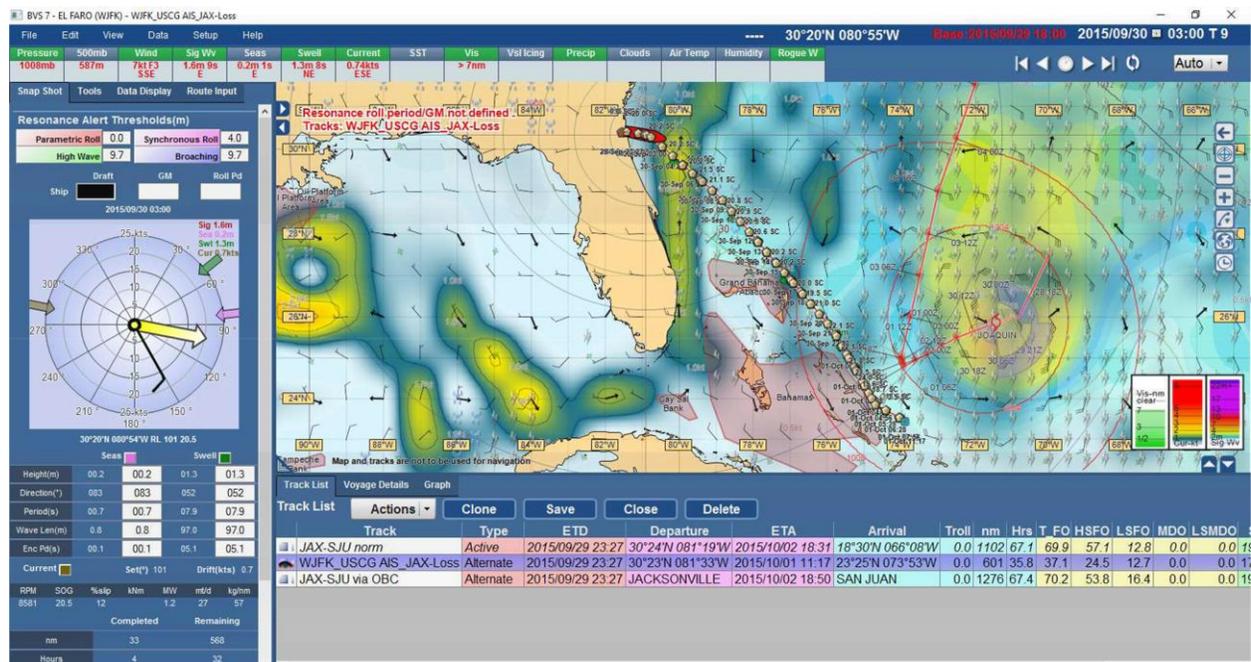
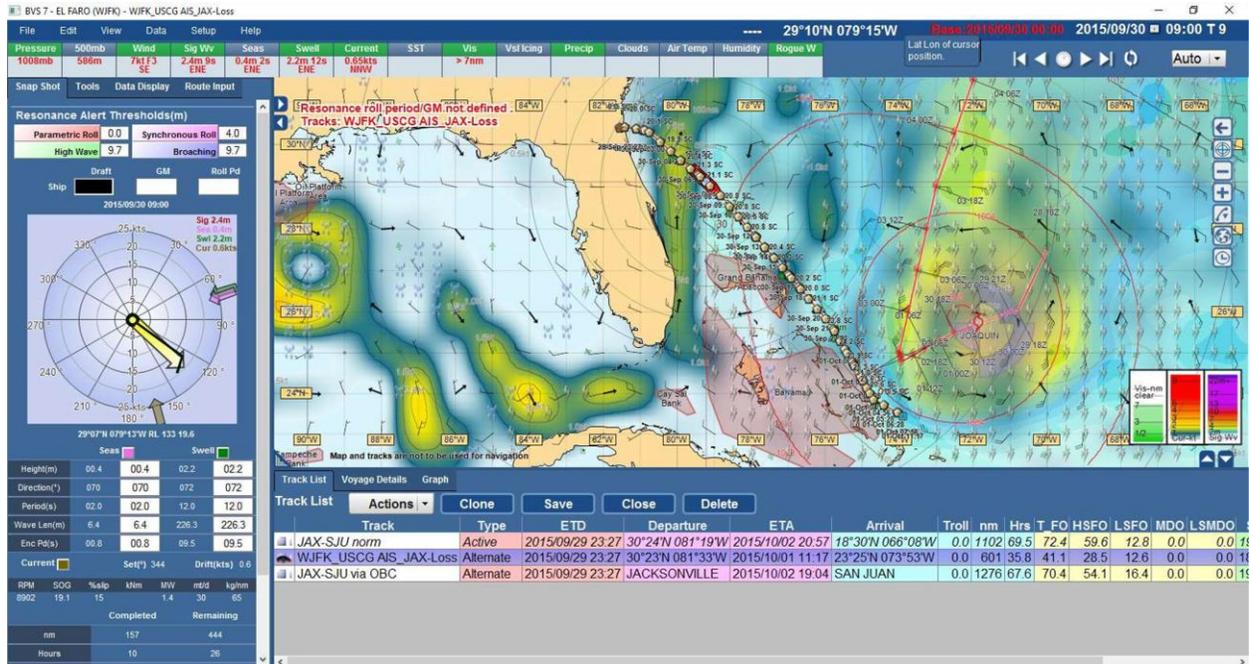
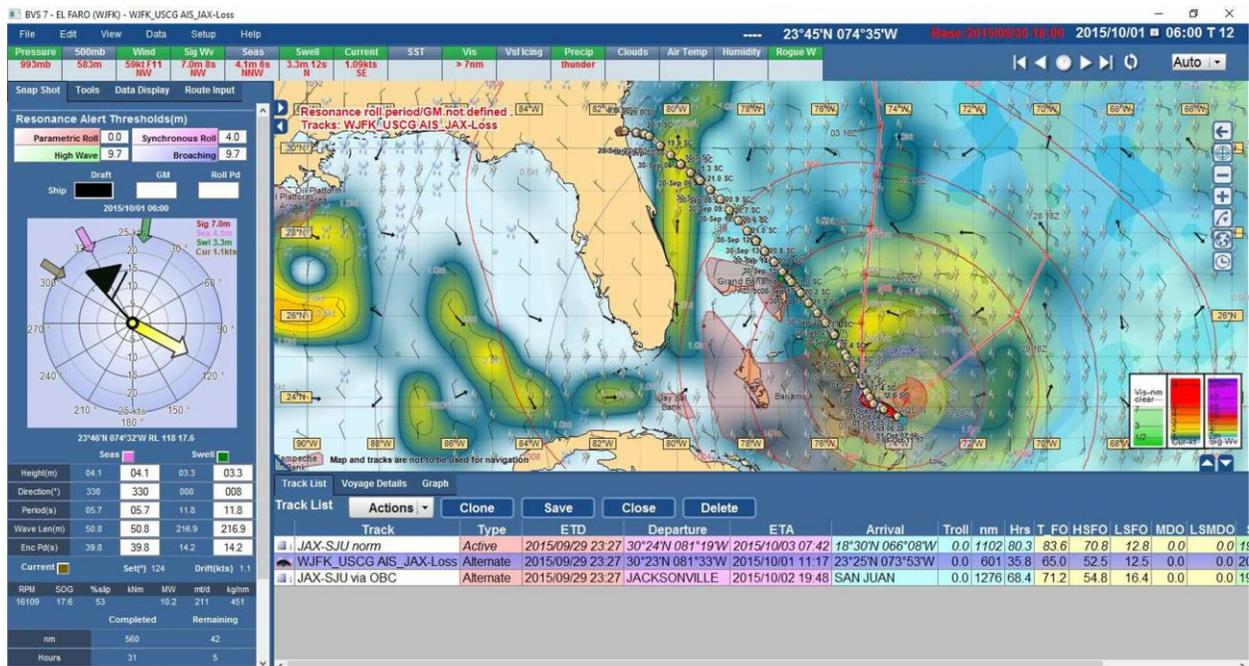
Figure 42. BVS weather package transmitted to EL FARO at 5:04 PM and downloaded at 6:37 PM on September 29, 2015.

Figure 43. BVS weather package transmitted to EL FARO at 11:04 PM and downloaded at 11:29 PM on September 29, 2015.

Figure 44. BVS weather package transmitted to EL FARO at 5:04 AM and downloaded at 6:08 AM on September 30, 2015.

During the testimony from AWT, it was discovered that there was an error in one weather package sent on September 30, 2015. The message sent at about 0900Z (5:00 AM EDT) contained the same NHC forecast and advisory overlaid from the previous weather package sent at 0300Z (11:00 PM EDT) on September 29, 2015. The 0300Z weather package contained the

NHC forecast and advisory information published at the nominal time of 2100Z on September 29, 2015. This error meant that the 0900Z BVS weather package that was sent to EL FARO on September 30, 2015, still contained the NHC forecast and advisory from 12 hours prior. However, the 0900Z weather forecast with the duplicate NHC forecast did include properly updated oceanographic and atmospheric model data generated by AWT.²³³ The repeated hurricane forecast that was replicated in the error can be seen in the graphics above.

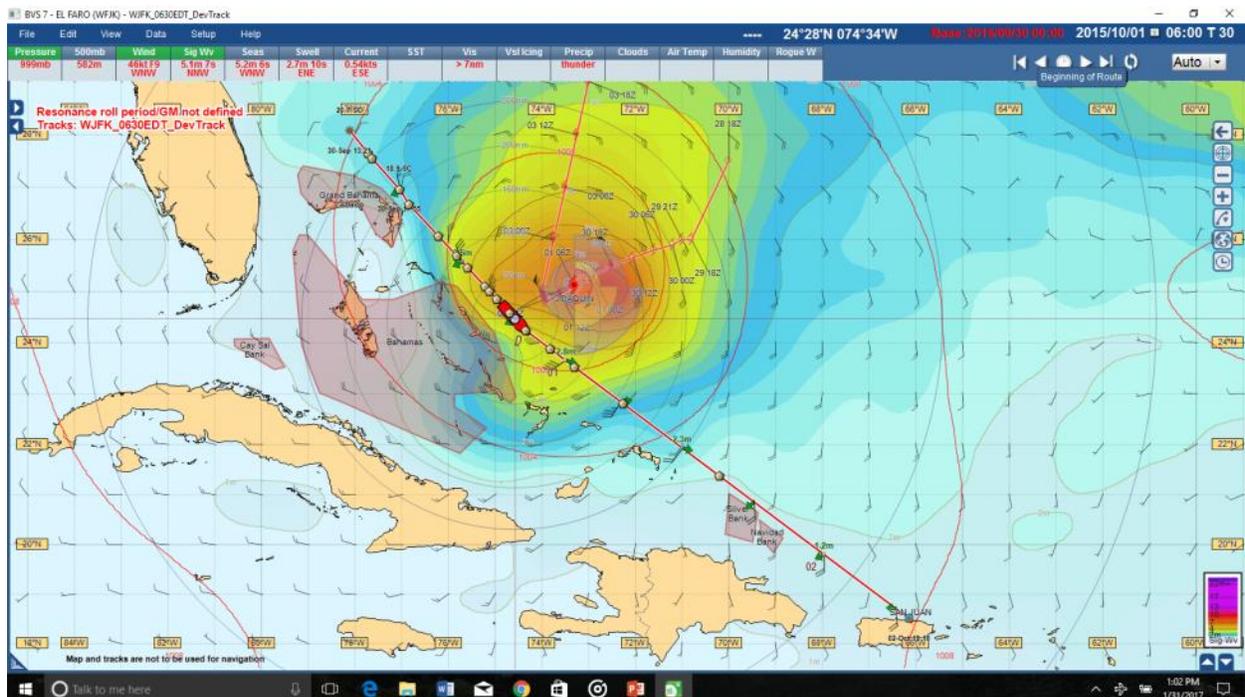
Beginning at about 6:14 AM on September 30, 2015, the C/M and Master discussed the weather and potentially altering EL FARO’s trackline.²³⁴ The route chosen provided two waypoints, waypoints “Alpha” and “Bravo.” The resulting trackline was then entered into BVS. The BVS screenshot below shows the new route with the weather forecast that was downloaded at 6:08 AM on September 30, 2015. This was the BVS forecast data package that was available to the Master and C/M at the time they were choosing waypoints “Alpha” and “Bravo.” The Tropical Cyclone forecasted track depicted in this package delivered to EL FARO is the duplicate report showing the NHC’s forecast from 5:00 PM on September 29, 2015.

Figure 46. BVS screenshot of EL FARO's adjusted route along with the weather forecast downloaded at 6:08 AM on September 30, 2015.

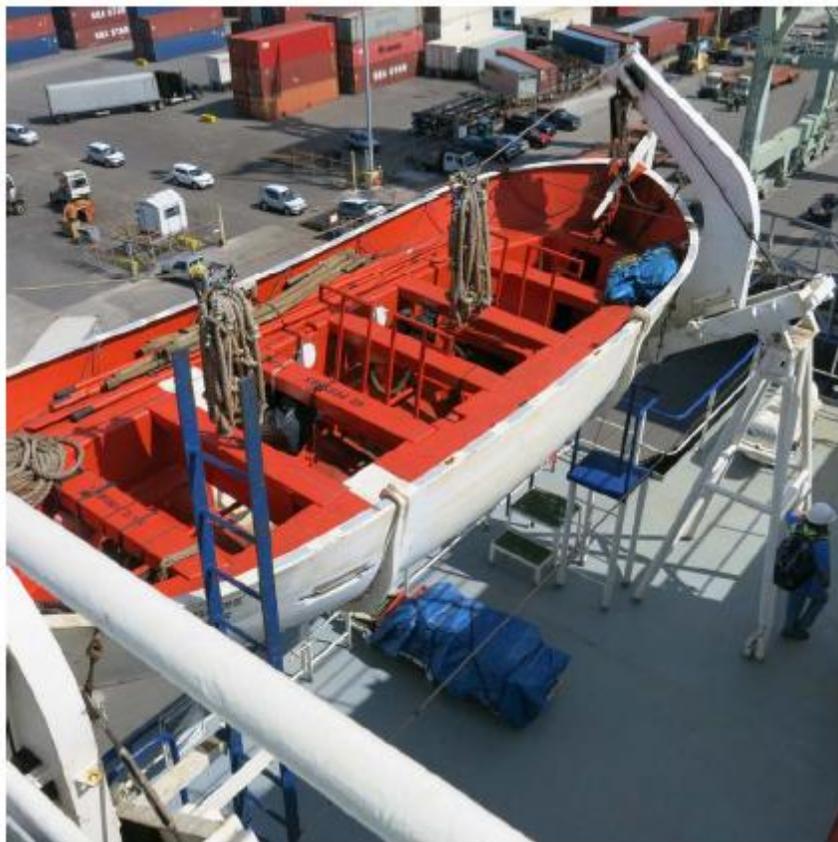
EL FARO’s starboard lifeboat, Boat 1, had a capacity of 43 persons and was propelled by the manual movement of levers which in turn operated a propeller. This propulsion system is known as Fleming gear.

Figure 47. EL YUNQUE starboard lifeboat. NTSB photo.

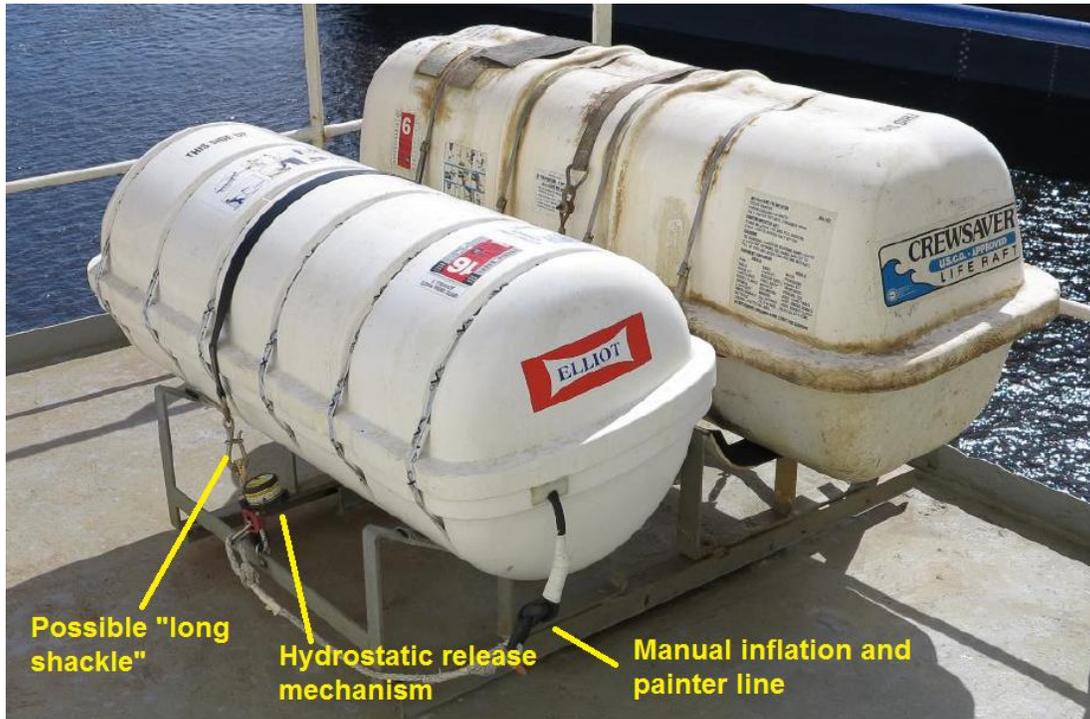
In addition to the required rafts, EL FARO had two additional 25-person rafts in cradles or lashed to the railings near the boat deck.³⁴⁸ The additional rafts were placed on EL FARO after issues with the davit deck foundations were discovered on EL YUNQUE in mid-summer 2015. These extra rafts were still onboard EL FARO when the ship departed Jacksonville on September 29.

Figure 50. Required 25 person life raft with extra raft on the port side of EL YUNQUE showing the storage of the rafts and the hydrostatic release mechanism.

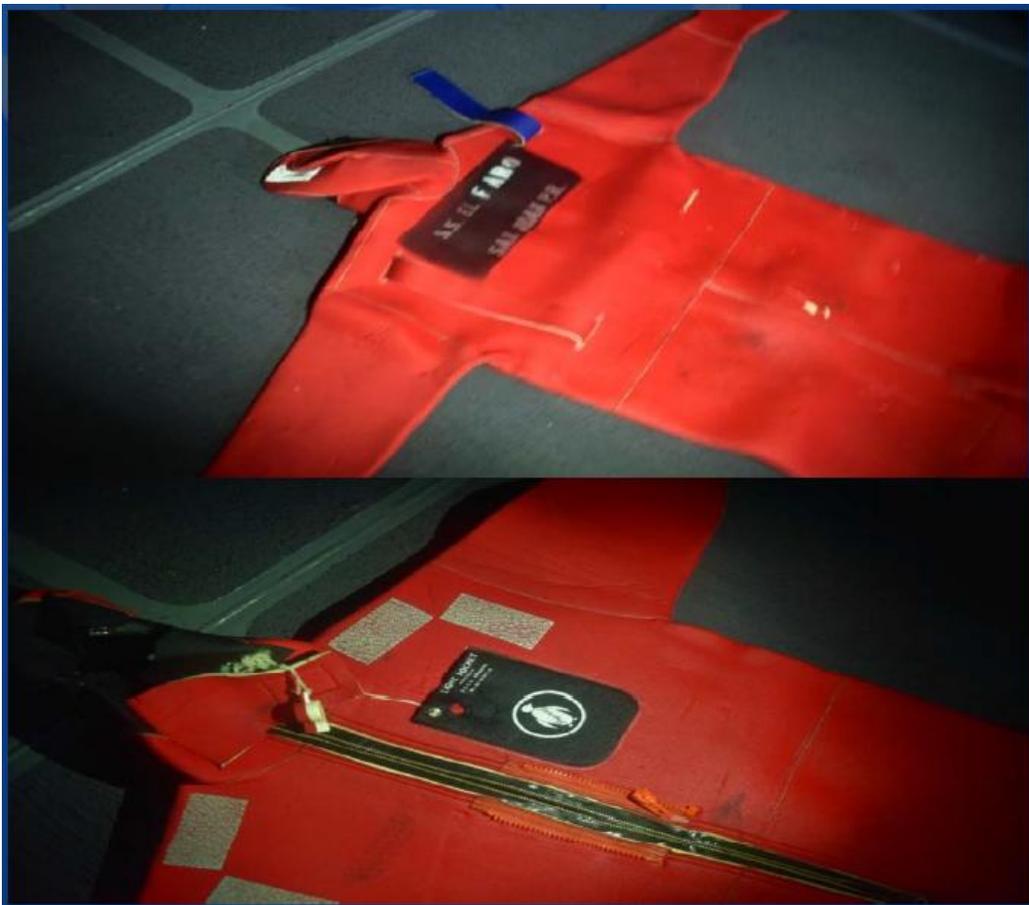
Three EL FARO immersion suits were located during search and rescue activities. One of the suits found floating at sea contained a deceased crew member’s remains, which were not able to be identified or recovered. Further details regarding that suit are discussed in the Search and Rescue section of this report. Two other empty immersion suits, found floating on the surface, were recovered and brought ashore. One of the recovered suits was undamaged. The other recovered suit had a large tear at the waist on the front right side extending from the zipper to the side of the suit. The two recovered immersion suits were manufactured in June of 1985.

Figure 51. One of the two immersion suits that were recovered during the EL FARO search.

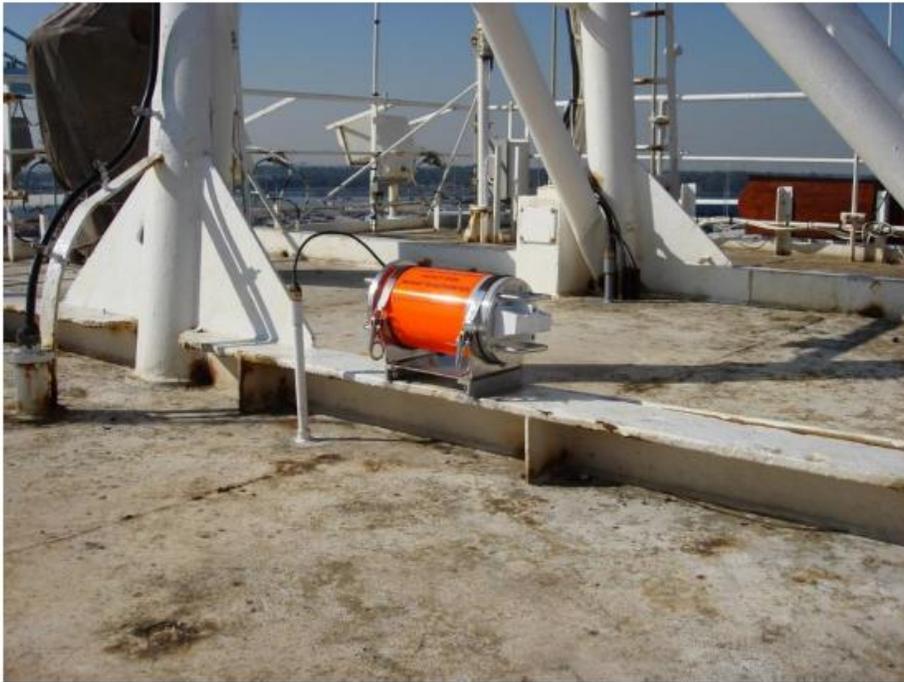
Figure 62. Archive photo of the EL FARO S-VDR capsule mounted on a beam on the flying bridge, port side. (Source: Radio Holland)

pinger battery expiration date must be after the expiration of the APT certificate. The IMO,³⁹¹ on the other hand, only required that the battery not be expired at the time of the APT. The acoustic beacon itself was set to expire in May 2015 and the typical service protocol³⁹² was to change out the beacon itself to ensure reliability. The checklist that the APT technician used to verify proper operation included the notation that the battery should have been replaced as part of the inspection and issuance of the Compliance Certificate.³⁹³

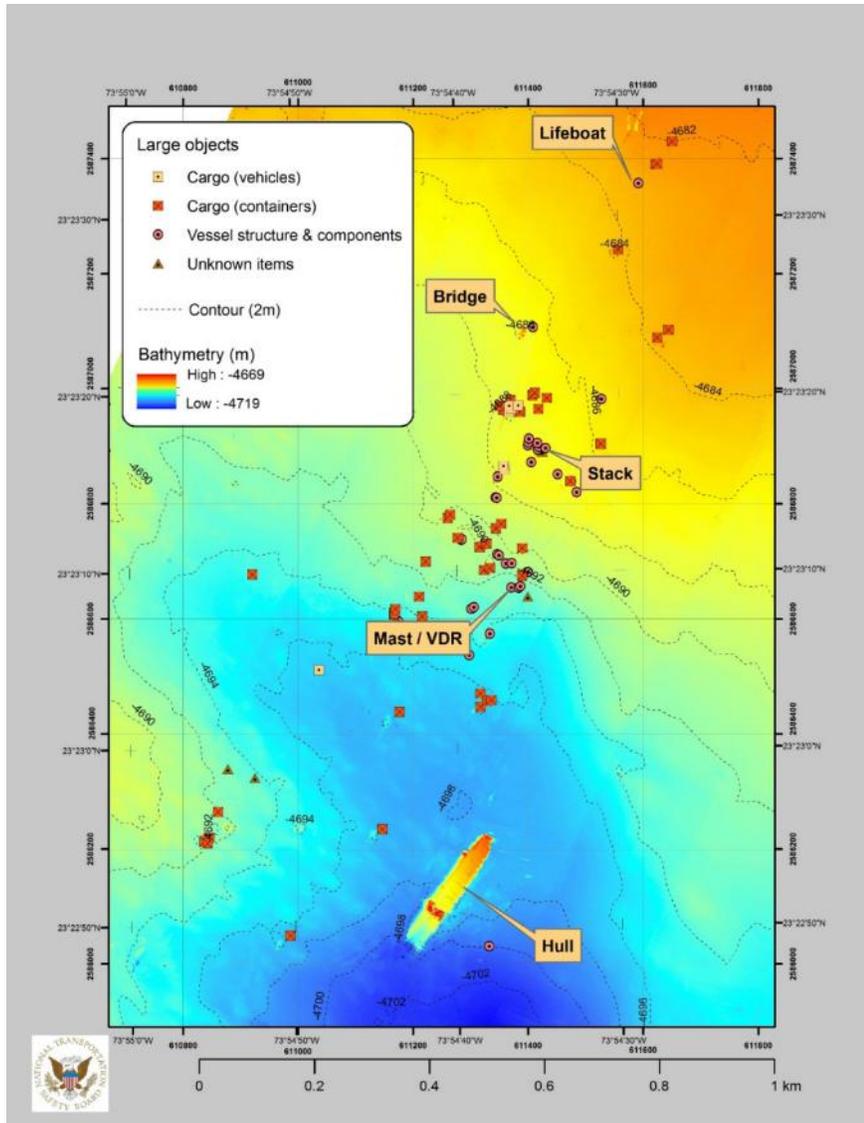
Figure 64. Composite EL FARO debris field chart (reproduced from NSTB Naval Architecture Group factual report).

The ship’s accommodations space, called the “house,” is partially intact, and the majority of that structure remains affixed to the hull. The navigation bridge was separated from the rest of the vessel and was located north of the vessel, as indicated in figure #64. The navigation bridge structure was damaged, but landed upright and structurally intact on the sea floor, about half a mile from the hull. The deck that housed the staterooms and offices for senior officers immediately below the bridge is missing, and the bulkheads for that portion of the superstructure are scattered around the wreck. The rest of the superstructure decks were still affixed to the hull along with ship fixtures, including the lifeboat davits, ladders, and lockers. There were large, arch-shaped scratches noticeable on the vertical surface of the exterior accommodation space on the port side of the vessel, in the vicinity of where the port lifeboat was cradled. The exterior starboard side vertical surface of the accommodation area does not have this same damage, and the starboard lifeboat davits were not as severely damaged as the portside davits.

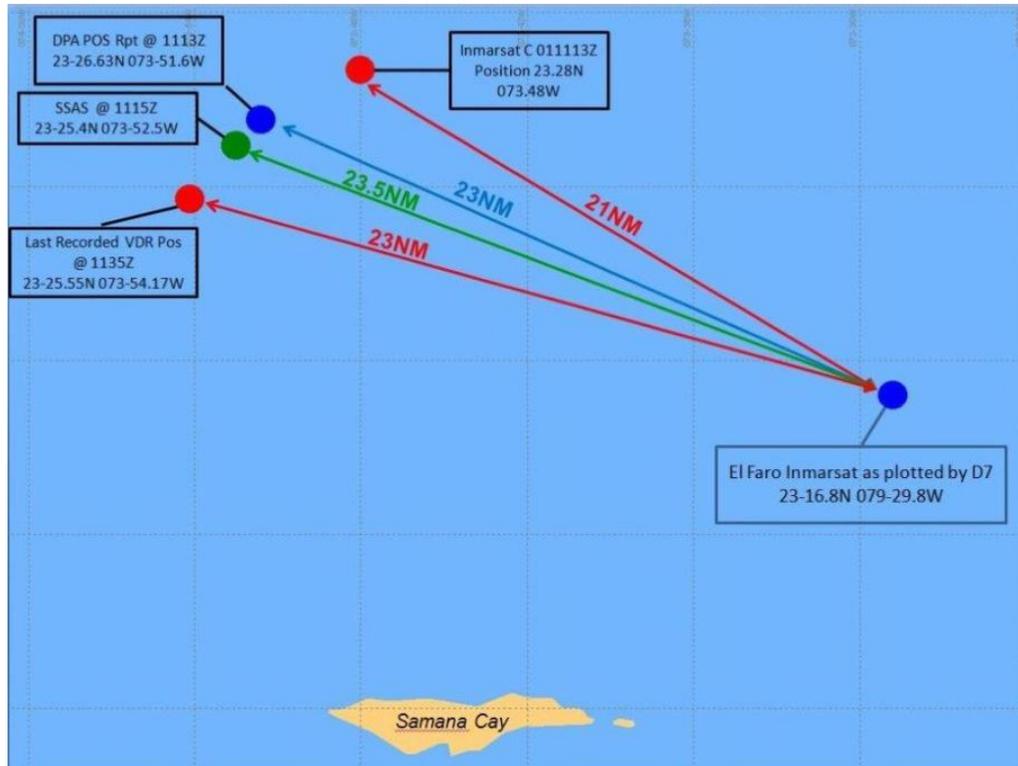
DD.dd. SAROPS did not distinguish the difference between tenths of degrees or minutes in this format.⁴¹⁹ The United States recognizes the format as degrees, decimal degrees⁴²⁰ and it is the watchstanders responsibility to convert coordinates into that format before entering them into SAROPS.

Figure 67. D7CC electronic alert plot SAROPS. The position entered into SAROPS (displayed on the right) was more than 20 nautical miles away from the actual last known position of EL FARO.

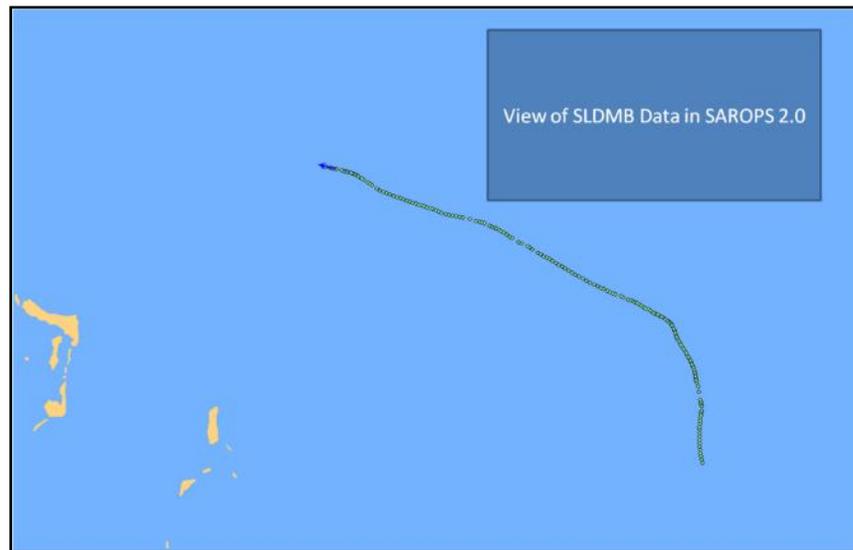
The – generation 2 self-locating datum marker beacons have a 40 to 50 percent failure rate. We’re in the process of fielding 3rd generation datum marker beacons.

Figure 70. An example of a sample self locating datum marker buoy (SLDMB) plot in SAROPS (Not EL FARO case related).
