UNITED STATES COAST GUARD

**REPORT OF THE MARINE BOARD OF INVESTIGATION
INTO THE
STEAM SHIP EL FARO (O.N. 561732)
SINKING AND LOSS OF THE VESSEL
WITH 33 PERSONS MISSING AND PRESUMED DECEASED
NORTHEAST OF ACKLINS AND CROOKED ISLAND,
BAHAMAS
ON OCTOBER 1, 2015**

**STEAM SHIP EL FARO (O.N. 561732) SINKING AND LOSS OF THE VESSEL WITH
33 PERSONS MISSING AND PRESUMED DECEASED NORTHEAST OF ACKLINS
AND CROOKED ISLAND, BAHAMAS ON OCTOBER 1, 2015**

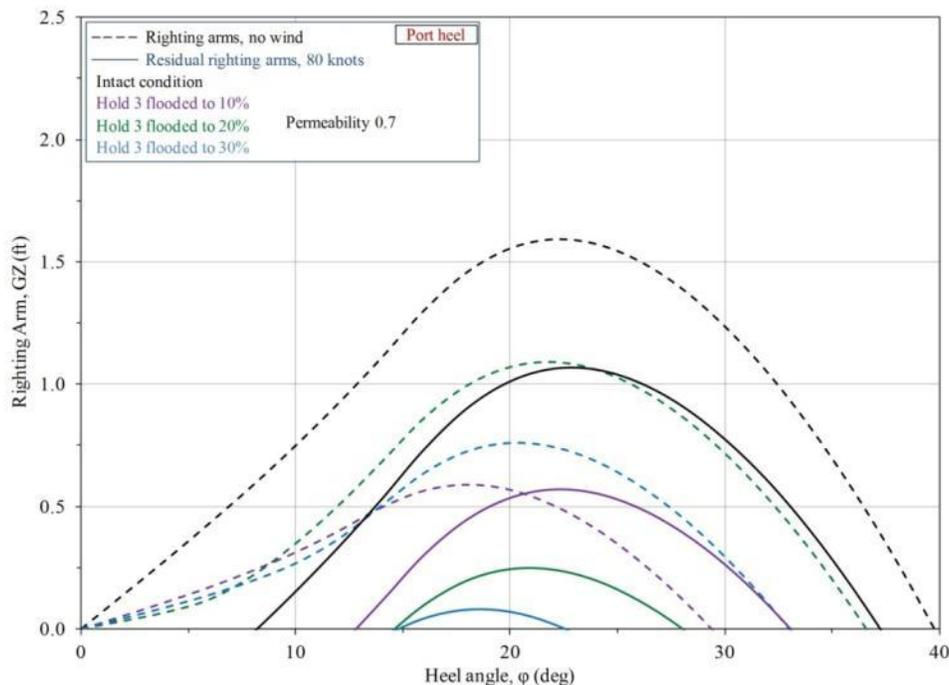
Regardless of the initial source or sources of flooding on EL FARO during the accident voyage, the free surface associated with the floodwater in the cargo holds combined with hurricane force winds and seas would have inevitably resulted in the capsizing of the vessel. The capsizing may have been slowed or temporarily arrested as containers on deck began to wash overboard, but as the vessel slowly rolled onto its port side, a large volume of floodwater would have been entering through the ventilation openings into all of the cargo holds and the engine room, resulting in the sinking.

Figure 71. Righting arms (dashed curves) and residual righting arms (solid curves) with 80 knot beam winds with Hold 3 flooded to 10%, 20%, and 30%. Permeability is 0.7 (Figure 6-24 of the MSC report).

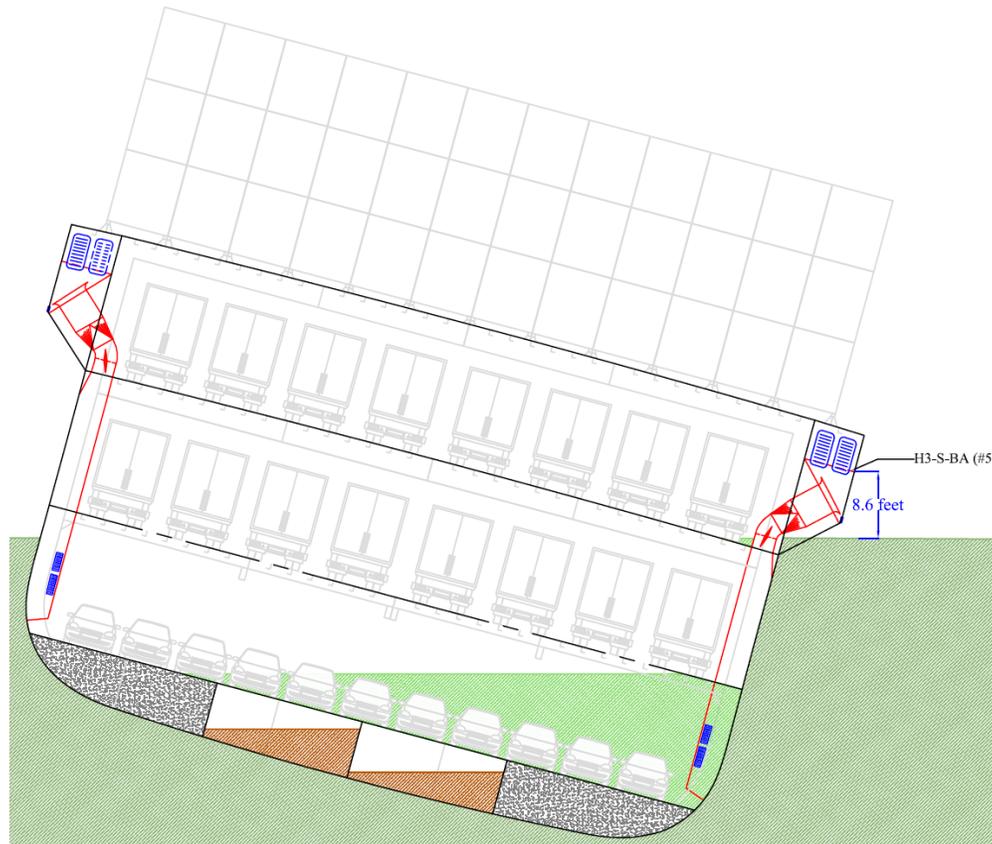
Figure 72. Section at frame 143 (Hold 3 ventilation supply trunk) with flooding of Hold 3 to 20% with heel angle 15 degrees. Downflooding point at the top of the vertical baffle plate is shown (Figure 6-18 of the MSC report).

It is not possible to determine exactly when downflooding of EL FARO started, as there were multiple paths for seawater to enter the ship other than the first specific source of flooding that was identified on the VDR as the 2nd Deck starboard scuttle for Hold 3. Other possible sources include hull breaches, watertight openings left open or failing to function properly, or internal failures of the ventilation trunk structures.

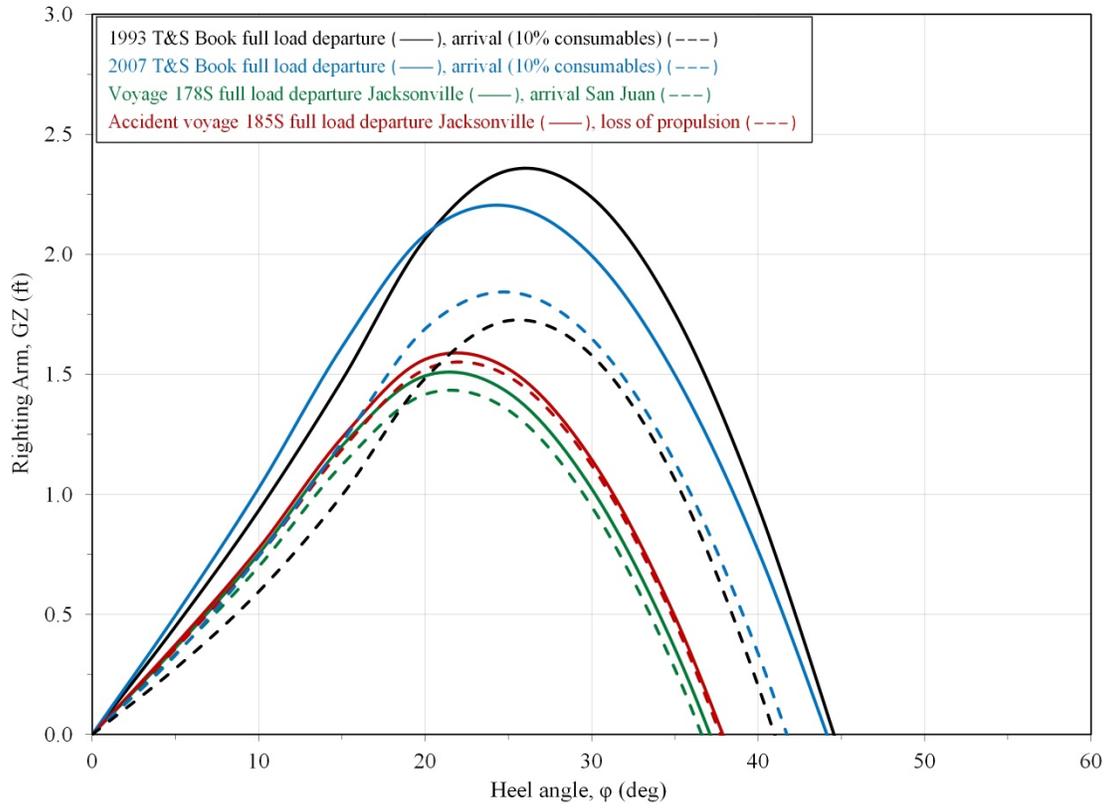
For the righting arm curves shown in Figure 5-7, the 2008 IS Code righting arm criteria were applied, with results summarized in Table 5-2. Red (*italics*) indicates that the attained value does not meet the specific criteria and green indicates that the attained value meets the specific criteria. For the general righting arm criteria (Part A, Section 2.2), due to the relatively low range of stability, the actual operating conditions of voyage 178S and the accident voyage 185S do not meet criteria for minimum area between 30 and 40 degrees and minimum angle of maximum righting arm. All of the eight conditions meet the severe wind and rolling righting arm criteria (Part A, Section 2.3). This can be seen in greater detail in Figure 5-8, which illustrates the application of the criteria for the accident voyage (185S). In order for the EL FARO to have fully met the criteria of Part A of the 2008 IS Code at the full load draft, the minimum required GM would have been approximately 6.8 feet, which is 2.5 feet greater than the GM of the actual departure loading condition of the accident voyage.

Figure 5-7: Righting arm curves for the eight benchmark full load conditions.

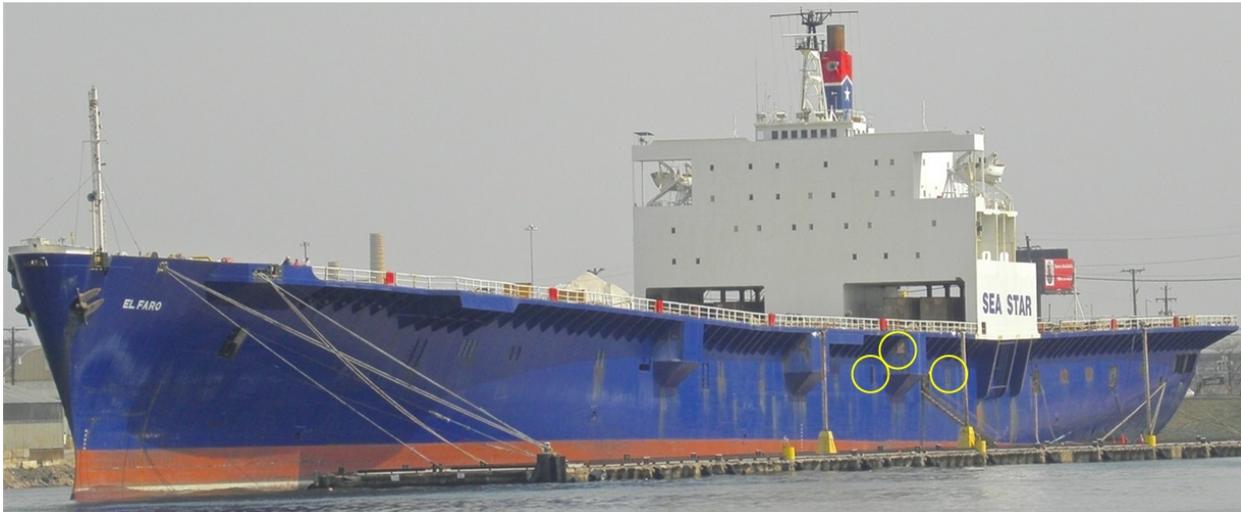
The cargo hold ventilation system consists of ventilation supply trunks with integrated supply fans and fire dampers and ducting, and ventilation exhaust trunks with integrated fire dampers and ducting. The supply and exhaust trunks for Holds 2, 2A and 3 were all similar in configuration and differed primarily in internal details and height due to the sheer of the 2nd deck, with the Hold 3 openings being the lowest and closest to the waterline due to deck sheer and vessel trim aft. Figure 6-8 shows a photograph of the EL FARO port side, highlighting the ventilation supply and exhaust hull openings for Hold 3.

Figure 6-8: EL FARO port side showing ventilation supply and exhaust louvered hull openings. The openings for Hold 3 are highlighted. Photo copyright Will Van Dorp, used with permission.

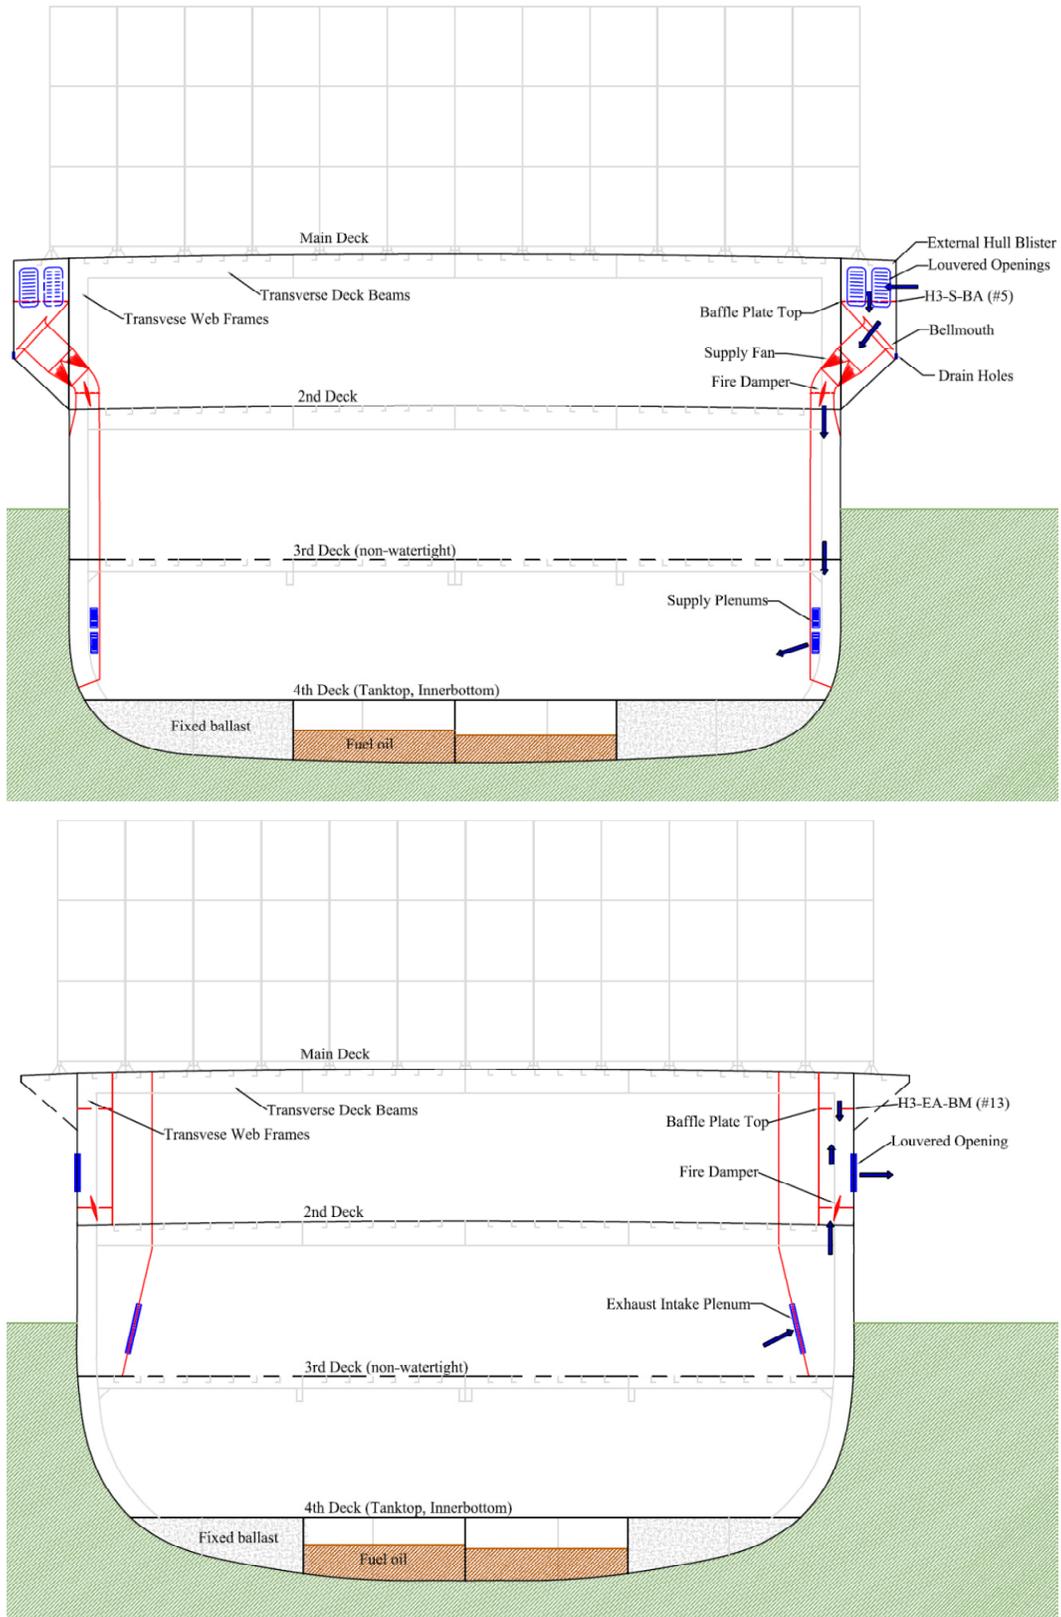
Scaled drawings of sections at frames 143 and 159 showing the supply and aft exhaust arrangements are provided in Figure 6-9. The section at frame 143 shows the Hold 3 ventilation supply arrangement. The supply arrangement includes an external hull blister with side shell louvered openings, baffle plates, bellmouth, supply fan, fire damper and supply plenum. The louvered openings are forward and aft of the bellmouth, separated by the vertical baffle plates. The section at frame 159 shows the Hold 3 aft exhaust arrangement. The exhaust arrangement includes an intake plenum, a fire damper, and an exhaust trunk with a 12-ft high baffle plate and side shell louvered opening. The louvered opening is forward of the fire damper trunk, separated by the vertical baffle plate. Based on the system design, the baffle plates were intended to provide a vertical boundary to limit water from entering the cargo hold through the fire dampers. For the accident voyage, the tops of the baffle plates were approximately 25 feet above the still waterline, and they would submerge at an angle of heel of approximately 27-29 degrees.

Figure 6-9: Sections at frames 143 (top) and 159 (bottom) showing Hold 3 ventilation supply and exhaust arrangements, respectively. Normal air supply and exhaust paths are shown.

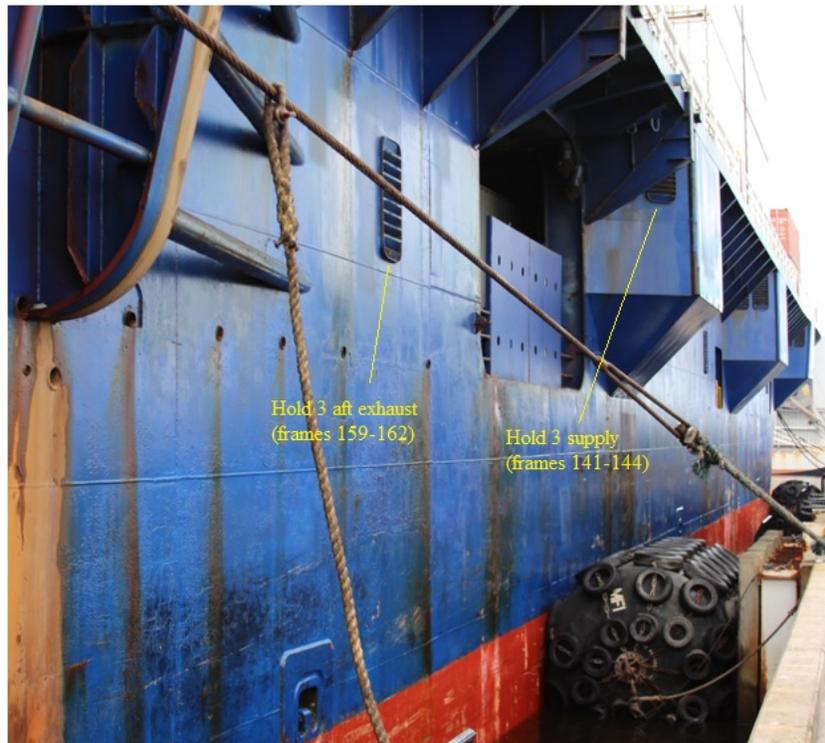
Figure 6-10 through Figure 6-14 provide a series of photographs showing important components of the cargo hold ventilation system which illustrate the vulnerability of flooding through the ventilation supply and exhaust openings on the EL FARO. The ventilation system could be secured in the case of fire by manually closing the fire dampers. Otherwise the fire dampers were required to remain open at all times in port and at sea to provide positive ventilation of the vehicles holds, as required in 46 CFR 92.15-10. Based on MBI hearing testimony [19, 20, 32], crews did not close the fire dampers at sea for heavy weather. There was also no shipboard documentation in the form of a damage control plan or emergency plan which might recommend securing of the fire dampers in the case of extremely high seas to prevent flooding of the cargo holds.

Figure 6-10: Starboard ventilation louvered hull openings for Hold 3 ventilation supply and aft exhaust. Note that red paint delineates the load line (approximate full load waterline). Photo of sister vessel EL YUNQUE. USCG photo.

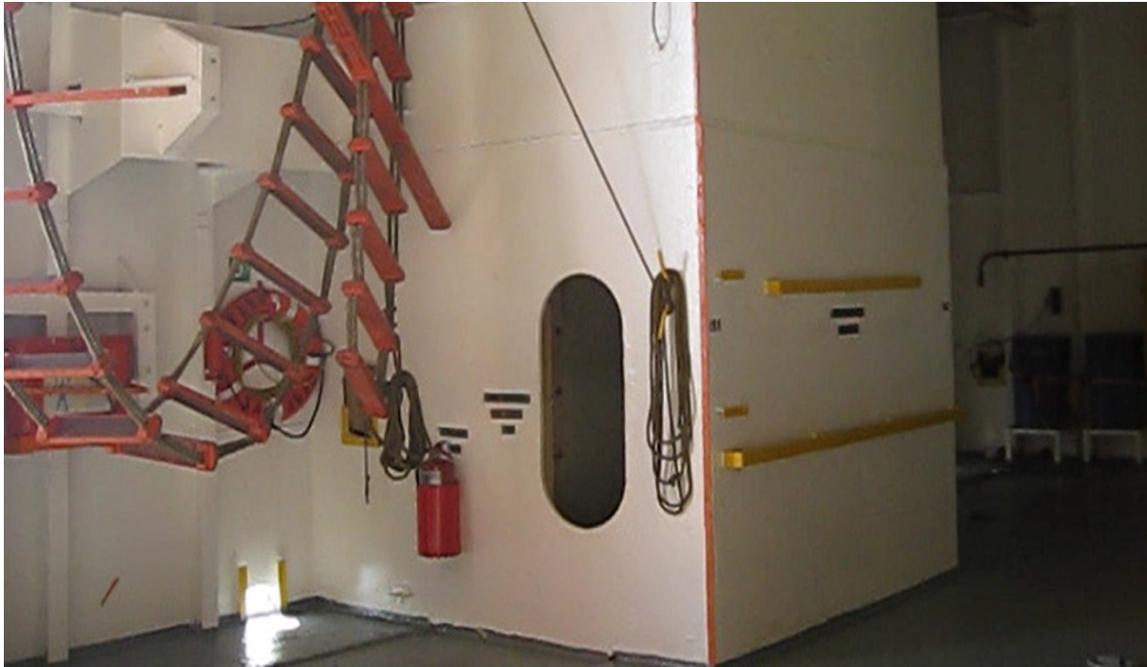
Figure 6-11: Hold 3 aft ventilation exhaust trunk with racking bulkhead, frames 159-162 starboard, 2nd deck. Screen capture from video taken September 2008 provided by Tote, Inc.

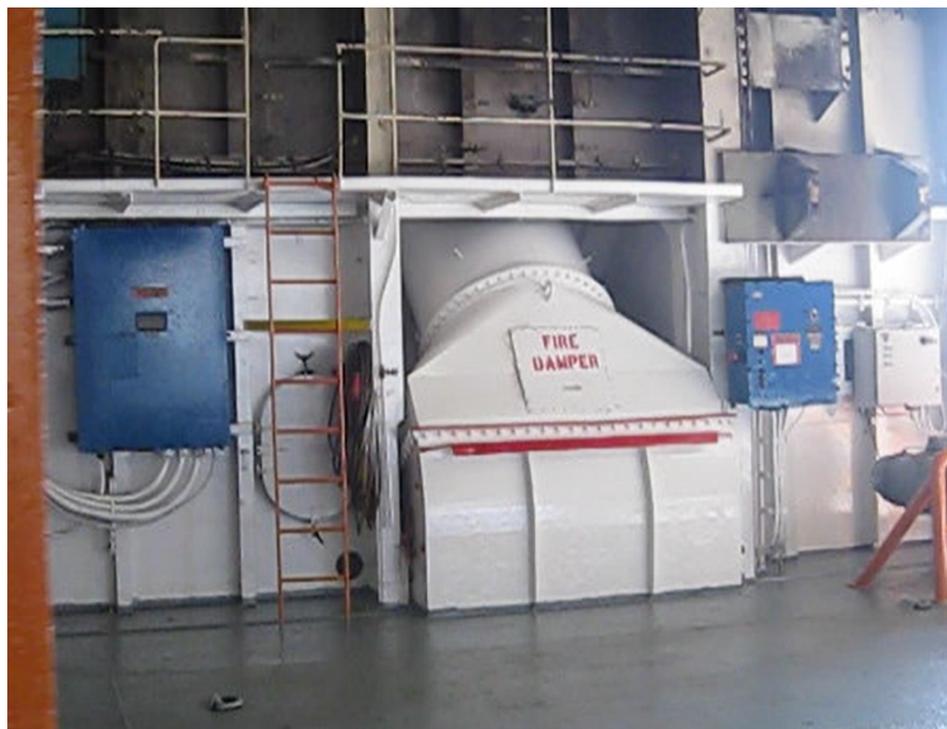
Figure 6-12: Hold 3 ventilation supply fan and fire damper enclosure, frames 141-144 starboard, 2nd deck. Screen capture from video taken September 2008 provided by Tote, Inc.

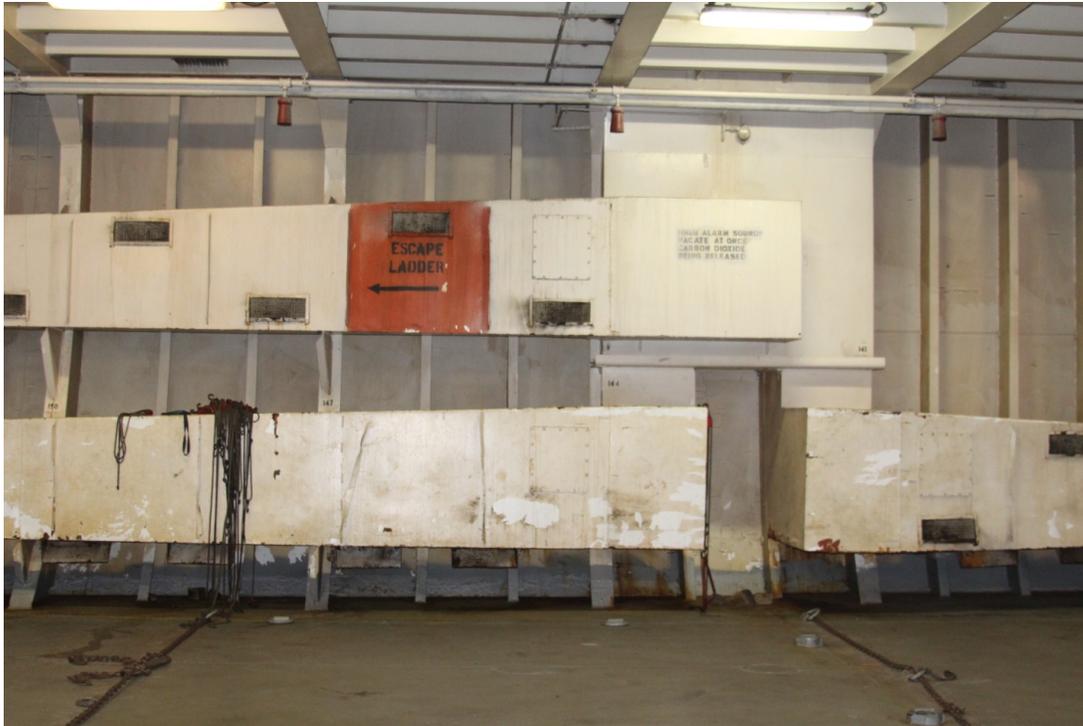
Figure 6-13: Ventilation supply plenums inside Hold 3, frames 141-144 port, 4th deck (tanktop, innerbottom). Photo of sister vessel EL YUNQUE. USCG photo.

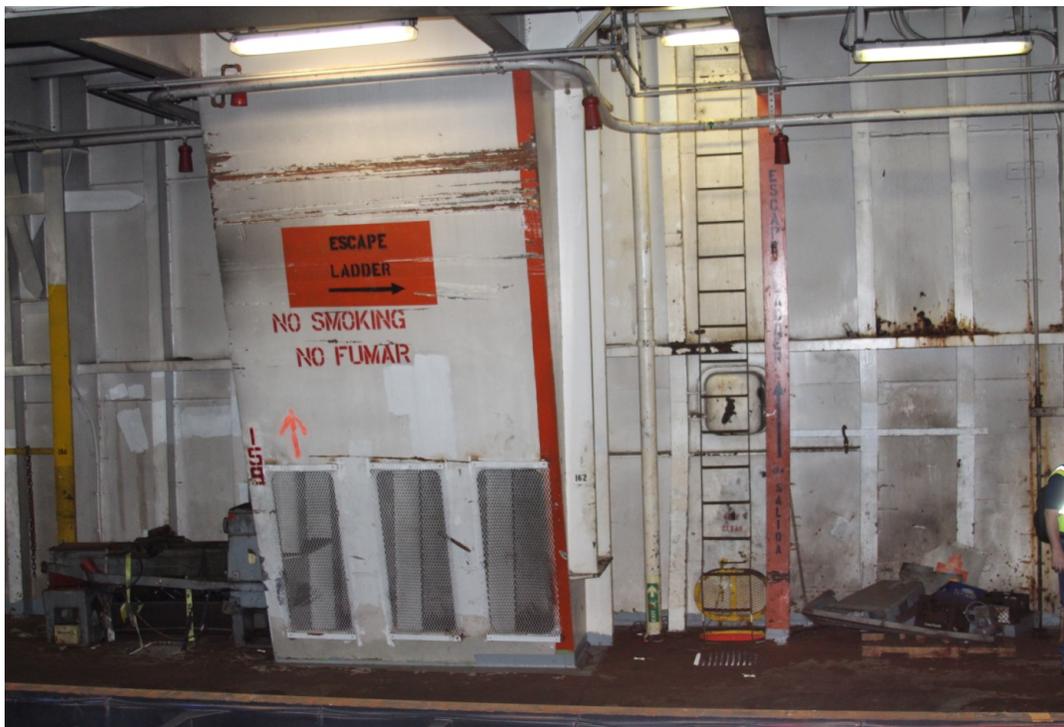
Figure 6-14: Ventilation exhaust intake plenum inside Hold 3, frames 159-162 starboard, 3rd deck. Hold 3 starboard scuttle personnel access ladder and remote operator rod for the emergency fire pump suction valve (sea-chest isolation) are shown on the right. Photo of sister vessel EL YUNQUE. USCG photo.

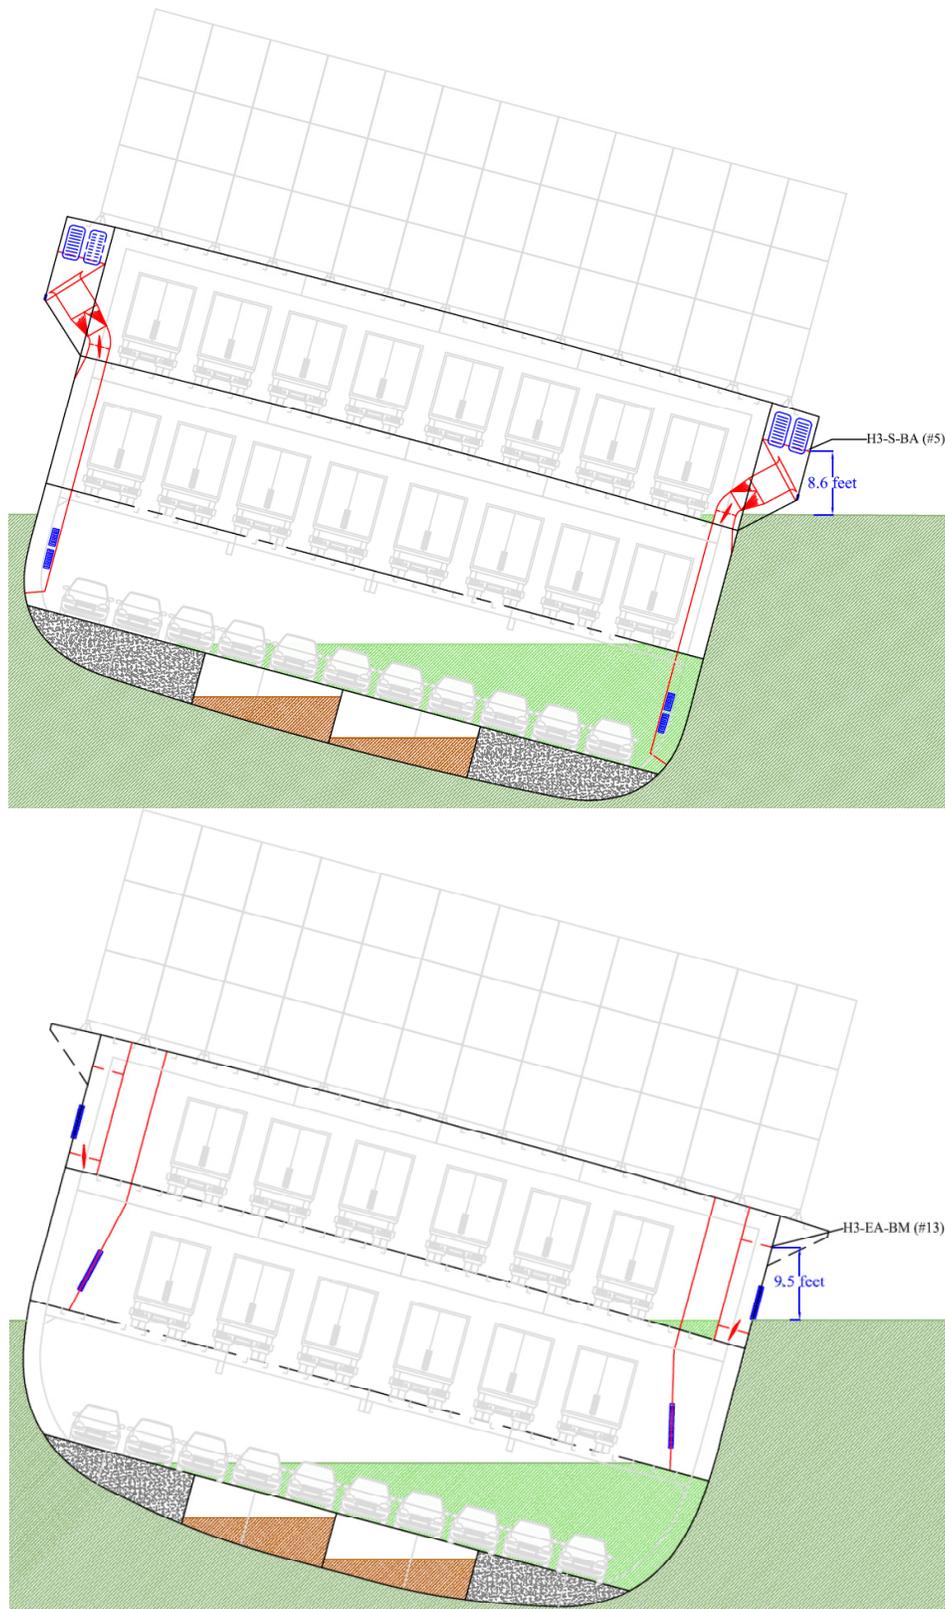
Figure 6-18: Scaled drawing of sections at frame 143 (Hold 3 ventilation supply trunk) and frame 159 (Hold 3 aft ventilation exhaust trunk), with flooding of Hold 3 to 20% with permeability 0.7 and heel angle of 15 degrees shown for example.

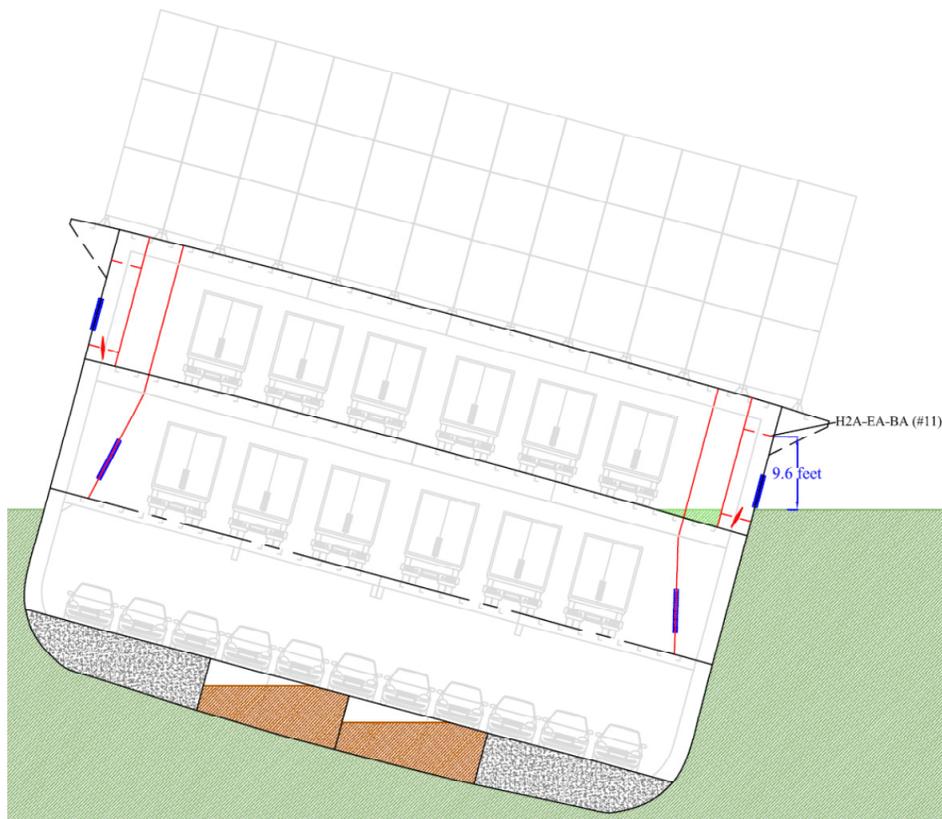
As discussed previously, it is not clear from the VDR audio transcript when and where progressive flooding was occurring prior to the eventual capsizing of the vessel at approximately 0739 on October 1st [64 (pp. 507-508)]. However, as Hold 3 continued to flood, eventually the ventilation openings for Hold 2A would have been brought to intermittent submergence as their freeboards were reduced due to the flooding of Hold 3, in combination with the wind heel, waves and roll motion. This is illustrated in Figure 6-19, which shows a scaled drawing of the section at frame 134/22, the location of the aft ventilation exhaust trunk for Hold 2A. For a wind heel angle of 15 degrees, the waterline is shown incorporating the effect of flooding of Hold 3 to 20%. It should be noted that it is likely that Hold 2A (and perhaps also Hold 2) may have been taking on some water, at least intermittently, as the vessel rolled about a wind heel angle of 15 degrees and while Hold 3 was flooding.

Figure 6-19: Scaled drawing of section at frame 134/22 (Hold 2A aft ventilation exhaust trunk) with still waterline resulting from flooding of Hold 3 to 20% with permeability 0.7 and heel angle of 15 degrees shown for example.

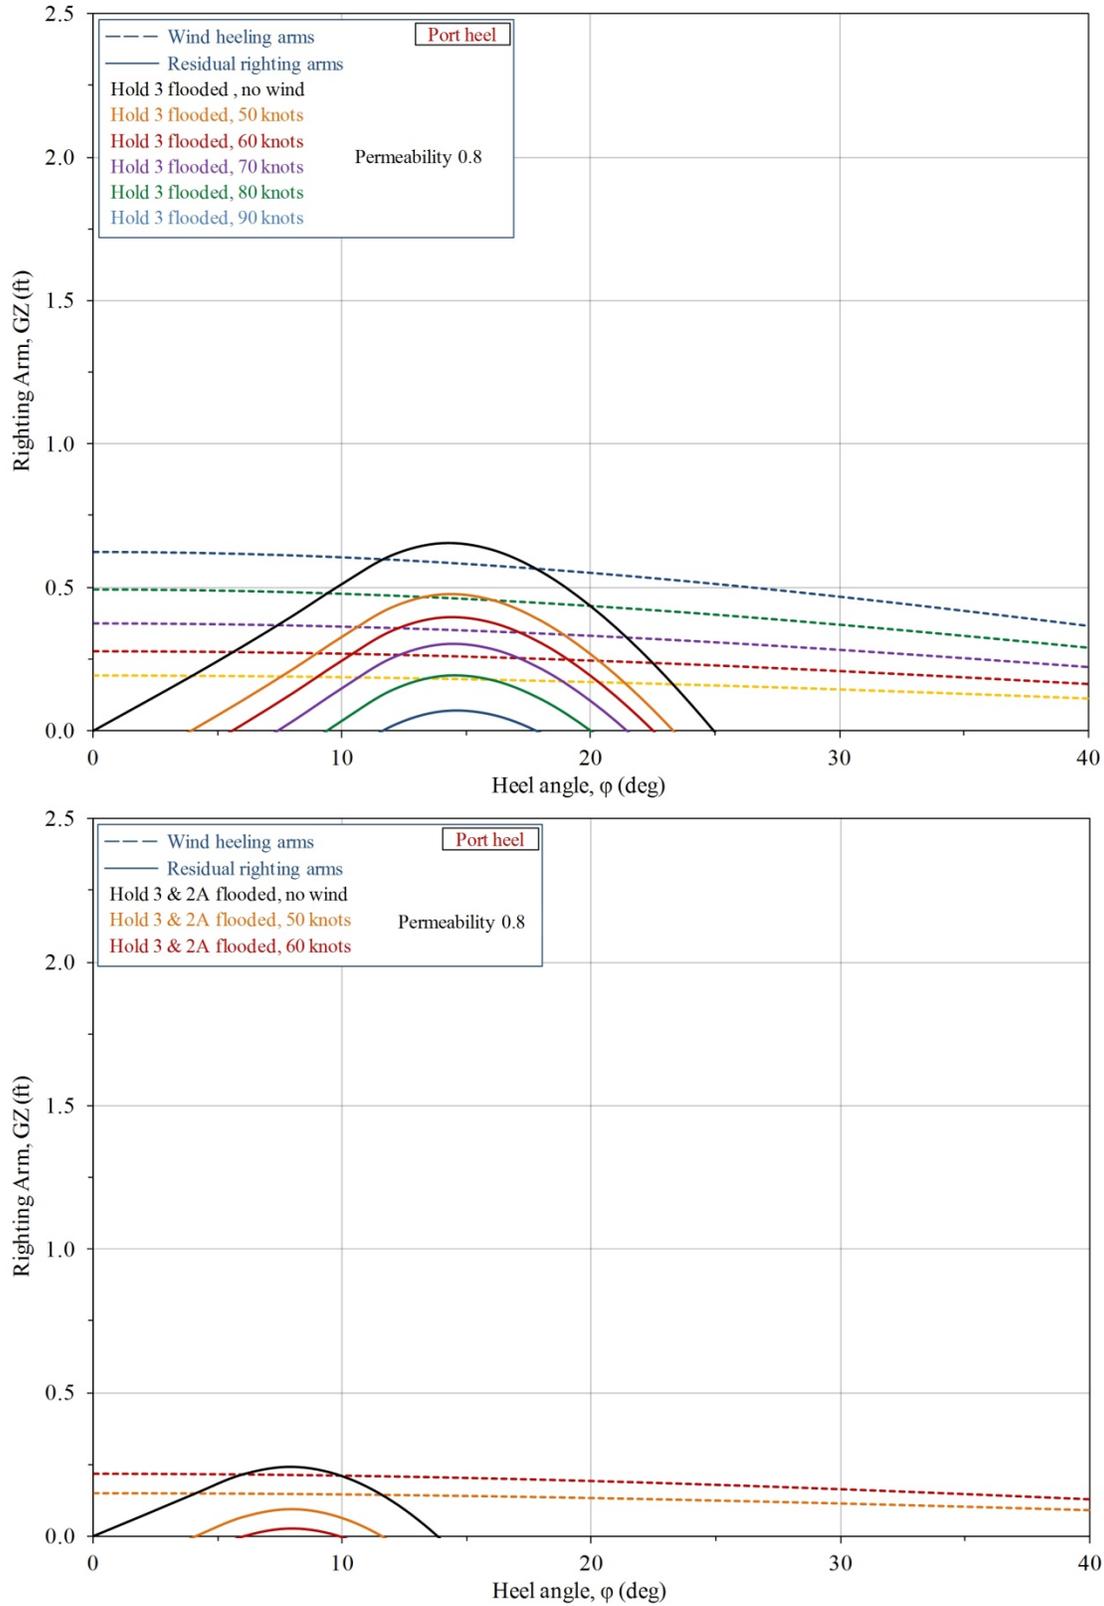
As illustrated in Figure 6-17 and Figure 6-21, flooding of Hold 3 and progressive flooding of Hold 2A would have left the ship with limited righting energy (area under the righting arm curve). The general effects of wind heel on the righting arm curve, including the calculation of residual righting arms and residual righting energy were discussed in Section 6.3. The combination of flooding and wind heel would have left the ship with little or no residual righting energy. Figure 6-22 shows the effects of wind heel on the righting arms with complete flooding of Hold 3 (top) and with complete flooding of Hold 3 and Hold 2A (bottom), both with average permeability of 0.8. Note that intermediate levels of flooding in either case would have reduced righting arms as shown in Figure 6-17 and Figure 6-21. One of the important conclusions that can be drawn from Figure 6-22 is that it is unlikely that the ship could survive uncontrolled flooding into even a single cargo hold with winds in excess of 70 or 80 knots, and it is unlikely that it could survive flooding of more than one cargo hold except in benign conditions with little wind and waves.

As discussed previously, for initial flooding of the lower cargo hold of Hold 3, the effective permeability factor would be closer to 0.7 up to the 20-30% flooding level. Combining these levels of flooding with permeability factor of 0.7 and wind heel in the range 70-90 knots, it can be demonstrated that a wind heel with initial flooding of Hold 3 could lead to a combined wind heel angle of approximately 15 degrees. This is illustrated in Figure 6-23, which shows wind heeling arms for 70, 80 and 90 knot winds and calculated residual righting arms, for flooding levels 10%, 20% and 30% in Hold 3, with permeability 0.7. It is clear that achieving a 15 degree heel angle as stated in the VDR transcript is possible with combined wind heel and initial flooding of Hold 3. Figure 6-24 shows the same calculation information, but shows righting arms with and without 80 knot wind for Hold 3 flooding levels 10%, 20% and 30%. It is important to recognize from these plots that the residual righting energy (area under the righting arm curves) is reduced significantly even for lower levels of flooding up to 30% when considered in combination with 80 knot beam wind. Thus, it is apparent that the vessel would have been in a vulnerable state and susceptible to capsizing even with flooding only of Hold 3, when considering the combined effects of partial flooding, wind heel and roll motion.

Figure 6-22: Wind heeling arms (dashed curves) and residual righting arms (solid curves) with Hold 3 flooded to equilibrium (top) and Hold 3 and Hold 2A flooded to equilibrium (bottom). Permeability is 0.8.

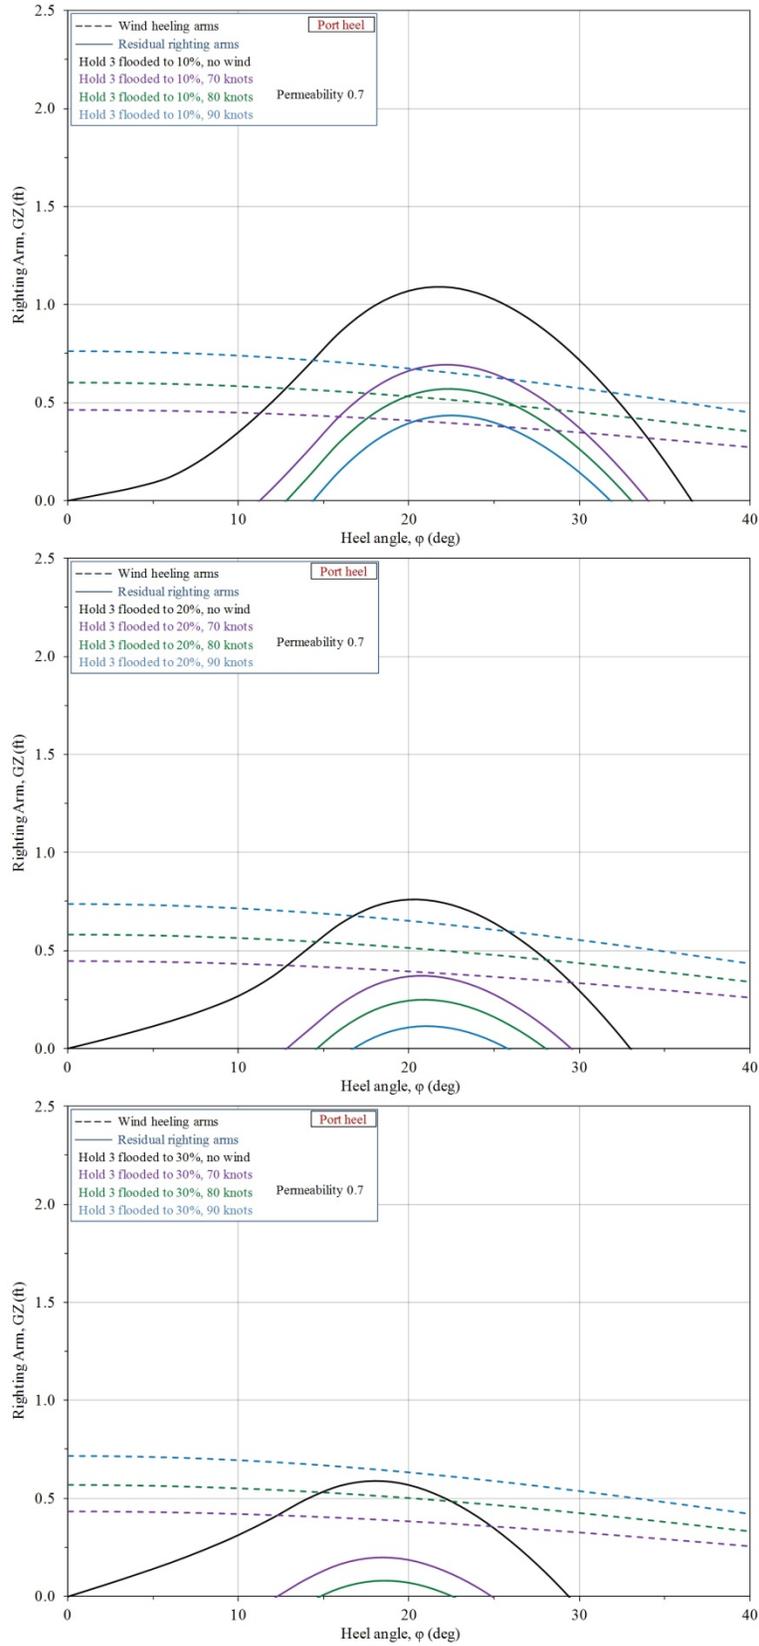
Figure 6-23: Beam wind heeling arms (dashed curves) and residual righting arms (solid curves) with Hold 3 flooded to 10% (top), 20% (middle) and 30% (bottom). Permeability is 0.7.

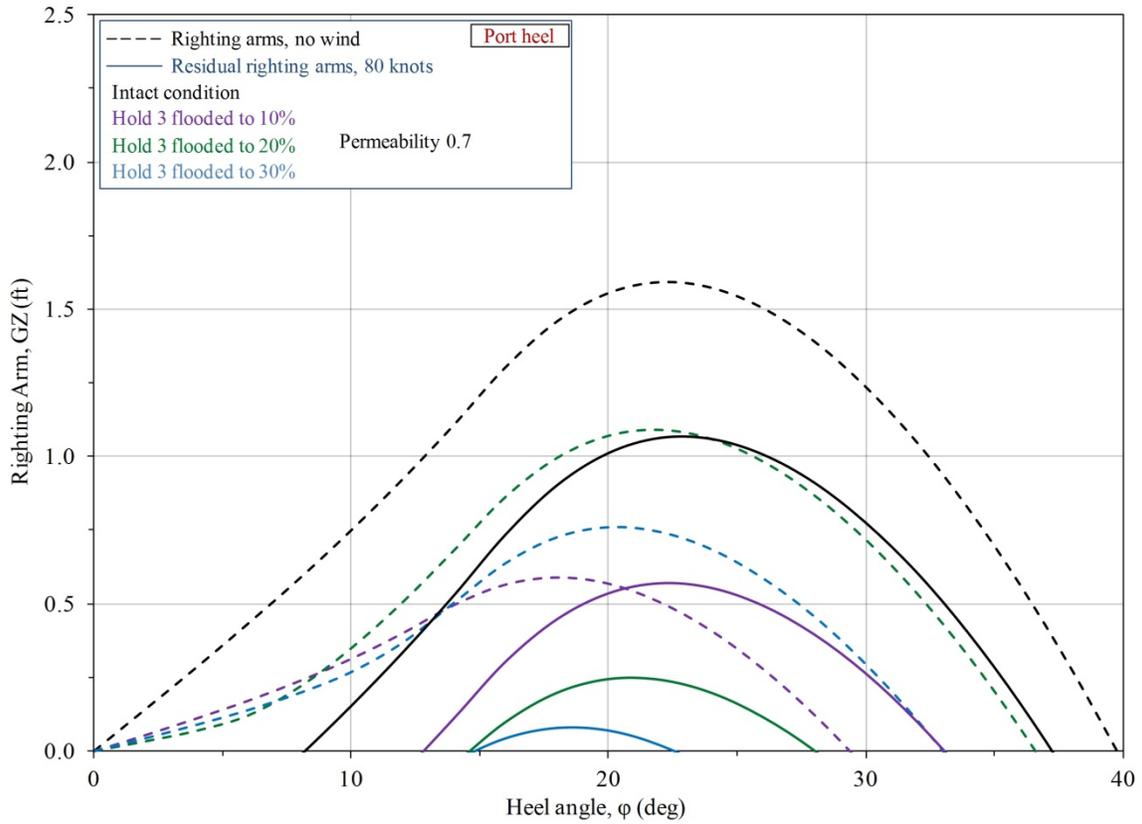
Figure 6-24: Righting arms (dashed curves) and residual righting arms (solid curves) for 80 knot beam winds with Hold 3 flooded to 10%, 20%, and 30%. Permeability is 0.7.

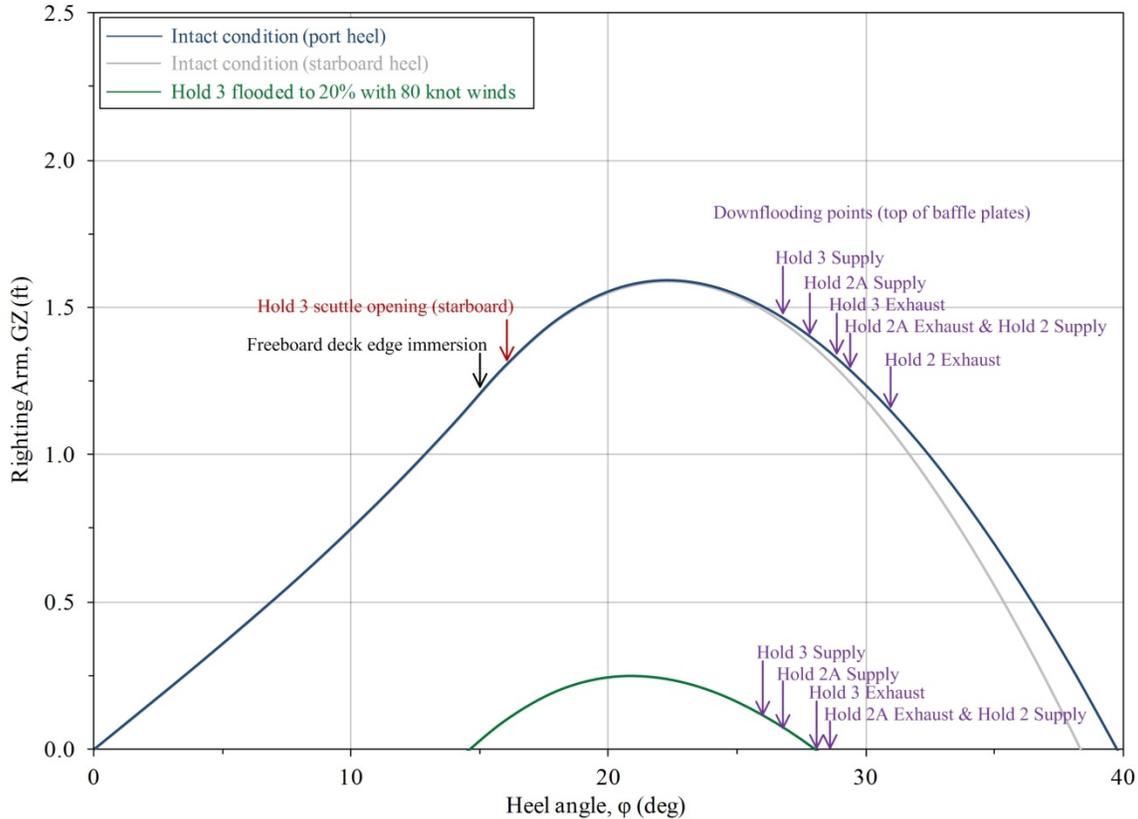
The flooding vulnerability presented by the cargo hold ventilation system was discussed in Section 6.4 and downflooding points were listed in Table 6-2. Downflooding angles for these points are tabulated and plotted on the righting arm curves for the intact condition at loss of propulsion (without flooding) and for the condition with Hold 3 flooded to 20%. Table 6-5 provides the downflooding angles for the listed points and Figure 6-25 plots downflooding points for each hold on the righting arm curves.

Figure 6-25: Righting arm curves with annotated downflooding angles from Table 6-5: intact condition (at loss of propulsion, without flooding) and Hold 3 flooded to 20% with 0.7 permeability and 80 knot winds.

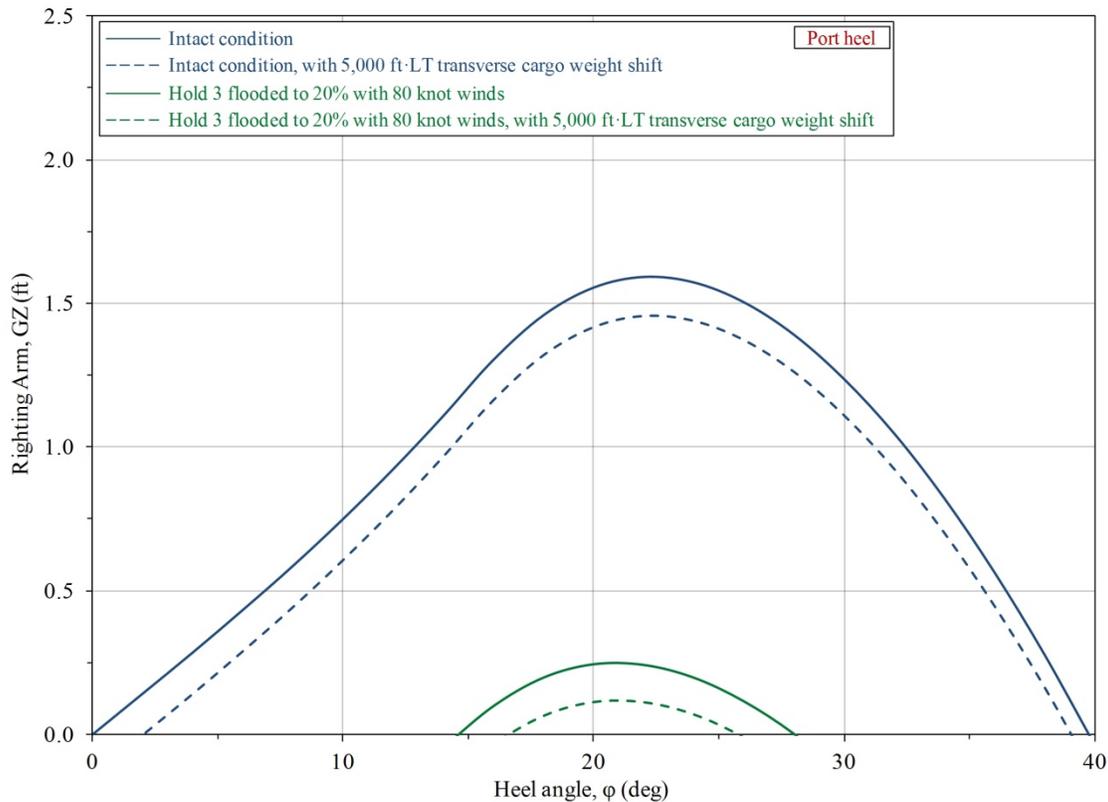
In the foregoing analyses, no consideration was given to the impact of cargo shifting, or cargo loss. Although there was no mention specifically of large-scale cargo shift or loss until the very end of the VDR audio as the vessel slowly capsized, there was one mention of a single trailer cargo shift which was witnessed by the Chief Mate at 0436 [64 (pg. 380)] and there was some discussion of automobiles breaking free and floating in Hold 3 [64 (pg. 486)]. Cargo shifting can best be considered in this analysis as a transverse weight shift; specifically a given transverse moment which might be calculated based on shifting of a given number of trailers or containers by a given transverse distance. This is illustrated in Figure 6-26 below, which shows the effects of a transverse moment applied to the intact condition (at the loss of propulsion, not including floodwater and beam wind) and the condition with Hold 3 flooded to 20% with 80 knot beam winds. The 5,000 ft·LT transverse moment (weight multiplied by distance shifted) is shown as an example and is based on a notional shift of 20 containers of weight 25 LT each, shifting an average 10 feet. The net effect of any transverse weight shift is equivalent to a transverse shift in the ship’s center of gravity, which results in a reduction in the righting arms and a list as shown. Note that in this case, even a 5,000 ft·LT transverse weight shift produces small reductions in righting arms and small induced heel angles, when compared to large reductions in righting arms and induced heel angles due to floodwater and hurricane force beam winds as discussed

previously. However, it should be noted that even small transverse shifts in containers would exacerbate effects of floodwater and beam winds.

Figure 6-26: Comparison of righting arm curves with effects of transverse cargo weight shifts: intact condition (at loss of propulsion, without flooding) and Hold 3 flooded to 20% with 0.7 permeability and 80 knot winds.

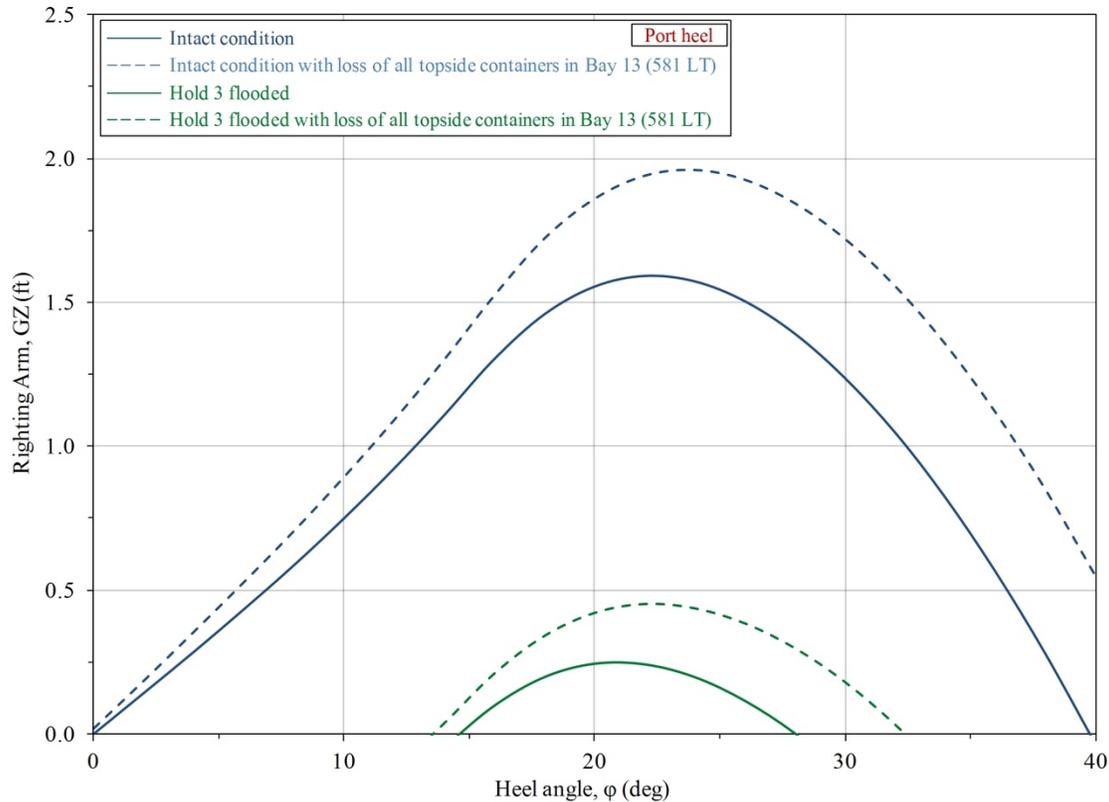
The complete loss of topside containers as the vessel took heavy rolls in the seaway or while capsizing would actually lead to a temporary improvement in the stability condition of the vessel. This is the case because complete loss of topside containers would necessarily lower the ship’s center of gravity and increase righting arms, providing temporary additional righting energy and stability margin. This is illustrated in Figure 6-27, which shows for an example the potential effects of a complete loss of all containers in Bay 13 (581 LT) applied to the intact condition (at the loss of propulsion, not including floodwater and beam wind) and the condition with Hold 3 flooded to 20% with 80 knot beam winds. However, it is also feasible that entire bays of containers or sections of bays could lose structural integrity and experience partial failure or deformation and lean to one side without actually washing overboard. This has occurred on container vessels in heavy seas in recent years, including as a consequence of so-called “parametric” roll motions. In this case, the results would be similar to those of container shifting shown in Figure 6-26 for example. There was, however, no statement made by the EL FARO crew on the VDR audio transcript regarding the loss or shifting of topside containers, until just prior to vessel capsizing at 0729 when it was noted that containers were in the water [64 (pg. 498)].

Figure 6-27: Comparison of righting arm curves with complete loss of all containers in Bay 13 for example: intact condition (at loss of propulsion, without flooding) and Hold 3 flooded to 20% with 0.7 permeability and 80 knot winds.
