UNITED STATES COAST GUARD

**REPORT OF THE MARINE BOARD OF INVESTIGATION
INTO THE
STEAM SHIP EL FARO (O.N. 561732)
SINKING AND LOSS OF THE VESSEL
WITH 33 PERSONS MISSING AND PRESUMED DECEASED
NORTHEAST OF ACKLINS AND CROOKED ISLAND,
BAHAMAS
ON OCTOBER 1, 2015**

**STEAM SHIP EL FARO (O.N. 561732) SINKING AND LOSS OF THE VESSEL WITH
33 PERSONS MISSING AND PRESUMED DECEASED NORTHEAST OF ACKLINS
AND CROOKED ISLAND, BAHAMAS ON OCTOBER 1, 2015**

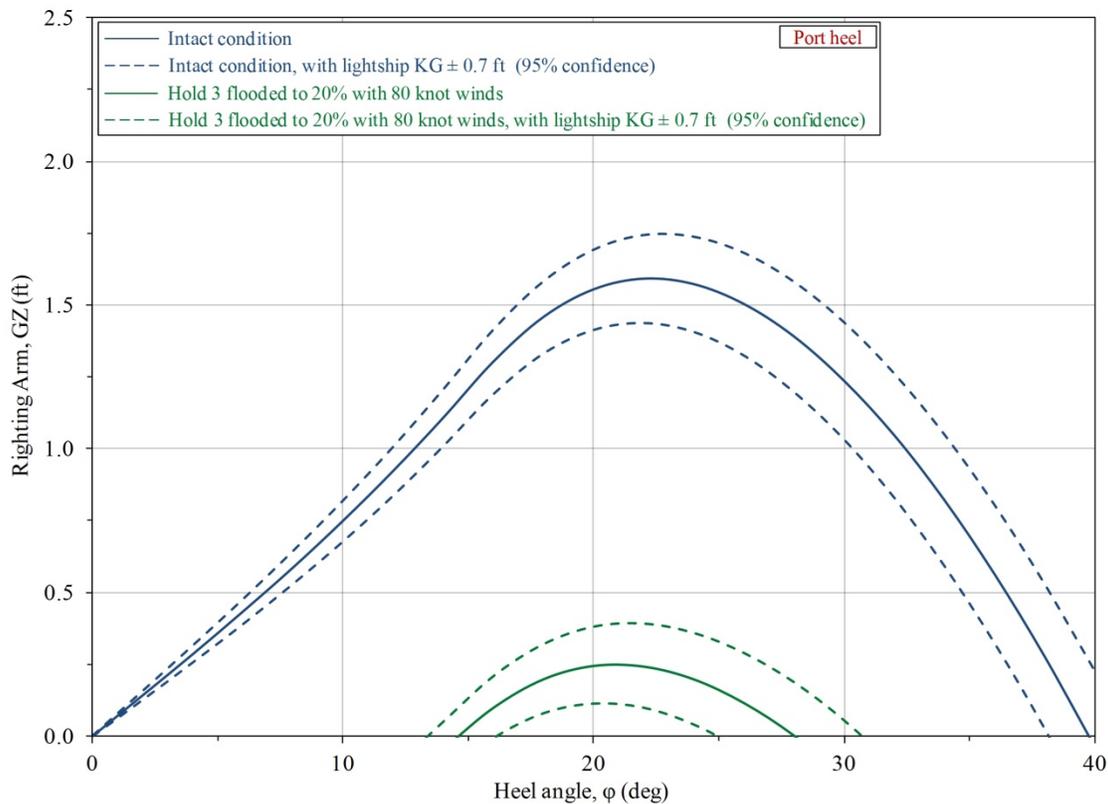
To conclude this section, it should be noted that all of the hydrostatic sinking analyses are based on an assumption that the weight and center of gravity of the vessel and its cargo are fairly well defined based on the departure loading condition documentation. However, based on the propagation of uncertainty from the 2006 stability test (see Section 3 and Appendix A of this

report), there exists a 95% confidence that uncertainty in the height of the center of gravity (KG) is on the order of 0.7 ft for the departure condition and for the lightship condition (see Table 3-2). These uncertainties could be considered in assessing the previous analyses, or should at least be used as a reminder of the uncertainty in any calculated results. To illustrate, Figure 6-28 provides a comparison of the righting arms for the accident voyage loading condition prior to the loss of propulsion (intact condition) and with Hold 3 flooded to 20% with 80 knot beam winds, with uncertainty in calculated lightship KG included. It should be noted that these righting arm curves include the uncertainty in the lightship KG, but do not include the additional uncertainty in the cargo and tank loading and weight and free surface associated with the floodwater. The primary point in illustrating this is to highlight the significant impact that uncertainty in the assumed lightship KG has on the righting arms. Note that for all of the previous righting arm plots, significant differences would exist in the calculated angle of wind heel and residual righting energy, depending on the desired level of confidence in the results.

Figure 6-28: Comparison of righting arm curves with effects of uncertainty in lightship KG considered: intact condition (at loss of propulsion, without flooding) and Hold 3 flooded to 20% with 0.7 permeability and 80 knot winds.

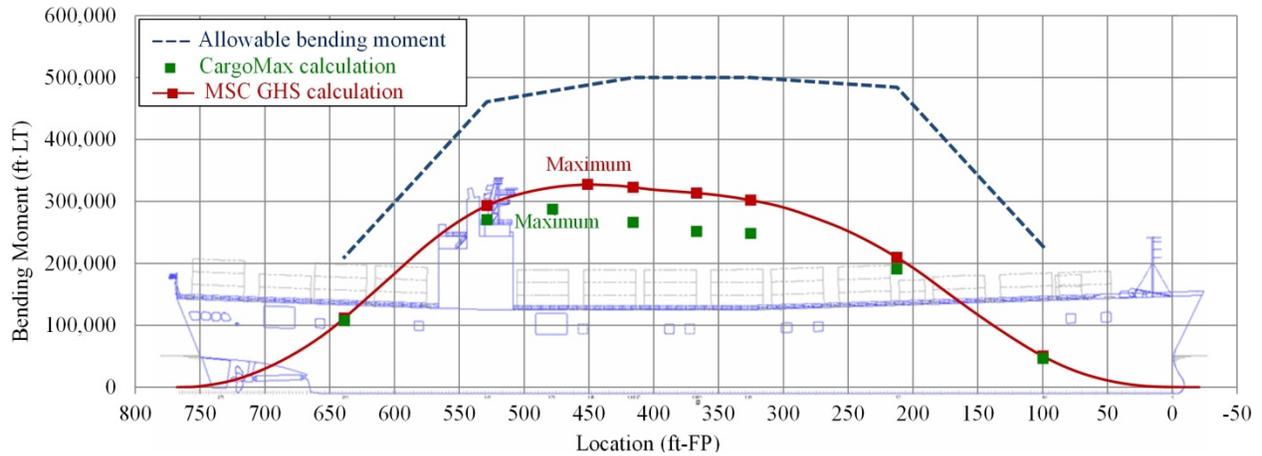
As discussed in Section 2 of this report, a lightship weight distribution was created for the MSC GHS computer model, and bending moment calculations were included in assessment of the accident voyage 185S departure condition. Figure 7-3 provides a plot of the calculated still water bending moments. For comparison, bending moments calculated by CargoMax are included, along with the allowable still water bending moment.

The bending moments calculated using the MSC GHS computer model are approximately 13% higher amidships compared to the CargoMax values, but are still within the ABS allowable bending moment limits. The differences in calculated bending moments can be attributed to differences in the estimated lightship weight distribution.

Figure 7-3: Calculated and allowable still water bending moments for the accident voyage 185S departure condition.

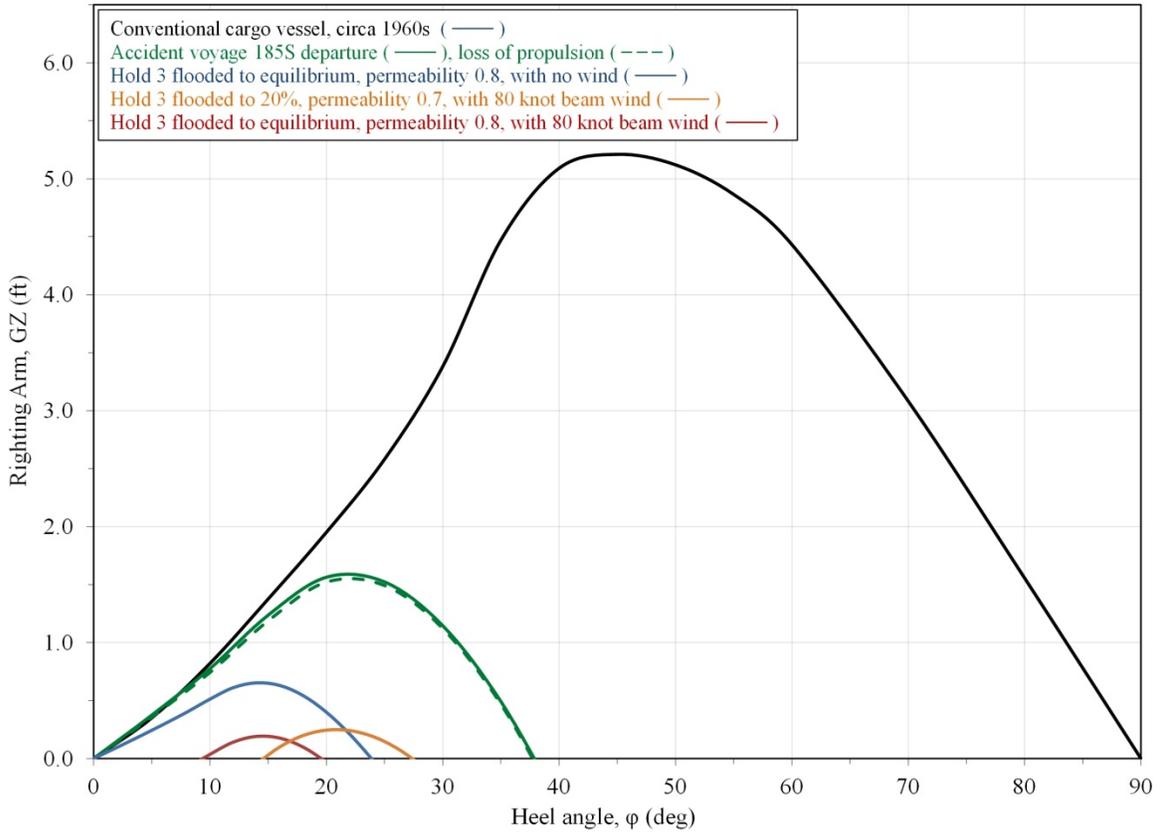
Figure 8-1: Righting arm curves for the accident voyage, with comparison to a conventional cargo vessel (conventional vessel curve reproduced from [51] with permission).

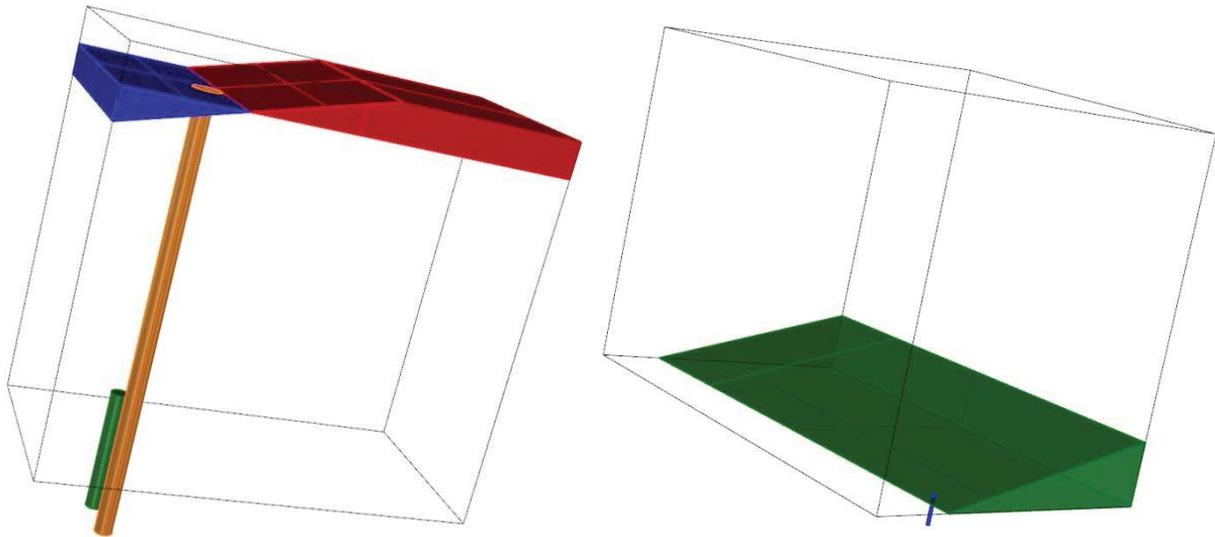
**Figure 6. Isometric Views of Gravity Tank (left) and Storage Tank (right) Pocketing
15° Port List; 3.5 ft (0.3°) Aft Trim⁵**

⁵ The volume shown in red represents the additional lube oil which would be accommodated as the vessel approaches this 15° list condition from 0° list, with the tank continuously filling via the supply pipe. The volume in blue represents the lube oil lost through the overflow pipe under this scenario.

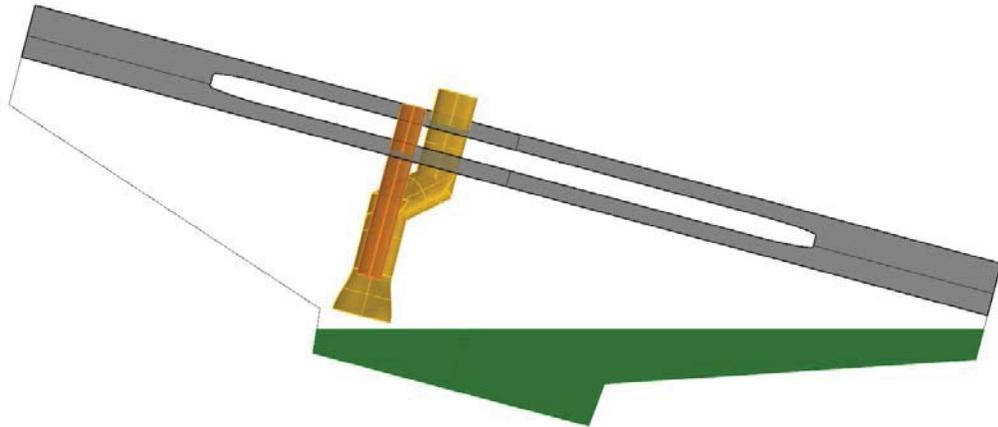
- (1) Design Low Level Capacity The following three figures are for the sump at a loading volume of 724 gallons (18 inch sounding), which is the design low level capacity noted in MBI Exhibit 352, and for which applicable rules for lube oil system design require continued operation under certain combinations of list and trim, as indicated in the CG-INV memorandum. Although visualizations for the vessel in a starboard list condition are not included, the MSC model showed the

suction pipe opening to be fully immersed when in a 15° starboard list for all three trim conditions shown in these figures.

**Figure 7. End View of Sump for the Design Low Level Capacity
15° Port List; 0° Trim**

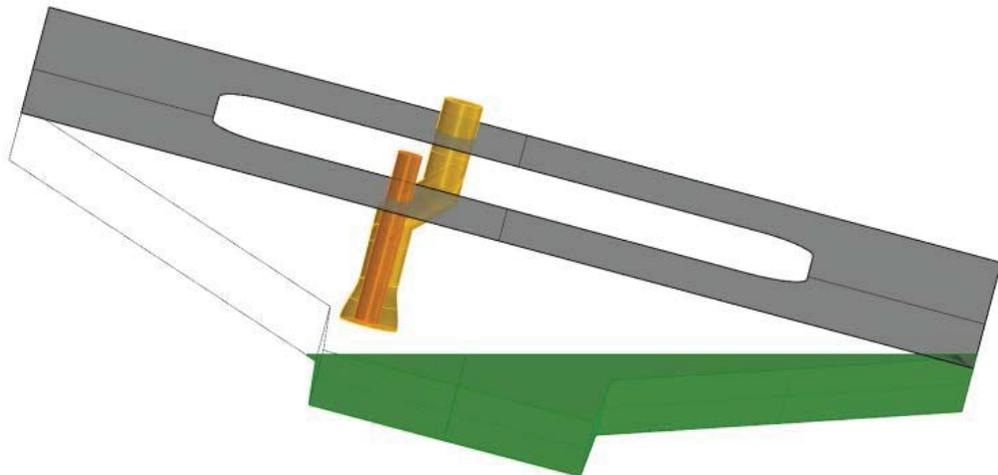
**Figure 8. End View of Sump for the Design Low Level Capacity
15° Port List; 5° (64.2 ft) Trim by the Bow**

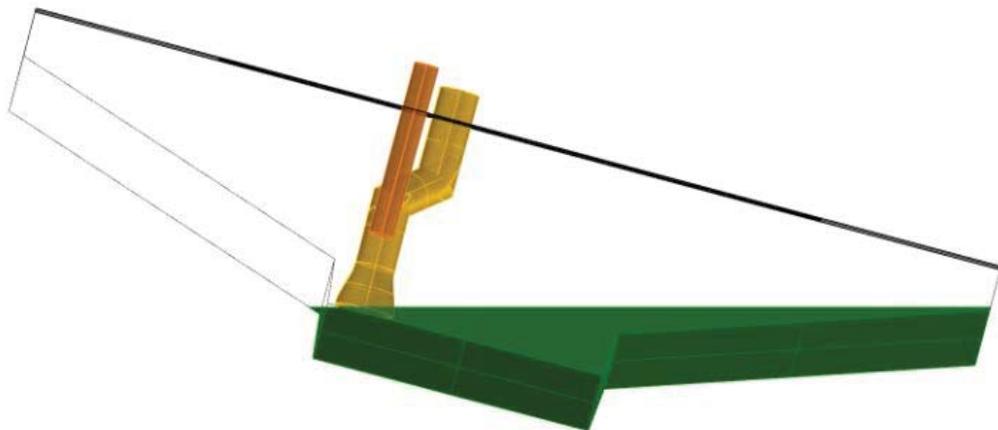
**Figure 9. End View of Sump for the Design Low Level Capacity
15° Port List; 5° (64.2 ft) Trim by the Stern**

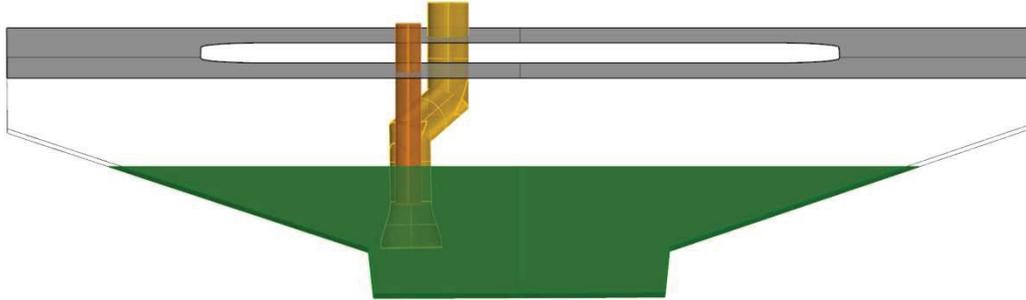
- (2) Accident Voyage Departure Loading The following two figures are for the sump at the accident voyage departure loading volume of 163.8 ft^3 , as taken from the EL FARO CargoMax printout for the accident voyage (MBI Exhibit 059). These visualizations have been corrected from those used in the animation presented at the MBI public hearing. Both depict a trim of 5 ft by the stern, which corresponds to an angle of 0.4° . Figure 11 shows the suction pipe opening breaking the lube oil surface, indicating a potential loss of suction at an 18° static list (as opposed to 19° shown in the animation). Per the CG-INV memorandum request, starboard list conditions were not examined for this trim.

**Figure 10. End View of Sump for the Accident Voyage Departure Loading
 0° List; 5 ft (0.4°) Trim by the Stern**

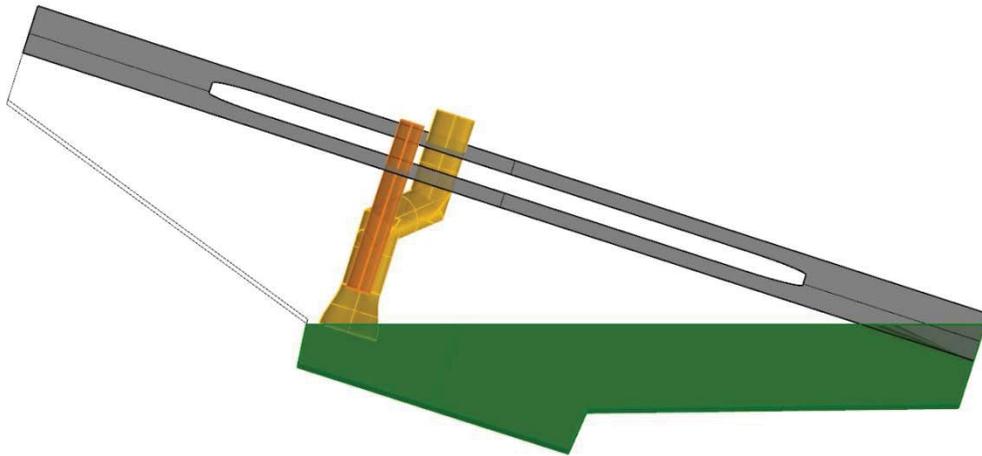
The Coast Guard MSC Lube Oil Modeling and Analyses of EL FARO¹⁴⁴ demonstrated that the lube oil system suction pipe bell mouth opening in the lube oil sump tank, using the 24.6” departure sounding obtained from the CargoMax entry, would have broken above the lube oil surface, resulting in a potential loss of suction at an 18° static list to port (see figures 9 and 10 below).

**Figure 11. End View of Sump for the Accident Voyage Departure Loading
 18° Port List; 5 ft (0.4°) Trim by the Stern**
