UNITED STATES COAST GUARD

**REPORT OF THE MARINE BOARD OF INVESTIGATION
INTO THE
COMMERCIAL FISHING VESSEL DESTINATION
SINKING AND LOSS OF THE VESSEL
WITH ALL SIX CREWMEMBERS
MISSING AND PRESUMED DECEASED
APPROXIMATELY 4.4 NM NORTHWEST OF
ST. GEORGE ISLAND, ALASKA
ON FEBRUARY 11, 2017**

16732
27 February 2019

**COMMERCIAL FISHING VESSEL DESTINATION (O.N. 632374)
SINKING AND LOSS OF VESSEL
WITH ALL SIX CREWMEMBERS MISSING AND PRESUMED DECEASED
APPROXIMATELY 4.4 NM NORTHWEST OF ST. GEORGE ISLAND, ALASKA ON
FEBRUARY 11, 2017**

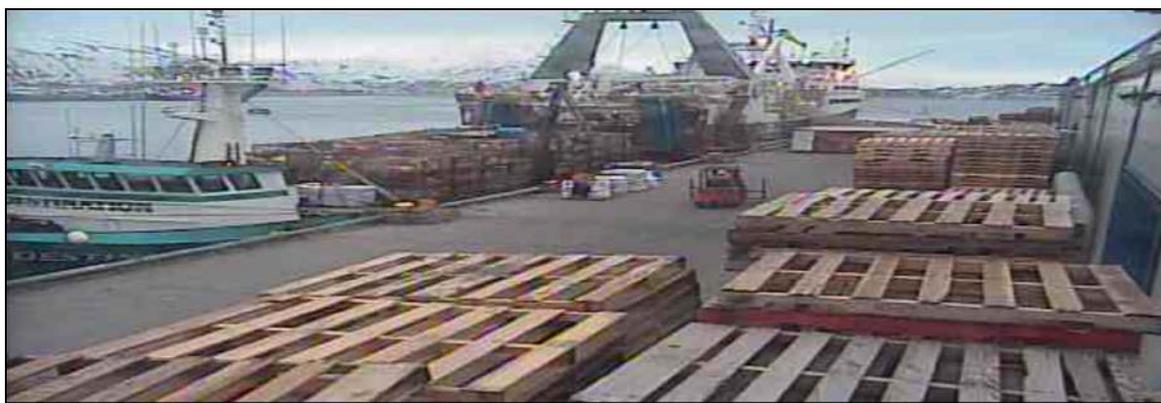
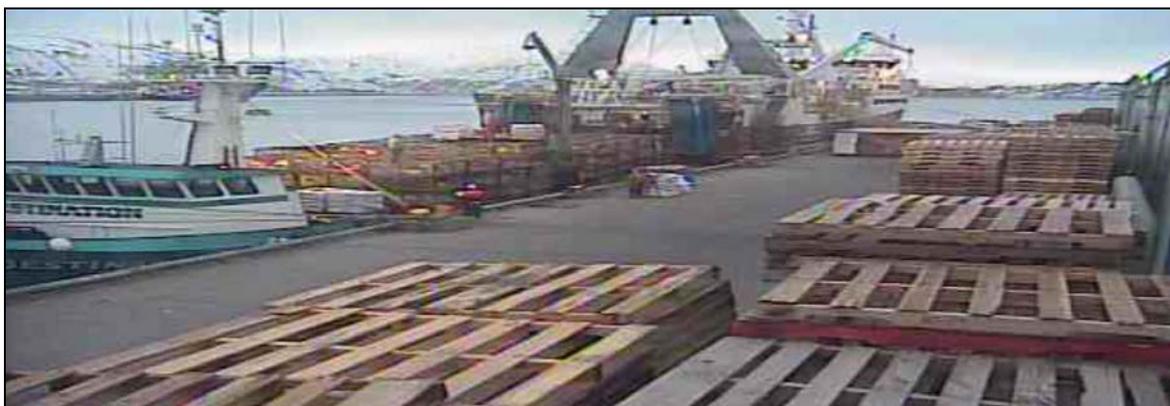
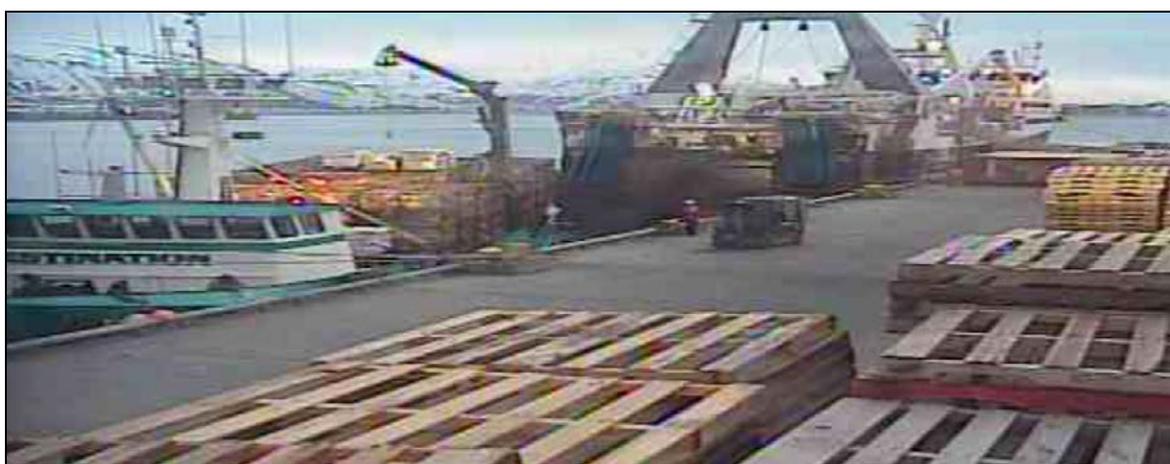
4.1.16. While moored at the Kloosterboer Cold Storage facility from approximately 1830 to 1900, the DESTINATION's crew loaded four pallets of squid bait weighing a total 7,060 pounds. The bait was loaded four-across on top of the crab pots, amidships, next to two totes and a sorting table. Figures 6, 7, and 8 are screenshots from the facility's security camera taken shortly after the vessel moored and as the vessel's crew loaded bait.

Figures 6. Still image from security camera video provided by Kloosterbor Cold Storage of the DESTINATION loading bait at their facility on February 9, 2017, at approximately 1830-1900.

Figures 7. Still image from security camera video provided by Kloosterbor Cold Storage of the DESTINATION loading bait at their facility on February 9, 2017, at approximately 1830-1900.

Figures 8. Still image from security camera video provided by Kloosterbor Cold Storage of the DESTINATION loading bait at their facility on February 9, 2017, at approximately 1830-1900.

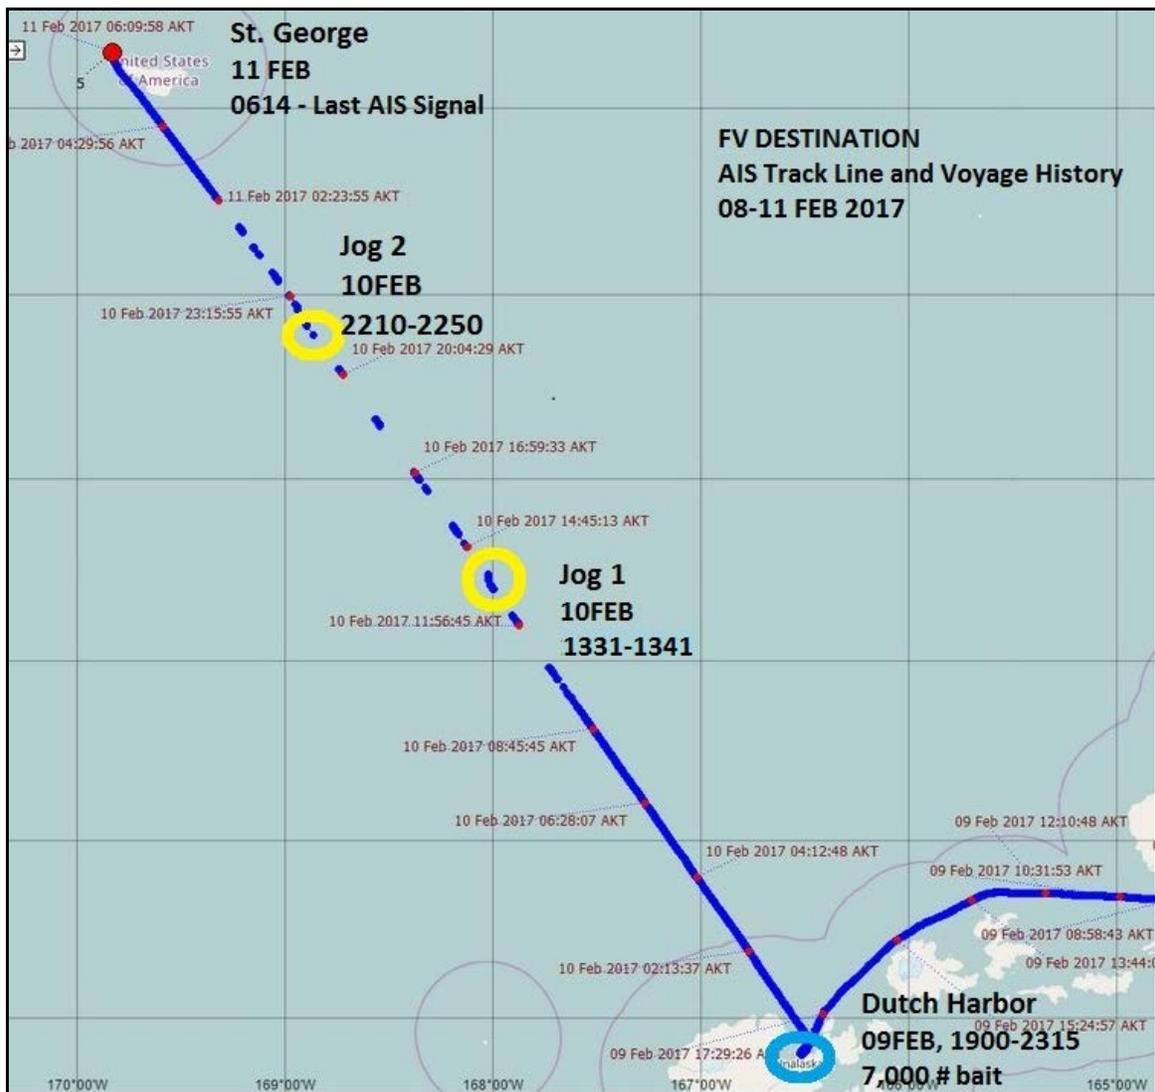
4.1.27. The DESTINATION’s AIS track indicates, on two separate occasions during the voyage to St. Paul, the vessel “jogged” into the seas (headed into the wind and/or slowed down). The first occasion was on February 10, 2017 from approximately 1331 to 1341 (10 minutes). The second jog occurred when the vessel reduced its speed from 6.5 knots down to 1.5 knots from approximately 2210 to 2250 (40 minutes). Figure 9 indicates the approximate locations and times of these jogs. Figures 10 and 11 provide more detailed AIS data of each jog.

Figure 9. AIS track line indicating the locations and times the DESTINATION conducted two jogs while en route to St. Paul. AIS track line provided by Alaska Marine Exchange. Illustration produced by the MBI.

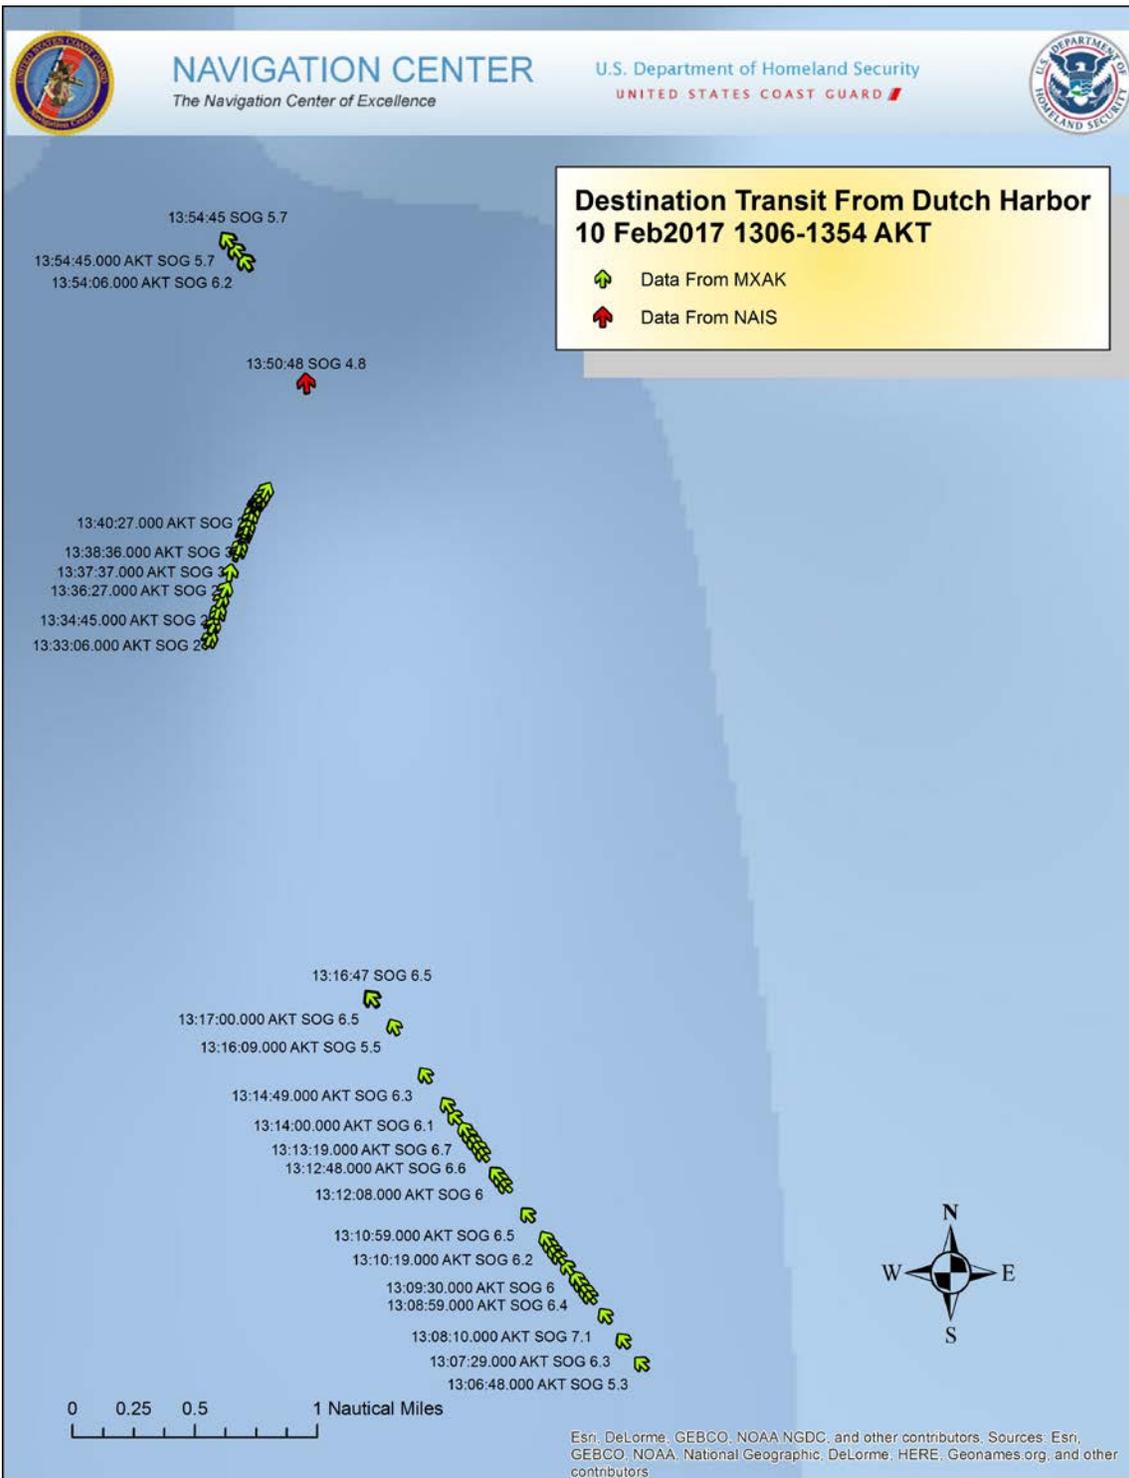
Figure 10. AIS track of the DESTINATION's first jog while en route to St. Paul. Provided by Coast Guard Navigation Center.

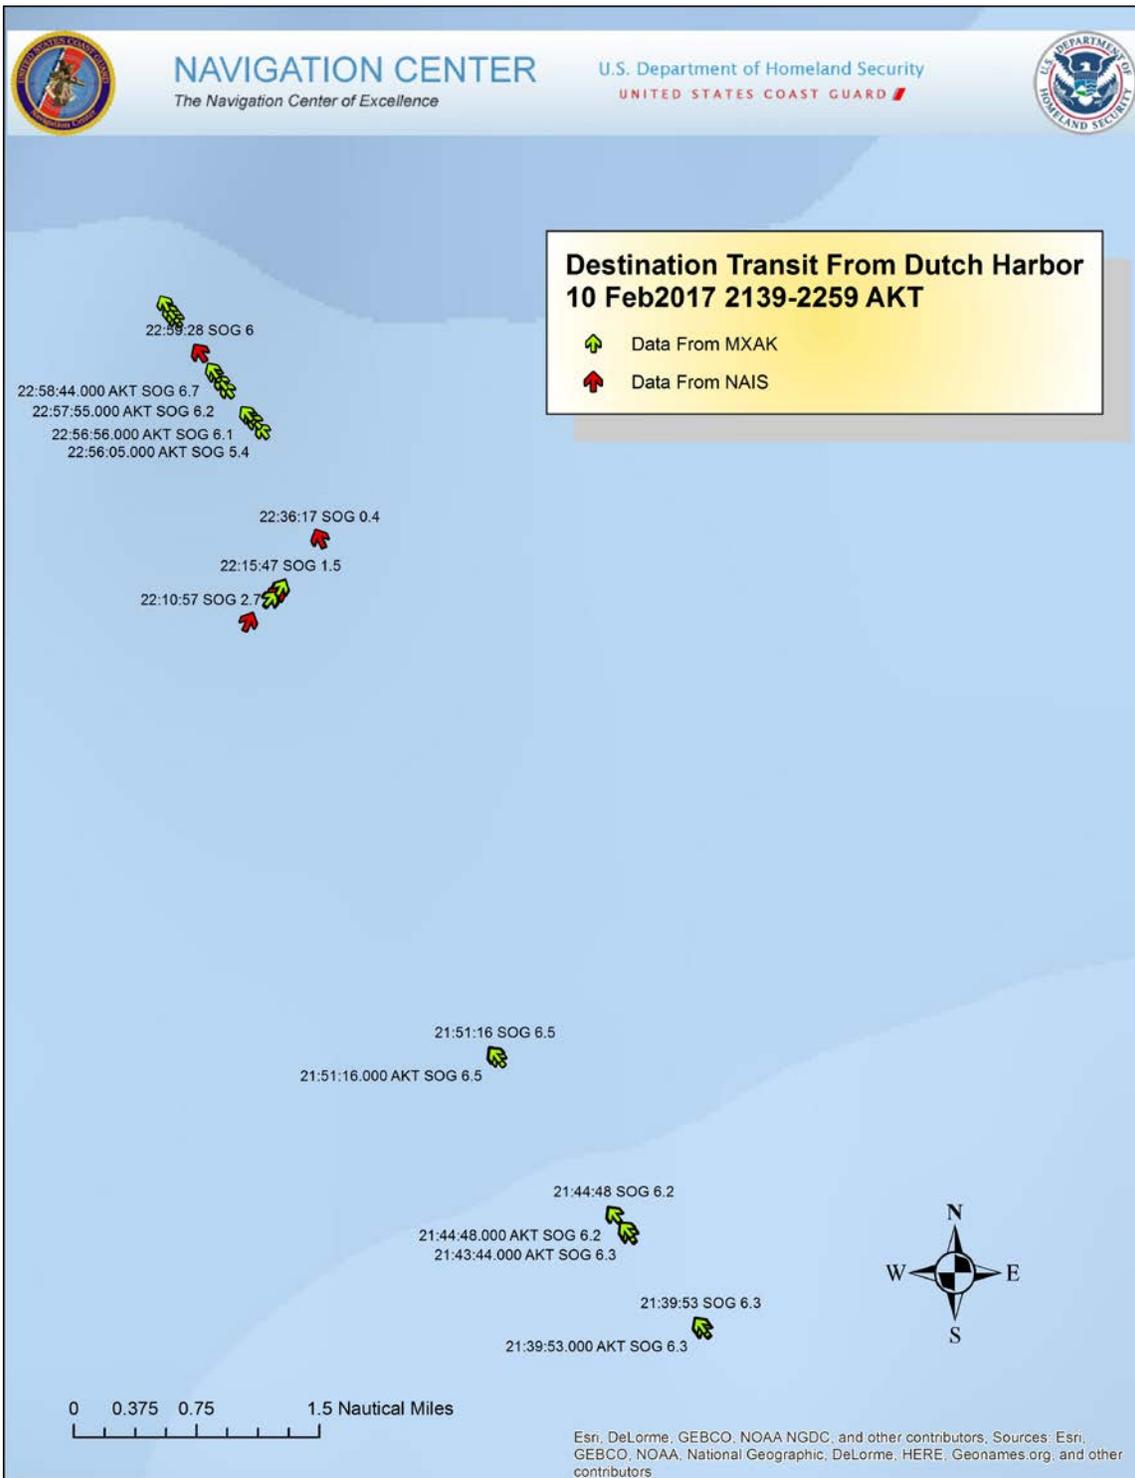
Figure 11. AIS track of the DESTINATION's second jog while en route to St. Paul. Provided by Coast Guard Navigation Center.

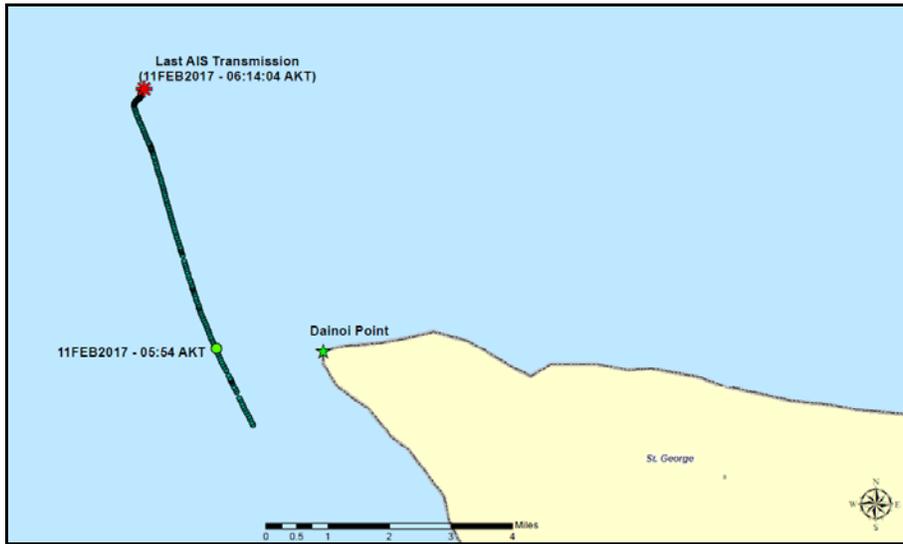
4.1.33. From approximately 0612 to 0614, the vessel's heading shifted to starboard from 090° to 270°. At the same time, the vessel's COG continued to the north at a SOG between 1-2 knots. Figures 14, 15 and 16 provide the vessel's AIS track which indicates the changes in heading, COG and SOG.

Figure 14. DESTINATION's AIS as it made its starboard turn on February 11, 2017 between 0554-0614. Image developed by MBI.

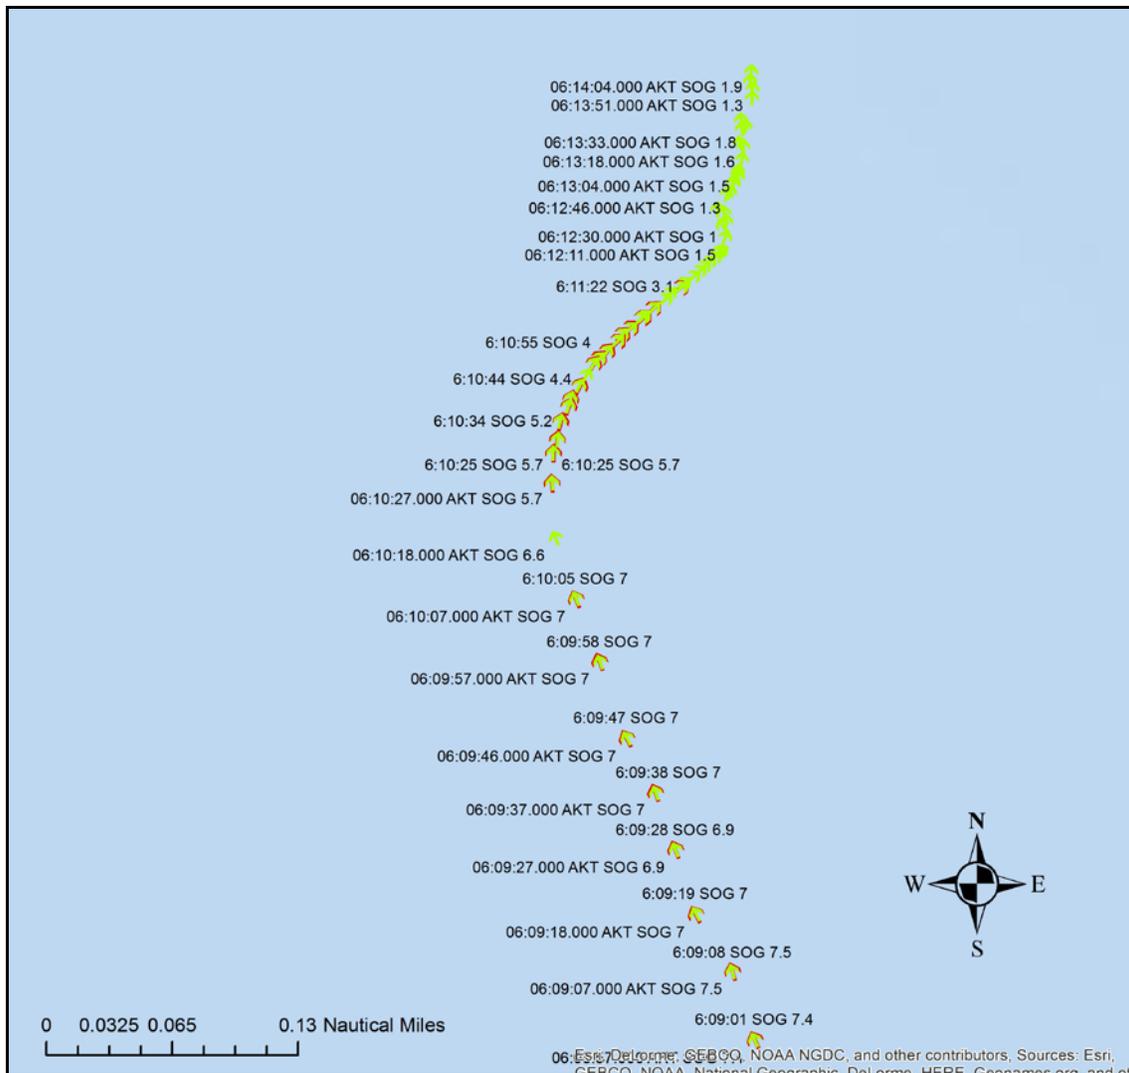
Figure 15. DESTINATION's AIS as it made its starboard turn on February 11, 2017 between 0609-0614. Image developed by Coast Guard Navigation Center.

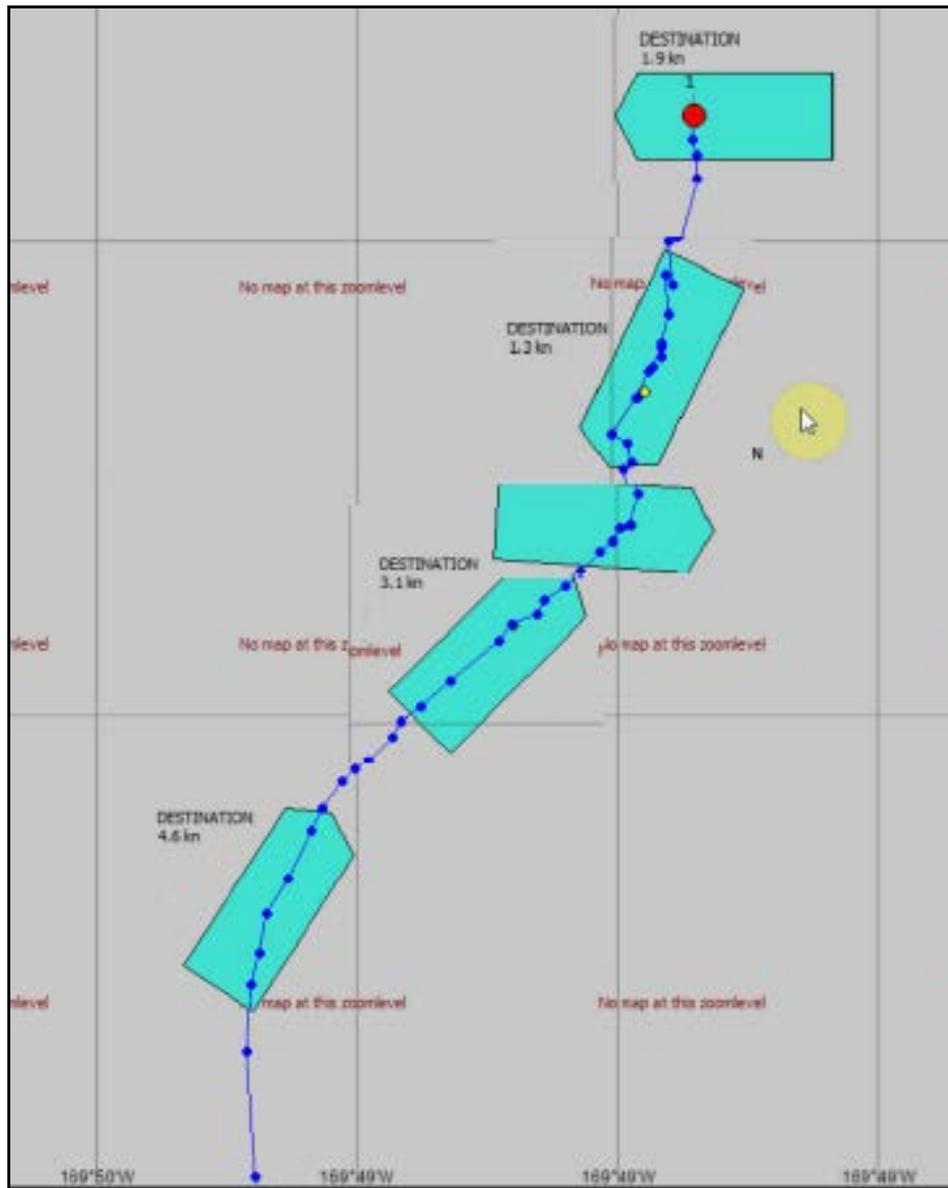
Figure 16. AIS track information indicating changes to the DESTINATION's heading and COG on February 11, 2017, between 0610-0614. AIS track information provided by Alaska Marine Exchange and image developed by MBI.

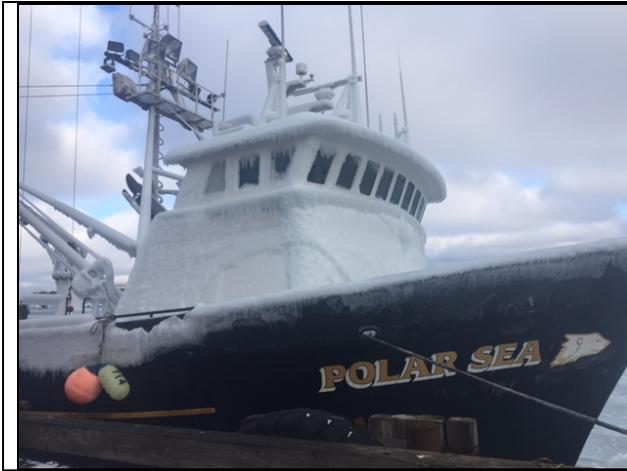
Figure 25

4.3.13. The captain of the POLAR SEA stated during the transit towards St. Paul Island on February 10, 2017, his vessel experienced "wind at about 35, 35 to 40 and I would say about a 15-foot sea." The vessel accumulated ice from freezing spray, requiring his crew to break ice off the decks. The captain stated that he stopped transiting four times on February 10, 2017 so his crew could work breaking off the ice, with each evolution lasting about five hours each. Figures 25-28 are pictures taken by the captain of ice accumulations on the POLAR SEA.

Figures 25-28. Photos taken by the captain of the POLAR SEA of ice accumulations during its transit towards St. Paul Island on February 10, 2017.

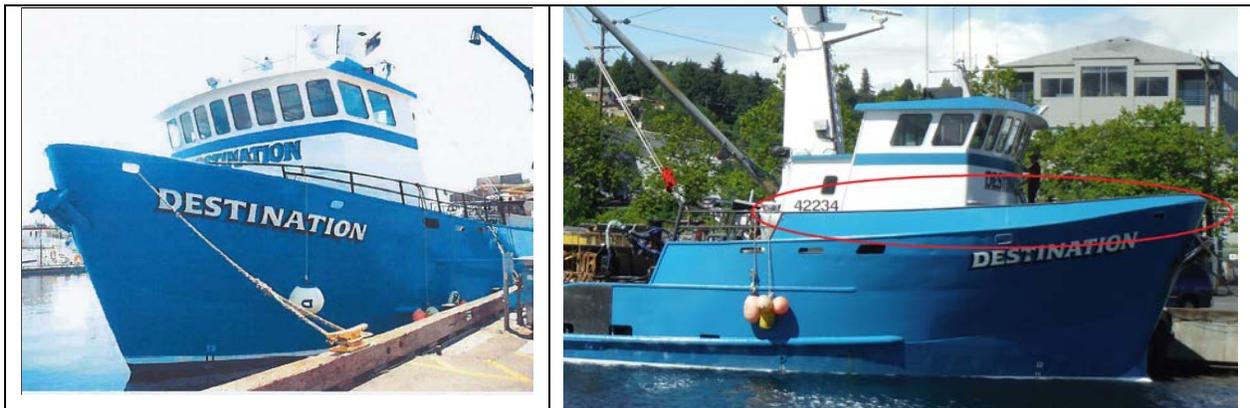
4.5.31. Figure 42 is a picture of the DESTINATION during a July 6, 2009 Report of Survey. Figure 43 is a picture of the vessel during its June 7, 2016 Valuation and Survey of Condition. These pictures illustrate a solid bulwark was installed between the 2009 and 2016 surveys.

Figures 42 and 43. Pictures of the DESTINATION taken by the Marine Surveyors during valuation surveys conducted in July 2009 and June 2016, respectively. Circled in red is the new bulwark installed in May 2011.

4.5.32. During the May 2011 dry-dock at Marine Fluid Systems Inc., the owner installed a new bulwark on the foredeck at the bow. A Marine Fluid Systems Inc. invoice dated May 9, 2011 described the installation as “bow additions/caprail” consisting of 264 square feet of 5/16-inch plate. Figure 43 illustrates the new bulwark.

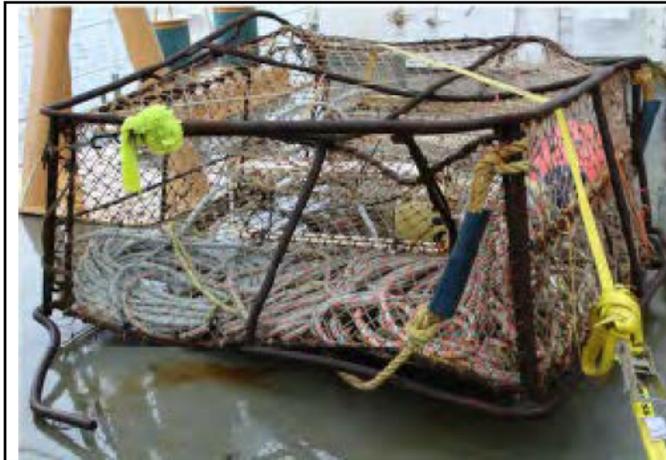
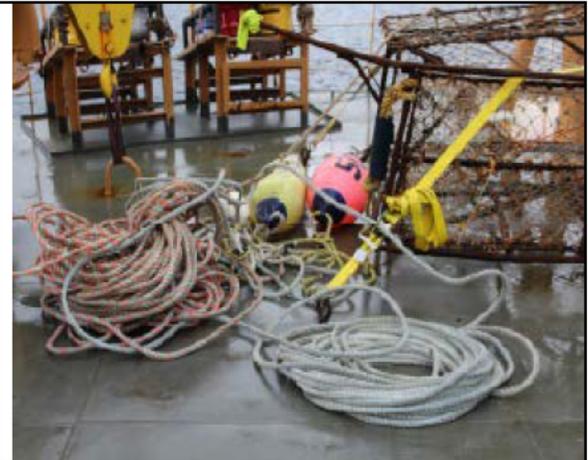
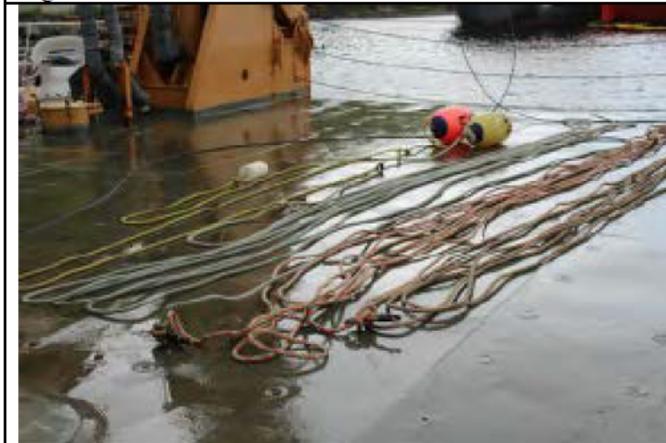
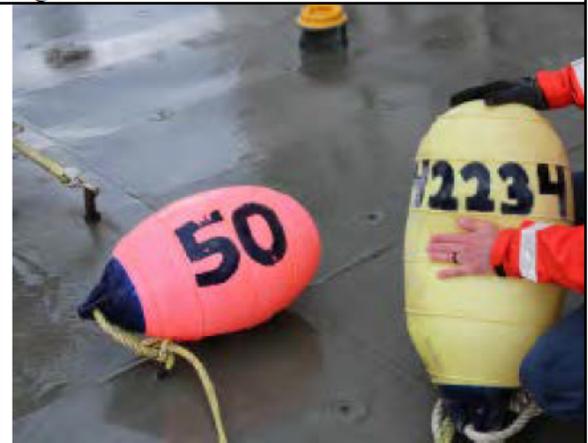
4.6.9. The crab pot was damaged, but measurements taken indicate a top bar length of 7 feet by 7 feet, and a depth overall of 32 inches. The pot contained two buoys, each stenciled with a number. The larger yellow buoy had “42234” and the smaller red buoy had “50”. The “42234” matches the DESTINATION’s ADF&G shellfish vessel registration number. There were three ¾ inch lines in the pot, two red and one light blue. When faked out on deck, the red lines measured at 177 and 197 feet, and the blue line measured at 189 feet. The combined weight of the gear (buoys and line) was 140 pounds, and the pot itself weighed 700 pounds, for a total combined weight of 840 pounds.

Figures 46-49. Photos of recovered crab pot examination taken by MSD Dutch Harbor vessel examiners.

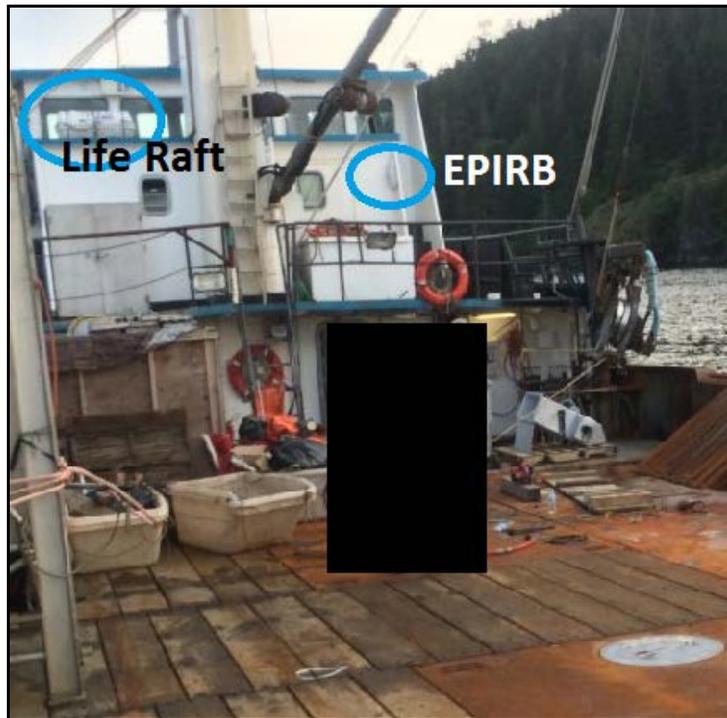
4.7.3. As illustrated in Figure 52, the inflatable liferaft was located on the port side on top of the captain’s cabin, aft of the wheelhouse. The EPIRB was stored on the starboard side, on the aft bulkhead of the captain’s cabin.

Figure 52. Locations of the liferaft and EPIRB.
Undated photo taken and provided by former crewmember.

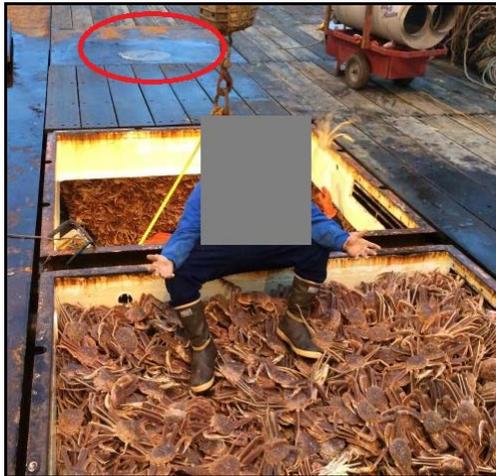
4.8.22. While in transit with pots on deck, the captain consistently directed the crew to keep access covers to number 1 and 2 holds closed and number 3 off. Figure 55 shows the access hatch cover to number 3 hold located on deck aft of the open number 2 hold hatch. The cover was typically stored on deck in close proximity to the number 3 hold.

Figure 55. Number 3 hold access hatch, circled in red.
Photo taken and provided by former crewmember.

4.8.23. One former crewmember stated, "When I was on the boat, I had a hatch cover open on the aft tank...The engineer said, [the captain] wants it that way, and that was the way it was." Another former crewmember stated, "Tank 3, we usually left the hatch off. Actually, we always left the hatch off."

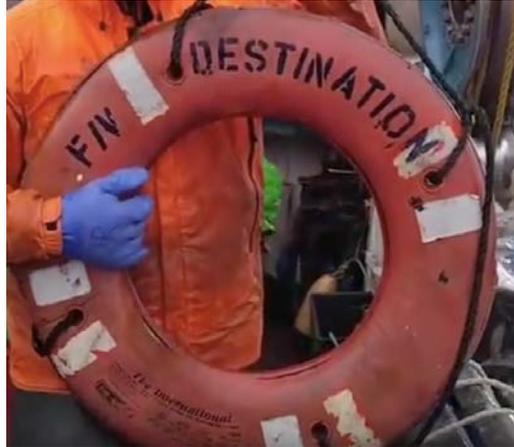
4.11.21. At approximately 1140, the SILVER SPRAY located and recovered a lifering bearing the name "DESTINATION". (see Figure 62).

Figure 62. Photo of recovered lifering taken by onboard the SILVER SPRAY.

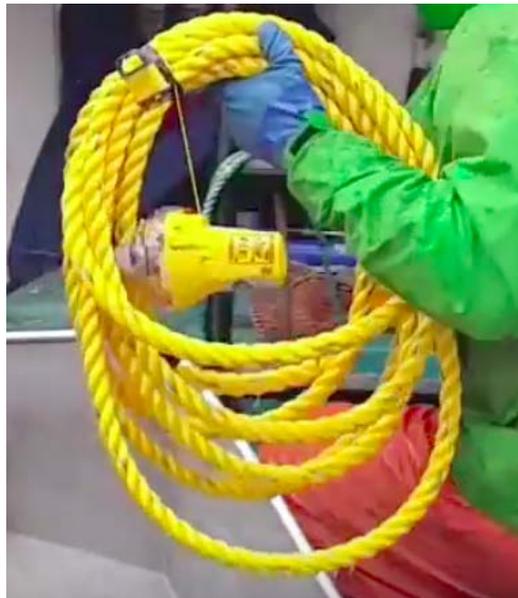
4.11.22. At approximately 1225, the SILVER SPRAY located and recovered the DESTINATION's EPIRB (Figure 63) and reported the NOAA registration number listed on the EPIRB to D17 CC. The SILVER SPRAY also reported they found the EPIRB's tether line attached with electrical tape to a floating yellow rope.

Figure 63. Photo of the recovered EPIRB taken onboard the SILVER SPRAY.

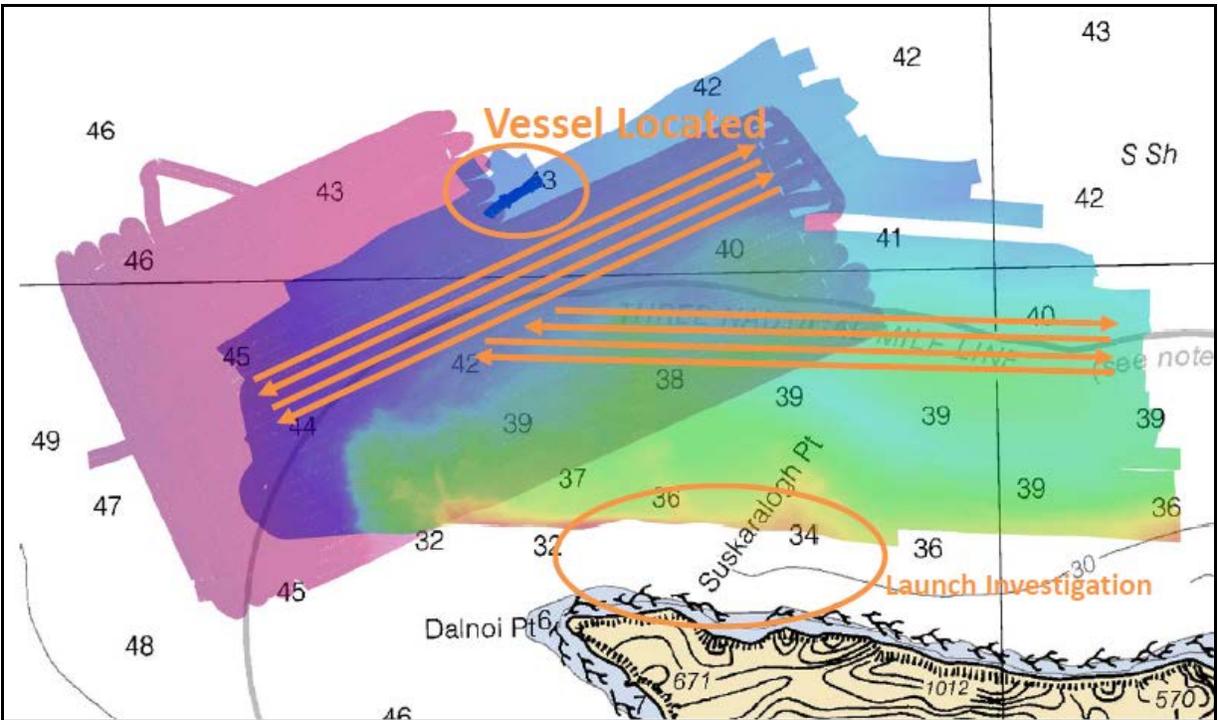
4.12.4. On July 8, 2017, the FAIRWEATHER arrived at the DESTINATION's LKP and commenced survey operations. Using its Klein 5000 side-scan sonar, the FAIRWEATHER's crew located a target matching the description of the vessel just outside the DYSON's echo sounder coverage area (see Figure 66).

Figure 66. NOAA side-scan sonar tracks to locate the DESTINATION. FAIRWEATHER's (blue and green), OSCAR DYSON's (red). Provided by NOAA Ship FAIRWEATHER.

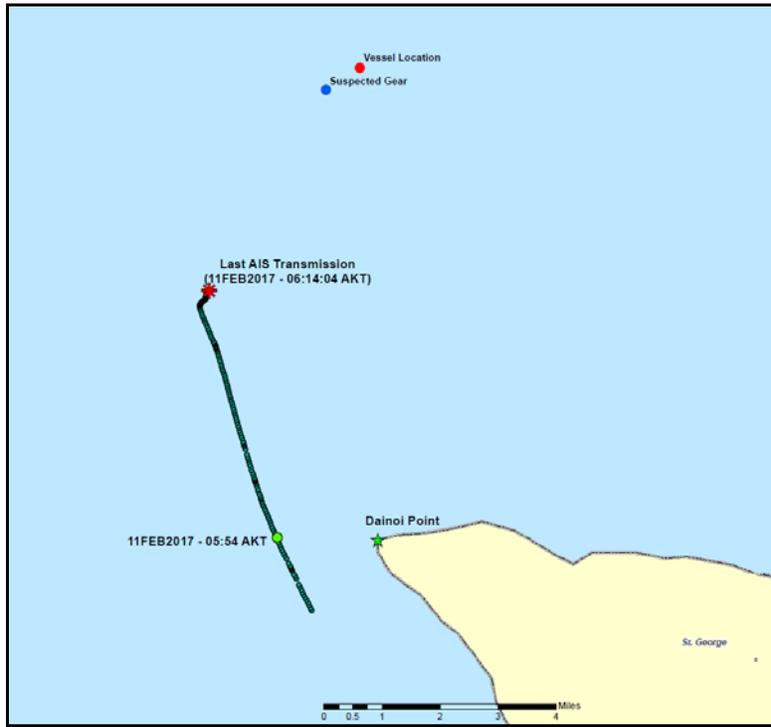
4.12.5. The FAIRWEATHER determined the DESTINATION's resting location was located at 56° 40.88 N and 169° 47.61 W, a position approximately 4.19 NM northeast of the vessel's last known AIS position and approximately 7 NM north of Dainoi Point. (see Figure 67).

Figure 67. Location of DESTINATION's resting location in relation to its last known AIS position and Dainoi Point. Image produced by MBI.

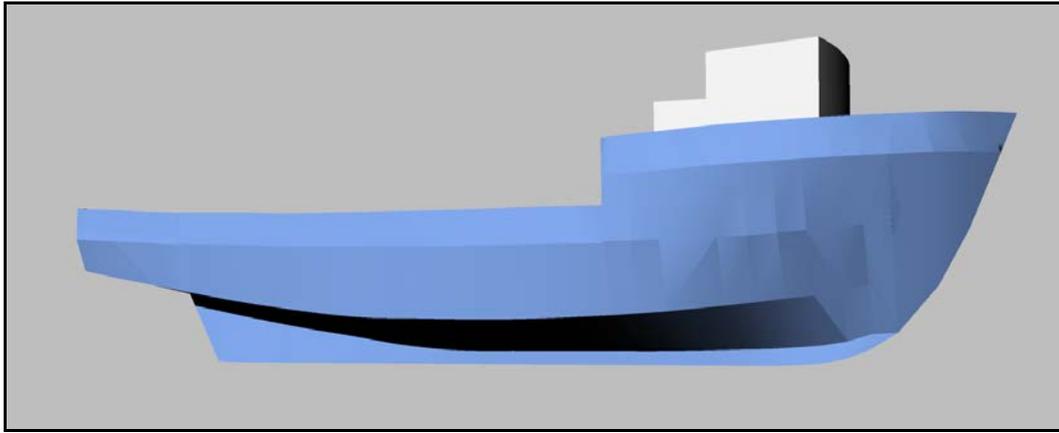
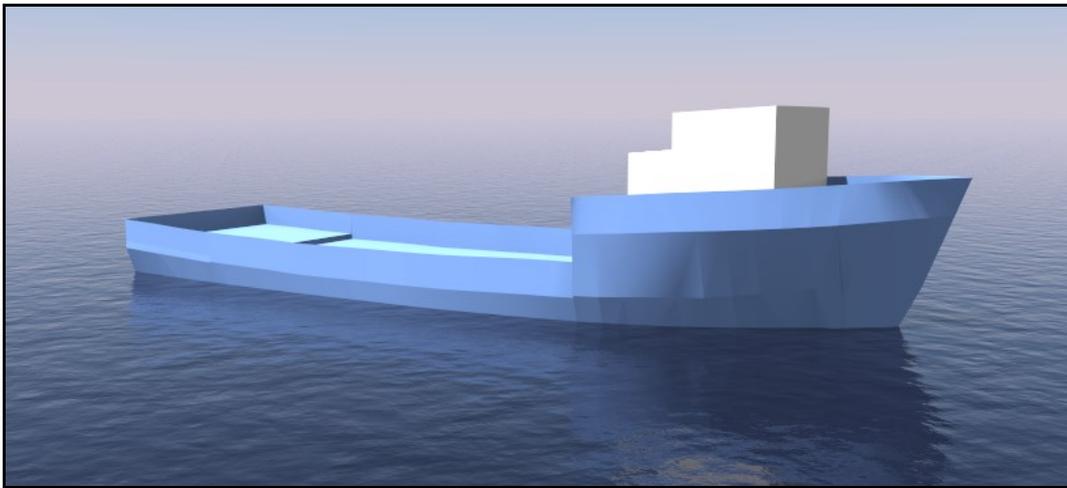
In order to validate the stability results of the DESTINATION's 1993 stability instructions and 2013 stability assessment of the bulbous bow to the intact righting energy criteria regulations, MSC independently developed a new computer hull model and used HydroStatics software. As illustrated in Figures 75 and 76, MSC generated the computer rendering using a digitizer to accurately transform the vessel's 1993 2-D lines plan into a 3-D computer hull model.

Within the 1993 stability instructions and stability letter, the qualified individual indicated the DESTINATION's stability characteristics met or exceed the minimum intact stability criteria found in 46 CFR 28, Subpart E – Stability. MSC's independent analysis shows the vessel did not comply with intact stability criteria for the majority of prescribed loading conditions found within the stability instructions. MSC's model results showed 5 out of 10 loading conditions did not comply with the intact stability criteria, including the loading condition 3 – winter condition.

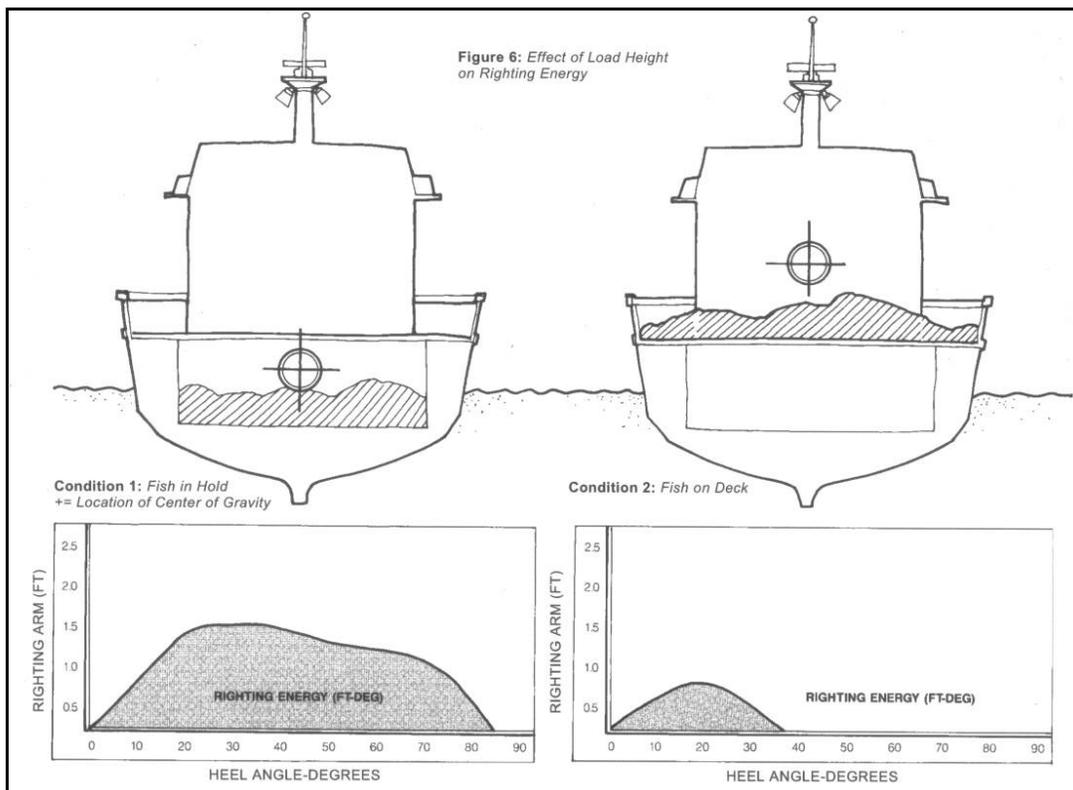
or cargo height for crab pots in a similar loading. In general, keep all loads stowed as low in the vessel as practicable.” With the DESTINATION already loaded with the maximum number of tiers (5) while moored at Kloosterboer Cold Storage Facility in Dutch Harbor, placing the cargo on top of the crab pots violated and exceeded this stability provision.

The DESTINATION’s stability instructions also included excerpts of the stability guidance chapter from the NPFVOA’s Vessel Safety Manual. The guidance in this section explains how various factors, such as load height, lifting, free surface and icing, can adversely affect vessel stability. Regarding effects of load height, the guidance warns against placing loads higher on the vessel. Figure 77 is an illustration provided within the guidance depicting the adverse effects of placing loads high on a vessel’s stability. As indicated, placing loads high will raise the center of gravity and cause a dramatic reduction in a vessel’s righting energy, range of stability and maximum righting arm.

Figure 77. Excerpt of the stability guidance within the stability instructions.

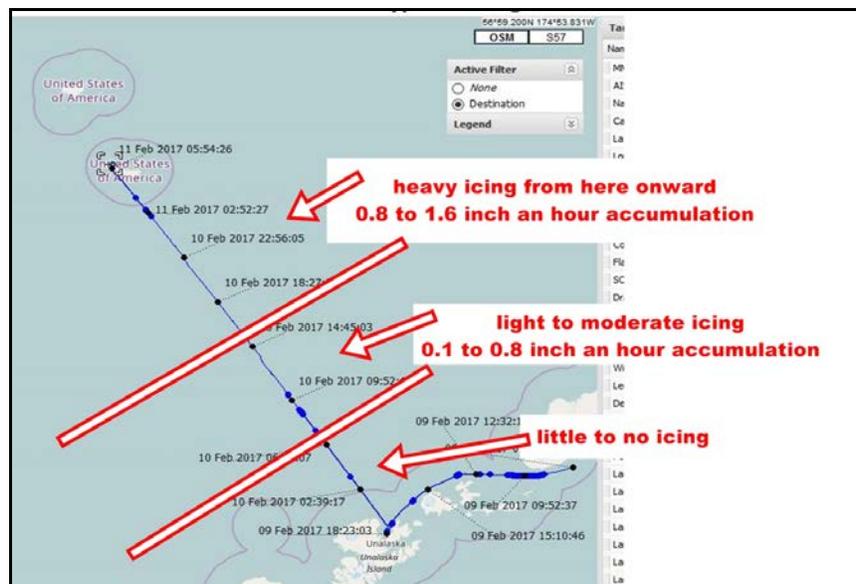
To determine the amount of ice the DESTINATION could have accumulated from freezing spray conditions during its transit towards St. Paul, the MBI conducted an analysis using NWS weather and sea state data, the Overland graphs and application of the icing predictor algorithm. As illustrated in Figure 81, the vessel experienced light to moderate icing conditions (0.1 to 0.8 inches an hour) in the morning hours of February 10, 2017 and heavy icing conditions (0.8 to 1.6 inches an hour) after 1500 on February 10, 2017. The vessel would have accumulated between 12 to 24 inches of ice between 1500 on February 10, 2017 and 0600 on February 11, 2017.

Figure 81. Calculated ice accumulation during the DESTINATION's transit. Provided by NTSB.

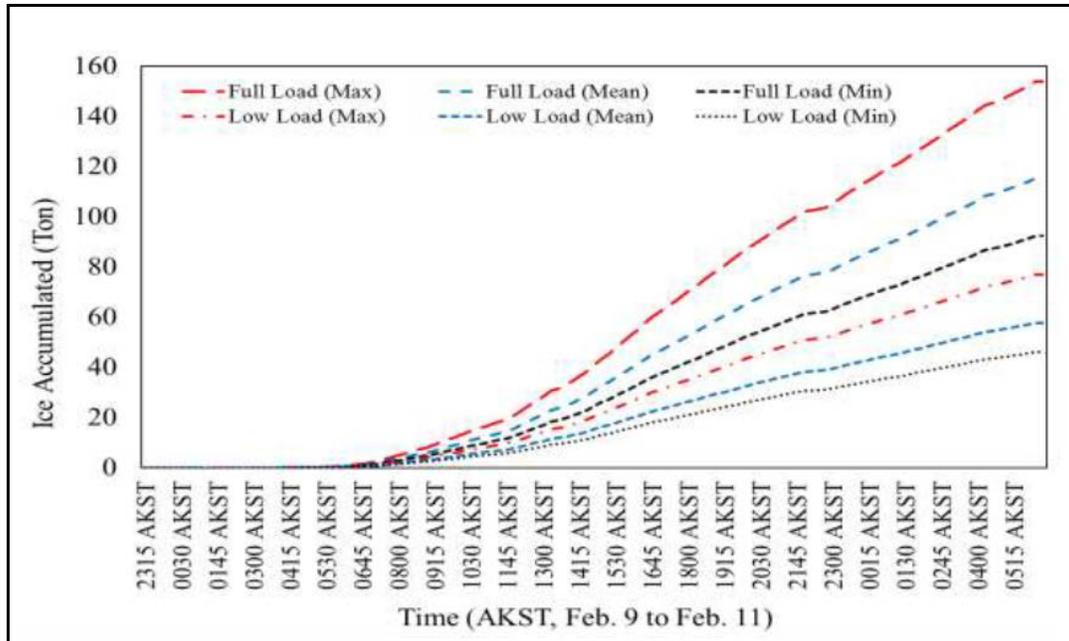
Figure 82 is a graph of MU’s simulation solution. Full load (Mean) data shows the vessel could have accumulated approximately 108 LT (241,920 pounds) of ice.

Figure 82. Simulated numerical solution of ice accumulation for the DESTINATION. Provided by Memorial University of Newfoundland, St. John’s, Canada.

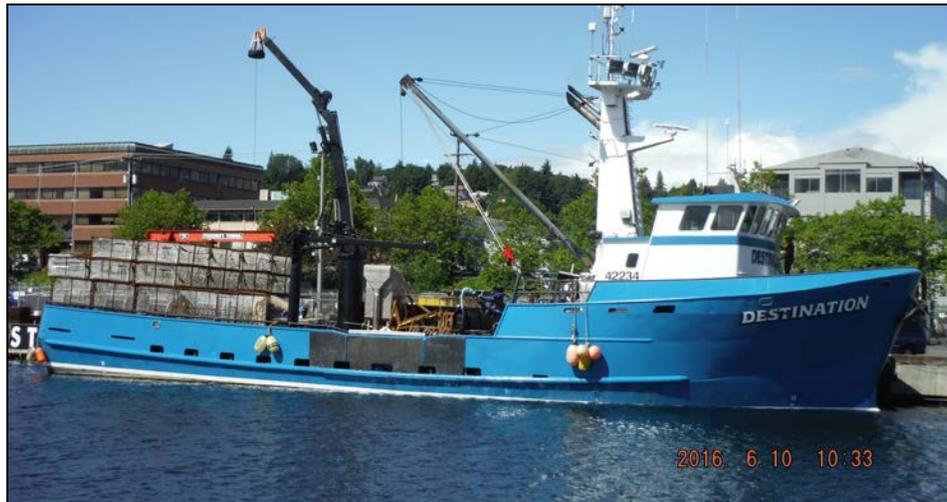
While the stability instructions indicate the DESTINATION's freeing ports comply with 46 CFR 28.555 requirements, it did not include its dimensions or aggregate area. Absent plans, MSC referred to a photo taken by the third party surveyor on June 10, 2016 (Figure 84) showing a detailed view of the vessel's starboard profile. Using this photo, MSC calculated the dimensions of the freeing ports using known measurements of the vessel, such as the vessel's draft marks.

Figure 84. DESTINATION, June 10, 2016 in Seattle, WA.
Photo provided by a third party surveyor.

The DESTINATION had nine freeing ports on each side of the main deck, with an estimated area of 120 square inches each, for a total of 1,080 square inches. In accordance with 46 CFR 28.555 requirements, with a bulwark length of 72 feet, the vessel is required to have 2,390 square inches of freeing port area per side. Only having 54 percent of required amount of aggregate clear area, the vessel failed to meet freeing port area requirements.

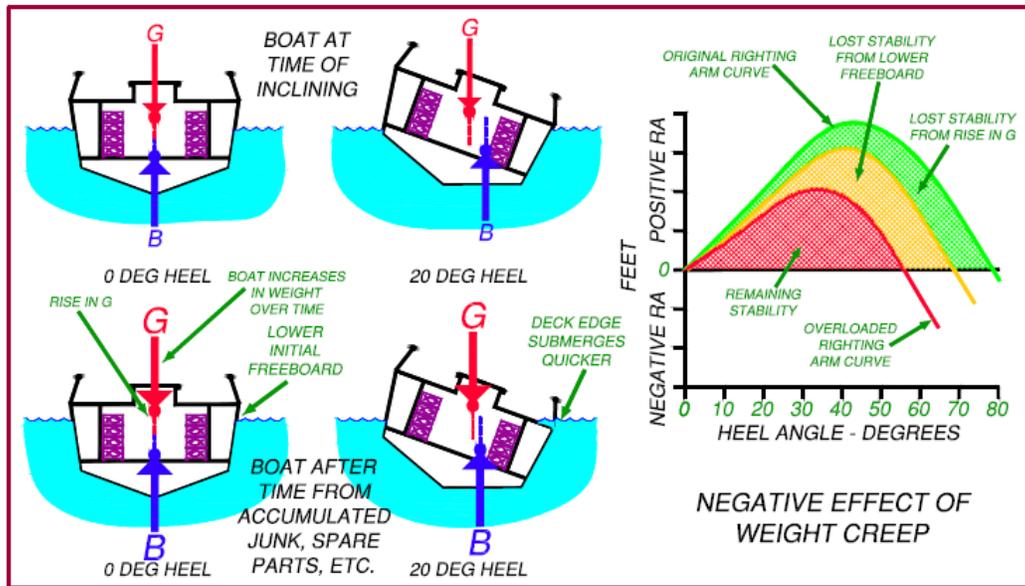
As described in the Coast Guard’s Best Practice Guide to Vessel Stability, weight creep is the accumulation of extra spare parts, fishing gear, or a series of seemingly small modifications to a vessel or its fishing gear that can significantly reduce a fishing vessel’s overall stability. As illustrated in Figure 85, weight creep reduces overall stability by raising the center of gravity “G” and reducing freeboard.

Figure 85. Illustration of weight creep effects on vessel stability. From the Coast Guard’s Best Practice Guide to Vessel Stability.

A vessel’s crew may not notice reduced initial stability levels from weight creep, as it often occurs over long periods in small amounts. The guide recommends fishing vessel owners and operators should thoroughly inspect and clean any extraneous spare parts, fishing gear and equipment every 6-12 months. If modifications to the vessel or its fishing gear not included in the current stability assessment must remain, the owner should consult a Naval Architect or qualified individual about developing new stability guidance. The Coast Guard’s Voluntary Safety Initiatives and Good Marine Practices for CFV published in January 2017 recommends the owner have the stability instructions reviewed by a qualified individual at least every five years, or after the vessel has been modified or altered in any way that changes its stability or handling characteristics.

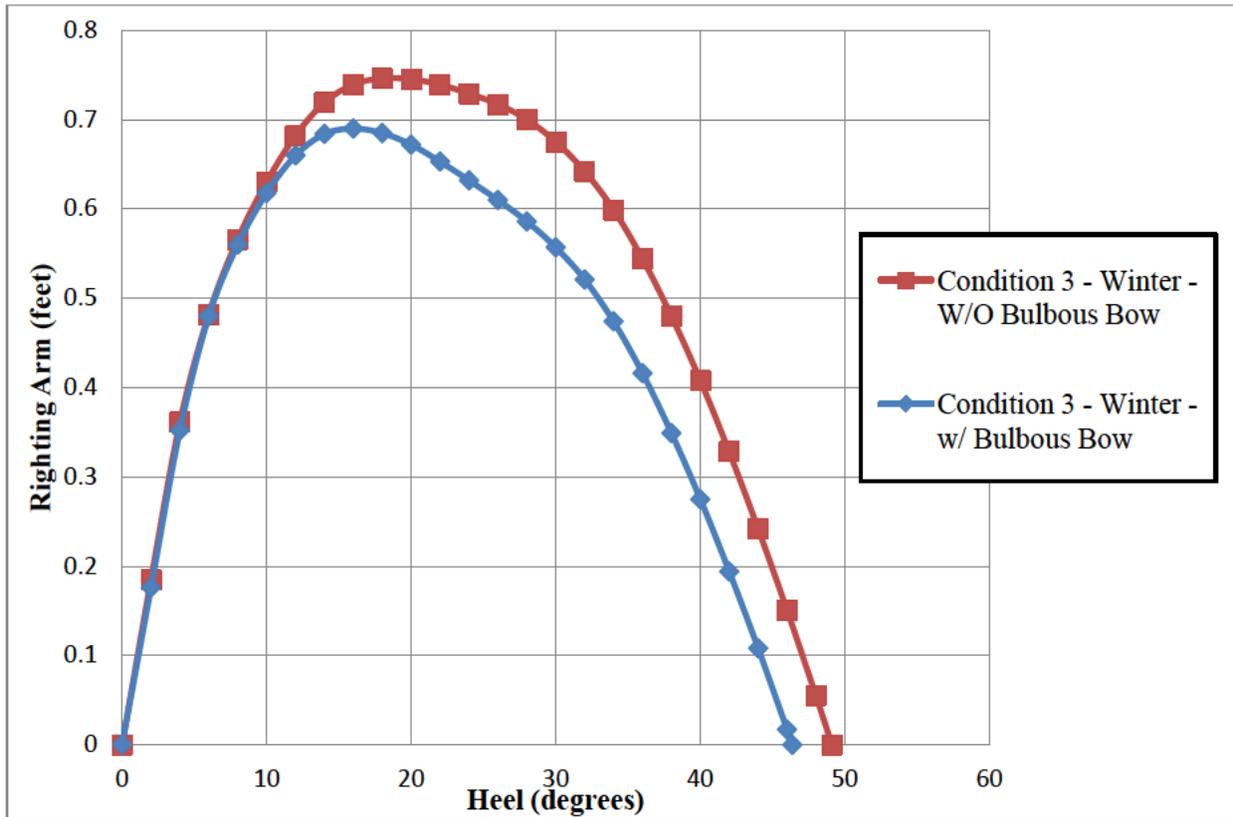
In general, our results showed the bulbous bow reduced the righting arm values and provided no additional benefit to the vessel's stability as all stability criteria results further decreased. Figure 4 below compares the righting arm curves of the winter loading condition 3 from reference (b) with and without the bulbous bow appendage.

Limits from 170.173 (c)	Required	Attained Condition 3 w/o Bulbous Bow	Attained Condition 3 w/ Bulbous Bow
Initial Metacentric Height (GM)	> 0.49 ft	5.29	5.02
Angle of Maximum Righting Arm	> 15°	18.00	16.00
Area up to 40° or Downflood Angle	> 16.9 ft-deg	23.79	21.05
Area between 30° and 40°	> 5.6 ft-deg	5.62	4.35
Area at Max Righting Arm	> 12.54 ft-deg	9.49	7.76

Figure (4): Comparison of Righting Arm Curves and Stability Criteria for Bulbous Bow Addition
