UNITED STATES COAST GUARD

**REPORT OF THE MARINE BOARD OF INVESTIGATION
INTO THE
COMMERCIAL FISHING VESSEL DESTINATION
SINKING AND LOSS OF THE VESSEL
WITH ALL SIX CREWMEMBERS
MISSING AND PRESUMED DECEASED
APPROXIMATELY 4.4 NM NORTHWEST OF
ST. GEORGE ISLAND, ALASKA
ON FEBRUARY 11, 2017**

16732
27 February 2019

**COMMERCIAL FISHING VESSEL DESTINATION (O.N. 632374)
SINKING AND LOSS OF VESSEL
WITH ALL SIX CREWMEMBERS MISSING AND PRESUMED DECEASED
APPROXIMATELY 4.4 NM NORTHWEST OF ST. GEORGE ISLAND, ALASKA ON
FEBRUARY 11, 2017**

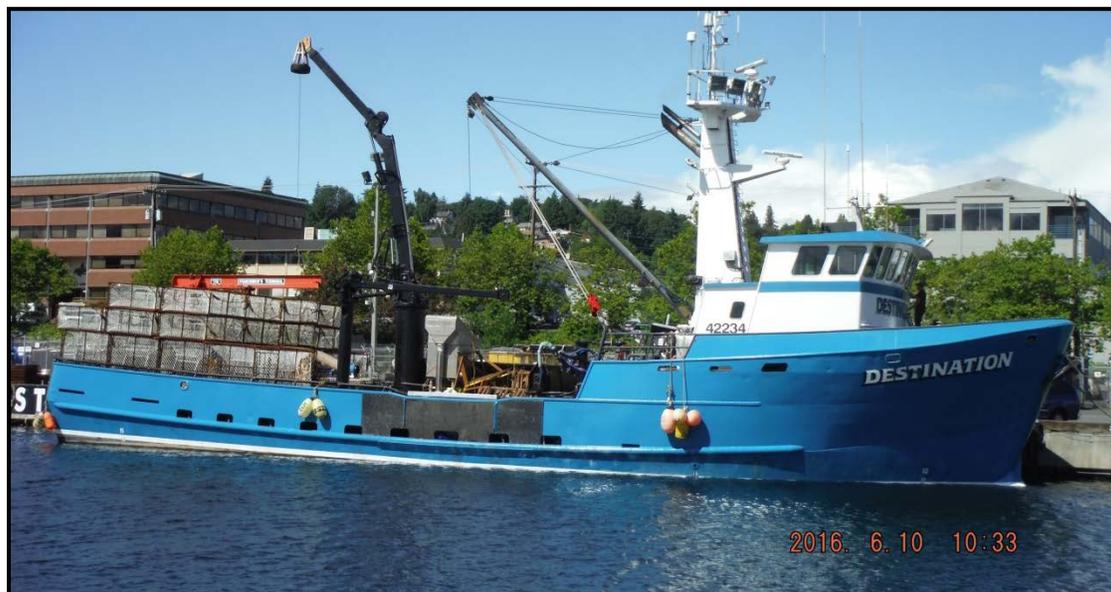
As shown in figure (6) below, the vessel had nine freeing ports on each side. Reference (a) indicates that each had an estimated area of 120 in² resulting in a total freeing port area on either side of the vessel of 1,080 in². For a vessel with a bulwark length of 72 feet, in accordance with 46 CFR 28.555(d), the required freeing port area per side is 2,390 in² (16.6 ft²). The required freeing port area far exceeds the actual freeing port area (1,080 in²). Additionally, the port side of the DESTINATION had a raised shelter bulwark from the deckhouse to the midship crane. Per 46 CFR 28.555(e), this would increase the required freeing port area on the port side by an additional 550 in².

Figure (6): Starboard Profile Showing 9 Freeing Ports

Figure (6) shows the starboard profile with the nine freeing ports. A vessel with insufficient freeing port area would likely result in more seawater becoming trapped on the main deck in foul weather. This water would add additional weight to the vessel, raise the

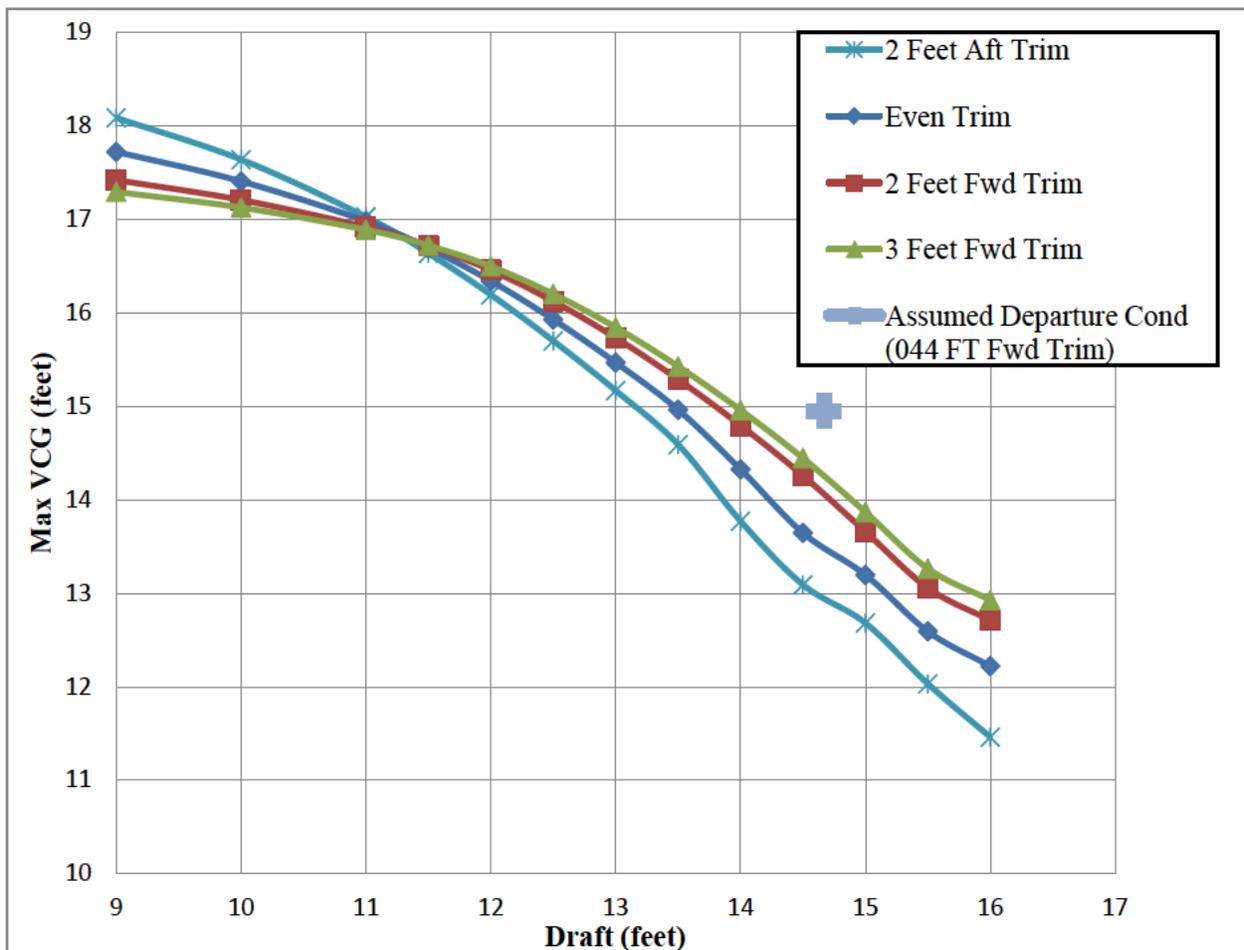
Using GHS, we analyzed the maximum VCG curves at varying drafts and trims. The results are displayed below for the 46 CFR 170.173(c) stability criteria. As the drafts and displacements increase, the maximum VCG for which the vessel passes the applicable stability criteria decreases. A point representing the assumed departure condition from reference (e) is plotted on Figure 7. The assumed departure condition point clearly falls outside the maximum VCG curves. Our calculations indicate that a trim of 6 feet forward or greater would be required to allow the vessel to pass the stability criteria given the assumed loading condition VCG and draft. This draft is well outside the normal operating trims in which the vessel would have been operating.

Figure (7): Maximum VCG Curves for Various Trims (46 CFR 170.173 Criteria)
