United States Coast Guard

**Report of the Investigation into the
Circumstances Surrounding the Capsize of
the Liftboat SEACOR POWER (O.N.
1115290) Approximately 7 Nautical Miles
South of Port Fourchon, LA in the Gulf of
Mexico Resulting in the Loss of 13 Lives on
April 13, 2021.**

THE CAPSIZING OF THE COMMERCIAL LIFTBOAT SEACOR POWER (O.N. 1115290) RESULTING IN MULTIPLE LOSSES OF LIFE APPROXIMATELY SEVEN NAUTICAL MILE SOUTH OF PORT FOURCHON, LA IN THE GULF OF MEXICO ON APRIL 13, 2021

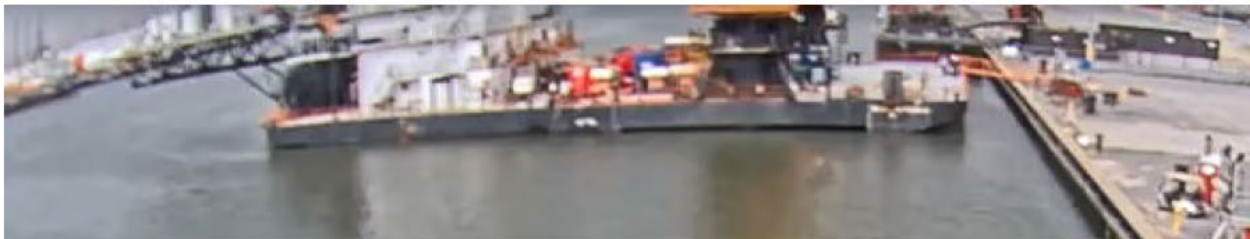
Figure 2: Cropped Image of SEACOR POWER at Bollinger North Dock on April 13, 2021

- 8.1.1. In April of 2021, SEACOR POWER was on charter to Talos. On the morning of April 13th, the vessel was located at the Bollinger North dock in the Floation Canal in Port Fourchon, LA. The vessel was in port conducting a crew change and loading equipment for a new job located in Main Pass Block Number 138.
- 8.1.2. SEACOR POWER was not tied to the dock; the vessel's three legs were resting on the bottom and the hull was lifted slightly out of the water, with a gangway extending from the bow of the vessel to the dock.

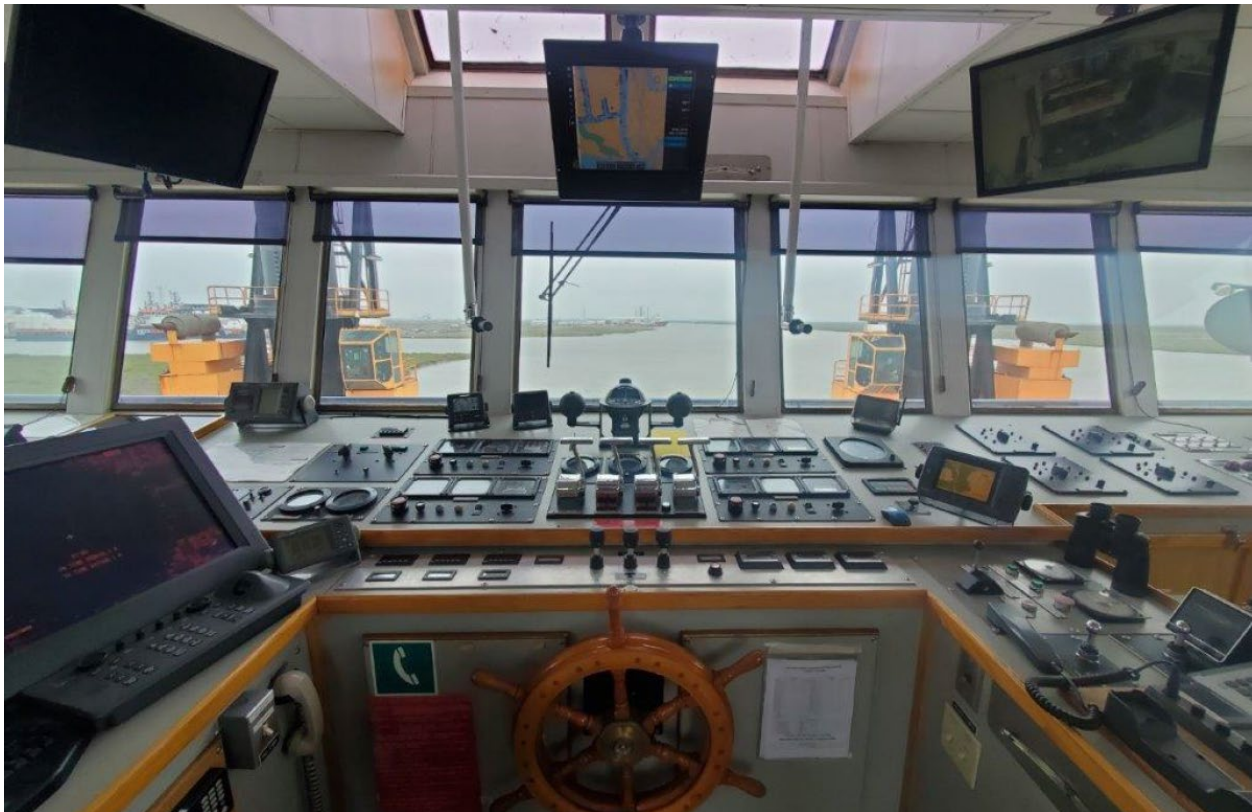
Figure 10: Wheelhouse Image of SEACOR POWER (from Exhibit 202)

- 8.1.35. The First Mate observed SEACOR POWER heel 5 degrees to starboard, and he felt like the vessel was "going over." The Master took over at the controls of SEACOR POWER and attempted to steer the vessel back to starboard. The Master used the Gai-tronics public address system to instruct everyone to put on lifejackets. The First Mate activated the vessel's tilt alarm, which was located on the port side of the forward control console.

8.1.36. At 1537, SEACOR POWER capsized to starboard.²⁰ The First Mate grabbed onto the port side pilothouse door as the vessel rolled. He saw the Master fall through the starboard pilothouse window. The First Mate attempted to signal distress. He pressed a button on the GMDSS console until he heard an audible beep.

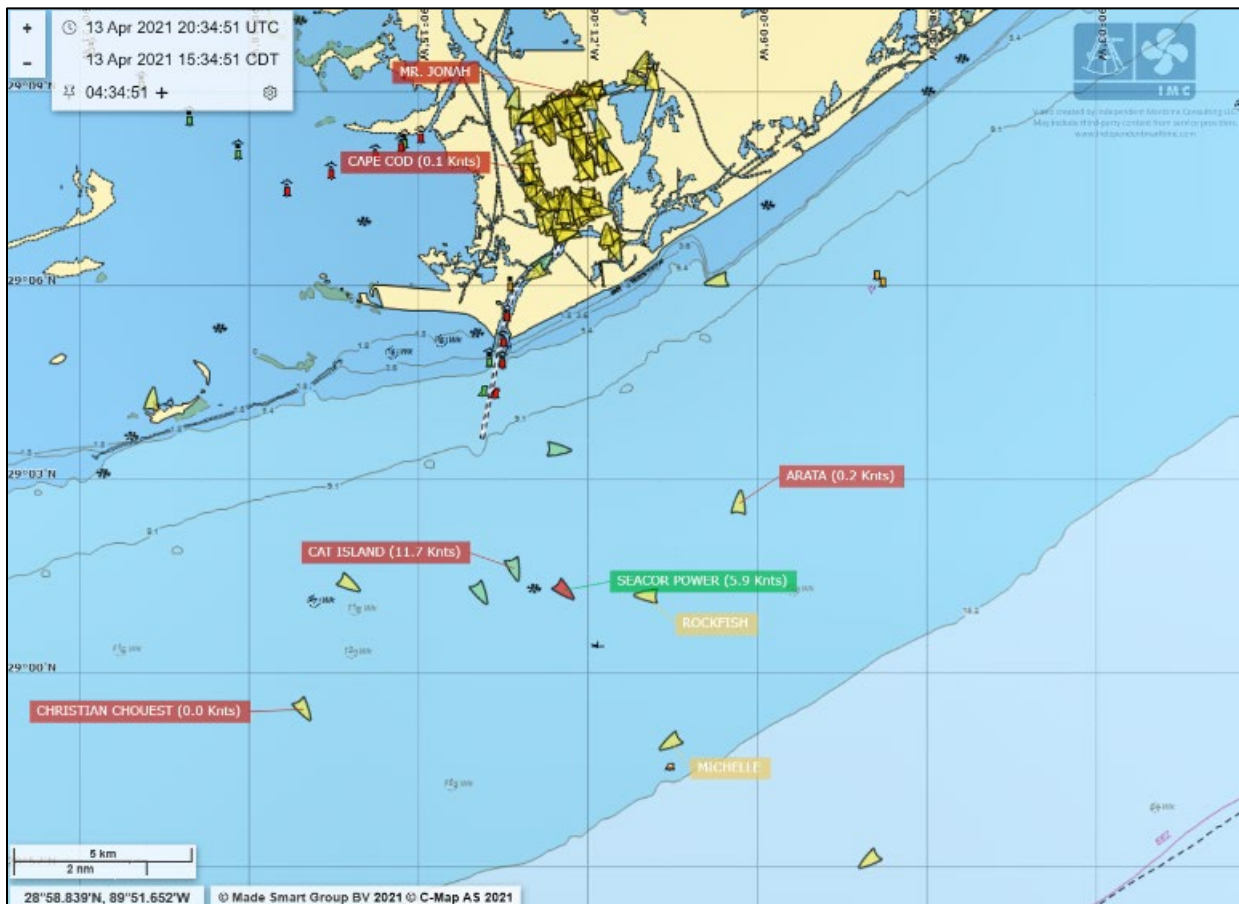
Figure 11: AIS Image of CAPT JACK II and CAT ISLAND passing near SEACOR POWER during capsizing

8.1.37. Data from the Automatic Identification System (AIS) indicated that at 1537, Fishing Vessel CAPT JACK II was transiting within one nautical mile of SEACOR POWER and Offshore Supply Vessel CAT ISLAND was transiting within 0.5 miles of SEACOR POWER. Liftboat ROCKFISH was jacked up at South Timbalier Block 24, 2.5 miles east of SEACOR POWER. Offshore Supply Vessel CHRISTIAN CHOUEST was located 4.5 miles west of SEACOR POWER.²¹

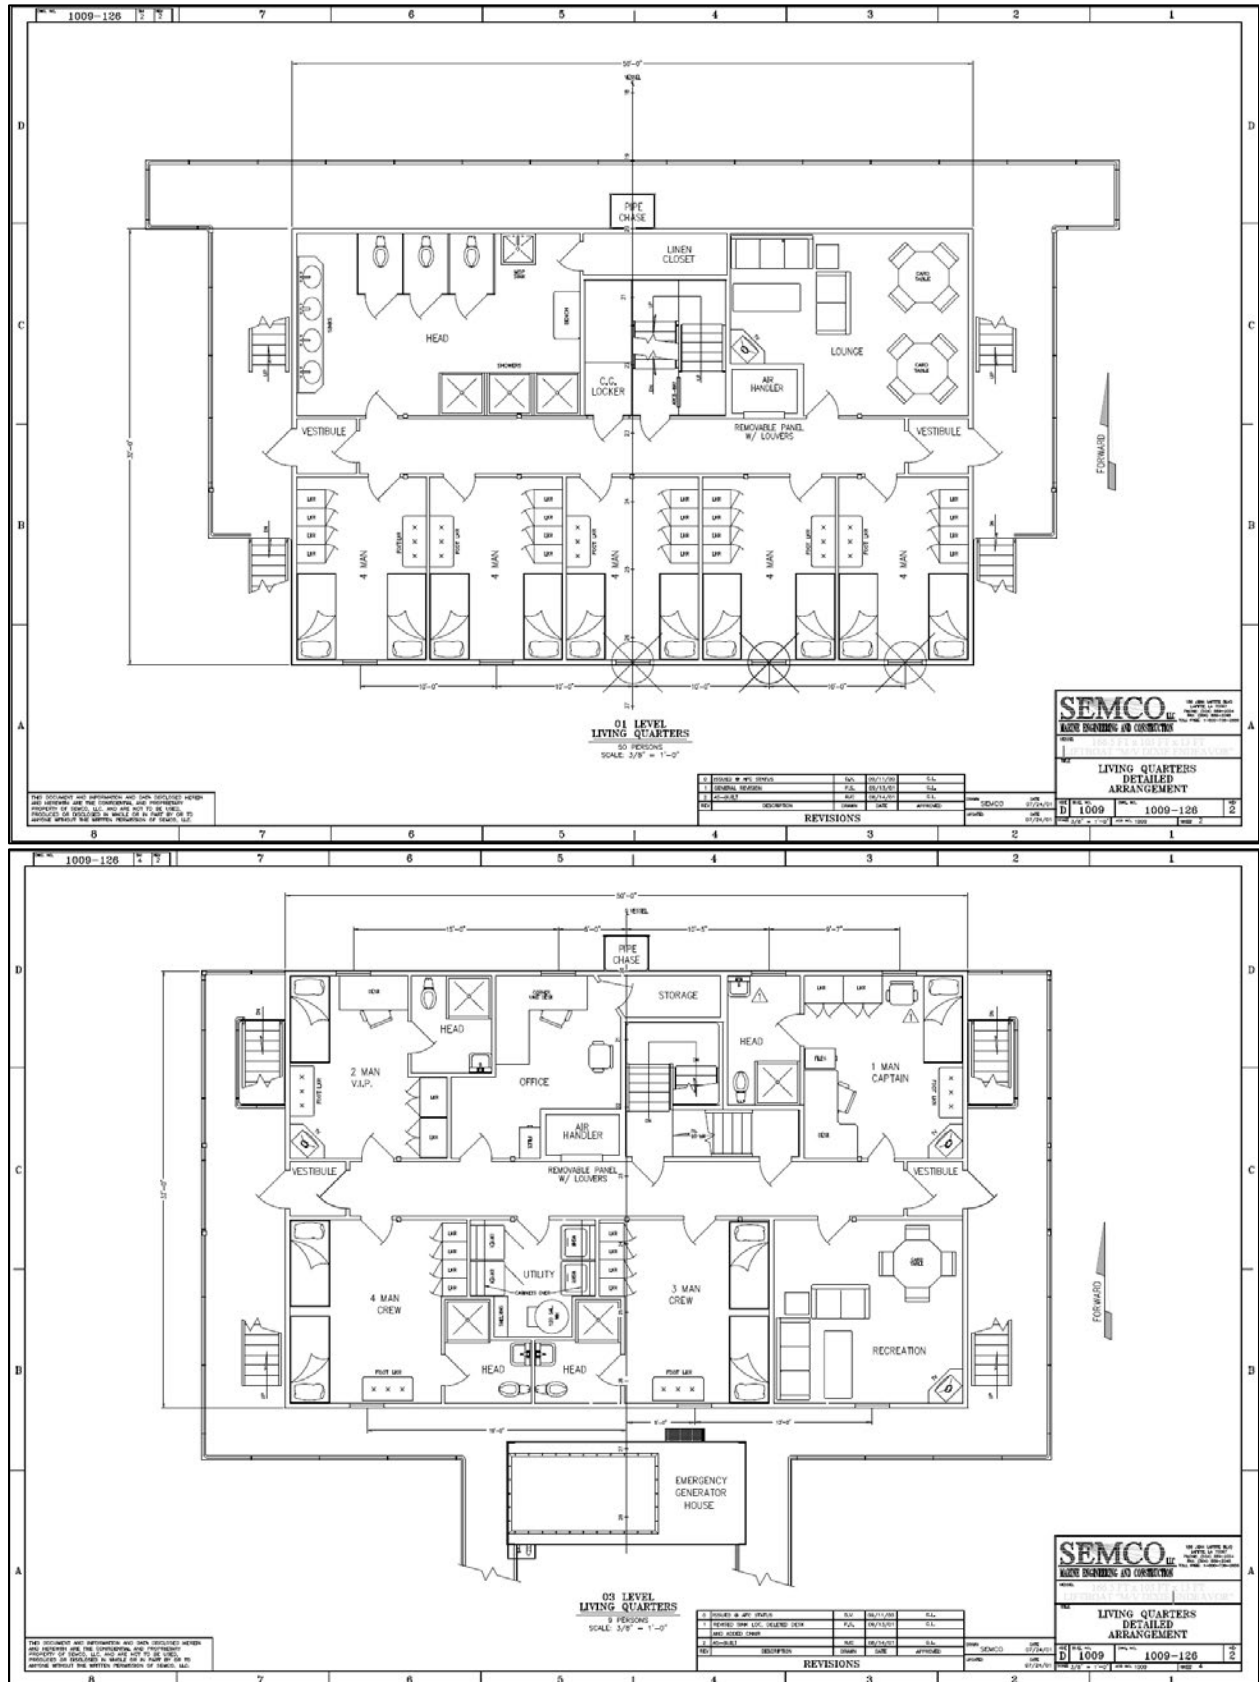
Figure 14: Living Quarters Arrangement on SEACOR POWER 01 Level (top, Exhibit 94) and 03 Level (bottom, Exhibit 96)

8.1.41. A/B 1 climbed up the ceiling in the 01-level passageway (hallway) to the portside exterior door, where A/B 3 pulled him out onto the port side of the deckhouse/superstructure. Neither A/B 1 nor A/B 3 were wearing a lifejacket.

- 8.1.42. Cardinal Worker 2 tried to find a lifejacket in his stateroom, but he did not find one. He crawled out of his room, via a crawlspace in the ceiling, and into the hallway. He saw the hallway was flooded with seawater up to the centerline (about halfway) and opened the hallway door. Cardinal Worker 2 then climbed back into his stateroom once Cardinal Worker 4 broke the window and exited.

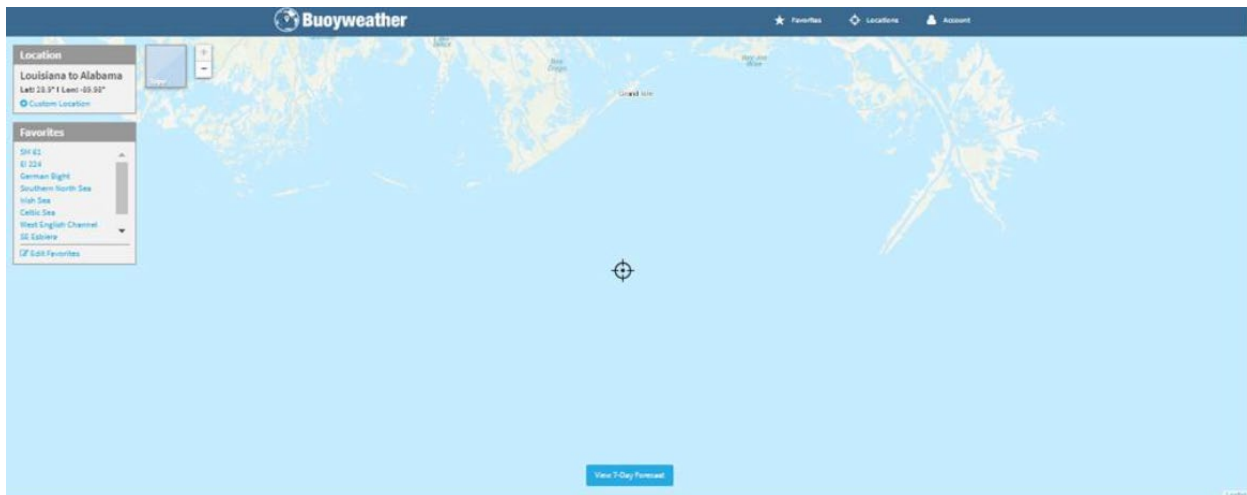
Figure 32: Buoy Weather coordinates used by Seacor Dispatcher for weather forecast distributed on April 13, 2021 (Exhibit 203)

Cat Island Pass, between coordinates 28.91°N and 89.99°W.¹⁵⁶ This weather report was sent out as a general guide for Seacor vessels in that operational area.

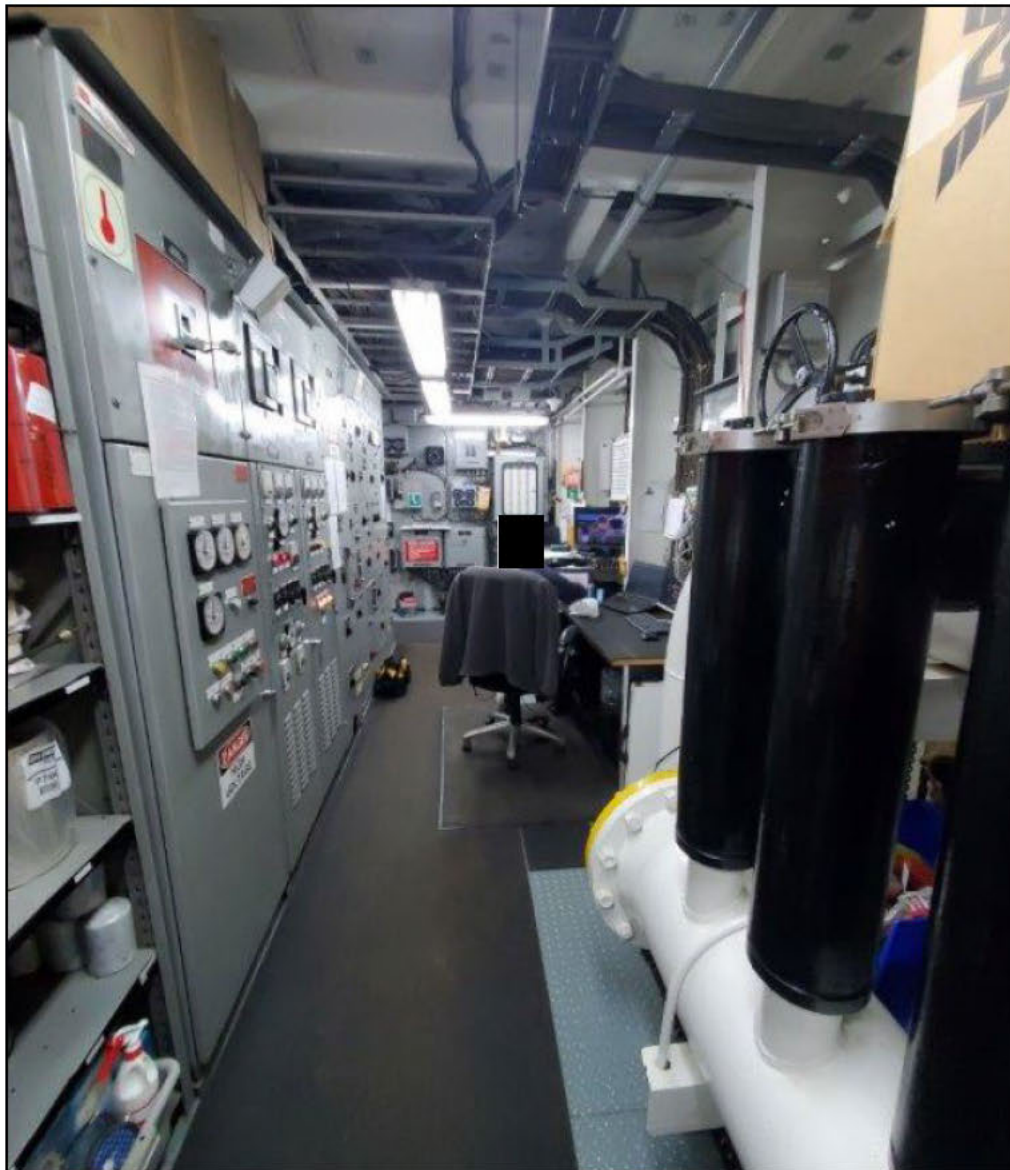
Figure 35: SEACOR POWER Engine Control Room (Exhibit 202)

- 8.7.45. The Off-Boat Chief Engineer stated that there were not any alarms to indicate flooding in the legs.
- 8.7.46. The Off-Boat Chief Engineer stated that there were two engine rooms on either side of the vessel, with the control room in the middle. There were watertight doors on each side of the control room. If he left the engine room and went out on deck he would close the watertight door. He said the watertight doors in the engine room had indicator lights on the bridge, and those lights showed whether the doors were open or closed. The First Mate stated the same thing. There were cameras in each engine room, with display monitors on the bridge.

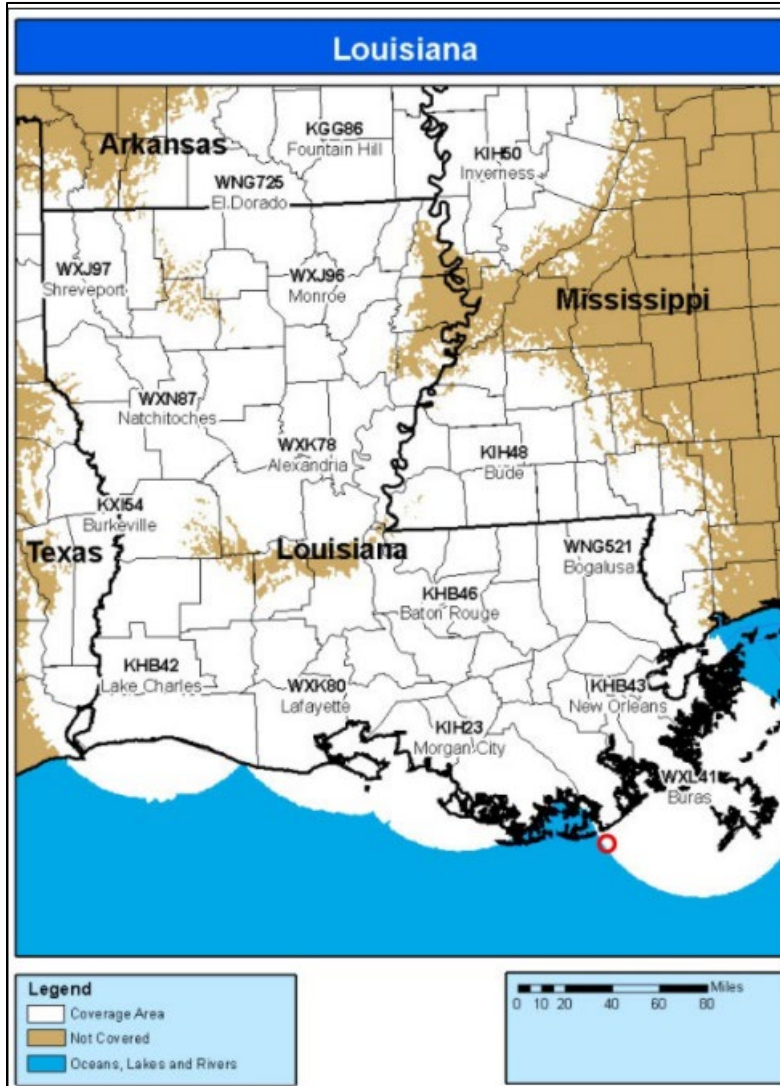
Figure 37: NWS Weather Radio coverage map

- 8.8.8. When the NWS sends out weather products over NOAA Weather Radio, the messages are sent to transmitters, which then send the messages out over VHF radio. The closest three transmitters to the area of the incident are located in Buras, New Orleans and Morgan City. Each site uses a different radio frequency. Since these are VHF systems, the broadcast range is limited to line of sight (roughly 25 miles offshore).

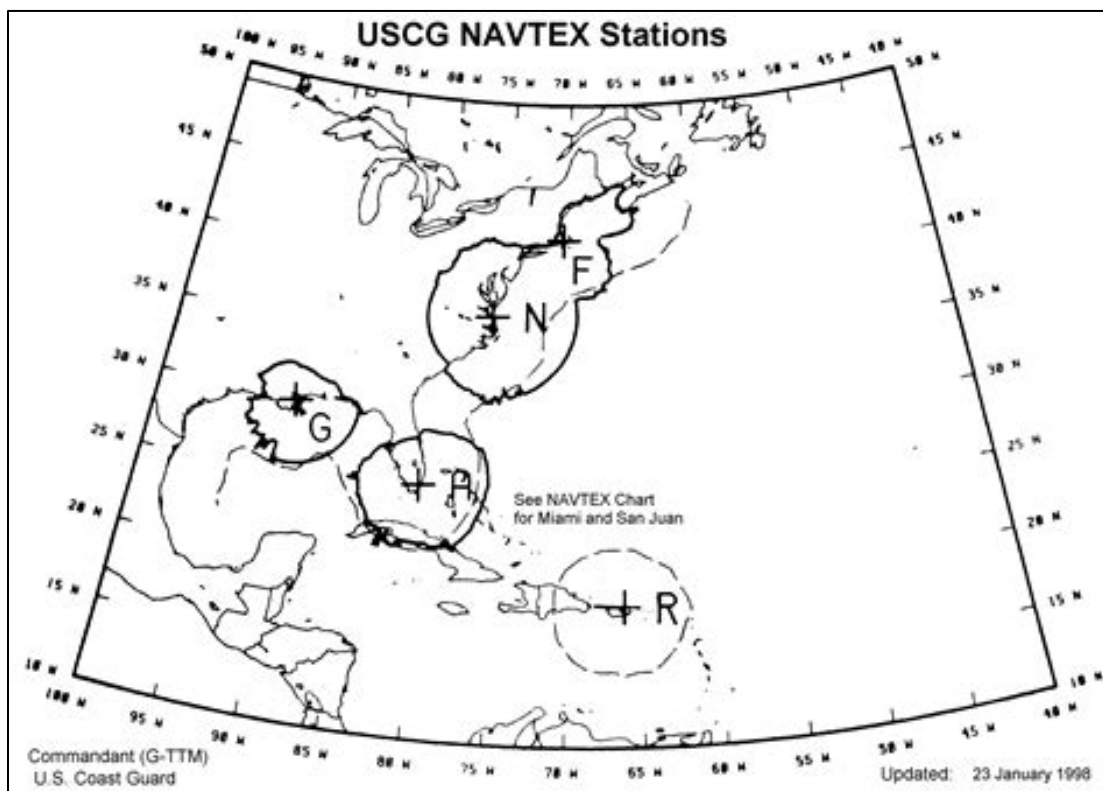
Figure 38: East Coast NAVTEX Coverage Map

- 8.8.32. The Communications Command distributes urgent marine safety information, navigational information, weather forecasts, and weather warnings to mariners. This information is sent using Navigational Telex (NAVTEX), which is part of the Global Maritime Distress and Safety System (GMDSS). NAVTEX transmissions are sent using medium frequency radio (518 kilohertz), which is designed to cover an area 40 to 200 nautical miles offshore, although the transmissions are also received by ships closer than 40 nautical miles from shore, and are sometimes received by ships up to 400 nautical miles offshore.
- 8.8.33. The NAVCEN website states that the Coast Guard only installed NAVTEX at sites that were previously used for Morse telegraphy transmissions. As a result, propagation analyses show some coverage gaps, particularly in the southeast United States, Alaska, and Guam.¹⁸⁴

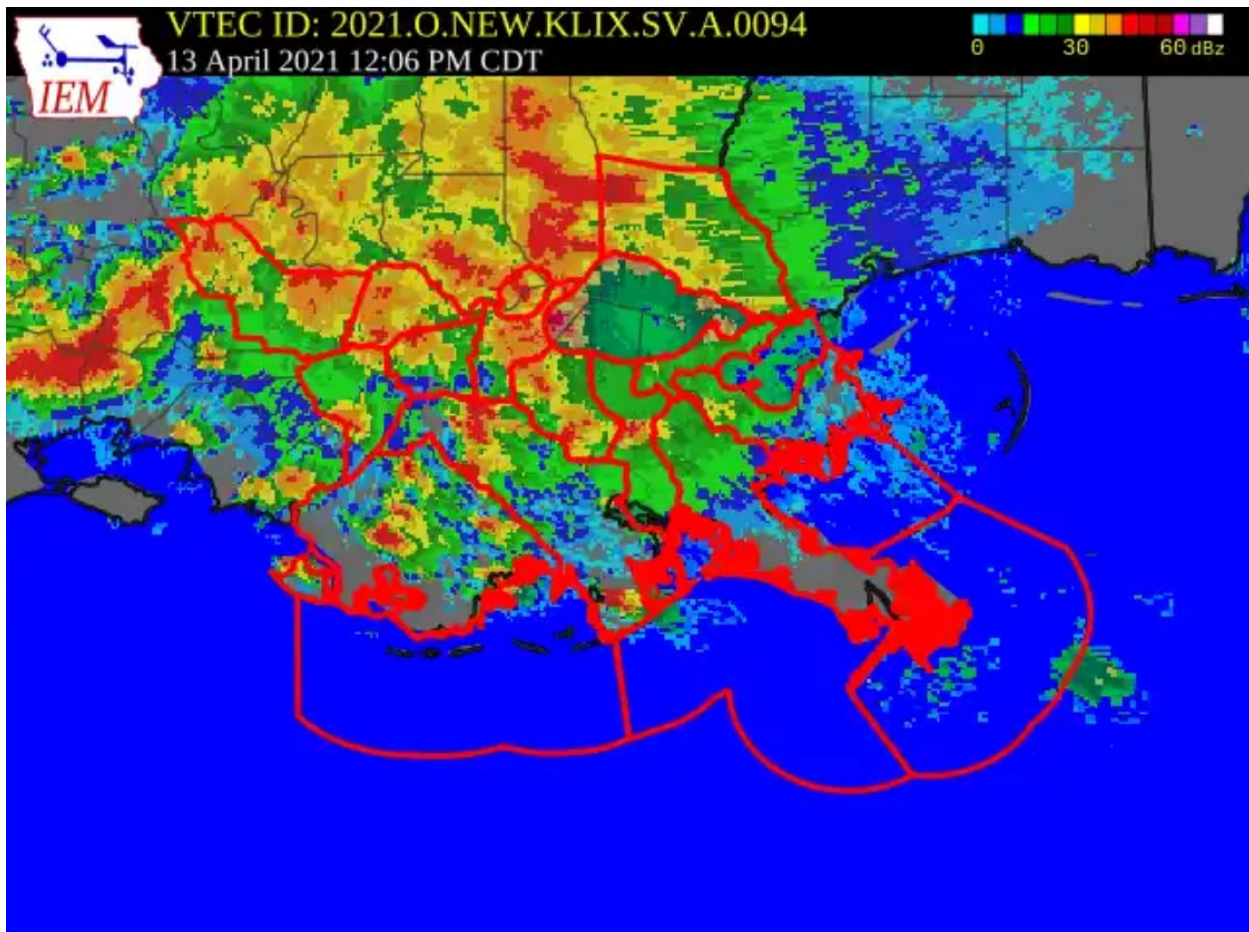
8.8.50. At 1205, the NWS's Storm Prediction Center in Norman, Oklahoma issued Severe Thunderstorm Watch Number 94. This watch pertained to portions of Southeast Louisiana and Coastal Waters. The latitudes and longitudes cited in the watch identified that the watch pertained to an area that covered from 40 miles northwest of New Orleans to 55 miles southwest of Boothville. The primary threats included scattered damaging wind gusts to 70 mph and scattered large hail events.¹⁸⁸ The NWS website stated that the Coast Guard broadcasted Special Marine Warnings and Marine Weather Statements on NAVTEX, but land based weather products, such as Thunderstorm Watches, were not on the list of products that the Coast Guard broadcasted via NAVTEX.¹⁸⁹

Figure 39: Warning Zone for Severe Thunderstorm Watch #94

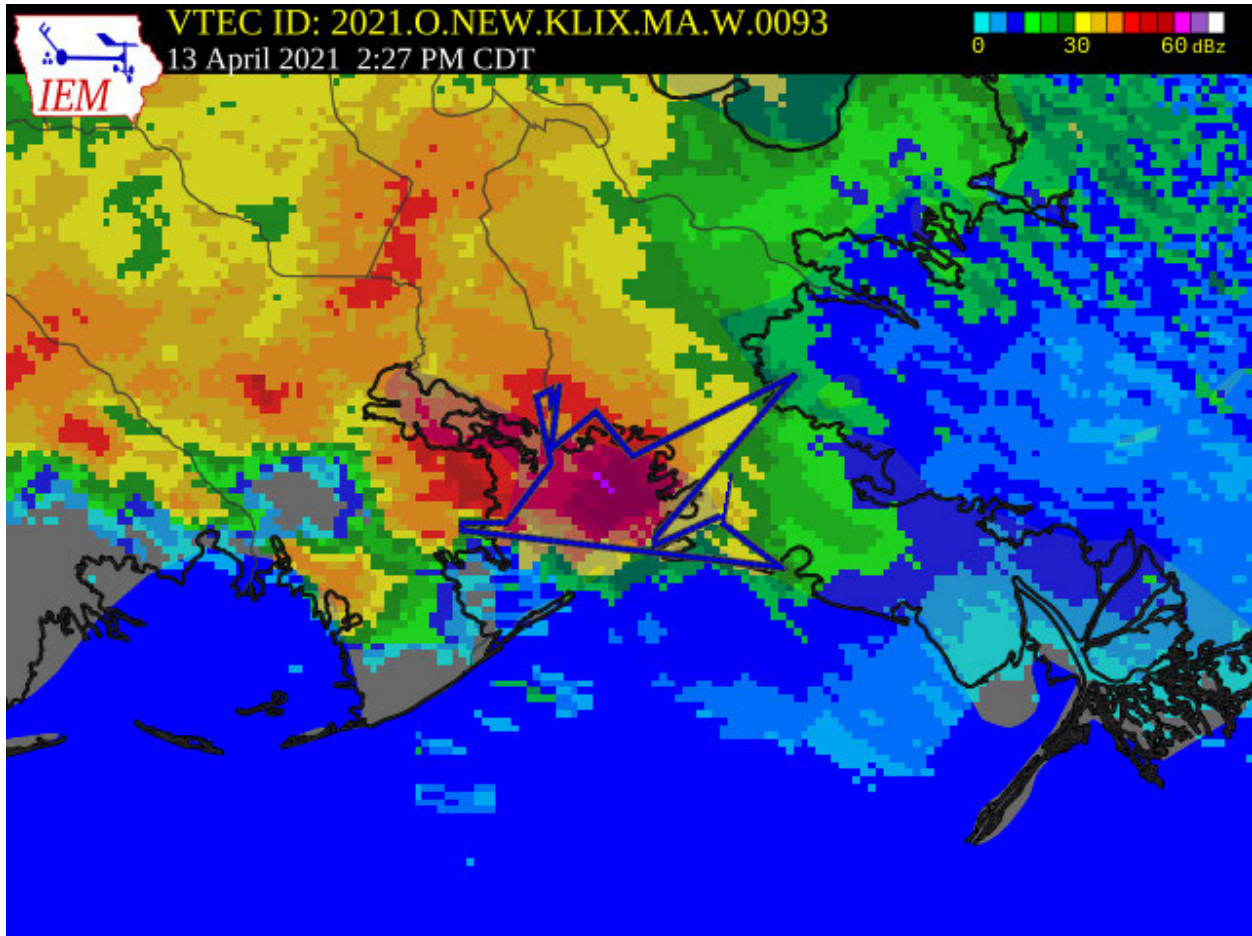
- 8.8.62. At 1427, the NWS issued a Special Marine Warning for Breton Sound, and for coastal waters, from Southwest Pass to Port Fourchon, out to 20 nautical miles. This warning noted a severe thunderstorm was located 9 nautical miles northwest of Barataria Bay (northeast of Port Fourchon), moving east at 15 knots, and impacting Barataria Bay. This did not apply to SEACOR POWER's location or planned trackline. The hazards included wind gusts of 34 knots or greater and large hail.¹⁹⁵ The Lead Forecaster stated that this warning was associated with the line of thunderstorms that was moving south. The warning pertained to the edge of the storm, which was actually moving to the east when the warning was issued. The western part of the storm was not as strong and did not warrant a warning at that time.

Figure 40: Applicable zone for and radar image Special Marine Warning issued at 1427 on April 13, 2021 (not for SEACOR POWER's location or intended location)

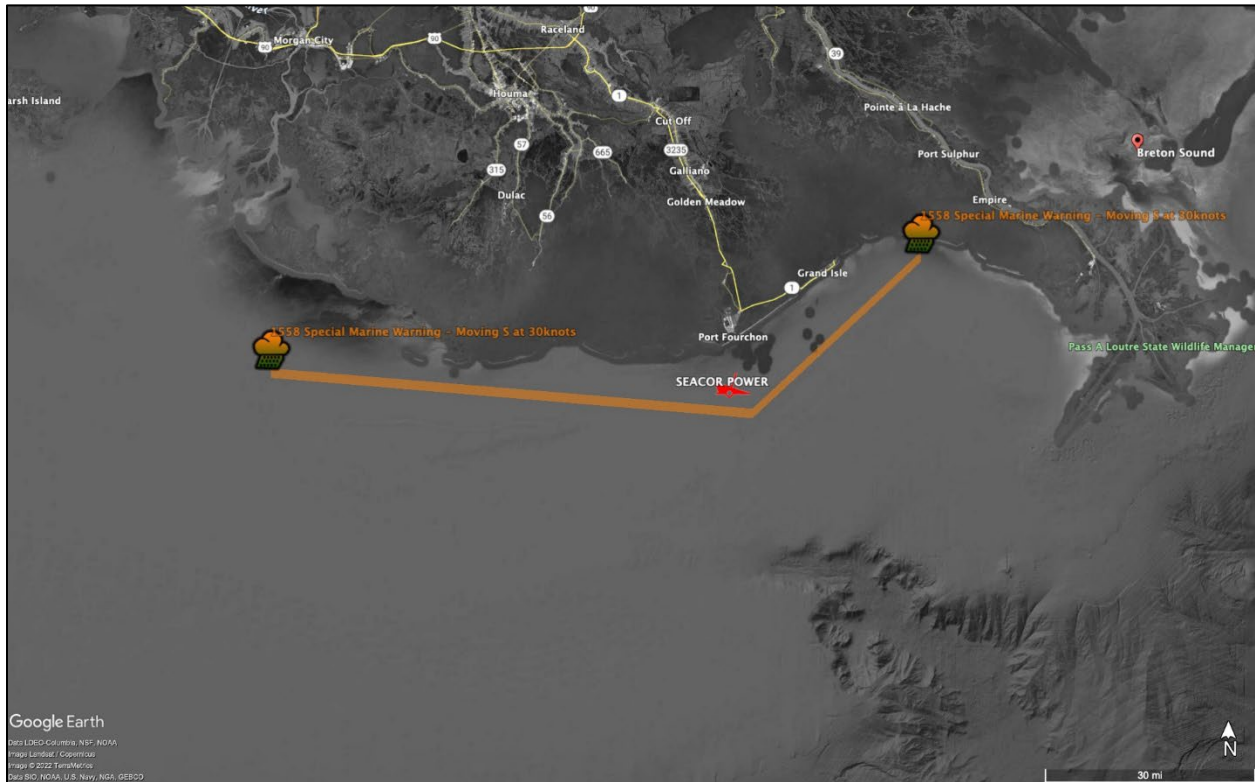
- 8.8.79. At 1558, the NWS issued a Special Marine Warning for coastal waters, from Southwest Pass to the Atchafalaya River, out to 60 nautical miles. This warning noted strong thunderstorms extending from 10 nautical miles southeast of Barataria Bay, to seven nautical miles northwest of LOOP, to nine nautical miles east of Eugene Island 105, moving south at 30 knots, and impacting the LOOP. This warning noted that the line of thunderstorms had already moved to the south of SEACOR POWER's location. The hazard associated with this line of storms was wind gusts 34 knots or greater.²¹⁵

Figure 44: Plotted line of thunderstorms from NWS Special Marine Warning at 1558 showing the line south of SEACOR POWER

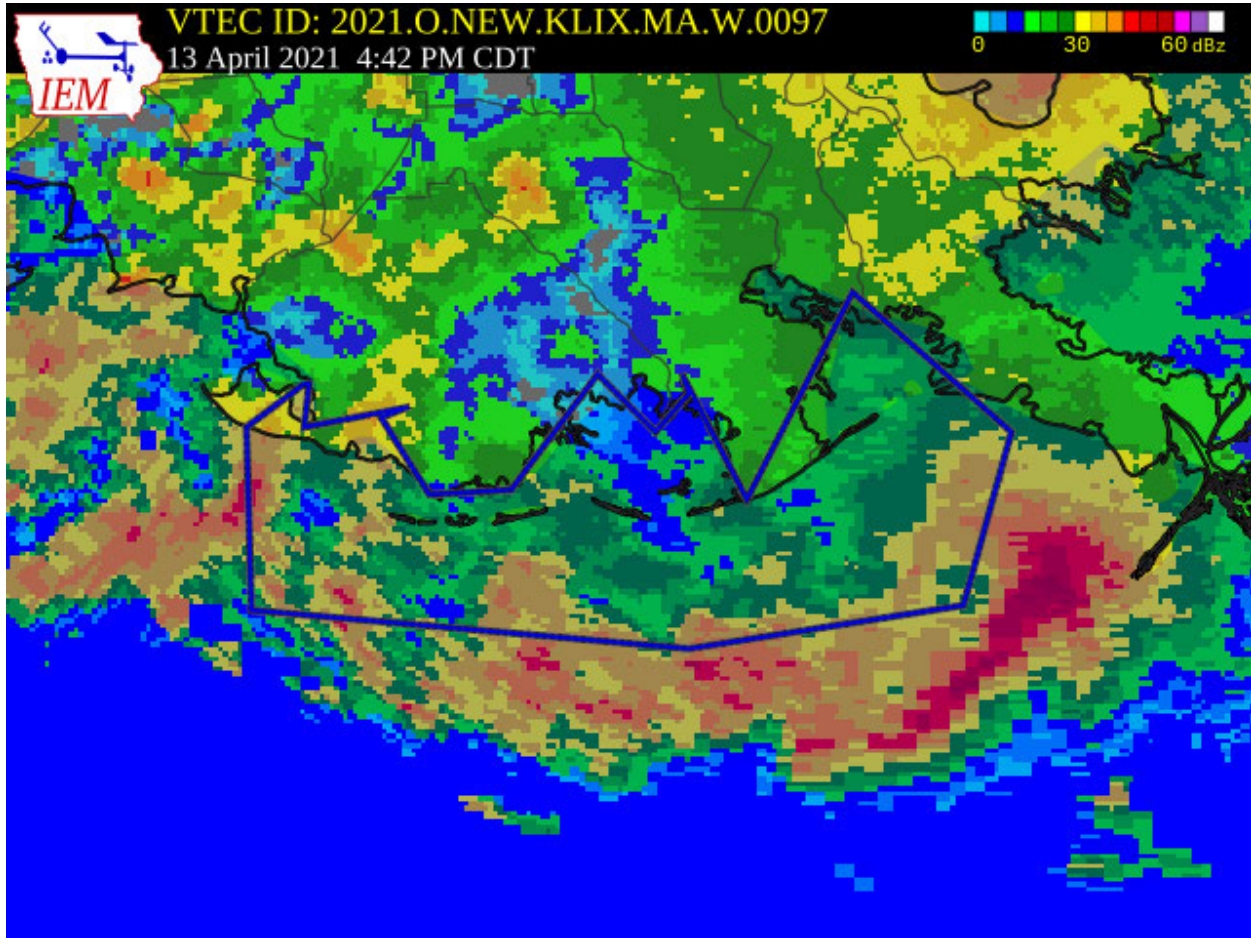
noted strong winds (34 to 50 knots) behind a gust front that extended from six nautical miles east of Barataria Bay, to eight nautical miles southeast of Timbalier Bay, to nine nautical miles south of Point Au Fer Island. The NWS obtained the information to generate this warning from buoy data.²²²

Figure 46: Applicable zone and radar image for Special Marine Warning issued at 1642 on April 13, 2021

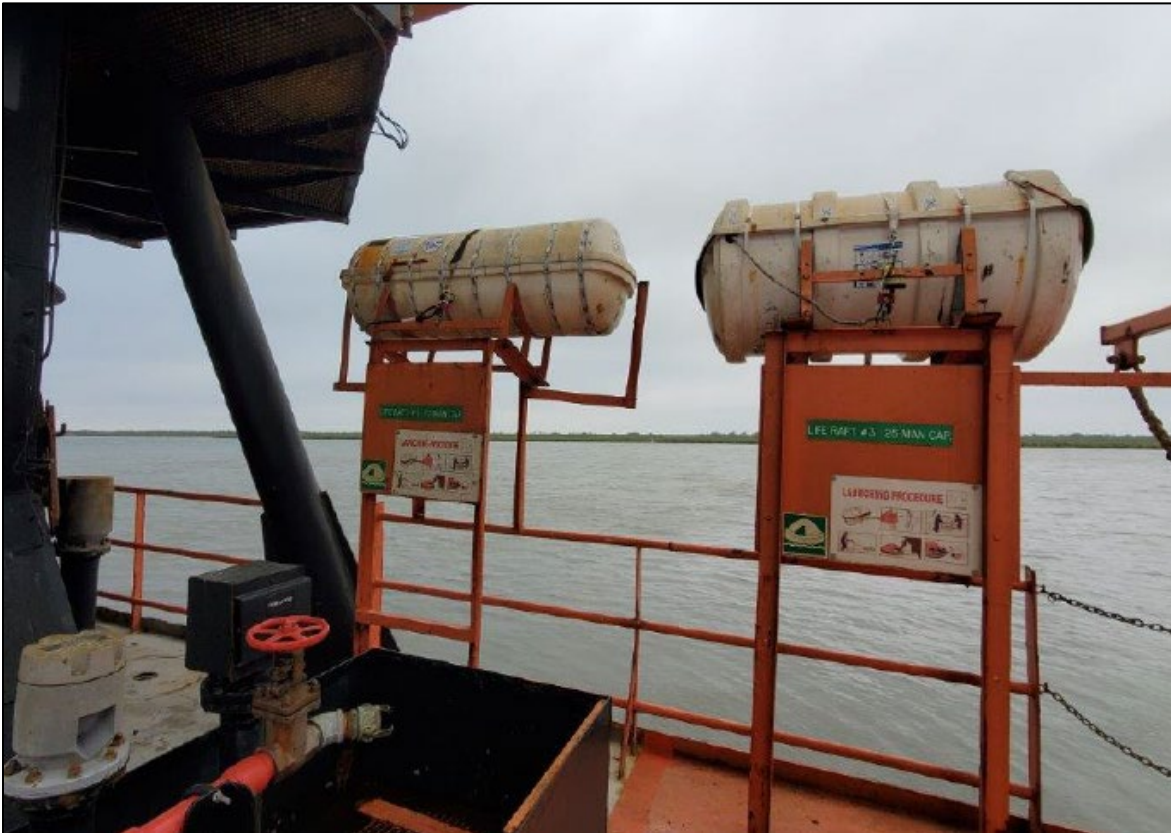
8.9.2. SEACOR POWER's inflatable liferafts were stored on the main deck, aft of the forward legs and around amidships. There were three on each side, and the total capacity of all six liferafts was 150. All of the liferafts were up to date on their life raft servicing.²³²

Figure 47: Liferafts stowed on SEACOR POWER (Exhibit 202)

- 8.9.3. During the capsizing, the three liferafts on the port side remained in their racks. The crew did not manually release these port side liferafts, and the rafts were not submerged, so they were not automatically deployed by the hydrostatic release. They remained up and out of the water, and they were still secured on the vessel, in their cradles, the morning after the incident. One of the liferafts on the starboard side released and was observed next to the boat on the morning of April 14th.

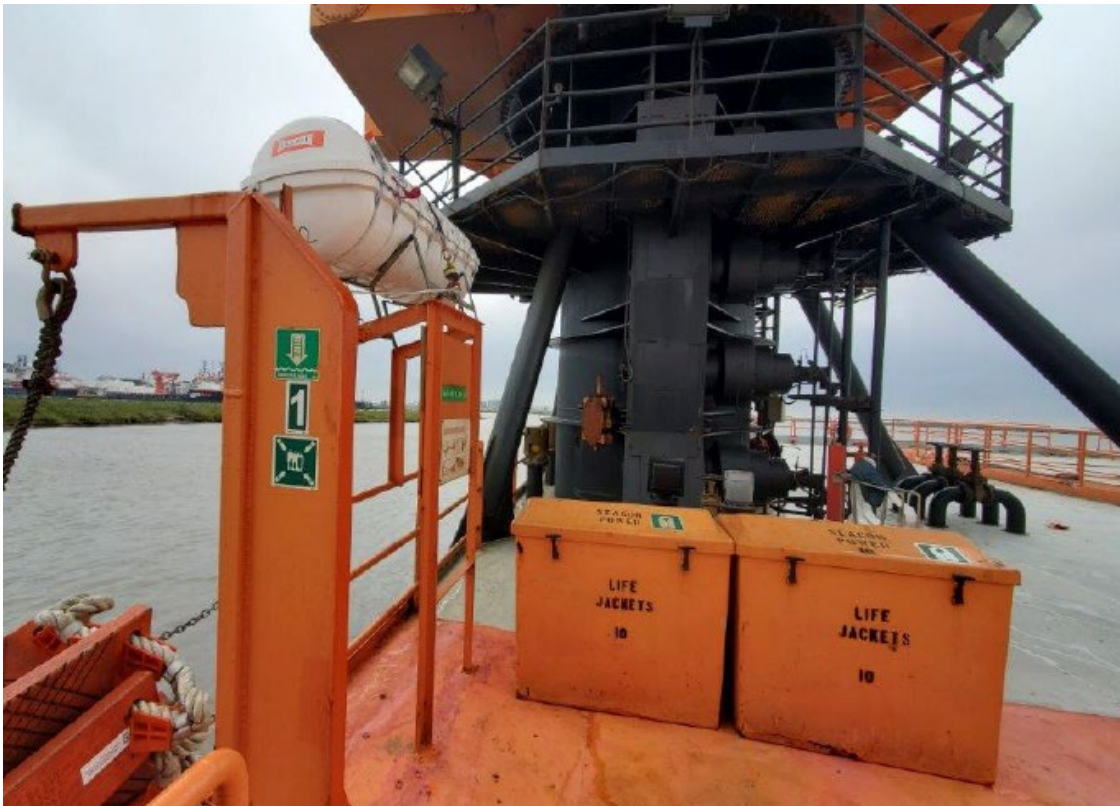
- 8.9.10. The First Mate stated that there were lifejackets stored on SEACOR POWER's bridge. The Off-Boat Master said that the vessel had lifejackets stored in each stateroom. He also stated that the vessel had two boxes of lifejackets at the muster station, which was on the main deck. These two boxes were in addition to the required complement of lifejackets. The extra boxes were not for use while underway; they were tied up and secured on the 01 level of the house while the vessel was underway.
- 8.9.11. A picture of the extra lifejacket boxes, taken on February 17, 2021, showed that each box held 10 lifejackets.

Figure 49: Extra lifejacket boxes (Exhibit 202)

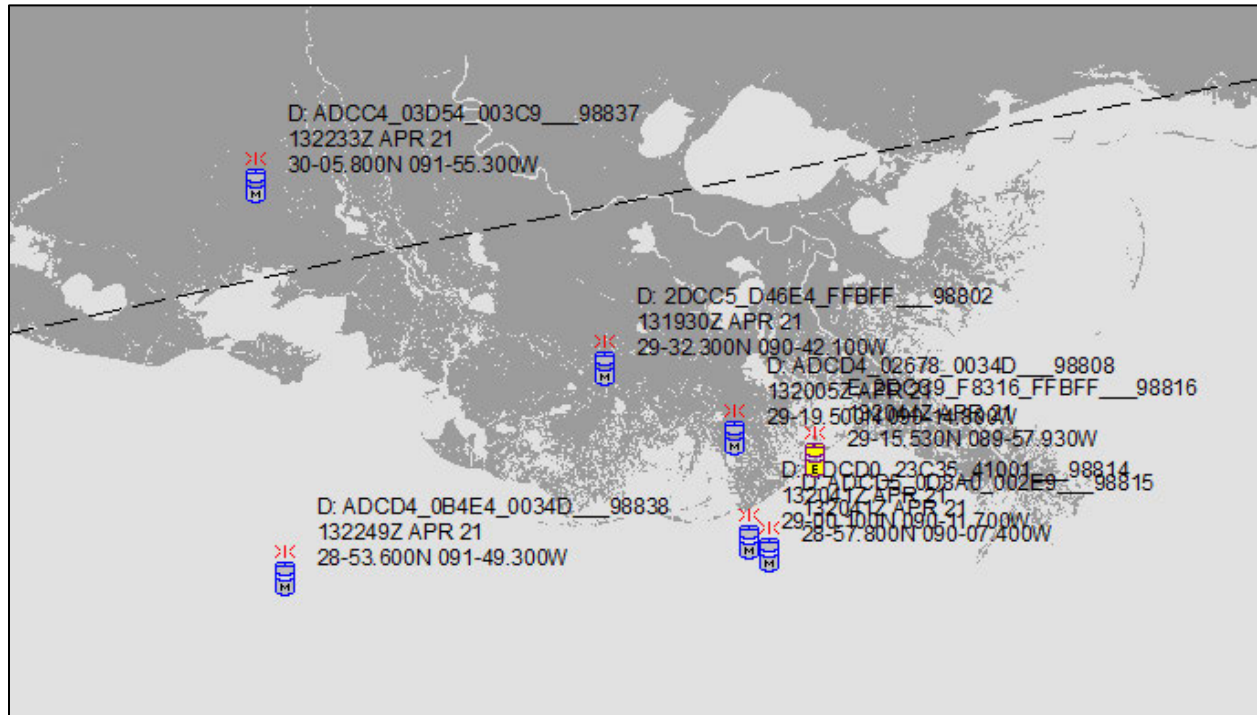
- 8.10.67. The District Eight CDO stated that, at approximately 1530, there were five EPIRB alerts in a span of 10 or 15 minutes. Three of the alerts came within one minute of each other, and almost all the alerts were in southern Louisiana. This was an unusually high number of EPIRB alerts, and the CDO had never seen this number of cases at the same time. The CDO stated that the number of cases presented communications challenges. The watch team made phone calls to check on the status of each vessel associated with an EPIRB alert. The watchstanders determined that a number of these EPIRB alerts did not involve distress cases.

Figure 51: EPIRB Alerts received by Coast Guard District 8 on April 13, 2021
