# MARINE CASUALTY REPORT

## ALEUTIAN ENTERPRISE

Flooding, capsizing, and sinking in the Bering  
Sea on March 22, 1990, with nine persons  
missing and presumed dead

U.S. COAST GUARD  
MARINE BOARD OF INVESTIGATION REPORT

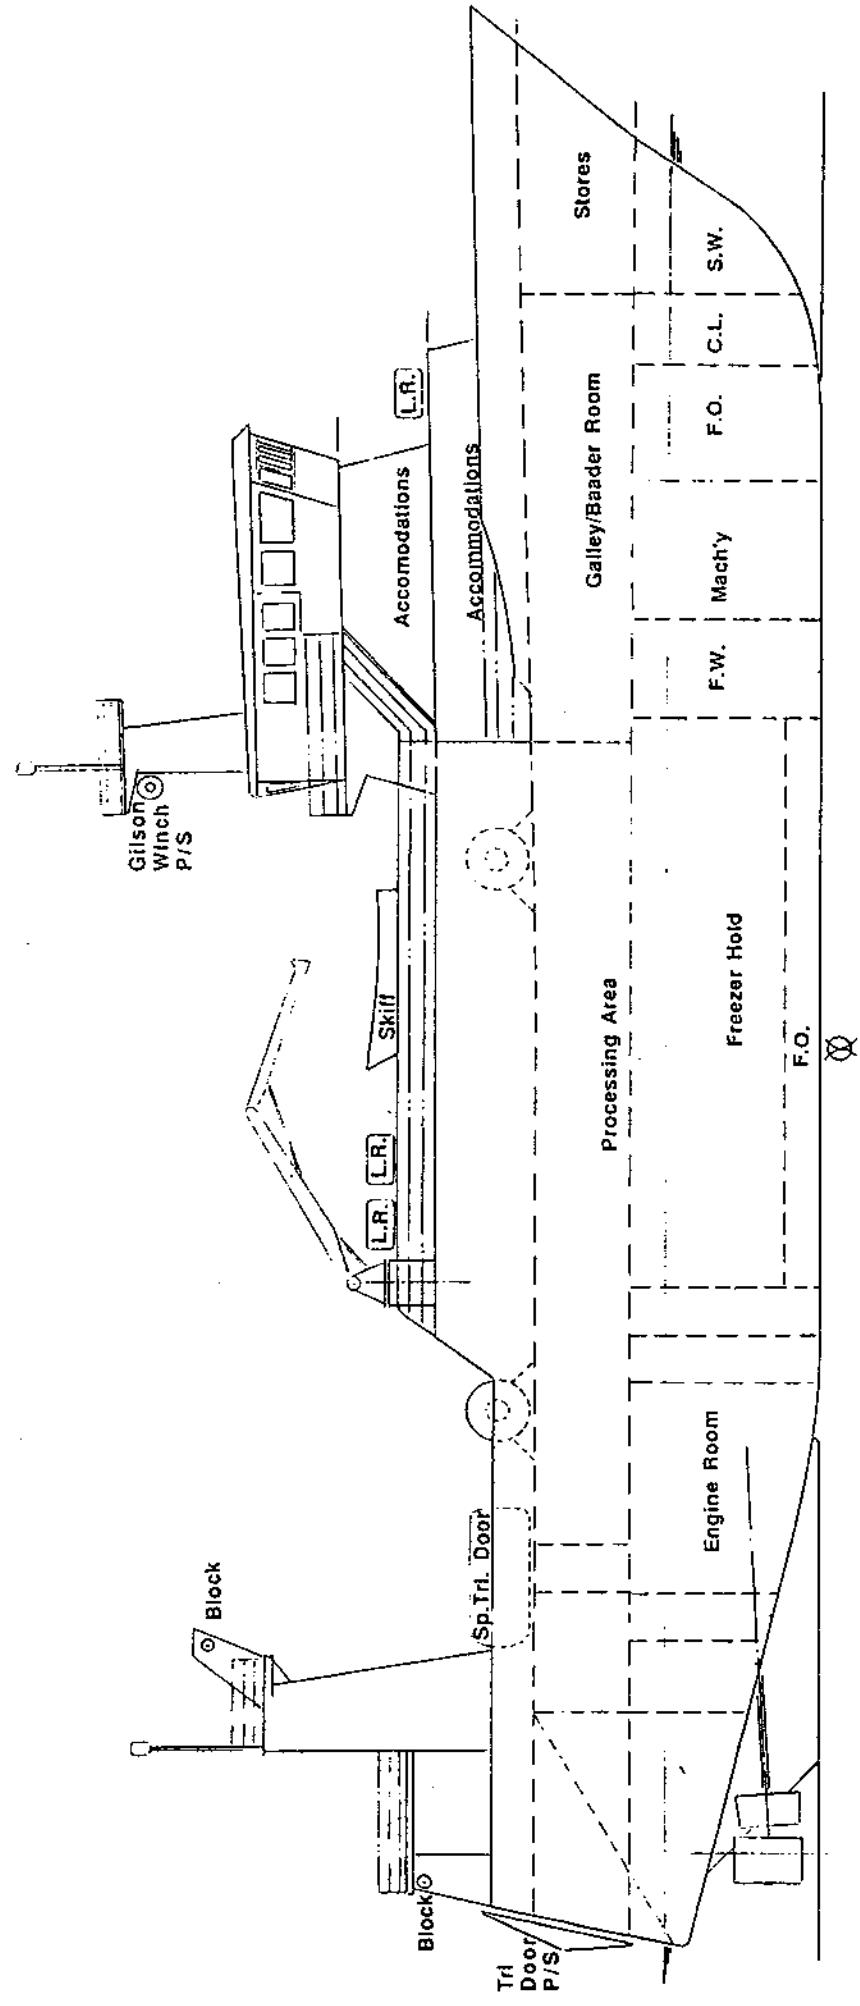
Figure 2

Figures (2) through (4) depict the vessel's profile and arrangement. Below the main deck level forward was a forepeak ballast tank, aft were two chain lockers, then a fuel oil tank to port and starboard of centerline. On centerline aft, a passageway led to a watertight door to the
