UNITED STATES COAST GUARD

**INVESTIGATION INTO THE CIRCUMSTANCES
SURROUNDING THE LOSS OF PROPULSION
ON THE BULK CARRIER**

BRIGHT FIELD

**AND ALLISION WITH THE RIVERWALK
SHOPPING COMPLEX ON DECEMBER 14, 1996,
NEW ORLEANS, LOUISIANA, WITH MULTIPLE
INJURIES AND NO LOSS OF LIFE**

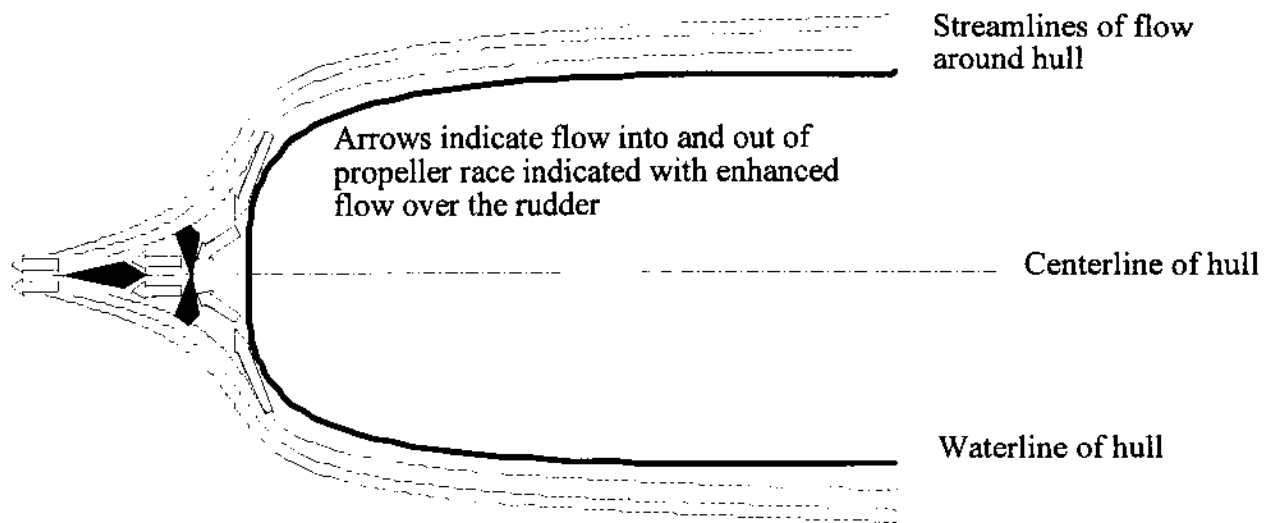
FIGURE 4

According to CAPT [REDACTED] this boxy hull form, when compared to vessels with more classic tapering stern lines, creates streamlines which do not naturally force full water flow over the rudder. The rotation of the propeller causes the streamlines to be drawn towards the rudder, enhancing water flow over the rudder. This, in concert with the outflow from the propeller, provides adequate steerage for a vessel of this type but is very much dependent on the propeller RPM. This is illustrated in the figure below.

WATER FLOW AROUND STERN OF VESSEL
