**MARINE CASUALTY REPORT**

**USCGC BLACKTHORN, SS CAPRICORN;  
COLLISION IN TAMPA BAY  
ON 28 JANUARY 1980 WITH LOSS OF LIFE**

**U.S. COAST GUARD  
MARINE BOARD OF INVESTIGATION REPORT**

**REPORT NO. USCG 16732/01279**

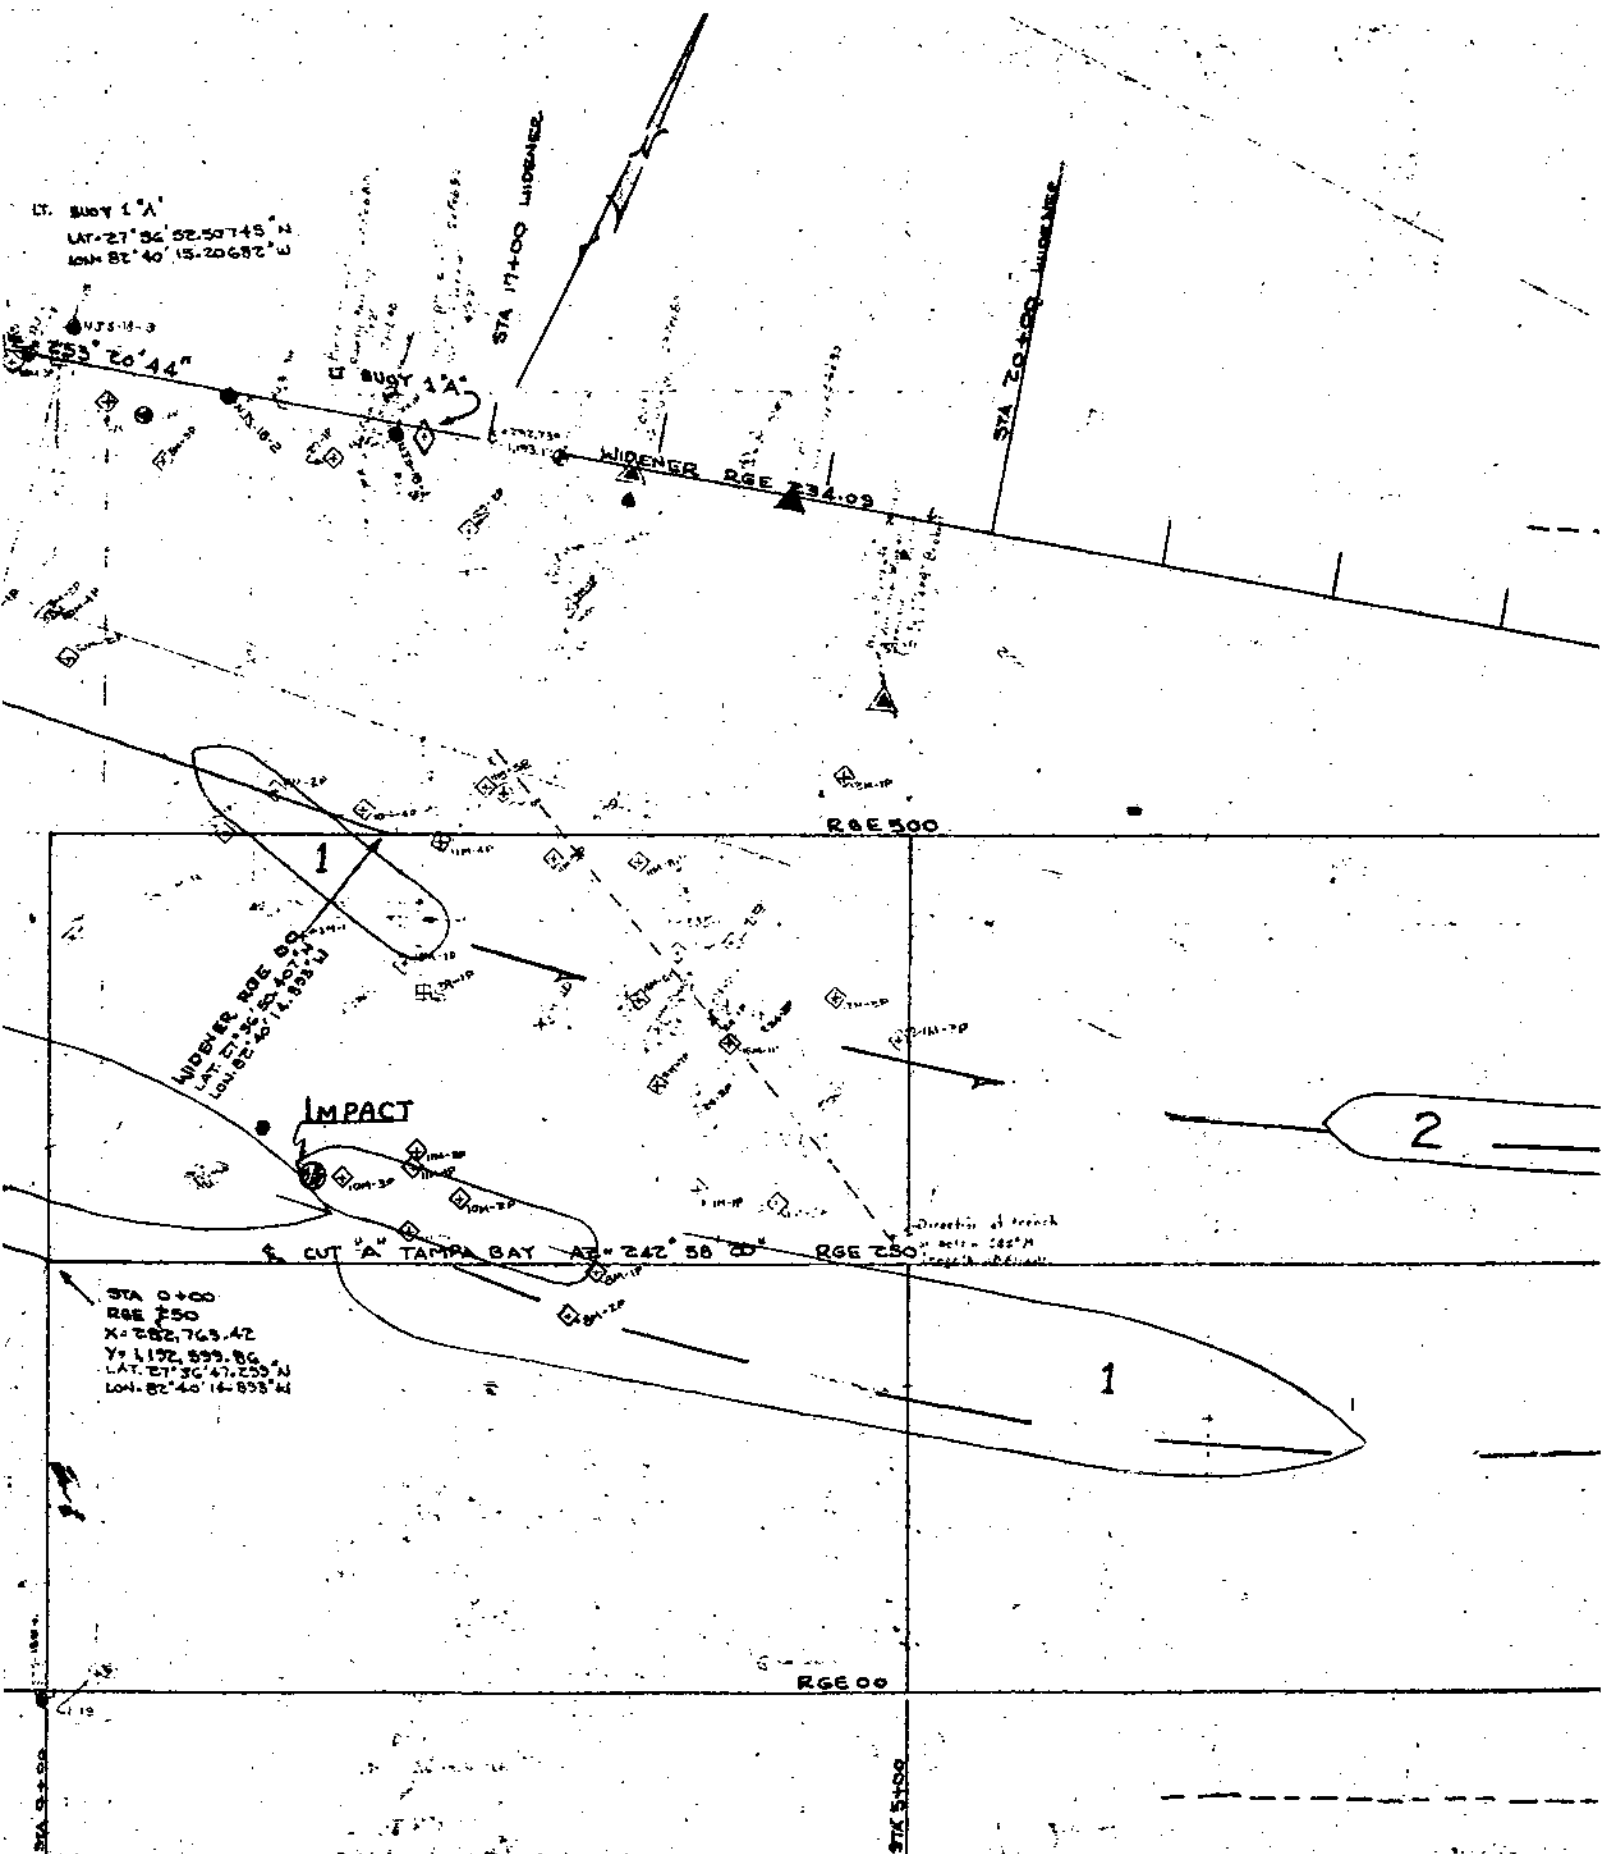
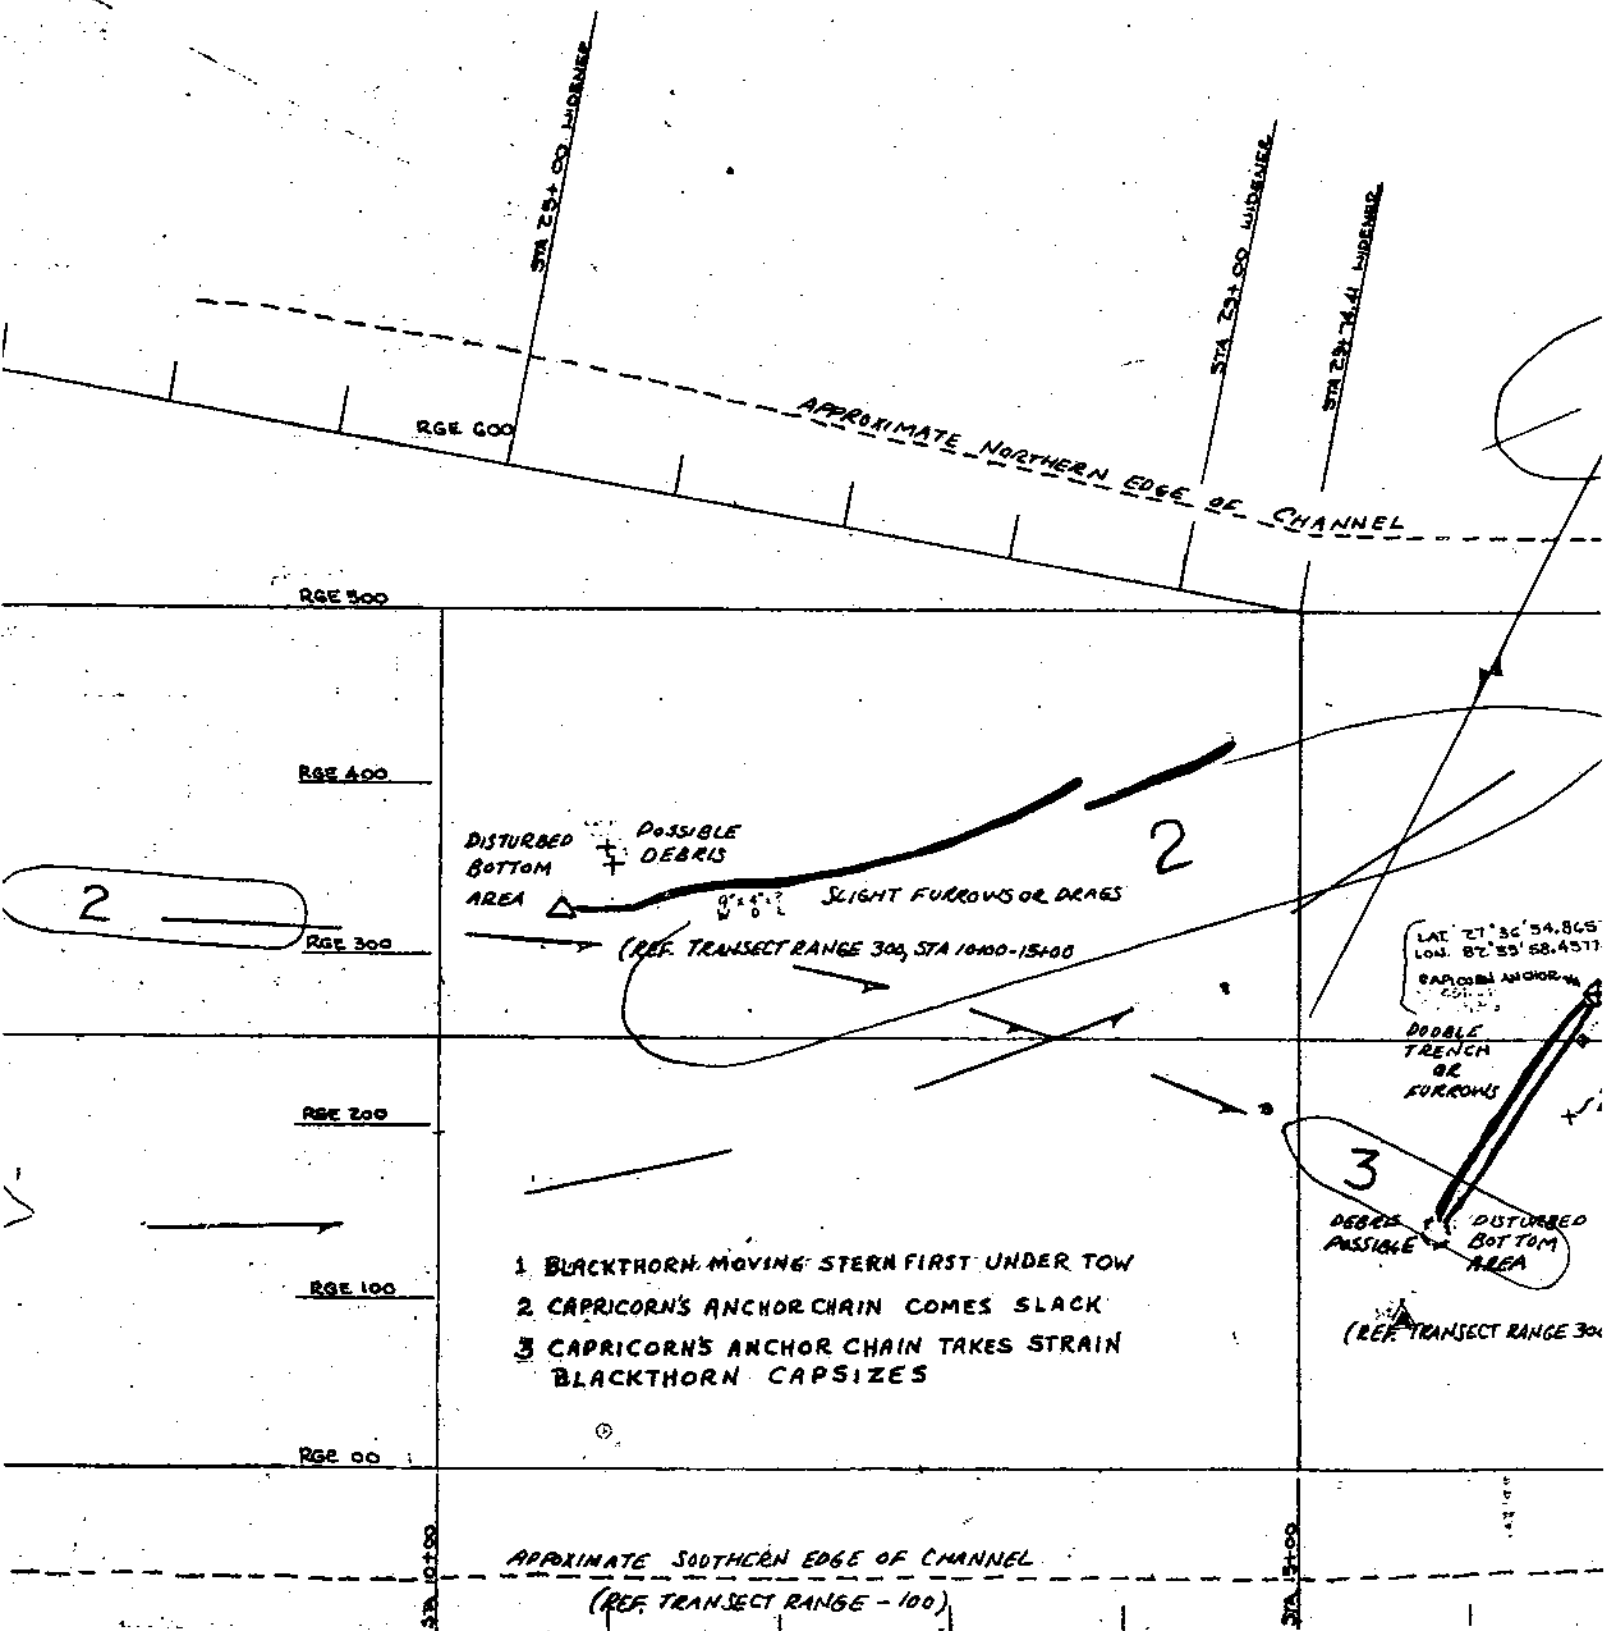
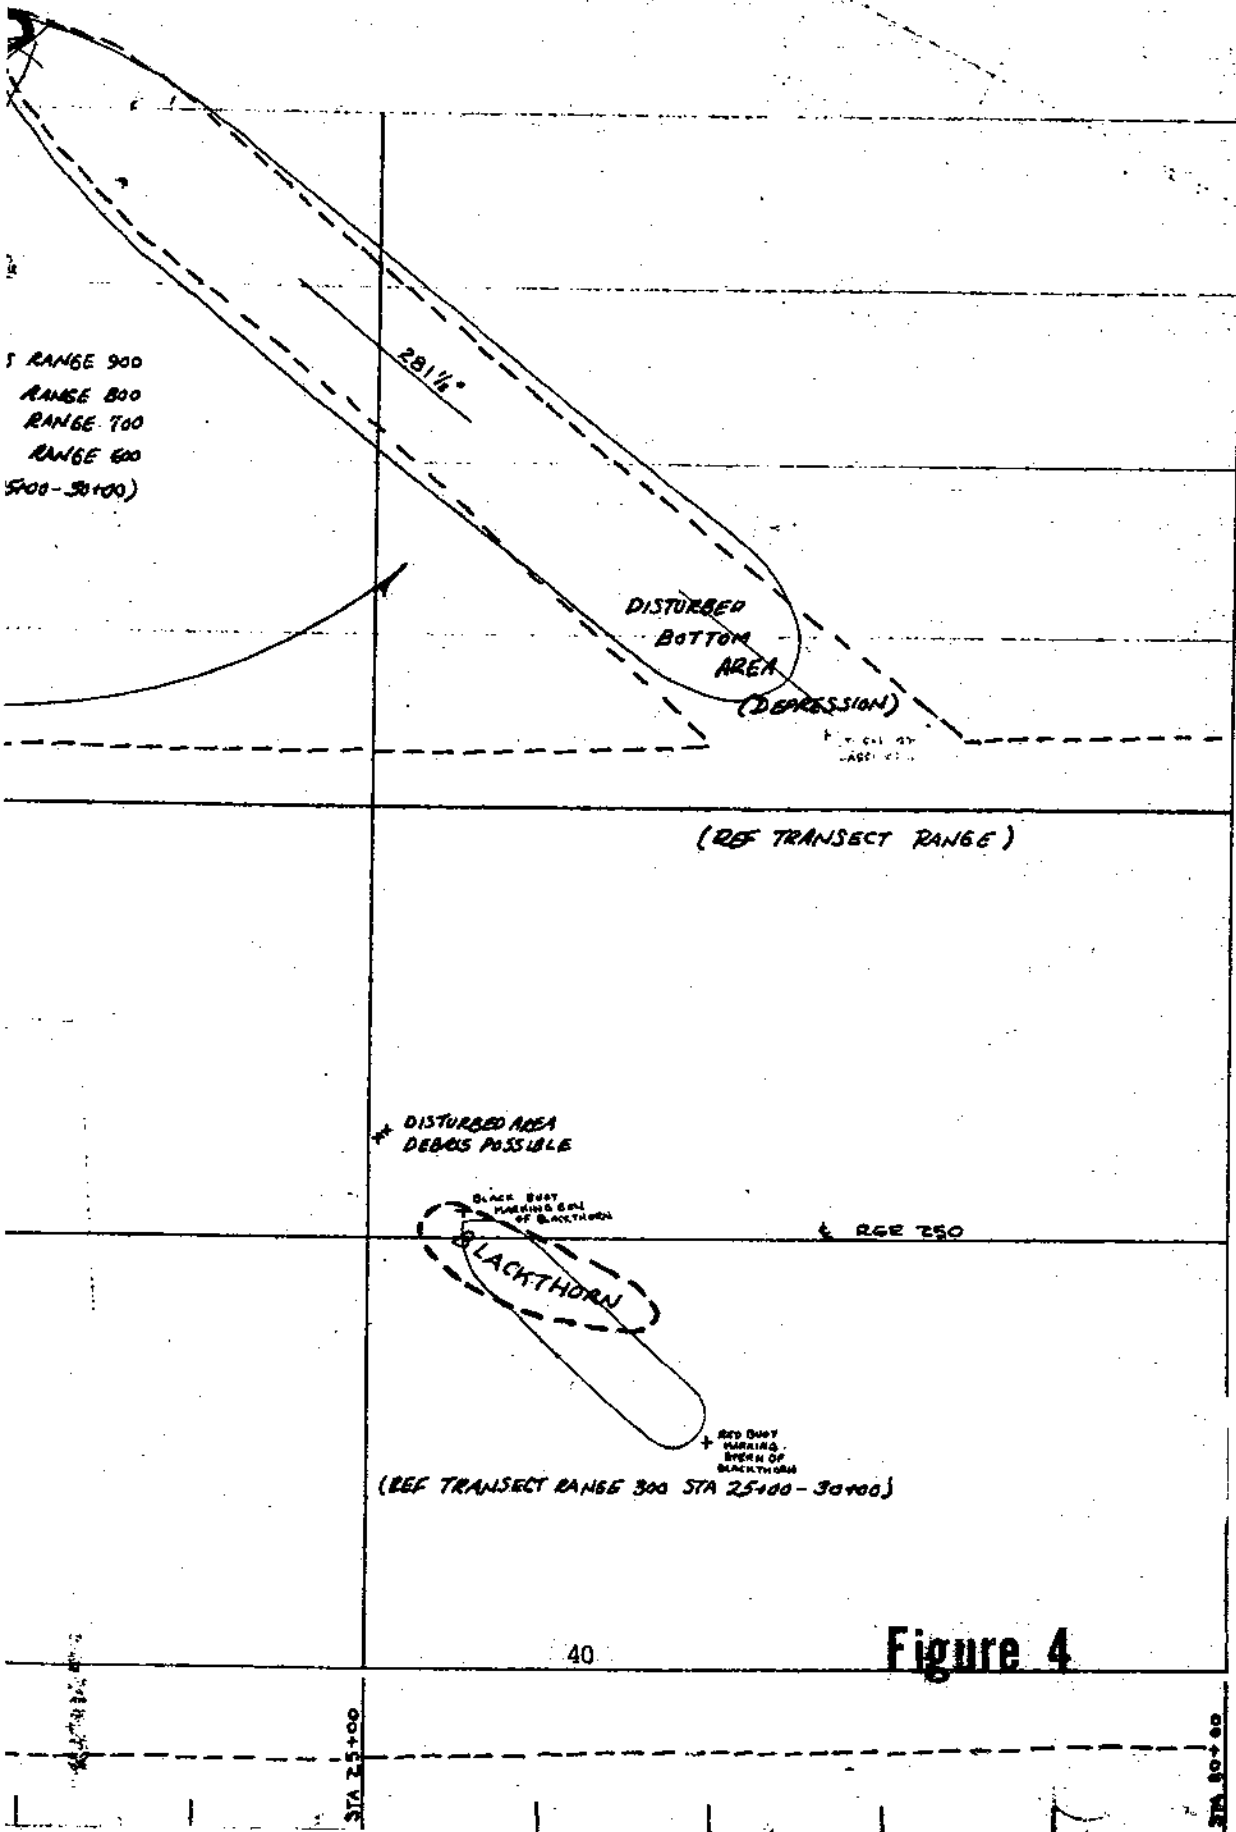
Figure 4

### 1. VESSEL MOVEMENTS AFTER IMPACT (SEE FIGURE 4)

d. The Board determined that CAPRICORN's bolster piece fell into BLACKTHORN's side during impact while both vessels were alongside each other. The rationale for this decision was that there is no other reasonable explanation for how the bolster piece could have been found on the channel bottom next to CAPRICORN's anchor marks. The bolster piece must have fallen out with the anchor when BLACKTHORN capsized.

e. In summary, the above discussion indicates that when CAPRICORN's port anchor impacted with BLACKTHORN, the hawse pipe was shattered and the port side of BLACKTHORN was ripped so that debris from both vessels fell to the channel bottom. This sequence has been reconstructed and, when taken with the bottom positioning of the debris, accurately reflects the position of collision.
