# MARINE CASUALTY REPORT

UNINSPECTED TOWING VESSEL  
FRANK PALLADINO JR  
O.N. 619166

GREAT LAKES BARGE  
KELLSTONE I  
O.N. 274472

COLLISION WITH A PLEASURE  
CRAFT (OH 0164 YU) IN THE  
SOUTH PASSAGE OF LAKE  
ERIE, ON 1 OCTOBER 1994,  
WITH AN INJURY AND  
MULTIPLE LOSS OF LIFE.

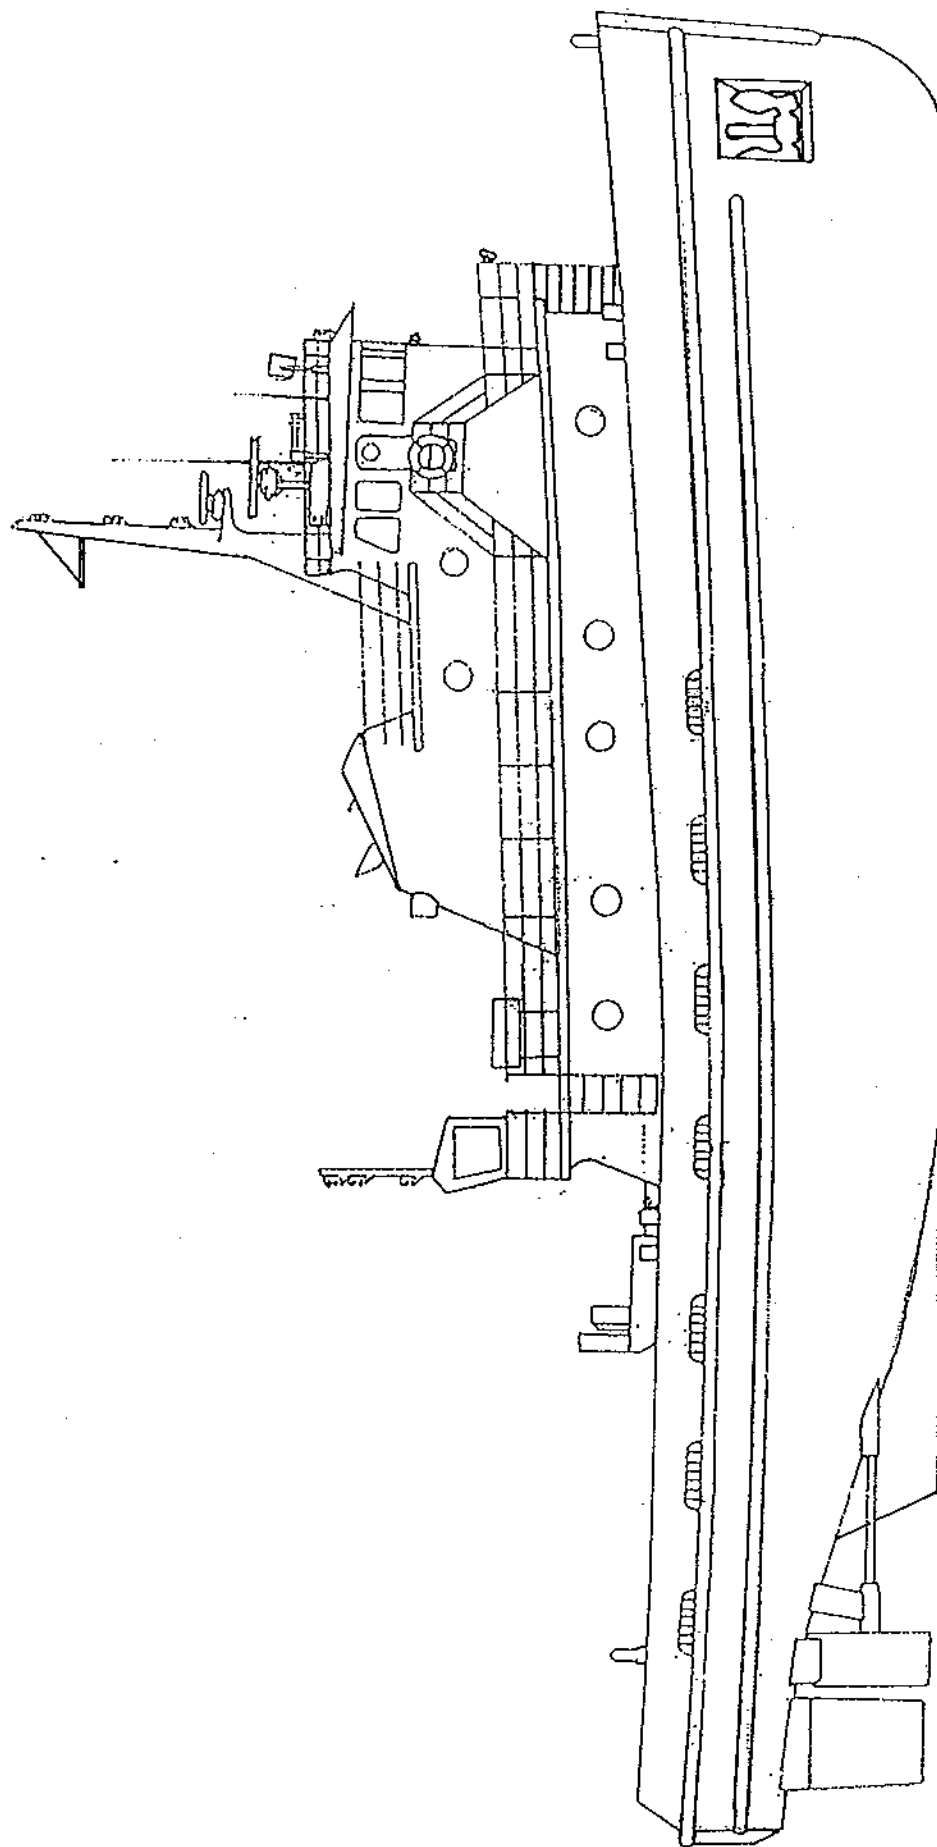
FIGURE 1 - 1

# M/V FRANK PALLADINO JR

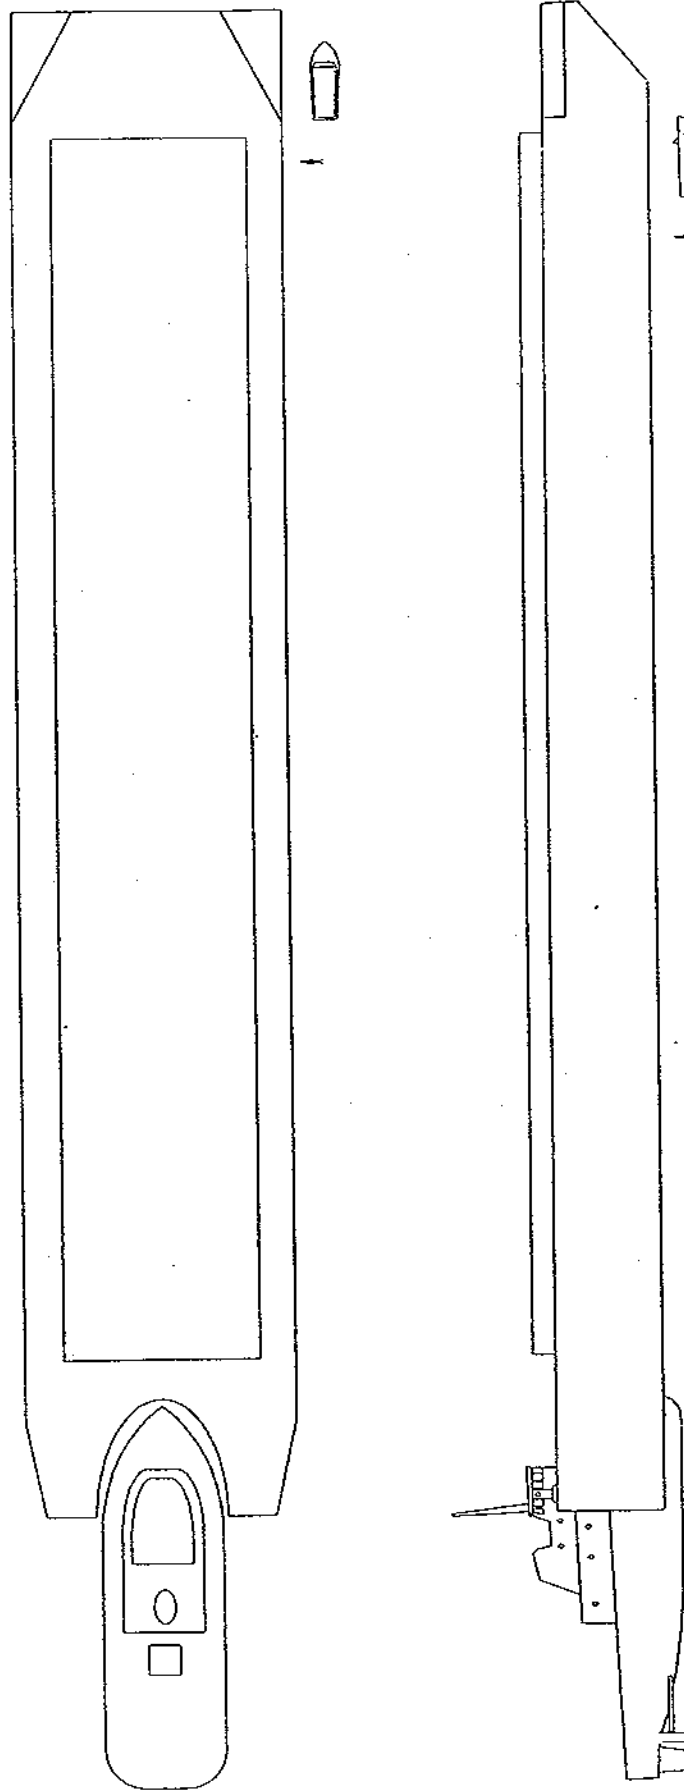
FIGURE 1 - 3

Tug: FRANK PALLADINO, JR. (ON 619166)  
Barge: KELLSTONE I (ON 274472)  
Pleasure Craft: OH 0164 YU

Outside dimensions to scale, all other dimensions estimated.

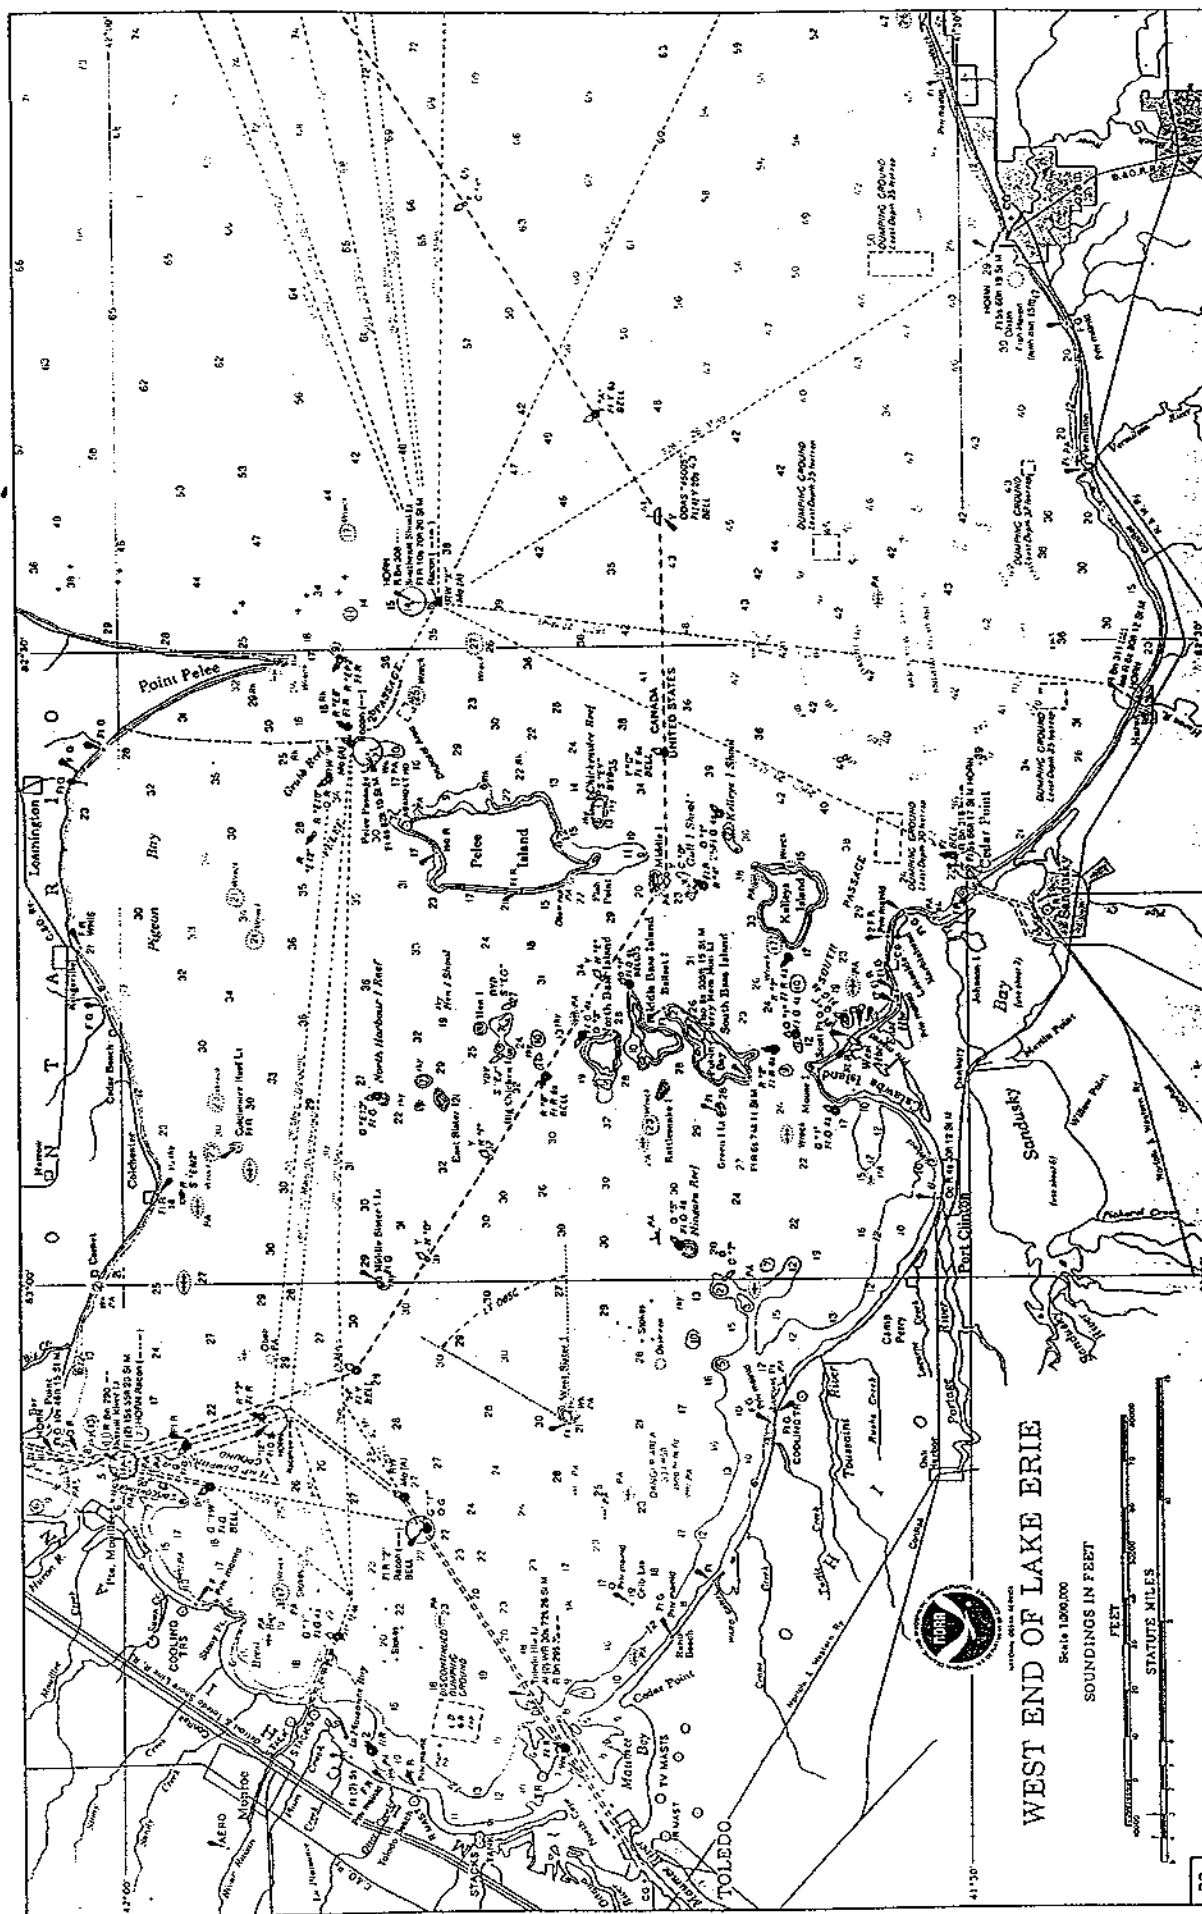
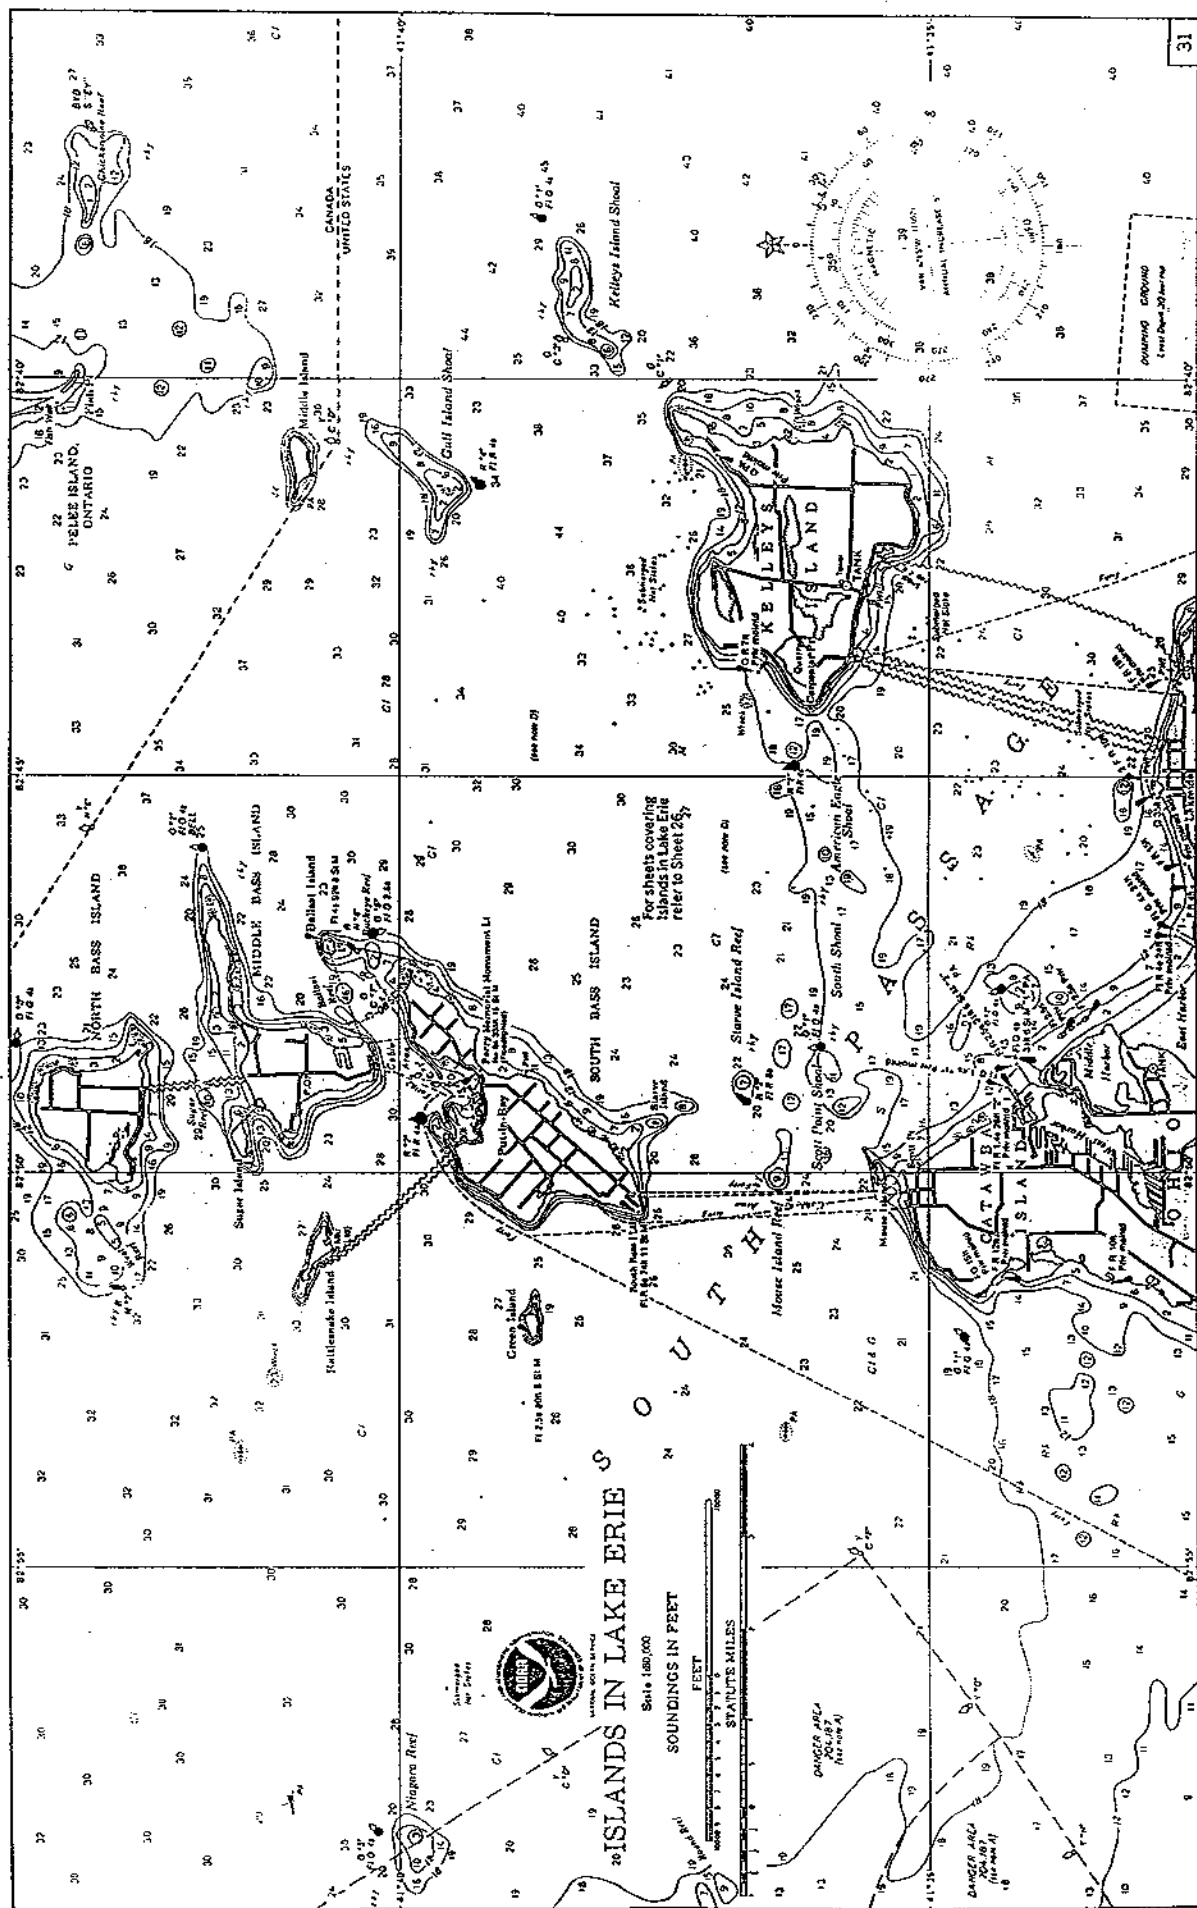
10. "South Shoal and American Eagle Shoal lie on the northeast side of the vessel route through South Passage." [CG13; USCP 6, 1994, p. 168; Figure 3 - 6; Figure 3 - 7]

11. "Starve Island Reef, with a least depth of 7 feet [2.13 m], is on the northeast side of the vessel route and is marked off its west side by Starve Island Reef Lighted Buoy 2 [LLNR 5525]." [CG13; CG14; USCP 6, 1994, p. 169; Figure 3 - 6; Figure 3 - 7]

12. "Scott Point Shoal, west of South Shoal on the southwest side of the vessel route, is rocky and has a least depth of 11 feet [3.35 m] at the northeast end where it is marked by a Scott Point Shoal Lighted Buoy 1 [LLNR 5520]." [CG13; CG14; USCP 6, 1994, p. 169; Figure 3 - 6; Figure 3 - 7]

13. "Green Can Buoy 1 marks the extent of the bank east of Long Point, the northeast point of Kelly's Island. A rock, covered 12 feet [3.66 m], is marked on the south side by Rock Shoal Lighted Buoy 2 [LLNR 5595] 0.6 mile WNW [292.5°T] of Carpenter Point." [CG6B; CG13; CG14; USCP 6, 1994, p. 168; Figure 3 - 6]
