LOSS OF THE
MOTOR TOWING VESSEL
MAJORIE McALLISTER
IN THE ATLANTIC OCEAN
ON NOVEMBER 2, 1969

U.S. COAST GUARD
MARINE BOARD of INVESTIGATION REPORT
and COMMANDANT'S ACTION

ACTION BY
NATIONAL TRANSPORTATION SAFETY BOARD

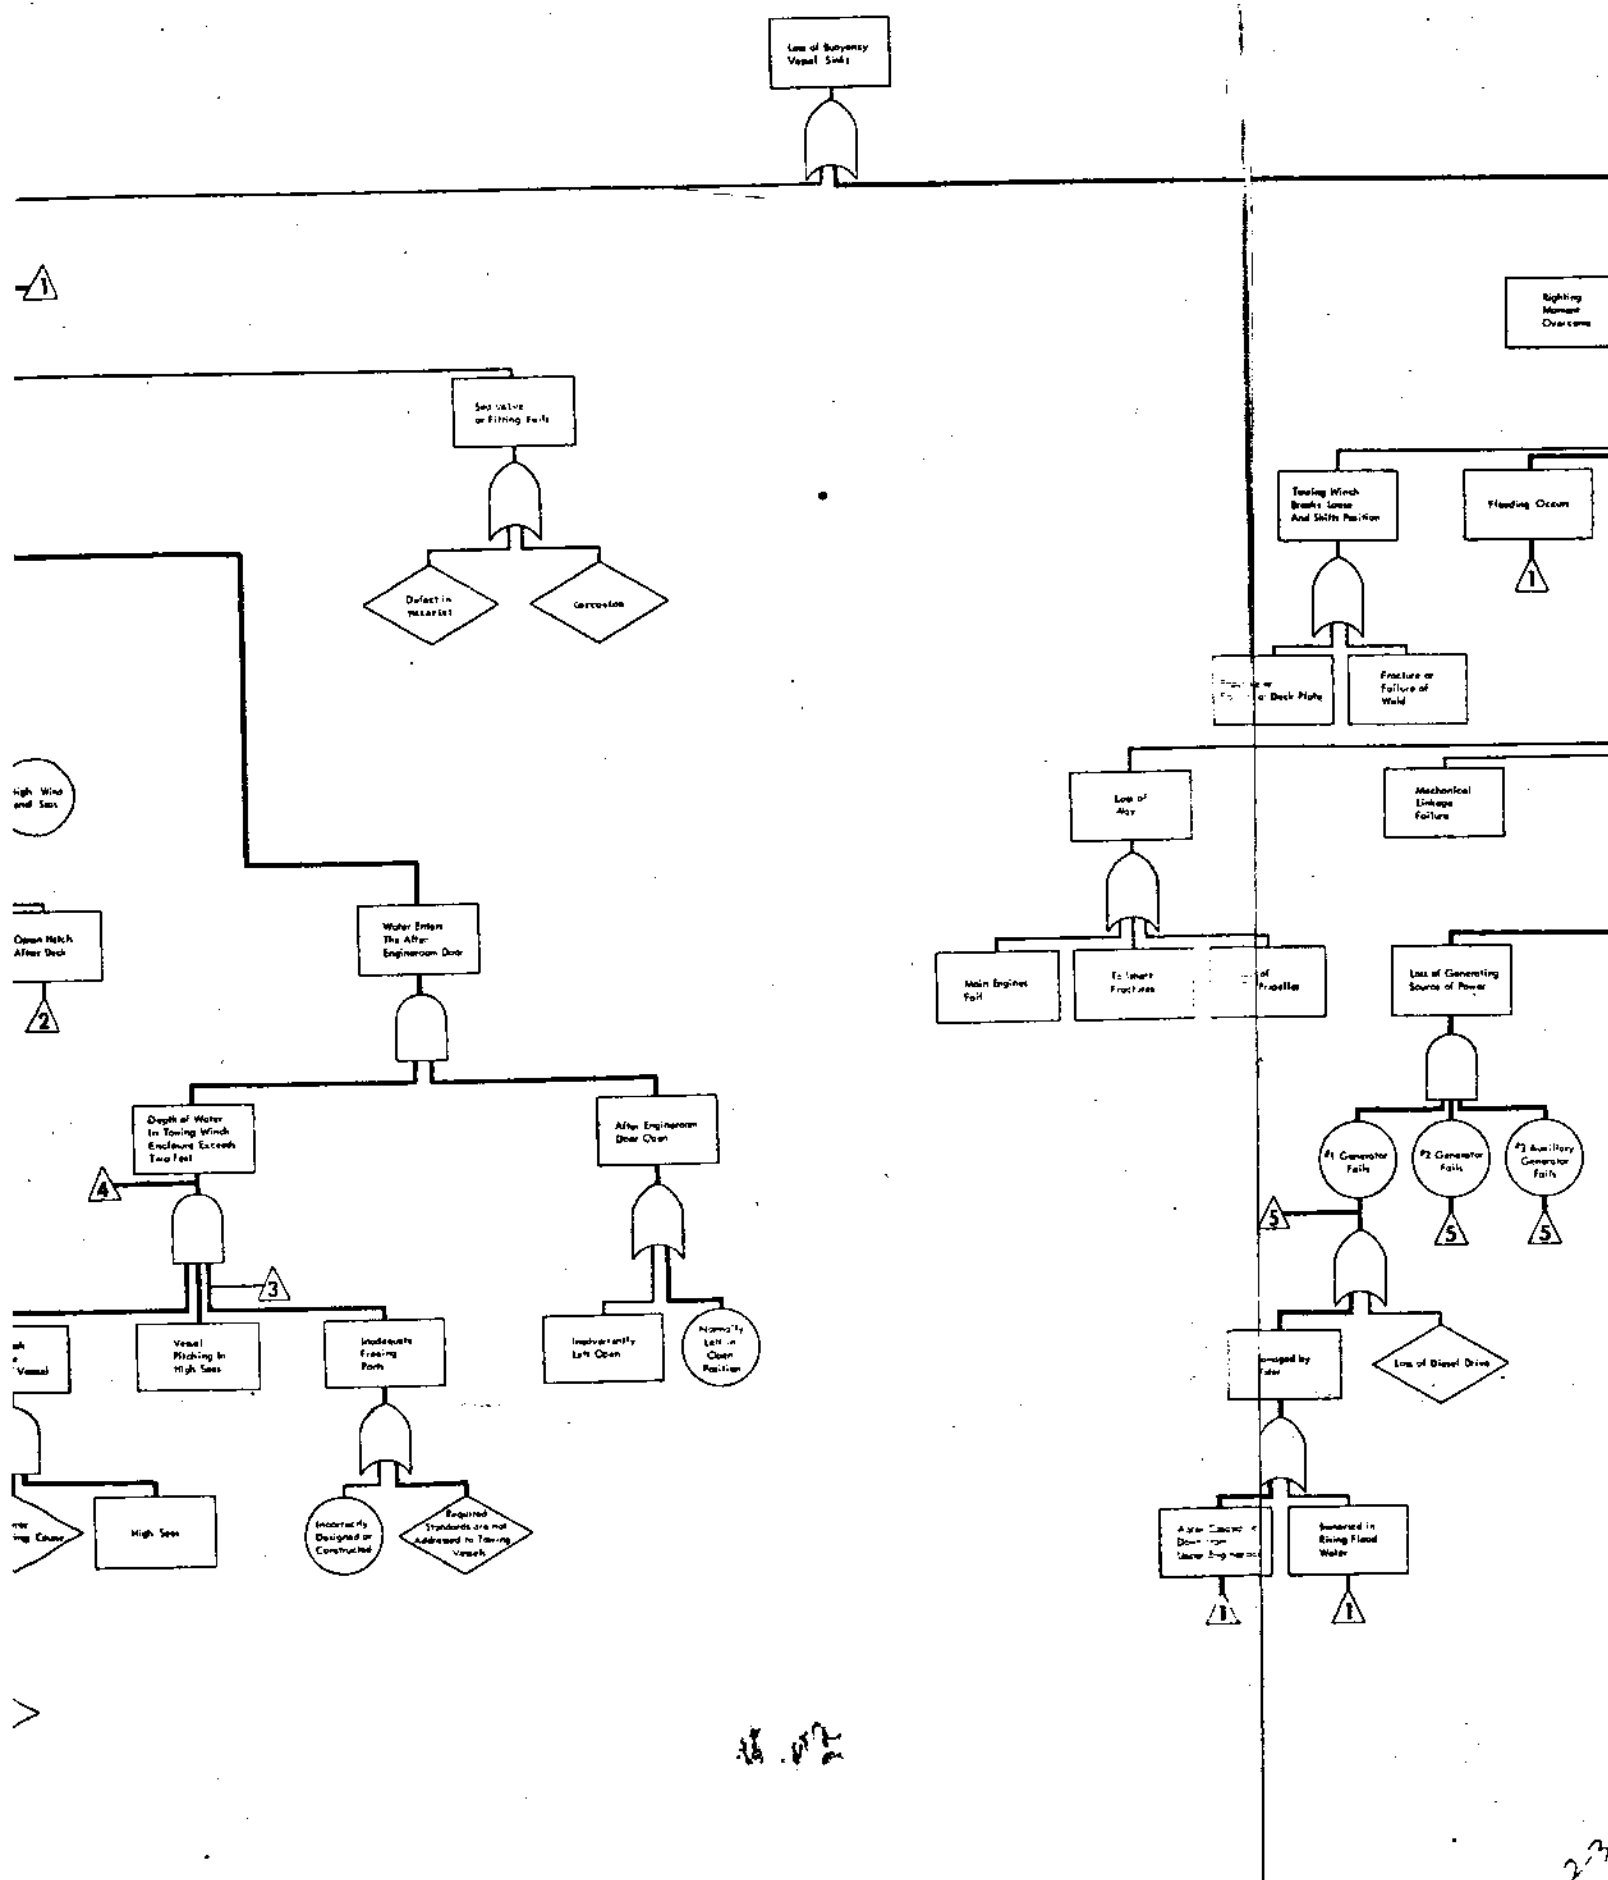
AM - CAUSE & EFFECT ANALYSIS OF TOWING VESSEL MARJORIE McALLISTER

The National Transportation Safety Board finds that the probable cause of the loss of this vessel was foundering. Extremely adverse weather, flooding of the engineroom, and the sudden capsizing of the vessel were the causes of the foundering and the loss of all hands. Other contributing factors were:

2. The Coast Guard, American Bureau of Shipping, and the organized ship design professions consider the usefulness of the fault tree or similar systems analysis technique as a predictor of potential failures and accidents, and as a guide to needed design requirements, during the design and plan approval stages of ship construction.
