**MARINE CASUALTY REPORT**

**OCEAN EXPRESS (DRILLING UNIT): CAPSIZING  
AND SINKING IN THE GULF OF MEXICO ON  
15 APRIL 1976 WITH LOSS OF LIFE**

**U.S. COAST GUARD  
MARINE BOARD OF INVESTIGATION REPORT**

**REPORT NO. USCG 16732/ 61865**

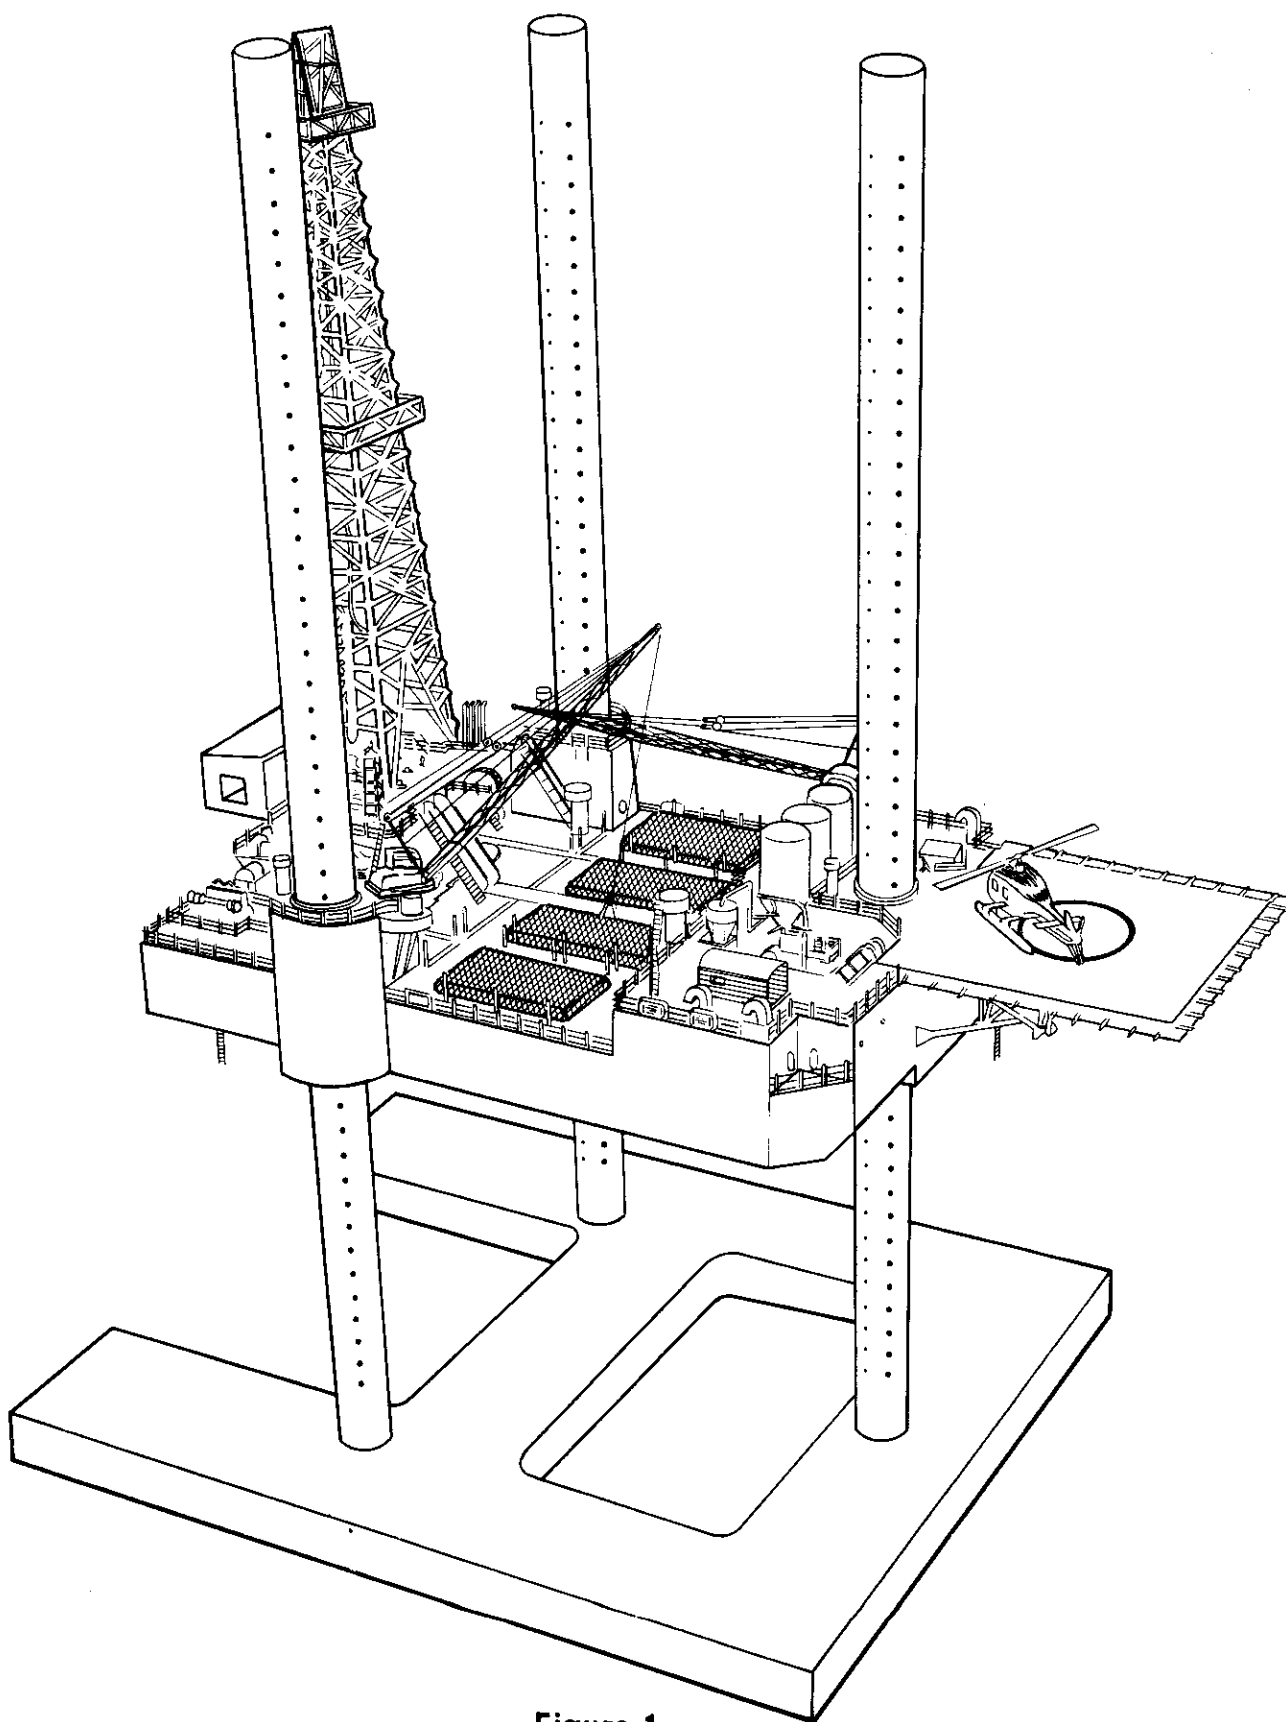
Figure 1

- a. Name: OCEAN EXPRESS (See Figure 1)
  - Official number: 569885
  - Material: Welded steel
  - Service: Self-elevating mobile drilling unit
  - Barge platform: Length: 166 feet
    - Breadth: 109 feet
    - Depth: 16 feet
  - Bottom mat: Length: 210 feet
    - Breadth: 170 feet
    - Depth: 12 feet
  - Classed: ABS (\*A1)
  - Year built: 1975
  - Where built: Beaumont, Texas
  - Owner: Odeco Drilling, Inc.
    - Canal Street
    - New Orleans, La.
