MARINE CASUALTY REPORT

SS POET: DISAPPEARANCE IN THE ATLANTIC OCEAN AFTER DEPARTURE FROM CAPE HENLOPEN, DELAWARE ON 24 OCTOBER 1980 WITH LOSS OF LIFE

MARINE BOARD OF INVESTIGATION REPORT

REPORT NO. USCG 16732/11486

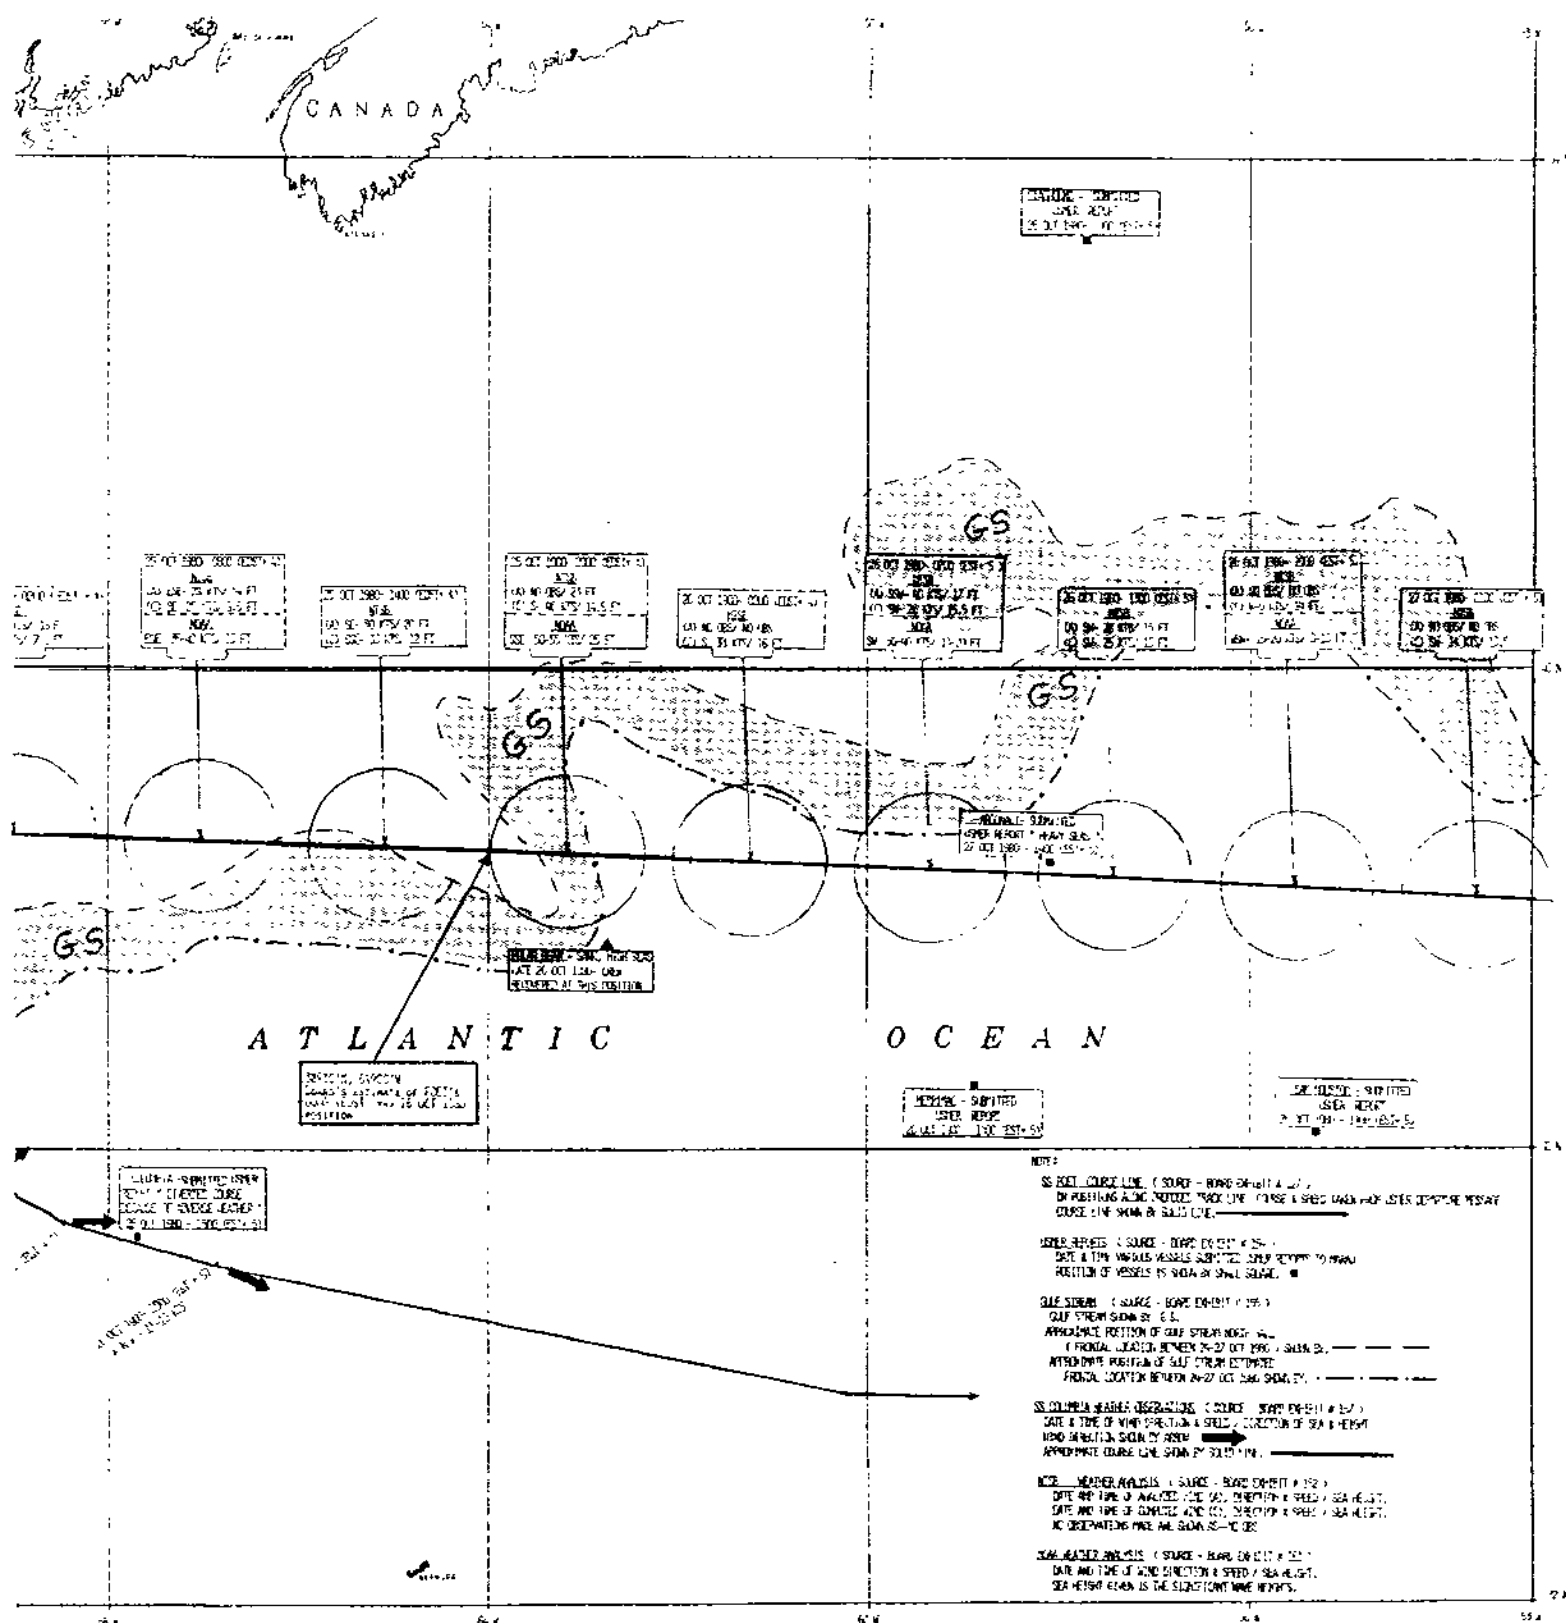
Figure 4 POET--Projected Track
24-26 October 1980

Using information in POET's USMER departure message indicating the vessel intended to follow a rhumb line track from Cape Henlopen to Gibraltar at a speed of 15 knots, the Board constructed the projected track of Figure 4. Also shown in Figure 4 is information on estimated wind and sea conditions along the track from NTSB and NOAA analyses, estimated location of Gulf Stream North Wall, and weather and weather-related problems experienced by other craft in the area. After departure on the 24th, POET would have initially encountered winds of 20-25 knots and seas of 10 feet from directly ahead. These would have gradually increased and shifted to the southeast during the day on the 25th as the low pressure area moved up the coast. The vessel would have approached within 50-100 nautical miles of the northern edge of the Gulf Stream late on the 24th or early on the 25th, a region where the Navy North Wall advisories indicate wind and seas may be more severe than generally forecast. It appears likely that the vessel's speed would have been reduced from 15 knots to 5-8 knots in order to moderate increasing ship motions, but this speed reduction would not have changed the vessel's estimated time of arrival at its destination enough to require an update message to USMER.

Other vessels in the area at the time reported speed reductions due to heavy weather in regular USMER messages they submitted. The POET would have encountered the most severe weather conditions late on the 25th and early on the 26th as wind and seas shifted from south-southeast (broad on the starboard bow) around to the south and southwest (on the starboard quarter). With the effect of the North Wall, POET may have encountered winds of up to 60 knots and seas up to 30 feet somewhere in the vicinity of 38 degrees 30 minutes north latitude, 64 degrees west longitude (indicated on Figure 4) around midnight on 25 October 1980. It was at this time that an unidentifiable and incomplete auto alarm signal was received by radio station WMH in Baltimore. In addition, the next regular USMER message scheduled to be sent around 1200-1400 on 26 October 1980 was not received.
