# MARINE CASUALTY REPORT

## TANKSHIP PUERTO RICAN

EXPLOSION AND FIRE  
IN THE PACIFIC OCEAN,  
ON 31 OCTOBER 1984

REPORT NO. USCG 16732/0003 HQS 84

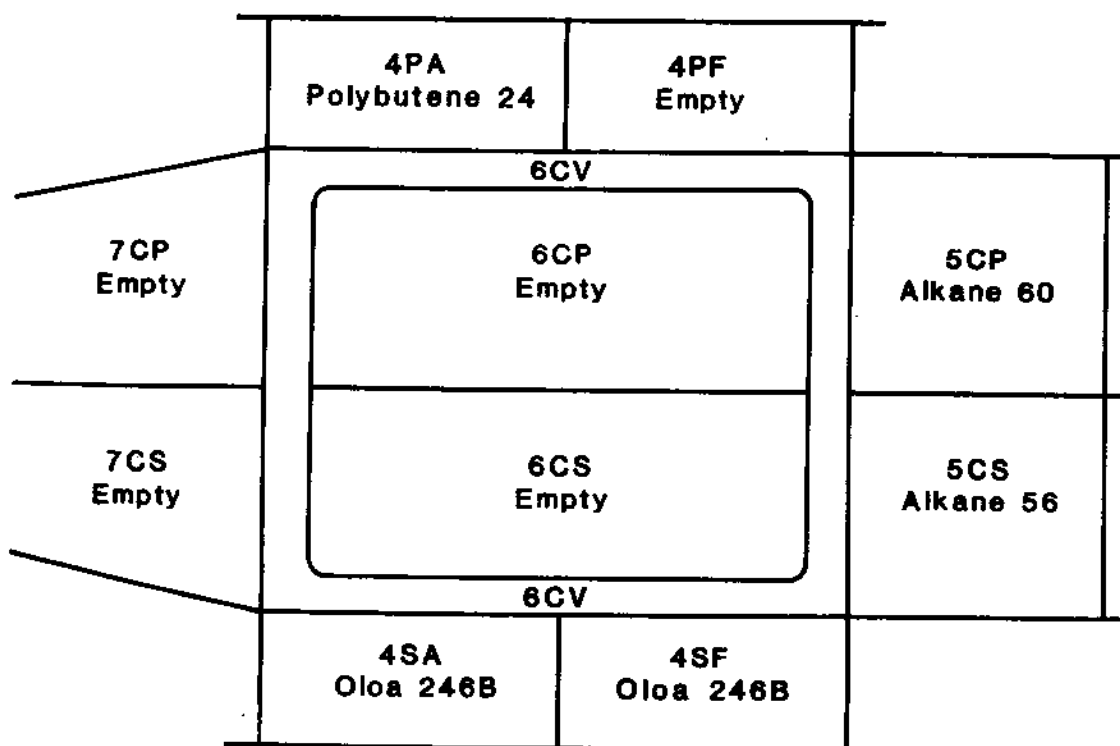
Figure 2. Cargoes in the tanks adjacent to 6CV, at the time of the casualty.

26. The cargoes immediately adjacent to 6CV on October 31, 1984 are shown in figure 2.

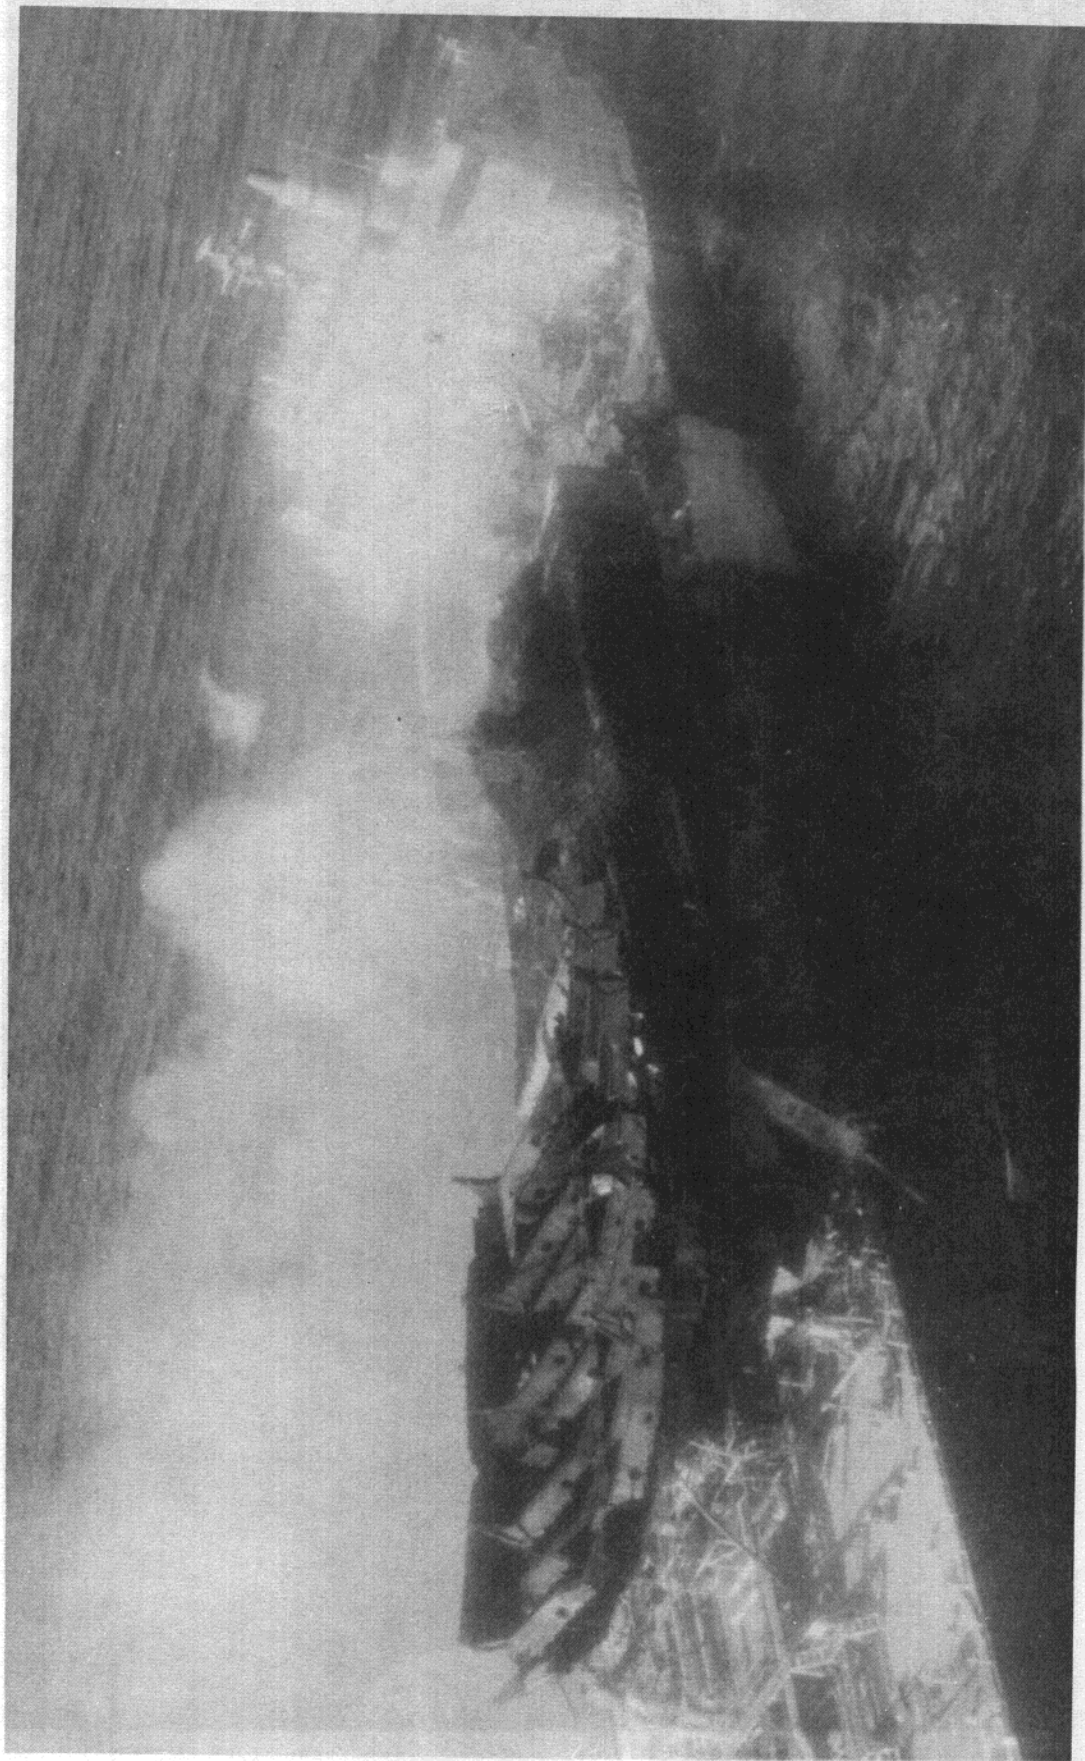
184. The Board examined the salvaged forebody of the PUERTO RICAN in a graving dock at Triple A Shipyard, San Francisco, California, on November 19, 1984 and January 10-11, 1985. The condition of the forebody is shown in photograph 9. With minor exceptions, the entire deck area above the 6CV and its adjacent wing tanks from frame 54 to 64 was blown off and landed in an inverted position on the deck area immediately forward of 6CV. The inverted deck was oriented along the centerline axis of the vessel. All underdeck transverse web frames were still attached. In the inverted position, the upper side of the deck corresponding to the area above 4S wing tank was concave in shape and the upper side of the deck corresponding to the area over 4P wing tank was convex. Photographs 2, 4, and 5 show this condition. There was a significant longitudinal tear in the deck

PHOTOGRAPH #4: PUERTO RICAN under tow on October 31, 1984 at approximately 1030 in position approximately 15.5 miles and 250°T from Point Bonita. (USCG Photo)

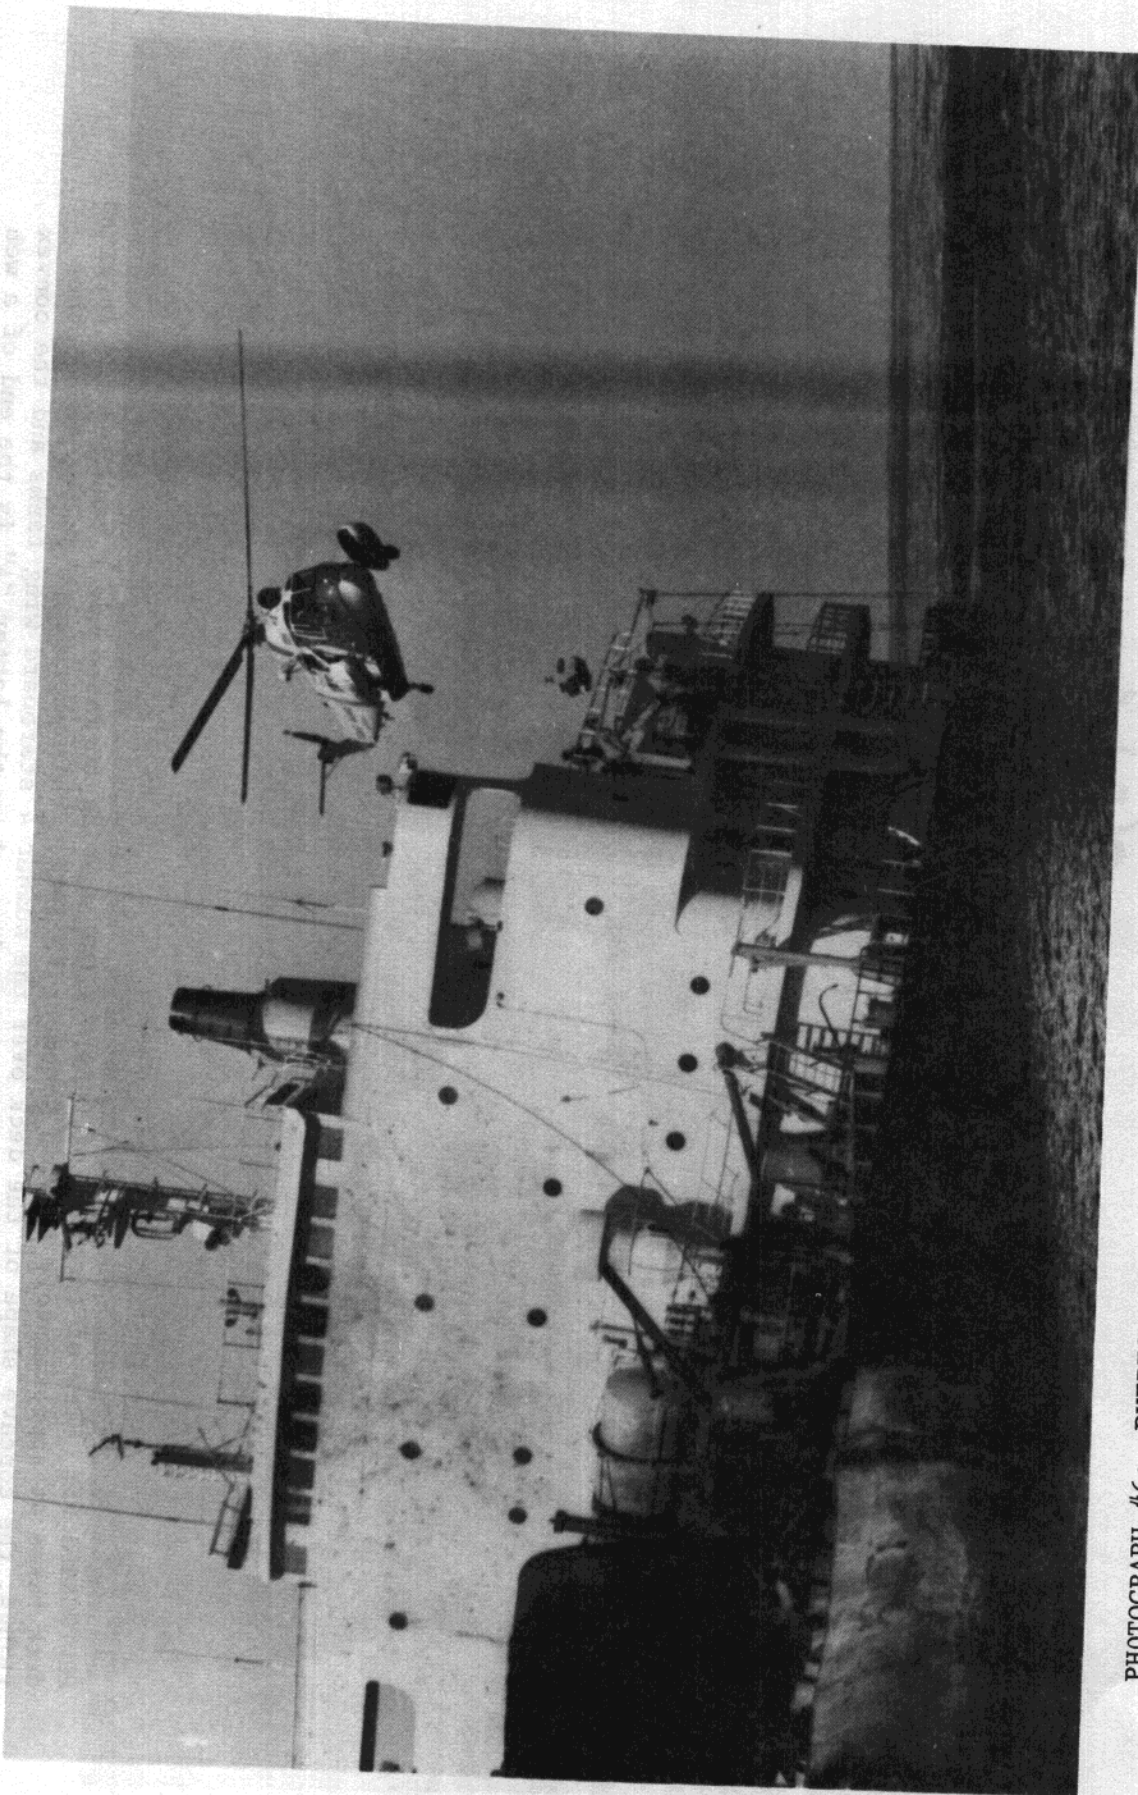
114. Almost immediately after the explosion, Captain [REDACTED] re-entered the pilothouse. There were eleven windows across the front of the bridge area. Four of the five center windows were blown out. This is shown in photograph 6. He sounded the general alarm and rang for water on the firemain and the foam systems. The emergency generator had come on-line almost immediately following the explosion. Though the engine order telegraph on the

PHOTOGRAPH #6: PUERTO RICAN under tow on November 1, 1984 at approximately 1000 in position approximately 35.5 miles and 215°T from Point Bonita. (USCG Photo)

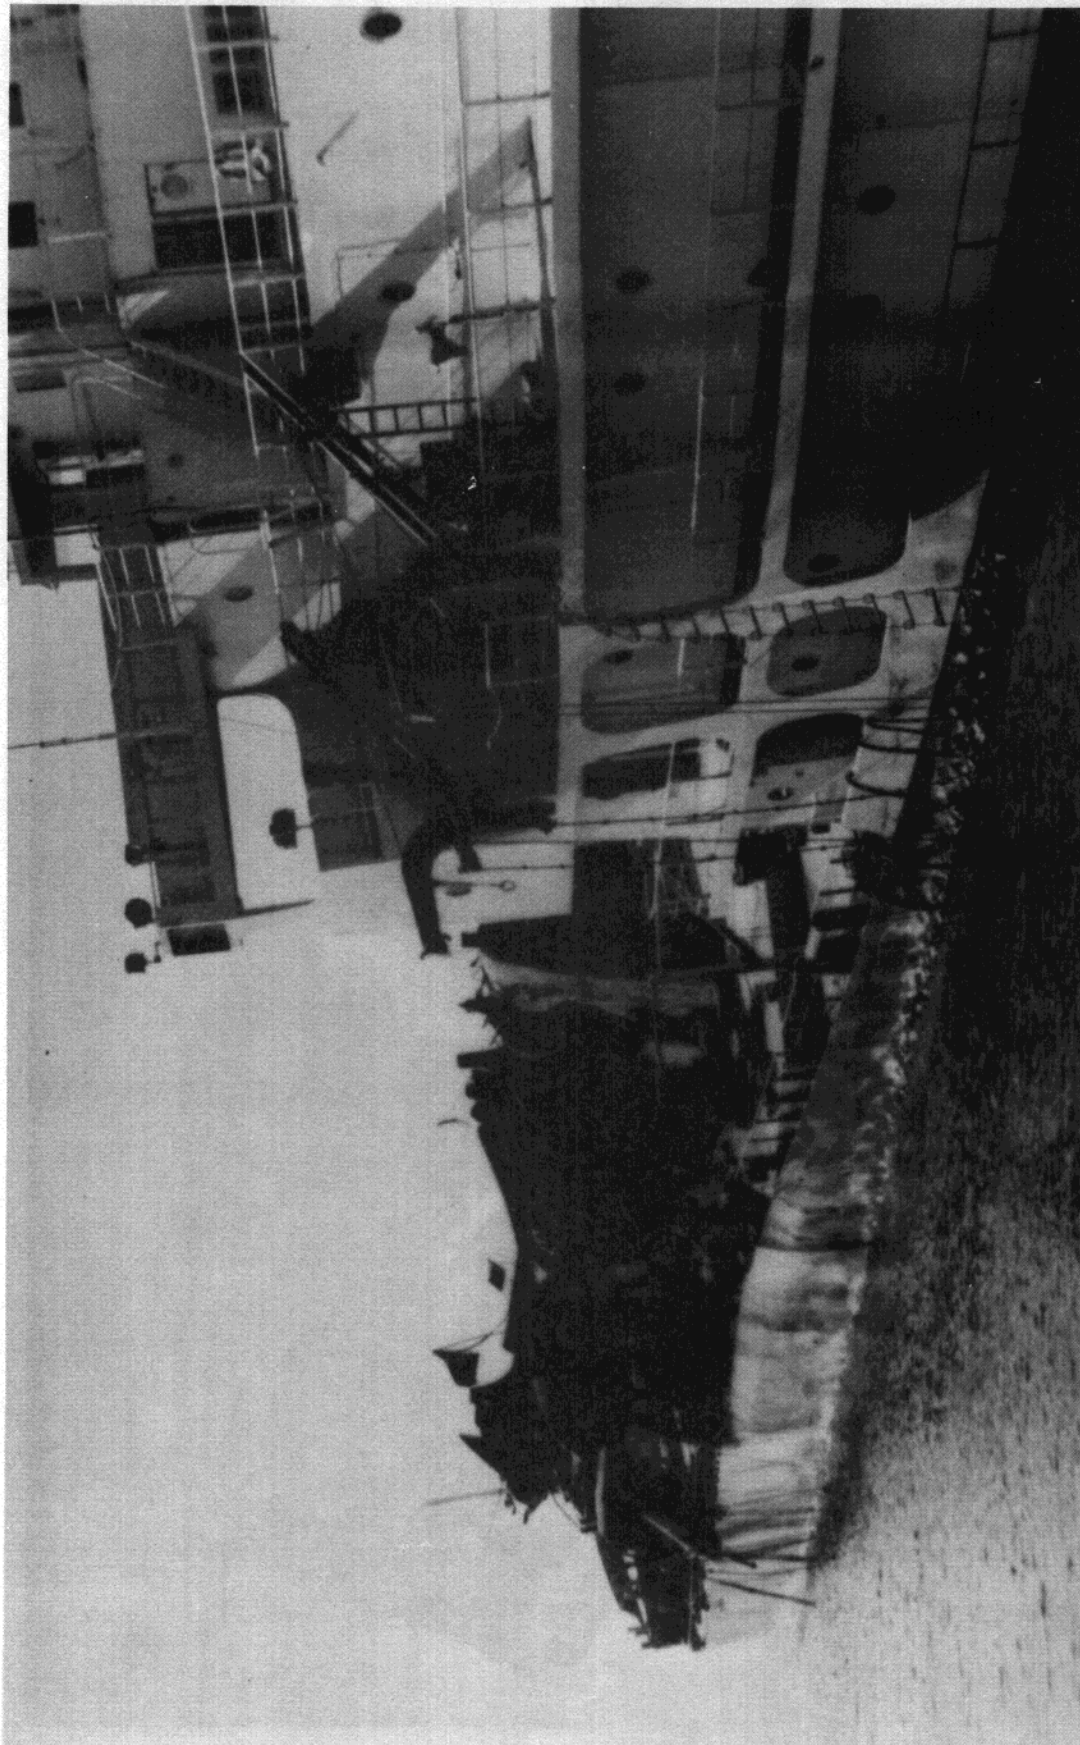
arrived, the freeboard at the stern was approximately ten feet. Approximately 30 minutes later, at about 0445, the freeboard was reduced to five feet. He noted that, although the freeboard at the stern had decreased, the forebody was still relatively level. The stern section was now also listing to port. Though it was racked to port, he never heard any cracking of the hull. When Captain [REDACTED], the last person to be removed, attempted to board the HARRY M from the stern of the PUERTO RICAN, he had to step on a chock and jump up to the bow of the HARRY M. The orientation of the forebody and the stern section is shown in photographs 7 and 8.

PHOTOGRAPH #7: PUERTO RICAN November 1, 1984 at approximately 0930 in position approximately 35.5 miles at 215°T from Point Bonita. (USCG Photo)

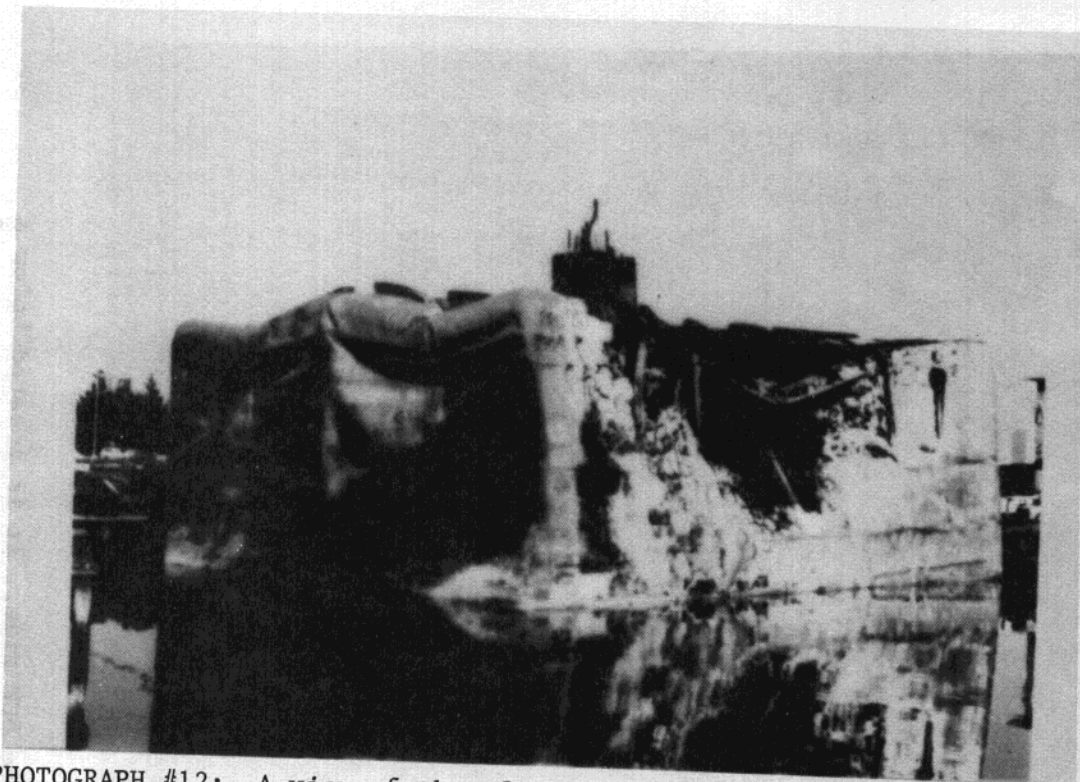
195. The Board examined the 6C independent tank on November 6, 1984, while it was afloat at Pacific Drydock and Repair, Oakland, California. See photographs 12 and 13. The top of the tank and after transverse bulkhead were dished inward on either side of the tank's centerline longitudinal watertight bulkhead. The forward transverse side received minimal structural damage. The upper portion of the port and starboard sides, including the upper knuckle area, were buckled near the tank's transverse centerline. The bottom and the lower 3 feet of the sides of the tank were undamaged, and the nominal 3 inch polyurethane insulation covering this area was intact and undamaged by the fire. All other polyurethane insulation was either charred significantly or burned away completely. The sideshell and top plating was dented and penetrated in several locations. All penetrations in the plating were small, consisting of approximately 1-foot tears. No evidence of damage resulting from a point source explosion was found.

PHOTOGRAPH #12: A view of the after end and starboard side of 6C; taken January 2, 1985 at Pacific Drydock Co., Oakland, CA. (FaAA Photo)
