BOARD OF INQUIRY REPORT
CONCERNING THE LOSS OF HAZARDOUS MATERIALS
NEAR THE NEW JERSEY COAST
ON 3 JANUARY 1992

**M/V SANTA CLARA I (PN)- BOARD OF INQUIRY CONCERNING LOSS
OF HAZARDOUS MATERIAL IN THE ATLANTIC OCEAN NEAR THE NEW
JERSEY COAST ON 4 JANUARY 1992**

M/V SANTA CLARA I (PN) LOSS OF HAZARDOUS MATERIAL IN THE ATLANTIC OCEAN OFF THE NEW JERSEY COAST ON 4 JANUARY 1992

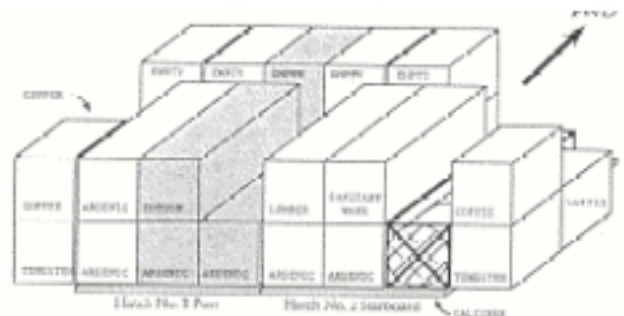
Cargo stowage on #2 Hatch upon departure Port Elizabeth
(Shaded containers remained after casualty)

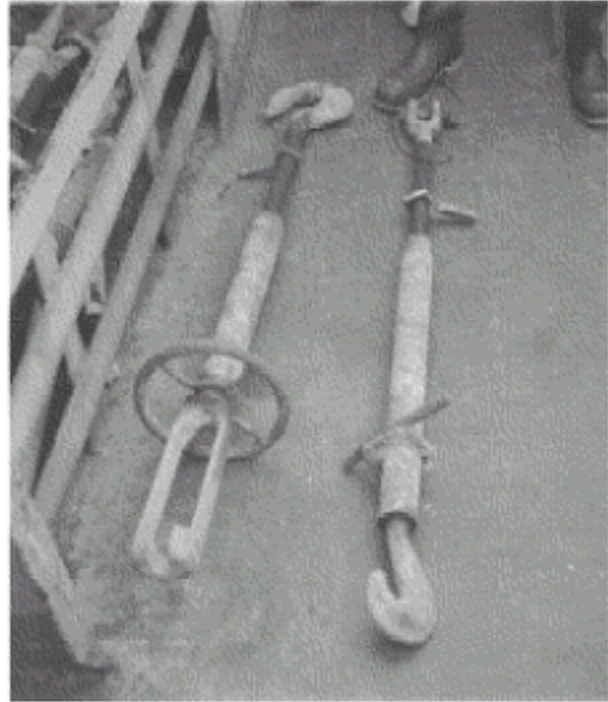
The most obvious irregularity was a mismatch between turnbuckles and the wire lashings. The press-fitted lashings are designed for use with cylindrical claw fittings on the turnbuckles, which take a straight, even strain on the wire; about half of the turnbuckles onboard were this type. But an approximately equal number of turnbuckles were fitted with a rigid hook at the working end. Installed on the

lashings, they result in a severe bend of about 75 degrees and a seriously unbalanced strain on the wire, effectively reducing its cross-section. The bearing surface is also significantly reduced, presenting the potential for a slackened wire to jump out of the hook. The Board observed both types of turnbuckles in use on the #3 hatch, and photos showed similar installation on the #4 hatch in Baltimore shortly after the casualty.

Two types of turnbuckles onboard SANTA CLARA I
(cylindrical claw on left; rigid hook on right)

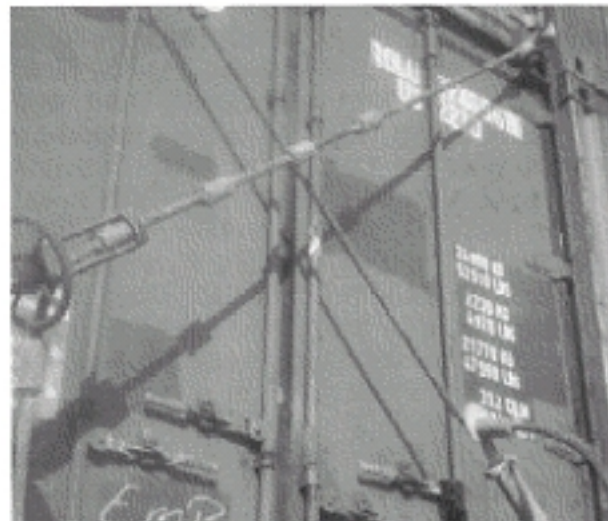
Both types in use

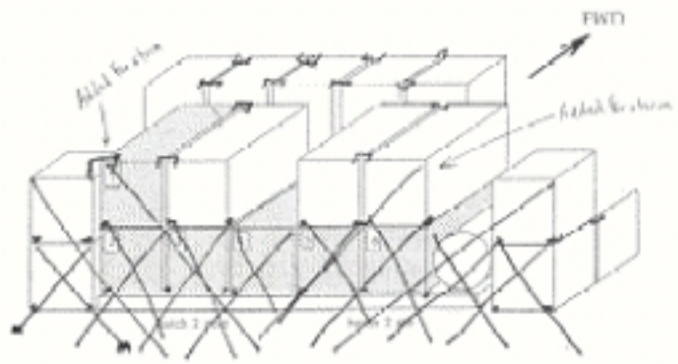
Lashing sketch by Bosun
(Arsenic trioxide containers are shaded)

An inherent weakness in this configuration is the stowage of 20-foot containers in the 40-foot spaces on both outboard sides. It leaves no room for lashing the abutting ends of the containers, which are separated by only about 3 inches. At the base they're resting on cones only. Essentially these containers are secured at one end only.

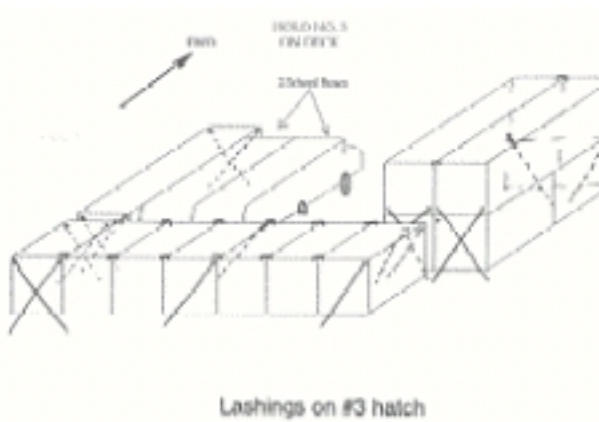
A study of the lashing at the #3 hatch was most revealing. In Charleston, the containers on #3 were found fully-bridged but only partially-lashed. Photos from Baltimore show the exact same configuration, and none of the cargo had been worked or scheduled between the two ports.

Two peculiarities stand out - a single lashing in the middle of the aft row, and more complete lashing of the 2-high stacks. But they have a common explanation: they both reflect a point of departure from a previous stow. As containers were added onboard in Baltimore, the "old" outboard lashings (in

the middle of the aft row) were left in place, and the "new" outboard container (3 spaces to the right) was lashed. The lashing of the 2-high stacks simply reflected the methods of the shoreside lashing gang in Baltimore - again newly loaded cargo.

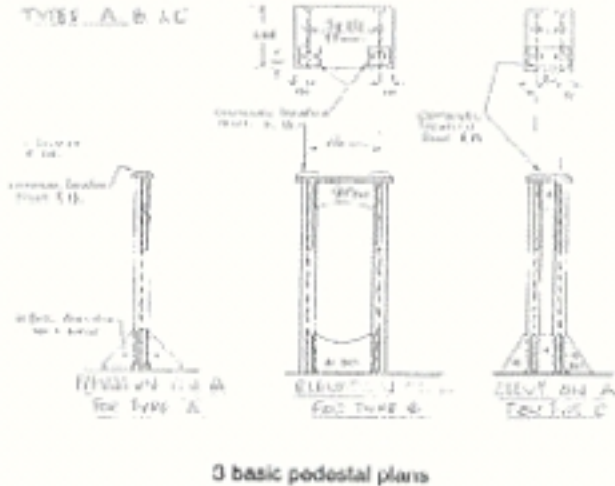
2) Only the middle two pedestals on the starboard side failed, with only a single

20-foot container spanning these. Both were double-width pedestals with double web frames. The weakest pedestal, with only a single web frame, didn't fail, yet supported a two-high stack and about twice the weight

3) Normal-to-deck forces were not enough to cause such failure in compression. In fact, the total downward forces on these two pedestals were substantially less with one container than under the simple static weight of two containers for which they were designed and often carried.

4) Transverse forces on these two pedestals in particular were also substantially less (over 50%) than the design condition of a two-high stack, and far less than with a three-high stack. The single 20-foot container was not tied to any inboard stack (a piece of machinery was stowed in that position, separately lashed), and therefore no additive loads were imposed.

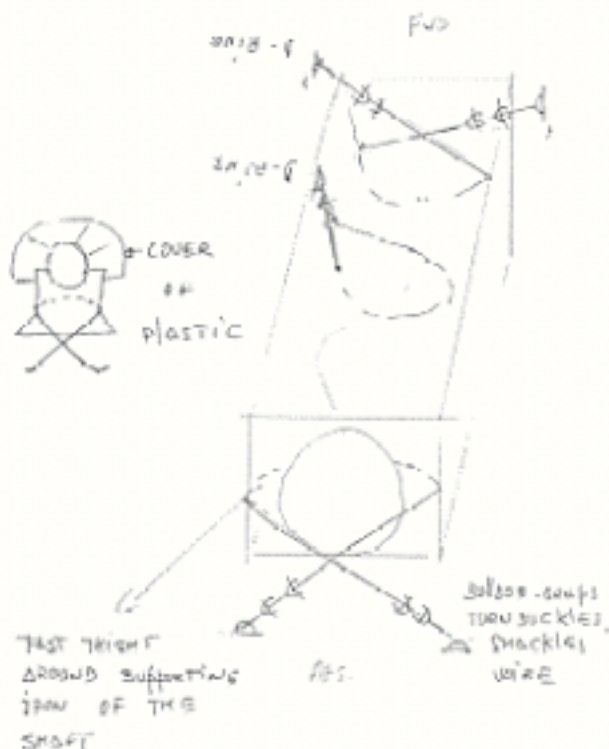
Lashing of calciner as drawn by Chief Mate

The weakness of this configuration is fairly evident. IMO guidelines for lashing this type of cargo unit (MSC Circular 530) specify that effective lashings are to be brought around the unit and both ends secured *at the same side*, to prevent transverse movement. The lashings depicted in the Chief Mate's drawing, in contrast, develop a sort of "rolling eye" in the wire as the cargo is permitted to shift short distances easily.

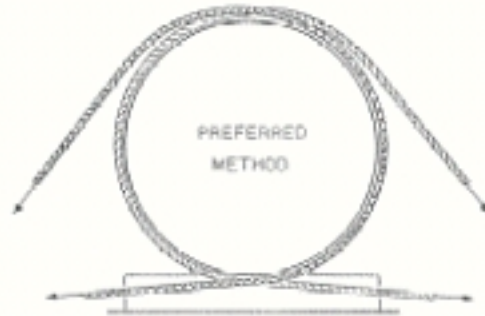
7.2 Lashings attached to lines without securing points should pass around the item, or a rigid part thereof, and both ends of the lashing should be secured to the same side of the unit (Figure 2).

IMO guideline for securing heavy items
