## MARINE CASUALTY REPORT

SS OMI YUKON, D.N. 5479 19

EXPLOSIONS AND FIRE ON 28 OCTOBER 1986  
IN THE PACIFIC OCEAN APPROXIMATELY  
1000 MILES WEST OF HONOLULU, HAWAII  
WITH MULTIPLE LOSS OF LIFE AND  
PERSONNEL INJURIES

Marine Board of Investigation Report  
and  
Commandant's Action

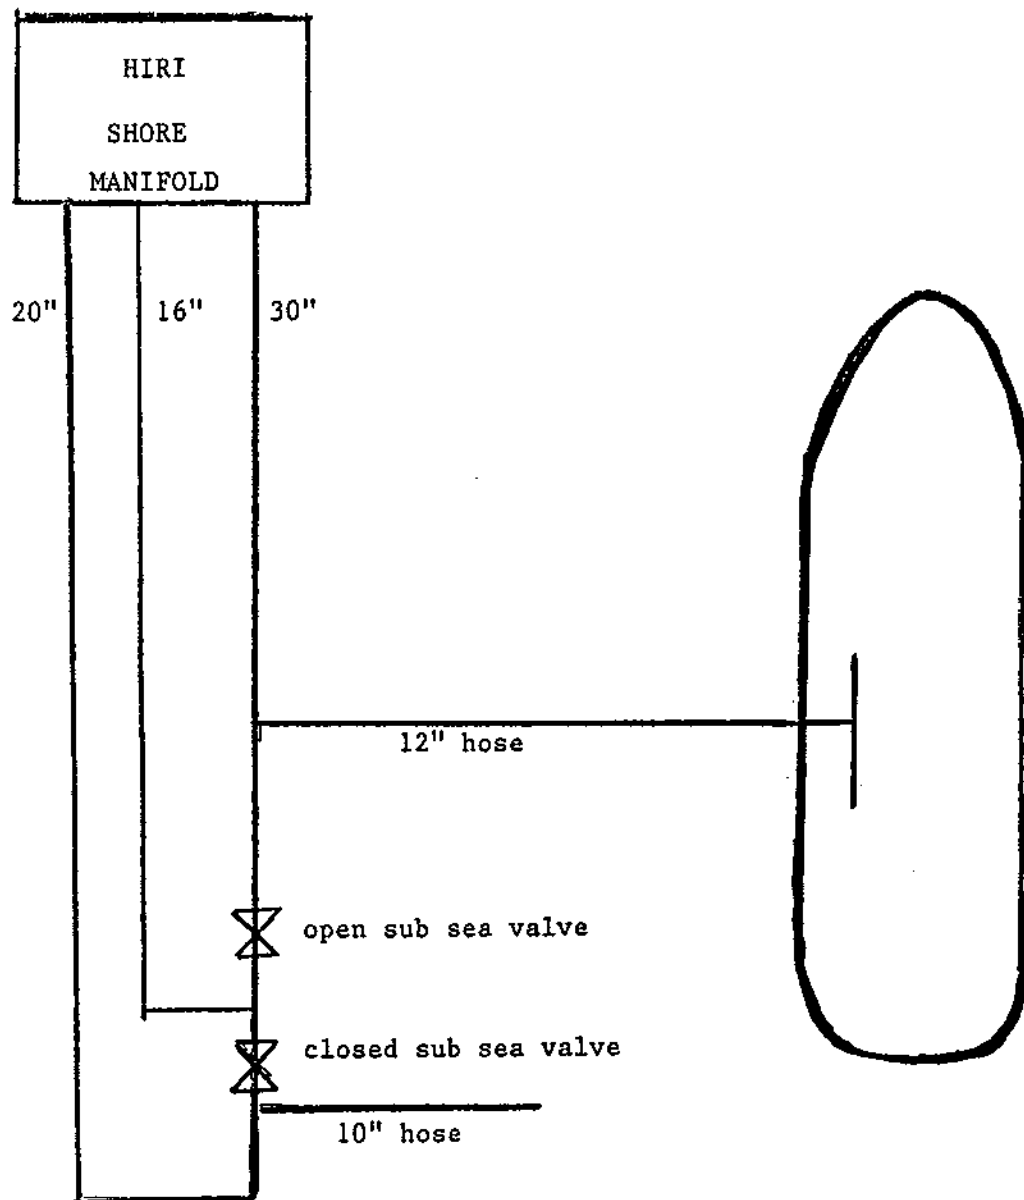
Redrawn from Exhibit #41 originally prepared by Captain [REDACTED]

24. At 1350 on 23 October 1986, the 30 inch line was reported to be filled with 10,325 bbls of bunkers from tank 307 (the tank used to blend the ordered bunkers for the vessel) and behind that in the 30 inch line was flush oil to push the bunkers out to the vessel. The 30 inch line holds approximately 12,500 bbls. The vessel only ordered 7,950 bbls but additional bunkers were put in the line to insure that the expected mixing of the flush oil with the bunkers at the interface was pushed well beyond the sub-sea hose connection. Refinery personnel determined the locations of the interface between products based on tank gaugings. The refinery pumps the leading interface between the flush oil and fuel oil past the location of the hose connection at the sub-sea manifold recirculating it back to the refinery through the 16 inch line.

25. The first step in bunkering the OMI YUKON was for the crew to hook up a specially manufactured jumper line between the cargo manifold and the midships bunker manifold. Prior to discharging cargo, bunkers were taken aboard using the same facility hose for off loading cargo. The 12" hose from the sub-sea manifold was connected to the cargo manifold. A jumper was connected to the cargo manifold, then to the bunker manifold. The jumper was used rather than transferring the refinery's hose between the two manifolds. Whatever product remained in the refinery's hose from its prior use, was flushed into the slop tank. It was easier to handle the residual product in the hose as part of the cargo discharge, rather than having to deal with it as a separate discharge operation. When good bunkers were observed at the cargo manifold, the valves on the cargo manifold system were changed to direct the flow of bunkers from the offshore hose past the first header through a cross over between cargo manifold lines, out of the cargo manifold header, into the temporarily installed jumper line to the midships bunker manifold.
