UNITED STATES COAST GUARD

INVESTIGATION INTO THE CIRCUMSTANCES
SURROUNDING THE SINKING OF THE
UNINSPECTED FISH PROCESSING VESSEL

ALASKA RANGER

OFFICIAL NUMBER 550138, IN THE BERING SEA ON
23 MARCH 2008 WITH THE LOSS OF FOUR LIVES AND
ONE PERSON MISSING AND PRESUMED DEAD

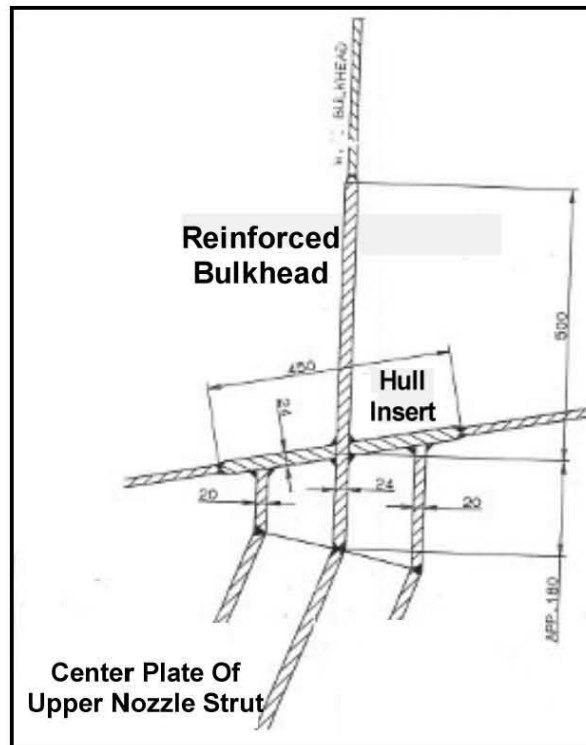
Figure 23: Portion of nozzle manufacturer's installation drawing

As shown in Figure 23, an excerpt from the MAN B&W installation plans, the center plates of the upper nozzle struts were to extend through the hull and join directly to a reinforced longitudinal bulkhead, which was to be 24mm thick and extend from frame 56 to frame 58. The existing 12 mm hull plating in way of the nozzle strut attachment was to be removed and replaced with hull plating twice as thick. The two plates inboard and outboard of the center plate of the upper nozzle supports were to be welded to the 24 mm hull plating insert.

This design transferred the weight of the Kort nozzles to the internal framing of the vessel, which is the recommended practice. According to Ship Design and Construction (██████████, Editor, 1980, published by Society of Naval Architects and Marine Engineers), “the inboard ends of shaft struts are usually carried through the shell and attached to special framing arranged to distribute the load from the arms to a sufficiently broad and rigid structure to eliminate any likelihood of local vibration. The hole in the shell plating is closed by heavy plate around the strut arm.”

The Kort nozzles were supposed to be installed in November 1991 while the ALASKA RANGER was at Yamanishi Ship Building & Iron Works, Ishinomaki City, Japan. While in the shipyard, TMPS discovered the actual structural arrangements of the vessel were different from that assumed during development of the installation plans. Correspondence between a TMPS employee with the vessel in the shipyard and the owner of TMPS states the potable water tanks had “no swash bulkheads or framing” and details of the cofferdams and #4 fuel oil tanks differed from what was shown in the MAN B&W installation plans.

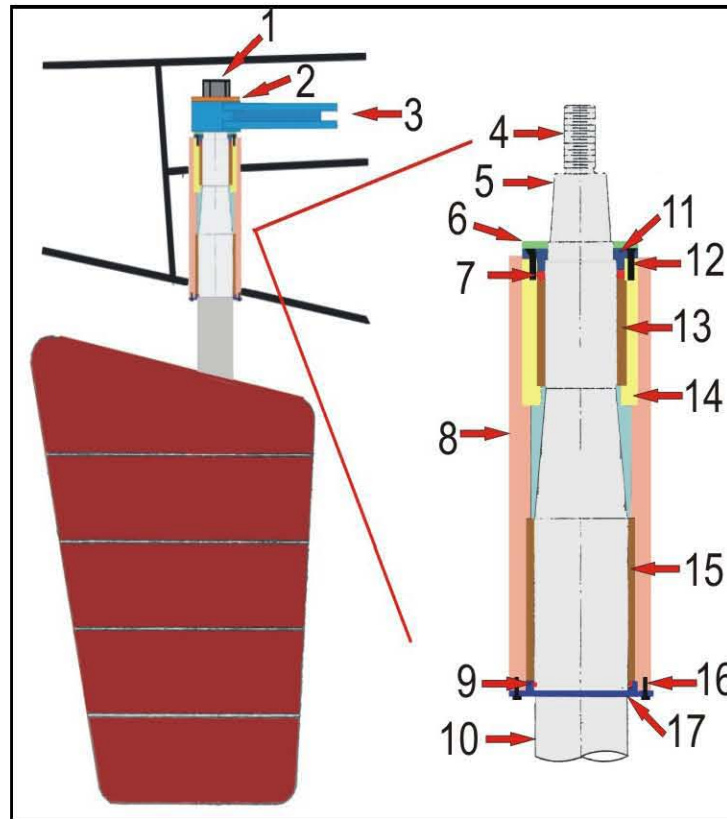
Figure 29: Rudder configuration

The ALASKA RANGER was equipped with two semi-balanced spade rudders. Each rudder blade was approximately nine feet high and is estimated to have weighed about 7,250 lbs.

The threaded section of the rudder stock accepted a 4 inch diameter, 4 threads per inch, national coarse rudder nut (1). A washer (2) was placed between the rudder arm and the nut. A steel keeper plate, not shown in Figure 29, was fitted on top of the steel nut and served as a locking device. It was welded to the top of the rudder stock and to both sides of the nut, and locked the entire assembly in place to prevent the nut from coming loose.

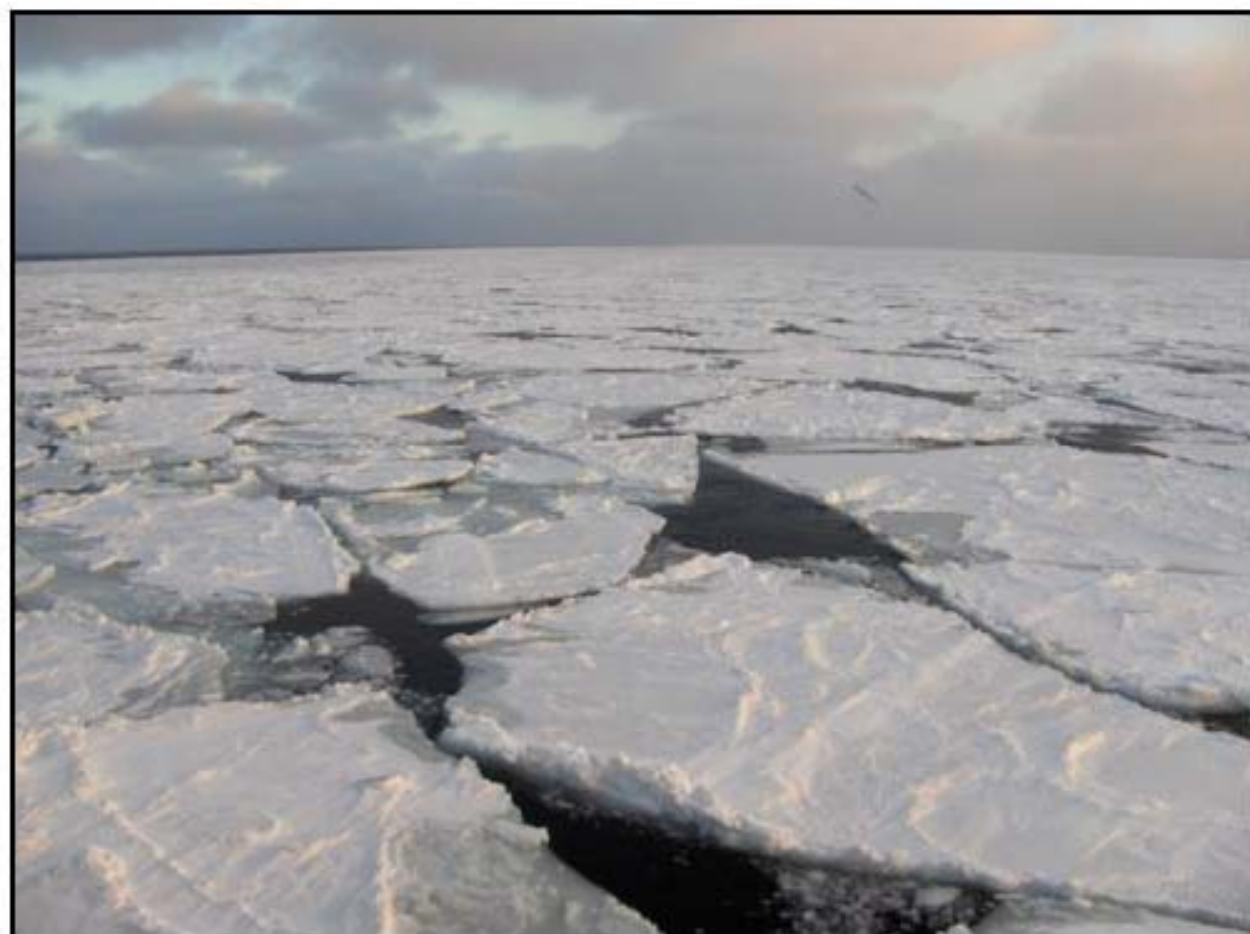
Figure 31: Photograph of ice encountered by the ALASKA RANGER in February 2008

The previous Captain also explained that the ALASKA RANGER “didn’t fish through the ice per se.” They would only fish during daylight, when they could find clearings in the ice. This

The MBI consulted with the naval architects at the USCG Engineering Logistics Command, which provides engineering design, support and repair assistance to USCG cutters, including the USCG's fleet of ice breakers. They reviewed the evidence and testimony, and indicated ALASKA RANGER would not likely have sustained severe damage to the stern appendages of the vessel. Though vessels operating in ice sometimes experience damage to the stern, it normally occurs when vessels make large turns or back down in ice.

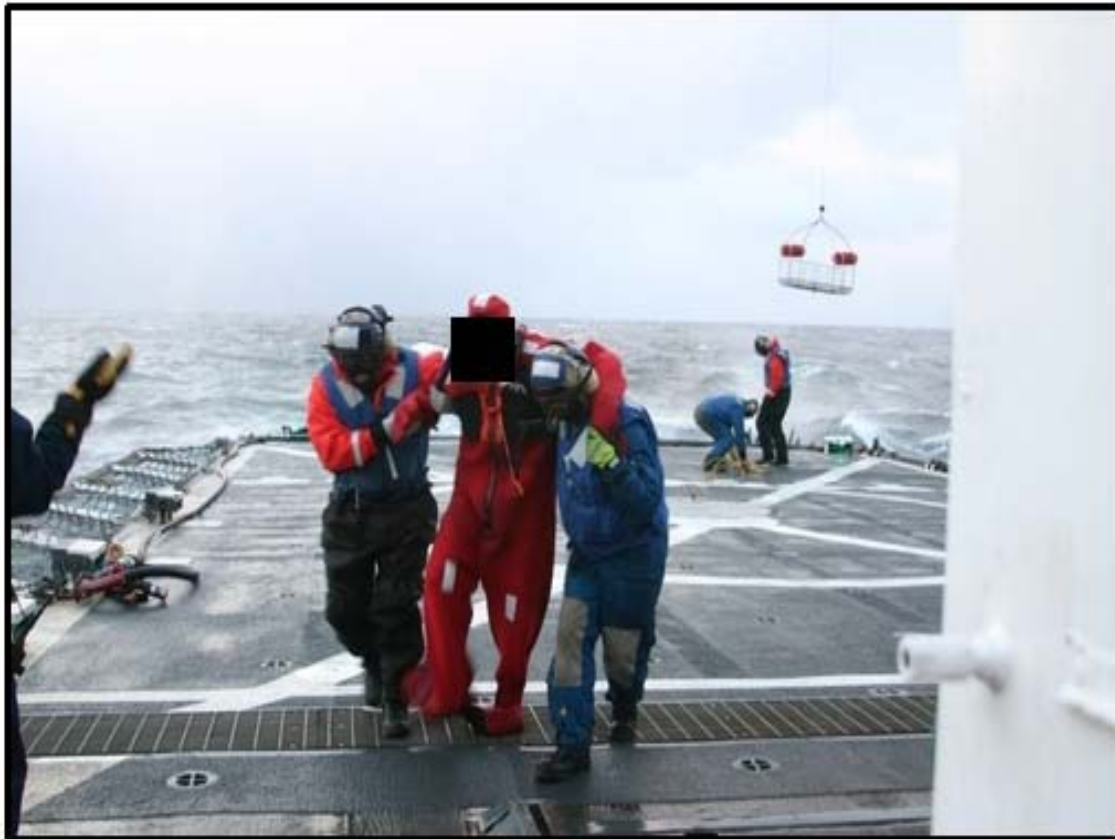
Figure 32: Photograph of rescued ALASKA RANGER crew member in survival suit

to get him into the helicopter. Personnel on the ALASKA WARRIOR had to cut the suit of another crew member in order to recover the man. In Figure 32, the midsection and legs of the survival suit of one survivor are much too large and his right foot does not reach the survival suit boot.

The water in these survival suits might be attributed to being in the ocean under conditions other than flat calm seas. Alternatively, the survival suits may not have fit correctly, may not have been donned properly, or may have leaked through seams or holes in the suits. Water may have also gotten into the survival suits due to the activities of crew member while in the water (e.g. swimming).

Two crew members testified their suits contained water and/or were damaged before they donned them. The MBI inspected the suits after the casualty and generally found the suits in acceptable condition. The tears, cuts, and areas of worn material on the suits could not be conclusively linked to the condition of the suit before the casualty.

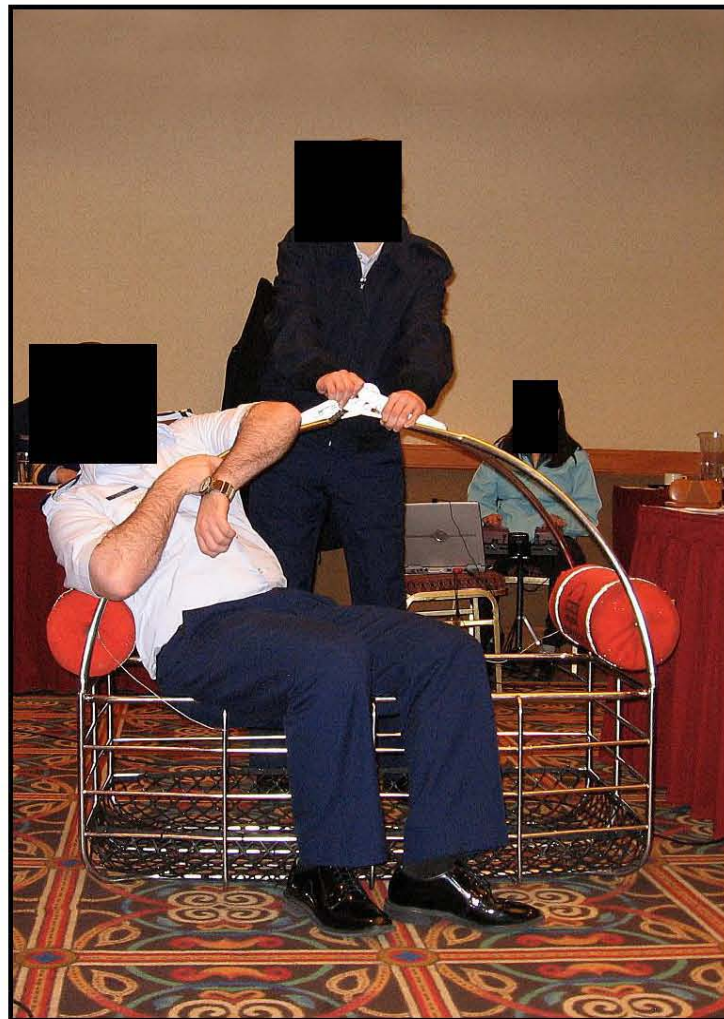
Figure 33: Photograph of LTJG [REDACTED] demonstrating position of Crew Member A

As the basket came out of the water, Crew Member A's legs were outside of the basket, and he appeared to be sitting on the top rail along the length of the basket, with his head and shoulders through the triangle formed by the lifting bale, as illustrated in Figure 33. As the hoist began, Crew Member A looked stable to the Flight Mechanic and the Rescue Swimmer began swimming to the next survivor to be hoisted.

The Flight Mechanic deviated from written procedures in Commandant Instruction CGTO 1H-65C-1, the H65 Flight Manual, and began to hoist before the rescue swimmer provided the “ready to be hoisted” signal. The Flight Mechanic’s decision to commence the hoist was based on several factors including the on scene weather conditions, sea state, Crew Member A’s difficulty getting into the basket, the limited time left on scene due to the helicopter’s dwindling fuel supply, and an awareness that there were still more survivors at risk.

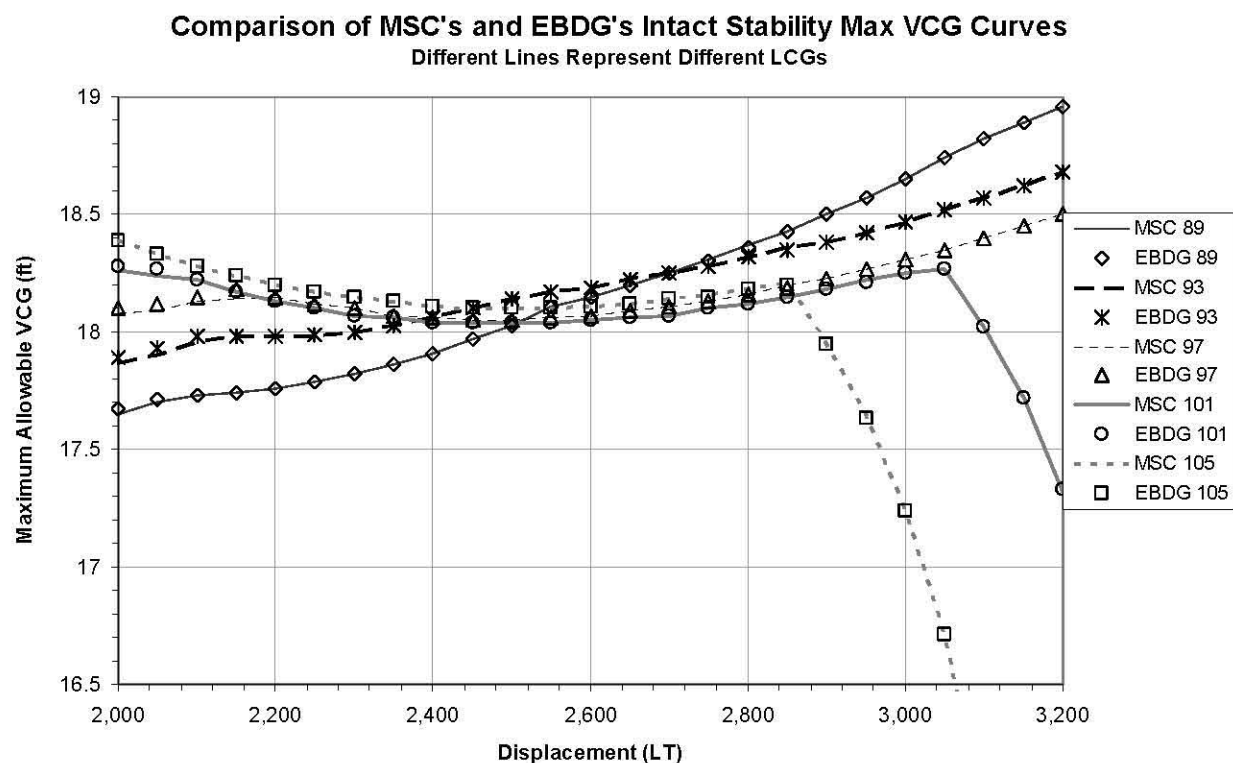
Figure 1: Comparison of Max VCG Curves

In order to verify the loading guidance provided in the T&S book, an independent generation of the ALASKA RANGER's max VCG curves was undertaken. In our review, the maximum VCG was computed using the four criteria considered by EBDG as well as the water on deck criteria in 46 CFR 28.565. As seen in Figure 1, there was good correlation between EBDG's and MSC's intact stability analyses. Our review revealed that the water on deck criteria was not limiting in any case so EBDG's omission of this criteria from their maximum VCG curves did not impact the results.

In general, the limiting criteria were the Intact Righting Energy requirements contained in 46 CFR 28.570. Specifically, the GM requirement and righting energy between 30° and downflooding were the most restrictive. Since the lowest downflooding points were aft on the ALASKA RANGER, aft trim conditions at deeper drafts quickly reduced the allowable VCG as seen in Figure 1 on the LCG = 105 curve at displacements greater than 2900 LT.

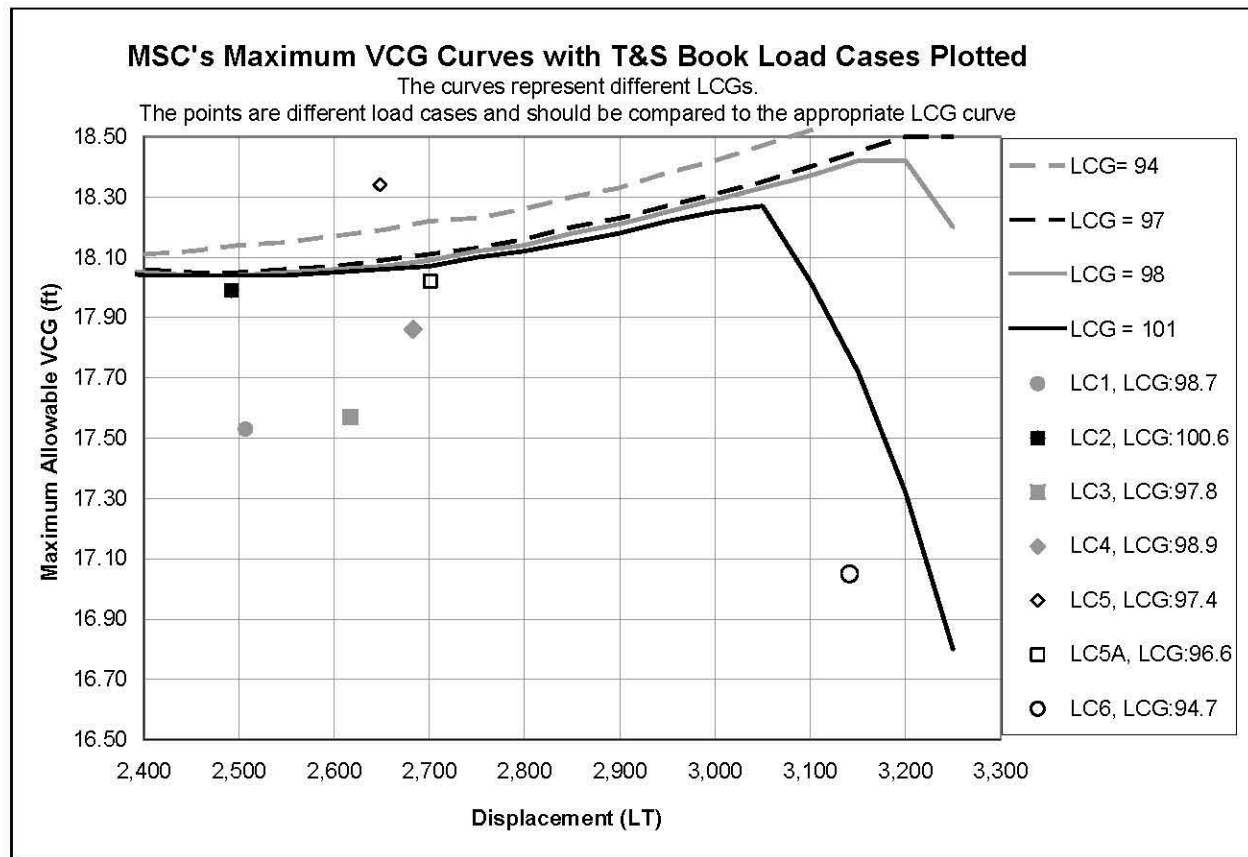
Figure 2: Load Case Evaluation

The load cases provided in the T&S booklet, including topside ice as required by 46 CFR 28.550, are plotted in Figure 2. It should be noted that the stability calculations in the ALASKA

RANGER's T&S booklet included an illustrative load case #5 which failed to meet the criteria, as well as a modified version, load case #5A which passed.

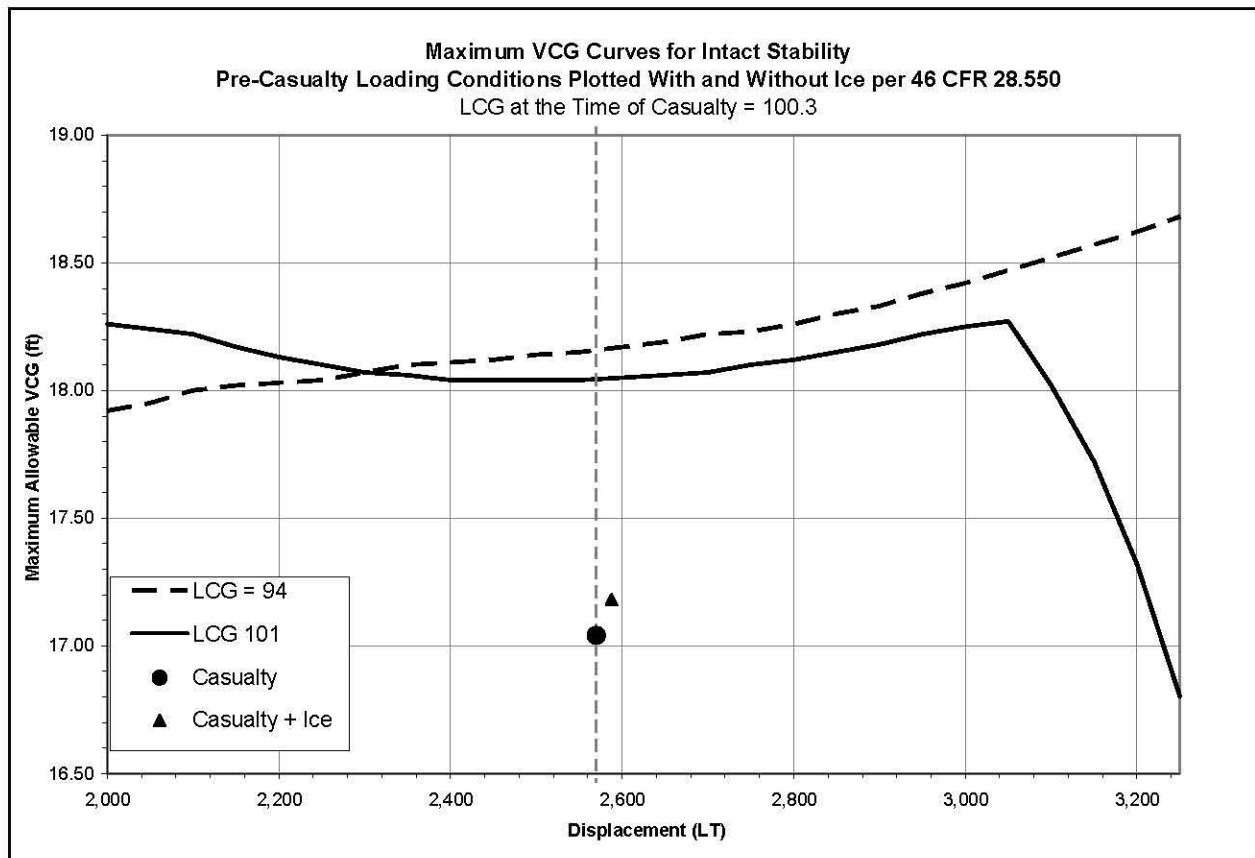
Figure 3: Range of Stability

Paragraph 2-e of reference (a) requested a determination of the maximum trim angles and displacements for which the ALASKA RANGER could pass the applicable intact and damaged stability requirements. Since the vessel did not meet the damage stability requirements of 46 CFR 28.580 in any of her conditions of loading, damage stability was excluded from this portion of the analysis. Based on the information provided, at the time of the casualty the ALASKA RANGER had a large intact stability margin for VCG, trim, and displacement. This large margin created many combinations of displacement and trim at which the vessel would meet intact stability requirements. Figure 3 displays the limiting KG curves over the range of displacements considered in the T&S booklet load cases. The dotted curve shows the forward most LCG considered among the load cases and corresponds to 2.9 feet of forward trim. The solid curve represents the aft most LCG corresponding to 3.5 feet of trim by the stern.

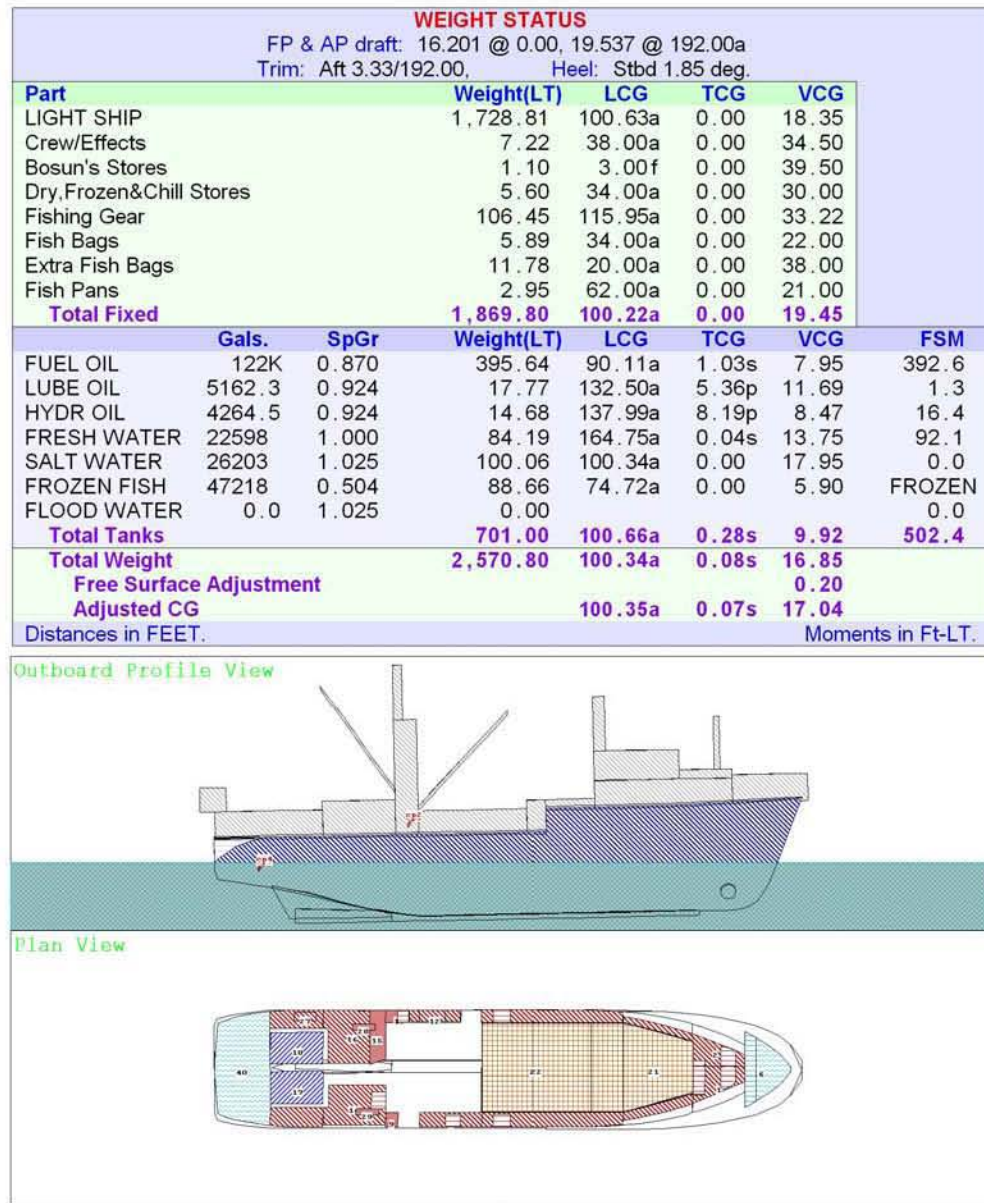
Figure 4: Summary of Pre-Casualty Load Condition

Based upon the information in the T&S booklet for full load departure as well as the additional modifications called out in paragraph 5-c of reference (a), an estimate of the pre-casualty loading condition was developed. This estimate is summarized in Figure 4. The 122,000 gallons of fuel

takes into account 12,000 gallons in the day tanks as well as 110,000 gallons in the fuel oil storage tanks.

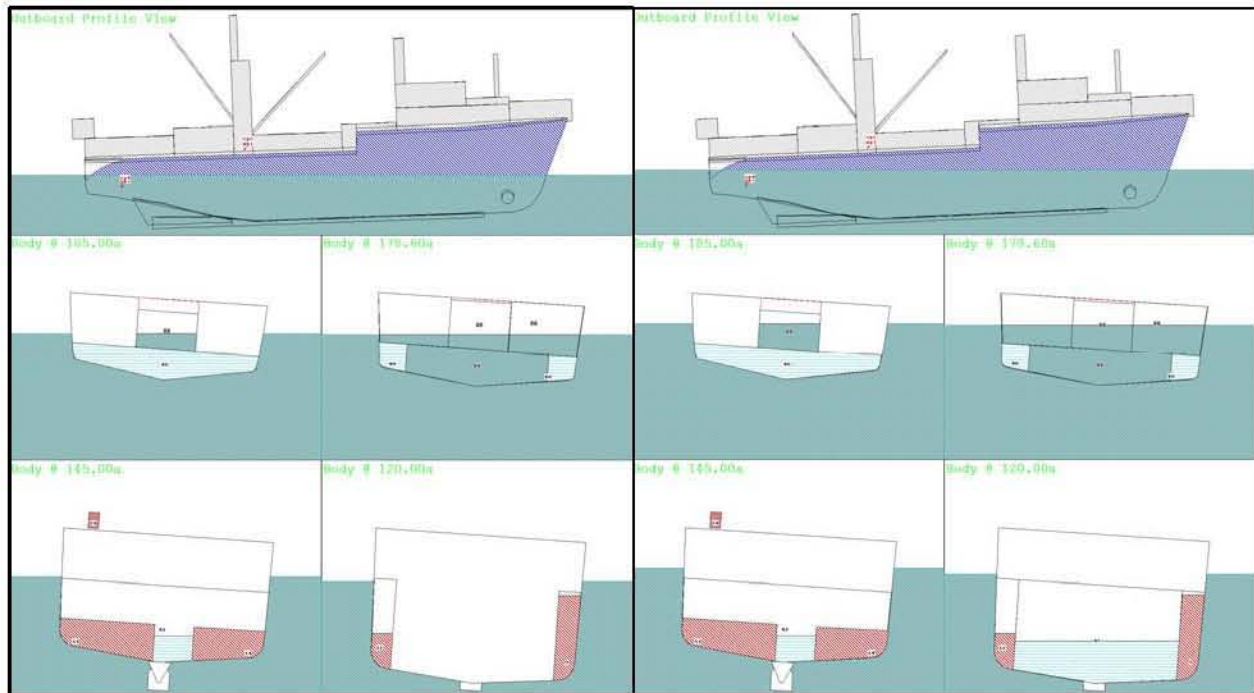
Figure 12: Step G in the 2nd Flooding Scenario

The engine room aboard the ALASKA RANGER was assumed to be made up of two separate compartments until flood water reached the main engine shafts. Cutouts in the bulkhead at frame 50 were considered to be the point where flood water would begin spilling from the hydraulics space forward into the machinery space. This spilling would have begun when there was approximately 6.8 ft of water at the forward end of the hydraulics room. This corresponds to approximately 29.5 LT of seawater as shown in Figure 11. After the spilling occurred, the forward machinery portion of the engine room was filled until the level at the spill point matched that in the hydraulics space. This occurred on the model with approximately 182 LT of water in the forward machinery space as shown in Figure 12.

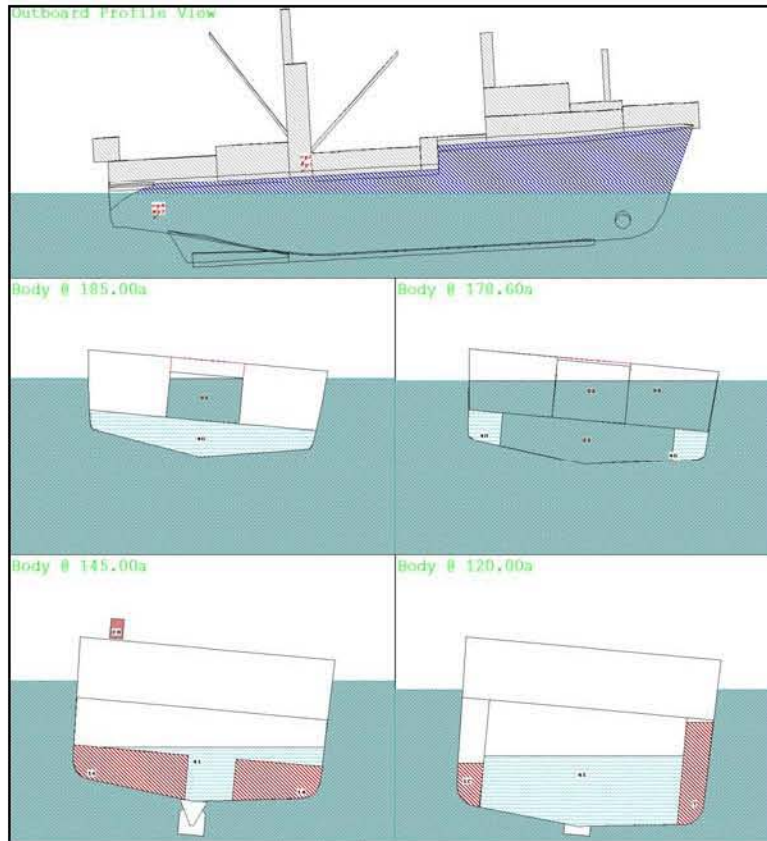
Figure 13: Step I in 2nd Progressive Flooding Scenario

Reference (a) also indicated that by 03:45, or 1 hour and 45 minutes after the initial report of flooding in the rudder room, the ALASKA RANGER had lost her generators and main diesel engines. It was assumed that the loss of the main engines corresponded to step I in the scenario where the engine rooms were flooded with 10 ft of water. Using the slowest flood rate in Table 2, the total 511 LT of flood water in all flooded compartments, would have taken approximately 50 minutes to ship through the rudder bearing. Presumably, the progressive flooding between compartments would occur more slowly than the initial flooding into the rudder room. However, this rough check verified that the flooding rates discussed in section 4.2 were not out of the question when compared with the timeline in reference (a).

As noted previously, the ALASKA RANGER reportedly listed hard to starboard after losing power (presumably due to flooding in the engine rooms). However, Table 4 shows only between 4° and 5° static starboard heel angle once the engine rooms are flooded. One plausible condition that would increase the free surface effect and create a greater heel angle is a small quantity of flood water on the processing deck. Limited flooding on the processing deck is a reasonable assumption considering the aft end of the trawl deck was nearly submerged in step I of the scenario. When only 15 LT of flood water was added to the processing deck, the model heeled sufficiently to put the starboard corner of the transom in the water as shown in Figure 14. With 50 LT of flood water on the processing deck, the heel angle doubled to 16°. At this point, our model indicated that the starboard side of the trawl deck was underwater from frame 47 to the transom.
