INVESTIGATION INTO THE STRIKING OF SUBMERGED
OBJECTS BY THE TANK VESSEL

ATHOS I

IN THE DELAWARE RIVER ON NOVEMBER 26, 2004
WITH A MAJOR DISCHARGE OF OIL

16732
January 19, 2006

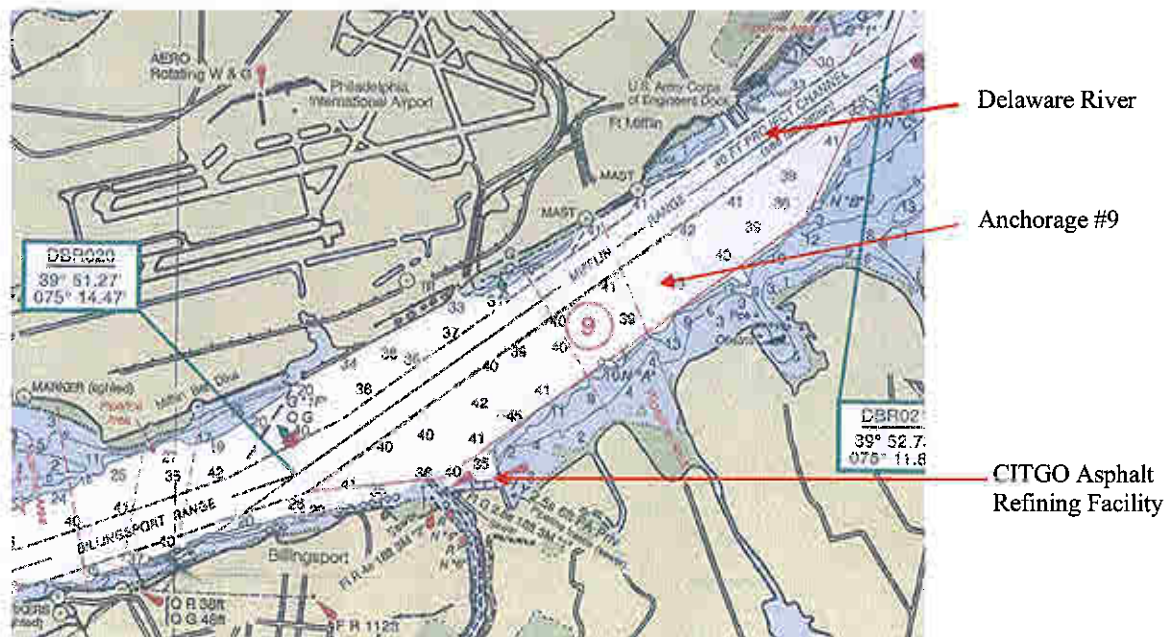
Delaware River / Anchorage #9

- 1.) ACOE conducted a water depth survey of Anchorage #9 in June 2004, which averaged between 40.8' to 46.9' within the vicinity of the incident. ACOE normally conducts

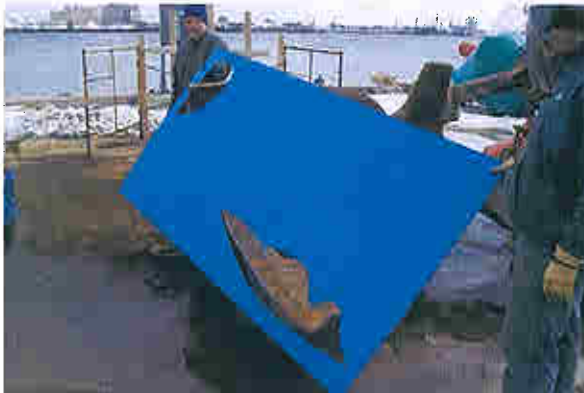
Figure 2 -Plastic Template

On the 2nd of March 2005, during cleaning operations performed on the recovered anchor, Mr. Joseph Crosson and his assistant made a more permanent template of the damaged section by transferring the cardboard template to a hard plastic sheet (shown below).
