INVESTIGATION INTO THE CIRCUMSTANCES  
SURROUNDING THE

## COMMERCIAL DIVING ACCIDENT

ONBOARD THE MOBILE OFFSHORE DRILLING UNIT  
CLIFF'S DRILLING RIG NO. 12 ON MARCH 4, 1996  
WITH THE LOSS OF LIFE

FORMAL INVESTIGATION INTO THE COMMERCIAL DIVING ACCIDENT ABOARD  
THE MOBILE OFFSHORE DRILLING UNIT CLIFF'S DRILLING RIG NO. 12 ON  
4 MARCH 1996, WITH LOSS OF LIFE

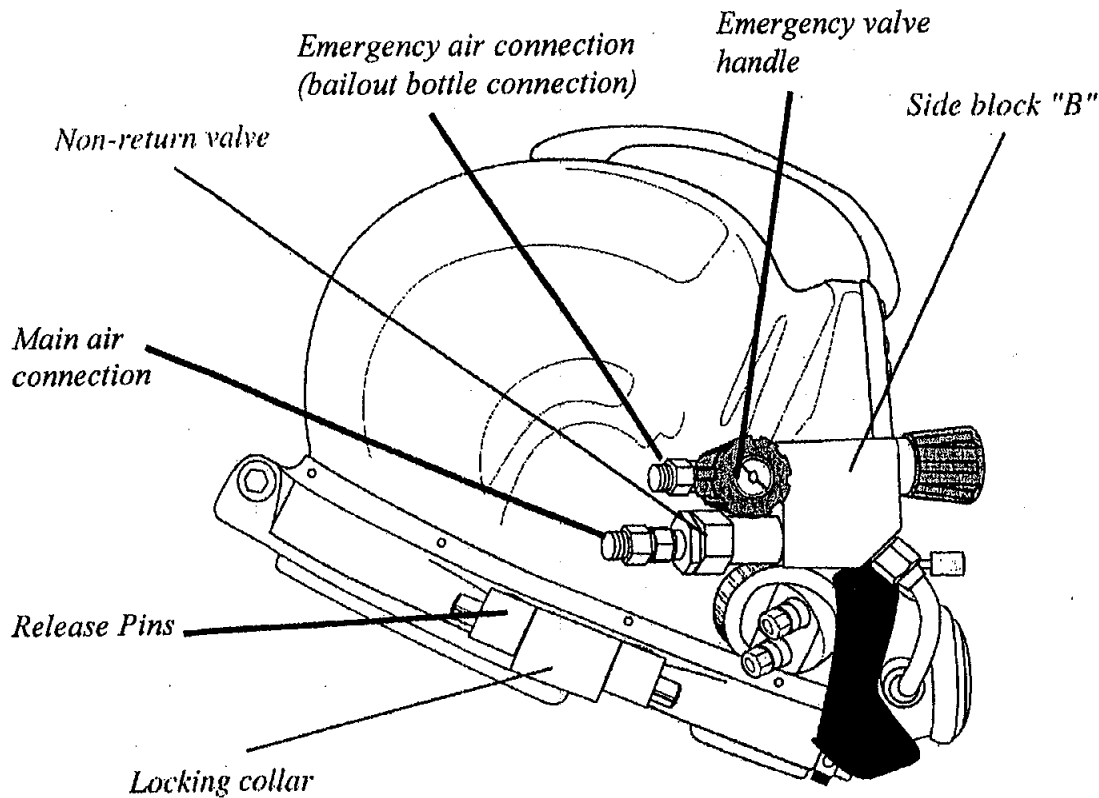
**Figure 7: Side view of SuperLite-27 helmet**

42. At about 1645 hours, Austin was watching the ultrasonic gauging monitor while Wiitala operated the air rack and directed Pilkington.<sup>106</sup> Wiitala checked the pressure gauge and saw that the pressure had again dropped to 90 psi. Wiitala told Pilkington once again to close his free flow valve, but Pilkington said that the valve was already closed. At this point, Wiitala realize there was a larger problem. Over the next several minutes Wiitala had a garbled conversation with Pilkington, during which Pilkington's manner became increasingly frantic and his breathing rapidly increased to the point it was apparent he was hyperventilating. "He [Pilkington] just kinda went into a whirl. He wouldn't really talk to me on an even keel, and he wouldn't respond to me. I mean, it just got away from him."<sup>107</sup> During the conversation, Pilkington complained of not being able to breathe and said that he heard a hissing noise. Pilkington speculated that he might have forgotten to tighten the airline to his helmet before

4. Finally, water may have entered Pilkington's helmet through the emergency air connection. In a last ditch attempt to trouble-shoot his emergency, Pilkington may have reached for the emergency valve handle directly adjacent to the main air connection. This connection is typically used to couple the bailout bottle to the helmet. When not used, the only barrier preventing water from entering the helmet is the emergency supply valve (See figure 7). When Pilkington's regulator bottomed out, he may have instinctively opened his emergency supply valve, the standard procedure taught in commercial dive schools, and allowed water to enter his helmet. If the emergency valve was opened, water would only have entered the helmet if the air pressure inside the helmet was extremely low (indicating an almost total interruption in air supply and pressure). Even the smallest pressure above ambient would have forced air out of the emergency valve which would have prevented water from entering.<sup>164</sup>

31. Wiitala's testimony raised the questions of whether Pilkington's main airline was secured to his helmet when he began his dive and whether Pilkington may have loosened the connection when he was underwater. Wiitala testified that before Pilkington quit talking, Pilkington said that he might have forgotten to tighten his airline.<sup>212</sup> The reasoning is that Pilkington may have reached up to his main air connection (See figure 7) and, while trying to tighten the fitting, loosened it instead. Master Chief Bradford opined that it was "plausible" that Pilkington had loosened his main airline connection near the end of his dive.<sup>213</sup> I disagree. The eyewitness testimony on this issue is contradictory, but some facts are undisputed. Townsend says that when he tried to pull Pilkington into the personnel basket, Pilkington's safety harness came free and the umbilical detached from Pilkington's helmet. Champagne, on the other hand, clearly remembers the hoses being connected to Pilkington's helmet when Champagne reached to remove the helmet on the deck of Rig 12.<sup>214</sup> Wiitala saw Pilkington's helmet underwater during the rescue and distinctly remembers seeing the line attached to the helmet and bubbles coming from the "whiskers" of Pilkington's helmet -- indicating that air was going through the helmet fitting to Pilkington's respirator.<sup>215</sup>

**Recommendation #2:** Commandant should require all unused auxiliary gas ports on diver worn life support equipment to be capped or blanked during all commercial diving operations. This will remove the possibility of water entering a diver's helmet if he inadvertently opens an emergency valve.
