# UNITED STATES COAST GUARD

## REPORT OF INVESTIGATION INTO THE CIRCUMSTANCES OF THE EXPLOSION, FIRE, AND SINKING OF THE TANK BARGE EMC 423 WITH ONE LOSS OF LIFE

ON THE CHICAGO SANITARY AND SHIP CANAL  
ON 01/19/2005

MISLE Activity Number: 2277817

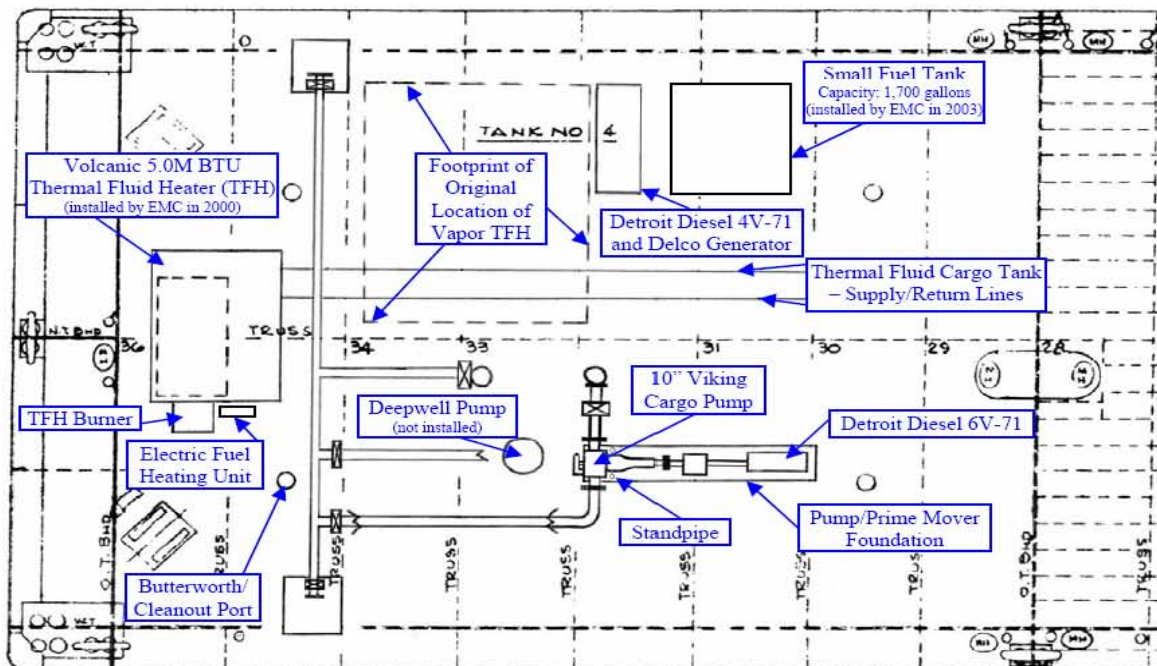
**Figure 5-2: Plan drawing of appurtenances, machinery and equipment**

*Cargo Pump Prime Mover* – The EMC 423 cargo pump was driven by a 6V-71 diesel engine located approximately 12' forward of cargo pump (Figure 5-2). The engine was never recovered from the canal but the engine cradle and foundation was examined by Detroit Diesel. From the examination they were “able to conclude that no thermo event occurred at this location due to the lack of scorch marks, soot residue, burned paint or melted plastic, aluminum or rubber components located on the cradle.” Prior to and at the time of the casualty, the crew reported that the engine was operating normally. Since there were no probable paths for the vapor within a couple of inches of the cargo pump prime mover and all indications are that it was working normally, it was deemed an improbable source of ignition.

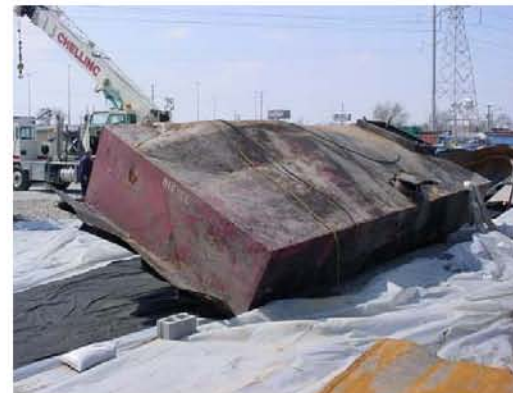
**Figure 5-6: Large fuel tank**

*Large fuel tank:* The larger fuel tank (Figure 5-6) was on the barge when Egan Marine purchased it (Pg. 52). The tank was located over cargo tank #3, on the port side, having a capacity of approximately 8,000 gallons (Pgs. 52-53). The large fuel tank was not in service at the time of the explosion and was empty, but not gas freed (Pgs. 52-53, 1361).

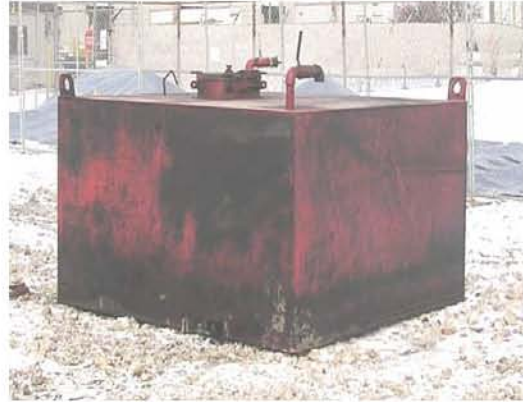
**Figure 5-7: Small Fuel Tank**

*Small fuel tank:* The small tank (Figure 5-7) was constructed by Egan Marine and had a capacity of approximately 1,700 gallons (Pgs. 53-54). It was installed on the EMC 423 in approximately 2003 (Pgs. 54-55) along with the associated piping. It was located transversely in line and forward of the drip pan manifold on the port side of the barge over cargo tank #4 (Pgs. 52-53, Exhibit CG-40). The 1,700 gallon tank was in service at the time of the explosion, and contained approximately 500 gallons of diesel fuel at that time (Pg. 1362). When the fuel tank was recovered from the bottom of the Chicago Sanitary and Ship Canal, only one of the fuel tank access hatch dogs was installed.

*Small Fuel Tank:* Egan Marine added a 1,700 gallon fuel tank, and associated piping, aboard the EMC 423 in September, 2004 (Figure 5-7) (Pg. 496). The fuel tank was to be used in conjunction with the fuel heating system that Egan Marine was installing. The tank was built by Egan Marine (Pg. 54). There is no record that the Coast Guard was

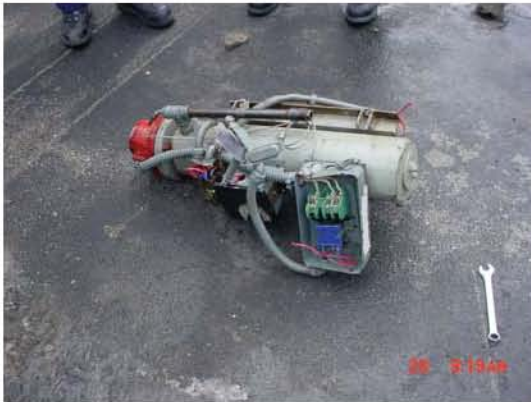
**Figure 5-8: Electric fuel heating unit**

The fuel heater was not in use at the time of the explosion (Pg. 59). The jacket heater was plumbed and had fuel running through it, but was not yet electrically wired (Exhibit CG-134, Pgs. 462, 498). The heater was mounted forward on the burner end of the thermal fluid heater. In conjunction with the installation of the heater, Egan Marine had placed a power converter on board the EMC 423 for the purpose of stepping up the generator voltage required by the heating unit (Figure 5-9). The power converter was not installed or in service at the time of the explosion (Pgs. 2940-2941).

*Fuel Heater:* In August, 2004 Egan Marine installed a heat exchanger on the EMC 423 with the purpose of heating heavy oils to be burned in the thermal fluid heater (Figure 5-8) (Pg. 461). The heat exchanger was mounted on the forward inboard side of the thermal fluid heater. It was plumbed to the fuel tanks aboard the EMC 423, but it was not electrically connected (Pgs. 462, 498). There is no record that the Coast Guard was notified, approved, or inspected the installation of the heat exchanger.

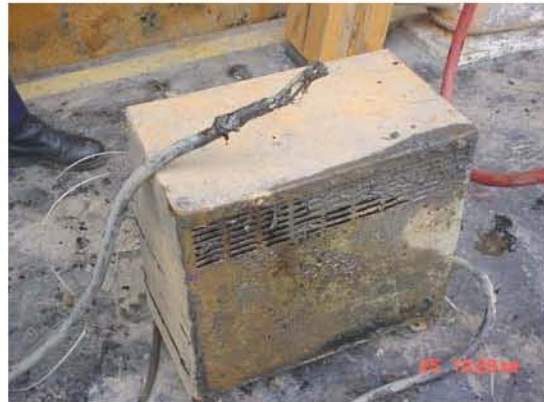
**Figure 5-9: Power converter**

A transformer was installed aboard the EMC 423 to operate in conjunction with the heat exchanger (Figure 5-9). The purpose of the transformer was to step up the generator voltage from 220 volts to 480 volts, which is what the heat exchanger required to operate. The transformer located on board the EMC 423 but was not in operation or installed at the time of the explosion (Pgs. 2940-2941). There is no record that the Coast Guard was notified or approved of the pending installation of the transformer.

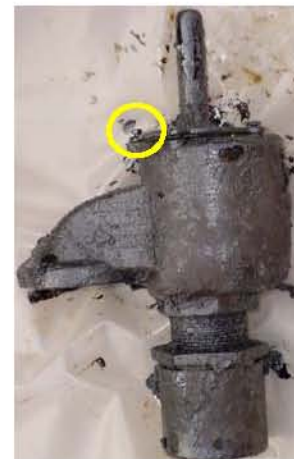
**Figure 5-18: Cargo tank P/V valve**

After the explosion it was discovered that one of the bolts holding cargo tank #1 PV valve in place was partially backed out (Figure 5-17). Three additional PV valves were recovered after the explosion with similar conditions found on those also (Figure 5-18). Additionally, the flame screen was largely clogged (Figure 5-19).

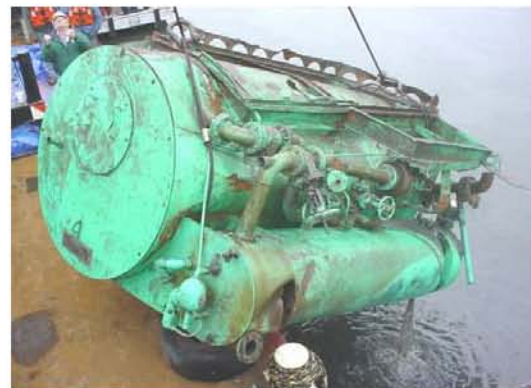
**Figure 5-21: Thermal fluid heater recovery**

(Exhibit CG-90). The heater was jettisoned from the EMC 423 during the explosion and was later recovered from the canal largely intact (Figure 5-21).

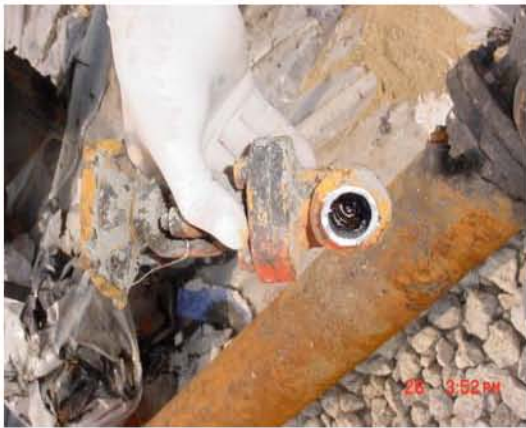
**Figure 5-23: Heat trace valve**

Of the heat trace valves recovered after the explosion, 3 of 4 were in the closed position (Figures 5-23, 5-24). Other valves were found of a similar size in the closed position but could not be clearly associated with the heat trace system.

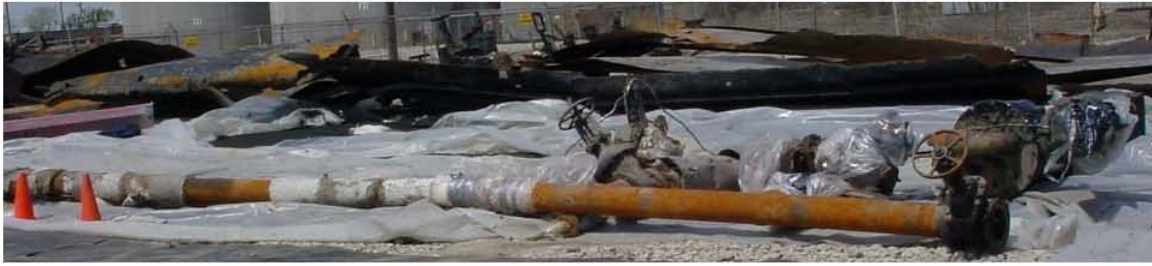
**Figure 5-25: Reconstructed transfer header, loading and discharge piping including cargo pump**

The crew of the M/V LISA E stated that the EMC 423 heat tracing system was in use at the time of the explosion (Pgs. 3103, 3105). Visual examination of the physical evidence after reconstruction of the transfer header, loading discharge piping and cargo piping heat trace system, including the cargo pump (Figure 5-25), indicated that a section of the heat trace piping/tubing between the cargo pump and transverse header was apparently not connected at the time of the explosion. Specifically, the examination of the debris revealed

several factors that indicated that this section of the heat trace piping/tubing was not connected when the barge suffered the casualty.

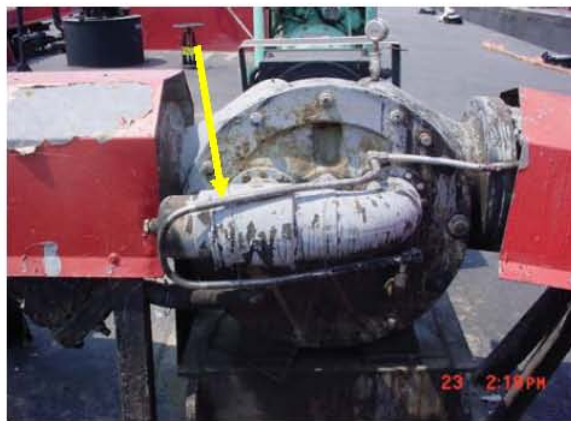
**Figure 5-26: EMC 427 Cargo pump with heat trace tubing**

walled stainless steel tubing used for the cargo pump heat trace system. Damage to the pump consisted of: 1) the pump casing flange on the suction side being broken off, 2) the pump discharge pipe (approximately 8 inch diameter mild steel pipe with approximately 1/2 inch wall thickness) was bent just past the elbow from the portion of pipe that leads to the discharge block valve (Figure 5-27(A)), 3) the cargo pump's cast feet and pump bracket feet were broken off and 4) the cargo pump, The pump, Faulk reduction gear and prime mover were all separated from the foundation and thrown from the barge and all but the prime mover

were later recovered from the Chicago Sanitary Ship Canal. This massive damage to the cargo pump and appurtenances significantly contrasted to apparent little to no damage incurred by the heat trace tubing on the EMC 423 cargo pump (Figure 5-27(B)) with its smooth bent shape, nearly identical to that found on the EMC 427, still intact. [REDACTED] (ATF) testified that he compared the heat trace line configuration from the EMC 472 (Figure 5-26) with that of the EMC 423 and concluded that the EMC 423 heat trace line (Figure 5-27(A)) was not bent or damaged at all during the explosion, despite the cargo pump being thrown from the barge during the explosion (Pgs. 3247-3250).

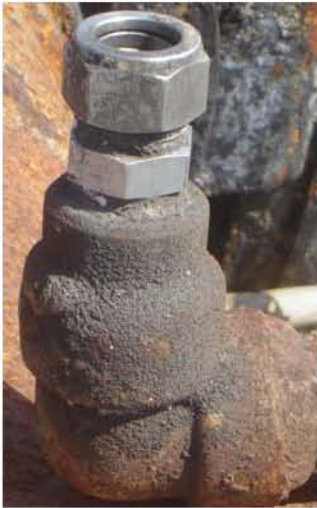
**Figure 5-28: Header compression fitting**

The second key factor that was discovered was the condition of the compression fittings found at the end of the tubing that remained connected to the cargo pump (Exhibit CG 131, Figure 5-29) and the fitting found at the intersection of the discharge pipe and the athwart ship cargo header (Exhibit CG 132, Figure 5-28). Field reconstruction of the above deck cargo piping and associated heat tracing piping/tubing allowed for not only determining how the heat tracing system was routed (Figure 5-20) but also where key components fit into the configuration. In the case of the section between the starboard header valve and the pump discharge piping connection, the determination was based on the matching length of the piece relative to the length of cargo piping between the

pipe, disassembly of the fitting found that the two key components, the nut and the olive, were present and undamaged (Figure 5-32). also testified that he examined this compression fitting finding no mechanical damage was sustained by the fitting and that he did not find any evidence of any tubing remaining in the fitting (Pg. 3246). Using

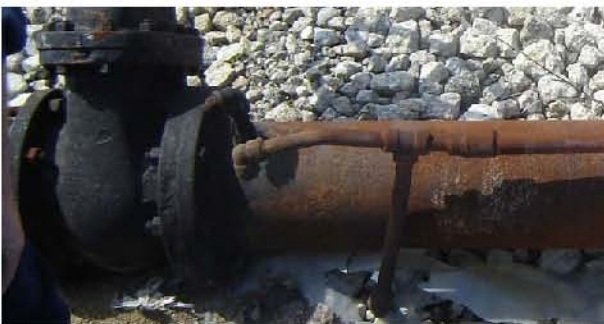
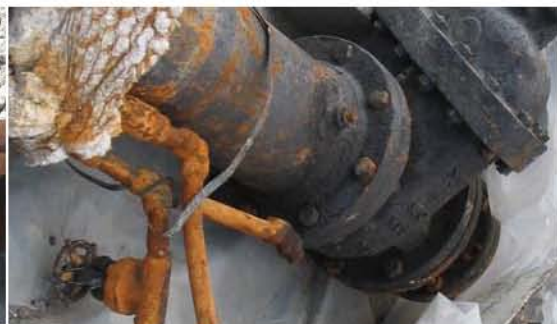
starboard discharge valve and the intersection of the discharge pipe and the athwart ship cargo header. The last factor was the branch line similarities to the port end of the header (Figures 5-30 and 5-31). The port heat trace piping was still banded in place when that section of the cargo header was recovered.

**Figure 5-30: Starboard header with heat trace piping      Figure 5-31: Port header with heat trace piping**

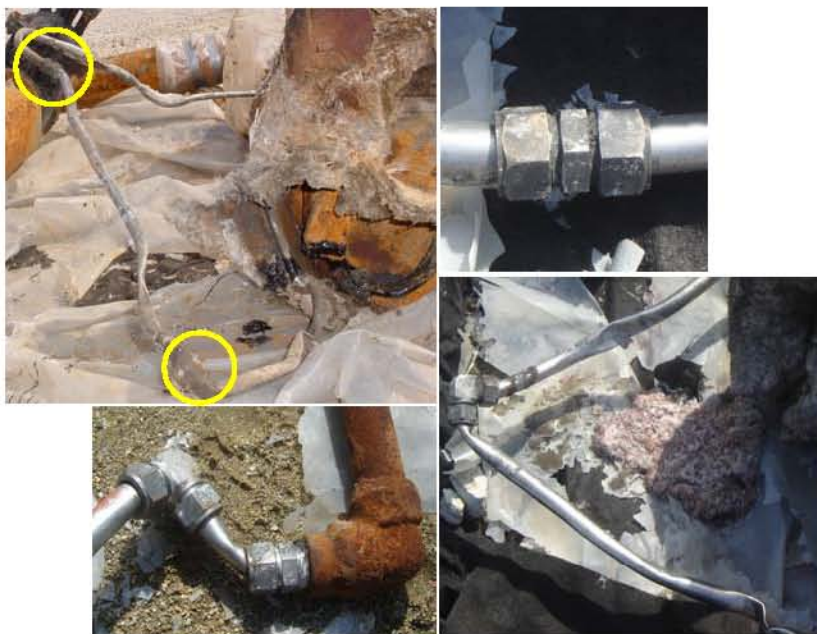
In contrast to the two undamaged/unconnected compression fittings (Figures 5-28 and 5-29) are the many other similar fittings that were found amongst the debris. These fittings, upon examination, were found to be of the same nature as those discussed above in that both the stainless steel tubing to tubing fittings were found as well as the mild steel piping to tubing connections (Figure 5-33). In each of these other instances, the fitting was still intact and the tubing or piping remained firmly in place. This remained true even where the severest of damage to the fittings and attached piping/tubing was observed. [REDACTED] finding, with regard to the other fittings available for examination, was that “[t]ubing was destroyed, bent, mashed, torn, but the fittings were in place” (Pg. 3250).

**Figure 5-33: Pictures of other fittings found intact amongst the recovered debris**

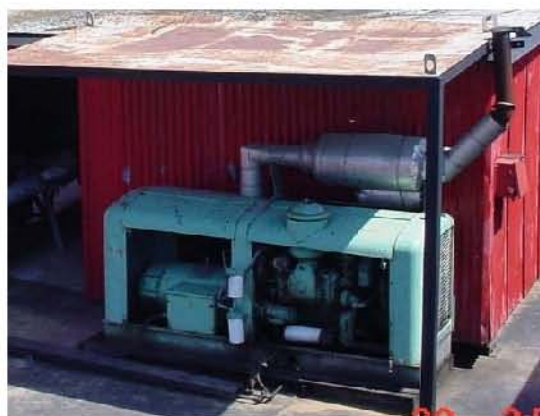
g. Electrical System Overview: The EMC 423 was equipped with a 60 kilowatt Delco brushless generator, powered by a Detroit Diesel 4V-71 prime mover. Figure (5-34) depicts an identical unit from the EMC 472. The generator was used exclusively to provide power to the thermal fluid heater control panel although there were plans to power the electric fuel heating element when the wiring was completed. The barge used portable navigation lights powered by 12 volt batteries. All wiring was run in conduit and was located above deck. The EMC 423 generator was located on the port side of the barge just forward of truss 32, above cargo tank #4.

The generator was running at the time of the explosion and was recovered from the canal after the explosion. The generator prime mover was examined after the explosion by representatives from Detroit Diesel Corporation, who concluded that the engine appeared to be in good condition and operating properly at the time of the casualty (Exhibit CG-140).

**Figure 5-34: EMC 472 generator/4V-71 Detroit Diesel**

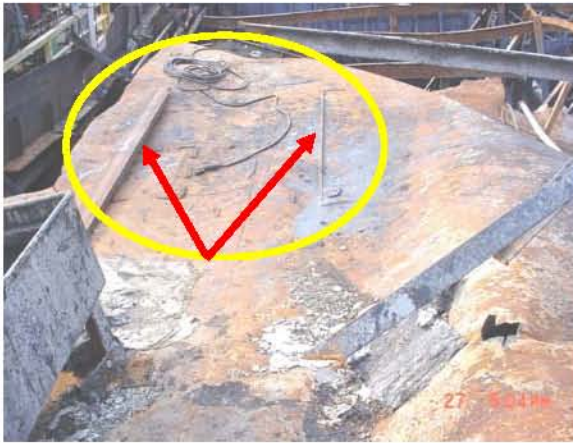
found forward of the cargo header, on the port side of the barge, adjacent to the generator (Figure 5-37).

**Figure 5-37: EMC 423 Vapor thermal fluid heater house foundation**

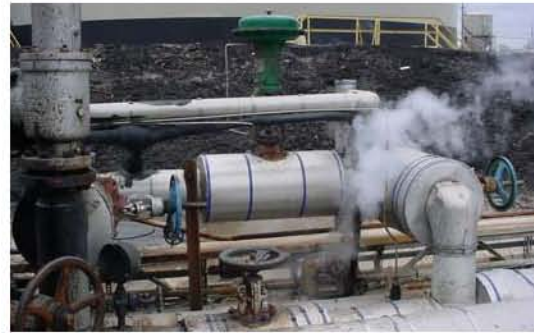
f. Set-up valve: Various portions of the CSO piping within the ExxonMobil facility are steam traced to prevent the CSO from setting up within the piping, especially during cold weather. However, during the loading of EMC 423 on January 18, 2005, ExxonMobil was unable to provide heat tracing to the cargo lines due to the failure of the steam control valve (Figure 8-6) (Pg. 1818 (SSI)). The inability to provide steam heat tracing resulted in CSO solidifying in the ExxonMobil tank 516 suction valve.

**Figure 8-6: Steam supply control valve for tanks 515/516**

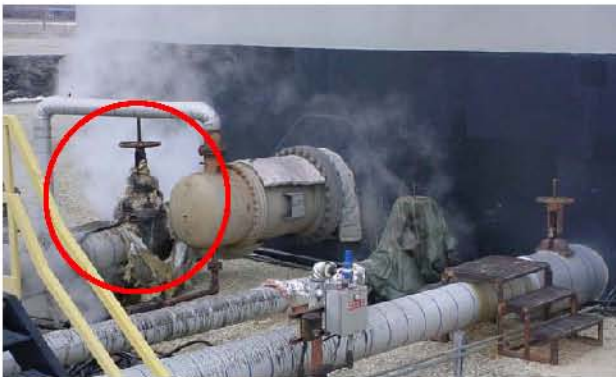
The EMC 423 was initially supposed to be loaded from tank 516, but that became impossible when the tank's suction valve set up (Figure 8-7).

**Figure 8-7: Main suction valve on storage tank 516**

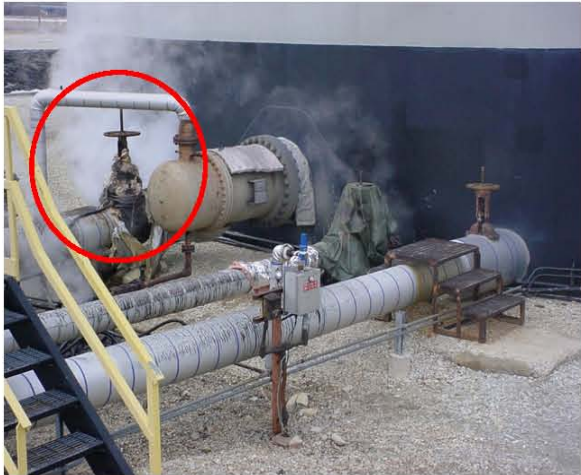
~1815: Transfer efforts suspended due to CSO being set-up in the main suction line valve (Figure 9-3), making loading from storage tank 516 impossible until the valve was cleared. Tankerman and shore side PIC departed (Exhibit CG-61,

**Figure 9-3: Main suction valve on storage tank 516**

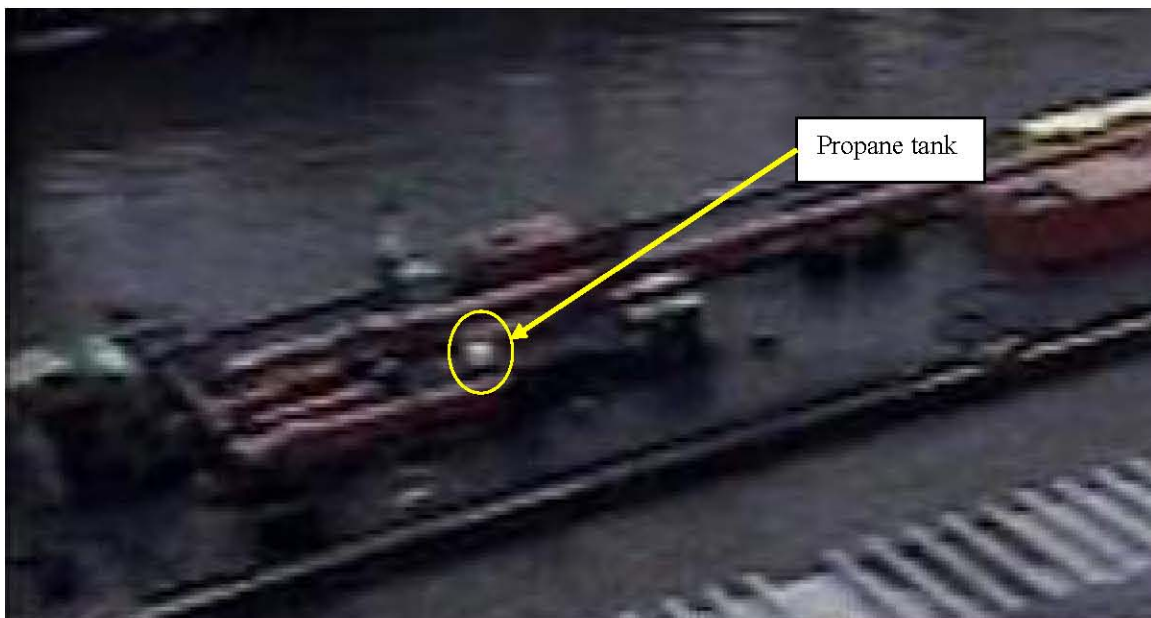
and a propane tank (Figure 9-6) aft of the cargo pump, on the inboard side of the discharge line (Exhibit CG-86).

Figure 9-6: Propane tank on board EMC423 (Photo from Olympic Oil)

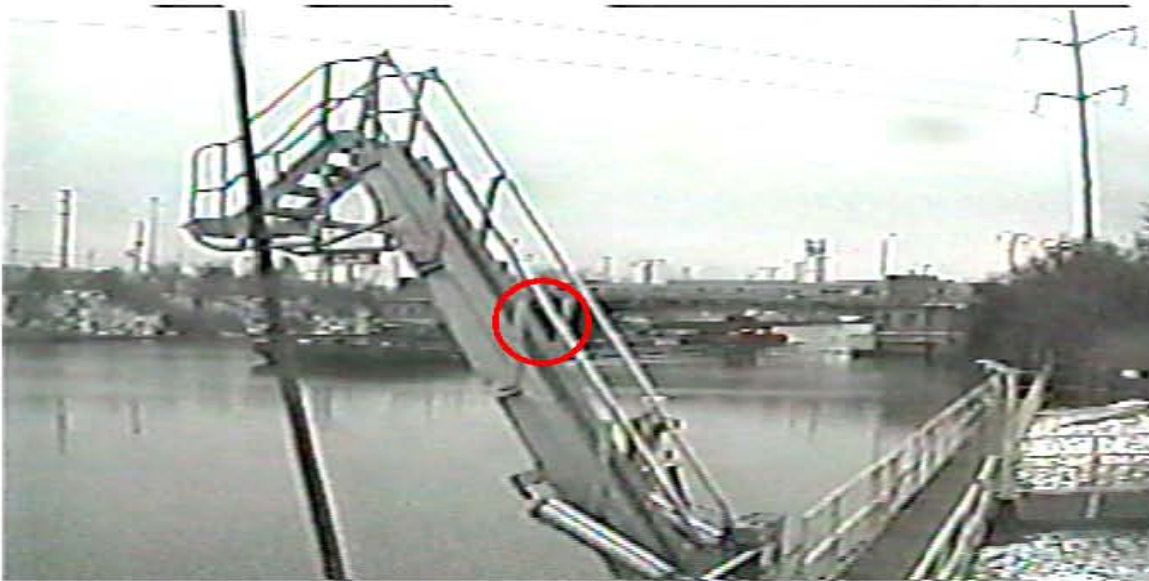
NOTE: Figure (9-8) is provided to illustrate that the area of the flash that is found in (Figure 9-9) is not an attribute of the background or of the gantry in the foreground.

Figure 9-8: Photo of EMC 423 passing under Cicero Ave Bridge, before flash (Citgo Petroleum surveillance camera)

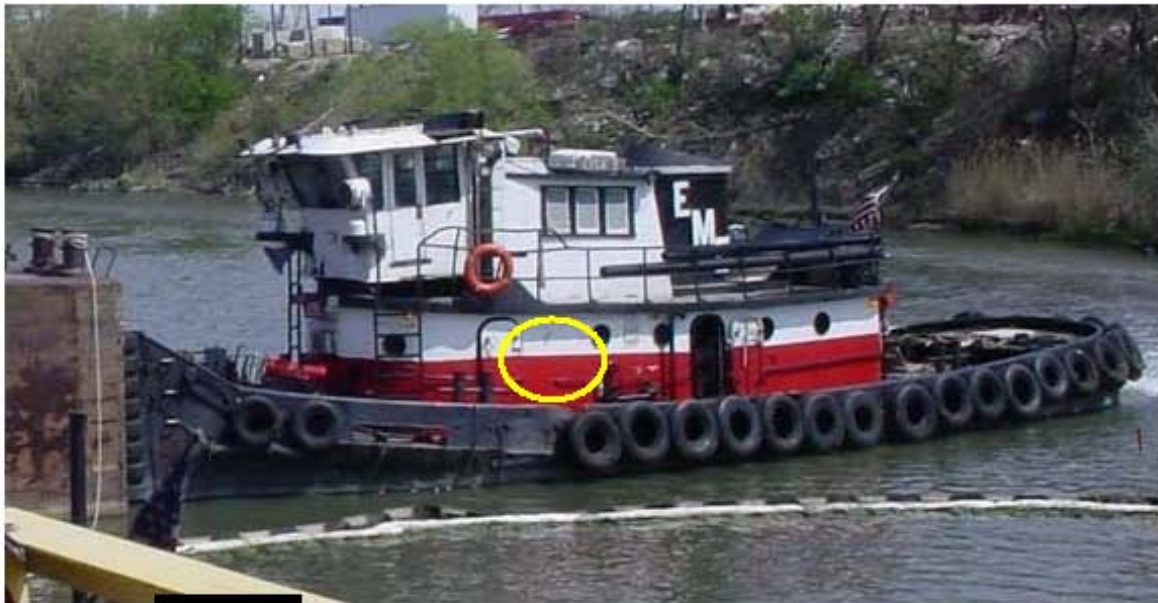
~1640: [REDACTED] from the port side, main deck of the EMC 423, sees the white flash and describes it as a “bright light”. [REDACTED] stated that the flash appeared on the opposite side of the thermal fluid heater and from where he was standing the flash was in line with the push-knee of the M/V LISA E (Pgs. 1156, 3079). [REDACTED]

██████████ approximate location aboard the M/V LISA E when he saw the white flash just before the explosion (Figure 9-10).

Figure 9-10: ██████████ location at time of explosion

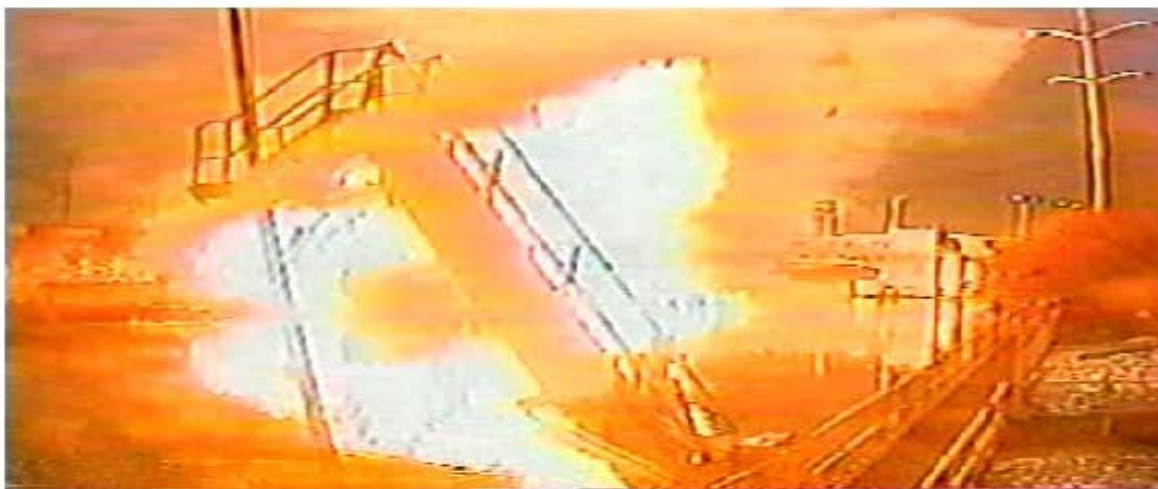
~1640: EMC 423 exploded at approximately mile 317.5 of the Chicago Sanitary and Ship Canal (Figure 9-11) (Exhibit CG-41). The tug and barge was just clearing the Cicero Avenue Bridge when the explosion occurred (Pgs. 754, 1152).

Figure 9-11: Explosion aboard EMC 423 (Citgo Petroleum surveillance camera)

██████████ was at the wheel of the M/V LISA E when the explosion occurred. He heard a “popping” noise, followed by a loud concussion and orange glow. He initially reported the explosion coming from the area of the thermal fluid heater. He ducked below the pilot house console upon seeing the explosion (Pgs. 755-756).

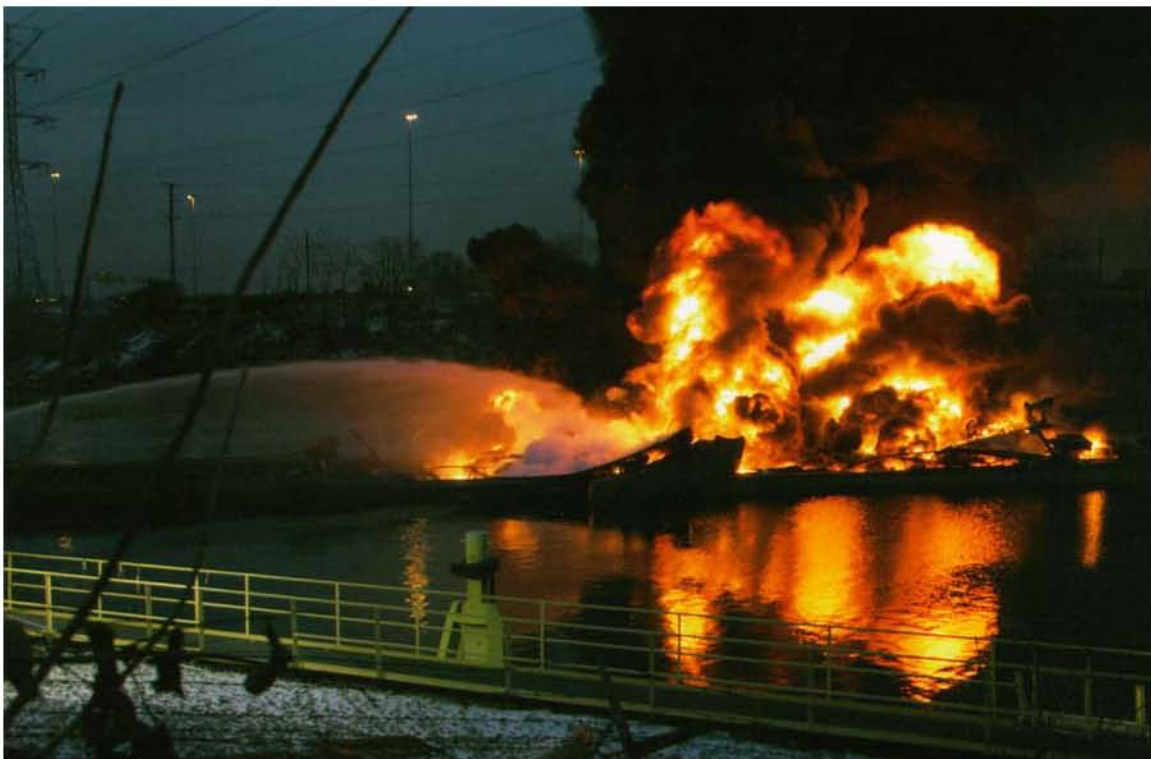
- ~1703: Chicago Fire Department pumper truck began application of water to EMC 423 from Citgo Petroleum Corporation dock on the east bank of the Chicago Sanitary and Ship Canal (Exhibit CG-86). The water was being applied from a single line at 500-600 gallons per minute (Figure 9-13) (Pg. 2751).

**Figure 9-13: Chicago Fire Department fighting fire on EMC 423**

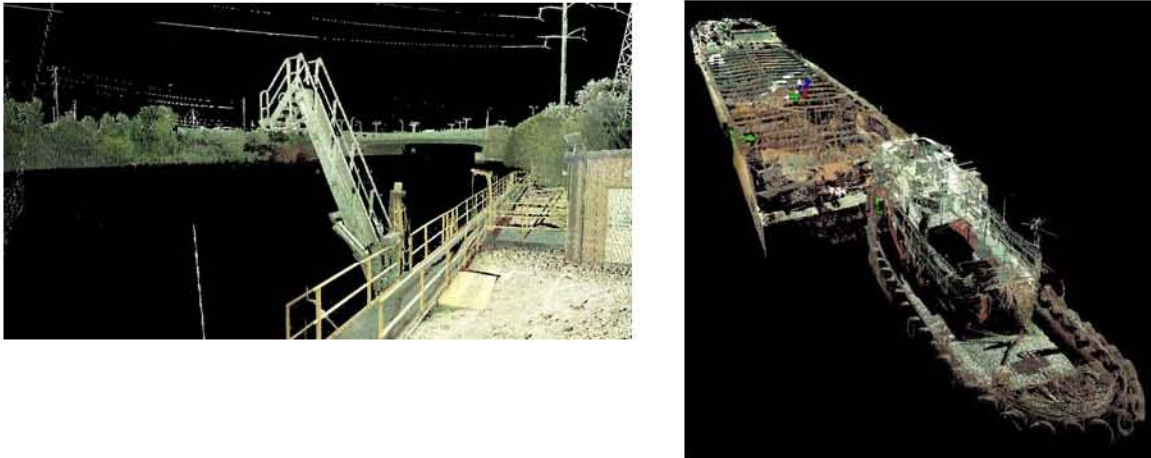
e. Casualty Recreation: In order to make optimal use of the video information garnered from the CITGO facility security camera and the testimony provided by [REDACTED] and [REDACTED] the length of the Chicago Sanitary and Ship Canal between the CITGO facility and the Cicero Ave Bridge was digitalized. The EMC 423 and M/V LISA E were individually laser scanned using a Leica HDS3000 with Leica Cyclone Software - version 5.5 (Figure 10-1).

**Figure 10-1: Individual digital scans of canal and tug/barge**

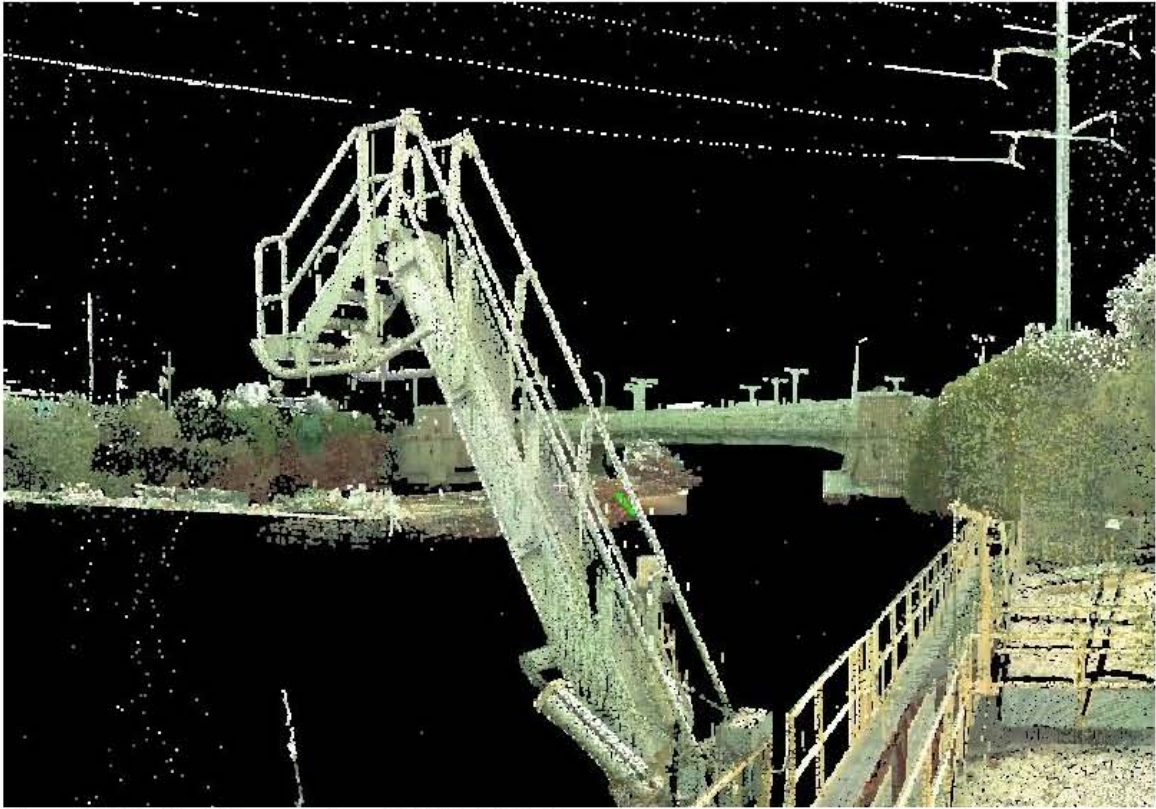
Six scanworlds were combined by registration in pairs of two. The three combined scanworlds were then merged to make the final model space to include the tug, barge and canal in a scene only seconds before the explosion (Figure 10-2). The vessels were positioned relative to one another based on the testimony provided during the hearings and during the course of field investigative work. The M/V LISA E and EMC 423 together were then positioned in the canal by comparing the digital image (Figure 10-2) with the photo data (Figure 10-3).

The photo graph line errors allow the tug to move plus or minus less than 9 feet in the canal. There is a 4 foot error moving up and down the canal. The error distributed to the barge would be less than 5 feet side to side and less than 2 feet up and down the canal. In conclusion, the overall accuracy of the tug and barge in relationship to the canal is placement within 1 foot of absolute position.

**Figure 10-2: Digital recreation of M/V LISA E and EMC 423 coming under Cicero Ave Bridge seconds before the explosion**

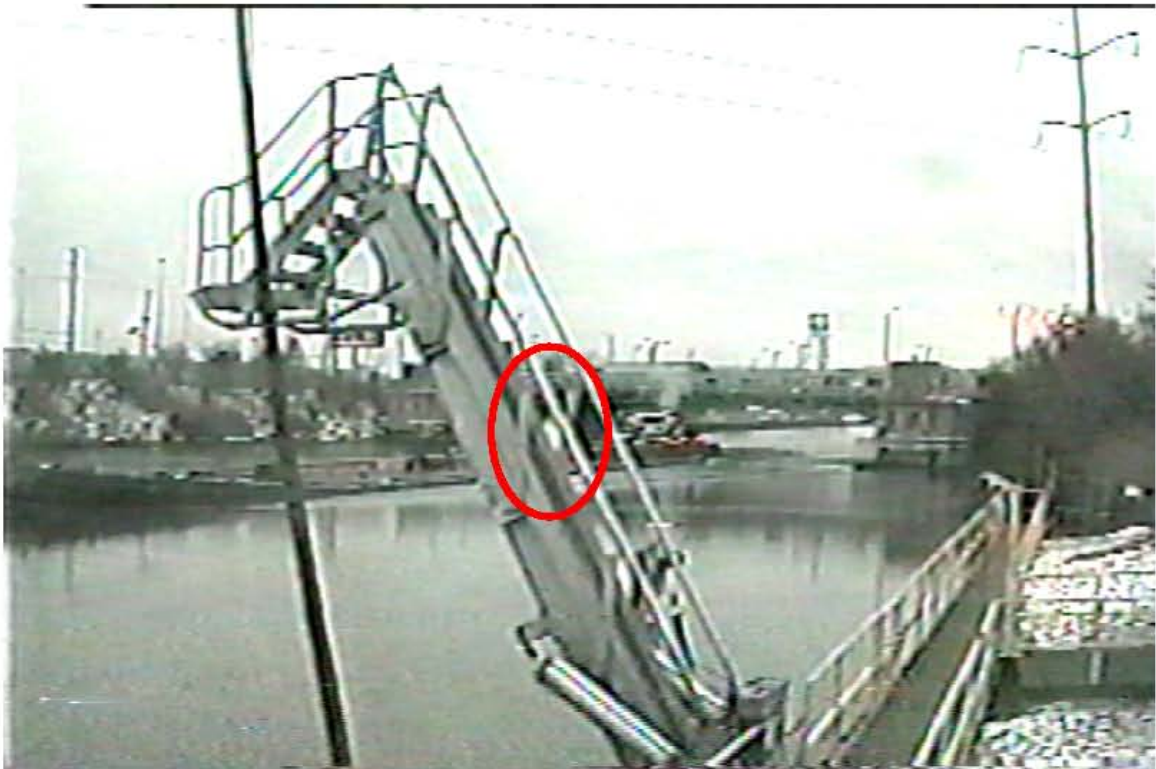
**Figure 10-3: CITGO security photo of M/V LISA E and EMC 423 coming under Cicero Ave Bridge seconds before the explosion**

Using the still photos from the security camera located at CITGO a sight line was projected through the gantry (Figure 10-5) in the foreground to a white flash (Figure 10-3 - circled) that appears in the distance.

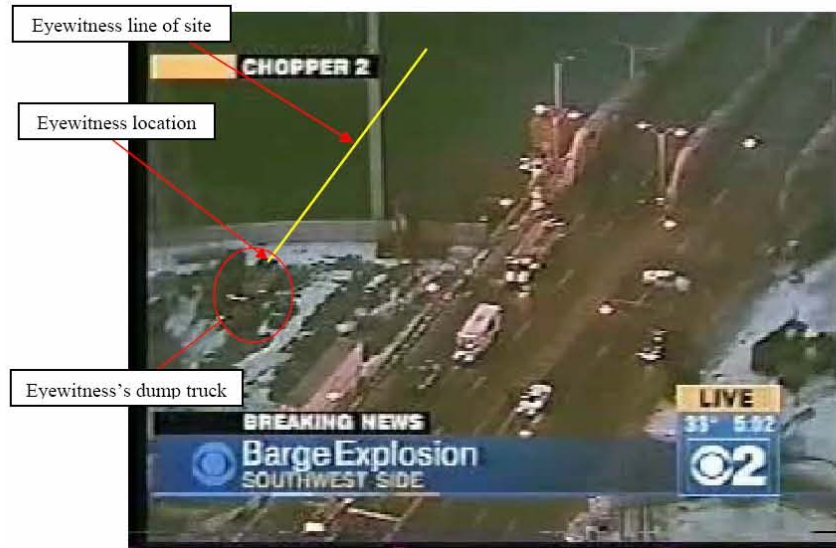
Figure 10-4: Eyewitness ( ) location at truck yard

immediately followed by the explosion. Using the live news film footage, a still image of the truck yard was created that showed the location and orientation of truck allowing an assessment of his direction of view across the canal and the area of the barge he was observing (Figure 10-4). This piece of information was then applied, as a sight line, to the digitalized recreation (Figure 10-5).

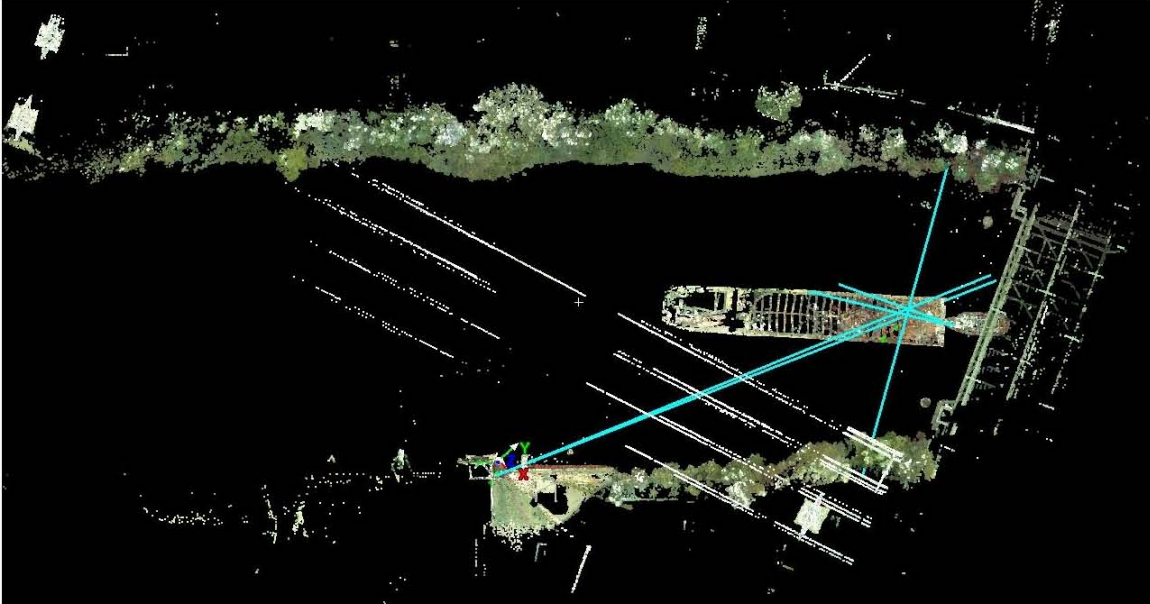
According to testimony, he was on the port side of the M/V LISA E looking forward over the single push knee when he observed the “white flash” followed immediately by a red fire ball/explosion in the same general area. By using this information, sight lines were projected from his approximate location over the push knee on the M/V LISA E and across the EMC 423 (Figure 10-5).

**Figure 10-5: Digital recreation with sight lines intersecting over EMC 423**

As indicated in Figures 10-5 and 10-6, the sight lines generated from two witnesses and the CITGO surveillance camera all cross in the immediate vicinity of the EMC 423 cargo pump. In combination with the testimony and physical findings, the crossing of these sight lines within the same immediate area serve to provide conclusive evidence that all the conditions necessary for the casualty to occur were present in the vicinity of the cargo pump. Present were a flammable vapor/air mixture confined within the number 4 cargo tank, a path for the vapor to travel from the confined space via the standpipe, and a competent source of ignition in the form of the propane torch on board the EMC 423 for the purpose of heating the cargo pump.

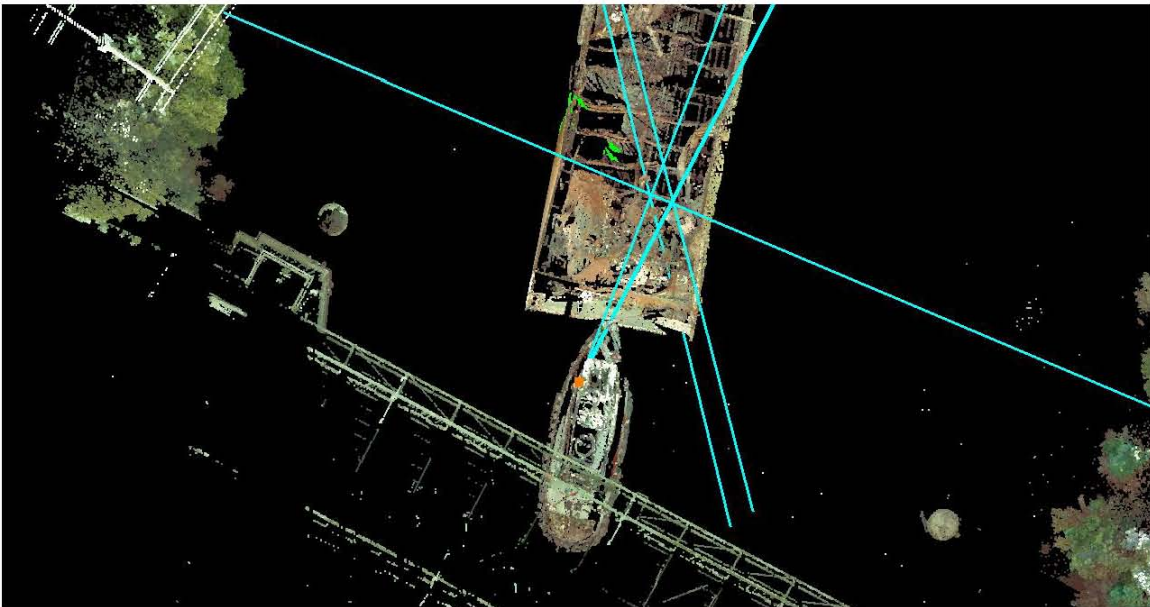
**Figure 10-6: Digital recreation directly above sight lines intersection on EMC 423**
