REPORT OF THE INVESTIGATION INTO THE CIRCUMSTANCES SURROUNDING THE ENGINE ROOM FIRE ON BOARD THE

M/V SSG EDWARD A. CARTER, JR.

WHILE MOORED AT MILITARY OCEAN TERMINAL
SUNNY POINT, N.C., ON JULY 14, 2001
WITH THE LOSS OF TWO LIVES

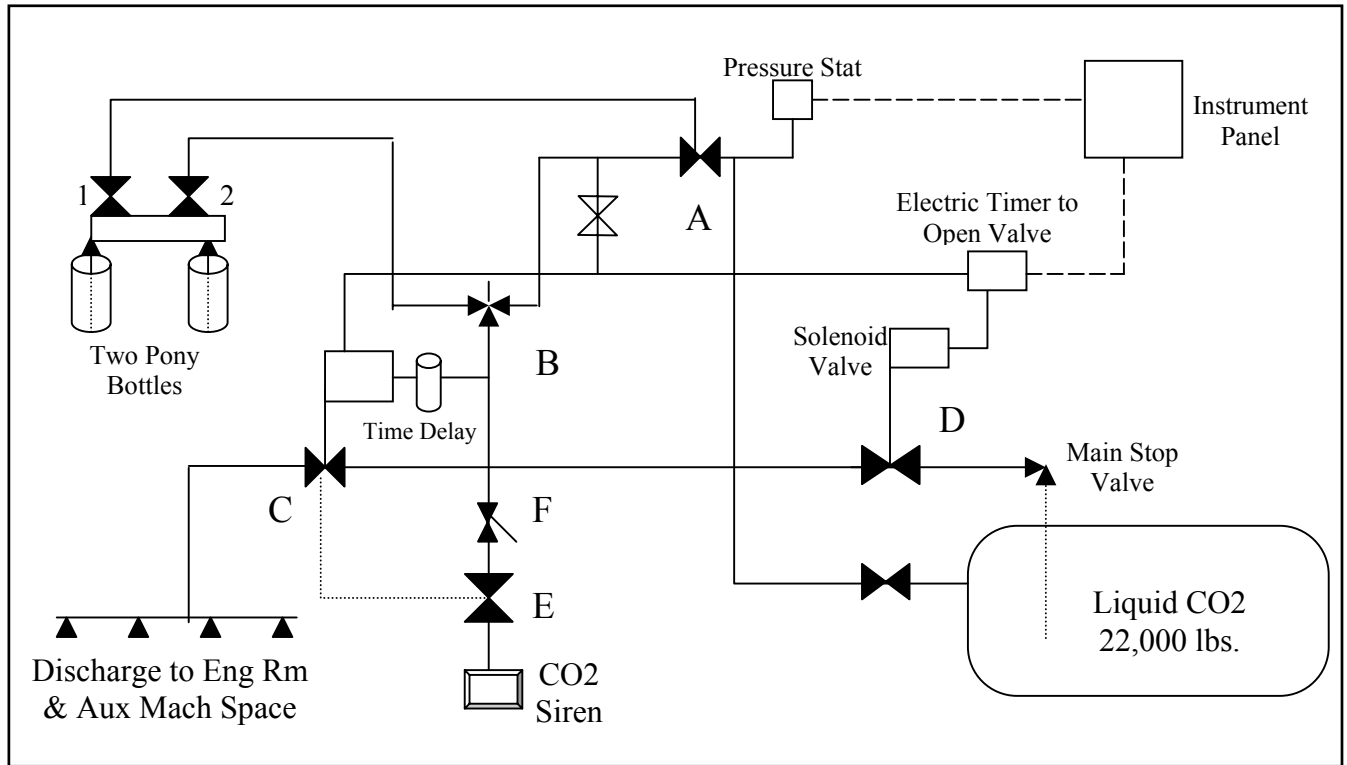
Figure 3: Simplified Drawing of Low-Pressure CO₂ System
(based upon Ginge-Brand Drawing 12-131A02D-HS)

63. Once the two levers are opened (labels 1 and 2, Figure 3), CO₂ gas from the pony bottle flows to open two pilot valves (labels A and B) located within the CO₂ room. When the two pilot valves open, CO₂ gas from the main tank flows to the 2-minute time delay before opening the two main distribution valves (combined together in label C) protecting the engine room and auxiliary machinery space. While the CO₂ gas is filling the 2-minute time delay bottle, the CO₂ siren is sounding throughout the engine room to alarm the crew to evacuate immediately. Once the distribution valve opens, an electrical signal is sent to the CO₂ instrument panel to start a timer to open the main block valve (label D).

For this type of release, the amount of time the main block valve remains open, and consequently the amount of CO₂ discharged to the protected space, is controlled by the amount of time the bypass pilot valve is held open. Additionally, the main block valve and the distribution valves (Figure 3, labels A, C, D) can be opened manually through use of wrenches placed at bottom of the valve bodies. Prior to using the wrenches, the pressure in the pneumatic control lines needs to be released.

72. Mr. Thompson testified that there was a ball valve in-line with the piping that provides CO₂ gas to the siren (label F in Figure 3). Mr. Thompson observed that this ball valve was closed and had a chain and an open lock wrapped around its handle when he first arrived on board the ship in April. He did not determine how or why the ball valve was closed. Neither the ABS surveyors, nor any representatives from FPS or Norshipco required the chain to be removed nor the ball valve opened.

183. On 16 July, CWO Gonzales examined the position of various valves and controls for the low-pressure CO₂ system along with Mr. Gil Mabry from Koorsen Fire Protection Services. CWO Gonzales testified that he found the main stop valve (see Figure 3) located on top of the CO₂ tank open. The CO₂ main stop valve did not have its locking cap installed. The locking cap was found on the deck next to the CO₂ tank. A sign which read, "Main Valve Closed, Open Main Valve Before Activating System" was seen hanging from the main stop valve body. The investigation did not determine who had placed this sign on this valve. Chief Engineer Champa testified that he saw the sign hanging from valve since his arrival on board but was not sure what was written on it.

184. CWO Gonzales confirmed that the engine room distribution valve and the main block valve (labels C and D in Figure 3) were closed based upon the position indicators on the two valve bodies. The pneumatically-operated valve in-line with the CO₂ siren was found open. CWO Gonzales did not confirm the position of the 1.25" ball valve (label E in Figure 3) along the CO₂ siren line. This ball valve needs to be opened to provide CO₂ gas to the pneumatically-operated valve in order for the siren to sound. The two pilot valves (labels A and B in Figure 3), which are designed to open the main block valve and engine room distribution valve, were found open.

185. CWO Gonzales found that the safety seal attached to the right-side pony bottle cylinder valve (Figure 3) was broken. The two control valves positioned on the manifold in between the pony bottles were found open.

194. Mr. Bradley testified that when the crew opened one of the pilot valves identified as label A (Figure 3) from the CO₂ room during the fire response, a pressure switch activated which provides electric power to the re-release buttons located at both of the remote control stations. The purpose for the re-release button is to provide the ability to discharge additional amounts of CO₂ to any of the protected spaces. As long as the release button is depressed, the main block valve remains open to discharge CO₂. The re-release button provides the option to discharge the full contents of the CO₂ tank.

196. Mr. Bradley testified that if the crew activated the CO₂ release properly from the remote control station in the Fire Control Room, they would have found the main pilot valves in the CO₂ room (Figure 3, labels A and B) already open. Since the Electrician had to manually open these two valves in the CO₂ room, this is an indication that his attempt to open from the remote control station failed.
