# Report of Investigation

Sinking of the M/V ELIZABTH M (Official Number # 262962) and Six  
Barges with Four Fatalities on January 09, 2005 at the Montgomery  
Locks and Dam on the Ohio River at Mile Marker 31.7

USCG MISLE Incident Investigation Activity Number 2271812

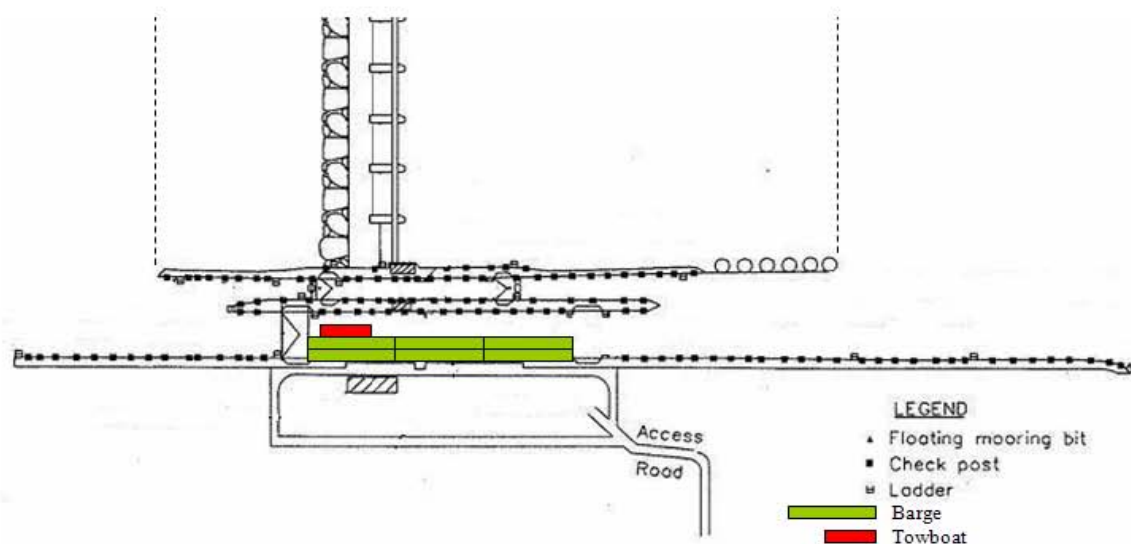
Figure 7: Configuration of the ELIZABETH M and tow while in the lock chamber.

54. On 09JAN05, the ELIZABETH M and her six (6) barge tow executed a "knockout" lockage. Because of the tow configuration and length, a towboat only set over was utilized during the lockage. The ELIZABETH M was moored starboard side to the stern barge in the tow's port string for the lockage. (IO Exhibits 052, 072, 077, 129, 131, Trans Vol II pg 203, ln 10, Vol IV pg 159 ln 1, Vol IV pg 256 ln 20, Vol IV pg 280 ln 1, Vol IV pg 335 ln 6, Vol V pg 23 ln 1, Vol V pg 132 ln 9, Vol V pg 147 ln 13, Vol V pg 149 ln 4)

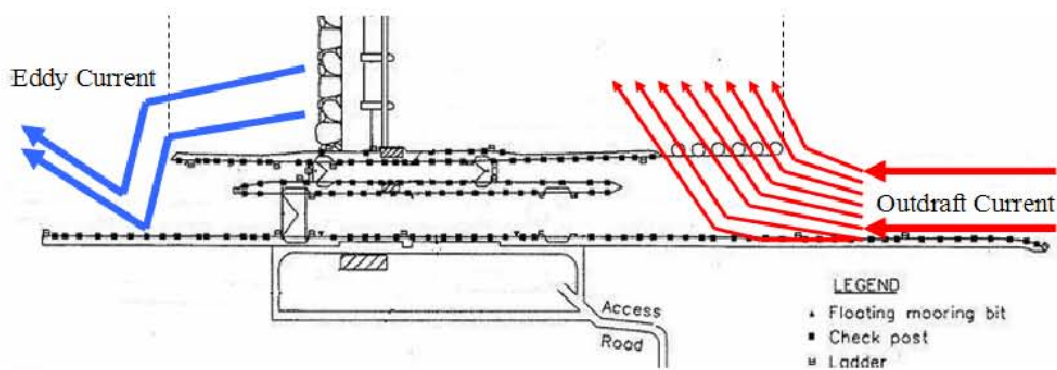
Figure 9: Approximate location of Montgomery Locks and Dam outdraft and eddy current.

56. There are five operating conditions that are peculiar to the Montgomery Locks and Dam. First is the outdraft at the upper approach. The stronger the current flow over the dam the stronger the outdraft. Second is the eddy current at the lower approach. Third is the short lock chamber - the “600 foot” main chamber is actually 592 feet in length. Fourth is the constant wind. Fifth is tows may have problems exiting the lock after a down bound lockage when the lock’s lower gauge reaches 24 feet – it tends to push the tow back into the lock chamber. (IO Exhibit 064, Trans Vol IV pg 164 ln 3)

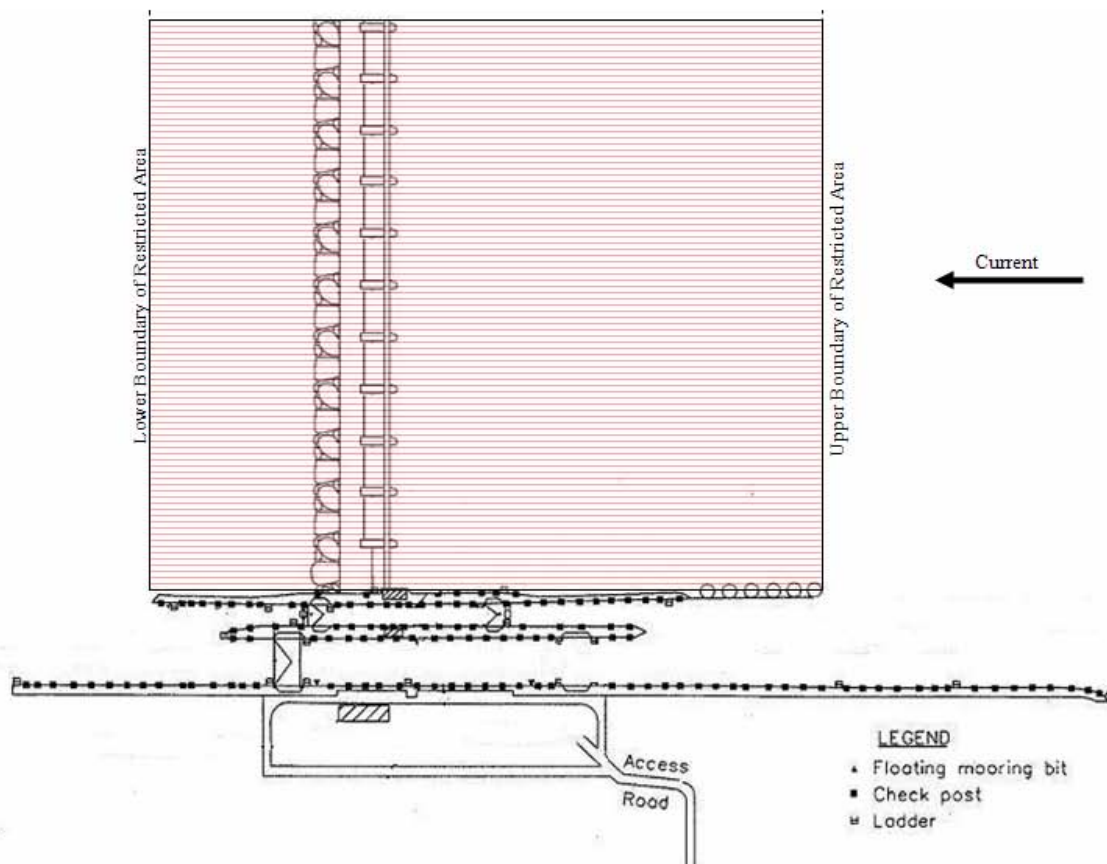
Figure 10: Approximate boundaries of the restricted areas of Montgomery Locks and Dam.

58. The Montgomery Locks and Dam has restricted areas above and below the dam. Restricted areas are areas designated by the responsible District Engineer of U.S. Army Corps of Engineers. No vessels are supposed to enter any restricted areas at any time. The restricted area at the Montgomery Locks and Dam extends the entire width of the river up to approximately 1000 feet above the dam and approximately 500 feet below the dam. (PI Exhibit 008)

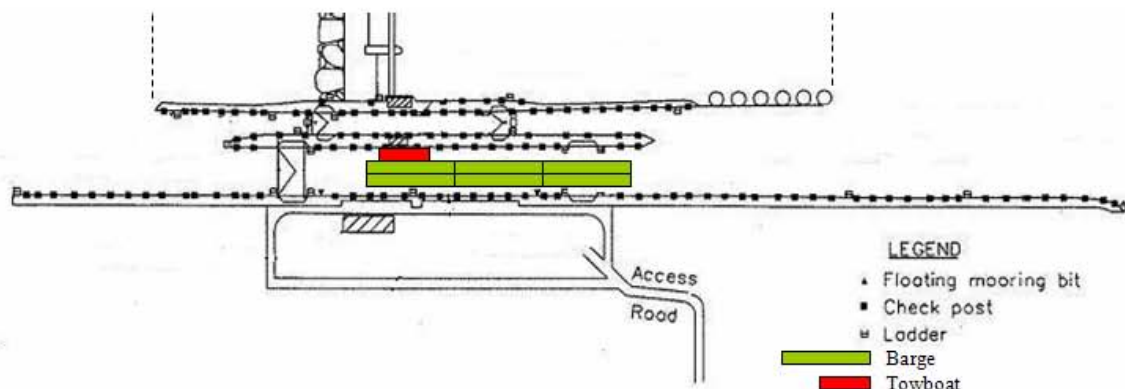
Figure 11: Approximate location and configuration of the ELIZABETH M and tow just prior to maneuvering to face up to the stern of the tow.

63. On 09JAN05, at approximately 0154, the ELIZABETH M began maneuvering to face up to the tow on the fly. The ELIZABETH M pushed the tow approximately 200 feet out of the lock chamber before releasing the tow and prior to maneuvering around to the stern of the tow to face up. While the towboat was maneuvering around to the stern of the tow to face up, the tow was adrift with no positive control. (IO Exhibit 138 Trans Vol III pg 293 ln 3, Vol III pg 295 ln 1, Vol III pg 349 ln 6)

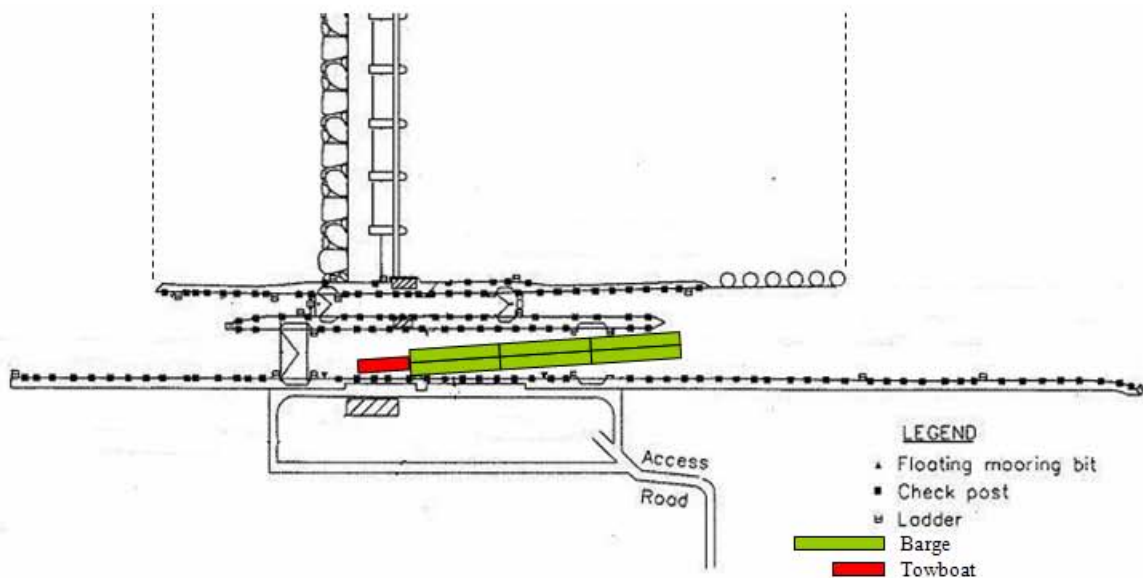
Figure 12: Approximate location and configuration of the ELIZABETH M after facing up to the tow.

64. On 09JAN05, at approximately 0157, the ELIZABETH M completed facing up to the tow. At this time the towboat and part of the tow were still within the main lock chamber. This is the approximate time and location where the effects of the outdraft would have been felt at the head of the tow. The tow was out of shape and being set towards the center of the river by the outdraft. Just after the tow was faced up, [REDACTED] noticed "...the head of the tow, it looked weird. It was headed out. The stern of the boat was riding against the land wall." (IO Exhibit 050, Trans Vol III pg 274 ln 16, Vol III pg 293 ln 3, Vol III pg 295 ln 1, Vol III pg 355 ln 10, Vol V pg 49 ln 1, Vol V pg 153 ln 23)

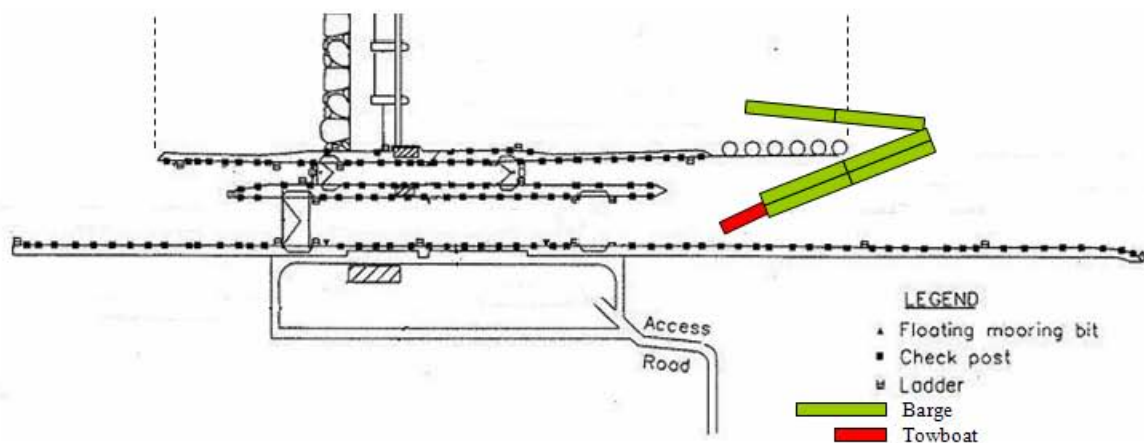
Figure 14: Approximate location and configuration of the ELIZABETH M and tow after the allision with the river side lock wall.

FM radio to see if they needed assistance. The vessel replied back "...I think we got it under control, I think we can handle it..." [REDACTED] also attempted, without success, to contact other vessels in the area that might have been able to provide assistance. At this time two of the lock personnel ([REDACTED] and [REDACTED]) proceeded to the dam and opened dam gates 2 and 9 in case the tow broke away from the ELIZABETH M. This was also about the time [REDACTED] arrived in the pilothouse after being awoken by the general alarm. [REDACTED] observed Stewart operating the ELIZABETH M and Conklin was located at the portside pilothouse door. Conklin told [REDACTED], "They didn't get me faced up fast enough." Two deckhands ([REDACTED] and Crevda) were on the tow attempting to regain control of the two barges at the head of the tow. Stewart directed the deckhands to run a line from the tow out to the mooring cell located at the end of the riverside lock wall. [REDACTED] was successful in securing a line between the last upstream mooring cell on the river wall and the tow in the vicinity of the coupling between the center barge and stern barge in the port string. Once the line was secured between the tow and the mooring cell, [REDACTED] departed the bridge to retrieve his glasses from his stateroom. (IO Exhibit 070, 117, Trans Vol II pg 41 ln 19, Vol II pg 42 ln 23, Vol II pg 49 ln 17, Vol II pg 49 ln 23, Vol II pg 50 ln 1, Vol II pg 50 ln 3, Vol II pg 50 ln 6, Vol II pg 50 ln 16, Vol II pg 50 ln 17, Vol II pg 74 ln 8, Vol II pg 117 ln 19, Vol II pg 119 ln 3, Vol II pg 120 ln 16, Vol II pg 194 ln 21, Vol II pg 207 ln 2, Vol III pg 275 ln 15, Vol III pg 318 ln 9, Vol IV pg 259 ln 8, Vol IV pg 264 ln 12, Vol V pg 28 ln 17, Vol V pg 30 ln 19, Vol V pg 53 ln 10, Vol V pg 56 ln 3, Vol V pg 80 ln 7, Vol V pg 135 ln 4, Vol V pg 135 ln 13, Vol V pg 156 ln 20)

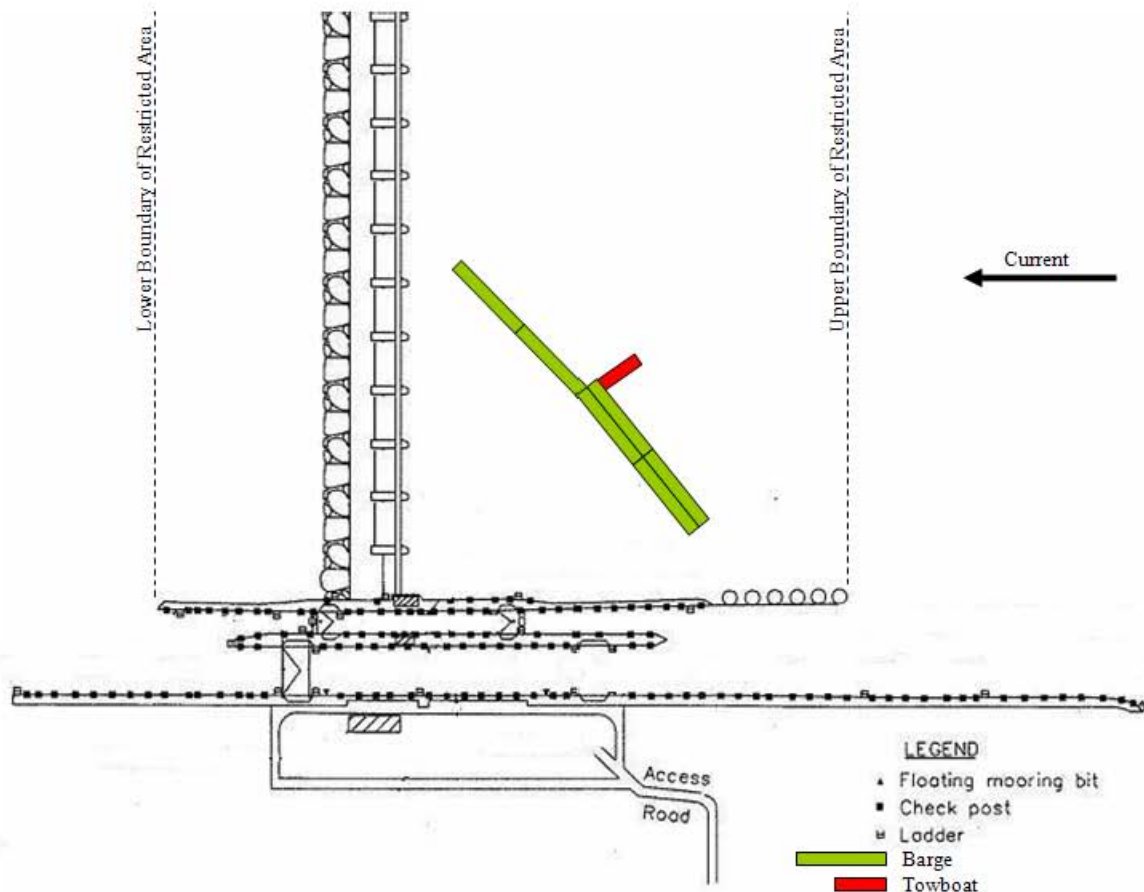
Figure 17: Approximate location and configuration of the ELIZABETH M and tow after placing a line onto a timberhead on the starboard bow of the center barge in the starboard string.

on the starboard bow of the center barge in the starboard string. At this time the towboat and tow were located well within the restricted zone above the dam. (IO Exhibit 050, Trans Vol II pg 53 ln 11, Vol II pg 64 ln 7, Vol II pg 131 ln 5, Vol III pg 160 ln 13, Vol III pg 161 ln 12, Vol III pg 162 ln 17, Vol III pg 278 ln 19, Vol III pg 318 ln 19)
