REPORT OF THE INVESTIGATION INTO THE

FLOATING OCS FACILITY - TENSION LEG PLATFORM

FPS AUGER

LIFEBOAT FALL WITH LOSS OF LIFE ON JUNE 30, 2019

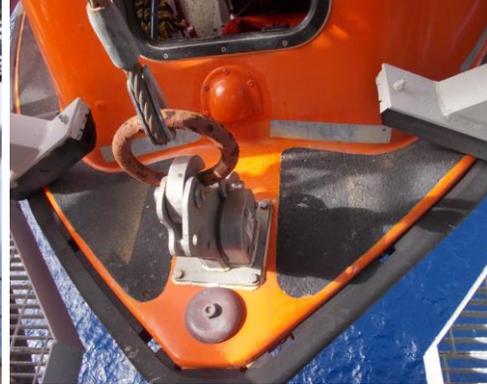
*Image 1 (left): Lifeboat No. 6.
Image 2 (above): Photo Lifeboat No. 6 aft hook
from 2014. Credits: Palfinger Marine.*

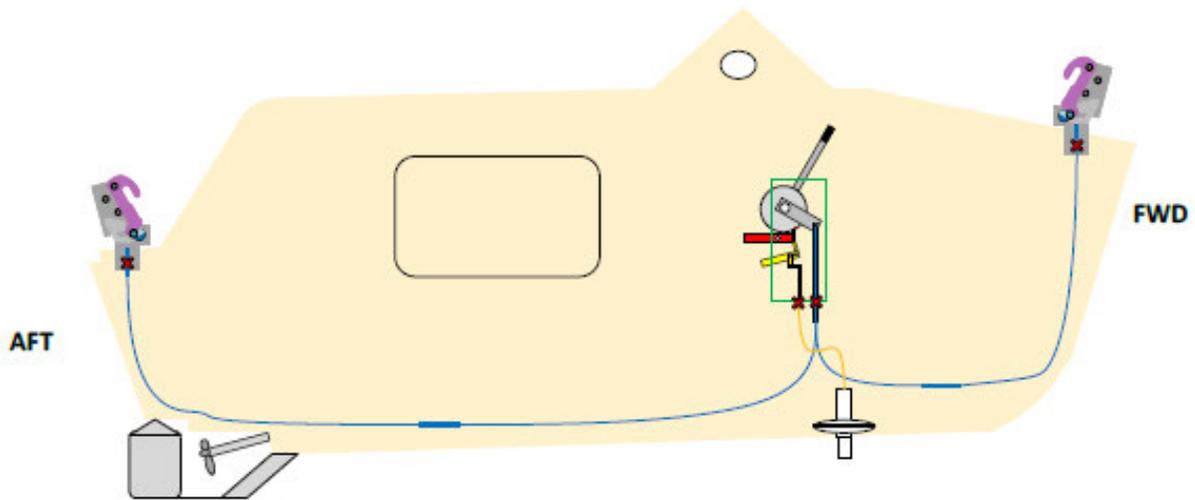
The release mechanism was comprised of two hooks, a hook release unit (located inside the lifeboat adjacent to the helm), a hydrostat unit, and three control (push-pull) cables (see Image 3). One control cable connected the hook release unit to the aft hook, the second control cable connected the release unit to the forward hook, and the third control cable connected the release unit to the hydrostat unit.

Image 3: Drawing of EL24 outfitted with LHR3.5M2 release mechanism. Credit: Shell.

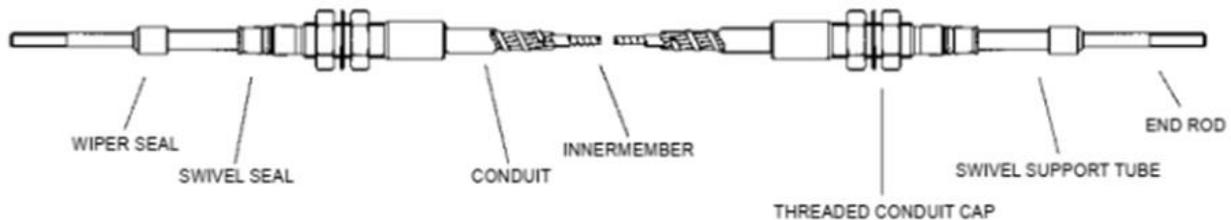
The hook control cables are heavy duty low friction cables with threaded end fittings and four inches of travel at the end rods (see Image 4). Each cable has an outer conduit and an inner member. The conduit is comprised of three layers: a green plastic cover; steel reinforcement; and a white polyethylene liner. The conduit provides a protected path for the steel inner member. With the ends of the conduit fixed at each terminal point (provided it is not fully compromised), the conduit also controls the travel length of the inner member. The inner member transmits linear motion from the hook release unit to the locking shafts located within the hooks via the end rods.

Image 4: Control cable components. Credit: Cablecraft, modified by the USCG.

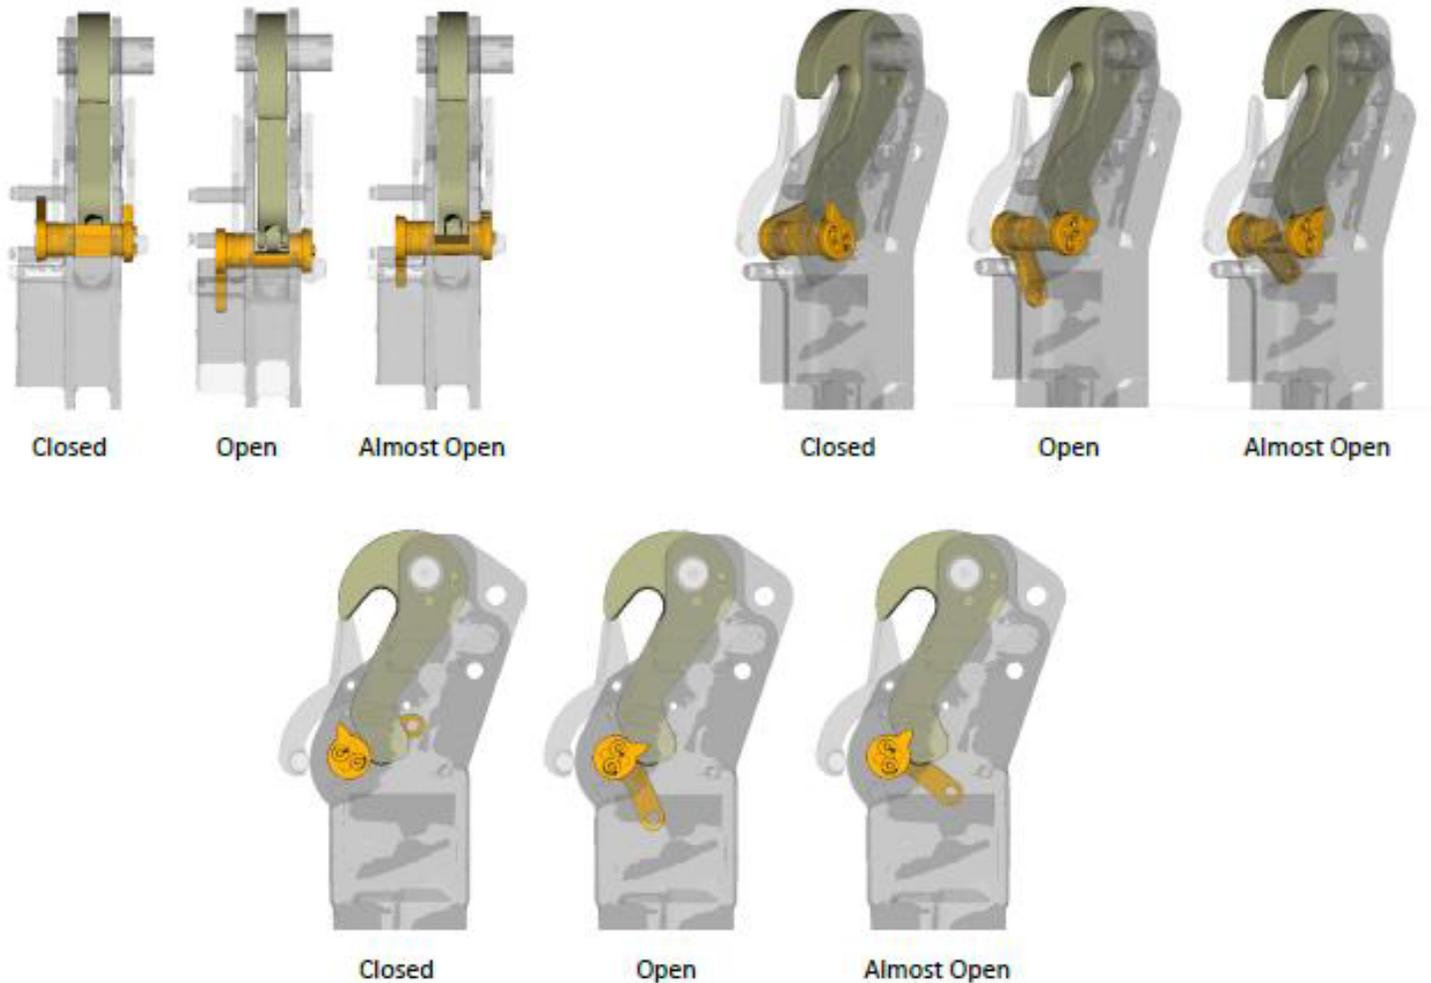
During the course of the investigation, the Coast Guard, Shell, and Palfinger Marine (the original equipment manufacturer or "OEM") identified a previously unknown vulnerability in the system: if all three layers of the conduit of a hook control cable separate or break, during a reset the locking shaft may not return to the fully closed position. Rather, the locking shaft may come to rest at an "almost open" position (see Image 5). In such a position, the hooks can support the weight of the boat and its occupants during retrieval. However, an additional load can cause the locking shaft to rotate to the open position, releasing the hook.

Image 5: Hook cutaway views of LHR3.5M2 hook in closed, open and almost open positions. Locking shaft depicted in yellow. Credit: CG (hook component data provided by DNV-GL).

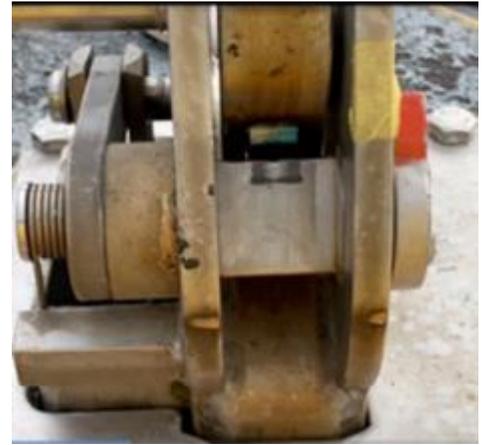
4.1.12. Boat Crew Person 1 had watched the hook locking shaft roll back into place. He looked for and saw the flat face of the locking shaft (see Figure 6). To him, this indicated that the locking shaft was in the correct position and the hooks were correctly reset. He also said he would generally look at the hook indicator on the side of the hook. He noted that if in the closed position, the arrow should be in the red; if in the open position, the arrow would indicate in the green.⁴

Figure 6: The “flat face” of the locking shaft on a LHR 3.5M2 hook (image does not depict Lifeboat No. 6’s hook). Credit: CG.

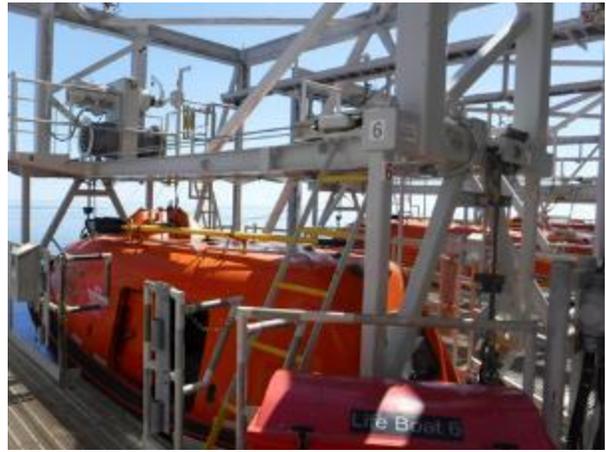
4.1.26. The winch is located on a raised landing above the forward end of the lifeboat (see Figure 7). The BCO reached the winch by climbing a ladder. At the winch, he inserted the handle and started to crank. The winch at Lifeboat Station No. 6 had recently been changed out. While the new winch was not “new,” it had been refurbished in or around 2018 and was in significantly “newer” condition than the previous winch at Lifeboat Station No. 6. Furthermore, it was a more powerful winch: the new winch was converted to a model 9300XL, rated for 9300 kg; while the old model, a 7800XL was rated for only 7800 kg. To the BCO, the winch model looked identical. However, he did note that it was easier to operate. Later, he recalled that it felt “smooth” and “like butter.” He observed, “Where the old one had like maybe two pounds of resistance . . . this one had like a half pound of resistance against it.”

Figure 7: Lifeboat Station No. 6 davit. Figure depicts raised landing where winch is located. Credit: Palfinger, dated May 2015.

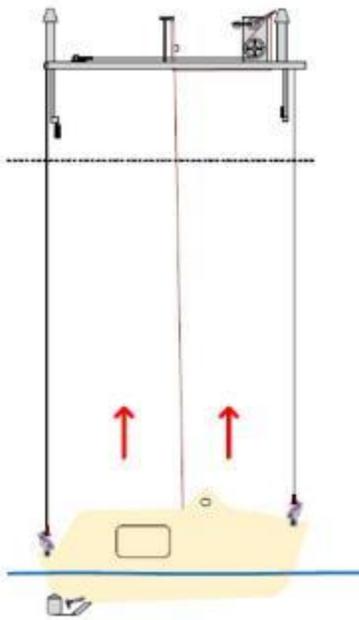
Figure 8: Quarterly lifeboat checks complete, the crew hooks the lifeboat back onto the falls.

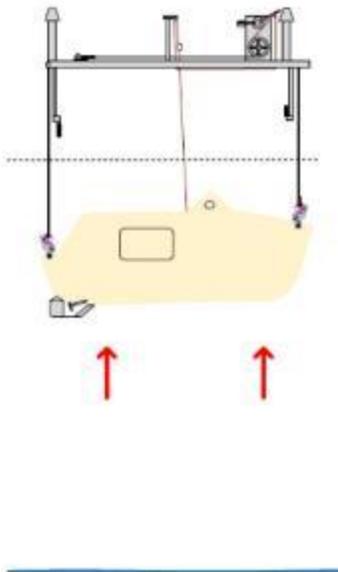
Figure 9: The lifeboat is winched upward using the electrically powered winch.

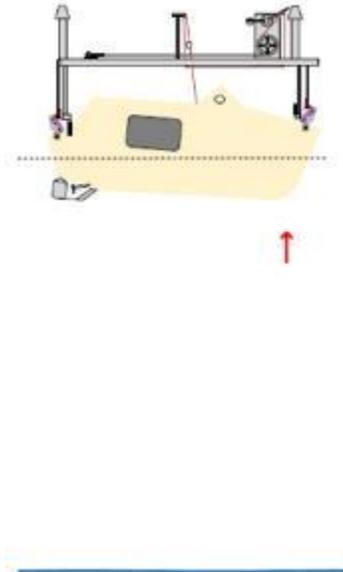
⁶ Based on measurements taken after the casualty, there is some evidence that when the limit switches opened on the day of the casualty, the aft part of the boat was already to the bumpers, while the forward part was still hanging up to 7.5 inches below bumpers. While the evidence solidly supports the fact that the lifeboat was not wholly level, modeling conducted by DNV-GL and Plastic Services Network (PSN), two firms hired to conduct independent forensic testing of the evidence, did not support the investigators’ initial findings regarding to what degree the lifeboat was offset. The Coast Guard’s final conclusions regarding cause are not determinative on the lifeboat being offset at all, only on the fact that the aft part of the lifeboat reached the bumpers at some point during the retrieval/stowage process. For the reasons above, the Coast Guard has elected not to analyze the potential offset. More information on the Coast Guard’s analysis can be found in Enclosure (2) and Paragraph 5.4 Below. DNV-GL’s and PSN’s modeling and analysis can be found in Enclosure (3).

Figure 10: The electrical winch stops when a limit switch is activated. The boat is manually winched to its final position against the forward and aft davit bumpers.

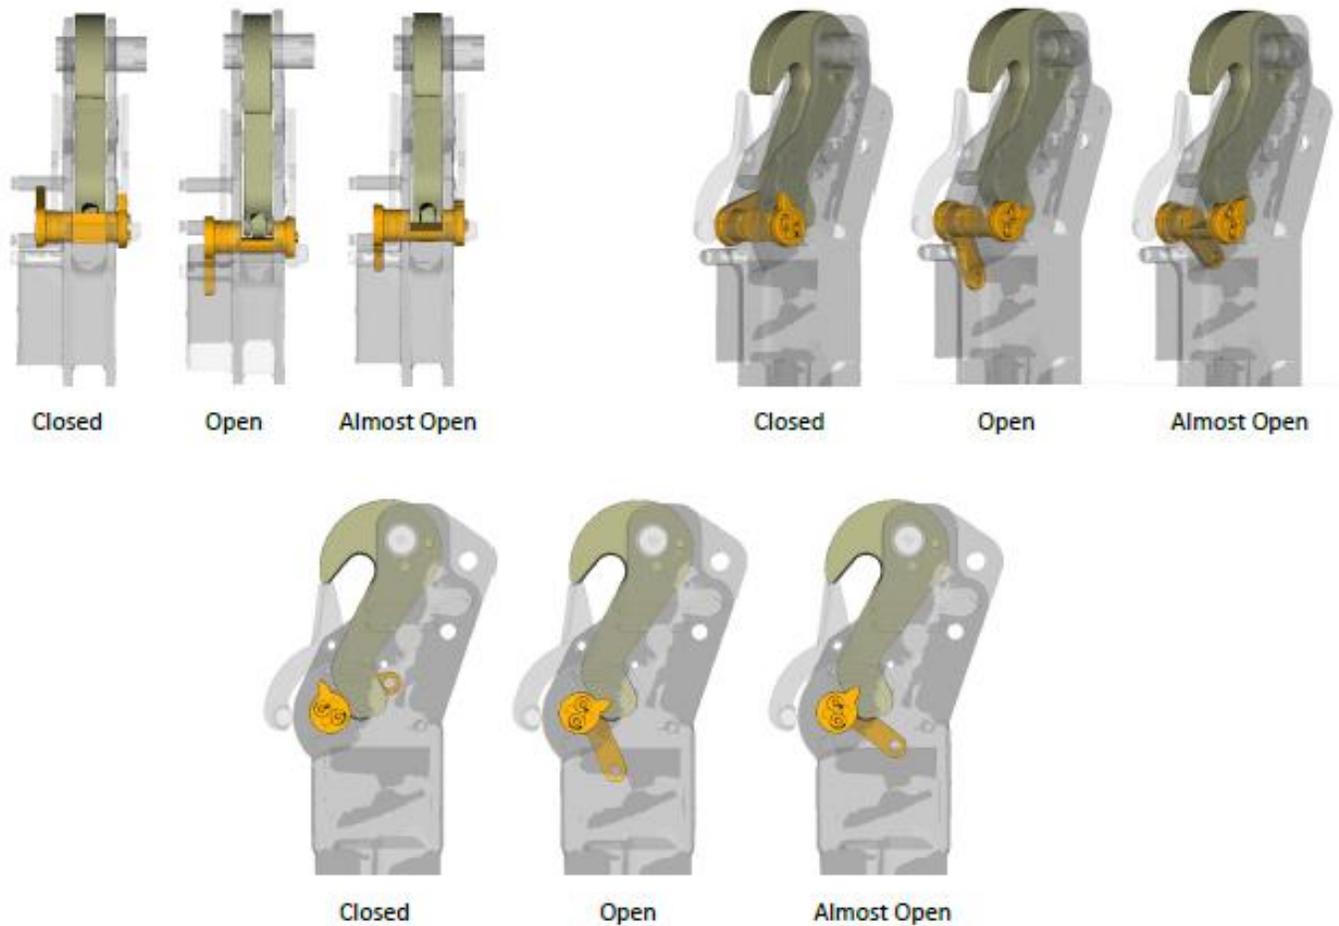
4.2.3.2.17. When the system is properly reset (in the closed position) and the locking shaft and hook roller are contacting at the correct location, the position indicator on the side of the hook will show in the green. If the position indicator is in the red, the locking shaft is either in the open position or “almost open” position.

Figure 17: Hook cutaway views of LHR3.5M2 hook in closed open and almost open positions. Locking shaft depicted in yellow. Credit: CG.

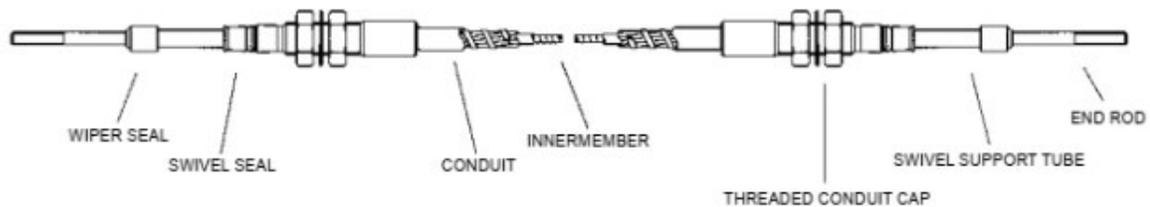
4.2.3.2.25. The construction and components of the control cables are shown in Figures 17 and 18. All external components (conduit cap, support tube and end rod) are stainless steel. The metal components in the conduit (steel band and steel strands) are galvanized and sealed from the outside environment by the outer jacket (cover) and a series of seals from the conduit cap to the end rod. The inner member consists of steel strands and banding, with a thin outer cover that is hydraulically crimped to the end rods and moves within the polyethylene liner of the conduit.

Figure 18: Control cable components. Credit: Cablecraft, modified by USCG to represent cables in Lifeboat 6.

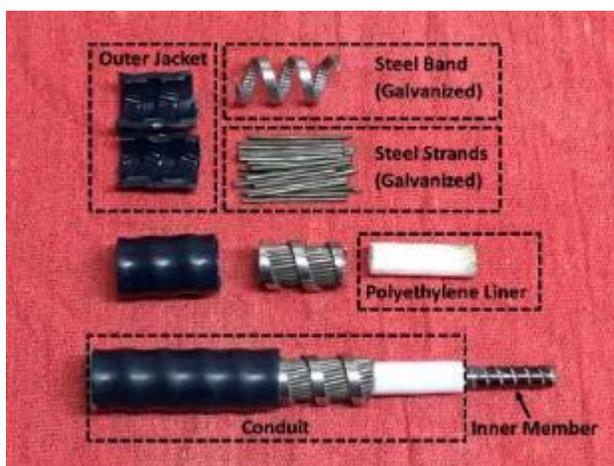
Figure 19 (left): Control cable cutaway and conduit components. Credit: CG.

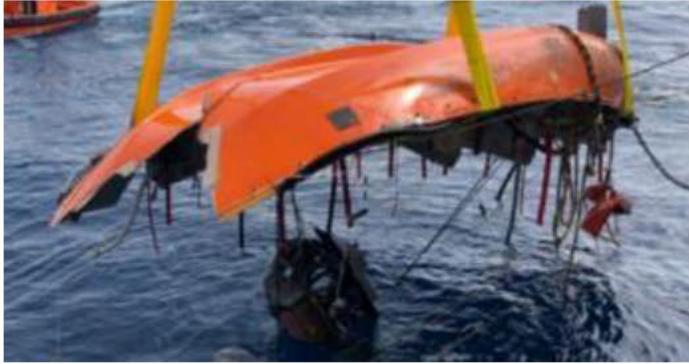
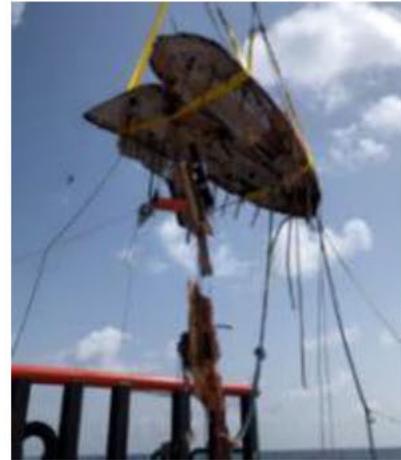
¹⁵ The split may be the result of several factors/causes, including impacting the water, floating semi-free in the GoM for nearly a week and opening during lift/recovery.

Figures 23 (above) and 24 (right): Photographs of Lifeboat No. 6 taken on July 5, 2019 during salvage operations. Credit: Shell.

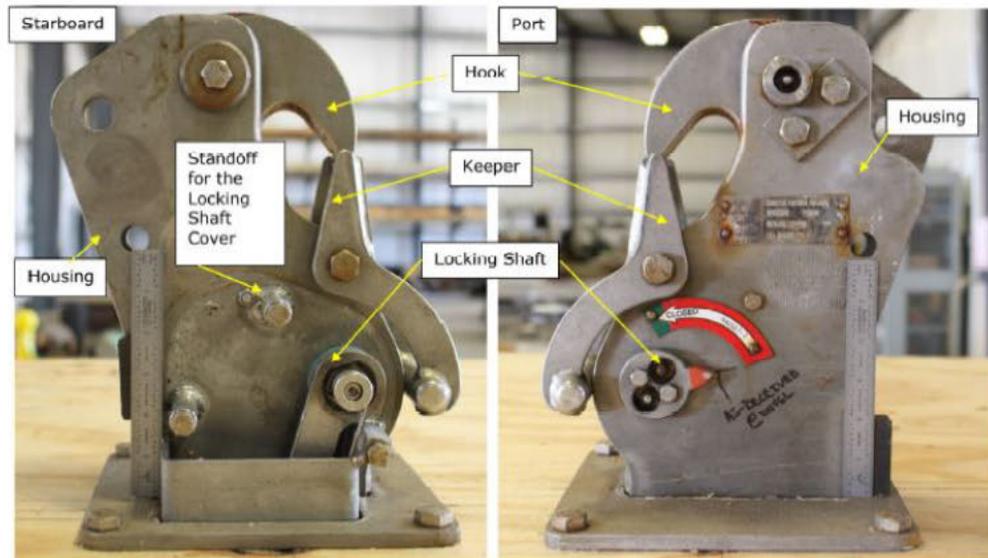
Figure 26: Photographs of the aft hook with the locking shaft removed. Credit: DNV-GL.

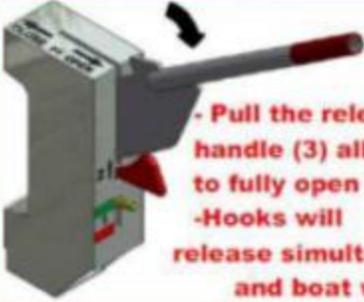
Figure 33: Release instructions posted in Lifeboat No. 6. Credit: Palfinger.

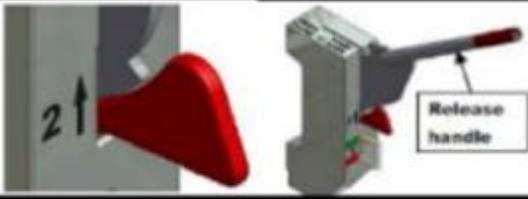
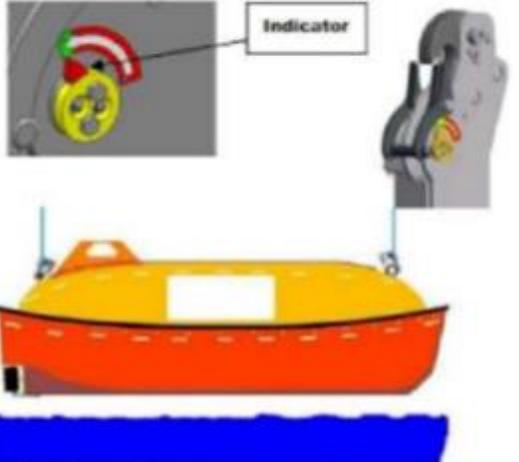
Figure 34: Resetting instructions posted in Lifeboat No. 6. Credit: Palfinger.

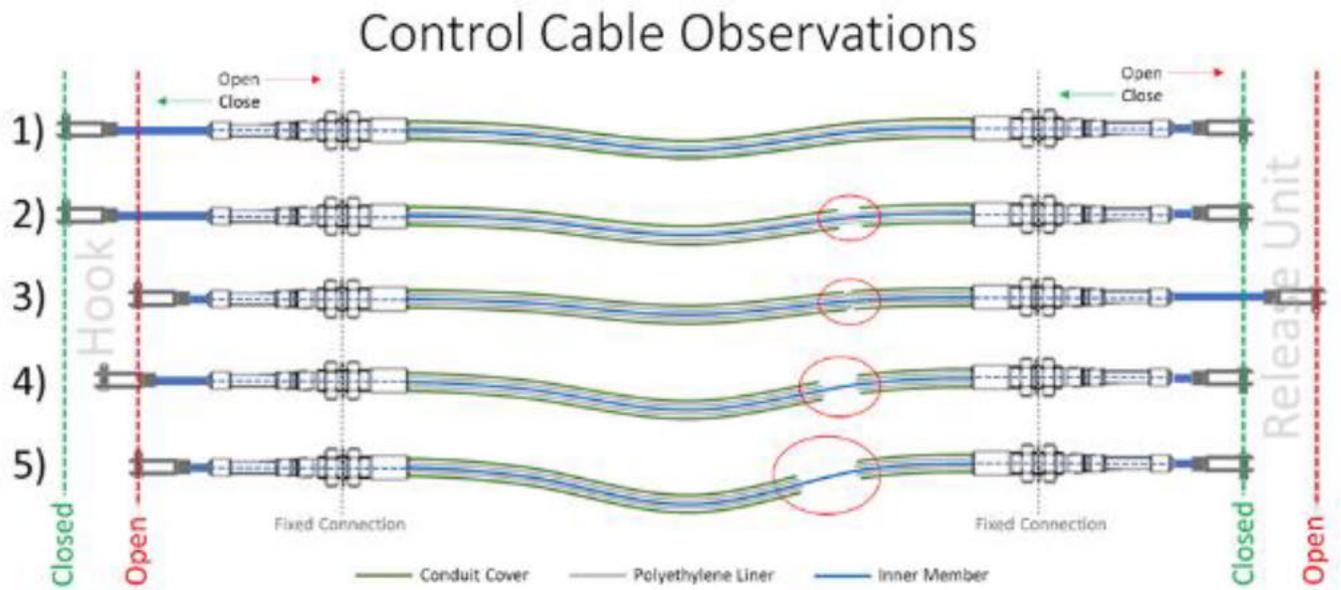
- 1) Hook closed with release handle locked in closed position (cable intact).
- 2) Hook closed with release handle closed. Conduit cover and steel layer removed (9 mm) with liner intact.
- 3) Hook open with release handle open (liner compression noted during testing).
- 4) Polyethylene liner failed during closing with 48 mm of conduit separation and locking shaft in partially-closed position (i.e., closed/locked, but almost open).
- 5) Subsequent release unit actuation after initial liner break extended conduit separation to 91 mm and would not rotate the locking shaft (i.e., hook remained open).

Figure 46: Control cable observations. Credit: CG.

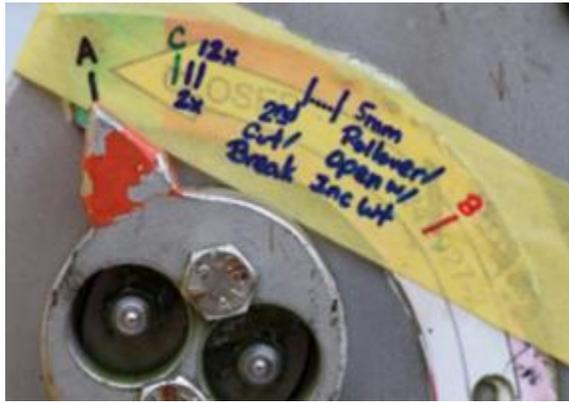
4.2.7.20. In summary, the results of the Coast Guard's experiments show that a separation in the conduit of a control cable, while cycling the release lever, can result in the hook locking shaft stopping between the open and closed positions ("B" and "C" positions, respectively, on Figure 48).

Figure 48: Locking shaft positions during experiment. Credit: CG.

However, it must be emphasized that after the initial liner failure and separation, any further cycling of the system will result in the locking shaft remaining in the open position. With a failed liner, the friction forces cause the cable conduit to freely extend, rendering the system unable to rotate the locking shaft to the closed position. This prevents the hooks from locking, rendering them unable to hold any load.

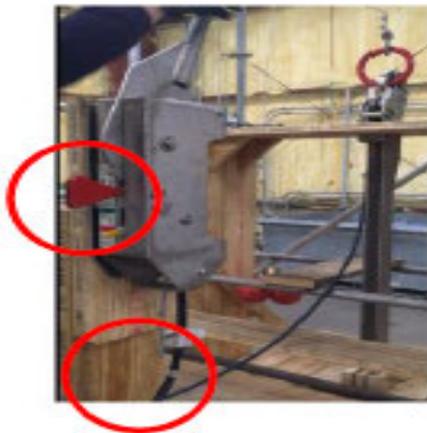
Image 50: The release handle is in the locked and closed position. However, the cable is damaged.

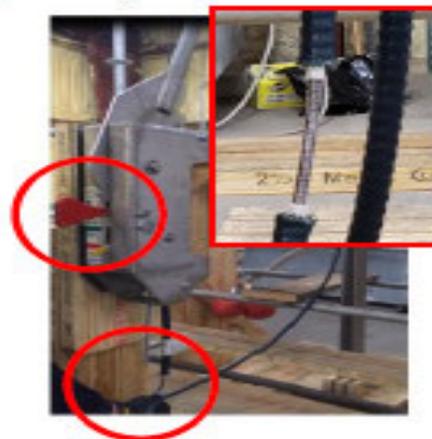
Image 51: Forces cause the outer layers of the cable to separate. The release handle stays closed.

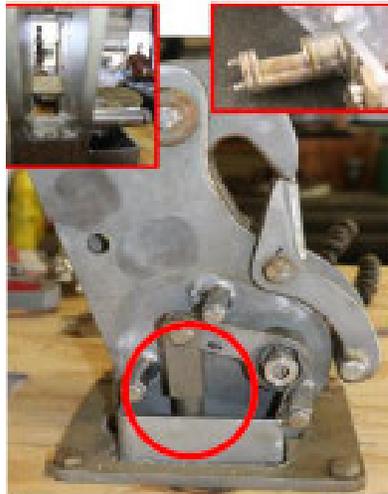
Image 52: At the hook end, the cable end rod moves. This causes the locking shaft to rotate.

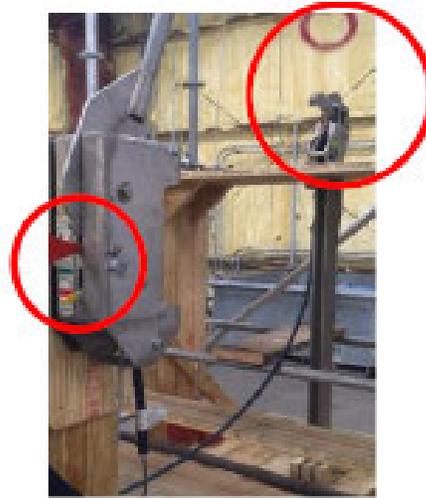
Image 53: If the locking shaft turns enough, the hook will release, even as the release handle stays locked.

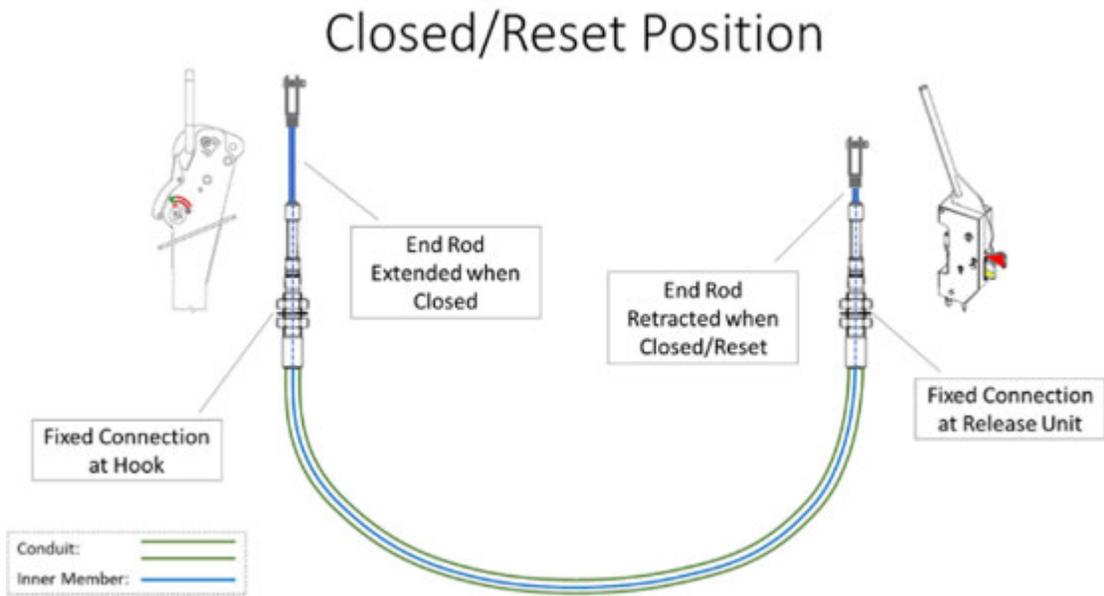
Figure 54: In this figure, the hook is closed or locked. There is no damage to the cable. Credit: CG.

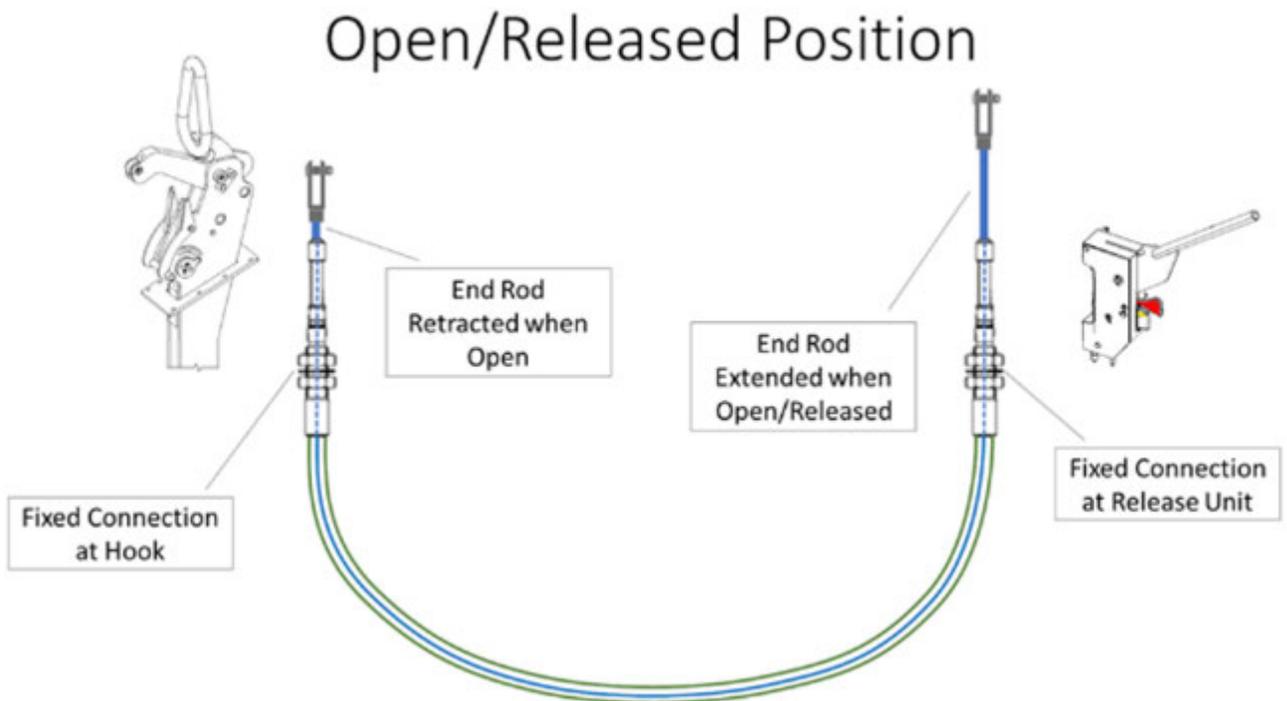
Figure 55: In this figure, the hook is open. There is no damage to the cable. Credit: CG.

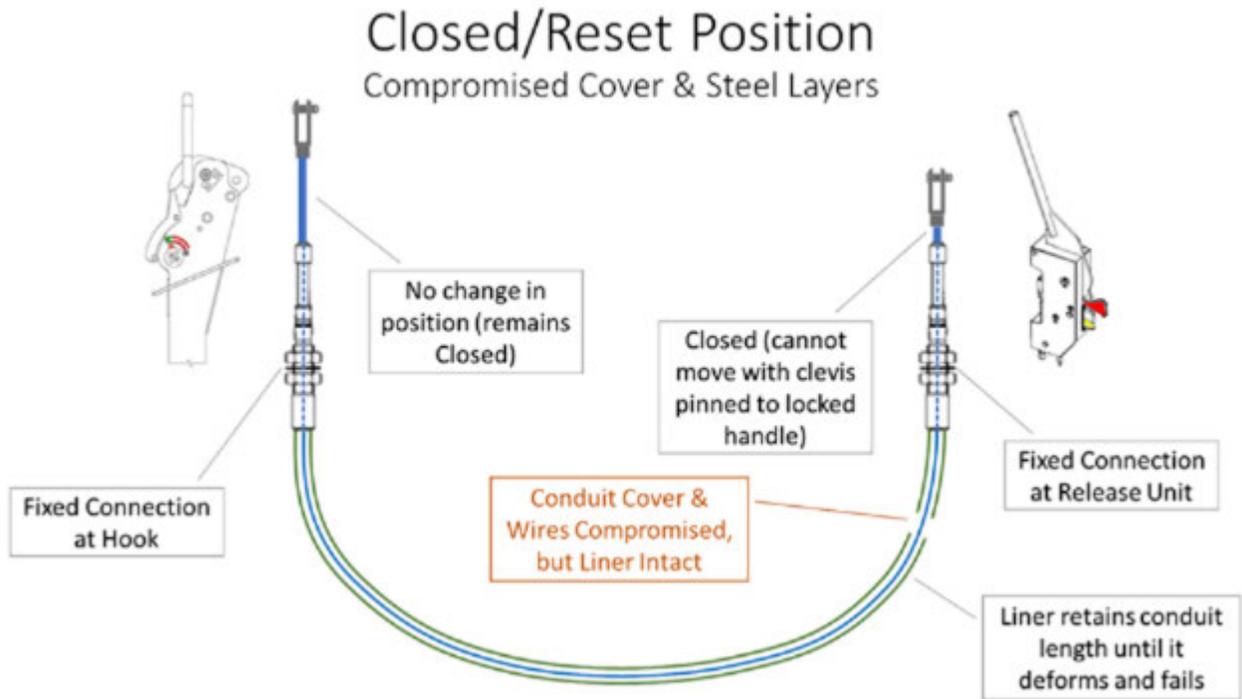
Figure 56: In this figure, the hook is closed or locked. The conduit is damaged, but the white polyethylene liner is intact. Credit: CG

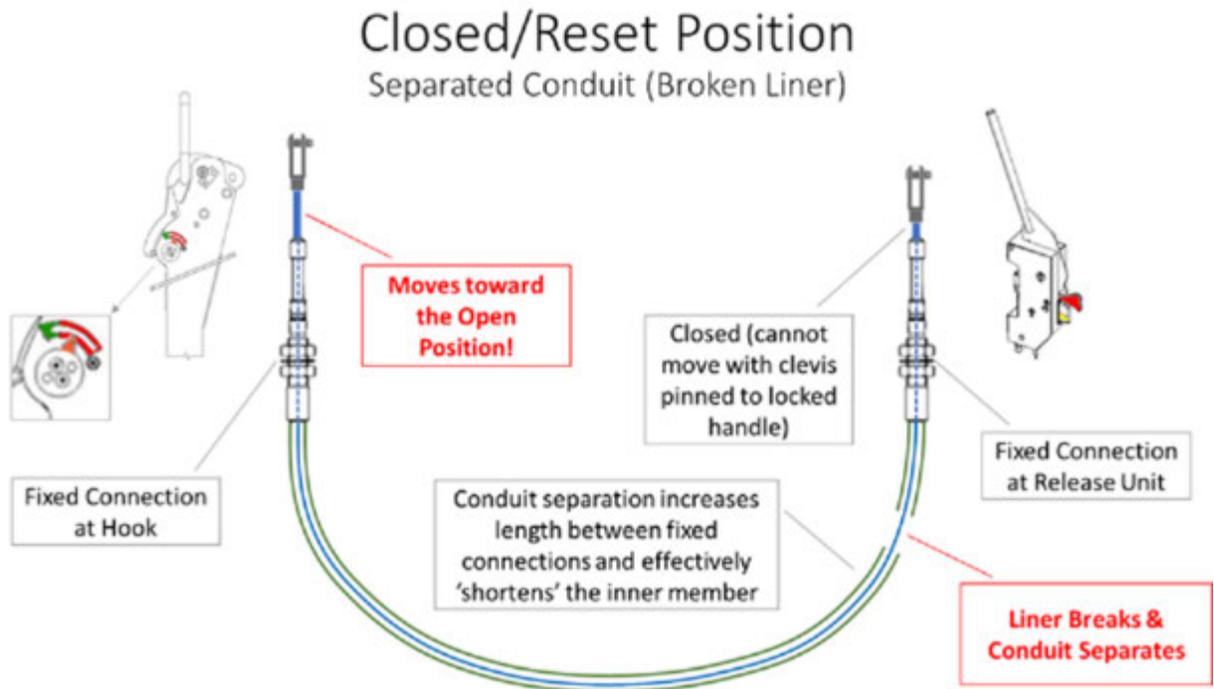
Figure 57: In this figure, the conduit separates. After an initial reset, the locking shaft now rests at an “almost open” position. Credit: CG

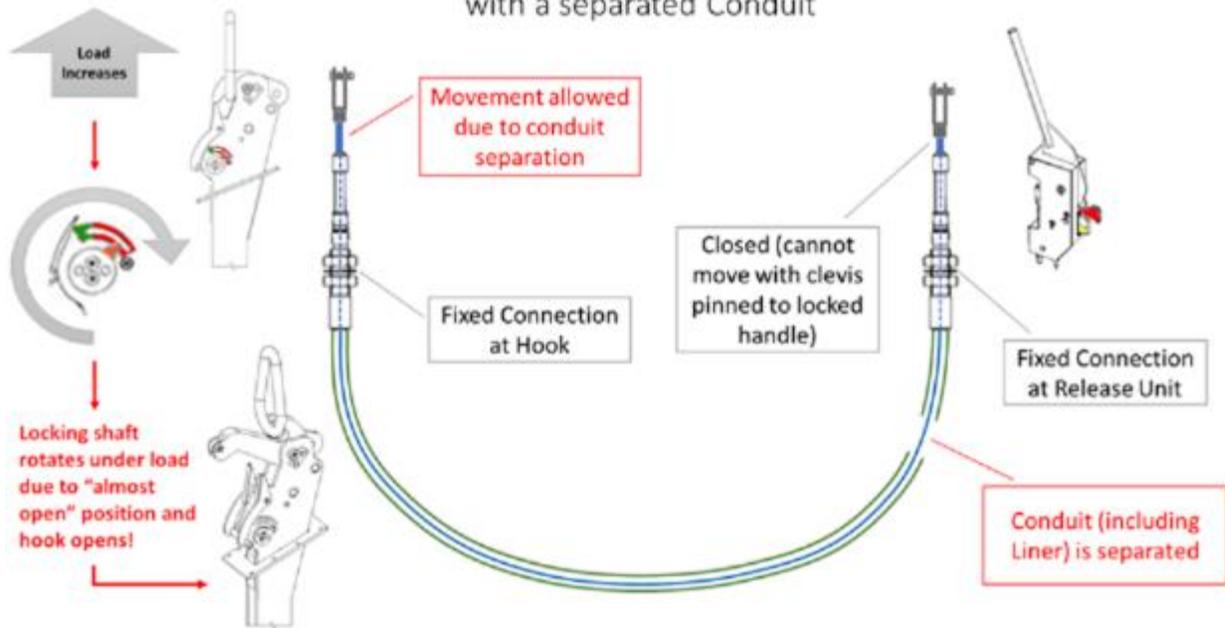
Figure 58: In this figure, the load is increased on the hook, as a result the locking shaft turns from “almost open” to open. Credit: CG

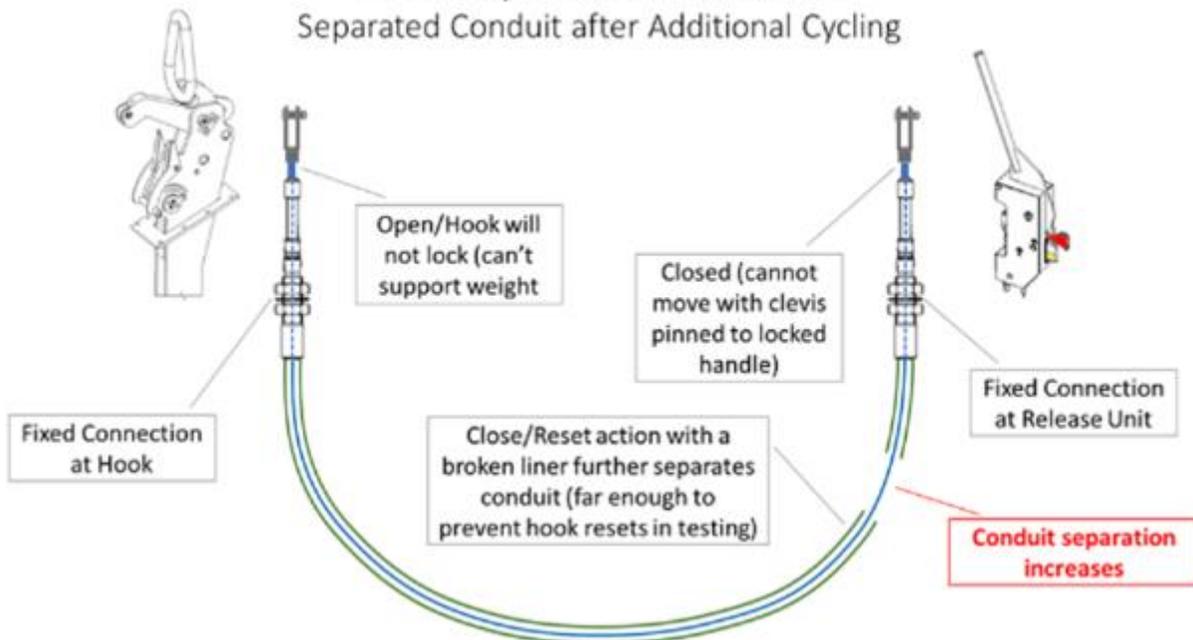
Figure 59: In the Coast Guard experiment, after one reset with a separated cable, the hook would not lock again. The conduit separation was so great that the locking shaft would not return to the “almost open” position, rather, upon reset, it would return to the open position. Credit: CG

In summary, there are two positions that the locking shaft in the LHR3.5M2 can take after conduit separation and subsequent cycling: “almost open” and open. The investigation team determined that the locking shaft won’t return to the “almost open” position a second time. If exposed to a second reset, it will rest in the open position. In the “almost open” position, the locking shaft can be forced to open with application of an additional or increased load. In the open position, the hook won’t reset. In the former case, while inadvertent hook opening is not inevitable, the risk is significant.

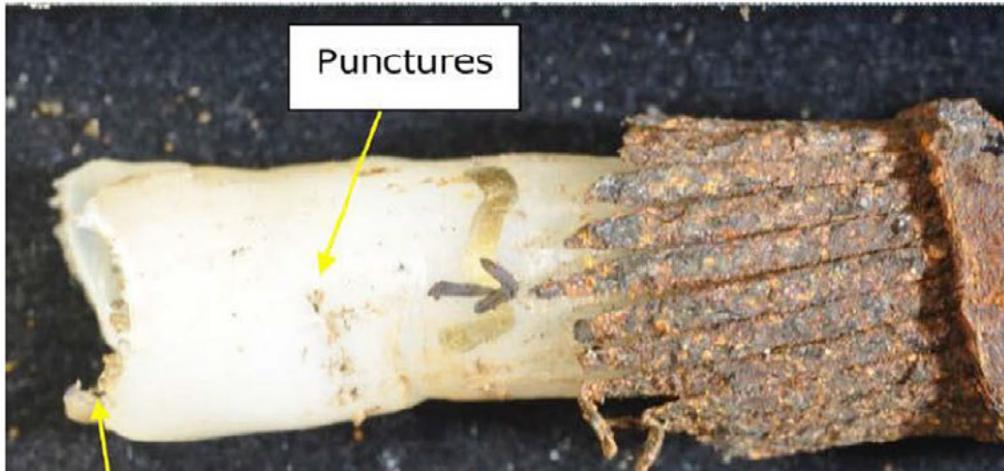
Once the steel wire was damaged, the white polyethylene liner also became vulnerable to damage. As demonstrated in the Coast Guard’s experiment and validated by DNV-GL’s testing, when the white polyethylene liner is no longer surrounded by an intact steel wire layer, the liner has the tendency to compress and stretch when a hook is opened and closed, respectively (see Figure 59). Further, broken steel wires can puncture the liner, especially during compression, causing additional damage and further weakening the liner. In the year of the incident (i.e, 2019), the Coast Guard estimates that the aft control cable was used to open and close the aft hook at least five times.

Figure 62 (below): Puncture marks found on the polyethylene liner of Lifeboat No. 6's aft control cable. Credit: DNV-GL.
