UNITED STATES COAST GUARD

**MARINE BOARD OF INVESTIGATION INTO THE
CIRCUMSTANCES SURROUNDING THE SINKING OF THE**

F/V KATMAI

**IN THE AMCHITKA PASS, NORTH PACIFIC OCEAN
ON OCTOBER 22, 2008, WITH MULTIPLE LOSS OF LIFE**

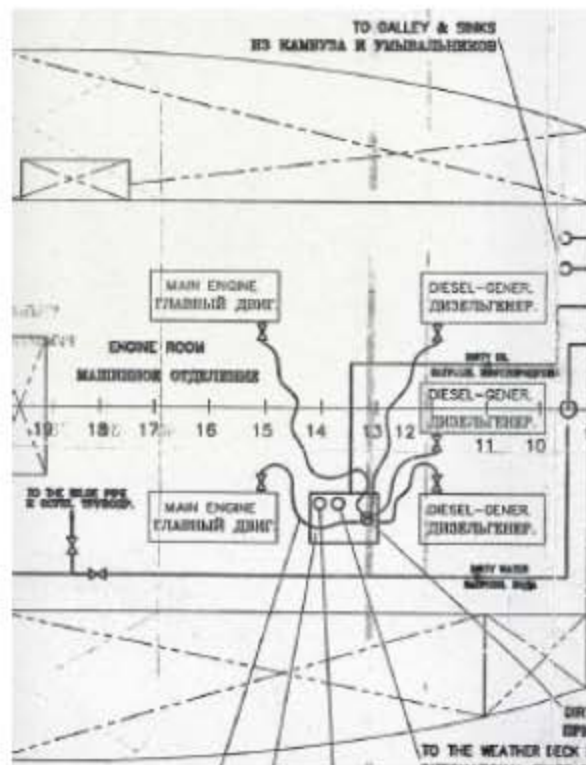
Figure 4: F/V KATMAI Engine Room

A review of the emails transmitted during the vessel's voyage using the SkyMate[®] VMS revealed that the GMC 6-71 75 KW generator was inoperable. The Captain and vessel operations manager indicated that the two remaining generators would have been sufficient to handle all electrical loads on the F/V KATMAI.

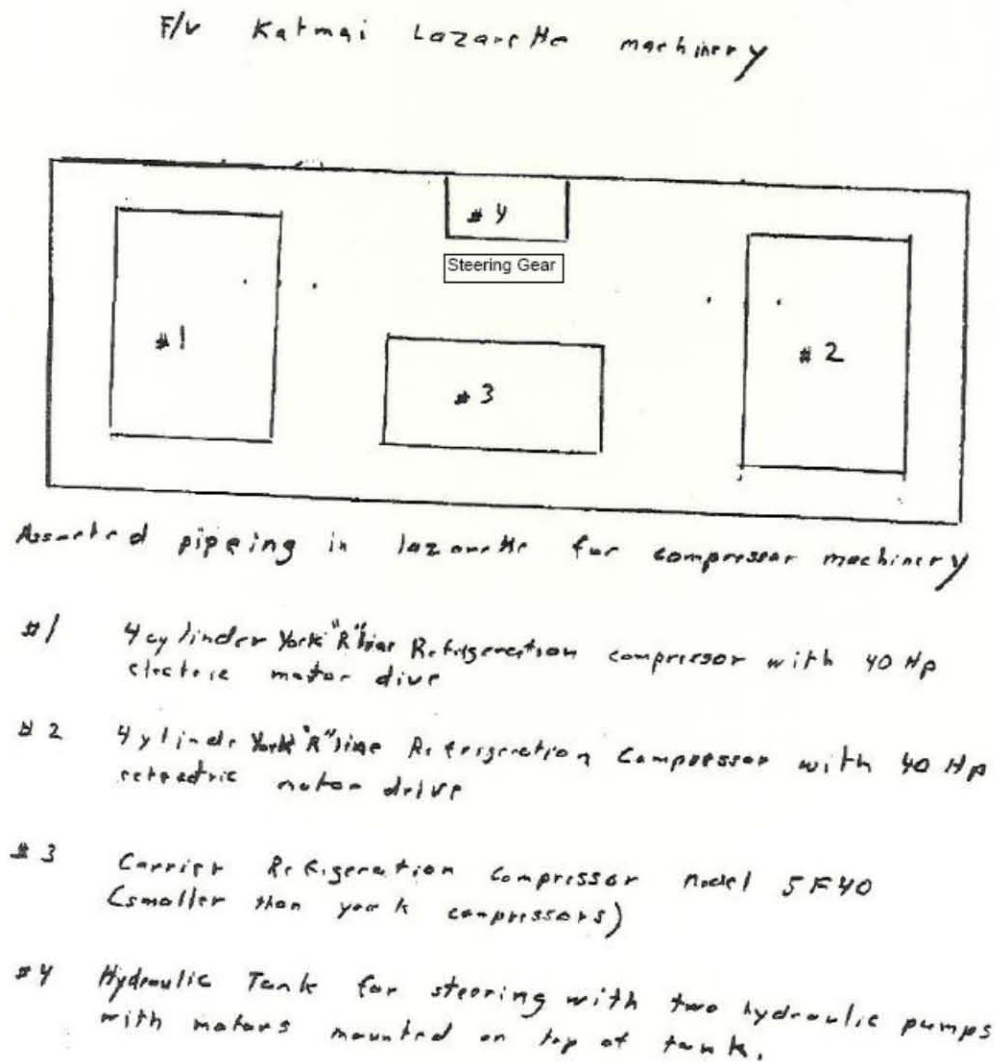
Figure 7: Layout of F/V KATMAI Lazarette (Drawn by Vessel Operations Manager)

Testimony indicated that there may have been a 1½" – 2" drain in the forward bilge on the centerline of the lazarette that could have permitted water to drain directly into the engine room. This drain may not have worked properly or may have been plugged through a previous modification that prevented water from draining from the lazarette into the engine room. A previous engineer on the vessel also indicated that the lazarette bilge drain was tied into the engine room bilge system which would have permitted water in the lazarette bilge to be pumped out from the engine room.

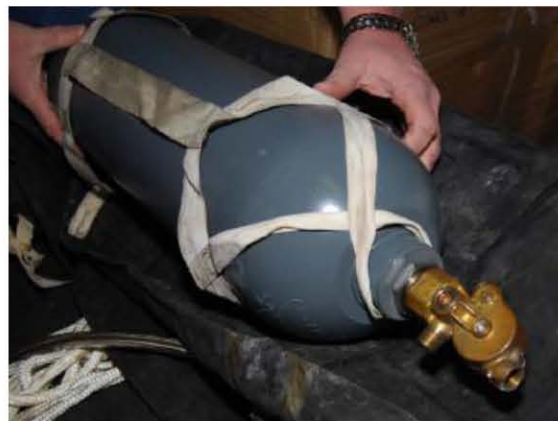
Sample Harness with Cylinder Inserted

The cylinder harness on the recovered liferaft was intact. In the left picture above, the right end of the harness that would permit the cylinder to be inserted or removed was also tied together as would have been done after a cylinder had been inserted into the harness prior to packaging of the liferaft. The left end of the harness shown in the left picture would have been looped around the neck of the cylinder as shown in the right picture. The only way the cylinder could have fallen out of the harness would have been improper installation or if the cylinder became disconnected from the inflation hose to permit the cylinder head to slide out of the loop and thus allowing the cylinder to slide out of the harness.

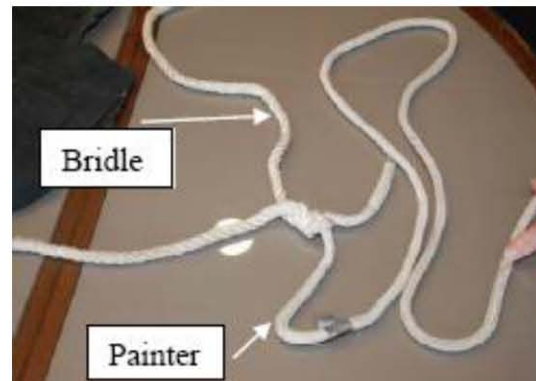
Liferaft Bridle and Painter

The picture above shows the bridle and painter from the recovered liferaft. A 12" long 1/8" diameter nylon cord should have been installed at least 60" from the bridle attachment. There was one location on the painter where it appeared that a line had passed through to connect to the inflation cable. However, it cannot be determined if a nylon cord was installed in the painter during the most recent servicing in December 2007. If the nylon cord was not installed properly and attached to the cylinder lanyard, then the liferaft could not have been deployed by pulling the painter. The nylon cord most likely came loose as the painter was tossed around in the rough seas.

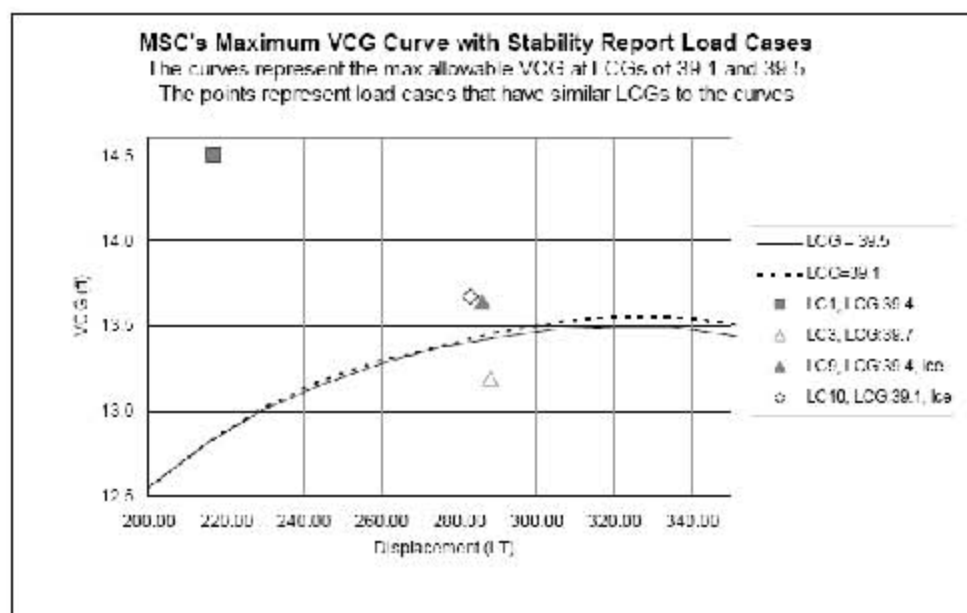
Based on our review, several of the conditions did not meet the intact stability requirements evaluated, specifically LC 1, 8, 9 and 10. In general, the limiting criteria were the Severe Wind and Roll requirements contained in 46 CFR 28.575. Adding the extra sail area to model the pots on the fish deck significantly reduced the maximum allowable VCG. Had the sail area from the pots not been included in the computer model's wind profile, LC 8, 9 and 10 would have met the requirements of 46 CFR 28.575.

Figure (6). Max VCG curve with vessel LCGs of 39.1 and 39.5

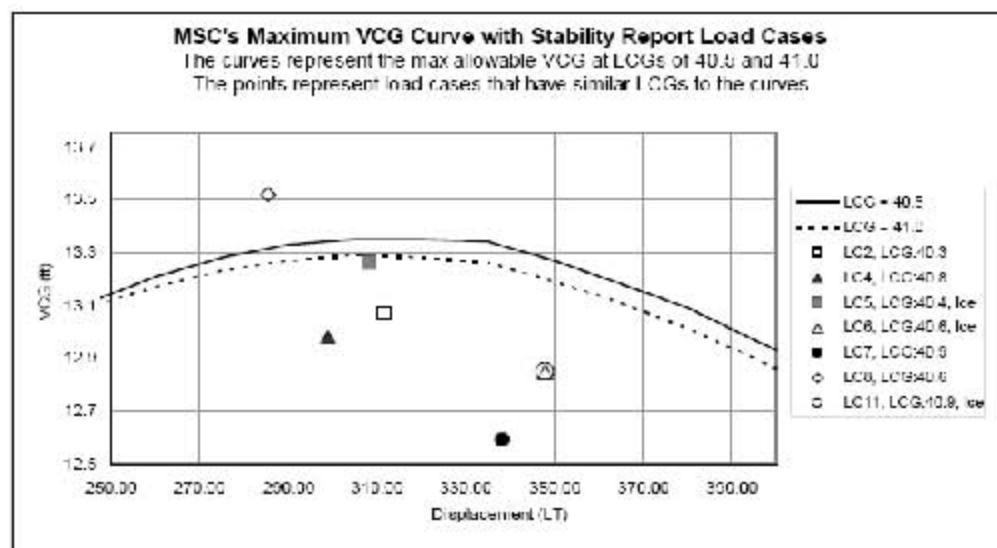
Figure (7). Max VCG curve with vessel LCGs of 40.0 and 41.0

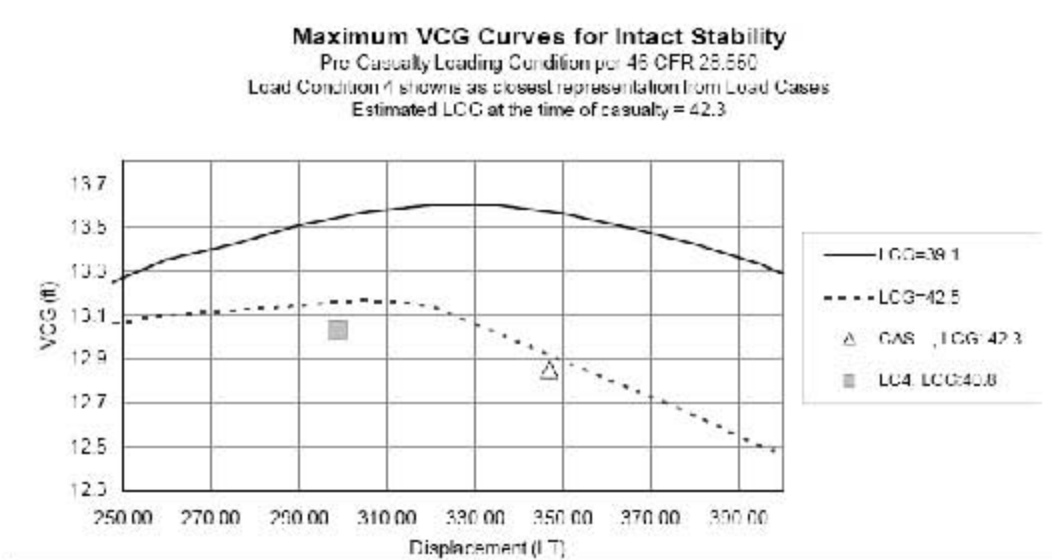
The estimated pre-casualty conditions were outside the range of displacements and LCGs reviewed in the Schwitters/Stevenson report; however, our model showed that the vessel likely would still have met the intact stability limits in Subchapter C.

Figure (8). Range of Stability

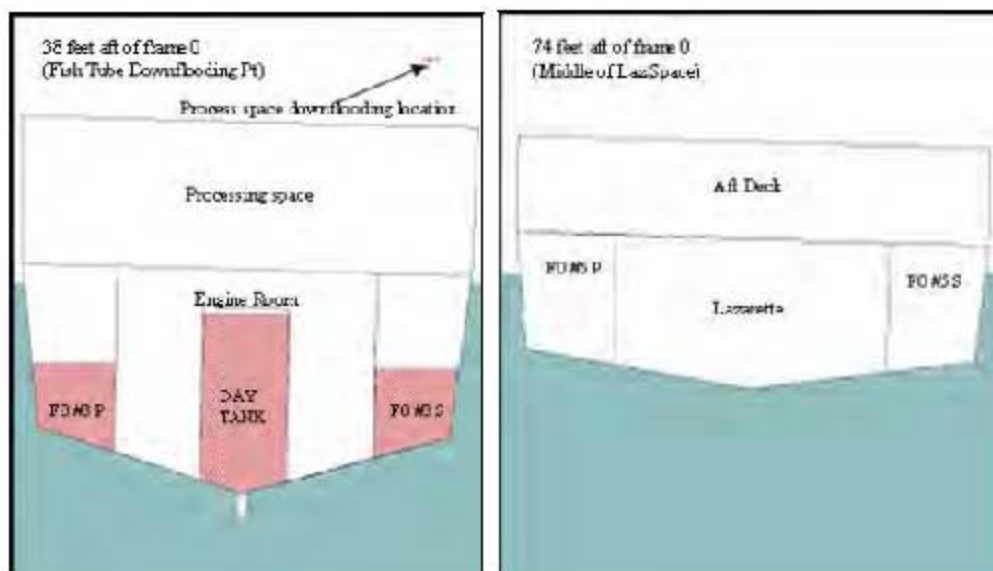
Figure (9) depicts the compartments on the body plan sections used throughout the remainder of the analysis. These are the primary areas of interest for the flooding scenarios to follow (note the location of the downflooding point into the processing space in the left figure).

Figure (9). Body Plan Space Description

Based on the information contained in reference (a), flooding occurred in the lazarette space and 2 feet of water above the deck plates was reported in the engine room. It was also reported that water was trapped on the aft deck. Additionally, the vessel was in 25-30 foot seas and experiencing 60-100 knot winds. Table (4) shows the results from our modeling analysis for this potential flooding scenario. The downflooding points in the engine room and processing space are listed referencing the height above the waterline.

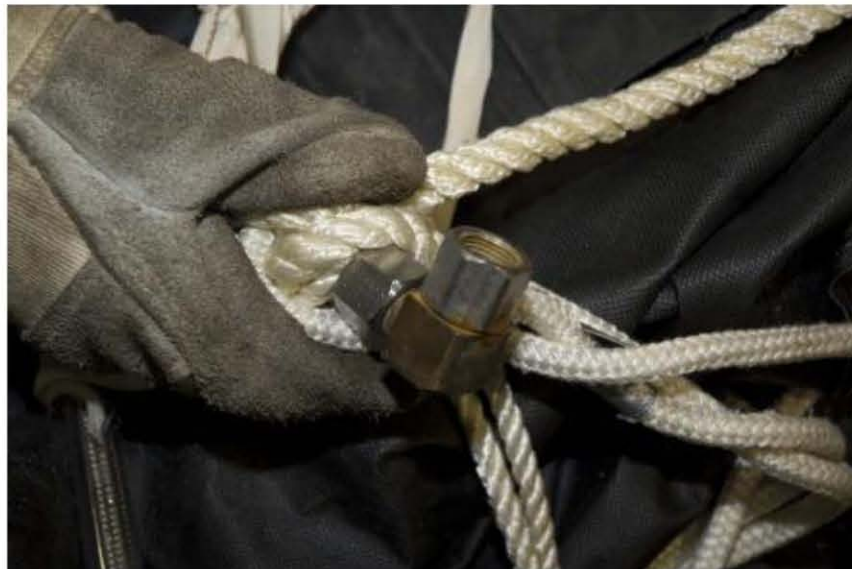
Figures 1, 2, and 3 show the CO₂ inflation hose assembly as found on the life raft when retrieved from the Bering Sea by the fishing vessel *Courageous* about 17 hours after the life raft's deployment during the sinking of the *Katmai*. The life raft did not appear to be inflated when brought on board the *Courageous*. During the life raft's duration at sea, the painter (a rope line that attaches the raft to the vessel and activates the inflation mechanism when pulled) became entangled with the inflation hose as shown in Figures 1 and 2. As evident in Figures 1, 2, and 3, the CO₂ tank was not attached to the inflation hose, nor was it found with the un-inflated life raft. Figure 3 shows the CO₂ inflation hose assembly after removal of the painter.

Figure 2. Close-up of the CO₂ inflation hose fitting, which is typically connected to the inflation valve and CO₂ tank.

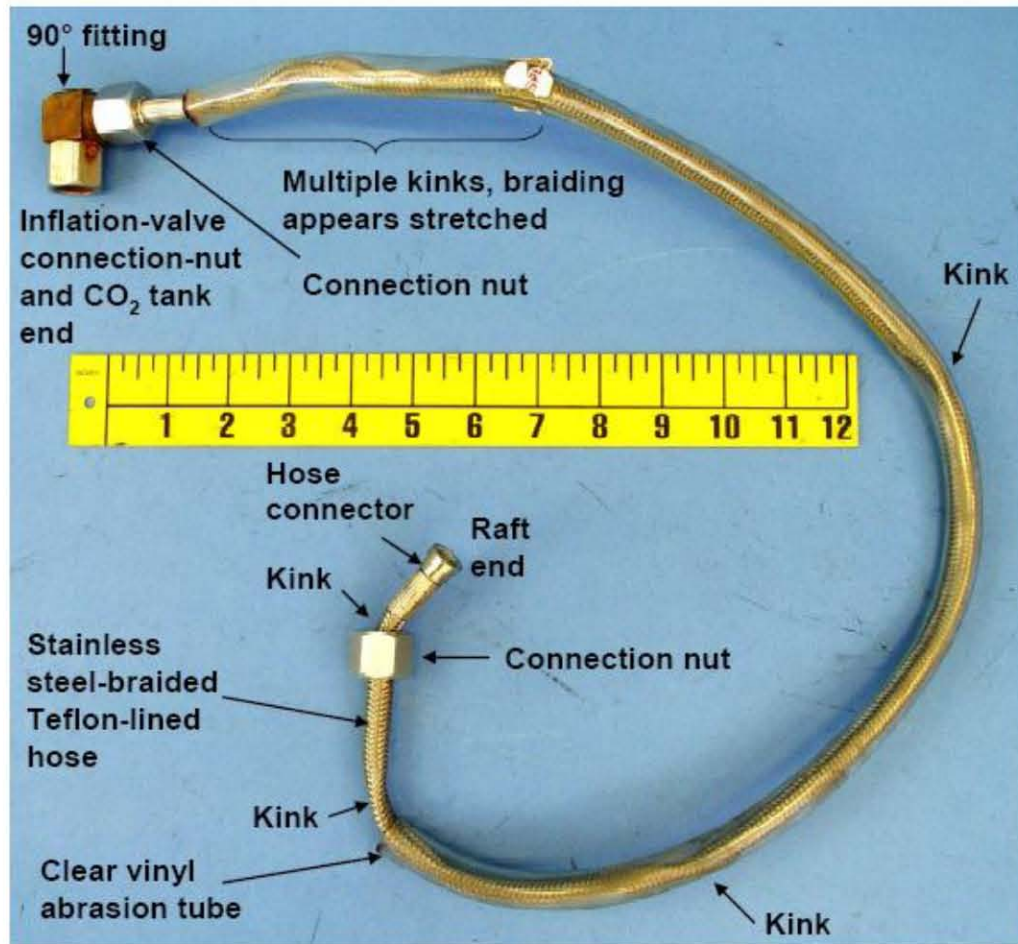
Figure 4 shows the hose and 90° fitting assembly as received by the NTSB Materials Laboratory. According to the Coast Guard Marine Board of Investigation, the hose was supplied by SMR Technologies as drawing number 4RA1174 at a length of 31 inches +/- 0.5 inch. The drawing indicates that the hose is composed of an inner Teflon[®] liner, an over-braid of stainless steel wire, an outer clear vinyl abrasion tube, and Type 316 stainless steel hose-connector and connector-nut fittings on each end. As shown in Table 1, the

As shown in Figure 4, the hose is kinked in 5 different regions. At the hose end connected to the 90° fitting, there is approximately a 5-inch region with multiple kinks. The braiding in this region shows evidence of stretching (as indicated by distortion of the regular pattern of the braiding). The length of this stretched region is consistent with the longer-than-specified length of the hose.

Figure 4. CO₂ inflation hose assembly as received in the NTSB Materials Laboratory. All critical features are identified in this figure.

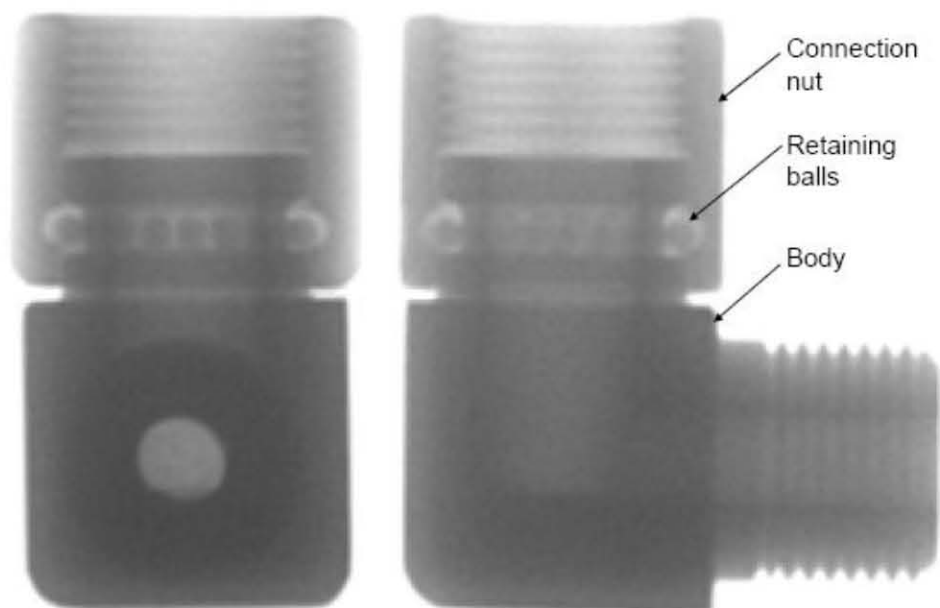
Once removed, the 90° fitting was x-rayed as shown in Figure 7. The inflation-valve connection-nut is mechanically attached to the body through the use of a series of retaining balls. These retaining balls are intended to allow the inflation-valve connection-nut to rotate relative to the body. However, with hand rotation using moderate torsional force, the inflation-valve connection-nut did not rotate freely relative to the body as intended by the design.

Figure 7. Radiograph of the 90° fitting showing the internal features. The connection-nut swivels relative to the body through the use of the retaining balls.
