**REPORT OF INVESTIGATION
INTO THE
COMMERCIAL FISHING VESSEL MARY B II
(O.N. 274604)
SINKING AND LOSS OF THE VESSEL WITH MULTIPLE
LOSS OF LIFE AT THE YAQUINA BAY BAR ENTRANCE,
NEWPORT, OREGON
ON JANUARY 8, 2019**

MISLE ACTIVITY NUMBER: 6607968

CAPSIZING AND LOSS OF LIFE OCCURRING ON THE COMMERCIAL FISHING VESSEL MARY B II (O.N. 274604) AT THE YAQUINA BAY BAR ENTRANCE NEWPORT, OREGON ON JANUARY 8, 2019

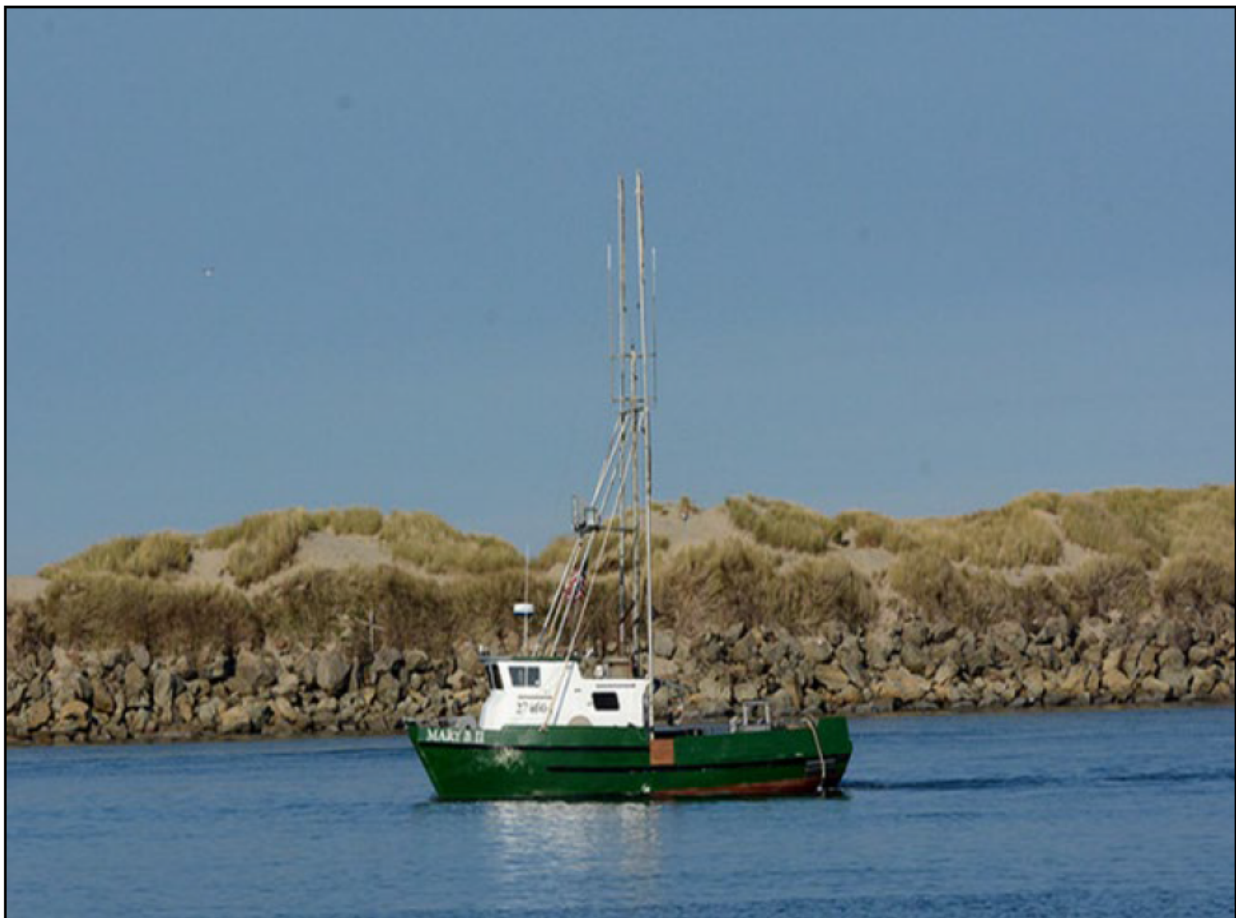
Figure 1. Photograph of the MARY B II near the shoreward end of the jetties in Yaquina Bay, November 18, 2018. (Source – [REDACTED])

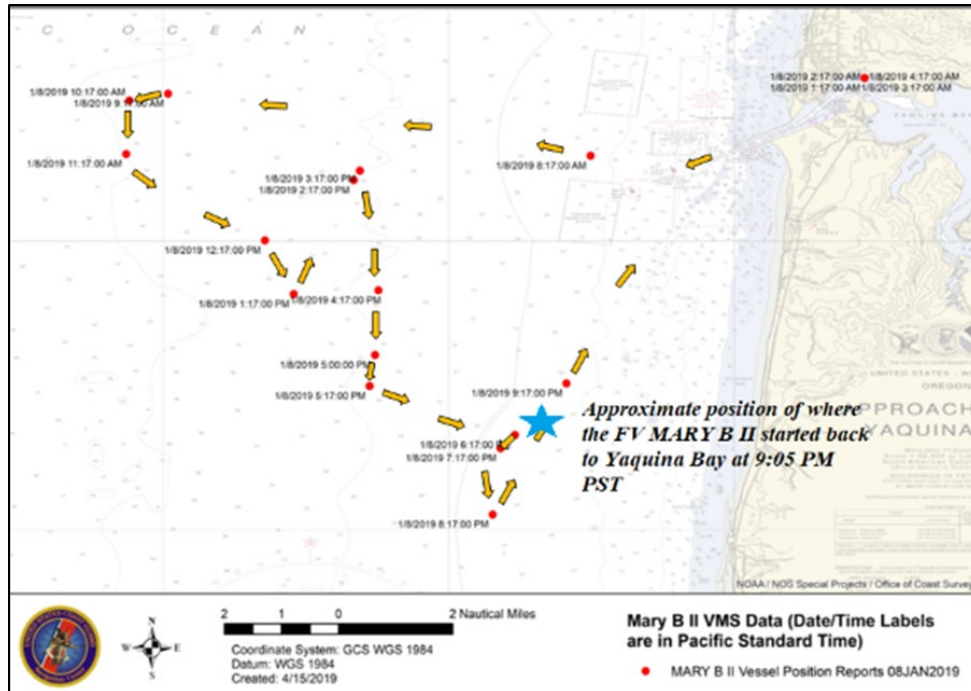
Figure 2. Chartlet showing the MARY B II's positions on January 8, 2019 based on Vessel Monitoring System (VMS) data. (Source – Created from VMS data provided by vessel owner)

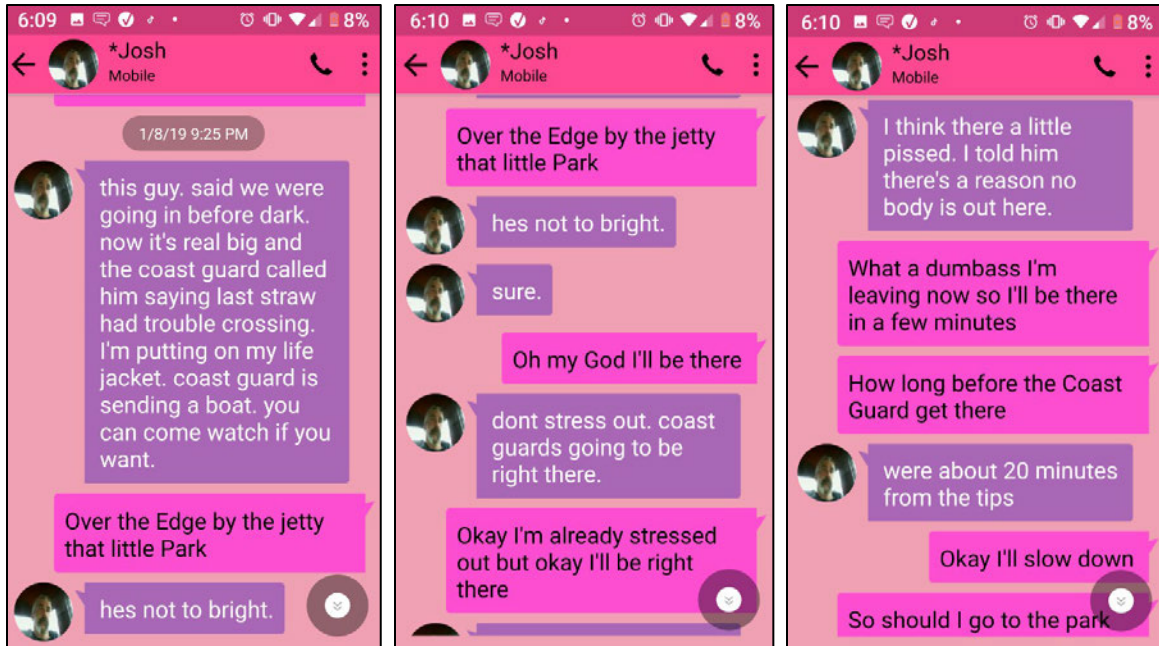
4.1.42. At approximately 9:25 p.m., deckhand Joshua Porter texted his wife from the MARY B II expressing frustration with the fact that they were still underway so late, given that the operator had stated that they would be in before dark. He stated that he thought the operator was "not to [sic] bright." He expressed concerns about the weather stating that "now it's really big." Mr. Porter added that he thought the rest of the crew was angry with him after he pointed out that there was a reason nobody else was out there at the time, referencing the inclement weather which had been forecasted.

Figure 3. Screen shots of Mrs. [REDACTED] last text conversation with the crewmember, Mr. Porter on board the MARY B II, as the vessel was transiting back from the fishing grounds to the Yaquina Bay Bar on the evening of January 8, 2019. (Source – CG Exhibit 024)

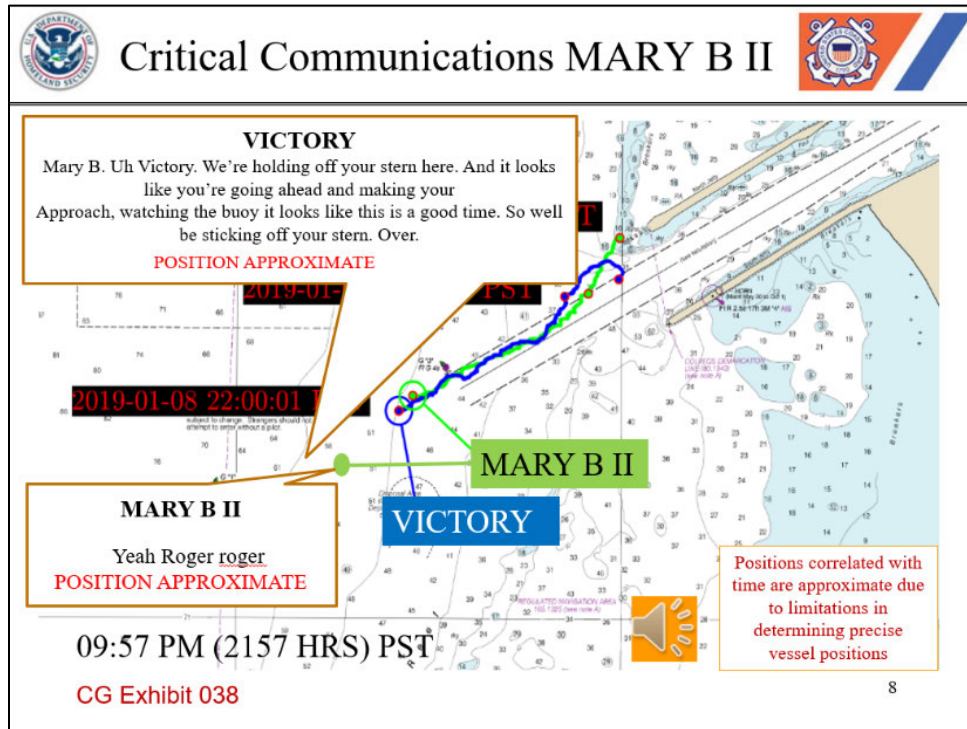
4.1.54. At approximately 9:57 p.m., the VICTORY indicated to MARY B II that it appeared that the MARY B II was beginning to make her approach to the Yaquina Bay channel and

reiterated that VICTORY would be “sticking off” her stern. Mr. Biernacki acknowledged this radio transmission, saying “Yeah. Roger, roger.”

Figure 4. Time approximately 9:57 p.m., slide from Critical Communications presentation used in the public hearing. (Source – Oregon State University/Coast Guard, CG Exhibit 038)

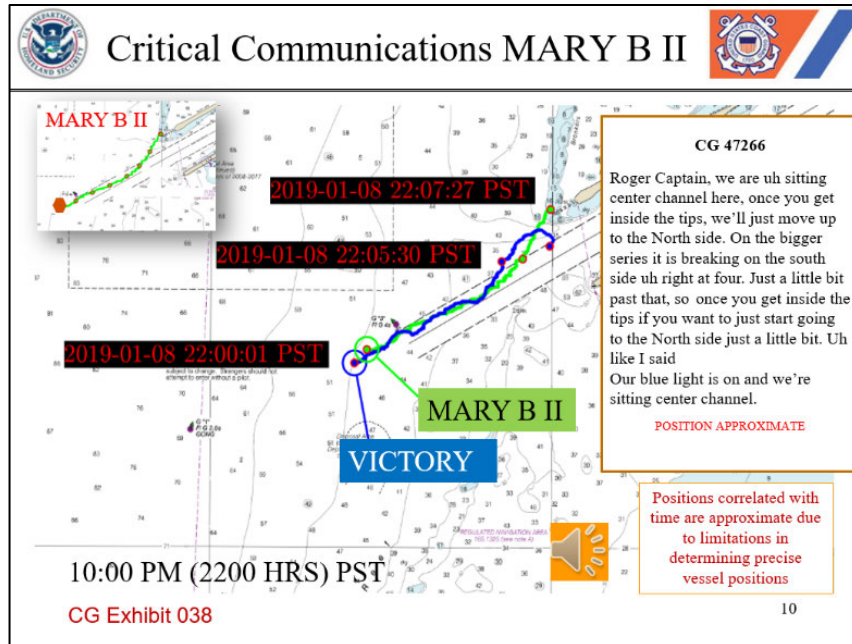
4.1.58. At approximately 10:00 p.m., the operator of the MARY B II acknowledged the MLB 47266’s transmission by stating that he saw their blue light and added, “I’m working my way to the North side here now.”

Figure 6. Time 10:00 p.m., slide from Critical Communications presentation used in the public hearing. (Source – Oregon State University/Coast Guard, CG Exhibit 038)

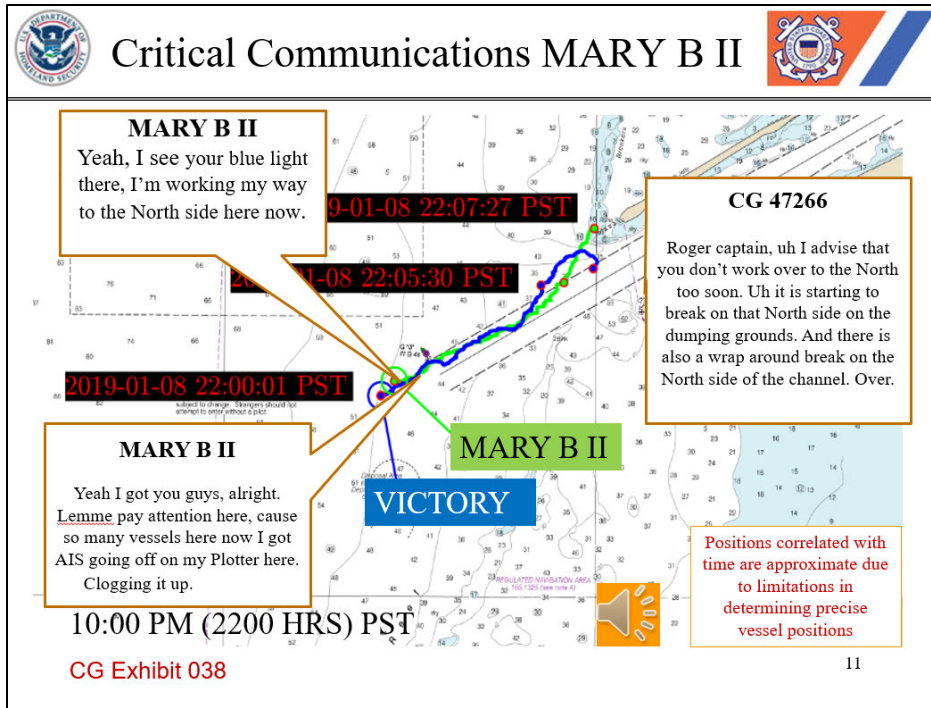
4.1.60. The operator of the MARY B II acknowledged the MLB 47266’s message stating “Yeah I got you guys, alright. Lemme pay attention here, cause so many vessels here now I got AIS going off on my Plotter here. Clogging it up.”

Figure 7. Subsequent 10:00 p.m. slide from Critical Communications presentation used in the public hearing. (Source – Oregon State University/Coast Guard, CG Exhibit 038)

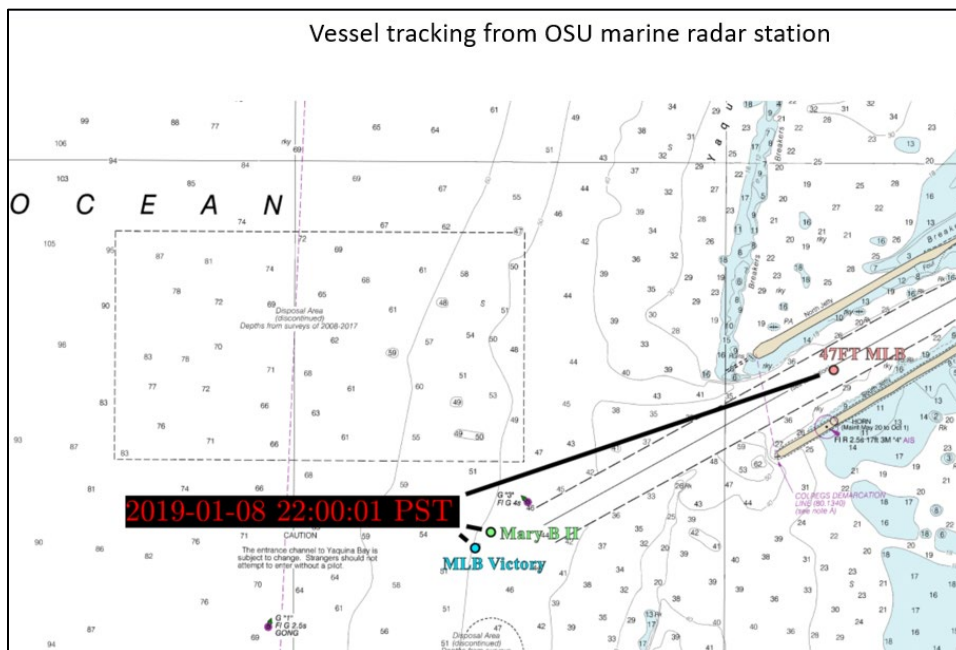
4.1.61. At that time and in close proximity to the scene, the VICTORY, the MLB 47266, South Jetty Light 4, and Entrance Buoy “Y” were AIS equipped and transmitting.

Figure 8. Positions of the vessels involved at 10:00 p.m. derived from the Oregon State University (OSU) marine radar located at Yaquina Bay. (Source – Coast Guard, CG Exhibit 071)

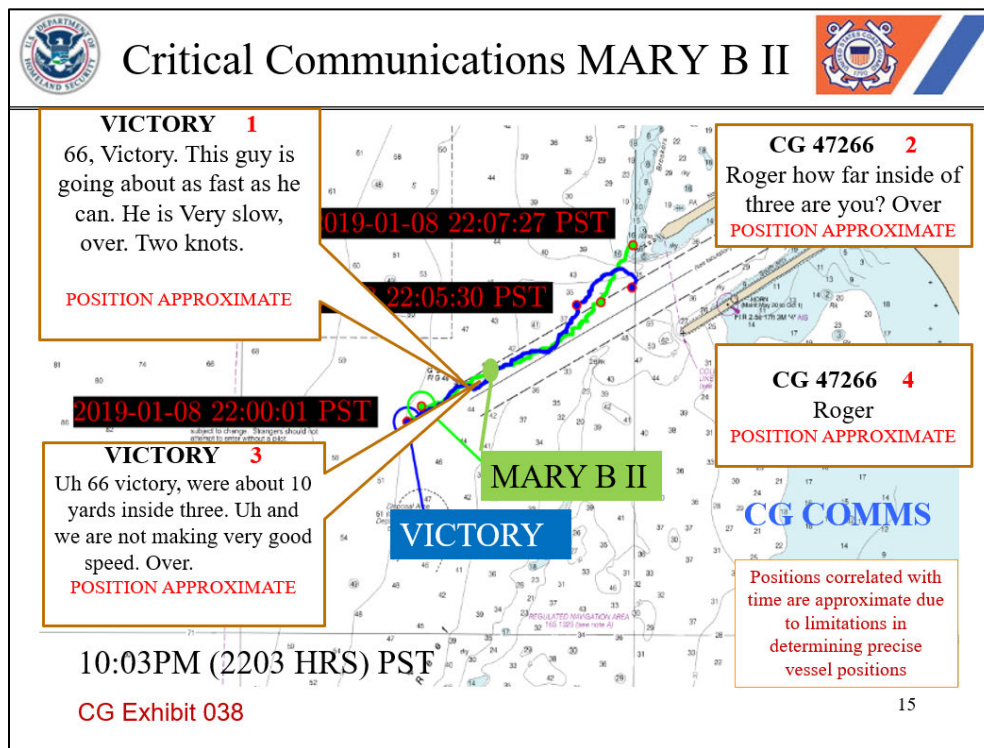
4.1.63. Between approximately 10:02 and 10:03 p.m., the MLB 47266 and the VICTORY engaged in a series of internal communications on Channel 121. At this time, the MLB 47266 tells the VICTORY that it appeared they were in the best part of the lull. The VICTORY reported that the MARY B II seemed to be going about as fast as it could, but that it was travelling “very slow” at about 2 knots. The VICTORY indicated the VICTORY and MARY B II’s approximate location as about “10 yards inside” Entrance Lighted Buoy 3 and that they were not making good speed.

4.1.64. The VICTORY had to back down at one point to maintain a safe distance off the stern of the MARY B II. The Coast Guard did not inquire as to the reason for the MARY B II’s slow speed. The operator of the MARY B II did not provide the Coast Guard with a reason for the slow speed.

Figure 9. Time 10:03 p.m., slide from Critical Communications presentation used in the public hearing. (Source – Oregon State University/Coast Guard, CG Exhibit 038)

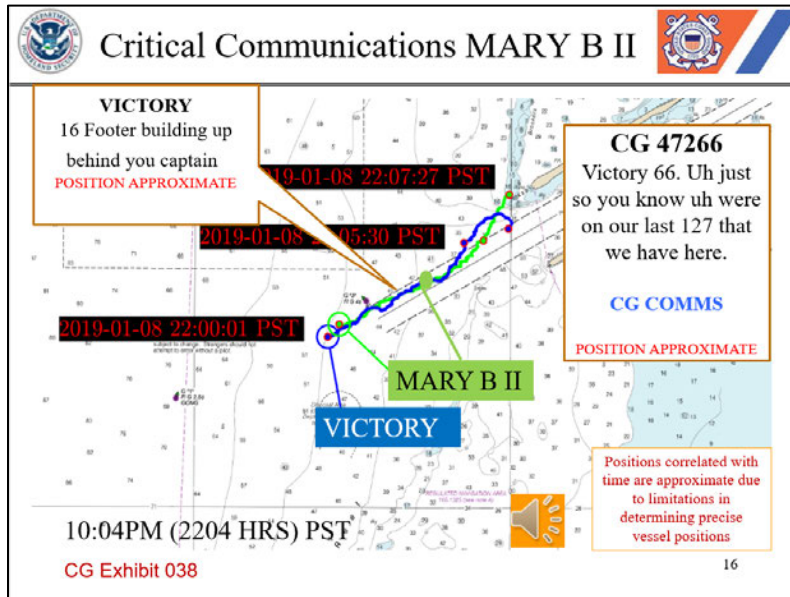
Figure 10. Time 10:04 p.m. slide, from Critical Communications presentation used in the public hearing. (Source – Oregon State University/Coast Guard, CG Exhibit 038)

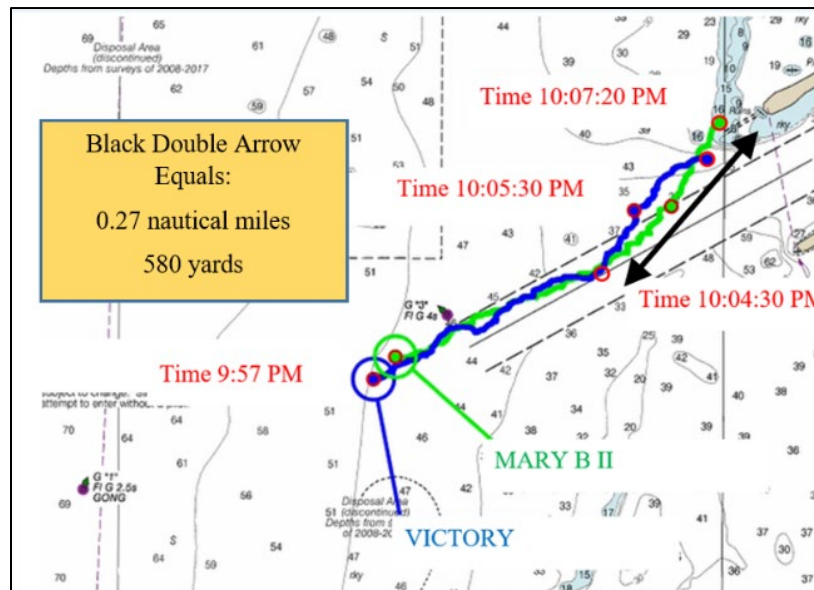
4.1.66. At approximately 10:04:30 p.m., the MARY B II began to drift off the centerline of the Yaquina Bay Bar navigation channel and continued this movement towards the seaward end of the North Jetty tip.

Figure 11. Slide displaying critical times along a radar track created from the OSU marine radar located in Yaquina Bay. An arrow has been placed to indicate distance from the 10:04:30 p.m. position of the MARY B II to the jetty end. (Source – Oregon State University/Coast Guard, CG Exhibit 038)

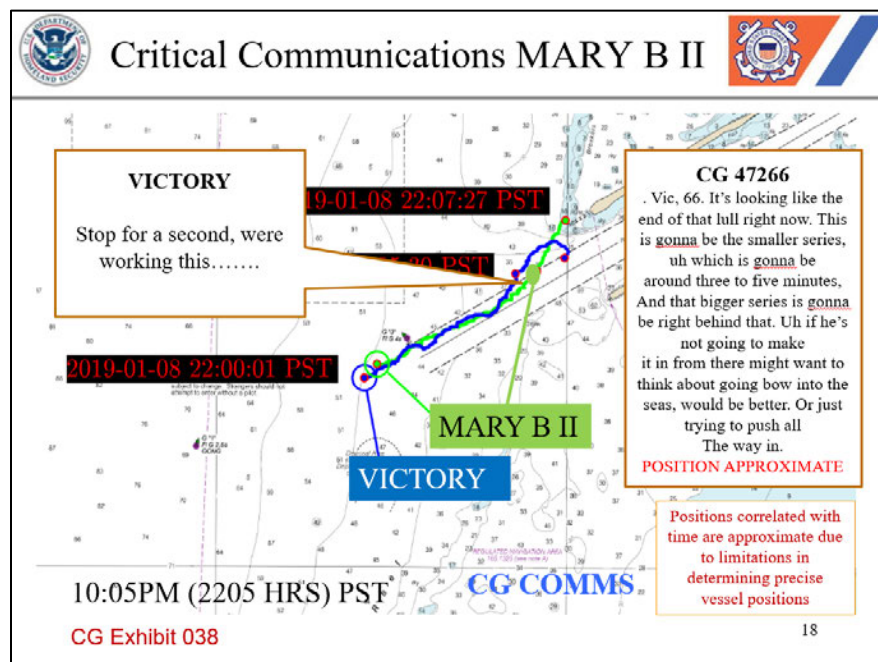
4.1.68. At approximately 10:05 p.m., the VICTORY called out to the MARY B II on Channel 22 and advised, "Mary B, This is the set right here. This is the set. Over." The operator of the MARY B II acknowledged the VICTORY's transmission with the statement "Yeah roger, roger. I see it."

Figure 12. Time 10:05 p.m. slide from Critical Communications presentation used in the public hearing. (Source – Oregon State University/Coast Guard, CG Exhibit 038)

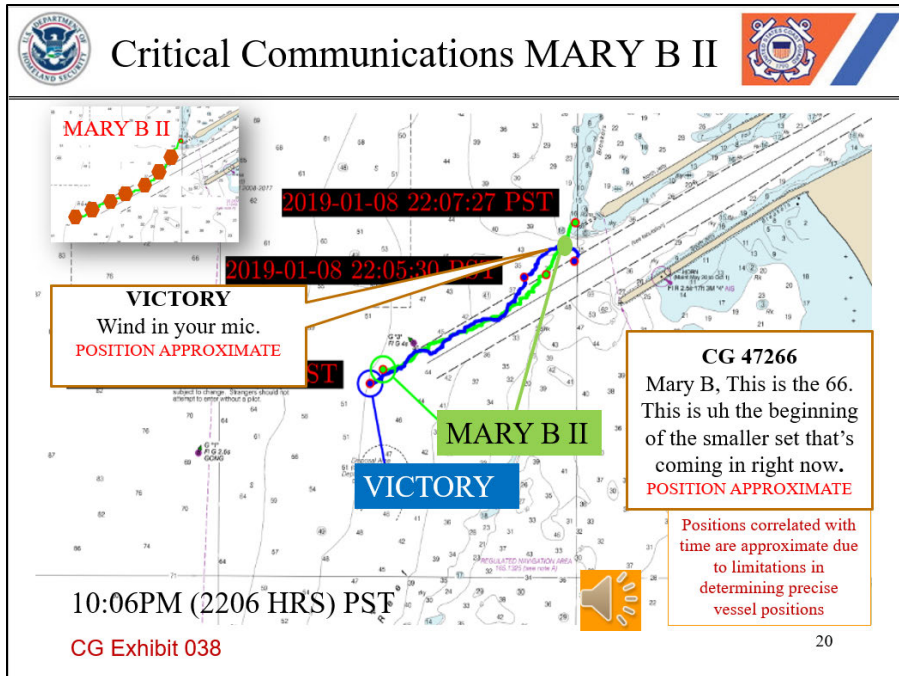
4.1.69. At approximately 10:06 p.m., the MLB 47266 followed up on Channel 22 that what they were experiencing the beginning of the smaller series of waves. It is unclear if the 47266's transmission was heard as VICTORY told MLB 47266 that there was "wind in the mic."

Figure 13. Time 10:06 p.m. slide from Critical Communications presentation used in the public hearing. (Source – Oregon State University/Coast Guard, CG Exhibit 038)

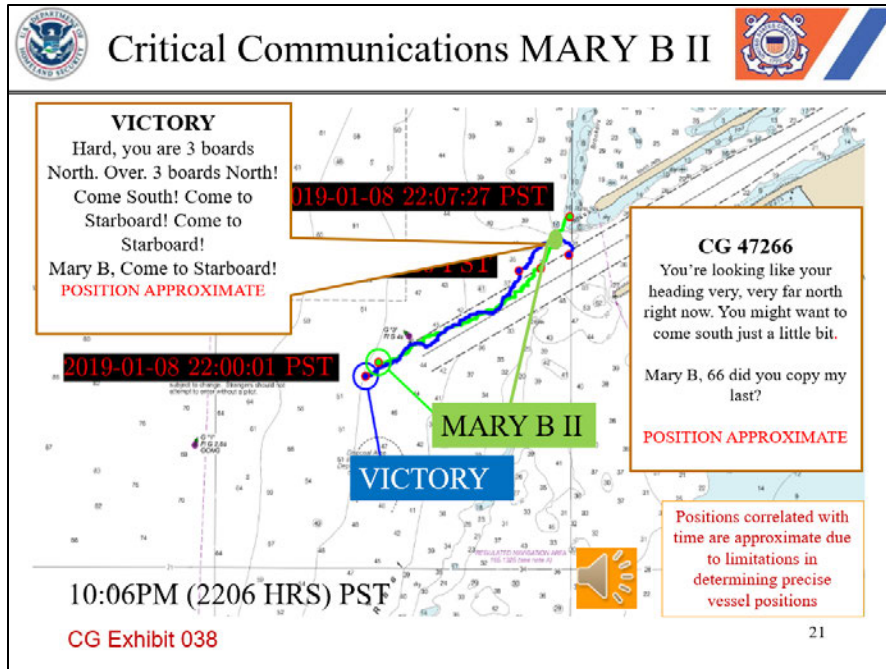
4.1.70. At approximately 10:06 p.m., the MLB 47266 called out to the MARY B II on Channel 22 and stated that they were “heading very, very far north right now. You might want to come south just a little bit” as the MARY B II continued to move towards the end of the North Jetty. MARY B II did not acknowledge the MLB 47266’s previous transmission. The MLB 47266 reached out again asking the MARY B II if they copied the last radio transmission and the MARY B II did not respond.

4.1.71. At approximately 10:06 p.m., the VICTORY called out to MARY B II on Channel 22 with a message of: “Hard, You are 3 boards North. Over. 3 boards north! Over. Come south! Come to Starboard! Come to Starboard! MARY B, come to Starboard!”

Figure 14. Time 10:06 p.m. slide from Critical Communications presentation used in the public hearing. (Source – Oregon State University/Coast Guard, CG Exhibit 038)

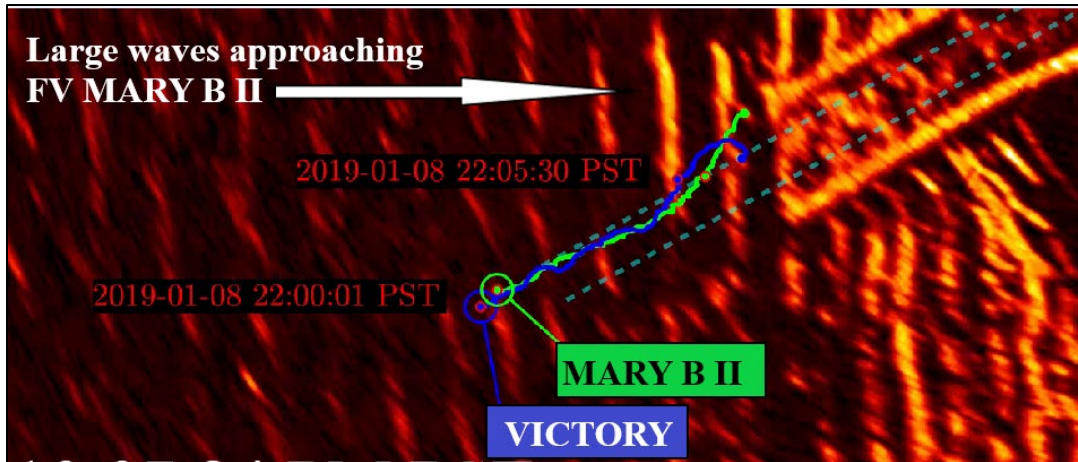
4.1.74. The largest wave of the series impacted the MARY B II, striking the vessel’s bow. Based on witness observations, the wave size was estimated to be 18 feet. That caused the vessel to pitch-pole and capsize into the waters north of the Yaquina Bay North Jetty tip.¹⁵

Figure 15. OSU marine radar product with notes showing the track of the MARY B II and the VICTORY moving from the start of the transit into Yaquina Bay Bar to the point of the loss of the MARY B II. Showing the series of large waves that impacted the MARY B II near the submerged end of the North Jetty Tip. (Source – Oregon State University/Coast Guard markup of still screen capture, CG Exhibit 034)

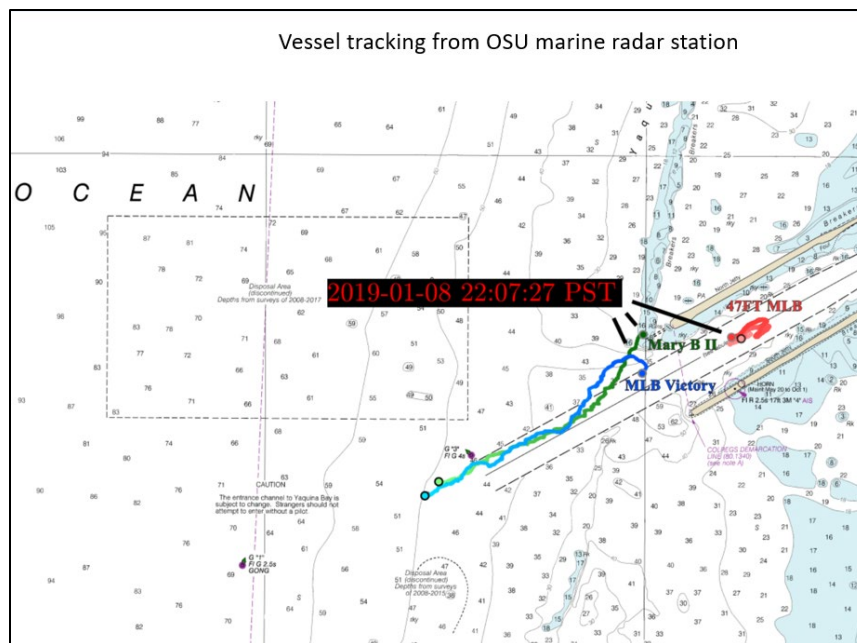
4.1.76. At approximately 10:07:27 p.m., the MLB 47266 reported that the MARY B II had been overtaken by a wave and was on the north side of the jetty. The VICTORY called out to Sector North Bend and requested that Sector North Bend launch a helicopter to respond to possible people in the water off the Yaquina Bay Bar.

Figure 16. OSU marine radar tracking of the VICTORY, MARY B II, and the MLB 47266 with radar target trails shown in color. Displaying the locations of the vessels involved on the accident night and with small dots marking the locations of vessels at 10:07:27 p.m., the estimated time of the sinking of the MARY B II. (Source – Coast Guard, CG Exhibit 071)

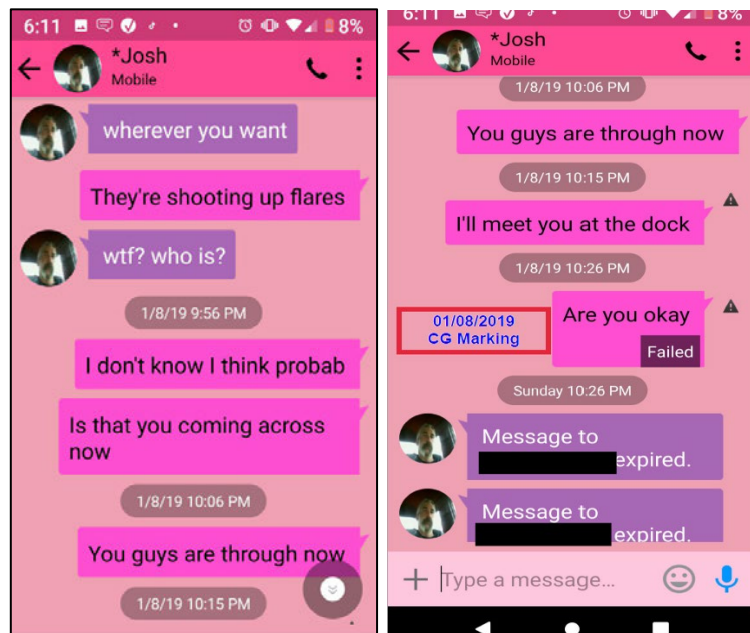
4.1.86. Between approximately 9:56 p.m. and 10:15 p.m., Mrs. [REDACTED] arrived in the vicinity of the South Jetty to watch the MARY B II's inbound transit. She texted Mr. Porter to relay her observation of Coast Guard personnel activating illumination flares.

Figure 17. Screen shots of Mrs. [REDACTED]'s last text conversation with Mr. Porter, a crewmember on board the MARY B II. (Source – CG Exhibit 024)

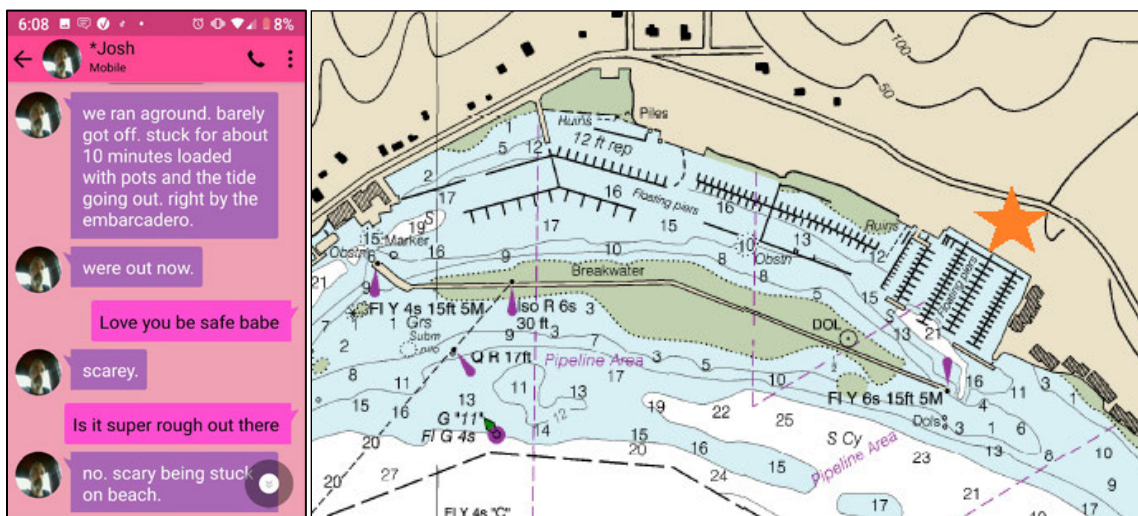
4.2.20. On or about January 1, 2019, Mr. Porter reported to his wife that the MARY B II had grounded on the beach in front of the Embarcadero Hotel when the vessel was loaded with pots. Mr. Porter indicated that the MARY B II was "stuck for 10 minutes" before the vessel floated free.

Figures 23. (Left). Screen shot of Mrs. [REDACTED] text conversation with MARY B II crewmember, Mr. Porter, regarding the grounding of the MARY B II. (Source – Coast Guard, CG Exhibit 024. (Right) Chartlet has an orange star that marks the general location of the Embarcadero Marina, Newport Harbor, OR and the grounding occurred somewhere in the light blue shaded area of the waterway, the exact position and circumstances cannot be precisely determined (Source – Coast Guard, CG Exhibit 004 marked up with star for position)

4.2.20.2. There was no written or verbal casualty notification report made to the Coast Guard after the MARY B II grounded and the amount of damage the vessel, if any was incurred, is unknown.

4.2.20.3. While Mr. Porter did not tell his wife that the grounding resulted in hull damage, he indicated there was “a major leak on the boat.”²¹

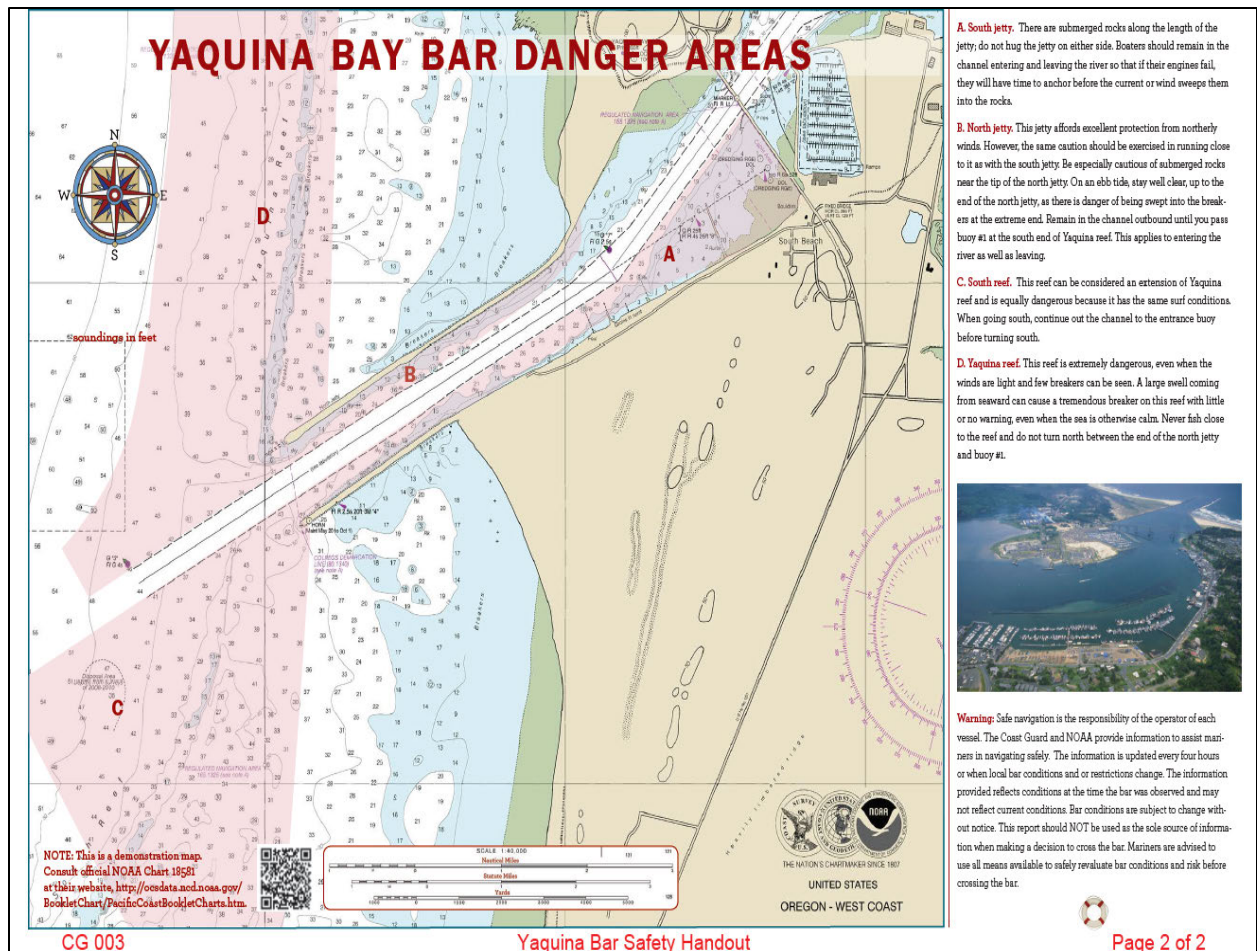
Figure 26. Page 2 of the Yaquina Bay Bar Hazards handout provided to mariners. Specific danger areas are noted. Area D, just north of the North Jetty is labeled “Yaquina Reef” and states this “bar is extremely dangerous, even when the winds are light and few breakers can be seen. A large swell coming from seaward can cause a tremendous breaker on this reef with little or no warning, even when the sea is otherwise calm. Never fish close to the reef and do not turn north between the end of the north jetty and buoy #1.” (Source – Coast Guard, CG Exhibit 003)

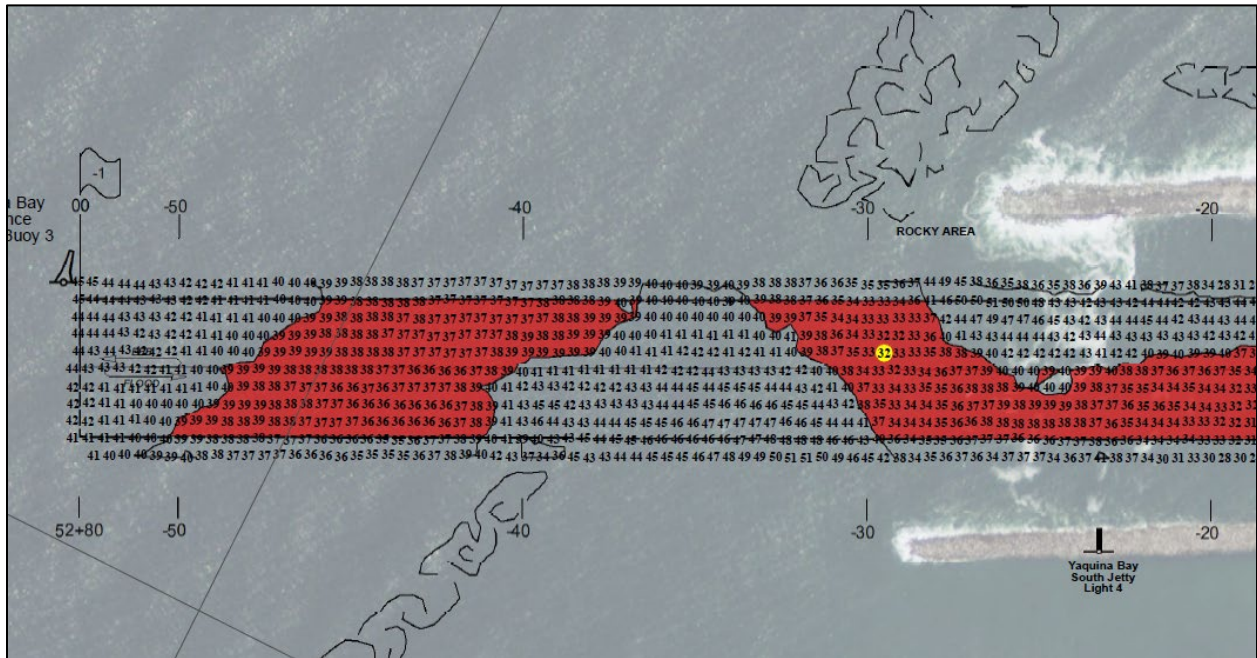
Figure 28. Section of a waterway bottom survey conducted by the U.S. Army Corps of Engineers (ACOE), post-accident. The ACOE does not survey areas outside the navigable channel but the image depicts submerged rocky areas just west of the North and South Jetties at Yaquina Bay Bar. (Source – ACOE, CG Exhibit 028)

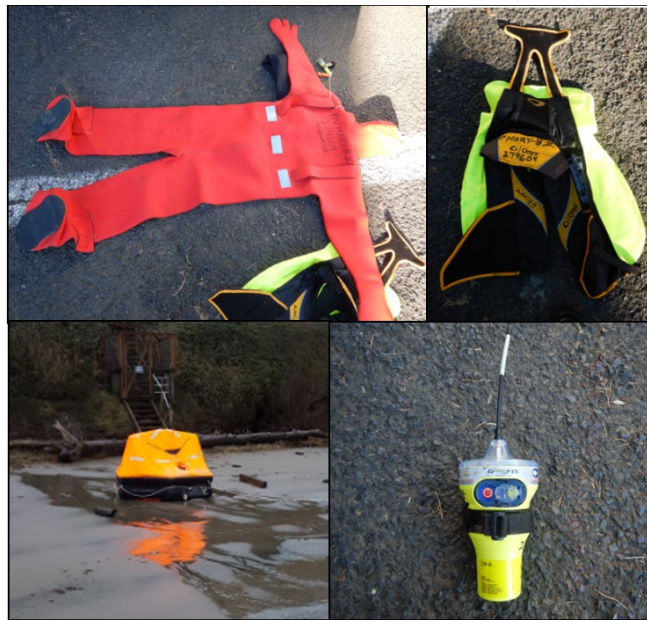
4.2.54. The MARY B II had all lifesaving equipment required to be onboard by the CFV regulations of 46 CFR Part 28.

Figure 30. Composite image of MARY B II's safety equipment. Showing an immersion suit, inflatable lifejacket, liferaft and an EPIRB distress device recovered after the accident. (Sources – Mr. [REDACTED] and Oregon State Parks)

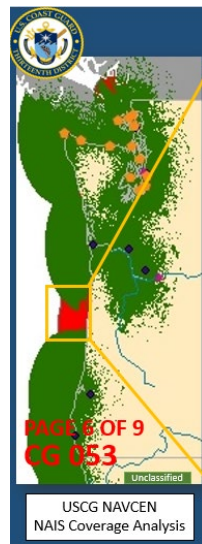
Figure 38. Map showing NAIS coverage for the coasts of Oregon and Washington. The area in red shows a NAIS coverage gap which exists in the Yaquina Bay, Oregon. (Source – Coast Guard, CG Exhibit 053)

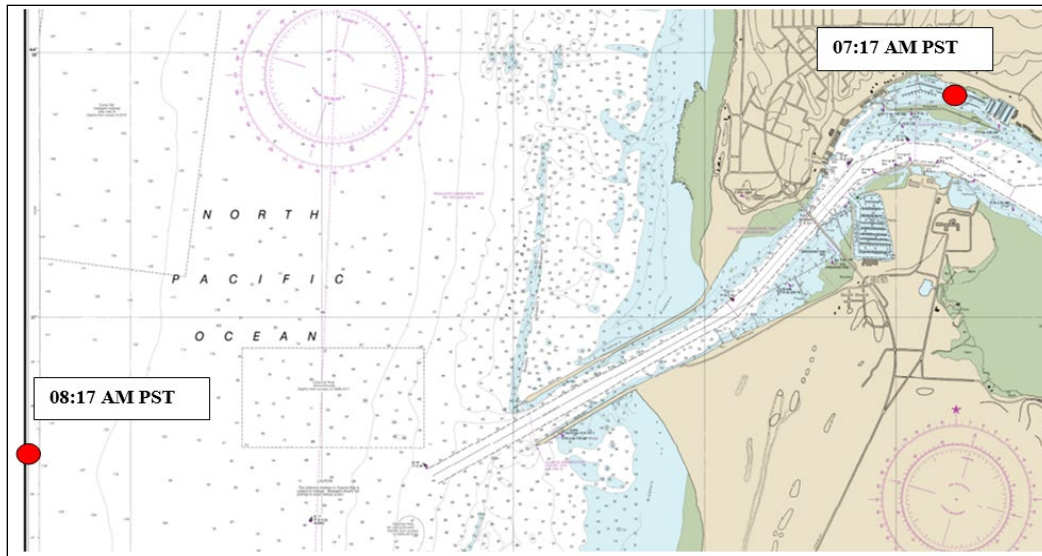
The operator of the MARY B II did not communicate with the Coast Guard the particulars of vessel name, vessel location or position, number of people aboard or destination on the morning he was outbound at or before sunrise. On the morning of January 8, 2019, sunrise occurred at 7:52 a.m.. The Coast Guard stations a watchstander in a lookout tower overlooking the Yaquina Bay Bar at first light and makes bar condition observations to assist vessel traffic when the bar is restricted. Although the name of the MARY B II appears in the CG tower log, there is no way to determine how this entry came to be in this log and this was most likely entered as a correction to “no response” after the name of the MARY B II became known. There is only one entry in the tower log for January 8, 2019. The image below indicates the position of the MARY B II prior to sunrise on the morning of the accident day. The precise position of the MARY B II prior to sunrise cannot be determined.

Figure 42. Two positions of the MARY B II on the morning of January 8, 2019 based on NOAA VMS data. There is no way to determine at what time the MARY B II departed the dock but the 7:17 a.m. and 8:17 a.m. positions are precise and transmitted by the VMS at intervals that are close to one hour. (Source – NOAA data, Coast Guard)

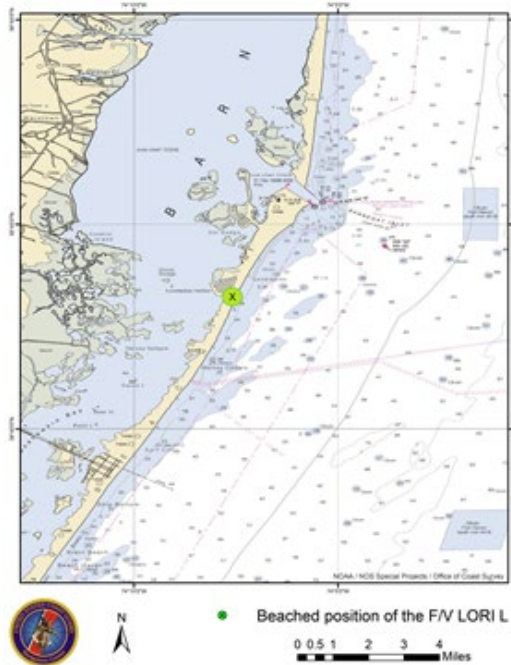
The experience and critical decision making of the operator of the MARY B II reveals a host of serious issues with his role and responsibilities as a vessel captain. In February 1997, Mr. Biernacki was employed as the captain of the LORI L. While acting as operator of the vessel, he was involved in a marine casualty where it was put on autopilot and the entire crew went to sleep. As a result of lack of lookout and vigilance, the vessel grounded on the coast of New Jersey having missed the entrance of Barnegat Inlet, NJ. The captain, Mr. Biernacki, was awakened when the vessel hit the offshore sandbar and the vessel then ended up sideways on the beach. The catch had to be unloaded and multiple vessels used to tow the vessel back into safe water.

Figure 46. Green circle with X indicates the approximate unintended beaching position of the LORI L in February 1997 several miles south of Barnegat Inlet, per Coast Guard MISLE Incident Activity number 90591 (Source - USCG Navigation Safety Center)

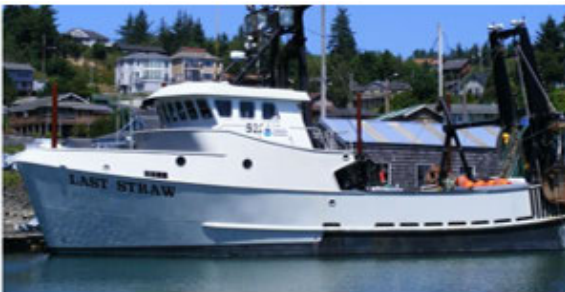
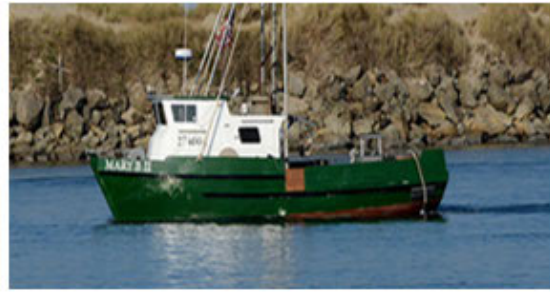
FV LAST STRAW on the left (75 feet in length) in comparison to the FV MARY B II (42 feet in length). Note the high bow and lack of outriggers on the FV LAST STRAW. Images are scaled to show the approximate size comparison and the FV MARY B II image is approximate in size.

Figure 48. Comparison of the size and characteristics of the LAST STRAW and the MARY B II. (Source: LAST STRAW – Mr. [REDACTED] Marine Traffic com with permission, MARY B II – Mr. [REDACTED])

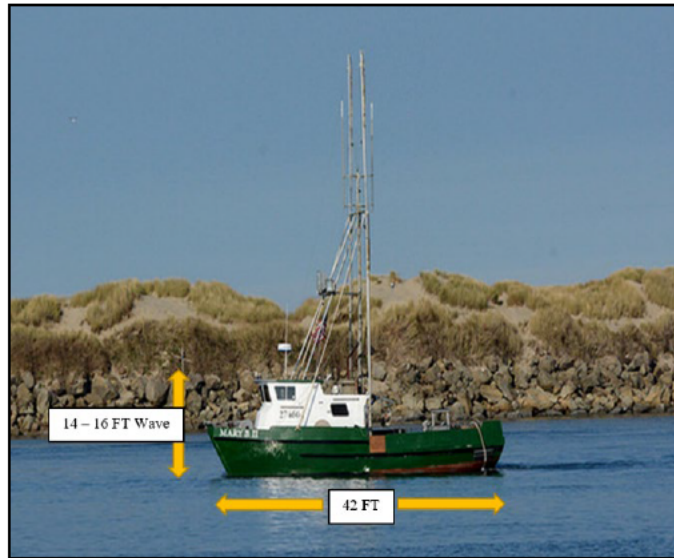
16 Footer building up behind you captain⁵⁰

Figure 49. Illustration showing the size of the MARY B II in comparison with the static height of 14-16 foot wave. In the background are the jetty and landmass behind the jetty rocks, November 18, 2018. (Source – Mr. [REDACTED])

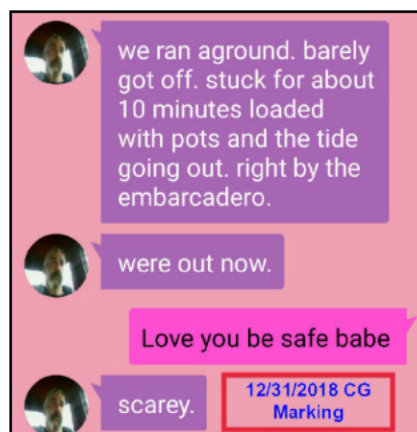
5.5.2. Potential Effects of Grounding in Newport Harbor on or about December 31, 2018
In late 2018, the MARY B II grounded in Newport Harbor vicinity of the Embarcadero. A crewman reported this event to shore via text messaging. At the time, the MARY B II was loaded with crab pots with an outgoing tide.

Figure 50. Screen capture of crewmember, Mr. Porter's communication ashore via text messaging from December 31, 2018 regarding the grounding of the MARY B II (Source- Coast Guard, CG Exhibit 024)

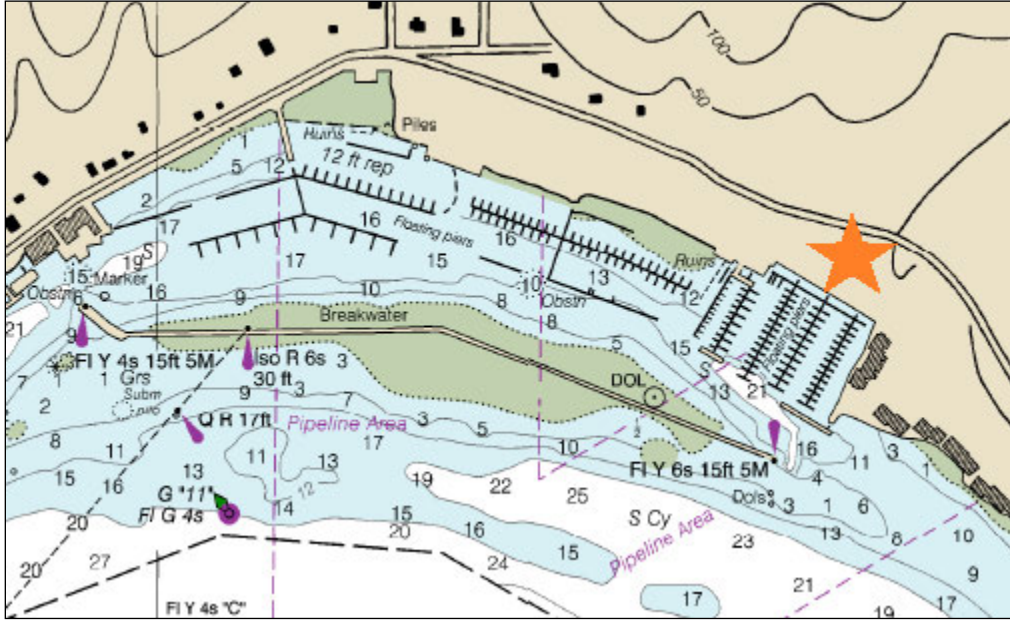
Figure 51. Orange star marks the general location of the Embarcadero Marina, Newport Harbor, OR. The grounding occurred somewhere in front of this area in the blue shaded area, the exact position and circumstances cannot be precisely determined. (Source – Coast Guard, CG Exhibit 004 marked up with star for position)

There is no way to determine if this grounding and resultant leak were a contributing factor to the accident. There is also no way to determine if the repairs to the leaking hull planks with the two part epoxy controlled any leakage of seawater into the hull. Any seawater that accumulated in the hull could have resulted in the sloshing of water, called free surface effect which decreases stability. It could also change the vessel's stability based on the weight of the water inside the hull.

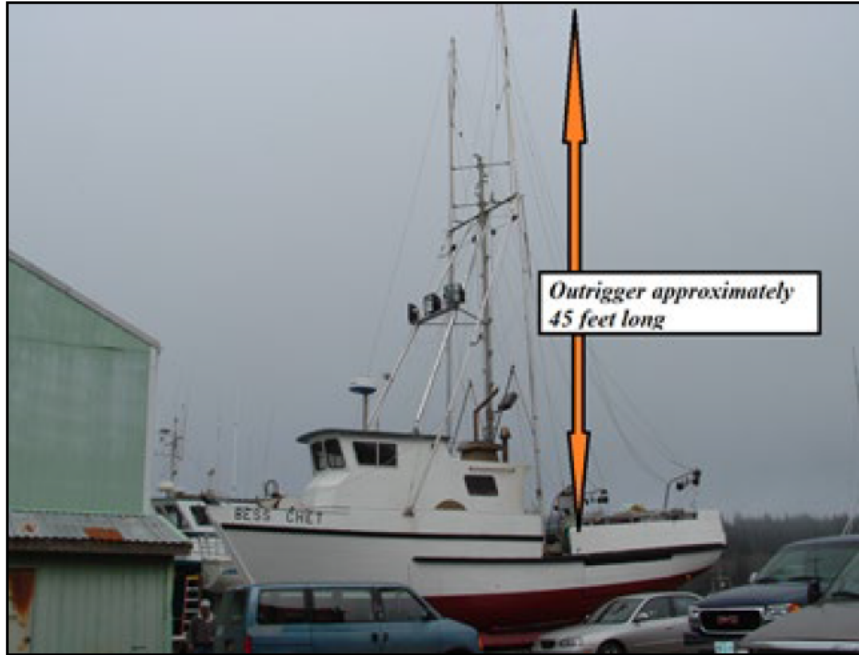
Figure 52. Source photo for the BESS CHET (later known as the MARY B II) Marine Survey report showing the outriggers onboard the vessel. (Source - Marine Surveyor, Mr. [REDACTED])

As evidenced in the image showing the outriggers in the marine survey report when the vessel was the BESS CHET, there is considerable rigging associated with the outriggers and this could have led to potential line entanglement when the outrigger was noted to be partially deployed during the vessel’s inbound transit. No evidence was available (observations) of where the lines were trailing. The port outrigger likely had a negative effect of the vessel’s stability or maneuverability in those weather and sea conditions, therefore, the fact that it was deployed may have contributed to the casualty.

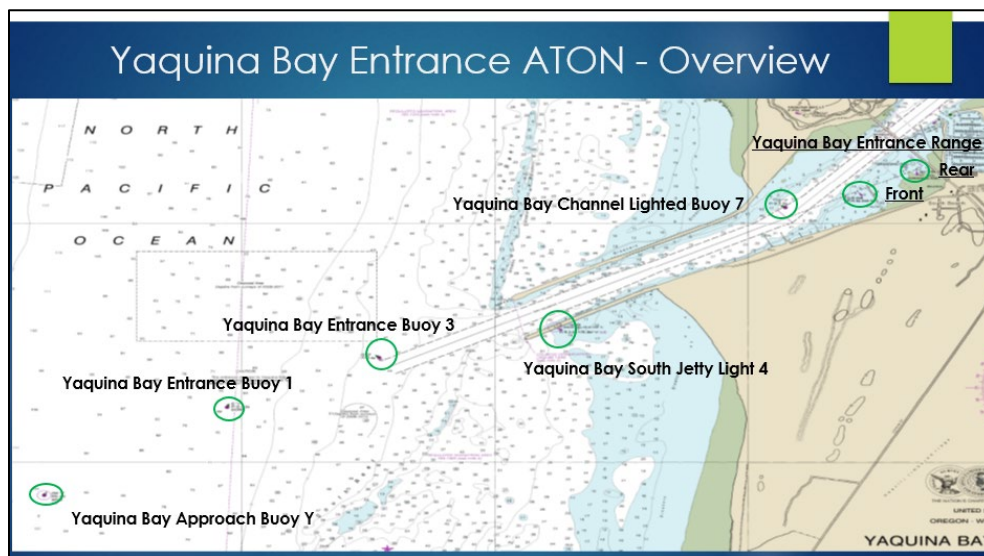
Figure 57. Aids to navigation associated with the MARY B II accident. This image depicts the total and charted aids to navigation on the Yaquina Bay Bar and channel. (Source – Coast Guard, CG Exhibit 052)

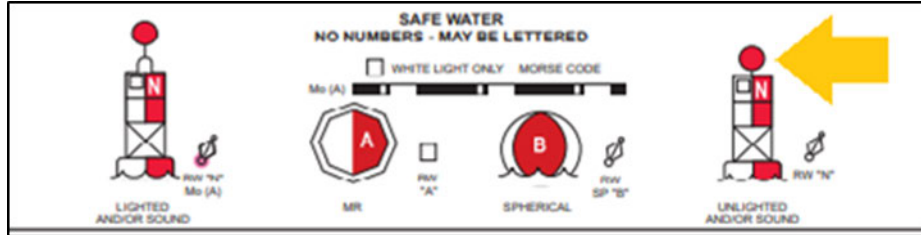
Figure 58. Image from a screen capture from the Coast Guard Light List showing a top mark (yellow arrow) which is a component of a buoy. Under normal conditions the furthest offshore buoy, “Y” buoy and others large buoys at Yaquina Bay would be equipped with a top mark. (Source – Coast Guard)

In the case of Yaquina Bay, the top marks on two of the offshore aids and the dayboards on South Jetty Light 4 were not installed and this was noted in the Coast Guard Light List, Volume VI, Pacific Coast and Pacific Islands. The Light List is updated anytime there are changes to the ATON such as discrepancies and changes to the ATON on the waterways. The image below indicates the notations about the principal ATON for Yaquina Bay Bar.

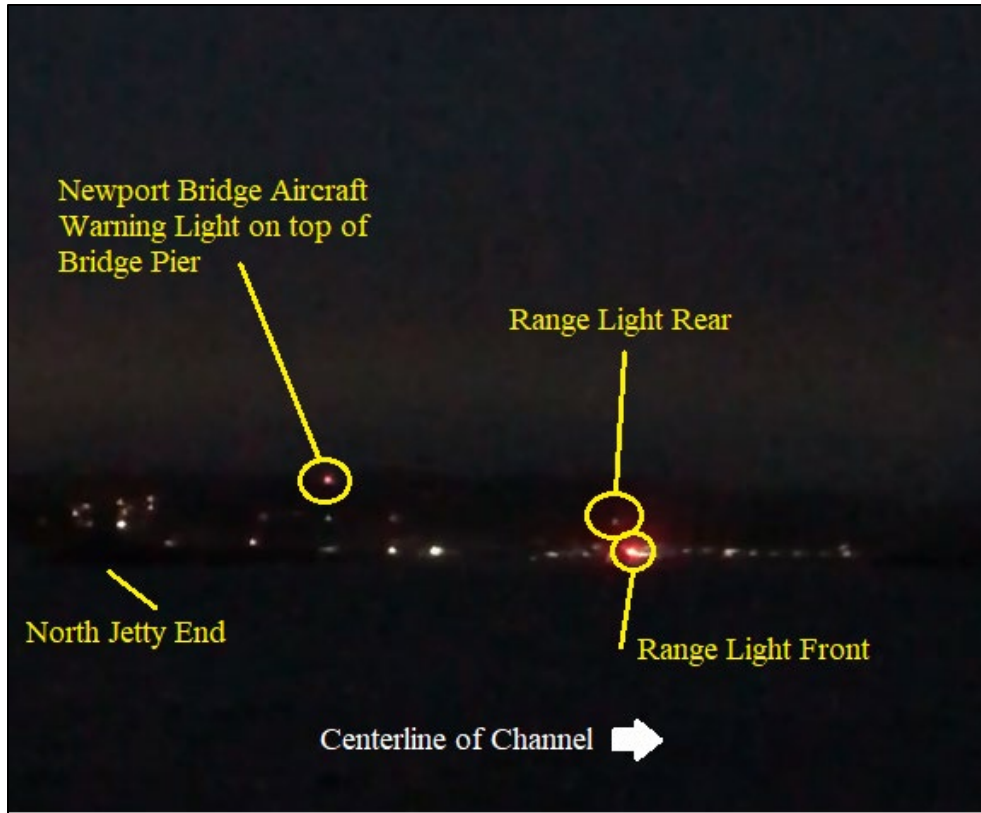
Figure 65. Cell phone image, post-accident at dawn prior to sunrise showing the entrance to Yaquina Bay Bar from near the North Jetty end and looking into the harbor approach. (Source – Coast Guard)

There is the possibility that the operator of the MARY B II experienced perceptual confusion on the red centerline navigation ranges marking the center of the channel and the center of the point between the two jetties. In the image above, the centerline of the channel is to the right of the white arrow in Figure 65. In the distance, the front range light is flashing red and slightly above that light and circled is the rear range light. To the left of the range lights, the Newport Bridge Aircraft Warning Light is also a flashing red light. When viewed from seaward, the front range and the red aircraft warning light on the top of the Newport Bridge pier form a range. The established rear range light for the range is much lower and of less intensity. The rear range light is visible but to those with limited local night transit experience this may cause conflicting information at a critical time. The location of the seaward end of the North Jetty in the photograph is indicated in the image.
