**REPORT OF INVESTIGATION
INTO THE
COMMERCIAL FISHING VESSEL MARY B II
(O.N. 274604)
SINKING AND LOSS OF THE VESSEL WITH MULTIPLE
LOSS OF LIFE AT THE YAQUINA BAY BAR ENTRANCE,
NEWPORT, OREGON
ON JANUARY 8, 2019**

MISLE ACTIVITY NUMBER: 6607968

CAPSIZING AND LOSS OF LIFE OCCURRING ON THE COMMERCIAL FISHING VESSEL MARY B II (O.N. 274604) AT THE YAQUINA BAY BAR ENTRANCE NEWPORT, OREGON ON JANUARY 8, 2019

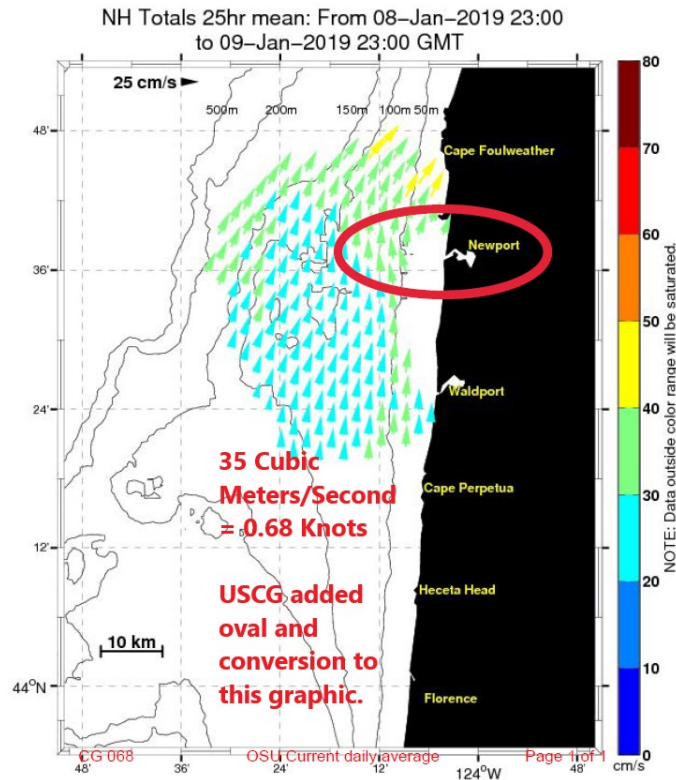
the movement of the vessel. OSU prepared a chart⁷³ showing the effects of the current and the general set of the current is to the north or north-northwest at approximately 0.5 knots. From 10:04:30 p.m. until the time that the MARY B II was observed to capsize shortly after 10:07 p.m., the vessel moved slowly off the centerline of the channel to the northeast and the end of the North Jetty.

Figure 68. Image showing the current velocity and generally northward direction off the Oregon Coast on the night of the accident. Red circle highlights the Yaquina Bay Bar. (Source – Coast Guard, CG Exhibit 068 with CG labels)

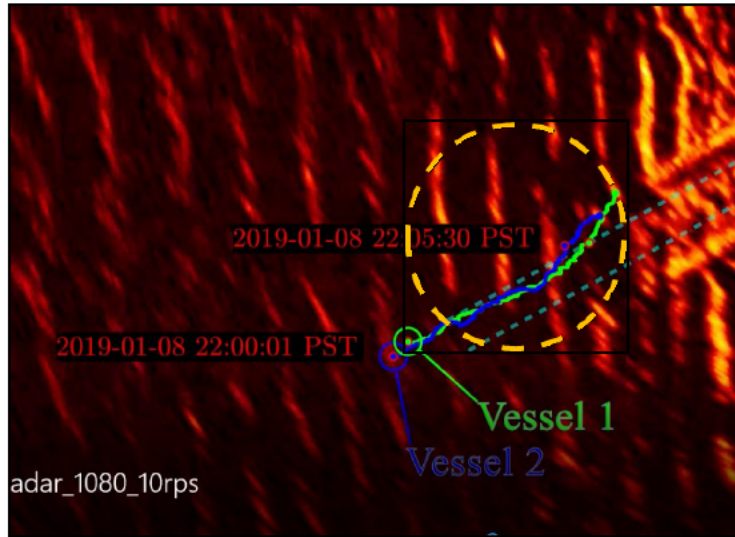
Figure 77. Screen shot of OSU radar video showing the MARY B II (VESSEL 1) and VICTORY (VESSEL 2) nearing the North Jetty End and larger waves are forming to the seaward of the vessels, these larger waves are circled for identification (Source – Oregon State University, CG Exhibit 034)

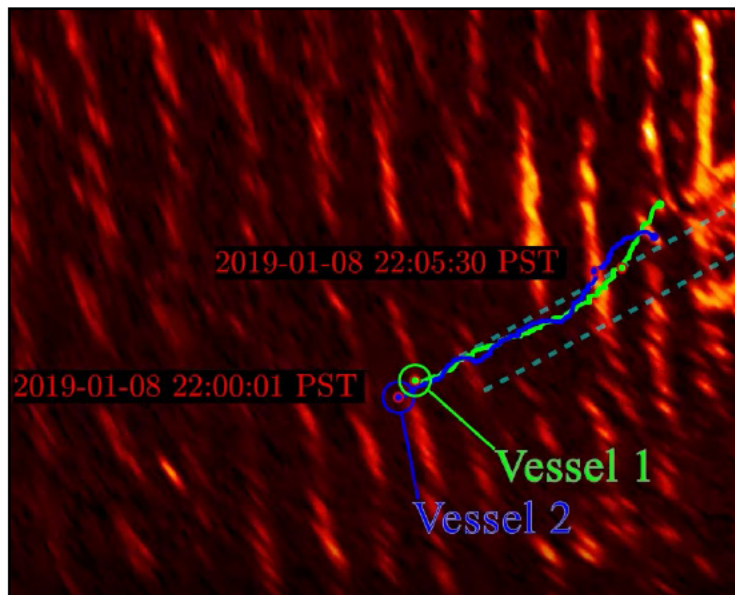
Figure 78. Screen shot of OSU radar video showing the MARY B II (VESSEL 1) and VICTORY (VESSEL 2) nearing the North Jetty End and larger waves are forming to the seaward of the vessels, these larger waves are growing in vertical height and steepness reflecting more radar energy (Source – Oregon State University, CG Exhibit 034)

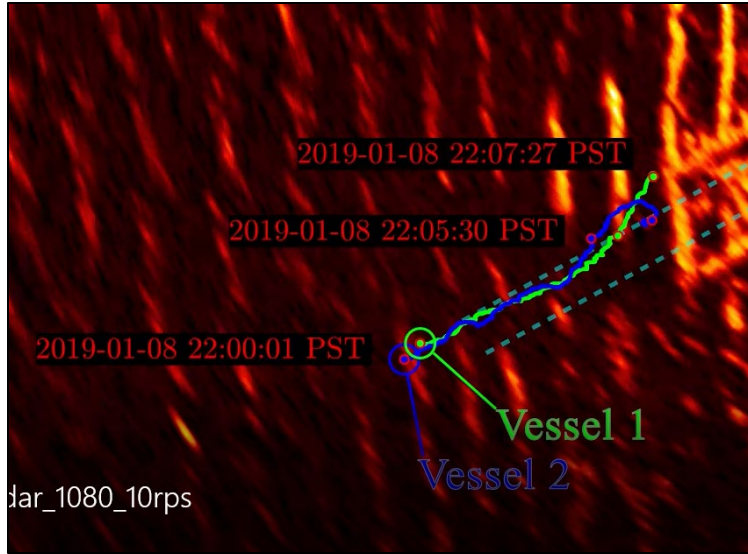
Figure 79. MARY B II indicated by the small green circle at 10:27:27 p.m., the approximate time where the vessel struggled after getting hit by a wave and then capsizing by reverse pitch poling and sinking. (Source – Oregon State University, CG Exhibit 034)

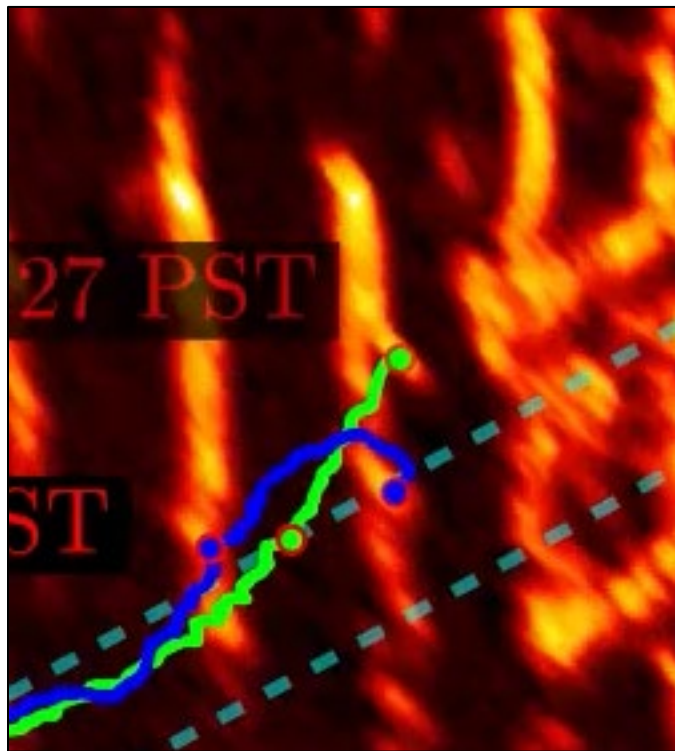
Figure 80. Screen shot of OSU radar video showing the MARY B II (VESSEL 1) and VICTORY (VESSEL 2) nearing the submerged rock portion of the North Jetty, the first large wave, reported to be 16 feet passed the MARY B II and engulfs the jetty tip. The second is about to strike the MARY B II. In this image you can make out the radar reflected energy of the vessel just ahead of the wave front. The VICTORY is turning away from the danger of the underwater portion of the jetty and the jetty tip. (Source – Oregon State University, CG Exhibit 034)

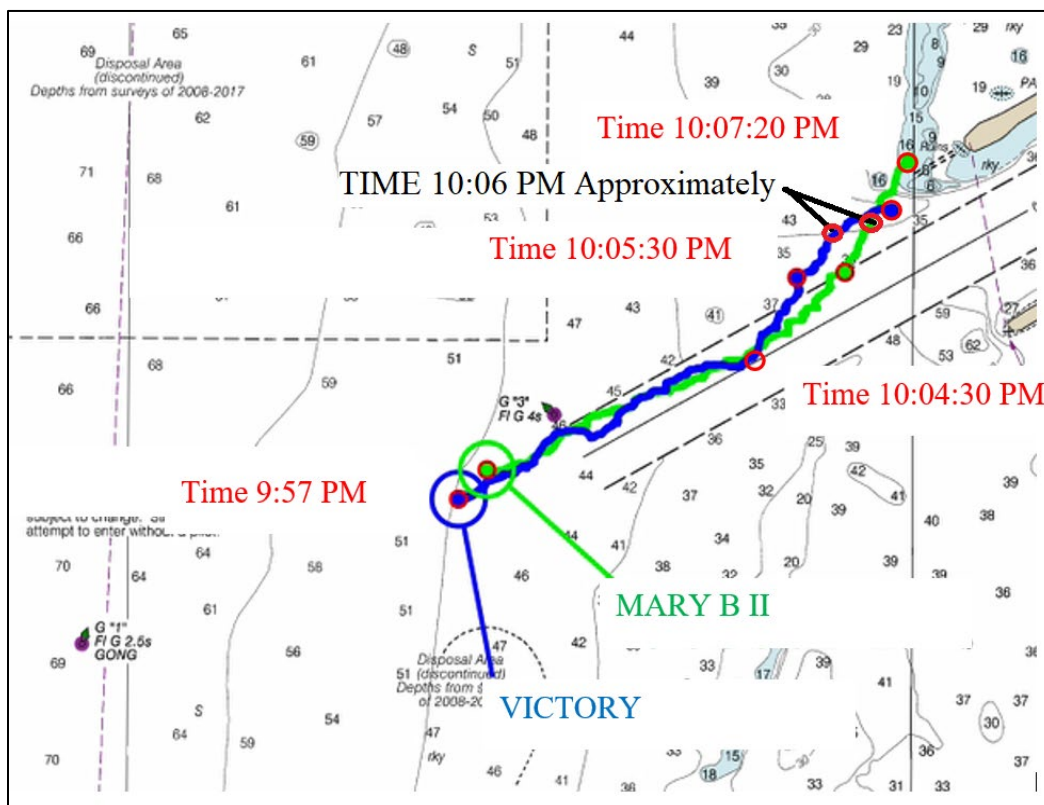
Figure 82. Positions of vessels throughout the escort. The approximate position of the final calls to the MARY B II are indicated for the time of 10:06 p.m. (Source – Oregon State University, CG Exhibit 071)

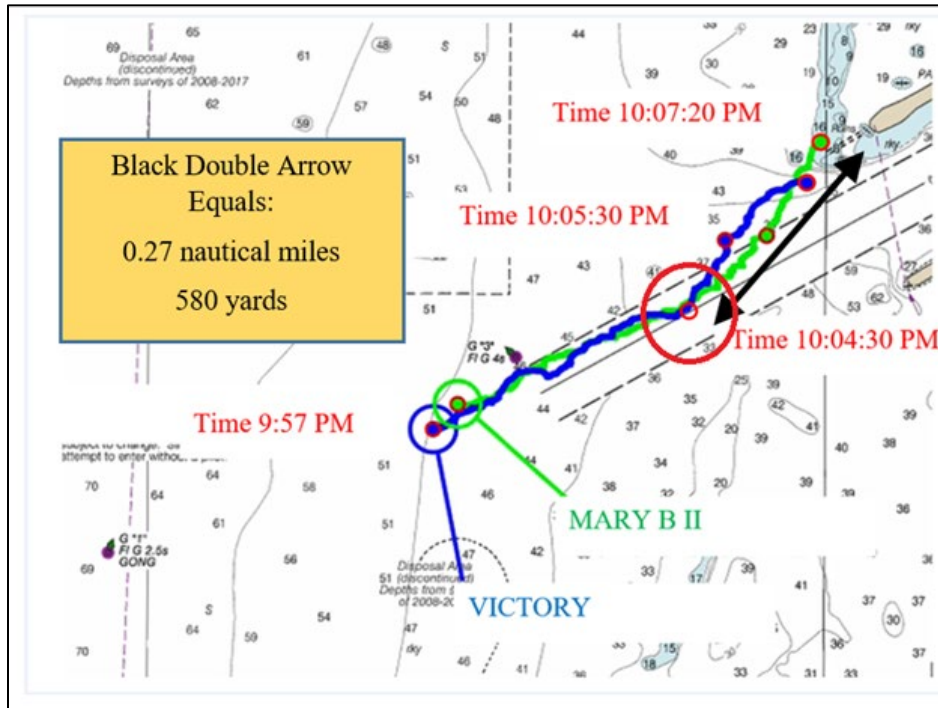
6.1.1. The initiating event for this casualty occurred when the MARY B II deviated from the centerline of the entrance channel for Yaquina Bay Bar at approximately 10:04:30 p.m. and began a general movement towards the submerged end of the North Jetty in breaking surf and near gale conditions.

Figure 83. Large red circle indicates the start of the initiating event, the deviation from the centerline of the Yaquina Bay Bar channel. Time 10:04:30 p.m., January 8, 2019. (Source – Coast Guard)
