**COLLISION BETWEEN THE T/V TINTOMARA AND BARGE DM932 BEING  
PUSHED BY THE MEL OLIVER AT MILE MARKER 99 OF THE LOWER  
MISSISSIPPI RIVER ON JULY 23, 2008**

**ACTION BY THE COMMANDANT**

## REPORT OF INVESTIGATION INTO THE CIRCUMSTANCES SURROUNDING THE **THE COLLISION BETWEEN THE T/V TINTOMARA AND THE BARGE DM932**

ON 07/23/2008

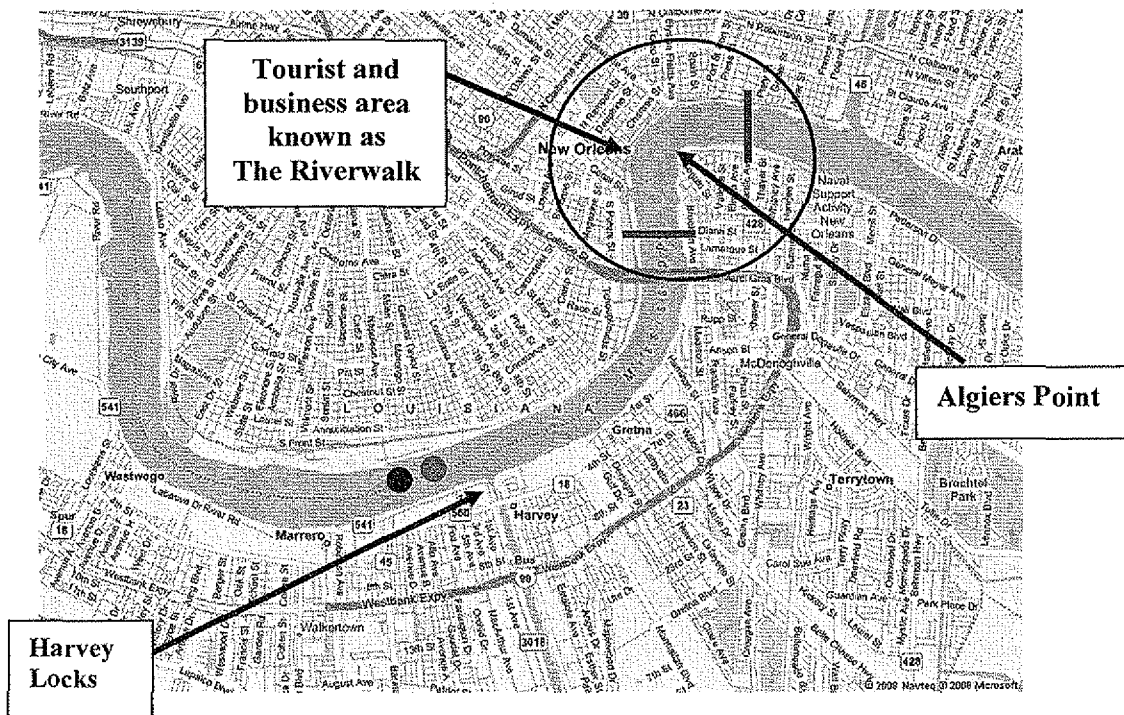
Figure 1: Aerial map of MM 99 LMR

- The **black dot** indicates the approximate location of MM99.
- The **red dot** indicates the approximate location of the collision.
- The two **purple lines** crossing the river on either side of Algiers Point indicate the beginning and ending points of the special restrictions area within the RNA.

- (b) A RNA is a water area within a defined boundary for which operating conditions have been established for any vessels operating within the area. The LMR RNA includes operating conditions for Algiers Point and its vicinity. While the collision occurred upriver or north of Algiers Point, as seen in Figure 1, the close proximity to the Point would put special emphasis on the approach from mile 99 of the LMR by any downbound vessel.

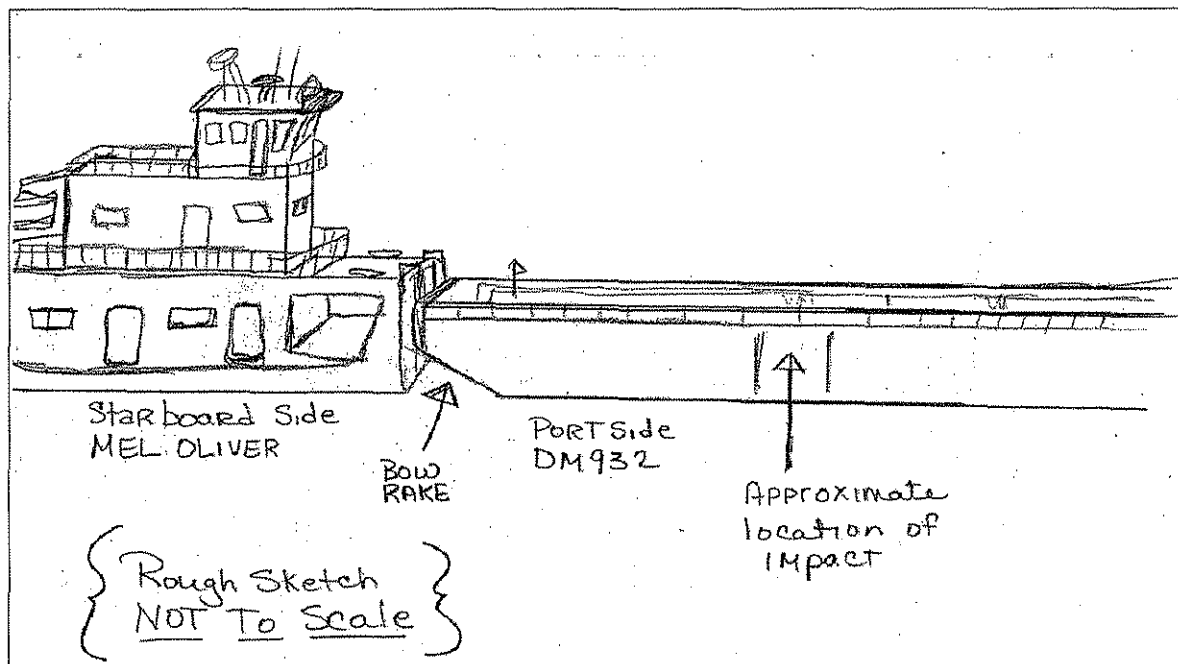
Figure 2: Sketch of MEL OLIVER / DM932 configuration

- (2) The MEL OLIVER was pushing one red-flag barge, the DM932, with the barge made up to the bow rake end (see sketch). The expected course was up-bound along the East Bank; however, at the time of collision, the tug and tow were traveling across the LMR (East Bank to West Bank). This particular tug and tow configuration placed the starboard side of the MEL OLIVER and the port side of the DM932 on the side of the collision impact. This configuration explains why the port side of the DM932 rather than the starboard side was struck by the TINTOMARA.

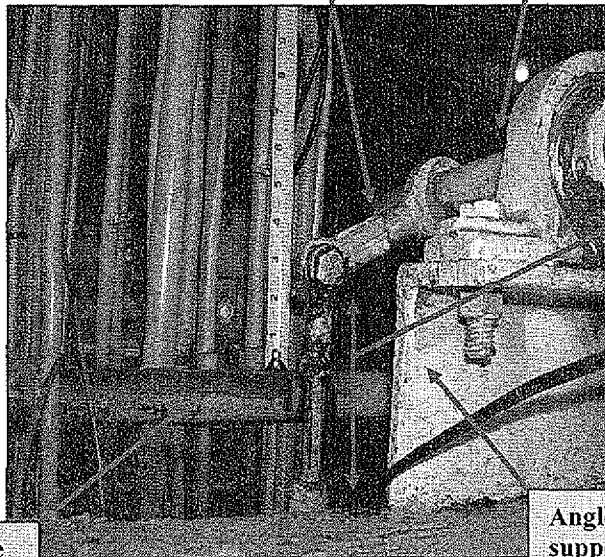
At the end of the linkage rod is a yoke.

Angle iron support for steering rod

Pipe

Angle iron support
