**U. S. Coast Guard  
Marine Safety Office  
Morgan City, LA**

**Investigative Report**

**M/V MR FRED Diving Fatality: Mr. Chris Mouritsen**

**July 6, 2002  
Gulf of Mexico  
Eugene Island Block 273**

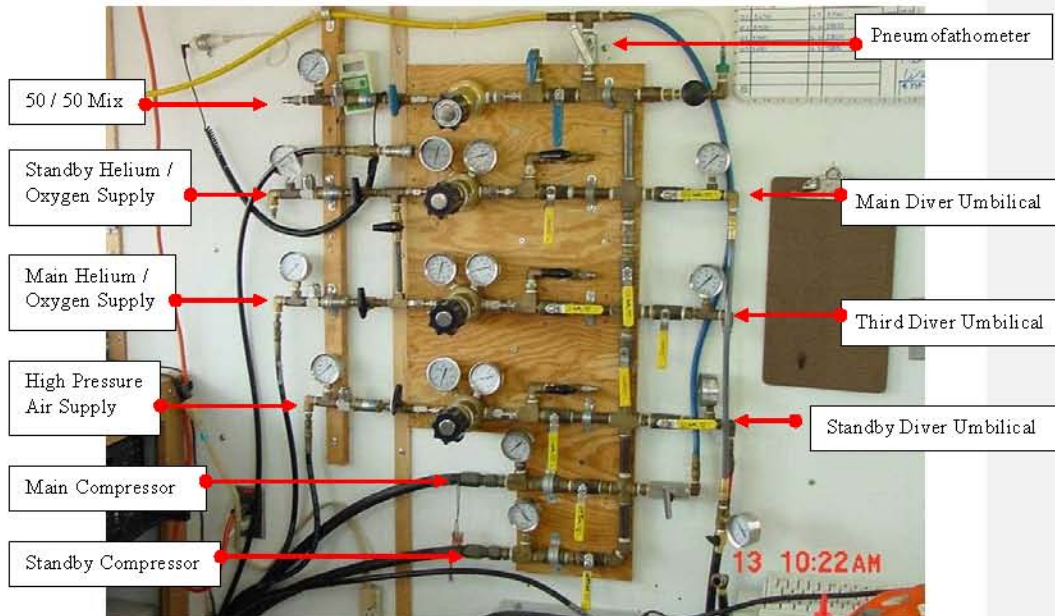
Photo 1 : Dive Manifold / Rack, Located in Dive Shack

8. The dive manifold (Diagram 2, produced by Mr. [REDACTED], see Encl # 3), or Rack, is a complex control panel that was built by CalDive/Aquatica. The dive manifold is a manually operated system that links the life support systems discussed above to the diver in the water (See Photo 1 below). The dive manifold is designed with multiple and redundant safety features. It receives air and/or mixed gas input from a total of six separate supply lines and can provide life support to three separate divers and air to a pneumofathometer system that is used to gauge the divers' depths (Table 1). The valves that control the air/gas flow are not labeled, but function as indicated below.

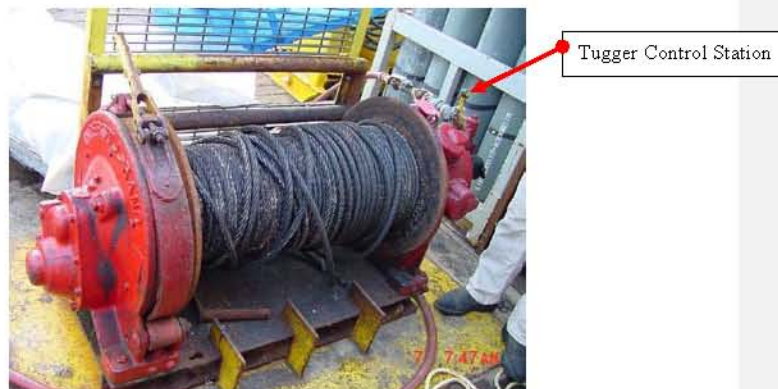
Photo 2: Tugger Winch

14. The tugger (Photo 2) is a wire rope used to pull equipment up from the diver's workstation to the vessel. It is fed onto a winch located on the vessel's aft deck. The controls for the tugger are located at the winch. The Dive Tenders that are on duty normally operate it.

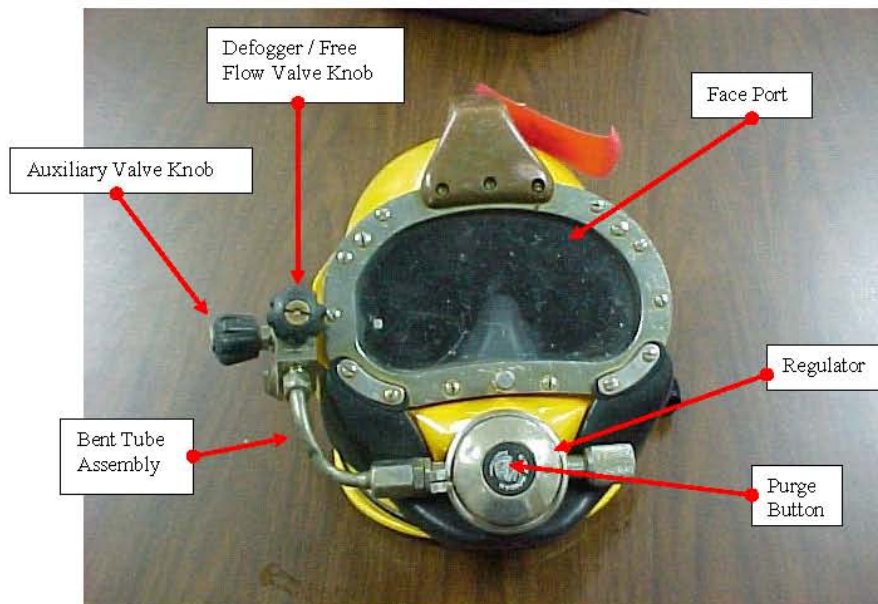
Photo 4: Mr. Mouritsen's Superlite 17B helmet, Serial Number 19348

3. Mr. Mouritsen's dive helmet was a Kirby Morgan SuperLite 17B, serial number 19348 (see Photo 4 below). This is the second dive helmet that he has owned. He acquired it new from Jack Vilas & Associates in Morgan City, LA, in June of 1998 as a replacement for one that was lost by Acme Trucking Company while returning from a dive job (Encl # 13, Telephonic interview with [REDACTED], and Encl # 14, Receipts for the replacement of Chris Mouritsen's Hardhat).

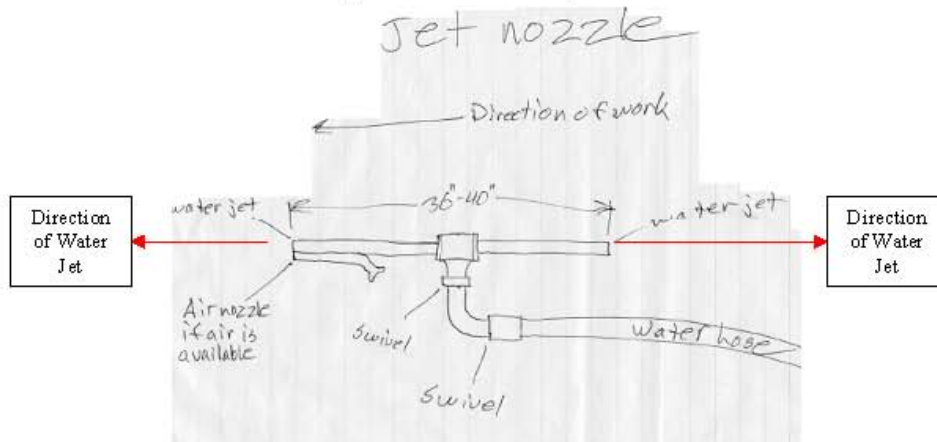
**Diagram 5 : Sketch of Waterjet Nozzle**

by Mr. [REDACTED] showing the type of nozzle Mr. Mouritsen was using. Mr. [REDACTED] added that the pressurized water flowing from both ends of the nozzle creates a great deal of turbulence inside of the cofferdam:

4. Mr. Mouritsen told Mr. [REDACTED] that the water flow from the backside of the jet nozzle had hit his helmet and knocked it off. Mr. [REDACTED] notified CalDive/Aquatica of the incident and then directed Mr. Mouritsen to tighten his helmet. Mr. Mouritsen later reported to Mr. [REDACTED] that he had fixed the problem and had even put the helmet back on his own head to ensure that it would be secure. He also told Mr. [REDACTED] that his helmet had never come off before. According to Mr. Mouritsen's Commercial Diver Logbook (Encl # 45), he used the helmet on five dives following the June 6, 2002 accident. He did not report any problems with the helmet after this incident.
