# UNITED STATES COAST GUARD

INVESTIGATION INTO THE CIRCUMSTANCES  
SURROUNDING THE SINKING OF THE

## F/V PATRIOT

14 NAUTICAL MILES OFF THE COAST OF GLOUCESTER, MA  
ON JANUARY 3, 2009 WITH THE LOSS OF TWO  
CREWMEMBERS

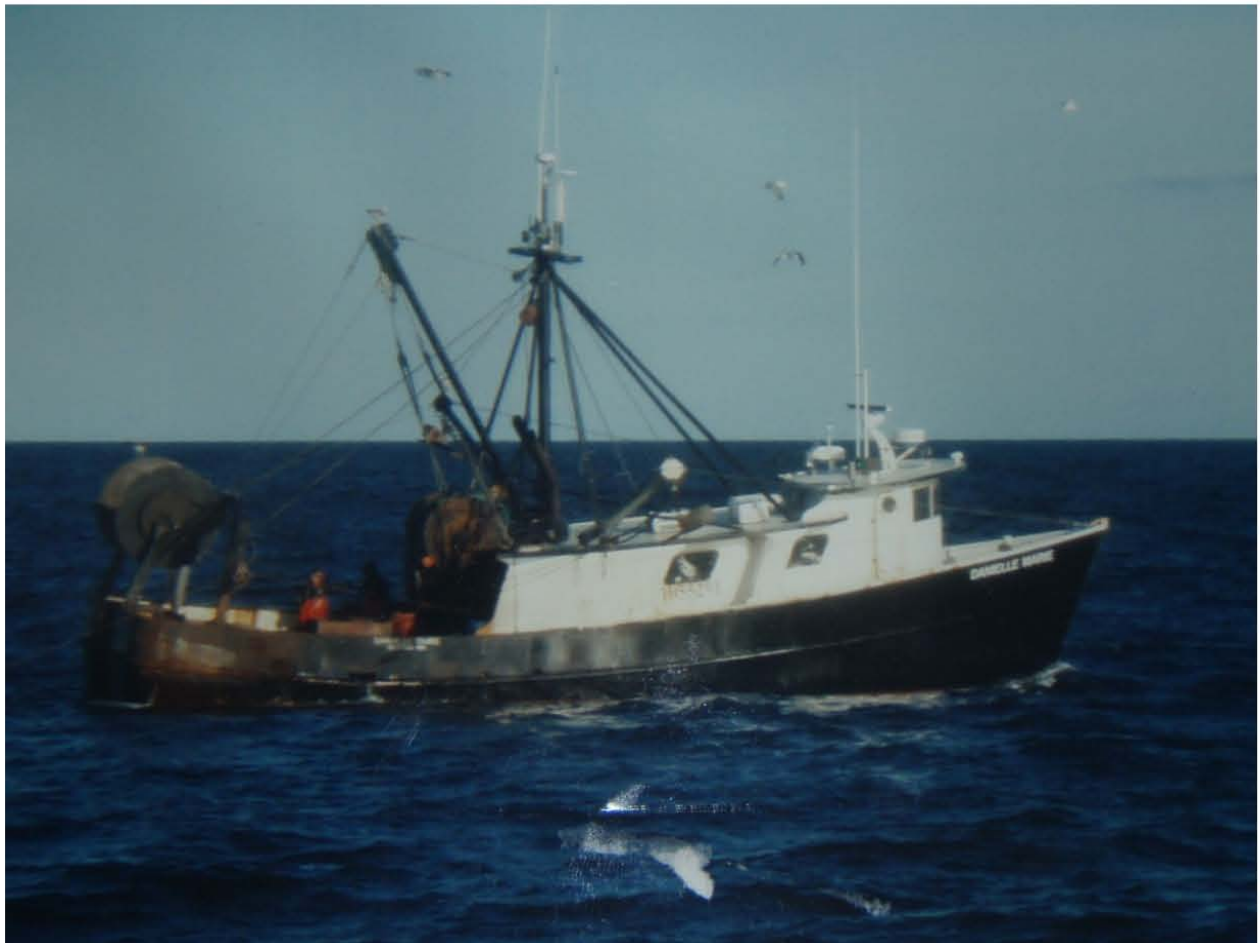
*Figure 1: Picture of the F/V PATRIOT as the F/V DANIELLE MARIE prior to sale and name change.*

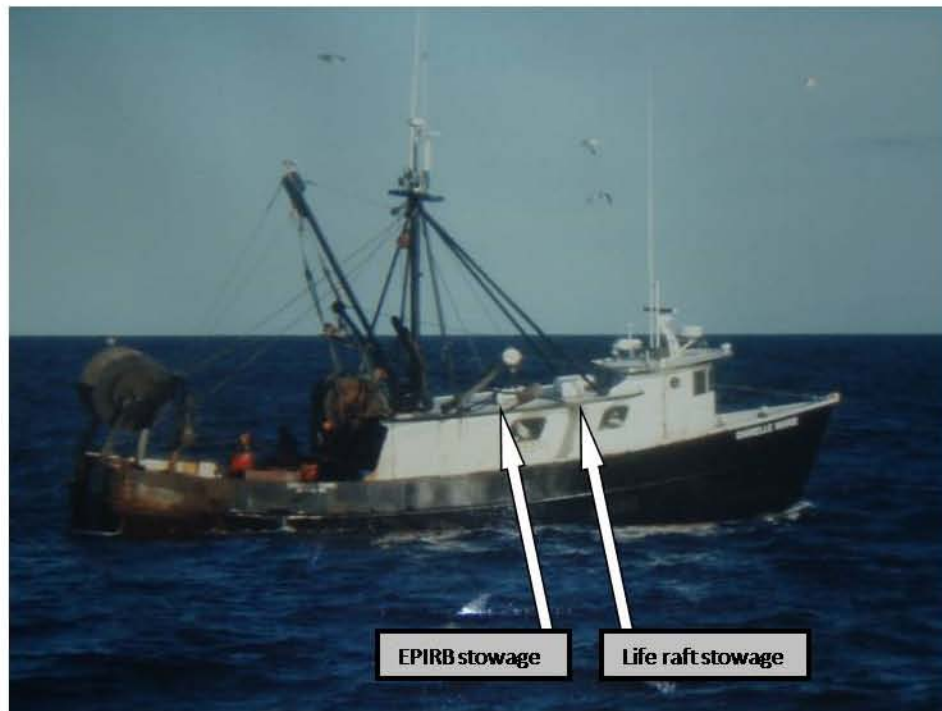
The F/V PATRIOT's inflatable life raft was a Zodiac 4-person self-inflatable life raft and was stowed on the upper deck behind the pilothouse. It was secured to the vessel by a hydrostatic release unit and designed to automatically release at approximately 13 feet of depth.

*Figure 3: Storage locations of EPIRB and life raft*

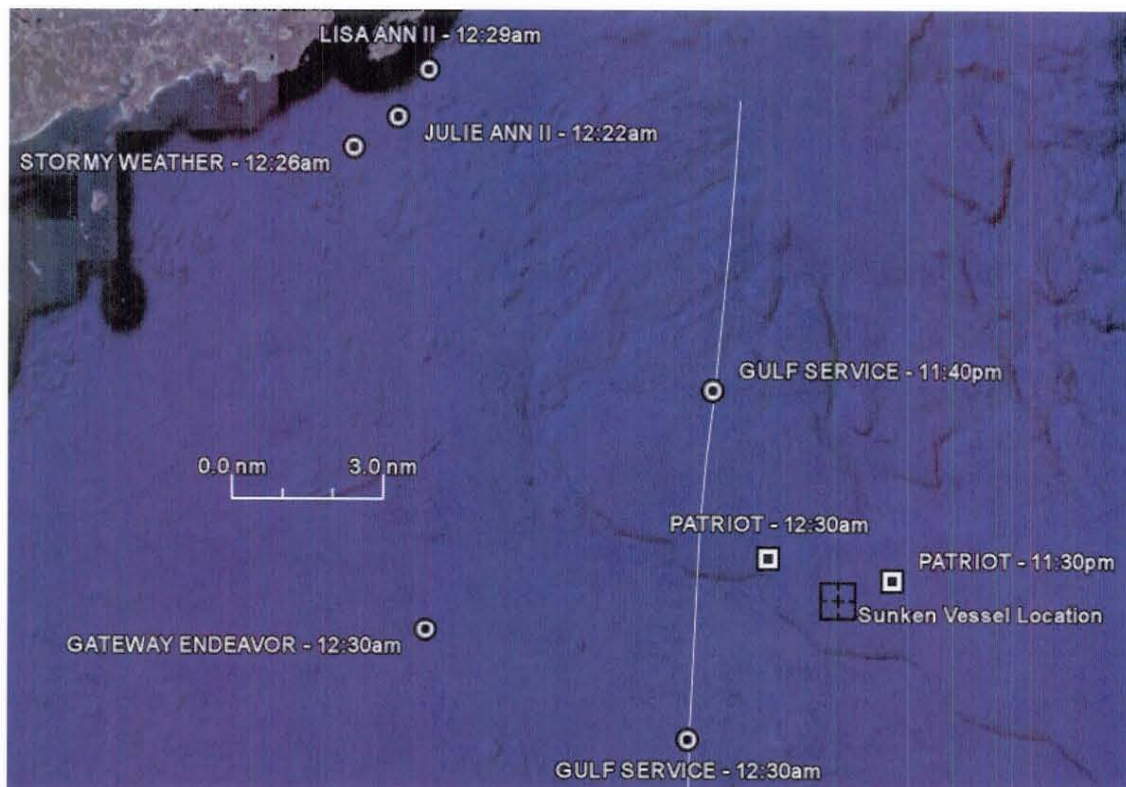
Figure 5 shows the positions of all nearby vessels between 11:30 p.m. on January 2nd and 1:30 a.m. on January 3rd. The F/V STORMY WEATHER, F/V JULIE ANN II, and F/V LISA ANN II were all either fishing, hove to, or anchored approximately 11 nm to the northwest. The M/V GATEWAY ENDEAVOR, a support vessel that stays at the Northeast Gateway Deepwater Port, stayed hove to throughout this period until getting underway to assist with the SAR efforts at 4:00 a.m. The Tug GULF SERVICE, towing the Barge ENERGY 11103 approximately 1,300 feet astern, transited through the immediate area and passed within approximately 2.5 nm of the F/V PATRIOT at 12:01 a.m.

The white line in Figure 5 is the Tug GULF SERVICE's track line traveling at 8-8.3 knots. At 12:30 a.m., the Tug GULF SERVICE's AIS position was over 4 nm south-south west of the F/V PATRIOT's last VMS position and continuing south. Because of the Tug GULF SERVICE and Barge ENERGY 11103's close proximity to the F/V PATRIOT on January 2, 2009, USCG Investigators boarded the vessel in Piney Point, MD (See Section 1.25).

*Figure 5: Vessels with VMS and AIS enabled at approximately 12:30 a.m.*

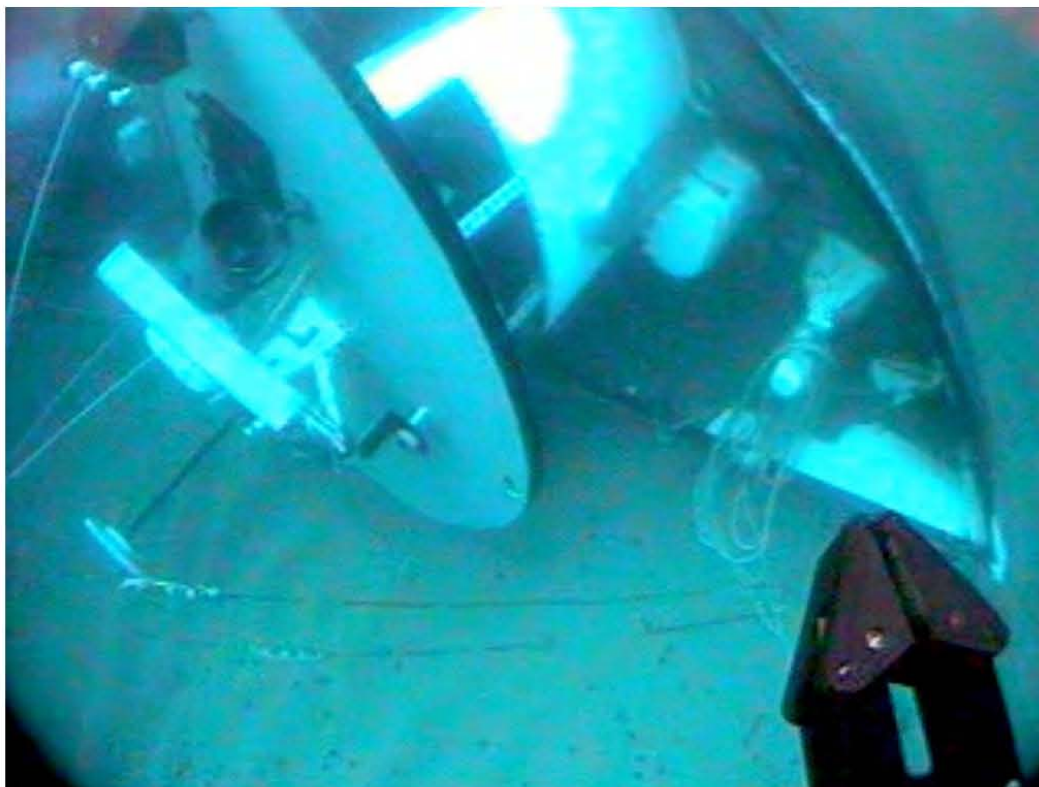
- Paint scrapes along the port side of the hull, including a heavy scrape on both sides of the bow (See Figure 8).
- A slight bend in the top of rudder (See Figure 14).
- The top of the pilot house shows significant scrapes and damage, including a bent radar stand and a sheered antenna (See Figure 9).
- The starboard block on the gallows frame has a significant bend in it and the wire running through it is parted (See Section 1.24)

*Figure 9: ROV photo of the pilothouse from above*

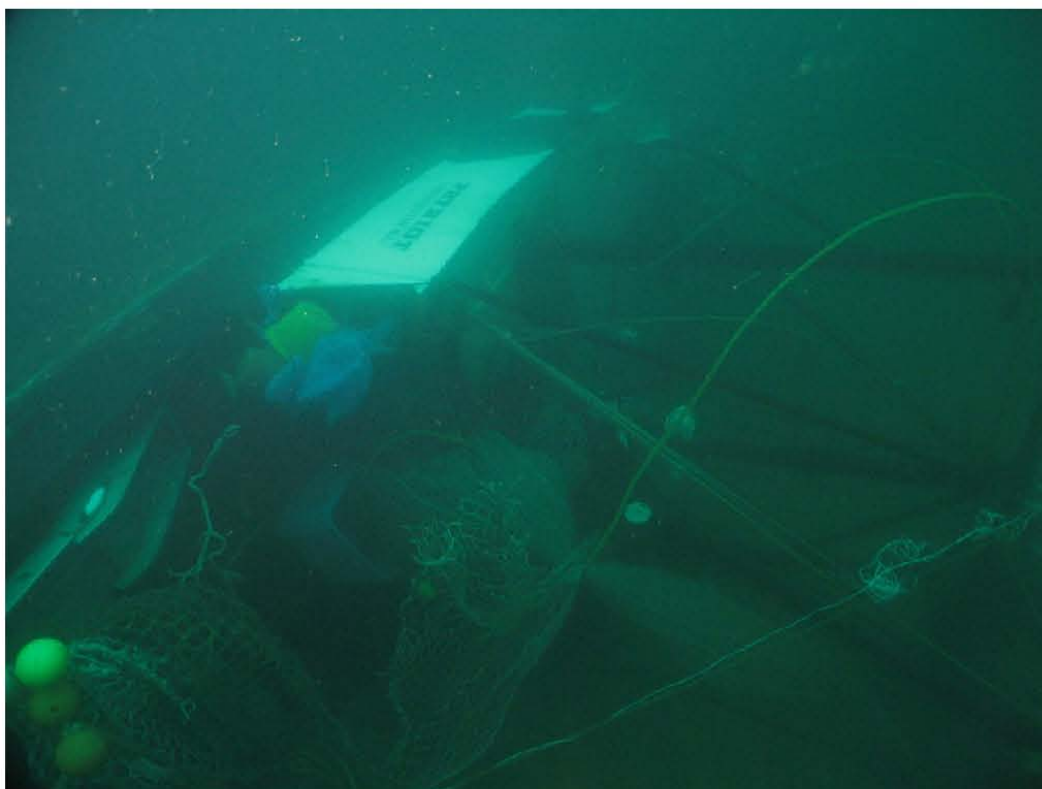
*Figure 10: Dive photo of the F/V PATRIOT port aft*

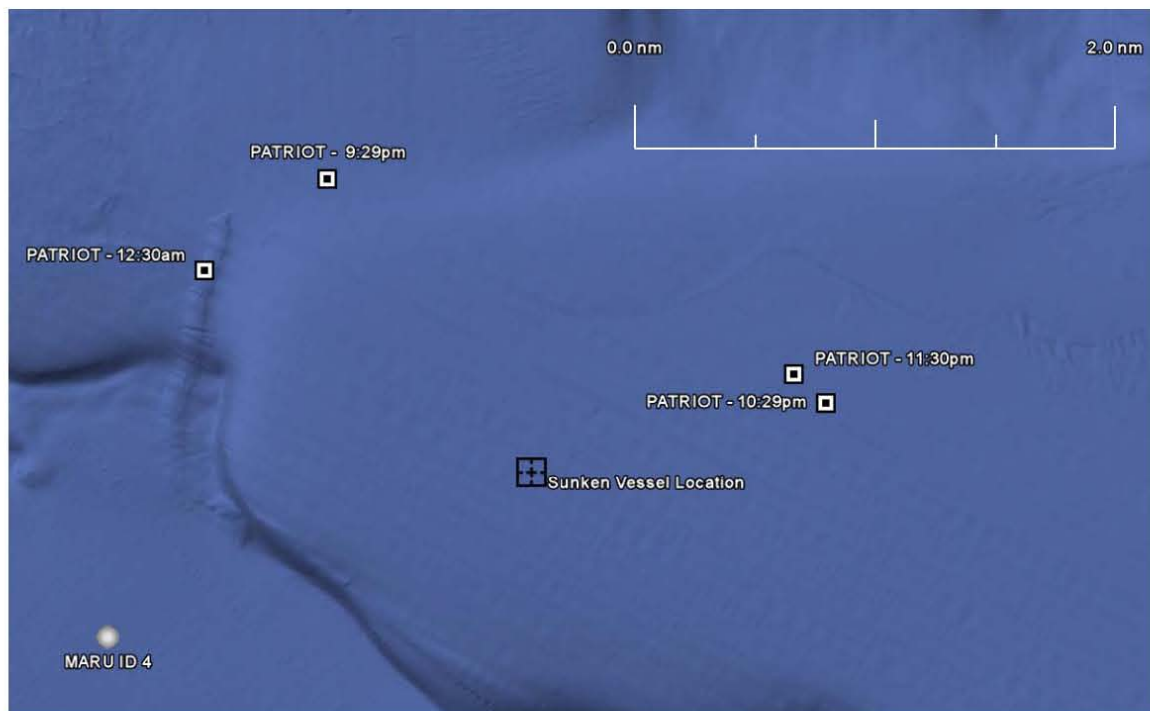
On February 9, 2010, Coast Guard Sector Boston received underwater, audio recordings from NOAA researchers for the night of January 2-3, 2009. The recordings were received by 19 separate passive, acoustic buoys called Marine Autonomous Recording Units (MARU) fabricated by Cornell Bioacoustics Research Program in Ithaca, NY. These MARU buoys were deployed underwater in a hexagonal pattern throughout Massachusetts Bay and are intended to record and track the vocal sounds of marine mammals. Four of the nineteen buoys recorded no sounds on the night of January 2 due to a malfunction. Eight functional MARU buoys were located within 10 nautical miles of the F/V PATRIOT's wreck location with two of these functional buoys located within 5 nautical miles. The closest buoy to the wreck site is MARU buoy 4 located at 42° 23.770' N by 70° 29.667' W, approx. 2 nm south west of the wreck site (See Figure 18).

*Figure 18: MARU Buoy 4 relative to F/V PATRIOT VMS and Wreck locations.*

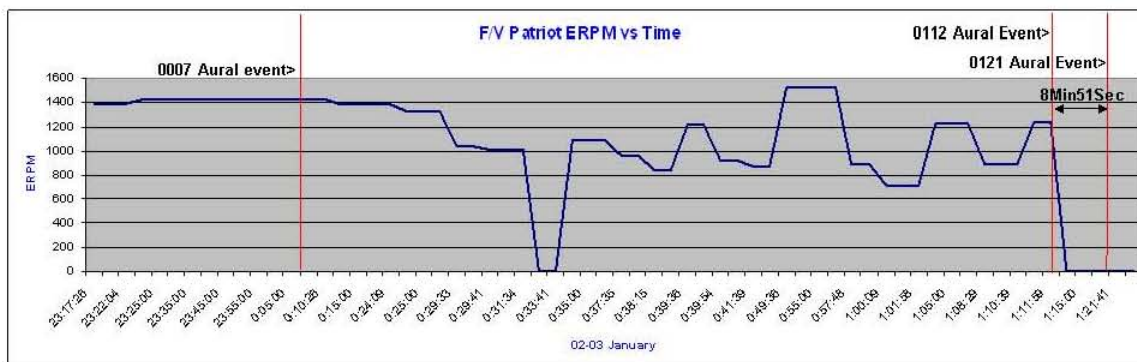
Time Difference On Arrival (TDOA)<sup>3</sup> analysis conducted by Cornell University placed ATE 1's location at 42° 25' 1.2"N by 70° 31' 1.9"W, approximately .3 nautical miles from the Tug GULF SERVICE's AIS position at 12:07 a.m. Both Tug GULF SERVICE and F/V PATRIOT engine RPM's remain at a constant speed throughout this event.

*Table 3: F/V PATRIOT Engine RPM vs Time<sup>4</sup> with a red line corresponding to each Aural Transient Event.*

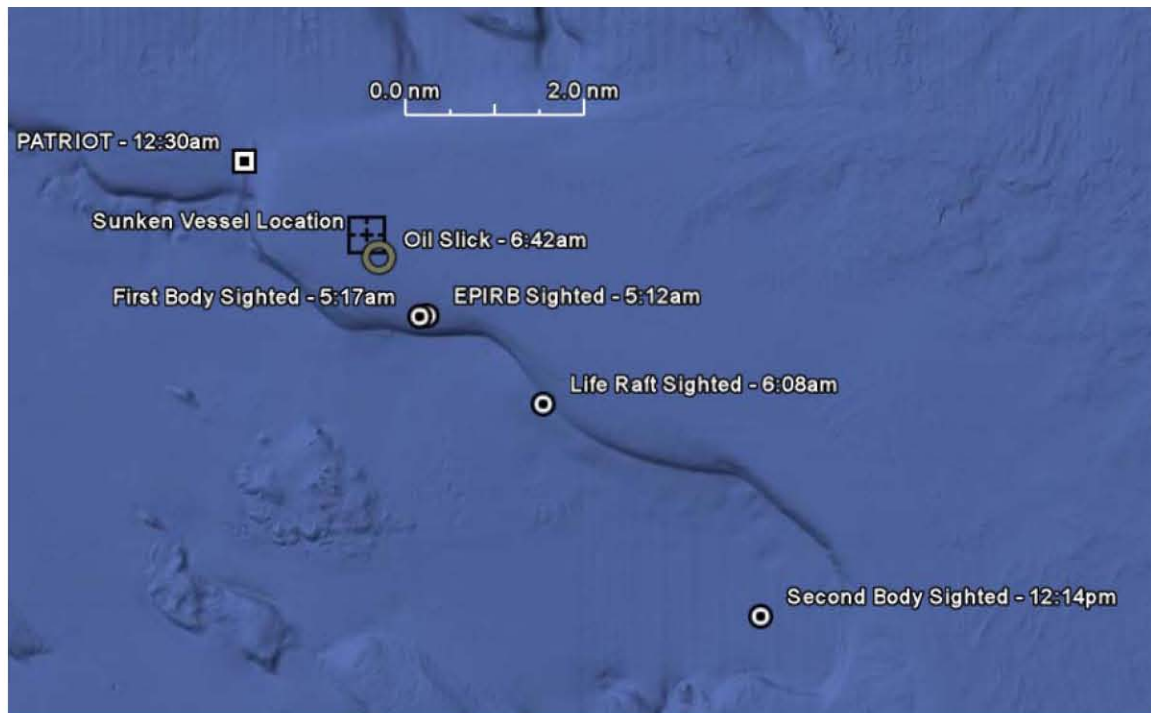
Figure 19 represents the Global Positioning System (GPS) positions based on logs and records from Coast Guard and Good Samaritan assets on scene, the F/V PATRIOT's VMS system, and the location of the wreck determined on January 23, 2009. Individual GPS systems have margins of error that differ by brand; usually these errors are less than 50 meters. For the purpose of this investigation, all positions are assumed to have a 0.1 nm error radius to compensate for this.

*Figure 19: Locations and times of items found during search and rescue.*

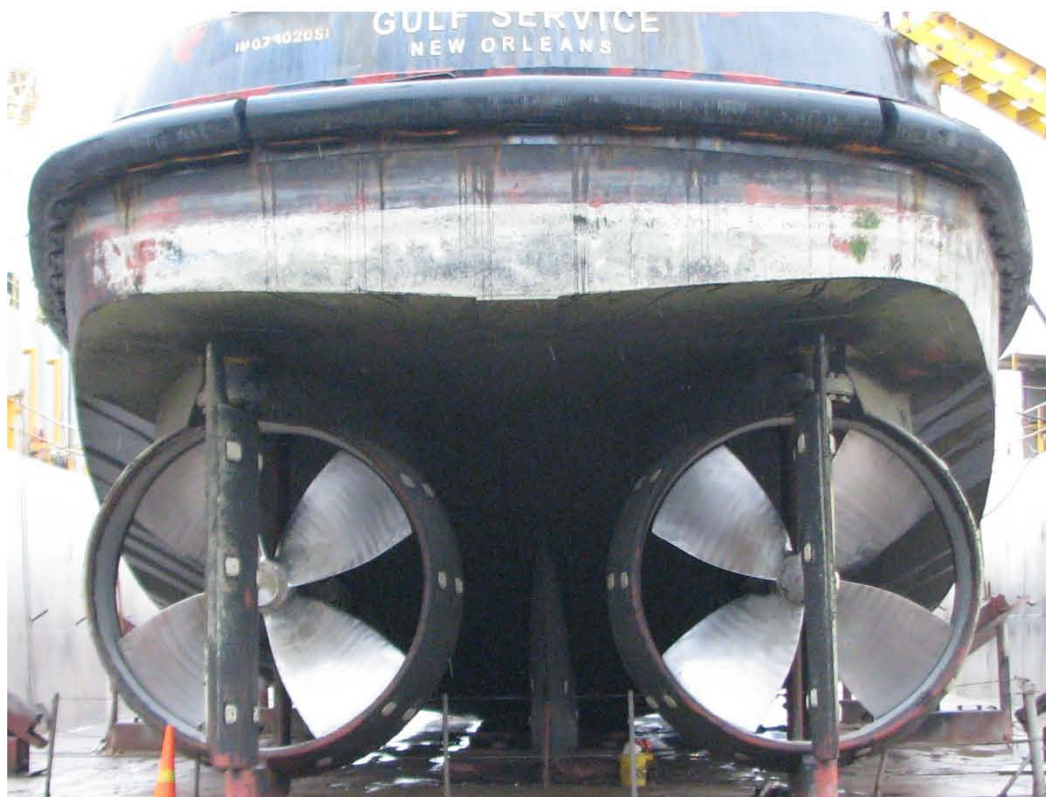
On January 7, 2009 at 9:45 p.m., the Tug GULF SERVICE and barge ENERGY 11103 arrived at the NuStar Piney Point Oil Terminal in Piney Point, MD. Coast Guard Investigators and Inspectors from Sector Baltimore met the Tug GULF SERVICE as she docked and immediately examined the tug and barge's hull from the shore and from a Coast Guard 26' Trailerable Aids to Navigation Boat (TANB) using spotlights. There were no visible scrapes or gouges on the tug or barge consistent with a collision with a smaller, steel-hulled vessel. The ENERGY 11103 was carrying 209 bbl. of #6 fuel oil on board when she was examined and had a draft of 14'. The draft of the barge ENERGY 11103 was 14' 6" when she departed Searsport, ME on January 2, 2009 and transited through Massachusetts Bay. After the USCG examination at Piney Point, approximately 100,000 bbl of #6 oil was loaded onto the Barge. Further photo documentation was taken during daylight hours after loading onto ENERGY 11103 had commenced.

*Figure 22: Tug GULF SERVICE in drydock*

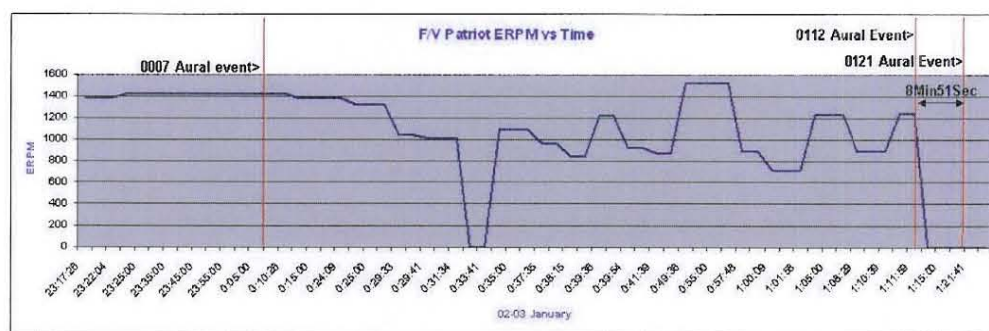
According to engine speeds provided by CUS analysts, the F/V PATRIOT probably began hauling back her fishing gear at 12:29 a.m. Both CUS and interviews with the crewmember and family members establish that a typical haul back took approximately 20 minutes start to finish. Table 6 shows the F/V PATRIOT's engine speed from 11:17 p.m. on January 2 through 1:21 a.m. on January 3. The frequent engine speed changes from 12:29 a.m. onward indicate the engaging and disengaging of the F/V PATRIOT's hydraulic system. This means it took the F/V PATRIOT approx. 42 minutes to haul back her gear that night (See Section 1.17).

Table 6: F/V PATRIOT engine RPM versus time<sup>13</sup>

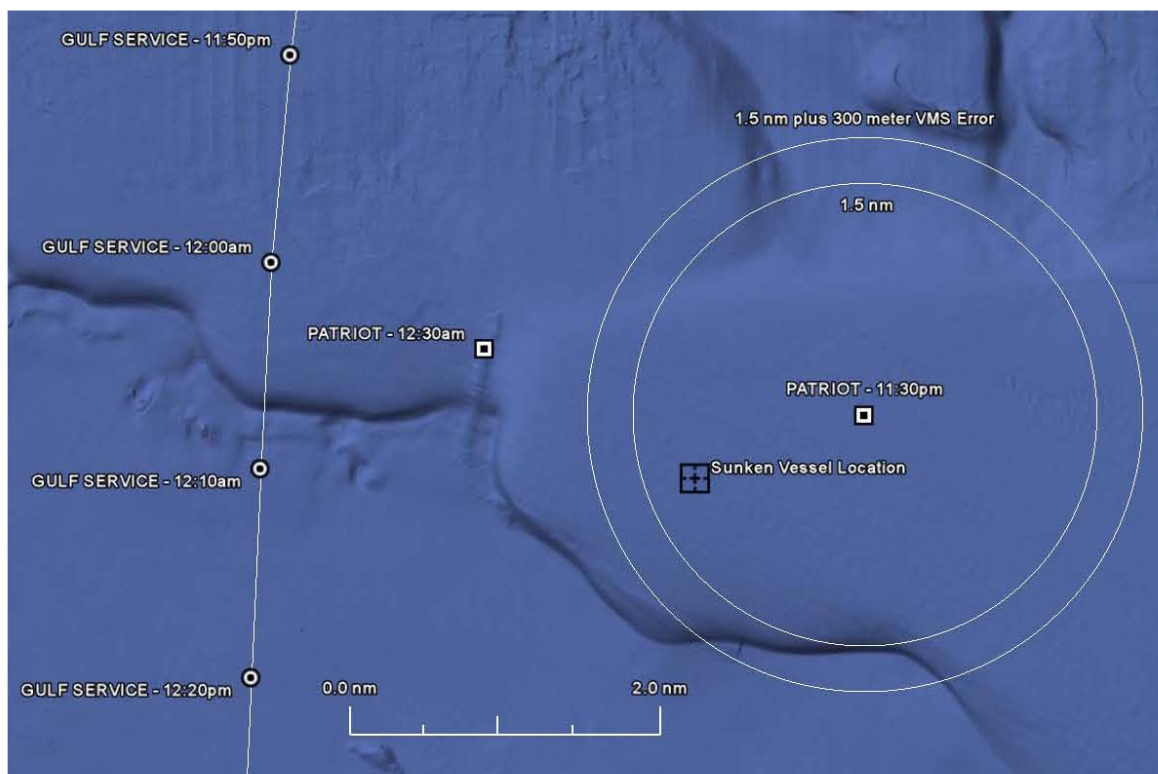
Furthermore, the F/V PATRIOT's performance while trawling would have prevented her from entering the path of the Tug GULF SERVICE. According to both interviews with a crewmember and a former owner and the VMS data for previous trips, the F/V PATRIOT could transit no more than 3.0 knots with her nets deployed. F/V PATRIOT engine speed data provided by CUS shows that the F/V PATRIOT finished deploying her fishing gear at 9:01 p.m. and began hauling it back at 12:29 a.m. At 12:00 a.m., the F/V PATRIOT would have been at most 1.5 nm from her 11:30 p.m. VMS position and over 2.0 nm east of the Tug GULF SERVICE. The F/V PATRIOT would have had to make at least 6.5 knots to reach the Tug GULF SERVICE's path (See Sections 1.13, 1.15, and 1.17). The Tug GULF SERVICE continued south and was 3.5 nm south of the F/V PATRIOT's 12:30 a.m. VMS position (See Figure 23).

*Figure 23: Locations of Tug GULF SERVICE and F/V PATRIOT between 11:30 p.m. and 12:30 a.m. The white circle is a 1.5nm range marker from the F/V PATRIOT's 11:30 position.*
