**REPORT OF THE DISTRICT FORMAL
INVESTIGATION
INTO THE
SMALL PASSENGER VESSEL SPIRIT OF
NORFOLK (O.N. 982944) FIRE AND
SUBSEQUENT TOTAL CONSTRUCTIVE LOSS
ON THE ELIZABETH RIVER, NORFOLK,
VIRGINIA ON JUNE 7, 2022**

MISLE ACTIVITY NUMBER: 7476562

SMALL PASSENGER VESSEL SPIRIT OF NORFOLK (O.N. 982944) FIRE AND SUBSEQUENT TOTAL CONSTRUCTIVE LOSS ON THE ELIZABETH RIVER, NORFOLK, VIRGINIA ON JUNE 7, 2022

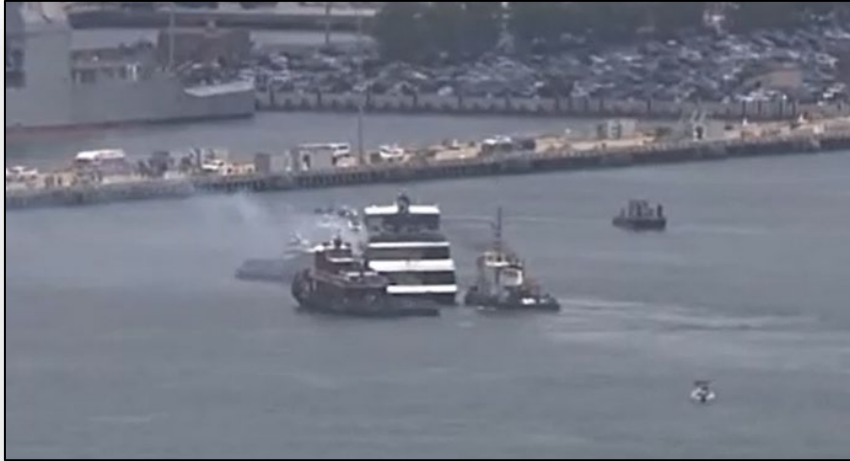
- 3.17. The *Spirit of Norfolk*, still on fire, with smoke emitting from the port side vents, was slowly towed to the Navy Base Pier #4, and moored starboard side to the pier at approximately 1:08 PM.

Figure 8 – Towing vessels maneuver the *Spirit of Norfolk* towards Navy Pier #4 after noon on June 7, 2022. The pier is in the background with staged fire personnel and equipment ready for the mooring of the vessel. (Source: WAVY TV 10 News Aerial Footage)

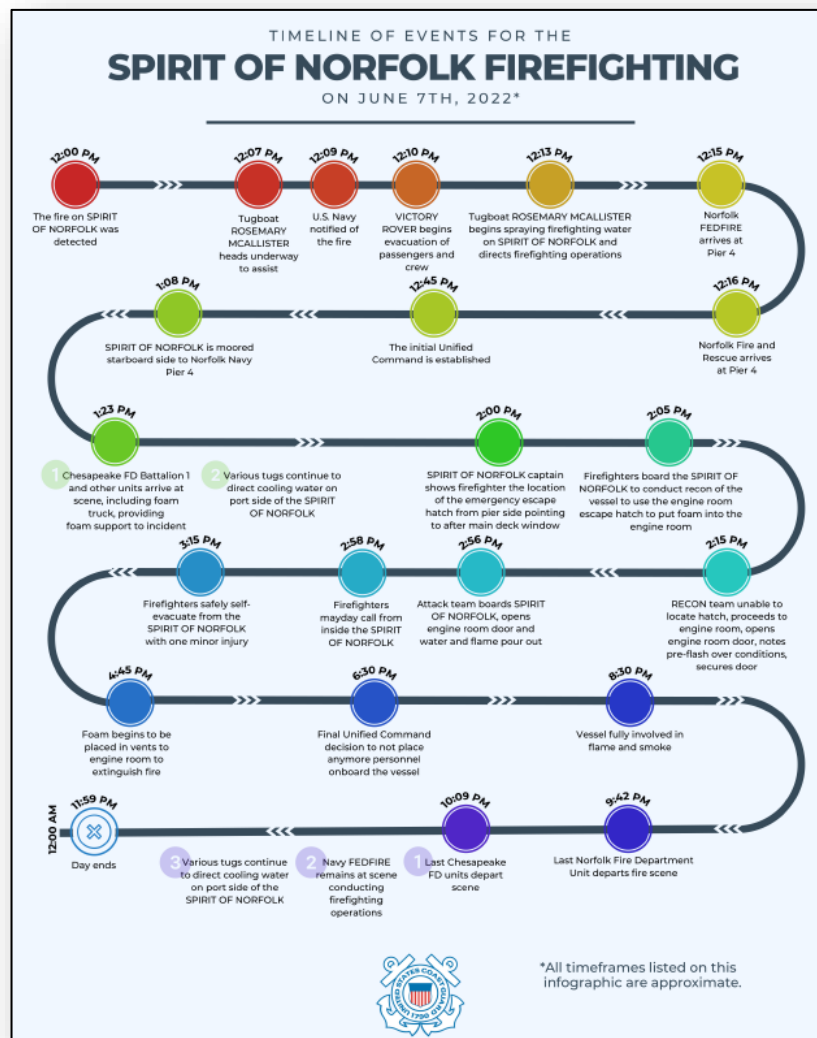
Figure 10 – Spirit of Norfolk fire reference timeline of key firefighting events on June 7, 2022. (Source: Coast Guard Auxiliary)

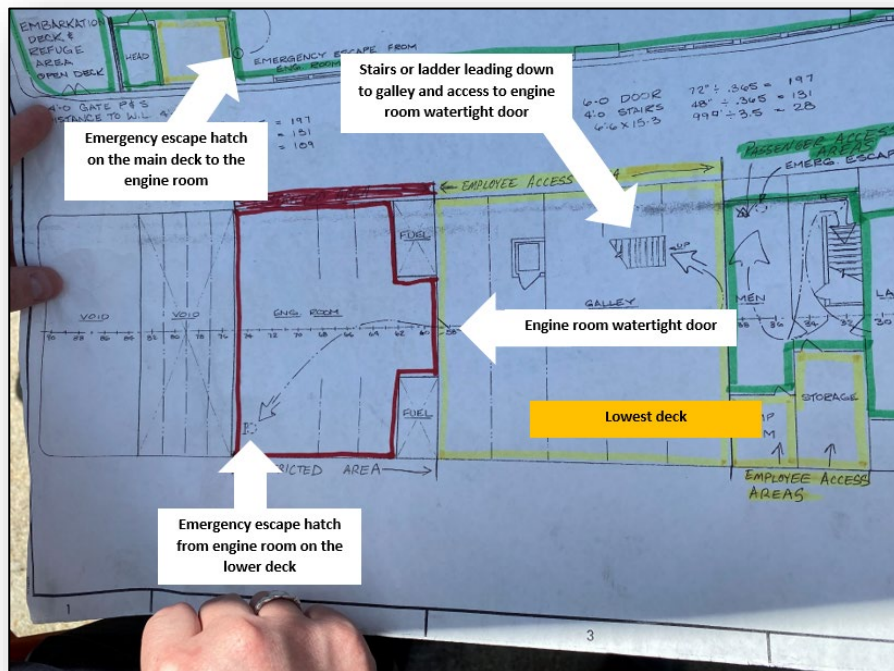
- 4.2.6. After the initial IAP was deemed mostly ineffective due to unsuccessful dockside firefighting tactics, a change in strategy occurred. The Captain of the *Spirit of Norfolk* provided firefighters with the location of the fire control plan, where access points on the vessel were located, including an escape hatch (vent hatch in firefighter nomenclature) to the engine room on the main deck.

- 4.2.7. A four-person (two Navy FEDFIRE, two Norfolk Fire and Rescue) Reconnaissance (RECON) team went onboard at approximately 2:05 PM and departed the vessel at approximately 2:20 PM. During that time, the RECON team was unable to locate the escape hatch so they made their way to the engine room. The RECON team opened the engine room door then re-secured the door between the engine room and the galley and exited the *Spirit of Norfolk*. Below is a continuing excerpt from the Norfolk Fire and Rescue report detailing these actions.

Figure 11 – *Spirit of Norfolk* fire plan recovered from the vessel on June 7, 2022, and annotated with colored outlines by the command post. Image has white arrowed labels applied by the investigation. (Source: USCG)

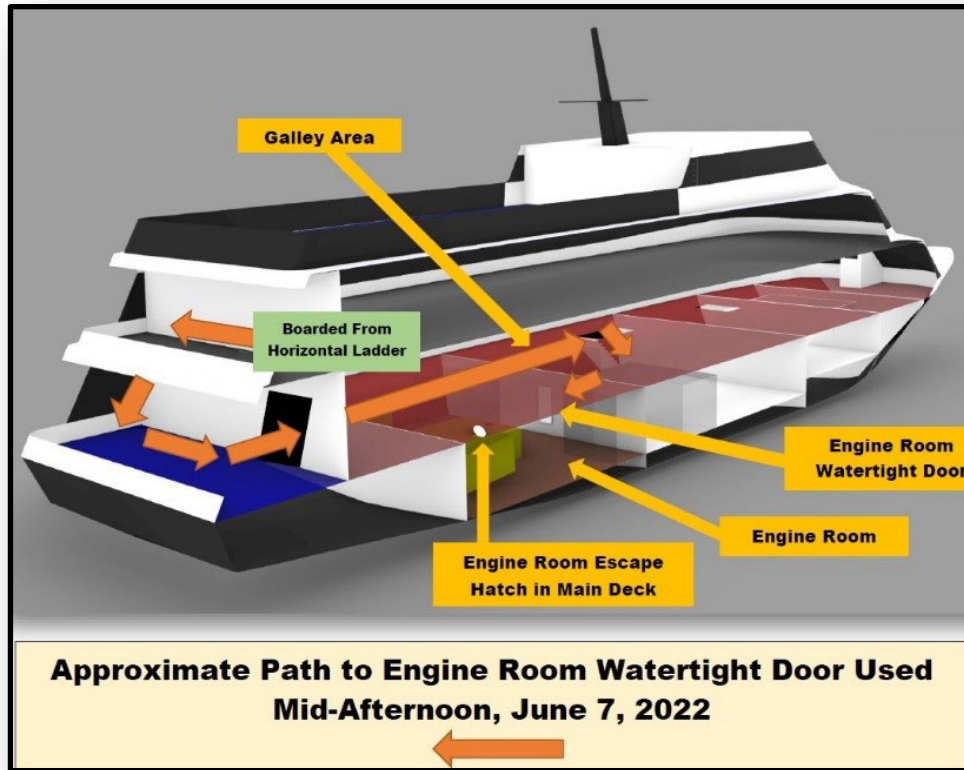
Figure 12 – Computer model showing the route from the dock, over a fire apparatus ladder and onto the *Spirit of Norfolk* on the afternoon of June 7, 2022. The image shows the two potential means of putting firefighting agent into the vessel’s engine room, the emergency escape hatch and/or the engine room watertight door. (Source: USCG)

- 4.2.8. After the RECON team went onboard, a subsequent strategy was developed to place firefighting foam into the engine room to combat the fire, as the fire was determined to be contained within the engine room. At some point, the tactics on how to accomplish this strategy altered from opening the escape hatch and inserting a hose (due to the fact the hatch could not be located), to inserting a foam line into the previously accessed engine room watertight door, then exit the vessel. The fire appeared to have intensified somewhat based upon reduced visibility conditions and an increase in deck temperatures during this time.

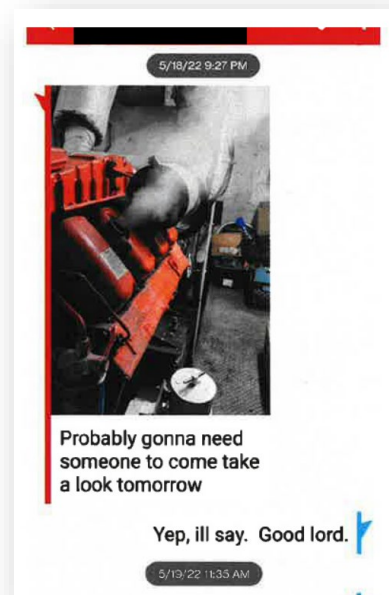
5.2.6.8. The following day, on May 19, 2022, while underway on an excursion, a second PMDE “smoke” incident was discovered (described as white smoke coming from the oil fill cap or “blow-by” from the crankcase). Bay Diesel technicians evaluated the PMDE engine finding coolant in the oil pan and significant liner damage. Technicians recommended a “top-end, in-frame” PMDE overhaul due to damage incurred from the overheating incident of May 15, 2022. The recommendations included replacement of liners, pistons, rings, pins, rod, and main bearings.

Figure 16 – City Cruises and Bay Diesel text message exchange on May 18, 2022. (Source: Bay Diesel & USCG)

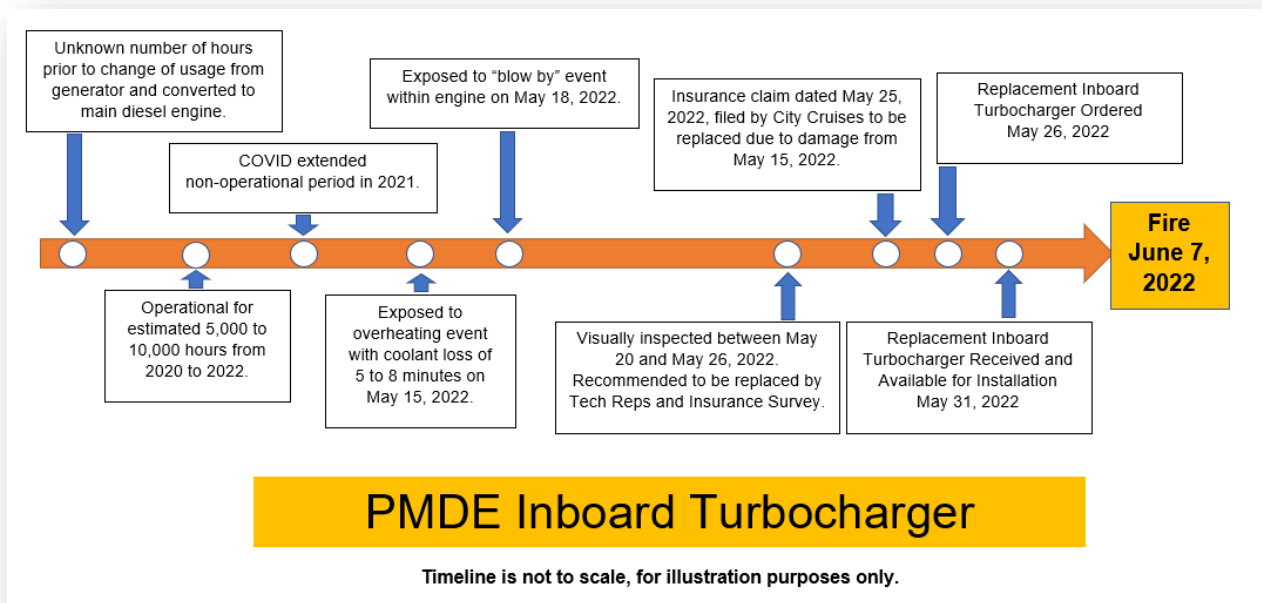
- 6.5.6. City Cruises ultimately filed an insurance damage claim for both turbochargers stemming from the May 15, 2022, incident. The total cost of the claim was approximately \$71,000. After the fire, the insurance claims surveyor emailed a Bay Diesel representative asking if both turbochargers had been replaced and if any additional charges were incurred. The Bay Diesel representative responded, *“The right bank turbo was not installed. It was ordered, received at our parts department and available to put on, but the boat was busy.”*

- 6.5.7. The following question was posed to the expert witness about the continued use of the right bank/inboard turbocharger: *“If the inspection of the right bank/inboard turbo had proved satisfactory and the engine ran for a couple of weeks, 50 hours or more of operating time without any indication or problem, no leak, no smoking, no sound, nothing to indicate that's a problem. Would that give you a degree of comfort that the left or right bank turbo the one that was due to be replaced, did not need to be replaced urgently?”* The expert witness responded, *“Total opposite ... that using it every day is the wrong way to go. I would ... in my opinion and my experience which I've managed thousands and hundreds of engines. Maybe 1000, as the manager of Marine of port engineer or maintenance, I would have changed that turbocharger.”*

Figure 22 – Timeline of the life cycle of the right bank/inboard turbocharger from approximately 2020 to the time of the fire, June 7, 2022. (Source: USCG)

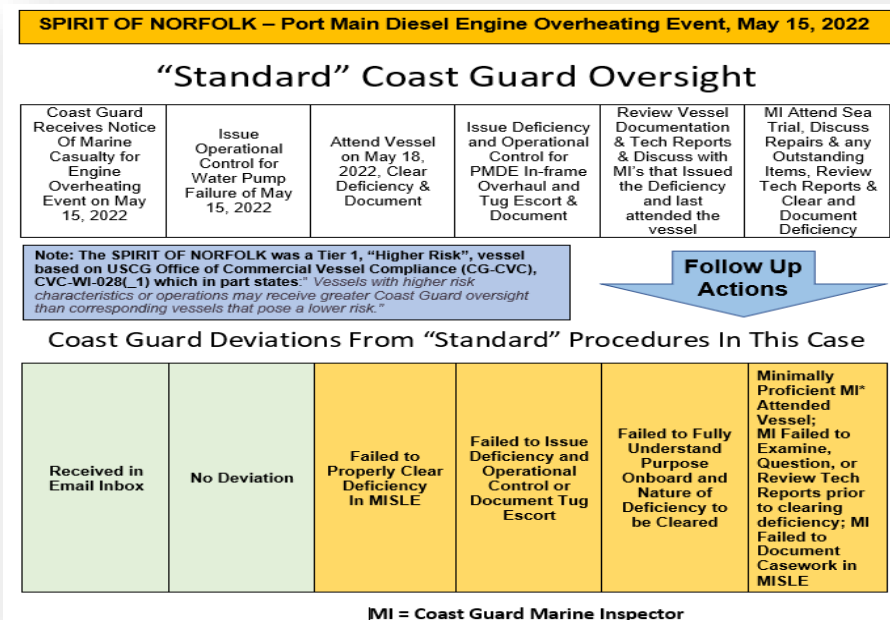
6.6.21. Below is a comparison chart of what may be considered "standard" Coast Guard oversight and any deviations that occurred in this instance. The investigation recognizes the fact that the ignition source was not precisely identified. However, the investigation attempted to highlight what it believes should have been the standard given the totality of circumstances. The investigation noted a proficiency gap with the Marine Inspector which may indicate a broader problem within the Coast Guard inspection program. There is currently no measure in place utilized by the Coast Guard to evaluate Marine Inspector proficiency after qualification. The Marine Inspector did not possess the proficiency to evaluate a marine diesel engine or know the questions to ask that would have identified potential risk of operating with a turbocharger that was recommended to be replaced by a technician.

Figure 23 – Chart comparing "standard" Coast Guard oversight process with the actions Coast Guard Sector Virginia personnel exhibited from May 15, 2022, until May 26, 2022. (Source: USCG)

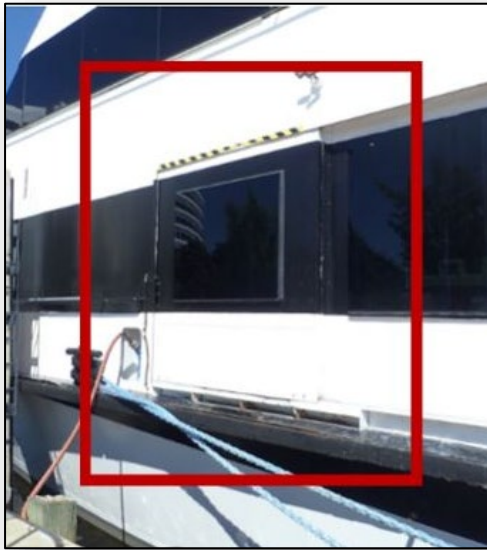
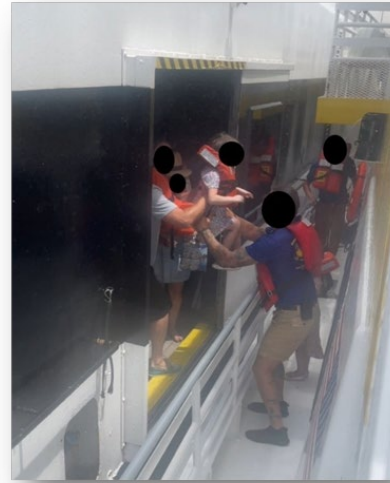
- 6.8.3. The company did not have an effective mass evacuation plan, for when the vessel was drifting without propulsion. It was stated by witnesses, that had the responding towing and other vessels not been available, with the *Spirit of Norfolk* lacking steering or propulsion, the passengers would have had to enter (jump into) the water if the fire got

out of control or smoke inhalation became too unbearable. This would have included three dozen children.

Figure 24 – (Left) Red box indicates the port side embarkation sliding door. This door was opened and utilized to allow the transfer of passengers to the *Victory Rover*. (Source: Castlerock Survey June 6, 2022) and (Right) – Screen capture from a video by a passenger on the *Victory Rover* (right) during the evacuation from the *Spirit of Norfolk*. (Source: passenger).
