UNITED STATES COAST GUARD

REPORT OF THE INVESTIGATION INTO THE

PIPELINE P00547 RUPTURE AND DISCHARGE OF OIL IN SAN PEDRO BAY APPROXIMATELY 4 MILES FROM HUNTINGTON BEACH, CA, ON OCTOBER 1, 2021

**ANCHOR STRIKE RESULTING IN A PIPELINE OIL SPILL FROM
FIXED PLATFORM ELLY IN SAN PEDRO BAY, CALIFORNIA
ON OCTOBER 1, 2021**

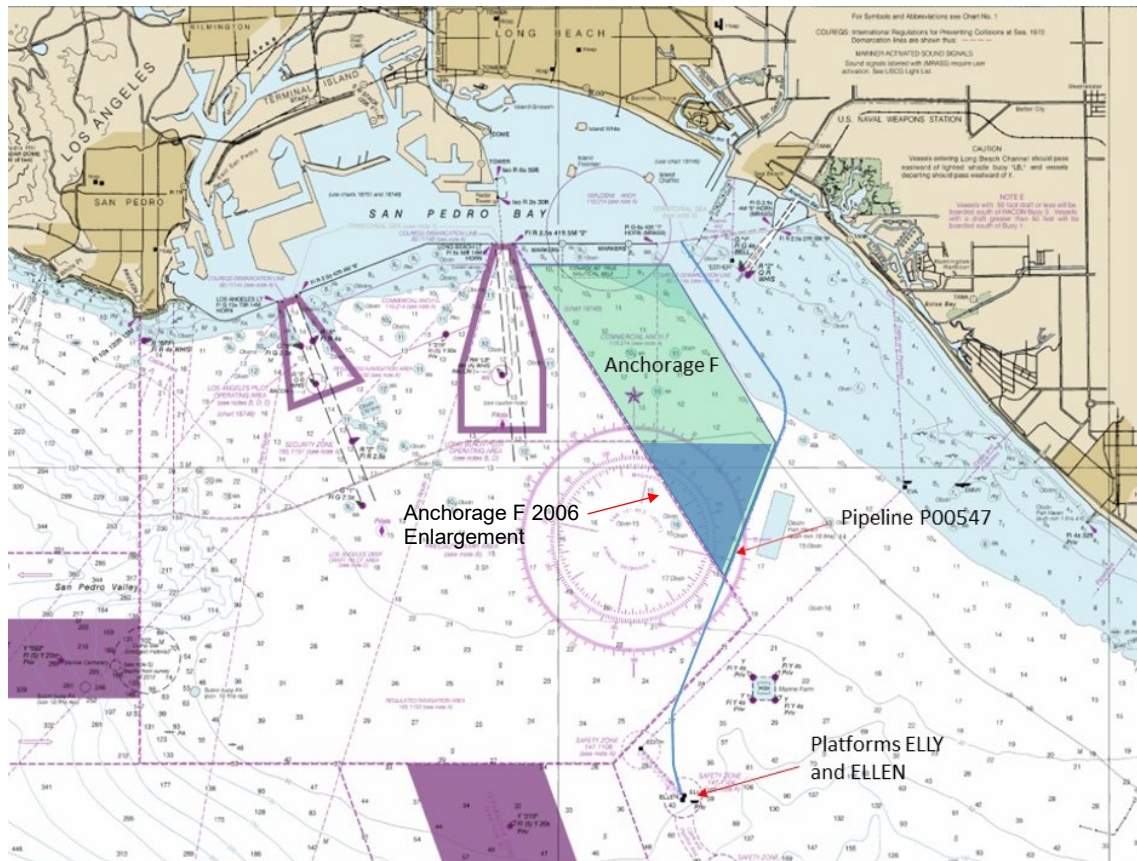
Figure 19 Edited image of NOAA chart 18749 depicting anchorage F, platform ELLY, platform ELLEN, and P00547

The process to establish and chart federal anchorages outside the Los Angeles – Long Beach breakwater began in the 1970s. Discussion in 45 Federal Register 30431 noted that existing anchorages inside the federal breakwater were becoming increasingly crowded from the large size, type, and volume of vessels common to the ports of Los Angeles and Long Beach. Because of this, many vessels were forced to anchor outside the breakwater, which created the potential for obstruction to the harbor entrances unless federal anchorages were established. The final rule, published in the Federal Register on May 8, 1980, reorganized anchorages that were already established inside the breakwater and created two new anchorages outside the breakwater, anchorages F and G. After publication of the final rule, the Coast Guard notified NOAA of the regulatory change and requested F and G anchorages to be charted along with individual anchorage circles. In 2004, prompted by ever-larger vessels calling at the ports of Los Angeles and Long Beach, the Coast Guard increased the radii of some anchorage circles in anchorage F. To add additional anchorage circles to anchorage F, the Coast Guard also proposed enlargement of the anchorage by moving the southwest corner approximately 1 NM to the south. By doing this, three additional anchorages could be added. After receiving no public comment or request for a meeting, in 2006 anchorage F was enlarged as described in the notice of proposed rulemaking. Three additional anchorage circles were added: SF-1, SF-2, and SF-3 with the outer edge of SF-3 being approximately 262 yards from the pipeline. After 2006, nine contingency anchorages were established to the southwest of anchorage F. Anchorages SF-4, SF-5, SF-6, SF-7, SF-8, SF-9, SF-10, SF-11, and SF-12 are designated contingency anchorages. VTS LA-LB assigns vessels to these anchorages if all other anchorages are full. Anchorages SF-4 through SF-12 are not charted on a NOAA chart.

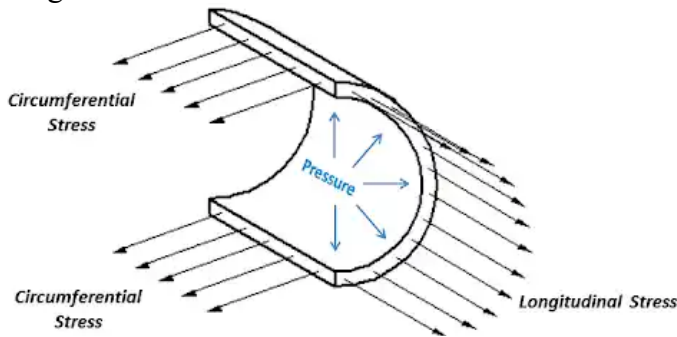
Figure 20 Diagram of pipe stresses (image from ASME BPVC VIII Div 1).

force applied to the pipeline, based on observation of ratchet mark features, it is likely that the altered stress state induced by the deformation damage led to localized crack initiation and propagation due to cyclic pressure loads from normal oil pipeline operations. The damage caused by the anchor strike went unnoticed until after the pipeline failed and oil was discharged in October 2021. Crack propagation and material failure due to fatigue cracking is characterized by the graph in Figure 22.
